Oxon Run, Washington, D.C. Watershed and Stream Assessment

CBFO-S03-03

September 2003

Stream Habitat Assessment and Restoration Program
U.S. Fish and Wildlife Service
Chesapeake Bay Field Office

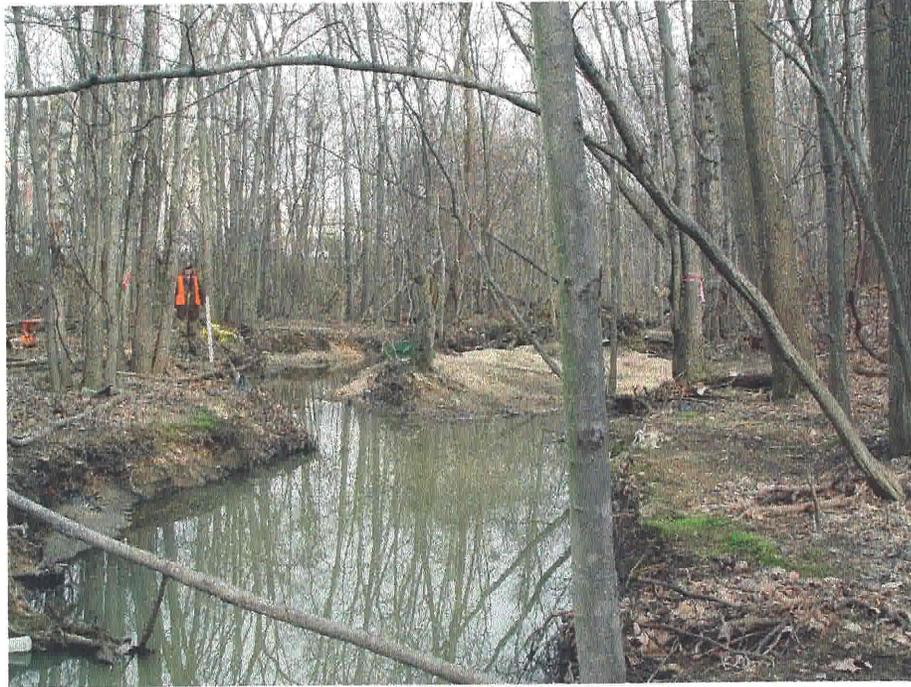
Photo 1. Near the headwaters Oxon Run is not deeply incised, but it has begun to both downcut and widen. Note obvious floodplain break. This is Reach OR(PG)-2, an unstable C4.

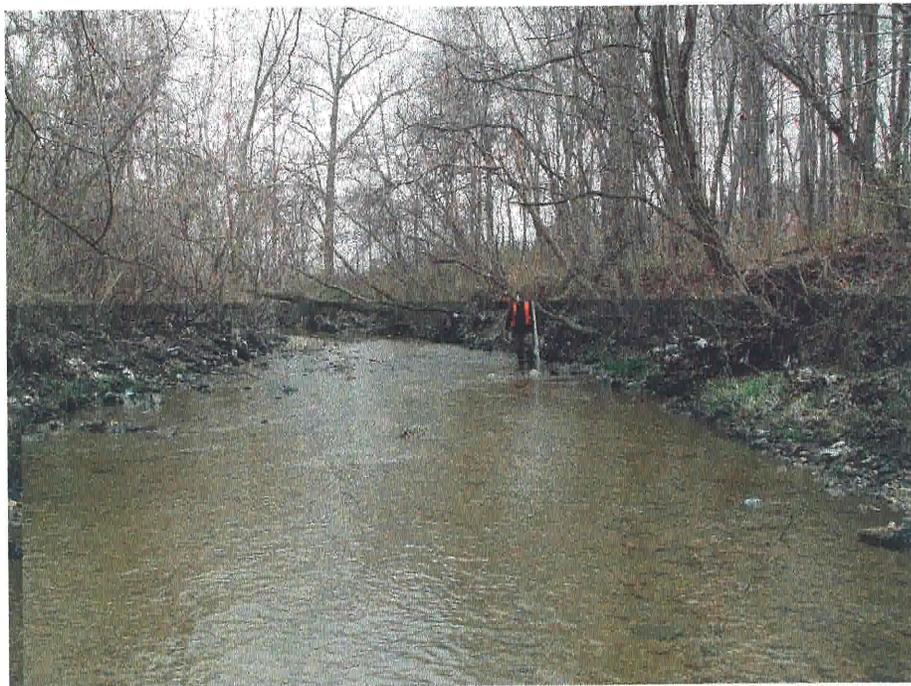
Photo 2. In many locations the stream has been channelized, resulting in an over-wide channel with poor bed features. This is Reach OR(PG)-9, an unstable F4.

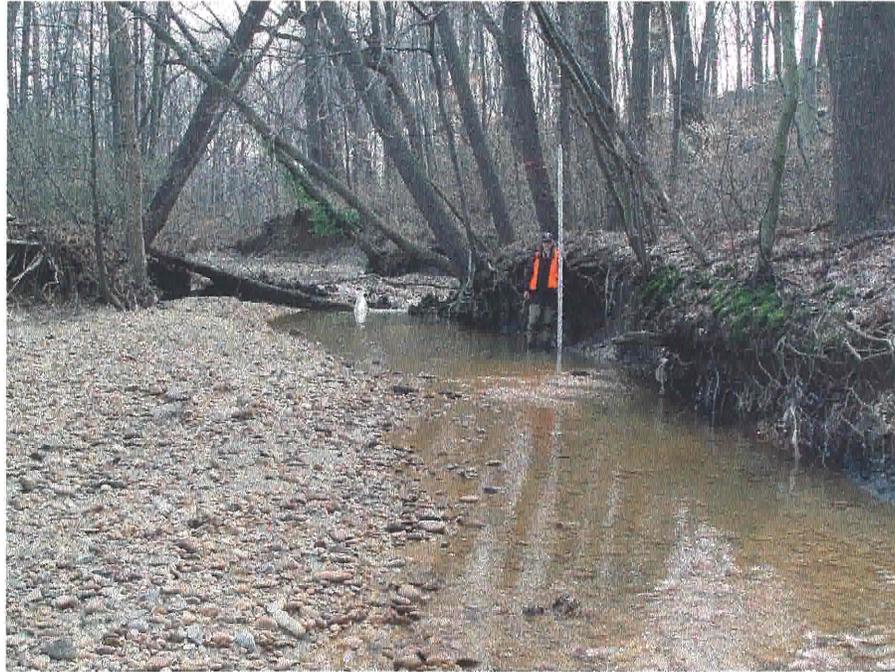
Photo 3. Portions of Suitland Parkway Tributary are deeply incised and have extensive gravel bars. Note the high, eroding banks and trees which have fallen as a result of the bank erosion. This is Reach SP-3, an unstable F4.

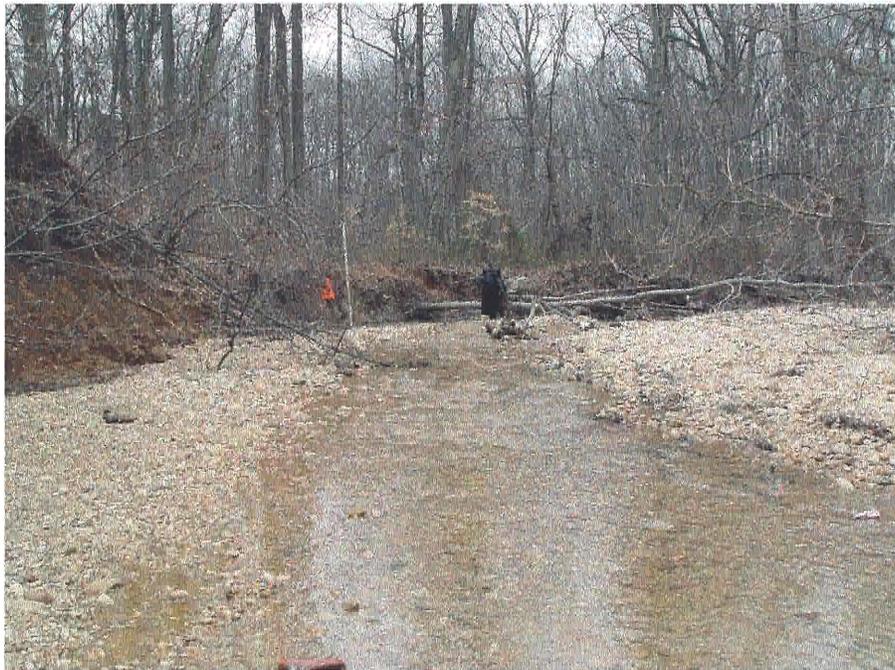
Photo 4. The majority of Barnaby Run carries a heavy sediment load, and is characterized by extensive gravel bars. In some locations, the stream has migrated across the floodplain, and is cutting into the high terrace (visible in left foreground). This is Reach BR-8, an unstable C4.

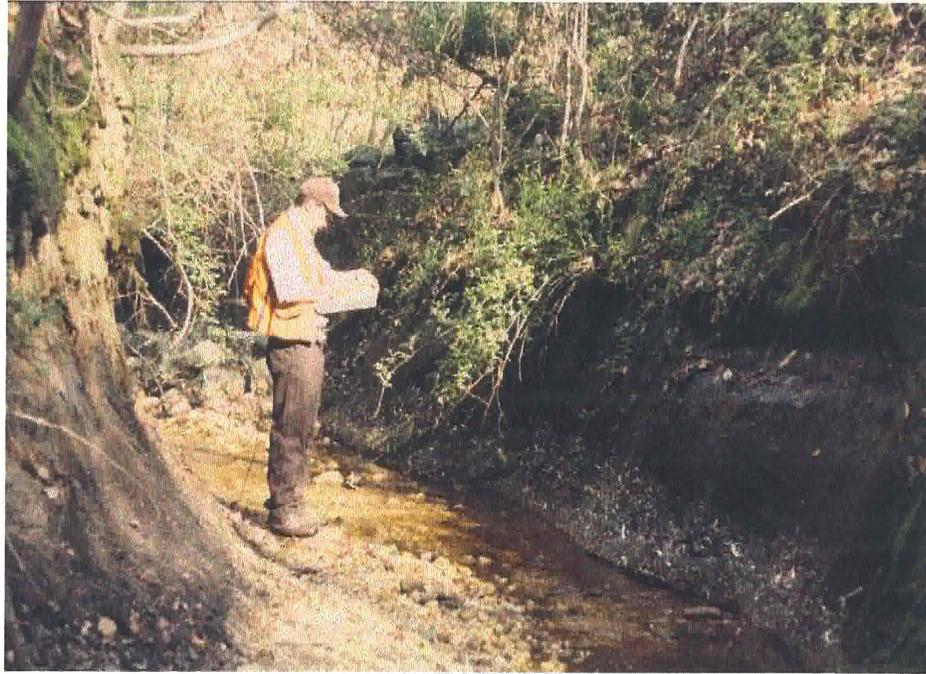
Photo 5. Most of the Glassmanor Tributary has incised and is characterized by high, eroding banks. In many locations, it has downcut to a clay lens. This is Reach GM-2, an unstable F6.

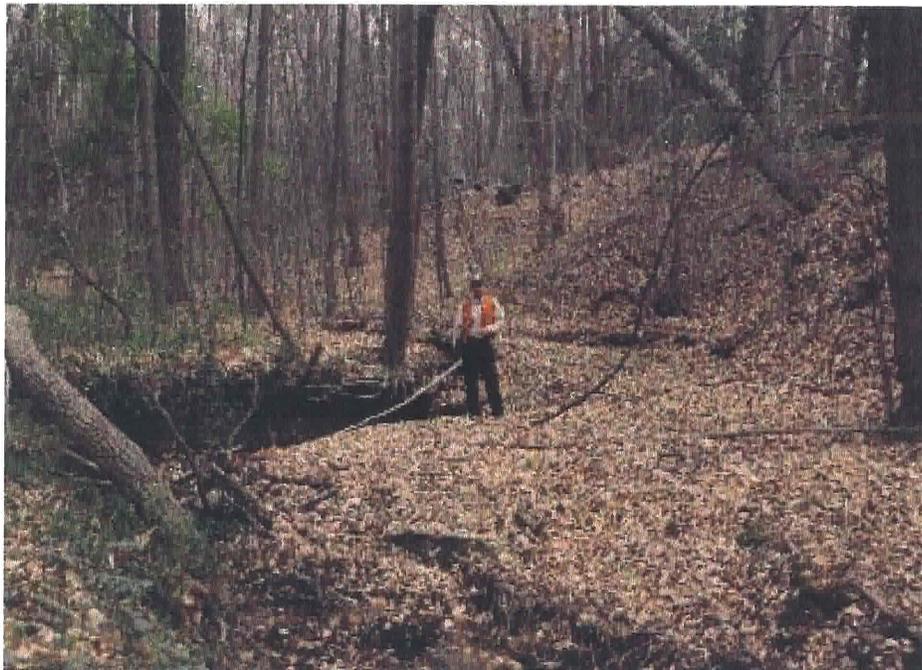
Photo 6. Much of the Owens Road Tributary still maintains some connectivity with the floodplain but the stream is migrating laterally, and eroding the banks. This is Reach OW-6, an unstable C4.

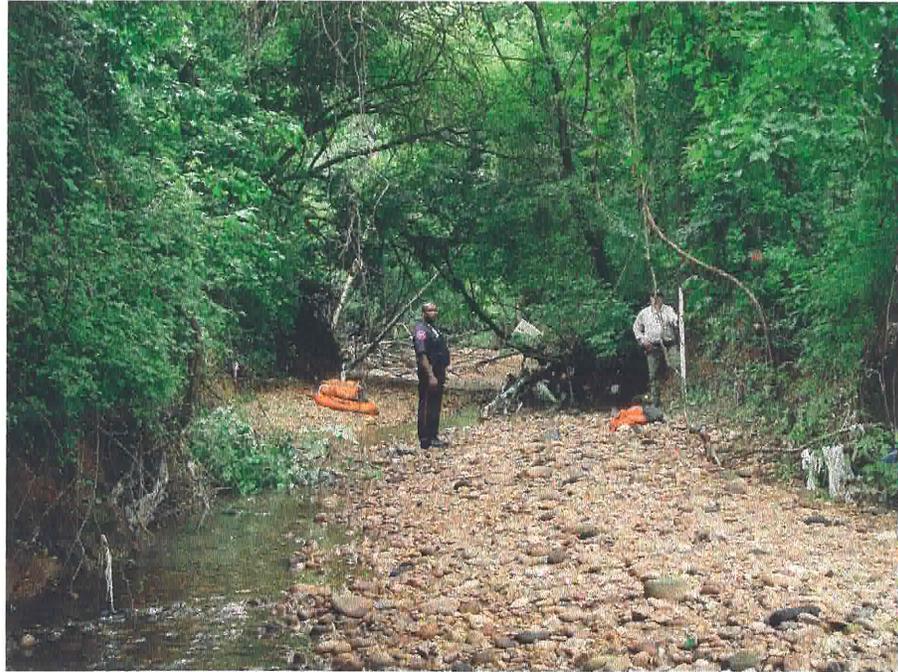
Photo 7. The natural channel reaches of the Forest Heights Tributary are characterized by high eroding banks. This is Reach FH-4, an unstable F4.

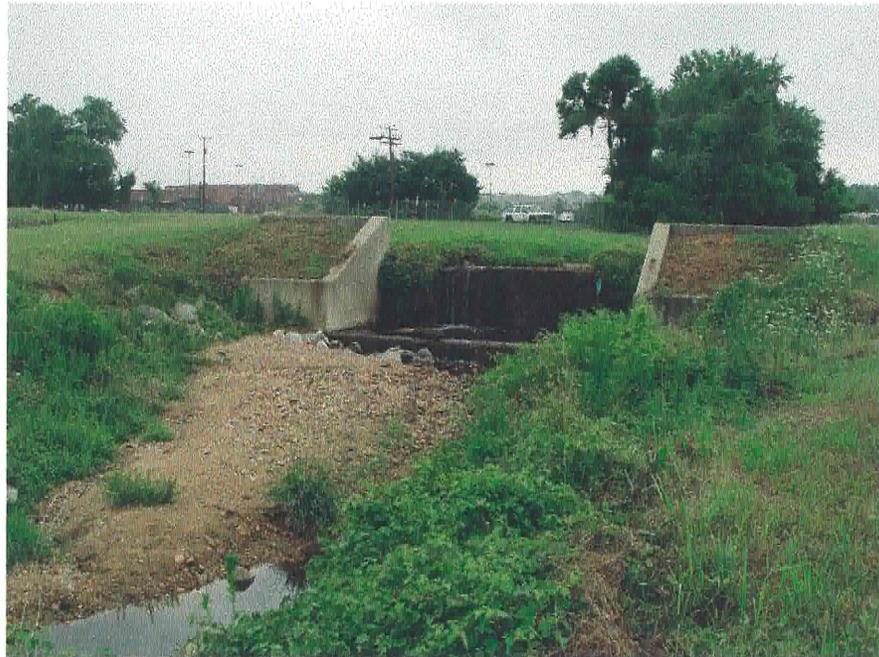
Photo 8. Concrete drop structure on the Forest Heights Tributary, at the confluence with Oxon Run (Reach FH-4). This structure is a barrier to fish passage.

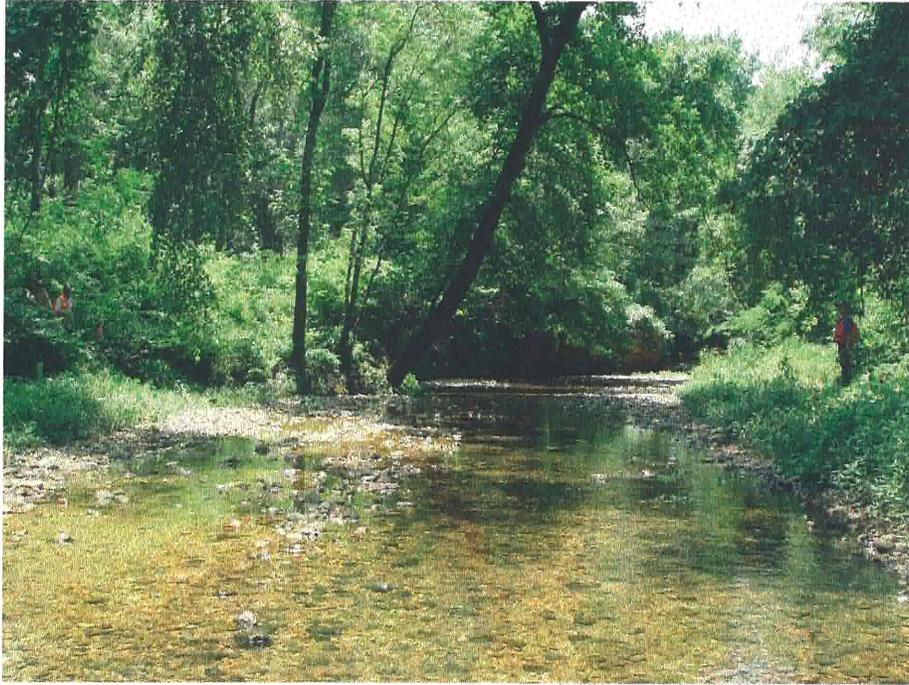
Photo 9. The meandering channel portions of the Upper Reach are characterized by an over-wide channel, shallow water, and extensive gravel bars. The stream is migrating laterally across the floodplain. This is OR(DC)-2.

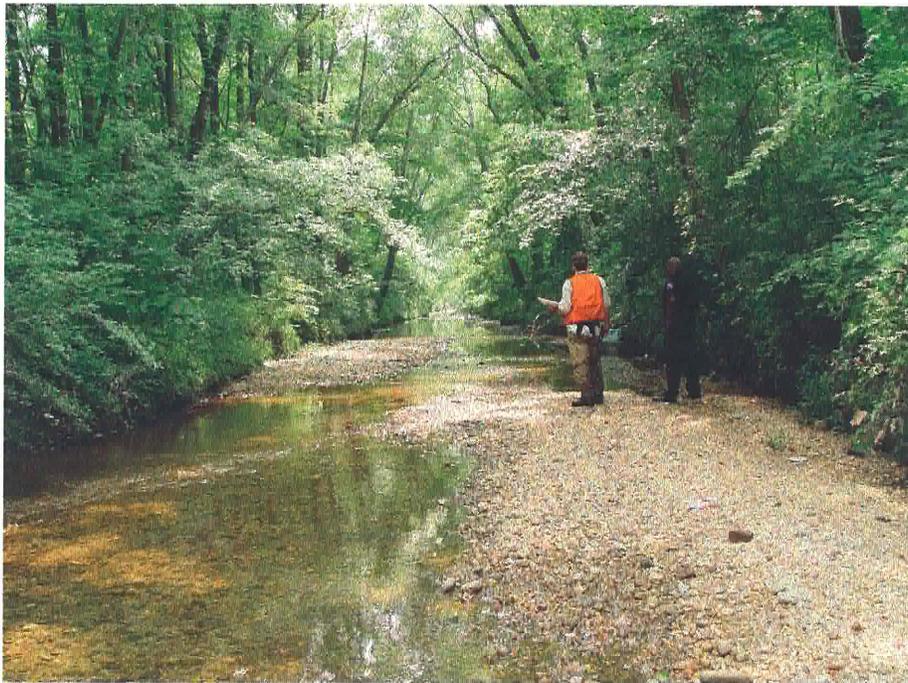
Photo 10. The shallow water and lack of bed features in straightened reaches provide poor aquatic habitat. This is Reach OR(DC)-4, which was straightened when the area was Camp Simms.

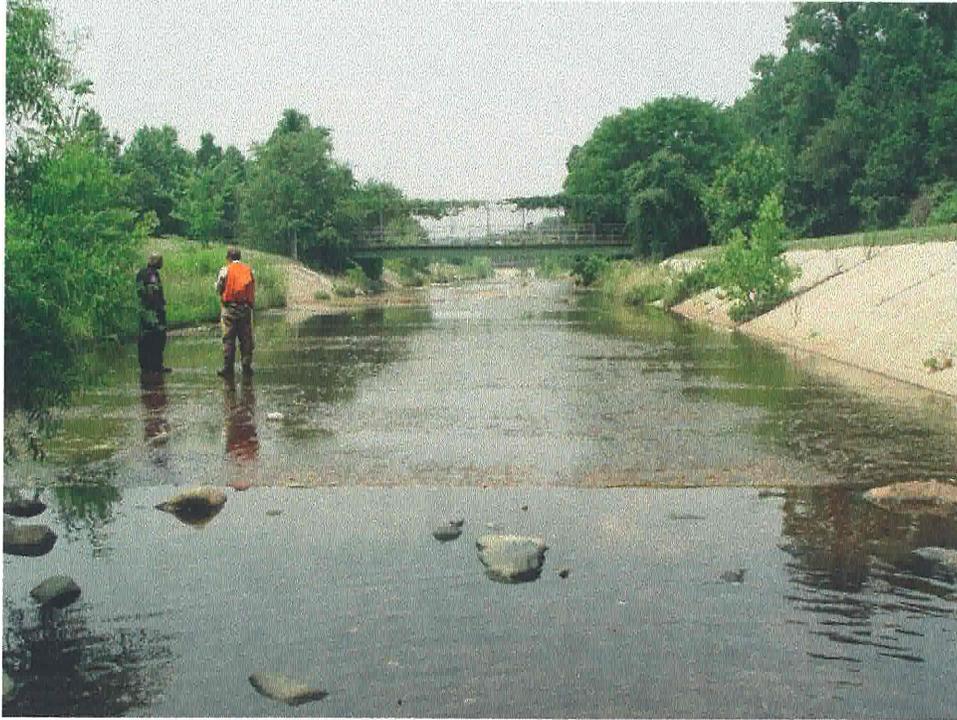
Photo 11. In 1978-79, a concrete-lined channel was installed for flood protection. Shallow water during low flow conditions is a barrier to fish passage. This is Reach OR(DC)-9.

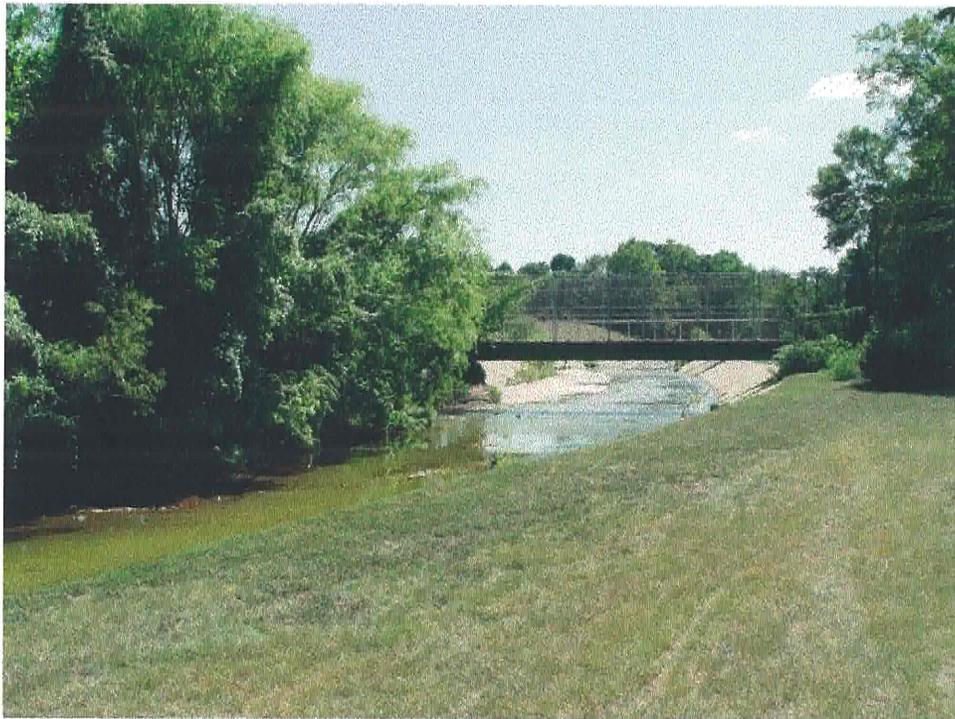
Photo 12. In some locations, vegetated bars have formed within the channel. This is Reach OR(DC)-9.

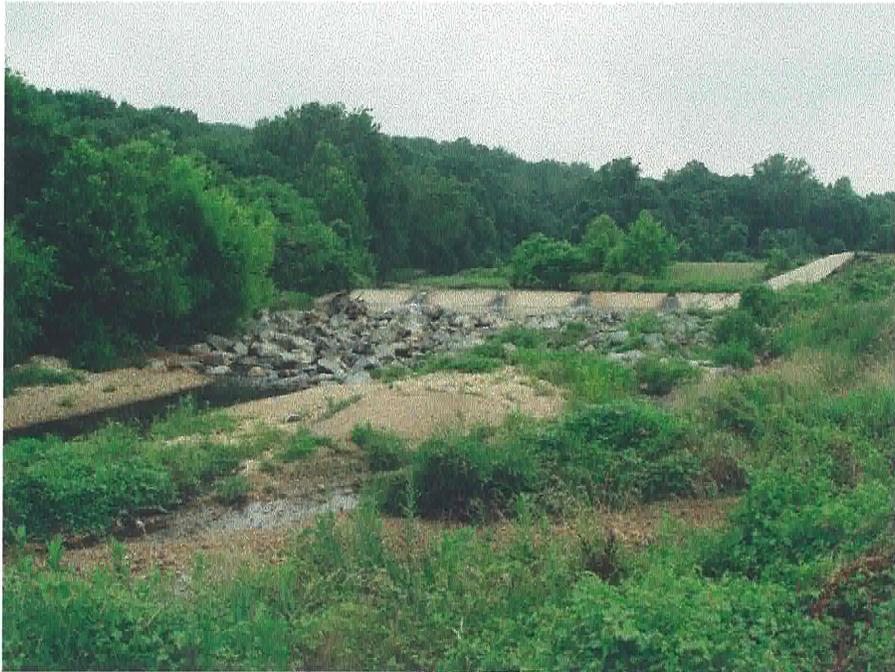
Photo 15. A concrete drop structure was placed on the main stem of Oxon Run (Reach OC-1) at the upstream terminus of the Forest Heights flood control project. This structure is a barrier to fish passage.

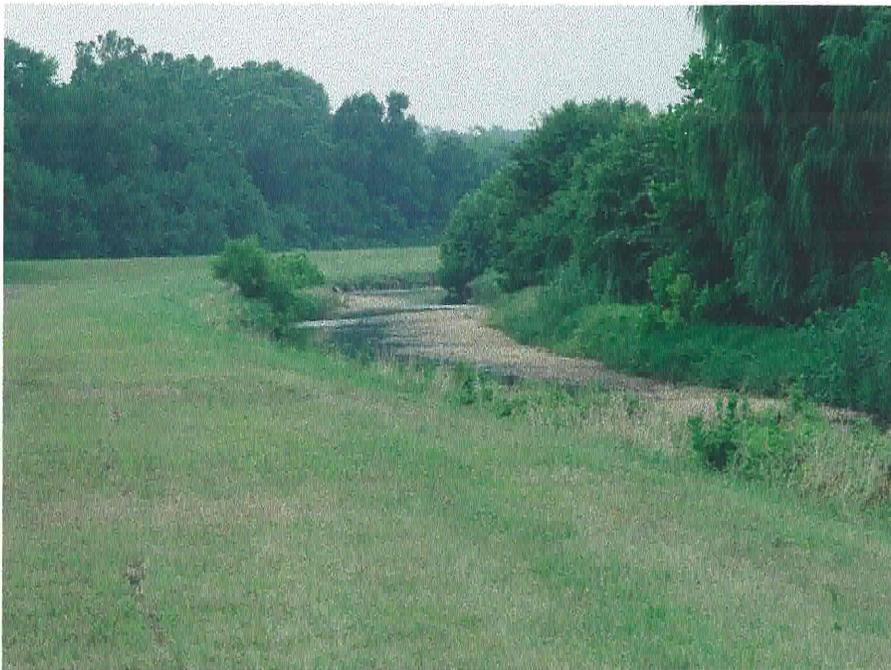
Photo 16. This is Reach OC-2, part of the channel constructed to prevent flooding in Forest Heights. The town is located to the left of the grassy area, behind levees.

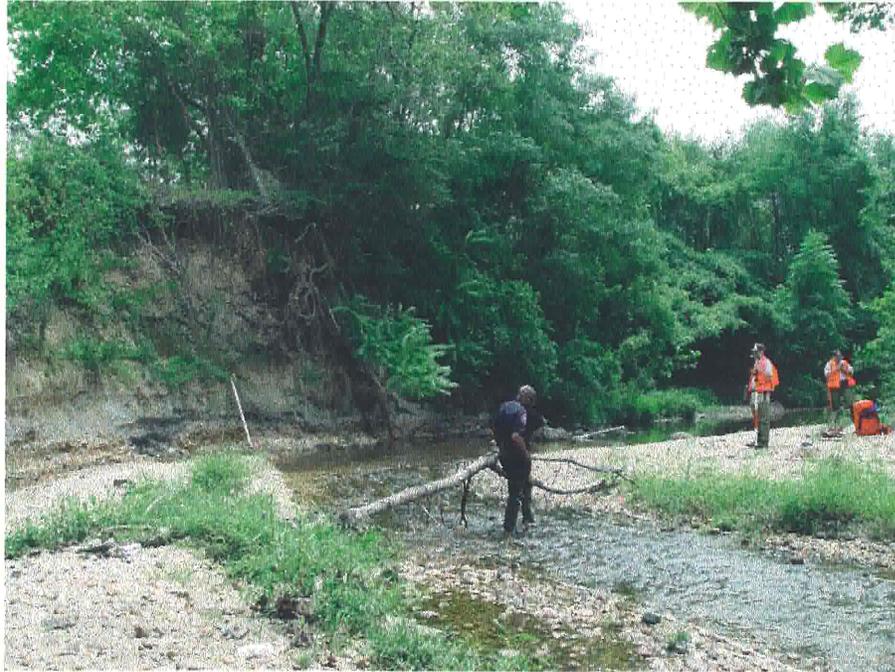
Photo 13. Reach OR(DC)-10 is a meandering reach with extensive gravel bars. An unlined landfill exists along most of the reach on the left bank.

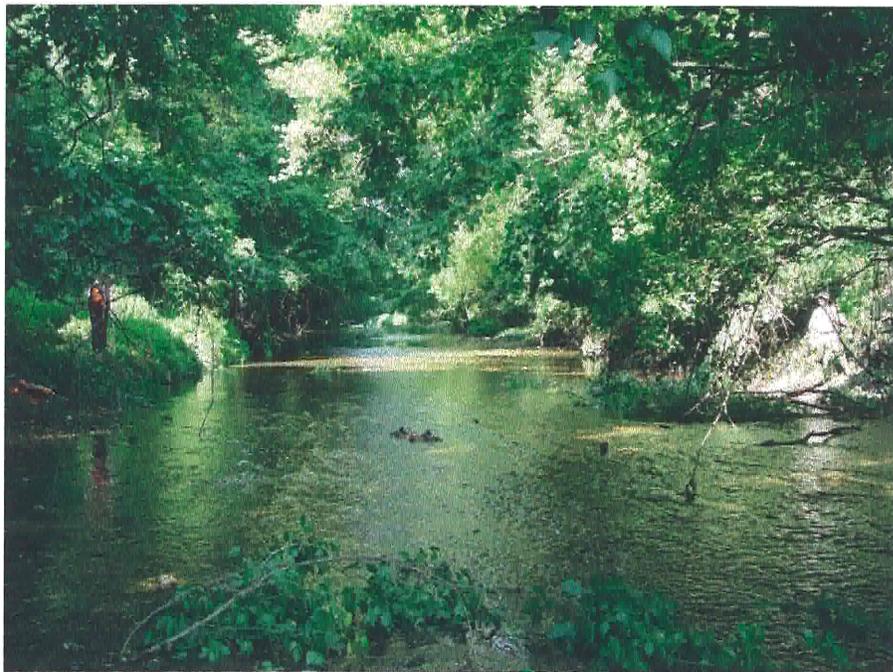
Photo 14. Reach OR(DC)-12 has been straightened in the past. The reach is over-wide and has poorly developed bed features.

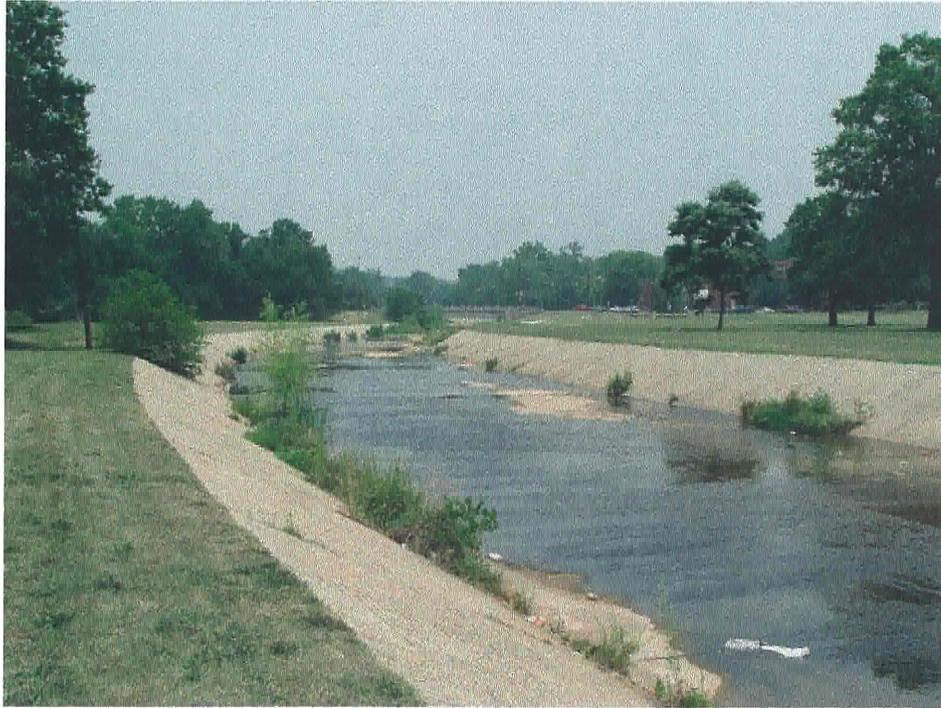
Photo 17. In many locations, a concrete-lined channel, such as Reach OR(DC)-9, was constructed to prevent flooding. This increases flow velocity, erosion downstream, and disruption of the hydrological regime.

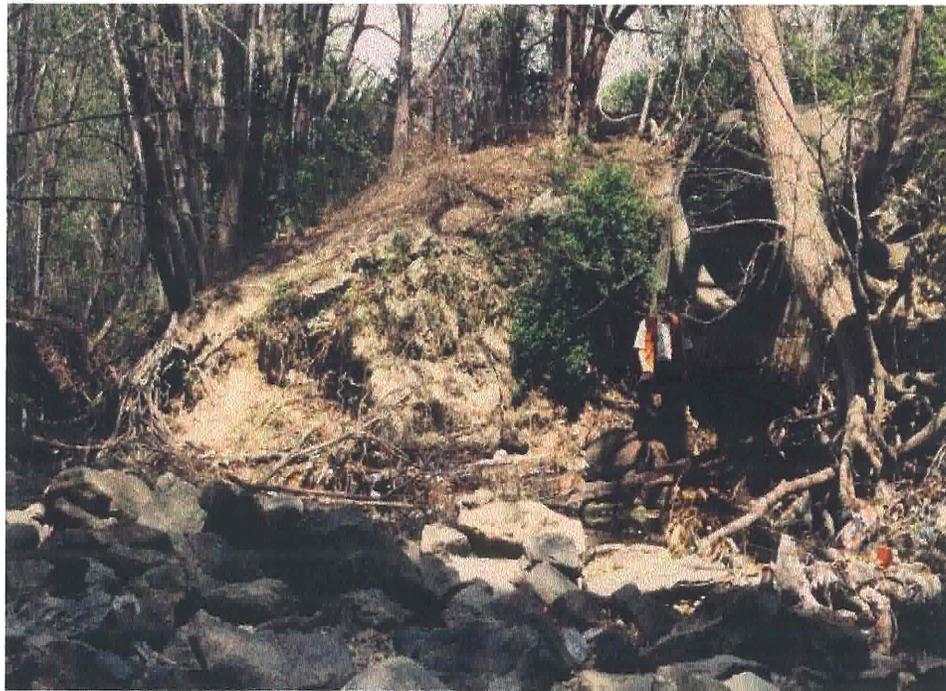
Photo 18. Stormwater outfalls drain high velocity water directly into the stream, causing bed and bank erosion. This outfall is located in Reach BR-1.

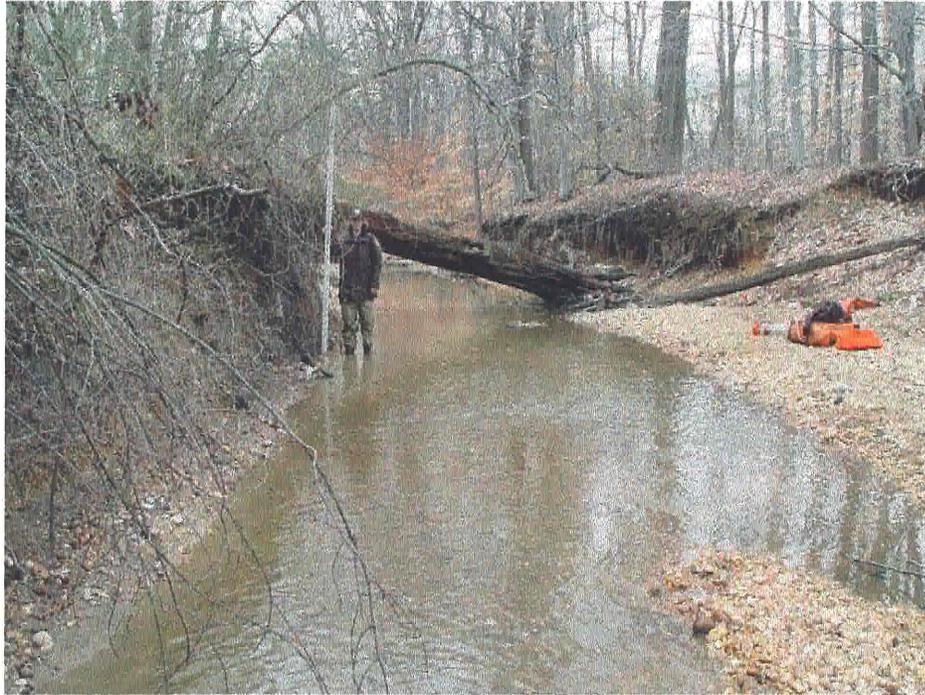
Nearly all of the natural channel streams in the watershed have incised, and/or widened (Photos 19 and 20). In the D.C. portion of Oxon Run, all of the meandering reaches in the Upper Reach (Reaches 2, 3, 5, and 6) and the Lower Reach (Reach 10) have both widened and incised. In highly erodible materials such as those found in the coastal plain, the stream may continue to incise and laterally adjust until it encounters more resistant material, either natural or anthropogenic. Streams dissipate energy in high flow situations by overtopping the streambanks and spreading across the floodplain. As the stream incises, it loses access to the floodplain, which then becomes a low terrace. With higher flows contained in the channel, erosive forces on the bed and banks increase. Eventually, it may recreate a new floodplain within the incised channel. Intentional channelization of the stream also initiates instability, although the response of the stream within the channelized reach may be different. Frequently, the stream will attempt to recreate a meander pattern within the over-wide channel, by building benches or point bars. Within the D.C. portion of Oxon Run, this response is visible in Reach 2 and 4 (Upper Reach), Reach 9 (Oxon Run Park) and Reaches 10, 11, and 12 (Lower Reach). This pattern was also noted at other locations in the watershed that had been channelized in the past.

Photo 19. In reaction to changes in the watershed, the stream channel adjusts, first cutting down through the bed and then widening, as seen here in Reach OR(PG)-3. In the highly erodible soils of the coastal plain, the high raw banks produce a large sediment load.

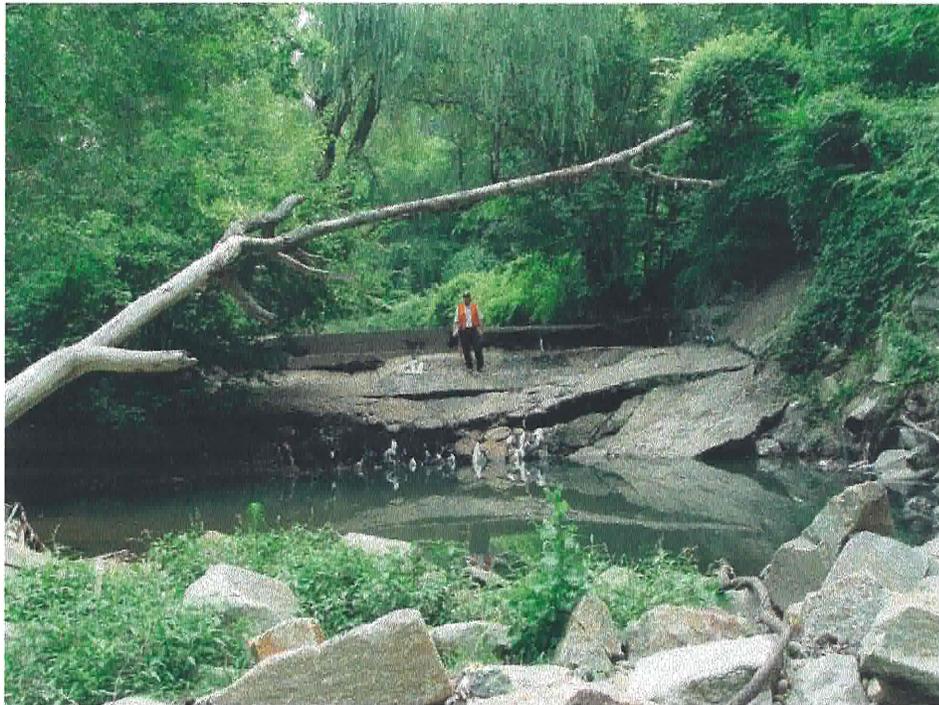
Photo 20. Concrete structures serve as grade control at many locations in the Oxon Run watershed. Here, in Reach BR-5, the stream has headcut up to the structure to adjust to changes in bed elevation downstream.

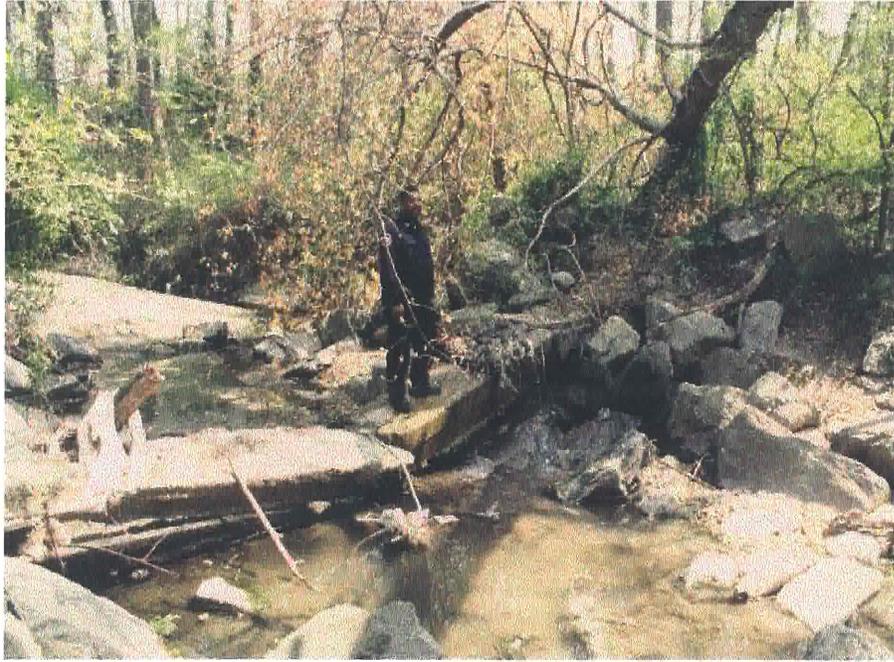
Photo 21. Sanitary sewers cross the stream in many locations. Breaks or leaks, like this one in Reach BR-4, can dump raw sewage, a source of nutrients and potentially pathogenic bacteria, into the stream.

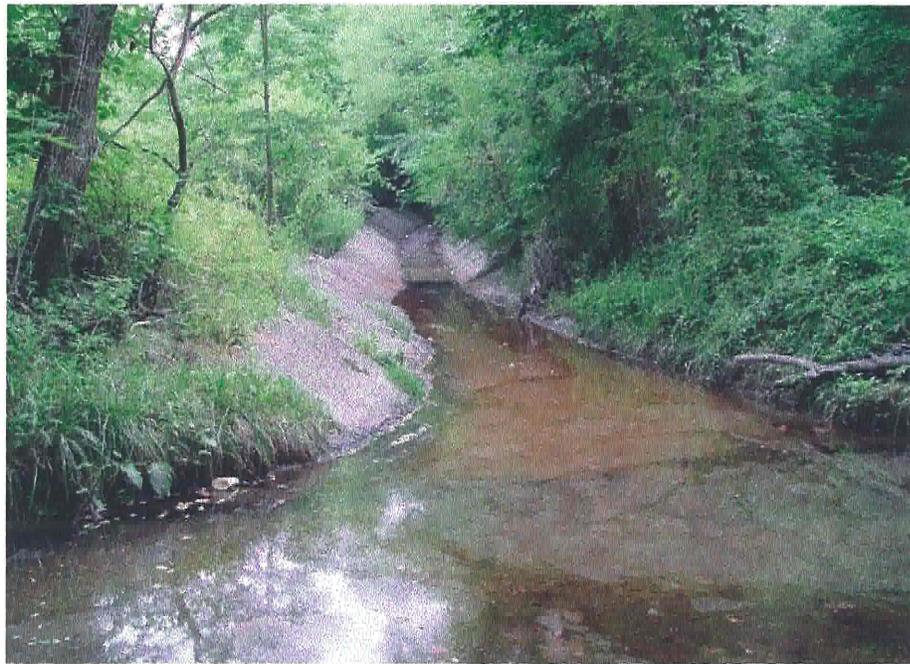
Photo 22. Runoff from storm drains, such as this one in Reach BR-4, carry pollutants such as motor oil directly into the stream. Large quantities of these substances can cause fish kills, and even in smaller quantities cause sublethal effects such as tumors and impaired reproduction.
