**PINE HILL RUN, ST. MARY'S COUNTY, MARYLAND  
WATERSHED AND STREAM ASSESSMENT PATUXENT RIVER NAVAL  
AIR STATION**

Stream Habitat Assessment and Restoration Program  
U.S. Fish and Wildlife Service  
Chesapeake Bay Field Office

CBFO-S04-05

Annapolis, MD  
October 2005

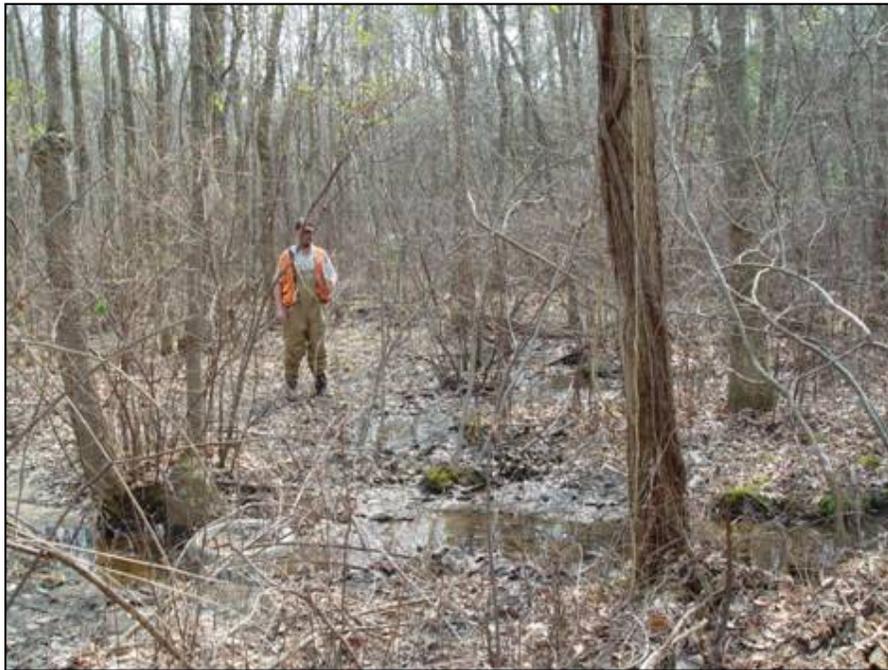
Rosgen D type streams represent approximately 3.9 percent of the total stream length within the watershed (Photograph 4). They are unstable, braided (multiple channels), high width/depth ratio channels found in well developed floodplains that are highly sensitive to disturbance and have a poor recovery potential. They are also typically considered unstable, transitional streams that were once a Rosgen C or E stream type.

Photograph 4. Example of Rosgen D type stream.

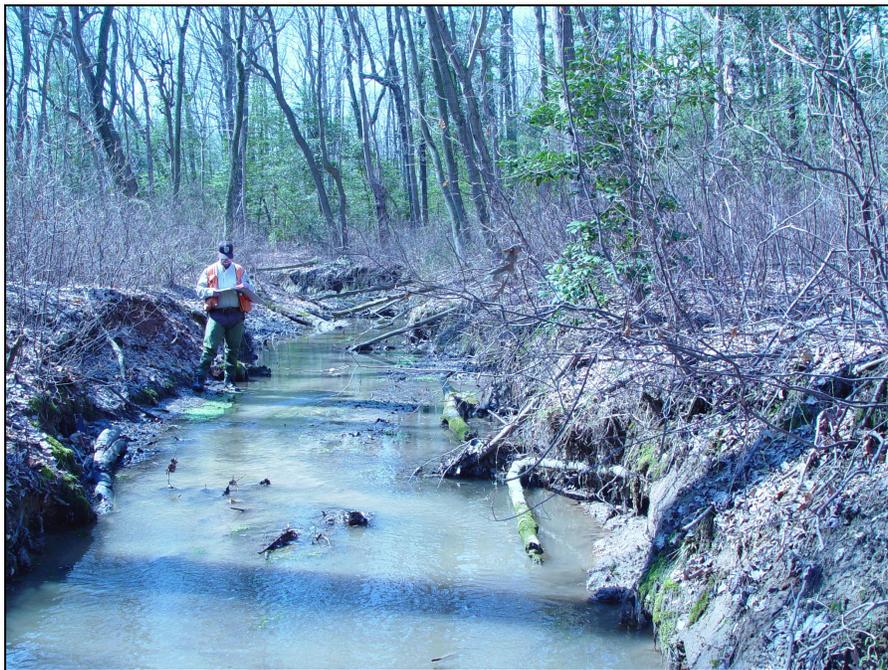
Rosgen F type streams represent approximately 7.3 percent of the total stream length within the watershed (Photograph 7). They are entrenched, incised channels that are highly sensitive to disturbance. Incision is defined as the ratio of the bankfull height to the top of the bank height. Streams with a large elevation difference between bankfull and top of bank height have a high incision ratio and streams with a small elevation distance between bankfull and top of bank height have a low incision ratio. Recovery potential for F streams is fair/poor.

Photograph 7. Example of Rosgen F type stream.

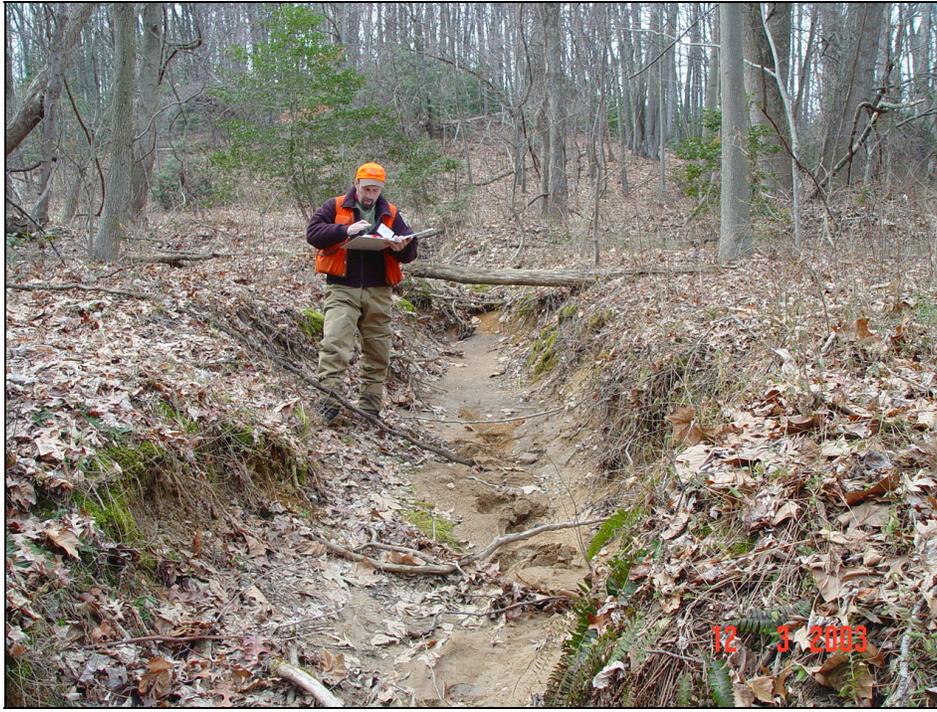
Rosgen G type streams represent approximately 39.3 percent of the total stream length within the watershed (Photograph 8). They are entrenched, moderately steep, incised channels that are highly sensitive to disturbance and have a very poor recovery potential. They are also typically considered unstable, transitional streams that were once a Rosgen A, B, C, or E stream type.

Photograph 8. Example of Rosgen G type stream.

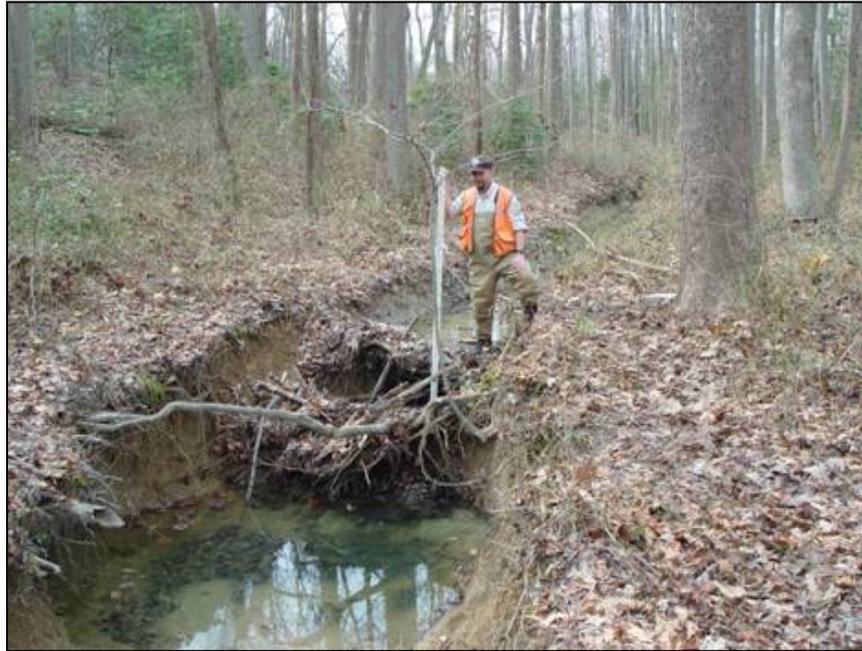
Reach PH LT04-D is 450 feet in length and is currently an unstable C5 that is downcutting due to localized bed erosion. A series of headcuts is located in the reach, with a total drop of 2 feet. At the bottom of Reach PH LT04-D is 4-foot headcut. The headcut has potential to move upstream through the reach and cause significant bed and bank erosion to the upstream reaches. If the problems are not addressed, the reach will continue to downcut to a G5, then widen to an F5 which would produce large volumes of sediment. Instream habitat is fair and riparian buffer width is 250-400 feet. The reach has a fair recovery potential if the destabilizing factors are corrected.

Photograph 9. This 4-foot headcut is located on PH LT04-D. This headcut is typical of many of the large headcuts located in the Pine Hill Run Watershed.

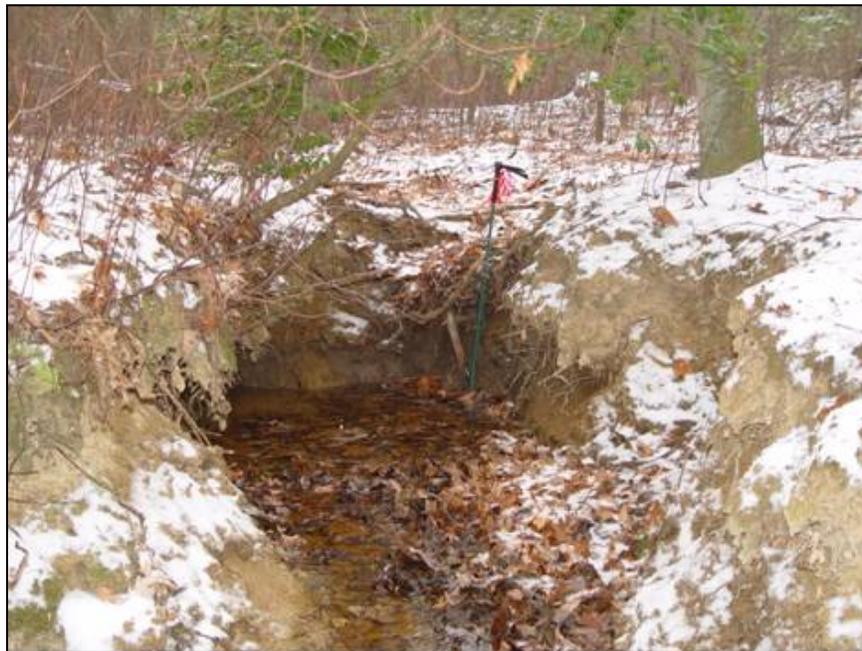
Photograph 10. The 3.5-foot Headcut is located in Reach PH RT03 LT01-E. This large headcut is typical of the rapid adjustment occurring in the watershed.

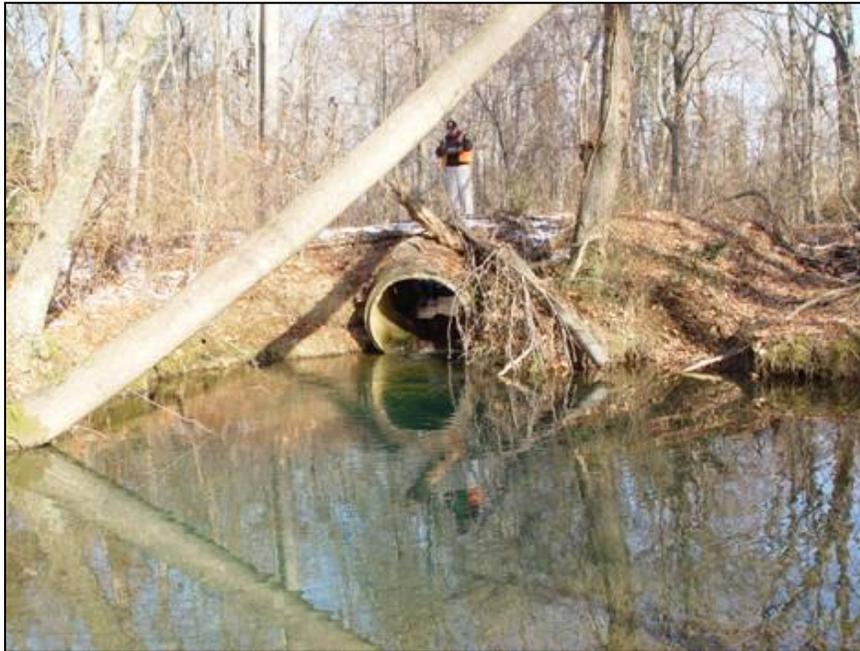
Reach PH LT01-A, 600 feet in length, is a stable DA4/5 that flows into Holton Pond. The only unstable section of the reach is associated with a road crossing approximately 350 feet upstream from the reach start. The road crossing is a 48-inch culvert that is failing on the downstream end with a 2-foot drop in water surface. There is localized bank and bed erosion around the pipe on the downstream side with a large scour pool. Failure of the culvert under the road crossing would cause the upstream section of Reach PH LT01-A and Reach PH LT01-B to downcut and cause instability in the reaches. Reach PH LT01-A has good instream habitat and a riparian buffer width of 600 feet.

Photograph 11. An example of a failing culvert found in PH LT01-A.

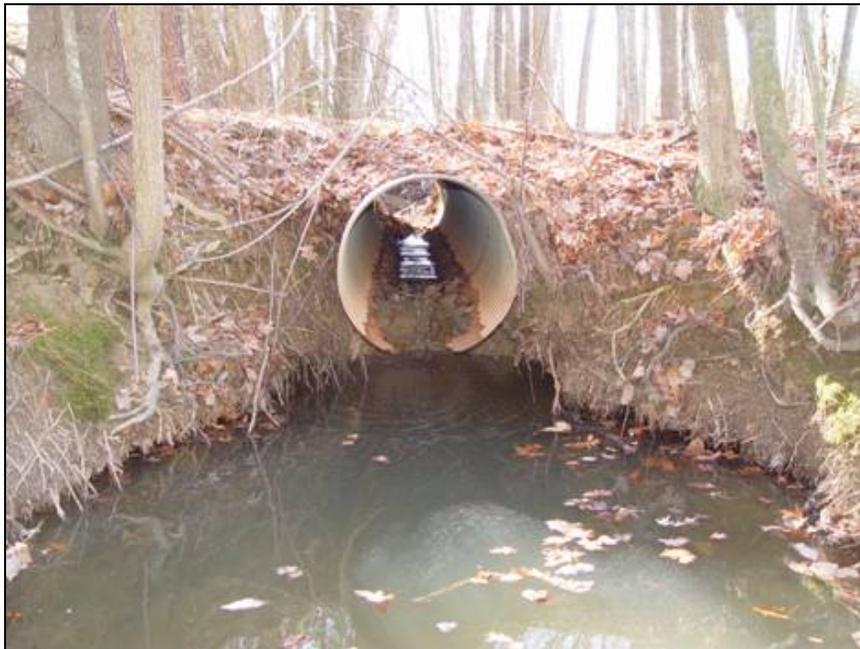
Photograph 12. A failing culvert located on PH RT03-I. The downstream end of the culvert is rusting away, allowing the road fill to erode.

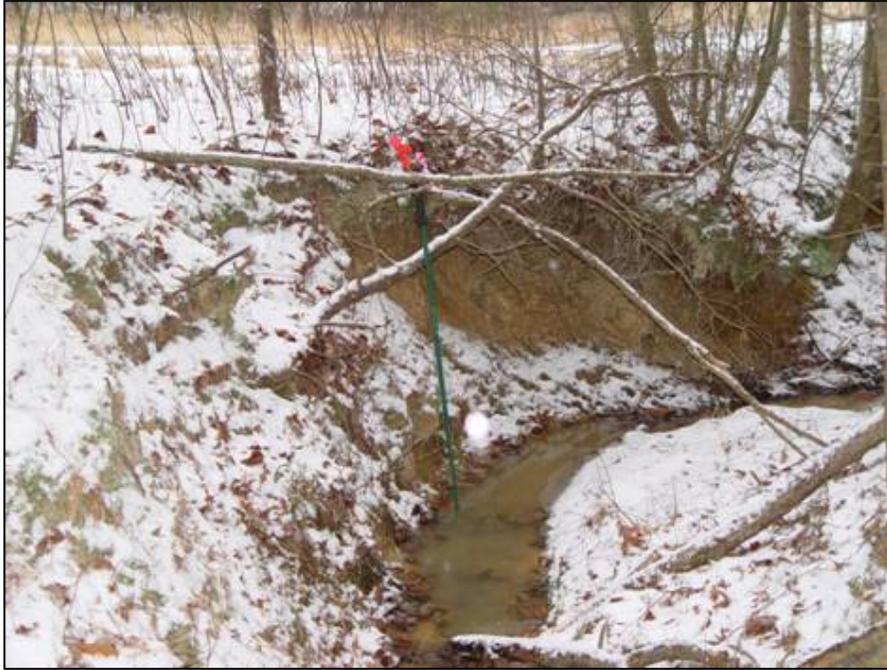
Photograph 13. High rate of bank erosion located on PH RT03 LT01-C. High bank erosion rates are typical of the Rosgen F and G stream types found in the watershed.

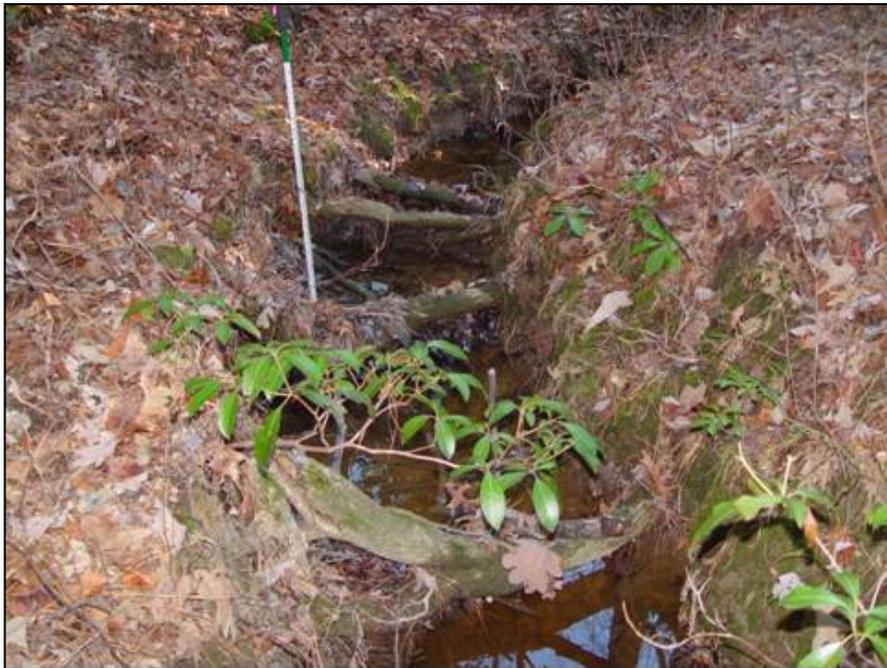
Photograph 14. Exposed roots in the channel of Reach PH RT05-B. The exposed roots are evidence that the channel has rapidly downcut and is typical of what is occurring in the watershed.

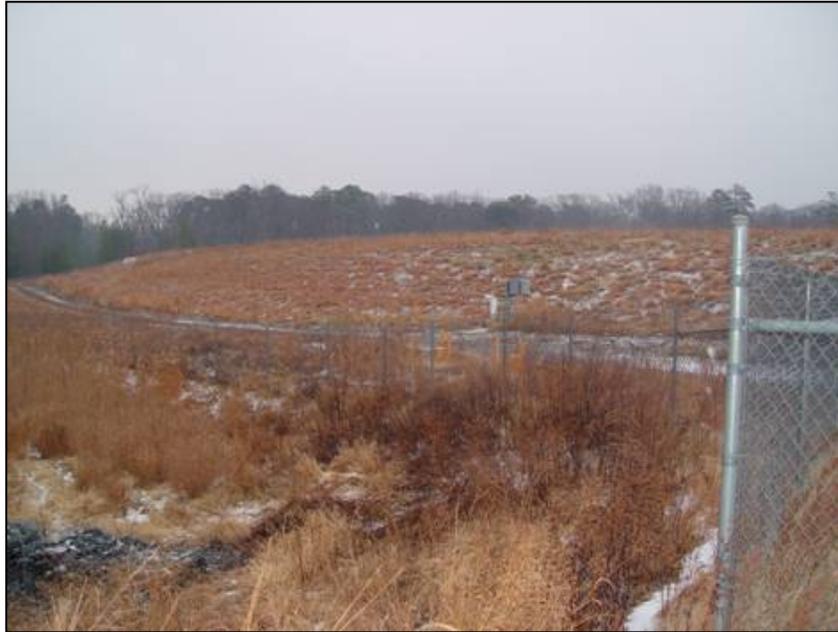
Photograph 15. Land use changes associated with Landfill Site 11 adjacent to PH RT03. Deforestation in the watershed with development has increased runoff and caused instability in many of the tributaries.

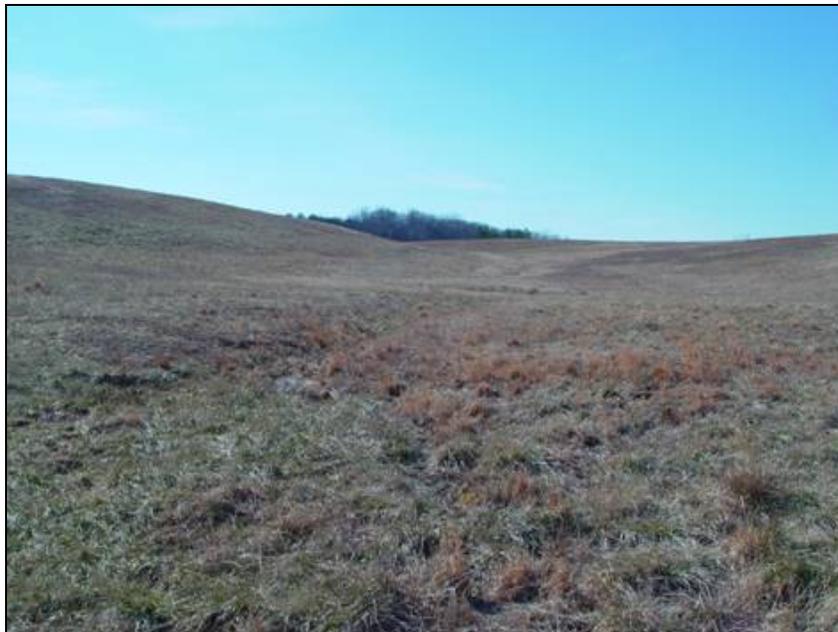
Photograph 16. Deforestation of the headwaters of PH RT06. This is typical of the land use changes that have caused much instability in the watershed.
