# Watts Branch, Washington, D.C.

## Natural Resources Conservation Service Stream Stabilization Monitoring Report

CBFO-S05-04

*October 2005*

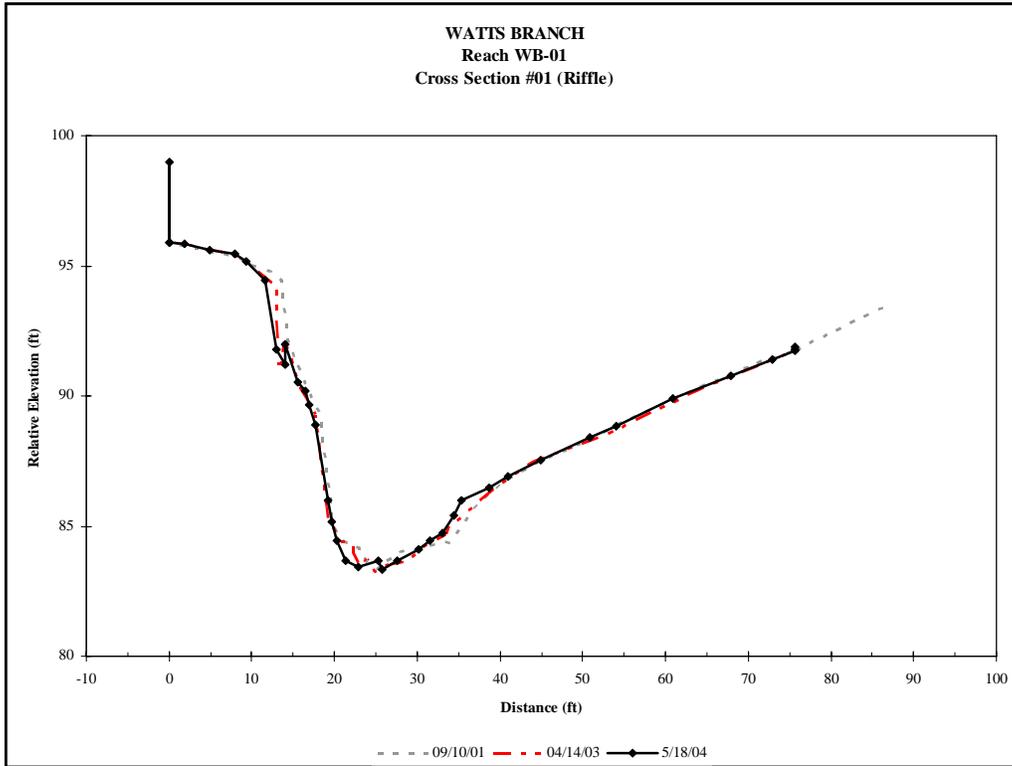
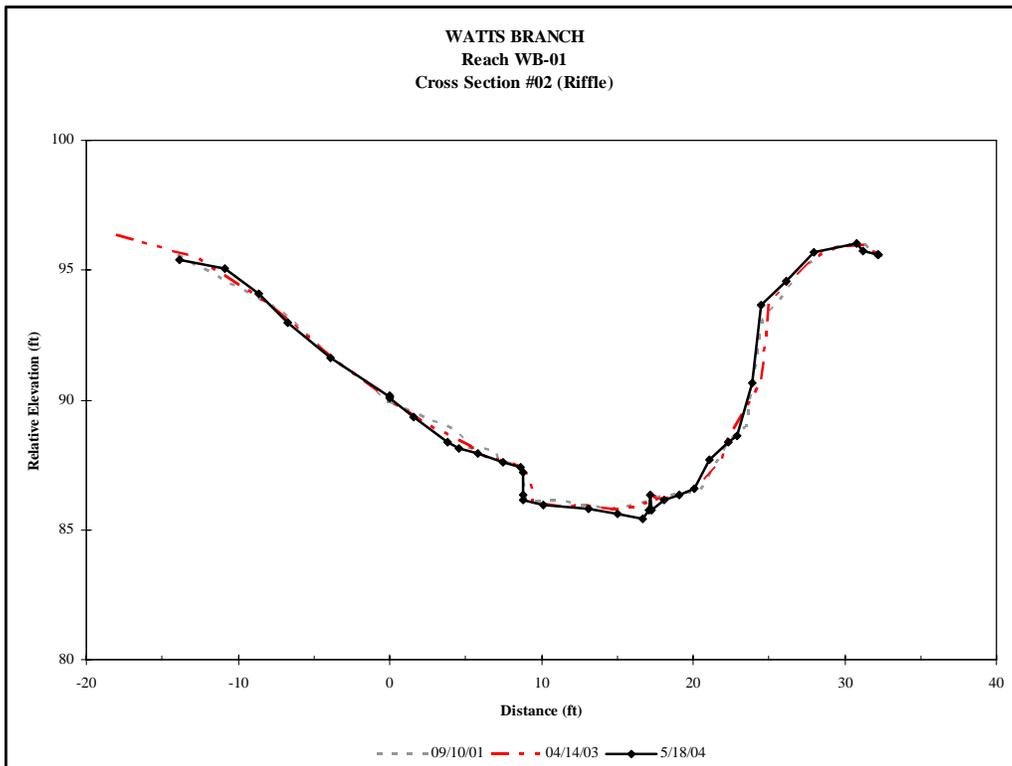
Figure 2a. Cross Section Overlay Plots

Total changes in bankfull width ranged from a 1.97-foot decrease to a 2.89-foot increase in width. Total changes in bankfull depth ranged from a 0.10-foot decrease to a 0.23-foot increase in depth. Total changes in bankfull area ranged from a 1.63-square foot decrease to a 9.65-square foot increase in area. Total changes in entrenchment ratio ranged from a 0.05 decrease to a 0.21 increase in entrenchment. Total changes in width/depth ratio ranged from a 2.5 decrease to a 0.81 increase in width/depth.

The Service anticipated little lateral adjustment for cross sections 01 and 06, because the banks prone to erosion are stabilized by imbricated rip rap. The only significant change was a 1.97-foot decrease in bankfull width for cross section 01, because of the development of a bankfull bench. The bench and the current bankfull depth will not affect the ability of the imbricated rip rap to protect the bank.

The right bank of cross section 02 has a very high erosion potential, because of the high bank, shallow root depth, low root density, and low surface protection. High banks can be more susceptible to erosion, because more of the bank is exposed to erosional forces. Shallow root depths and low root densities are less able to secure the bank and prevent bank scour and rotational bank failure. However, the Service measured no significant changes in channel dimensions for cross section 02. The lack of actual bank erosion is due to the low near bank shear stress, as the stream flow is directed away from the right bank. However, there still is a significant potential for erosion, because of the entrenched channel conditions. The Service will discuss its potential erosion concerns with an entrenched channel later in this section. There were also no significant changes for cross section 04, due to the low near bank shear stress and vegetated banks.

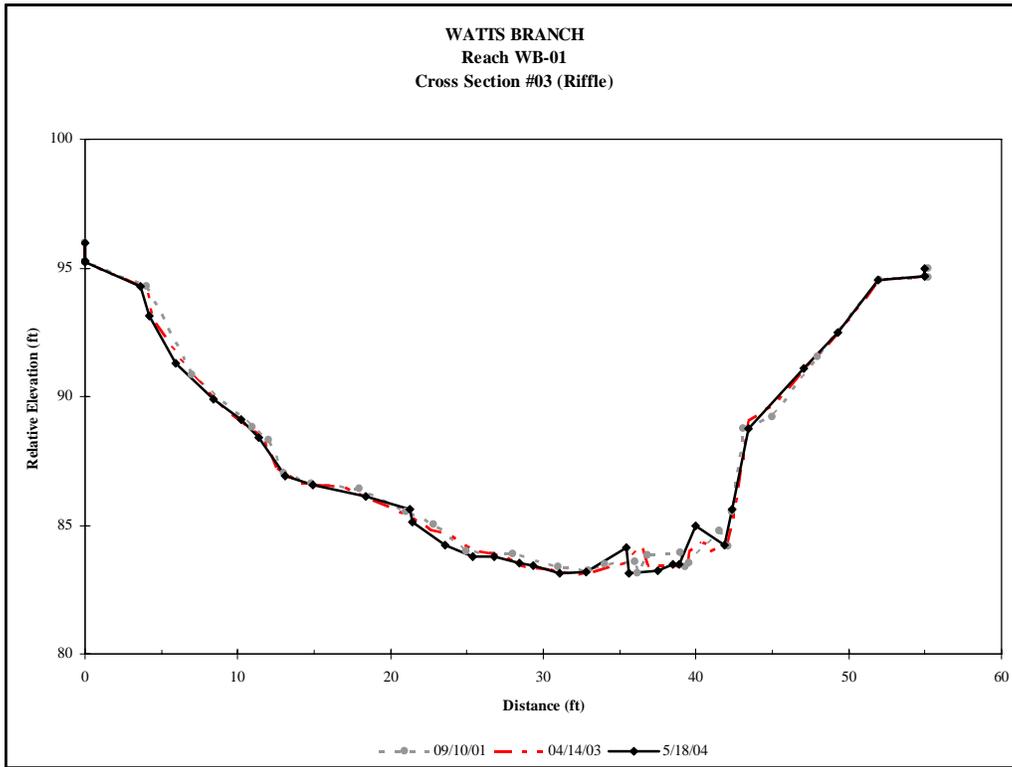
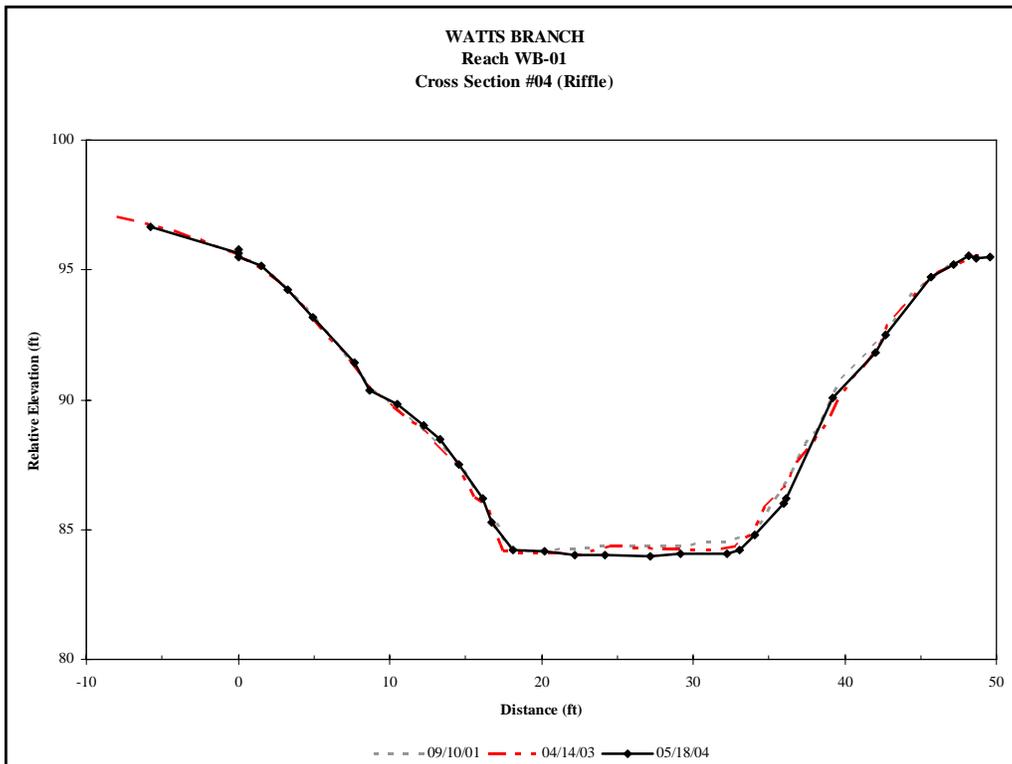
Figure 2b. Cross Section Overlay Plots

Although imbricated rip rap was used to stabilize cross sections 03 and 05, these cross sections had the largest change in bankfull cross-section area. The cross-section area change for cross section 03 is the result of a scour pool from the j-hook structure located at the cross section. Scour pools, downstream of j-hook structures, are a designed function of these structures. Cross section 05 had the largest change in bankfull cross-section area (*i.e.*, 9.65 square feet). Several factors contributed to the lateral erosion at cross section 05, including a high bank erosion potential and a moderate near bank shear stress. The high bank erosion potential is the result of a high bank and low root density. The moderate near bank shear stress is the result of more stream flow directed towards the bank. Another factor contributing to the lateral erosion is that upstream of the cross section, the left bank is stabilized with imbricated rip rap, which accelerates stream flows across the unprotected bank at the cross section.

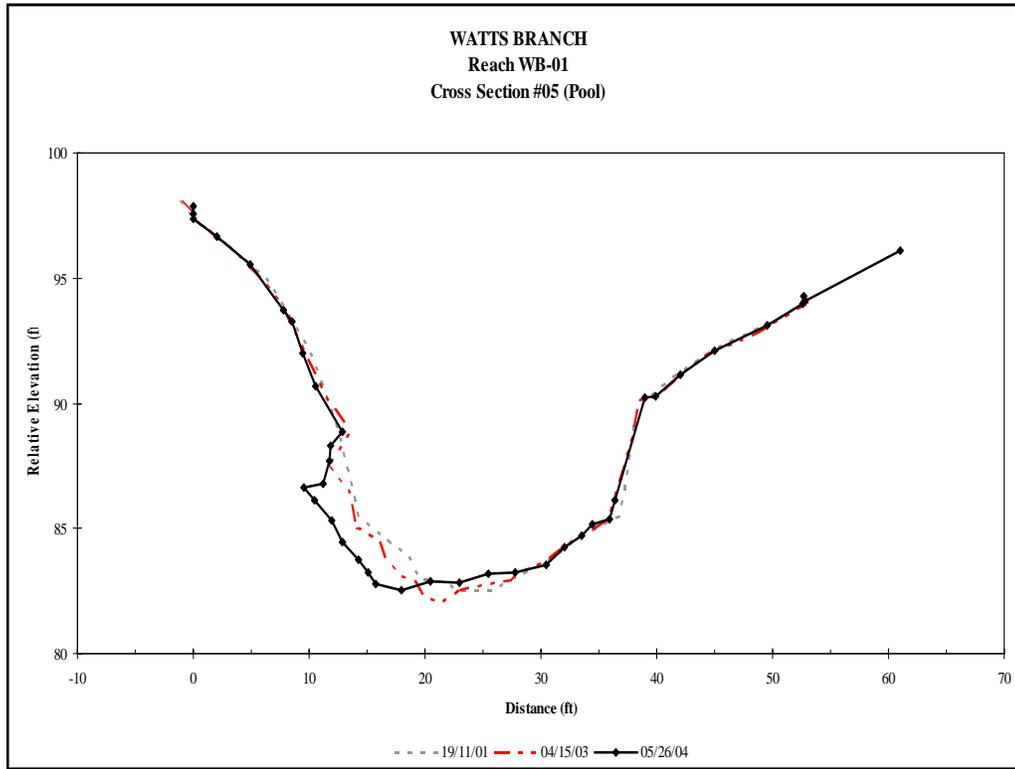
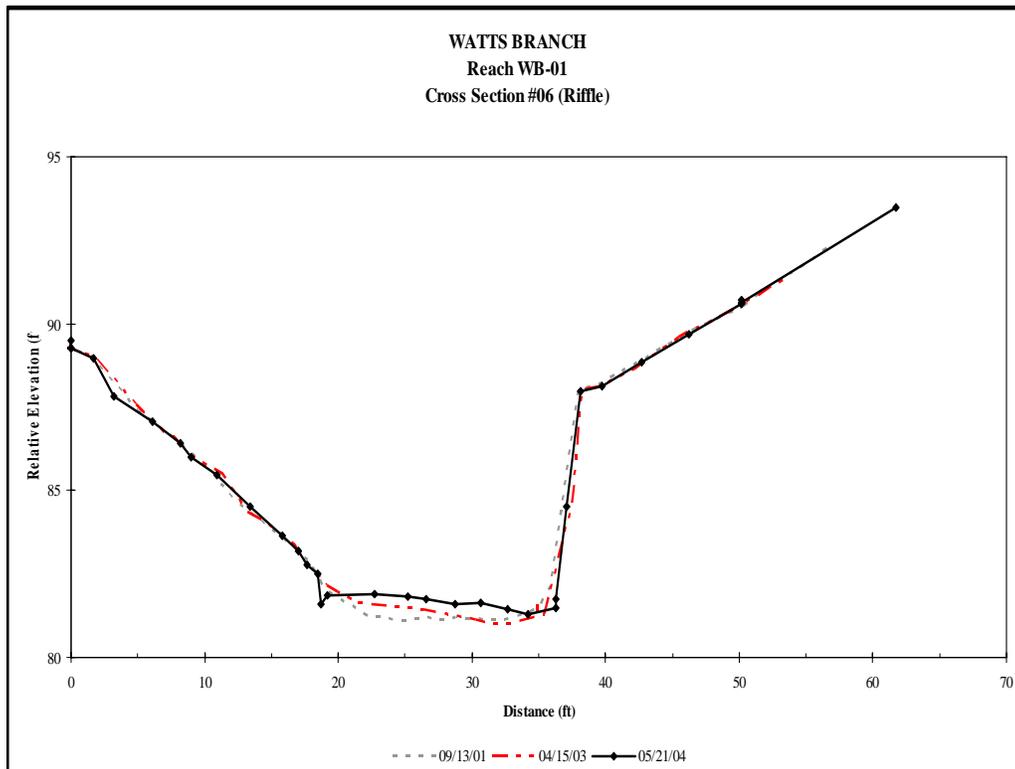
Figure 2c. Cross Section Overlay Plots

For all the cross sections, the Service calculated little change in the entrenchment ratio, which ranged from moderately entrenched (*i.e.*, cross sections 01-03 and 06) to entrenched (*i.e.*, cross sections 04 and 05). Entrenched streams contain high stream flows, which increases the potential for bank erosion because the stream does not have access to a floodplain for attenuation of shear stresses. The extensive bank revetments further increase the bank erosion potential by accelerating high flows along the hardened banks, which may cause toe erosion and result in undermining of the revetments. Unprotected banks are also at risk of increased erosion from the accelerated high flows.

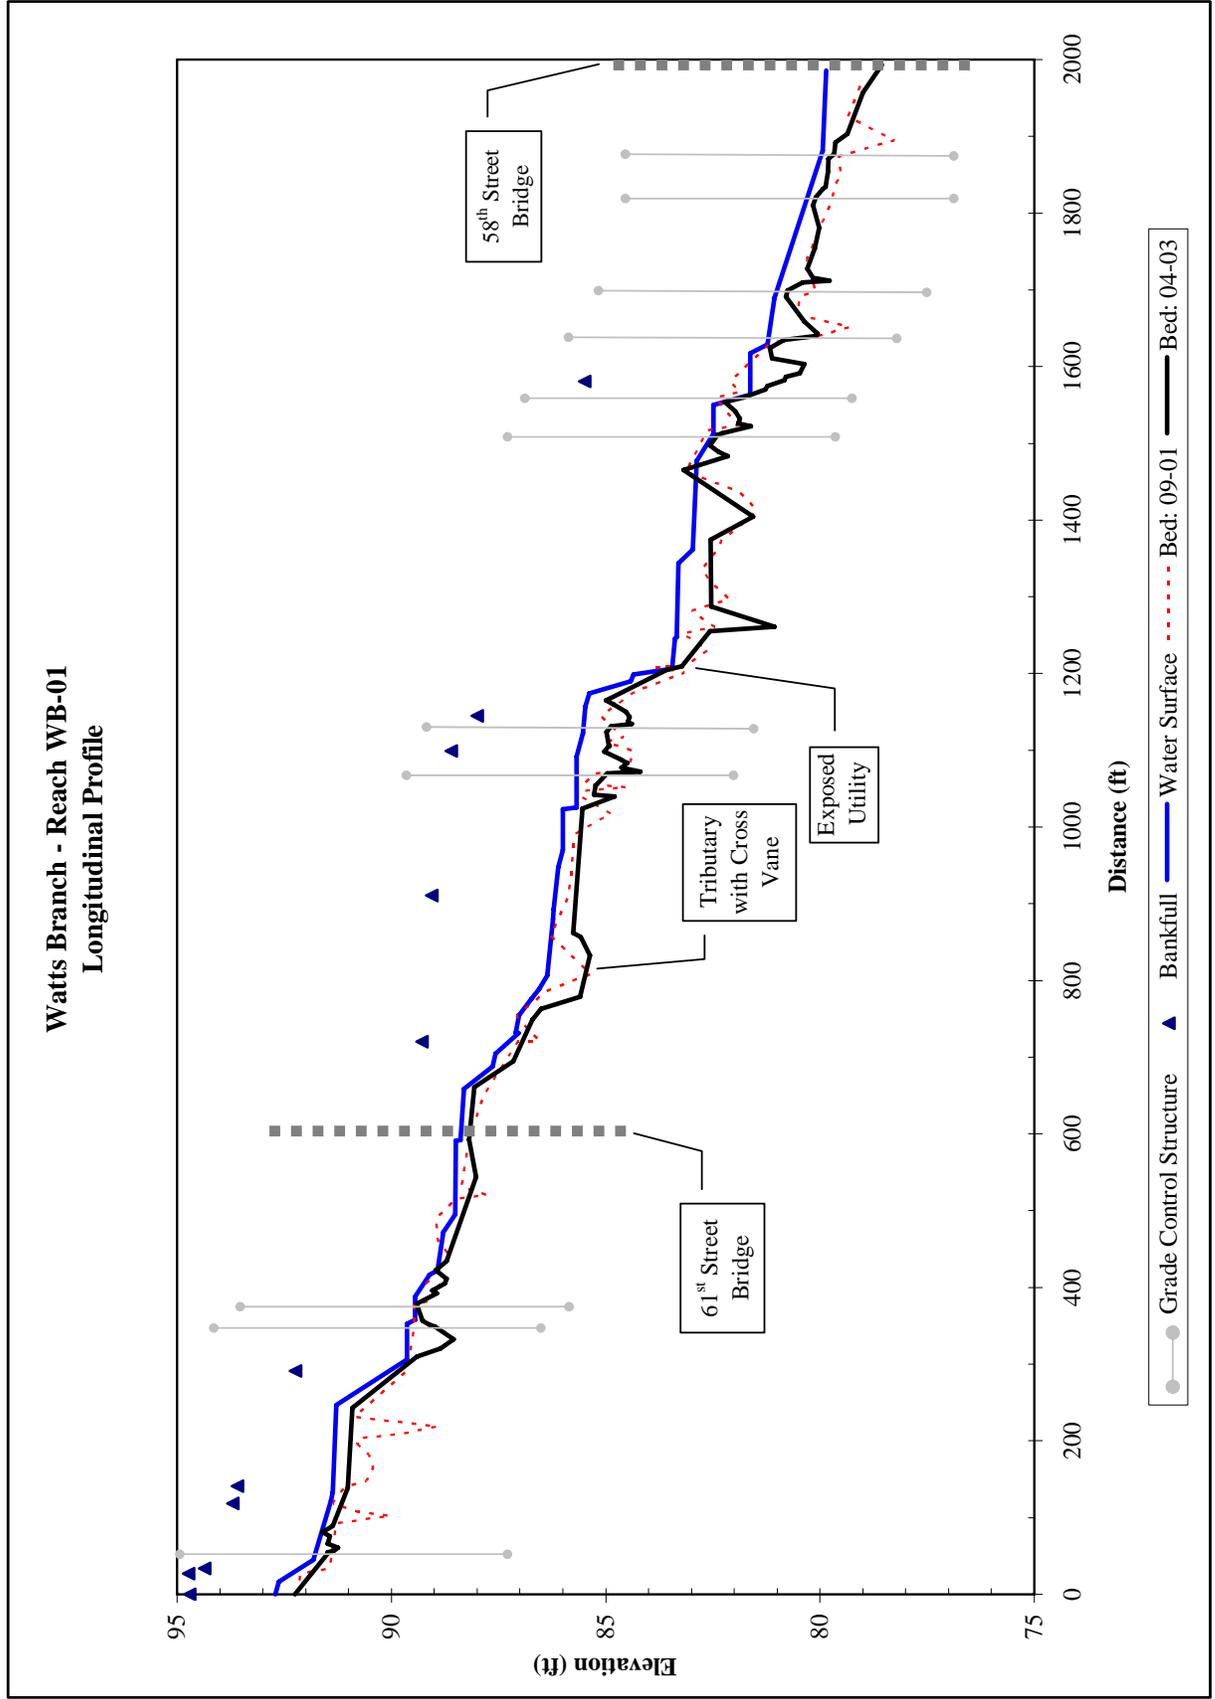
Figure 3a. Longitudinal Profile Overlay Plot for 2001 and 2003 Surveys

For the 2001 and 2003 longitudinal profile overlay, the Service observed approximately 20 percent degradation and approximately 19 percent aggradation (Figure 3a). In general, the upper section (station 00+00 to 07+00) and middle section (station 07+00 to 16+25) of the reach were stable, with areas of localized scour, ranging from 0.09 feet to 1.62 feet, and localized aggradation, ranging from 0.06 feet to 0.58 feet. Overall, the lower section of the reach (station 16+25 to 19+75) was aggrading, with the bed rising from 0.10 feet to 1.38 feet. The Service also observed aggradation in the pools, including those downstream of constructed grade control structures, which typically maintain pool depths of two to four times the riffle bankfull depth.

The Service measured a significant scour enlargement at the confluence of the Watts Branch main stem and unnamed tributary (station 07+60 to 08+60). NRCS installed a cross vane on the tributary at the confluence of the two streams. The maximum scour depth (*i.e.*, 1.0 feet) has remained the same; however the maximum depth is now more uniform throughout the pool, extending 30 feet farther upstream, and 24 feet farther downstream.

The Service compared the 2001 and 2003 thalweg profiles and found the stream channel to be stable, with only minor, localized, vertical adjustments. There was some scouring in the upper and middle section of the project area and aggradation in the lower section. The localized erosion in the upper and middle sections, at that time, did not affect the function of the bank revetments or grade control structures. The aggradation in the lower section has filled in some of the grade control structures rendering them nonfunctional; however, this condition was not affecting channel stability.

In the upper and middle sections of the study reach, the Service measured increased scour depths in existing scour pools, or newly formed scour pools downstream of grade control features/structures (*i.e.*, riffles, cross vanes, and construction debris). Riffles are natural grade control features characterized by steeper slopes, shallower depths, and coarser bed materials than other stream facet features (*e.g.*, runs, pools, and glides). Scour pools typically develop downstream of riffles because of the accelerated stream flows down the steep gradient of the riffles. The Service measured greater scour downstream of steeper riffles, as observed at stations 03+32 feet and 12+61 feet of the 2003 longitudinal profile (Figure 3a).

The Service measured aggradation in the lower section of the reach. The primary reasons for the aggradation are a lower reach average slope and backwater conditions from the 58<sup>th</sup> Street bridge. These conditions decrease stream velocities, which decrease the sediment transport competency of the stream and results in aggradation.

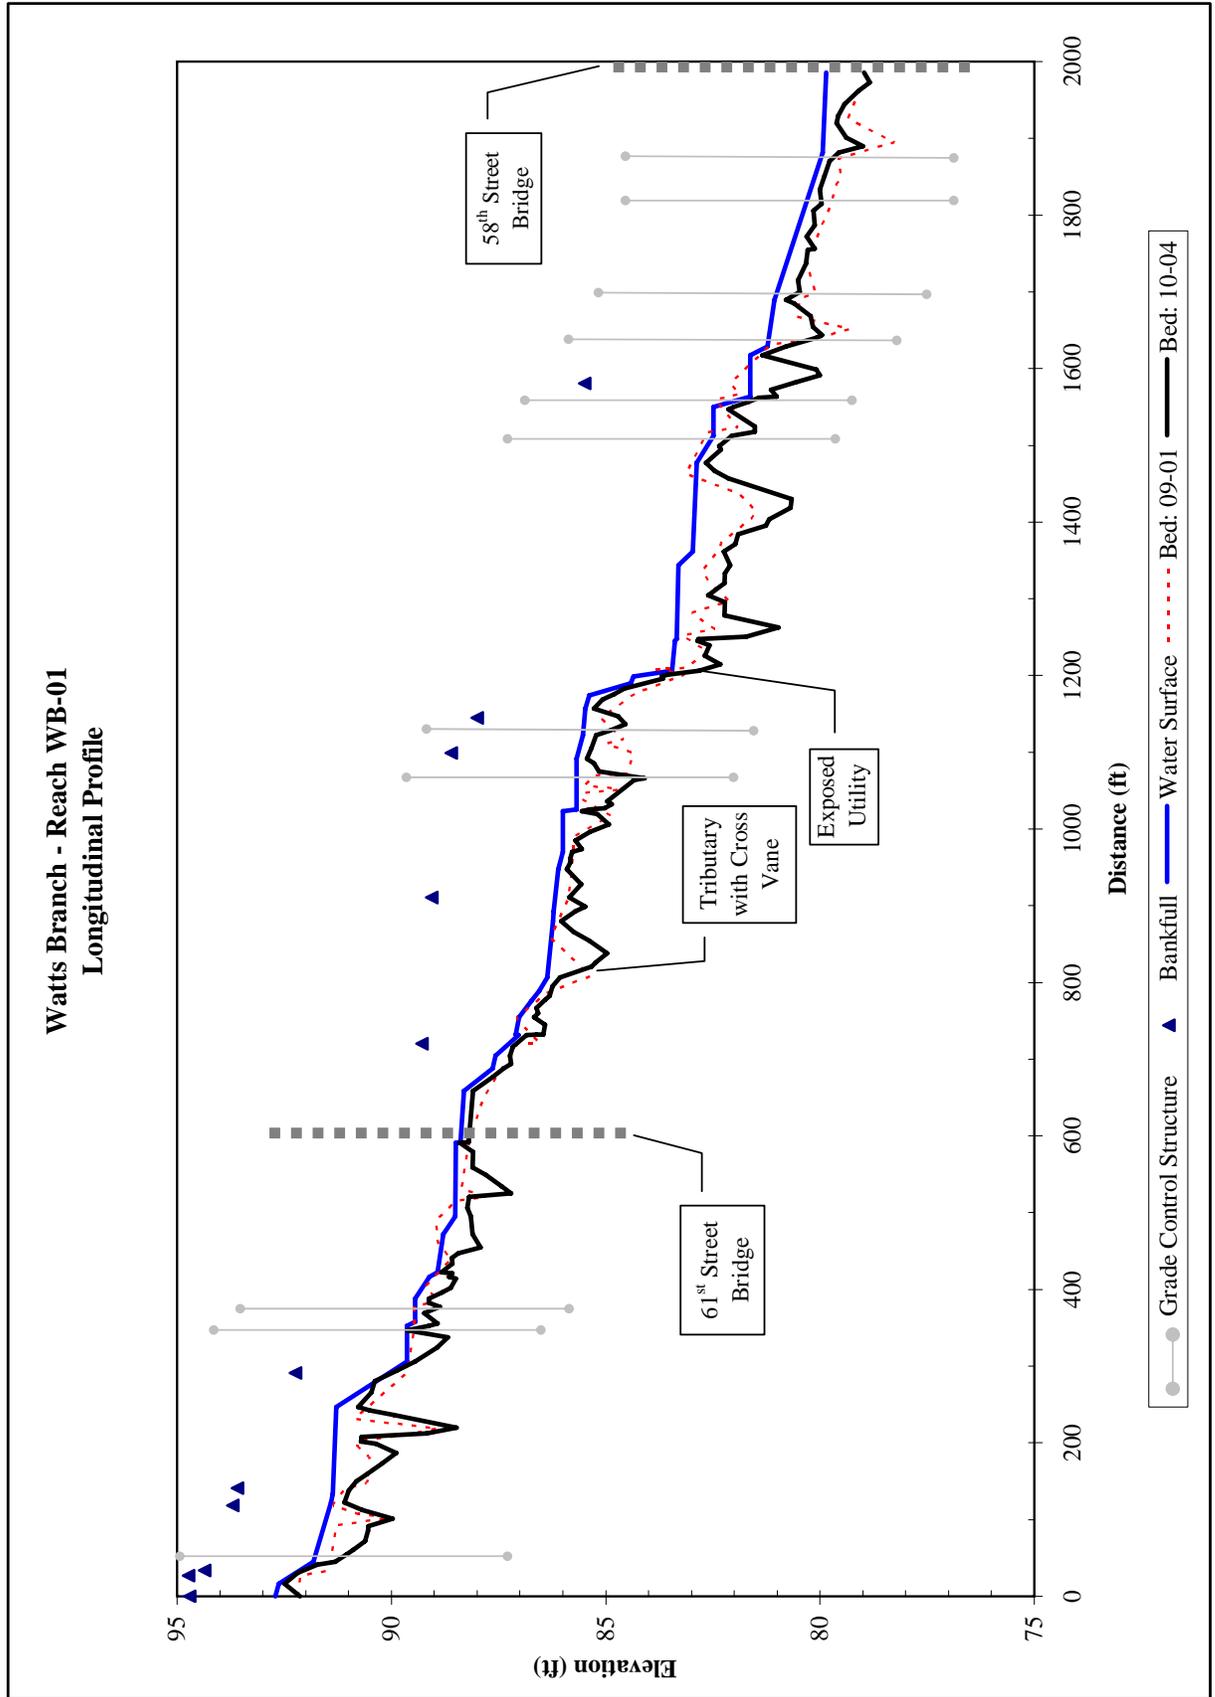
Figure 3b. Longitudinal Profile Overlay Plot for 2001 and 2004 Surveys

For the 2001 and 2004 longitudinal profile overlay, the Service observed approximately 46 percent degradation and approximately 19 percent aggradation (Figure 3b). The majority of the degradation was in the upper and middle sections of the reach, with the degradation ranging from 0.05 feet to 2.08 feet. The majority of the aggradation occurred in the lower section, with the aggradation ranging from 0.14 feet to 0.74 feet. The aggradation in the lower section of the 2004 survey was similar to the aggradation the Service observed in 2003 survey, with the exception of some minor scour development.

The Service also compared the 2001 and 2004 thalweg profiles and found the stream channel to be currently stable, with areas of increased bed scour, and similar aggradation to the 2003 profile. Although there was increased bed scour in the upper and middle sections of the project area, the localized erosion should not affect the function of the bank revetments or grade control structures. The grade control structures in the lower section remain nonfunctional, because of the reach-wide aggradation. Currently, this condition does not affect channel stability.

The Service anticipated increased scour depths, especially downstream of the constructed grade control structures, because some of the pools were shallower than the typical two to five times bankfull depth. The Service noted, for the previous year, that the pool depths at stations 00+81 and 03+96 were shallower than the typical two riffle bankfull depths. For 2004, the Service found that these scour pools had increased to 3.87 and 3.40 feet, an increase in depth of 1.51 and 0.29 feet, respectively.

The Service measured scour pool depths, downstream of natural riffles, ranging from 3.38 to 6.25 feet. The Service measured scour pools depths at five of the existing grade control structures ranging from 3.40 to 5.34 feet. Despite the increase in pool depths, there is still the potential for further enlargement of some pool depths.

The Service continued to measure aggradation in the lower section of the reach, similar in extent and depth to the previous years. Although aggradation in the lower section was similar to the previous year, future increases in sediment contributions from upstream may increase the depth and extent of the aggradation in this section. The reasons for the aggradation remain the same as discussed for the previous year, in the 2001 and 2004 Longitudinal Profile Discussion section, under the Aggradation Areas.

The Service also recommends inspections of the grade control structure at station 10+70. This structure had the largest decrease in bed elevation, potentially because of the scour from an outfall upstream of the structure. Inspections may be necessary to ensure that the scour does not compromise the structure. A minimum requirement for the inspections should include a physical inspection of the structure to determine if the scour is undermining the grade control structure.

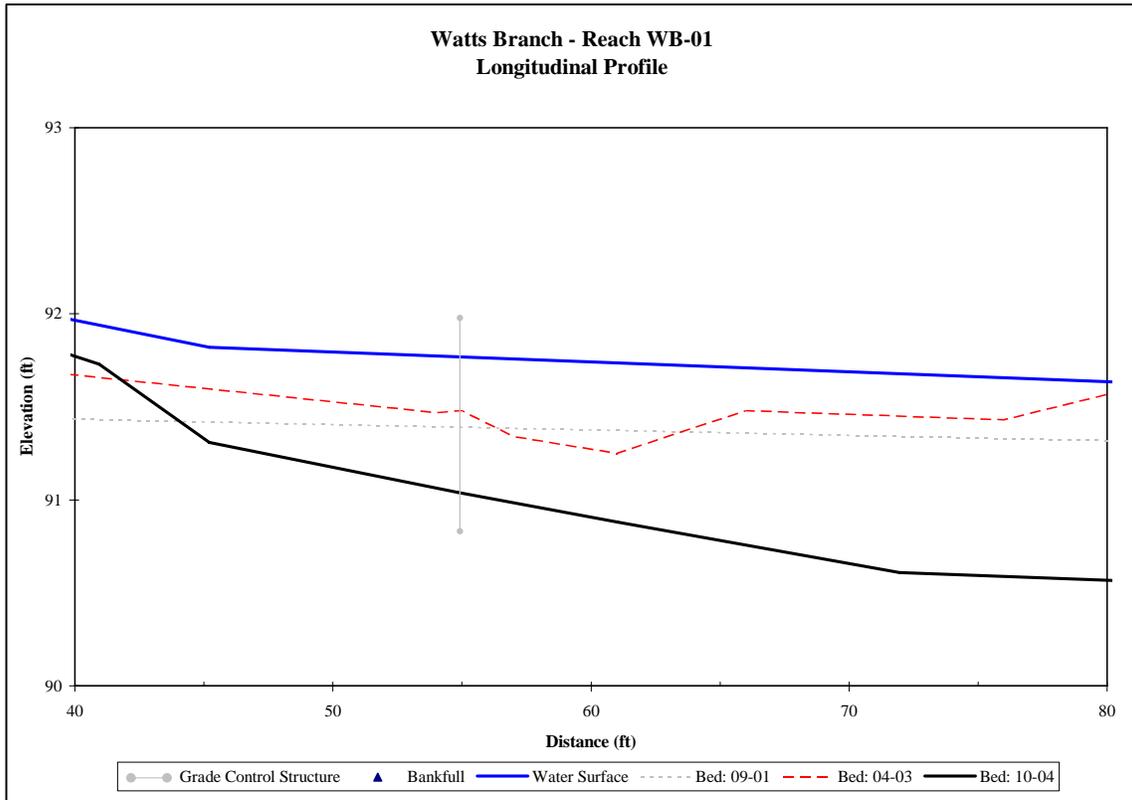
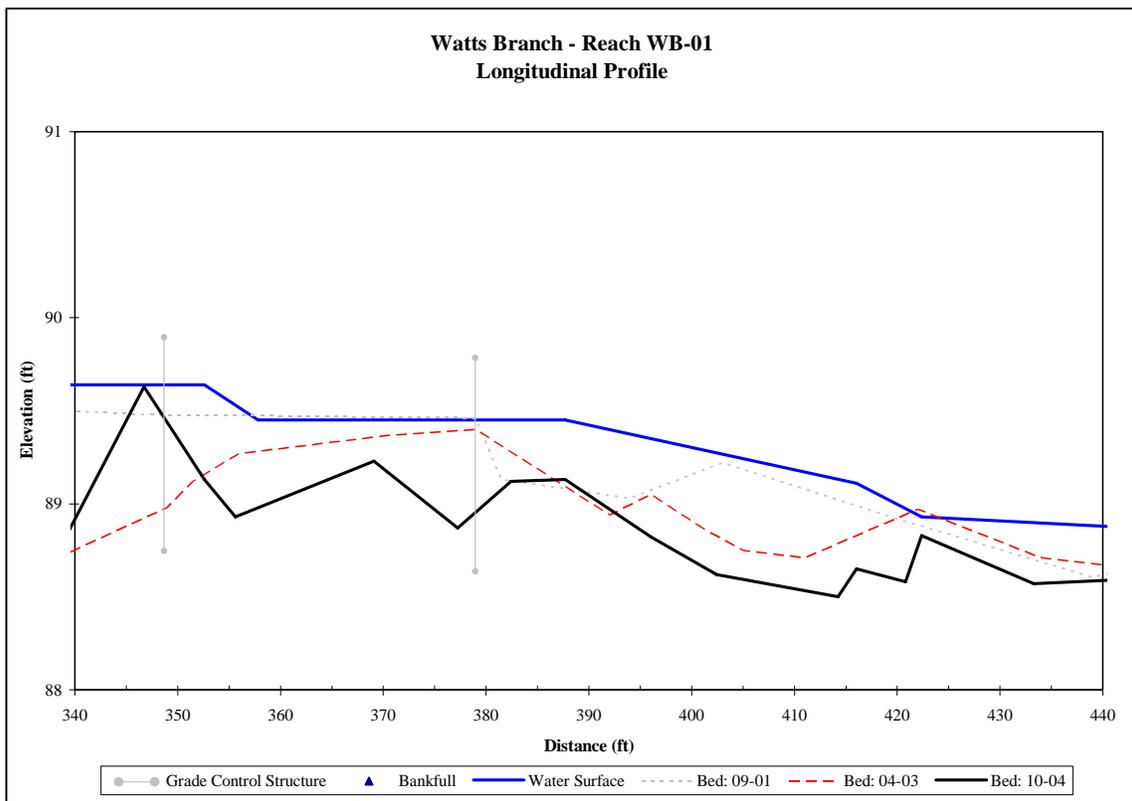
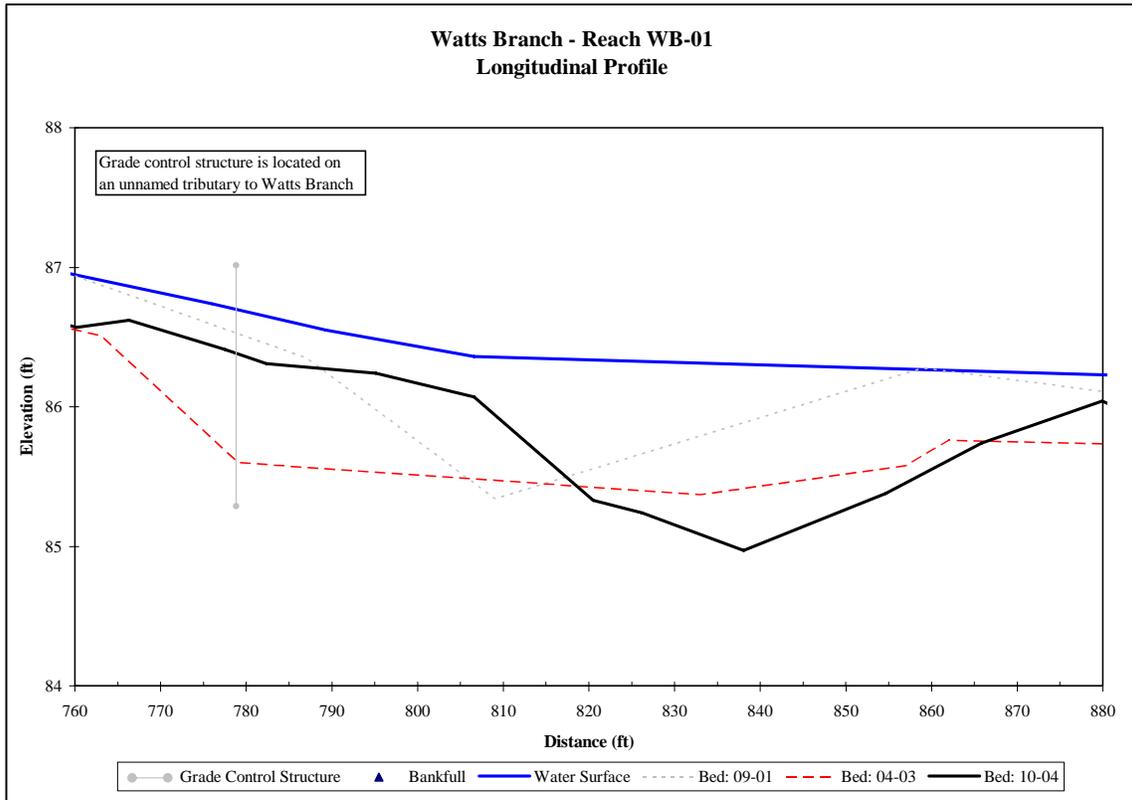
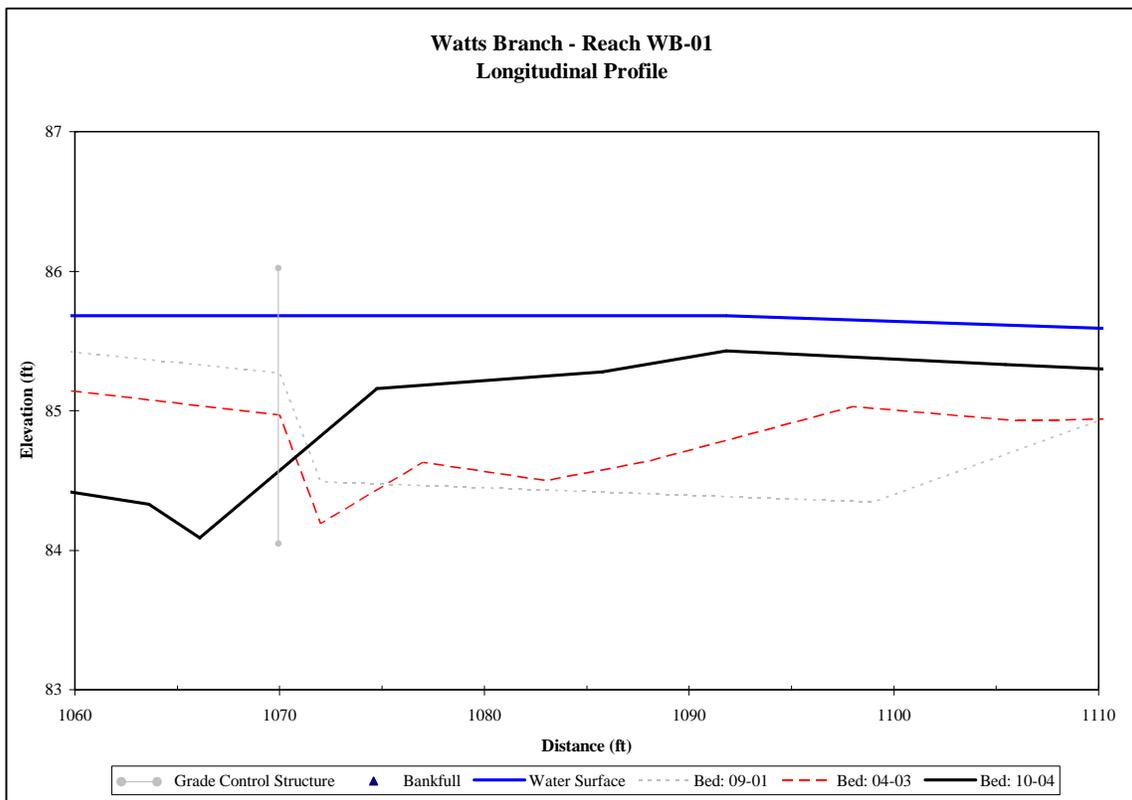
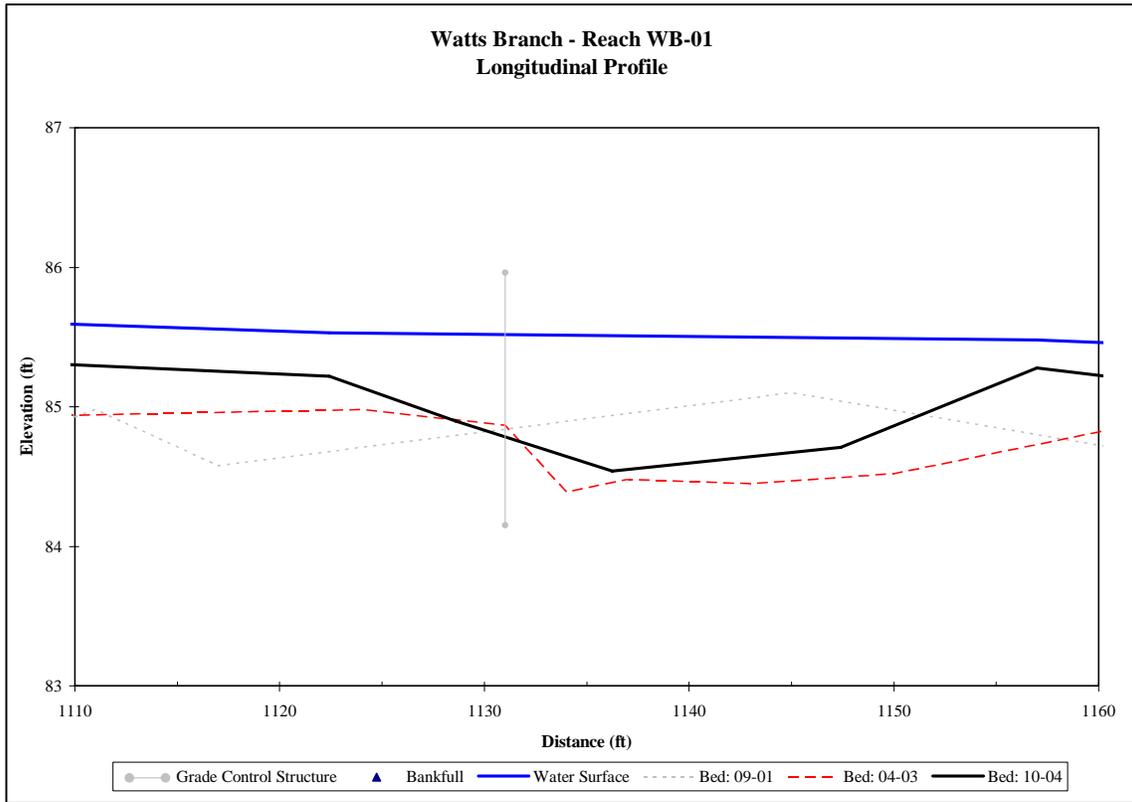
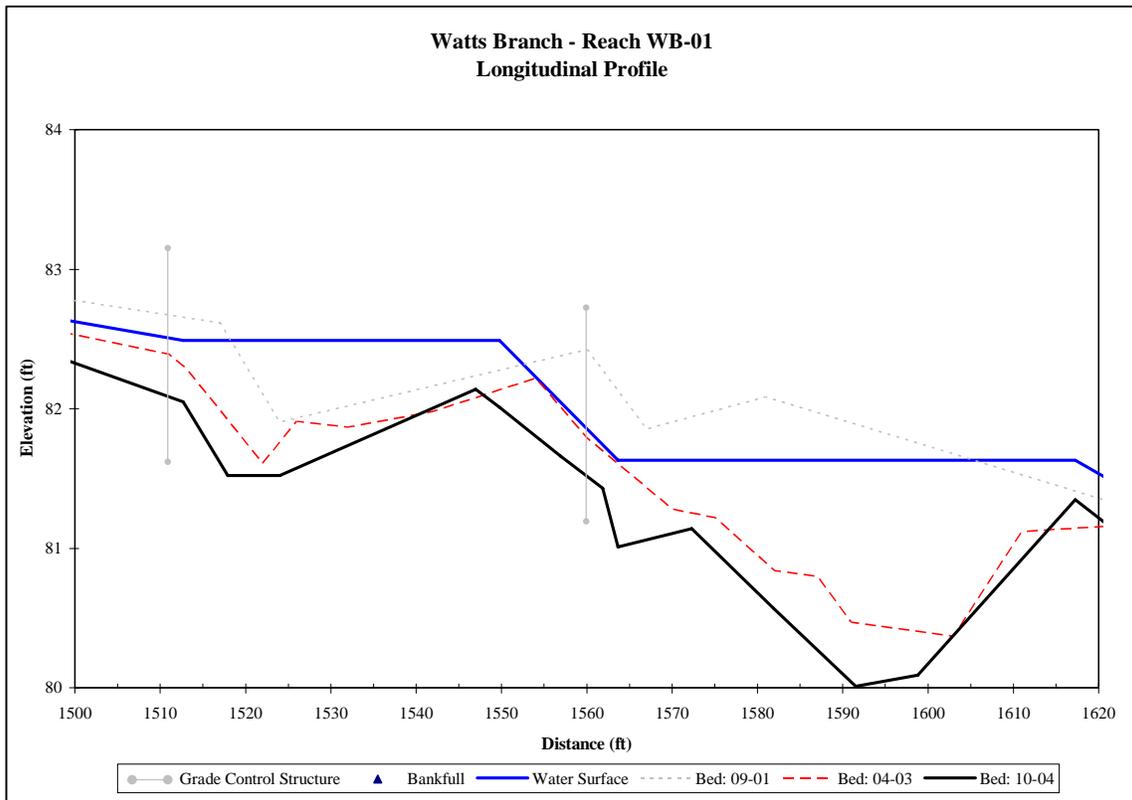
The Service presents enlargements of the longitudinal profile near the rock vanes, cross vanes, and j-hook structures to observe the influence these structures have on the streambed (Figures 4a, b, and c). The Service overlaid all three years of survey data for each profile enlargement.

In general, vertical adjustments at grade control structures reflected the overall adjustments observed in the upper, middle, and lower sections of the study reaches. For the 2001 and 2003 longitudinal profile overlay, the Service observed scour near the grade control structures, in the upper and middle sections, ranging from 0.09 feet to 1.62 feet. The Service also observed minor areas of aggradation in these sections. The Service observed significant aggradation at the grade control structures in the lower section, ranging from 0.10 feet to 1.38 feet.

For the 2001 and 2004 longitudinal profile overlay, the Service continued to observe scour near the grade control structures, in the upper and middle sections, ranging from 0.09 feet to 2.08 feet. The Service continued to observe minor areas of aggradation in these sections, and significant aggradation at grade control structures, in the lower section, ranging from 0.13 feet to 0.64 feet.

However, some of the grade control structures may not be operating at their full potential, based on the minor changes in bed elevation upstream of the structures and the shallow scour development. The changes in elevation should not affect the functions of the structures, assuming the structures were properly constructed with footer rocks.
