Daniels Run Stream Restoration Fairfax, Virginia

Survey and Alternative Analysis Report

CBFO-S06-04
July 2006

By: Richard R. Starr and Christopher K. Eng

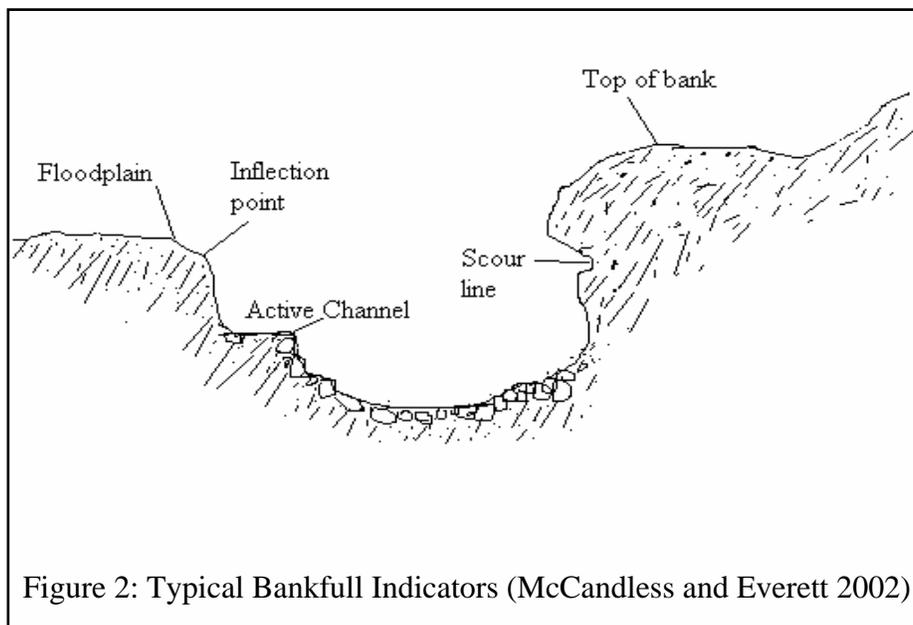
During the Daniels Run assessment, the Service identified bankfull stage using physical indicators of bankfull stage described by McCandless and Everett (2002). Figure 2 depicts significant geomorphic indicators typically found in Maryland. Based on these indicators, the Service identified a consistent geomorphic feature at Daniels Run. This geomorphic indicator was typically a significant slope break or back of bench found throughout the project area. However, in some locations, the indicators were less defined or absent because of active erosion or where the stream has a high entrenchment; and non-existent where there were bank revetments.

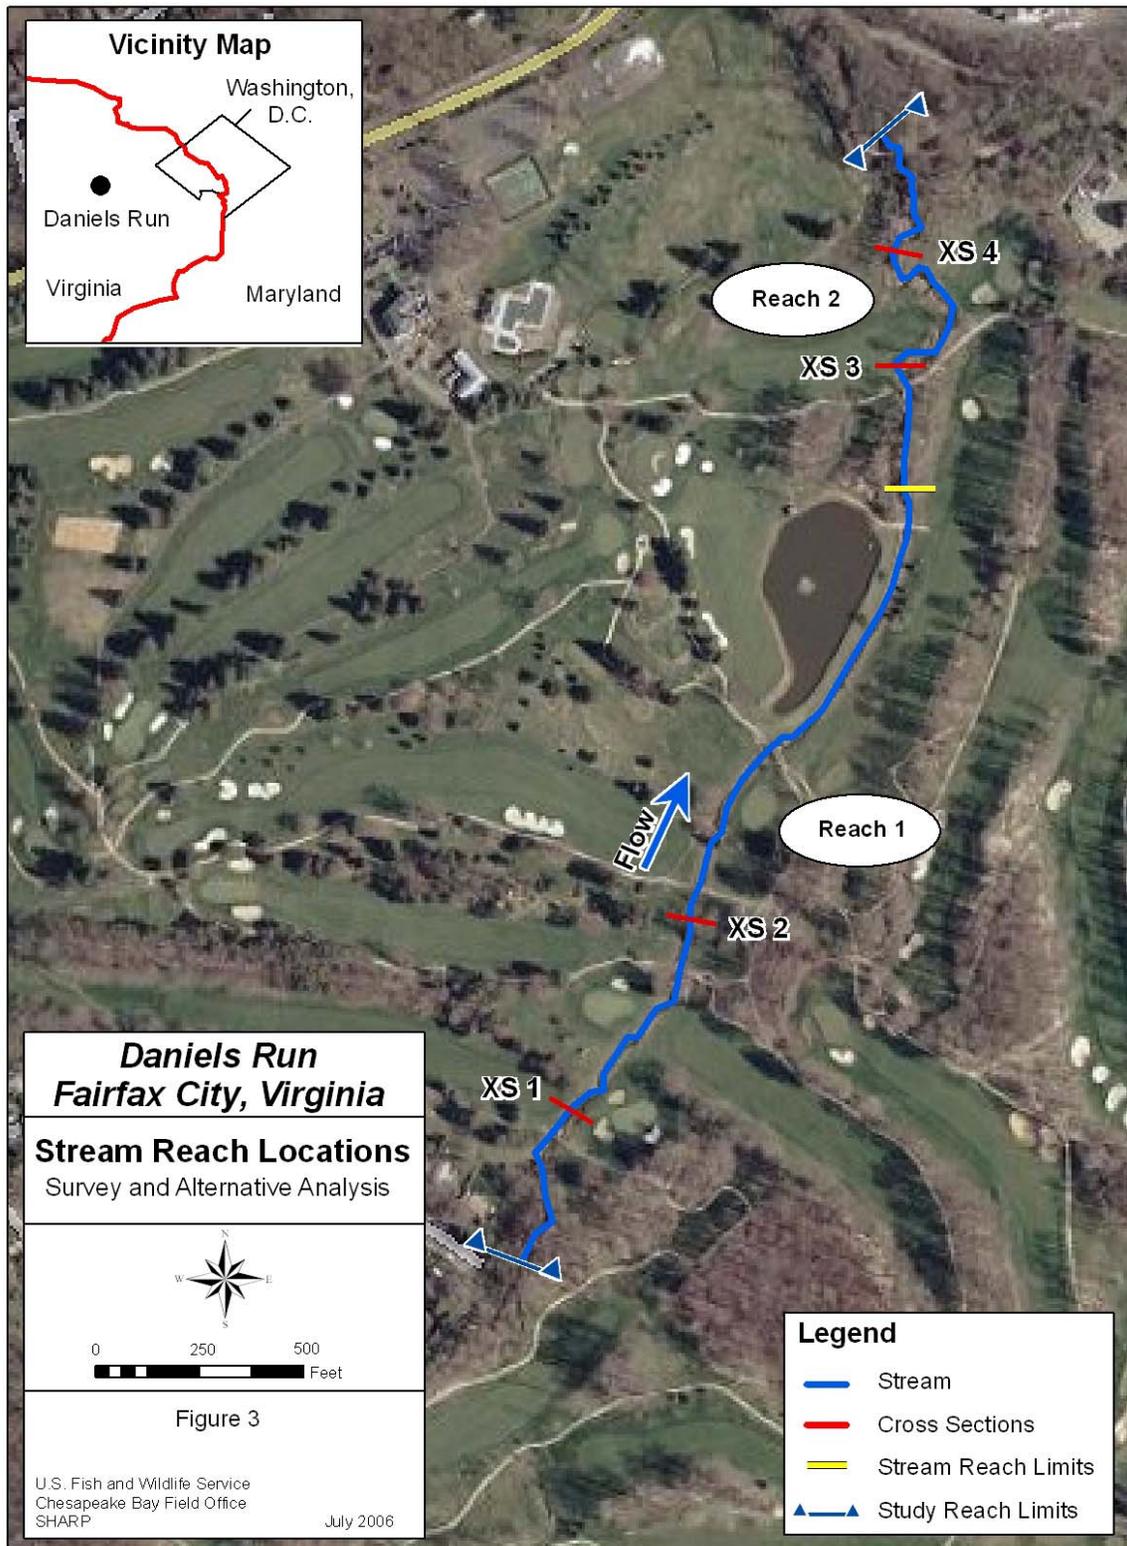
The Service delineated three Rosgen stream types (*i.e.*, E4 F4, and B4c) in the Daniels Run project area based on geomorphologic characteristics and stability conditions (Rosgen 1996) (Figure 3). The letter associated with the stream type indicates general stream characteristics (*e.g.*, entrenchment, width/depth ratio, and sinuosity). The “4” suffix indicates a gravel channel substrate and the “c” suffix indicates a lower than typical stream slope.

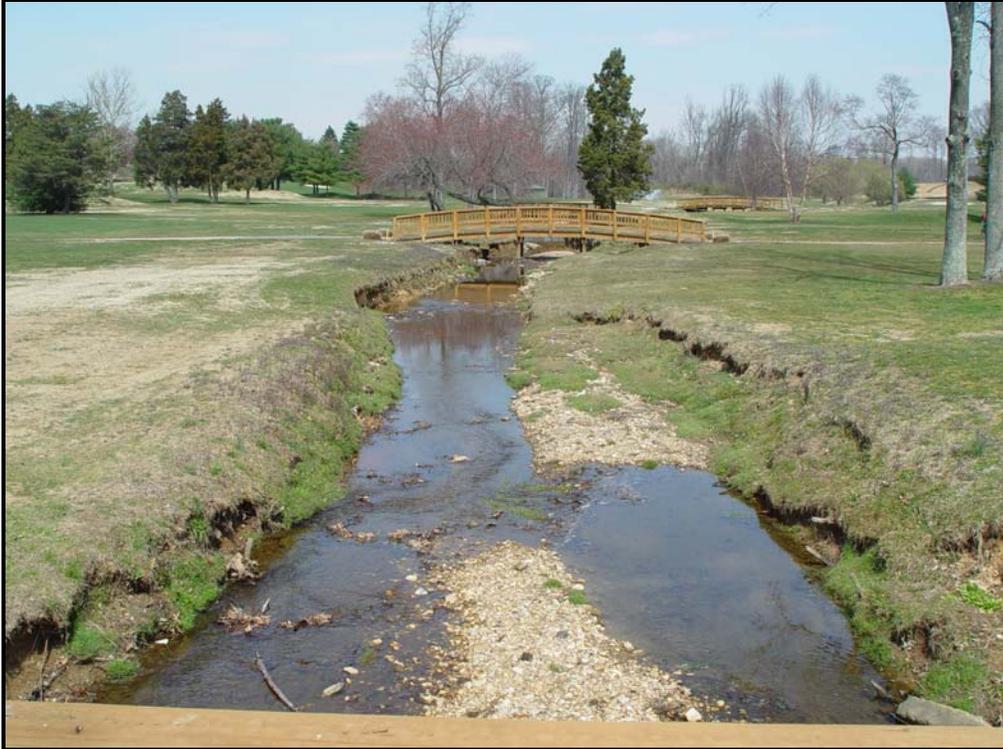
Reach 1 begins where Daniels Runs crosses the ANCC's southern property line and flows northward for approximately 1,746 ft, ending at an in-line wet-well inlet. The reach is a Rosgen E stream type that is adjusting to an F stream type. In general, the E4 stream type has a bankfull width of 16.25 feet, bankfull depth of 1.80 feet, cross-sectional area of 29.28 square feet, sinuosity of 1.07, and water surface of 0.0047 ft/ft. Banks are generally 3 to 5 feet in height and channel incision is low. The F4 stream type has a bankfull width of 35.36 feet, bankfull depth of 0.88 feet, and a cross-sectional area of 31.10 square feet (Photograph 1). Riprap revetments armor approximately 20 percent of the banks. Most of the riprap armoring is located on the right bank of the downstream portion of the reach (*i.e.*, approximately 600 feet). This section of the reach is also adjacent to the golf course water irrigation pond. The 8-foot high earthen dam of the pond runs parallel to the left bank of the stream. Instream habitat is poor to fair with slightly defined pools and riffles. The riparian buffer consists of mowed grass and a few mature canopy trees. Two storm drain outfalls enter the reach at the immediate upstream portion. There is a 40-inch outfall on the left bank and a 24-inch outfall on the right bank. There are also four golf cart bridges and one pedestrian bridge crossing the stream within this reach.

Photograph 1. Typical existing condition of Reach 1.

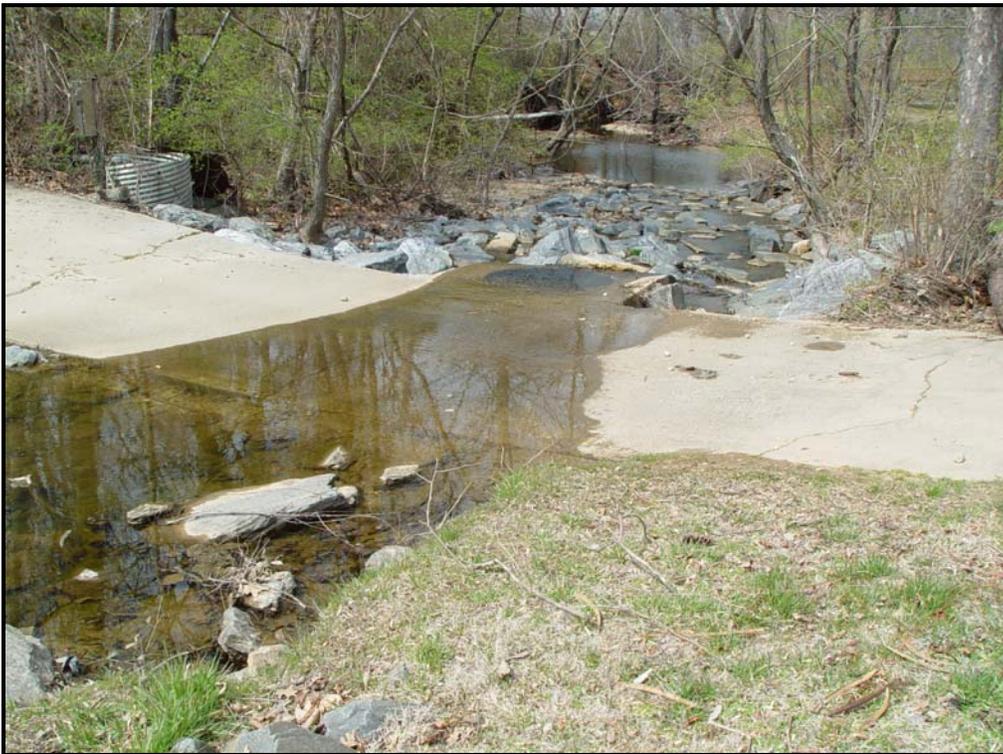
This reach is vertically stable because of the grade control provided by the wet-well inlet at the downstream end of the reach (Photograph 2). The wet-well inlet, constructed of concrete and riprap, has halted the headcut¹ that migrated through Reach 2. However, there is widespread lateral instability throughout the reach, even with the riprap revetments. Approximately 60 percent of the banks are actively eroding. A stream requires a certain sinuosity, based on fluvial processes, in order to remain stable (Leopold *et al* 1964). If the sinuosity is less than what is required, the stream will erode its banks on alternating sides of the stream until it develops a stable sinuosity (Photograph 3). Reach 1 was likely straightened in the past and is now attempting to increase its sinuosity by eroding its streambanks. Additional factors that contribute to reach instability include watershed development and riparian buffer loss. This type of stream has a high potential for sediment supply input, highly sensitive to disturbance and is unlikely to recover on its own. Significant adjustments need to occur for the stream to reach a stable channel dimension, pattern and profile. During that adjustment period, significant inputs of sediment will occur with adverse impacts to aquatic species and instream habitat.

Photograph 2. ANCC wet-well inlet.

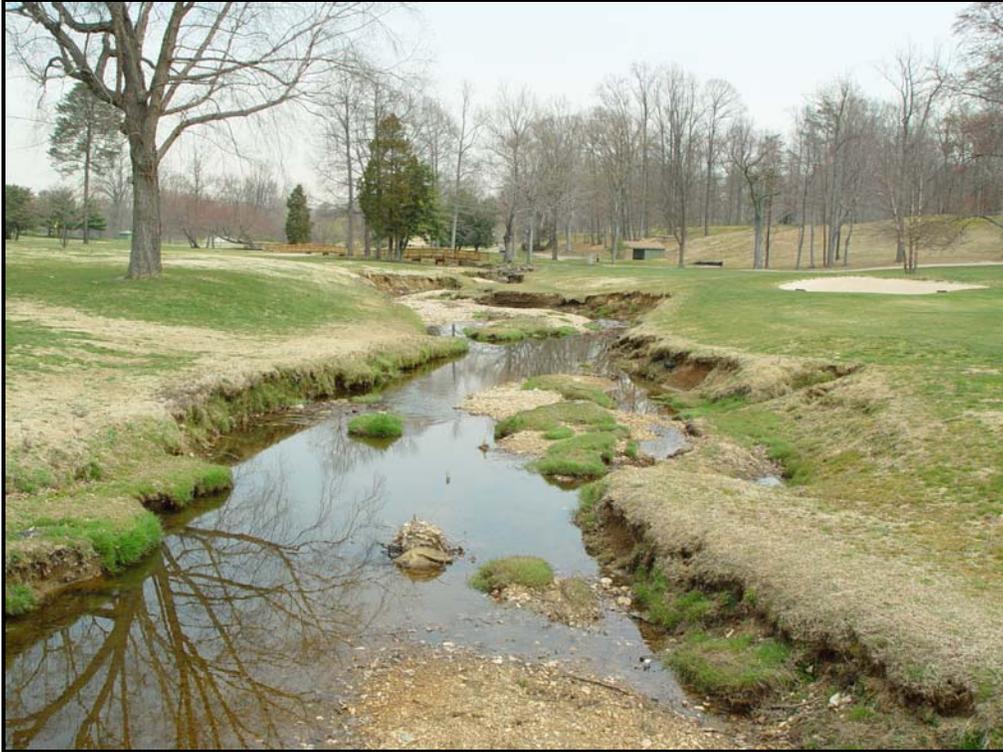
Photograph 3. Alternating bank erosion as stream adjusts to increase sinuosity.

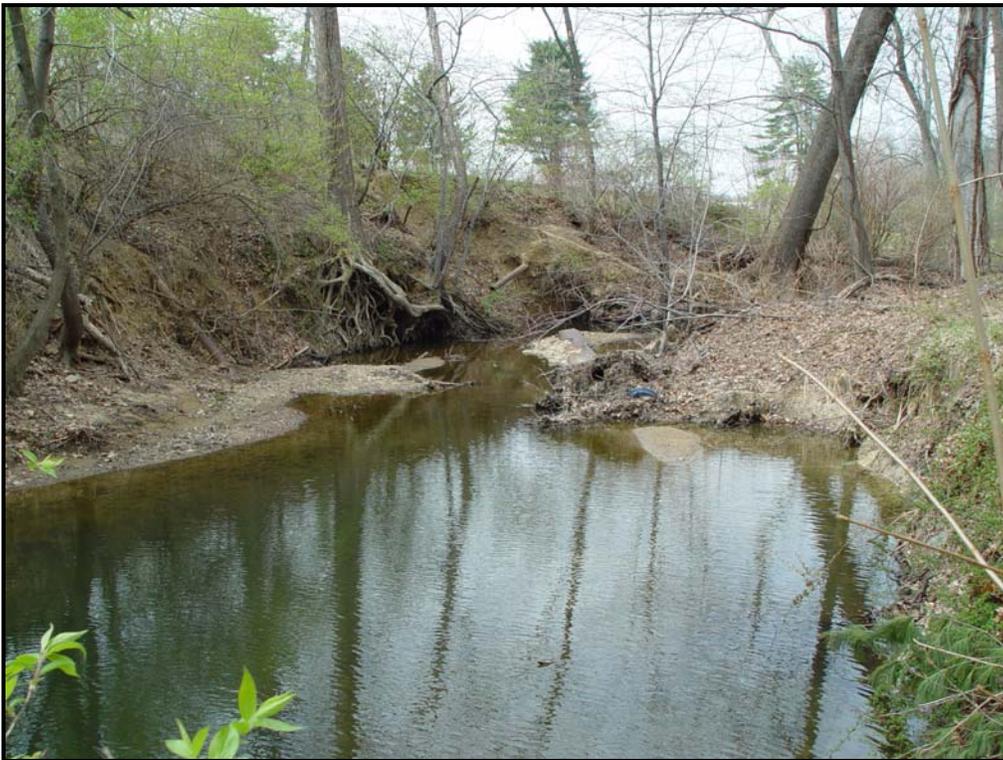
Photograph 4. Typical existing condition of Reach 2.

The reach appears vertically stable; however, sometime in the past a headcut moved through the reach and degraded the streambed by an average of 6 to 9 feet. The headcut was likely the result of a decrease in the base level at Accotink Creek. When there is a change in the base level of a stream, the streambeds of all tributaries to that stream will also degrade until stream equilibrium is re-established (Leopold 1994). The change in base level causes an increase in stream slope and erosive forces, resulting in stream degradation and abandonment of the active floodplain.

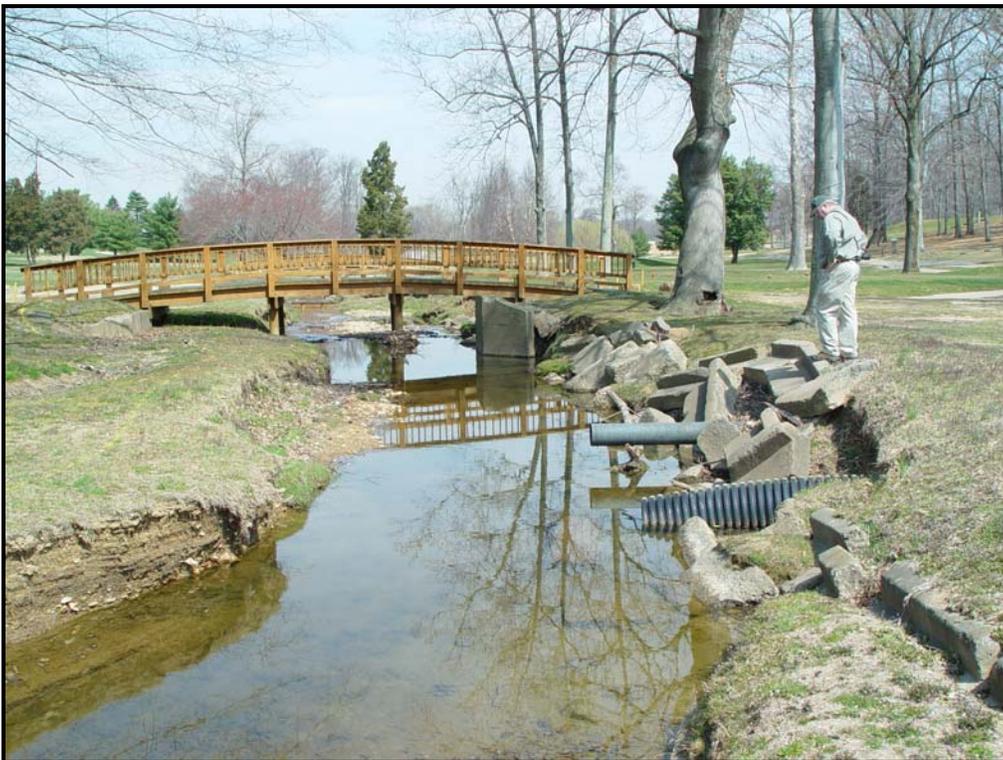
There are five golf cart bridges and two pedestrian bridges crossing Daniels Run within the project area. The bridges are wooden and set on wooden pylons (Photographs 6 and 7). The Service conducted a preliminary bridge analysis to determine if bridge modifications or relocations would be necessary as part of the stream restoration effort. The bridge analysis involved the determining of: 1) whether the bridge openings can pass the bankfull discharge and 2) whether the bridges openings could accommodate the appropriate stream entrenchment. The Service determined that all the bridges could pass the bankfull discharge. Most of the bridges could accommodate the appropriate stream entrenchment; those bridges that could not accommodate the appropriate entrenchment will require additional stream design engineering.

Photograph 6. Typical golf cart bridge.

Currently, the relocation or removal of only one bridge was required as part of the stream restoration effort. This bridge is the farthest downstream pedestrian bridge approximately 100 feet downstream from Blue One golf cart bridge. Preservation of the pedestrian bridge was not possible because realignment of the stream channel was necessary to achieve a stable stream plan form. Additionally, the Service has determined, based on a preliminary evaluation, that the relocation of the Blue One golf cart bridge will not be necessary at this time. This determination may change as the Service further develops the restoration design, and relocation of this bridge may be required to achieve a stable stream design.

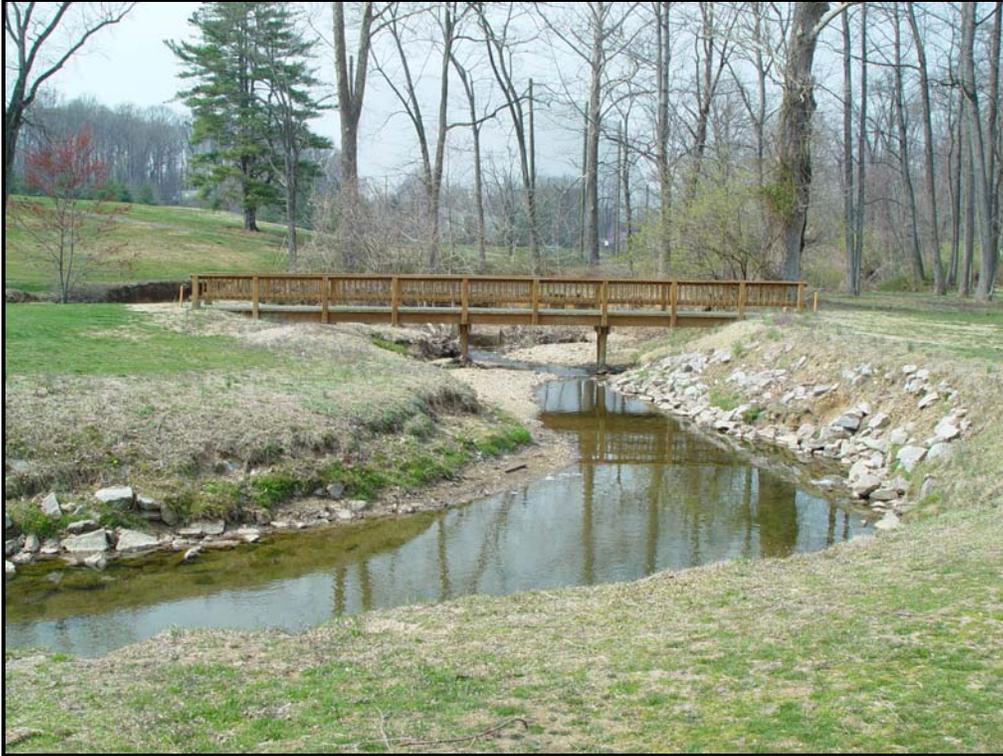
Photograph 7. Typical pedestrian bridge.

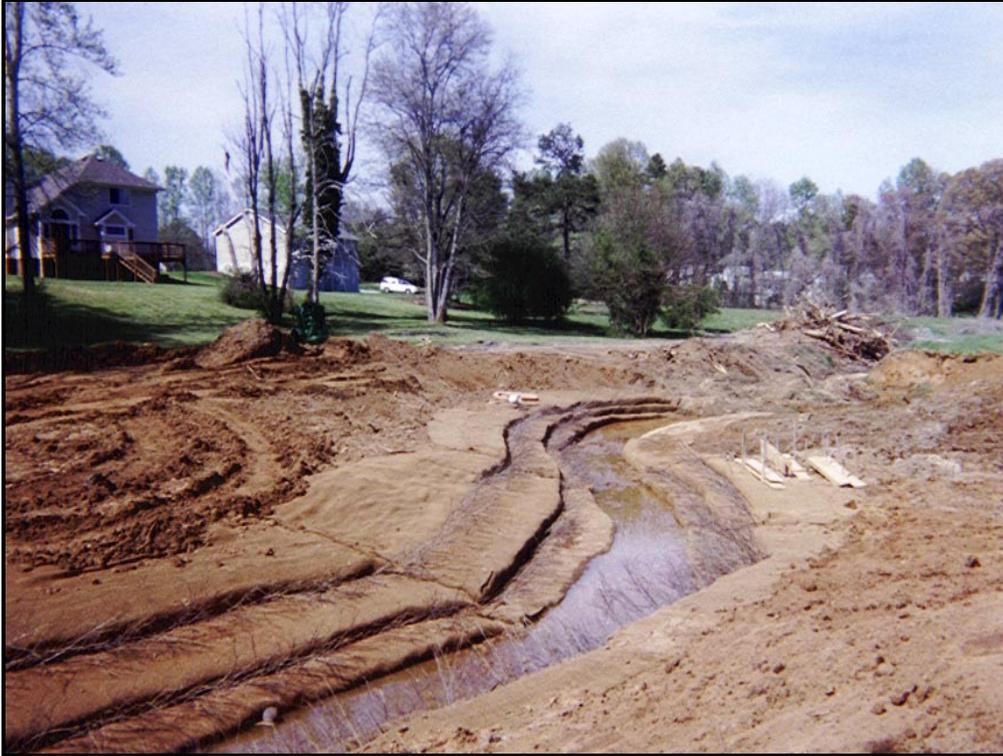
Photograph 8. Soil fabric lifts under construction.

Soil fabric lifts are layers of soil held temporally in-place with a bio-degradable fabric (Photographs 8 and 9). The soil lifts are vegetated with a grass seed mix and live cuttings are placed in between the soil layers. Roots from the grass and live cutting establish and naturally maintain the soil layers, replacing the degrading fabric. Adjustments to the vegetation plan may be required to accommodate golf playability.

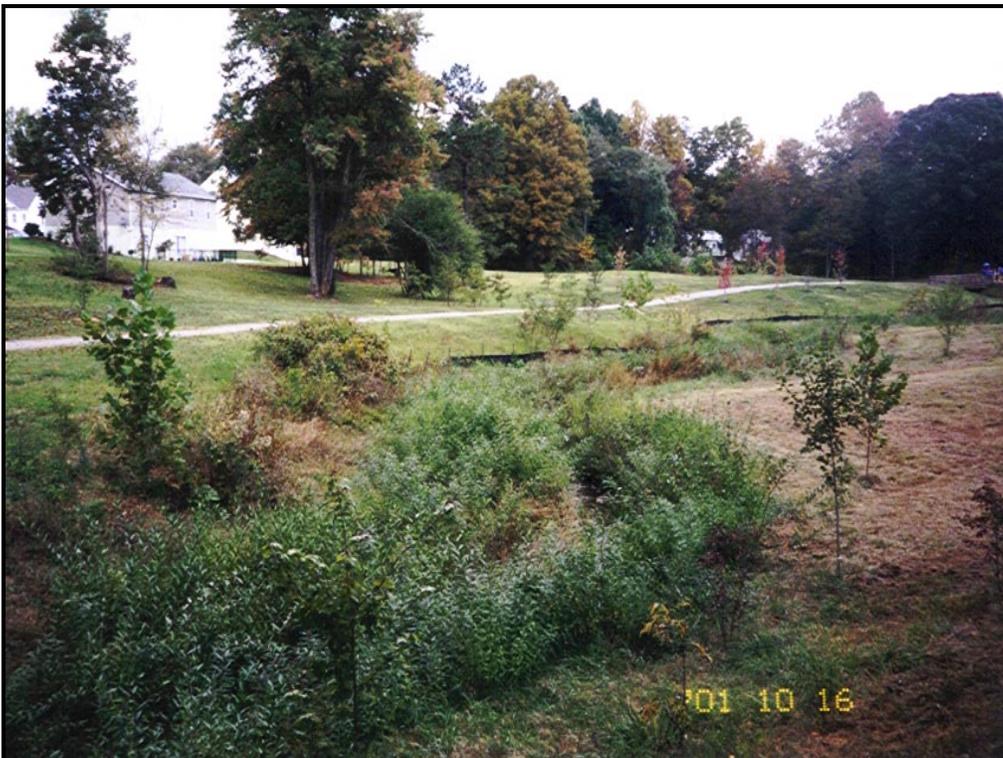
Photograph 9. Soil fabric lifts 17 months after construction.

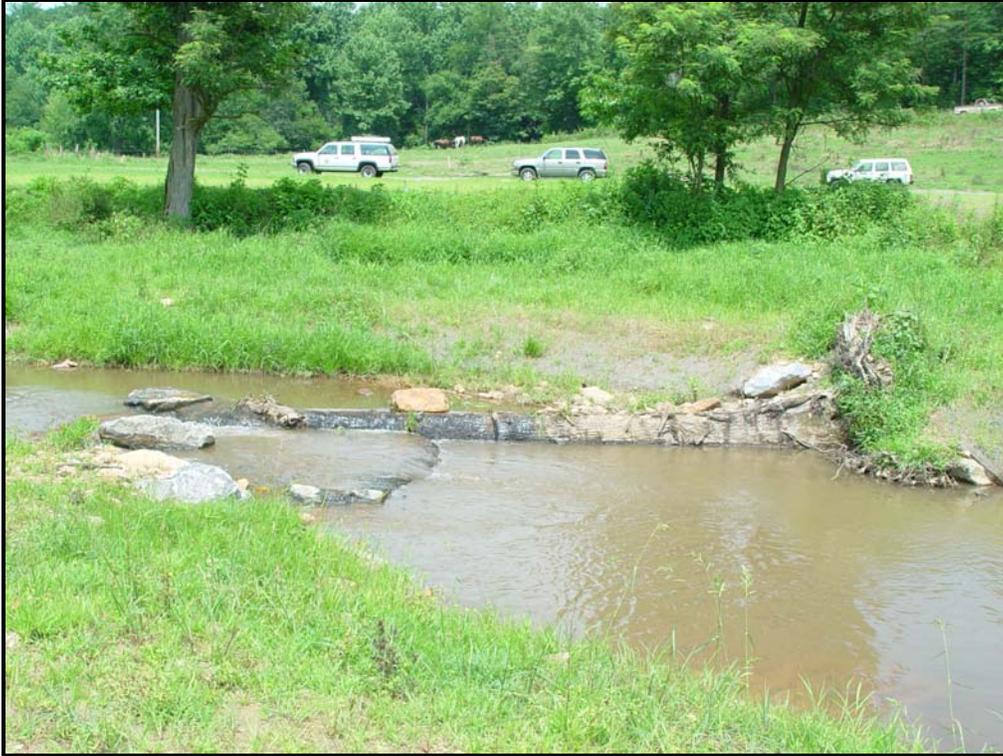
Photograph 10. Example of a log/rock j-hook.

Rock and log structures are instream structures, made of rocks and logs, used to divert erosive stream flows away from streambanks and maintain streambed elevations. The most typical rock and log structures used from stream restoration are vanes and j-hooks (Photographs 10, and 11). The rock and log structures provide streambed and bank stability and allow the streambed to naturally armor and the riparian vegetation to establish.

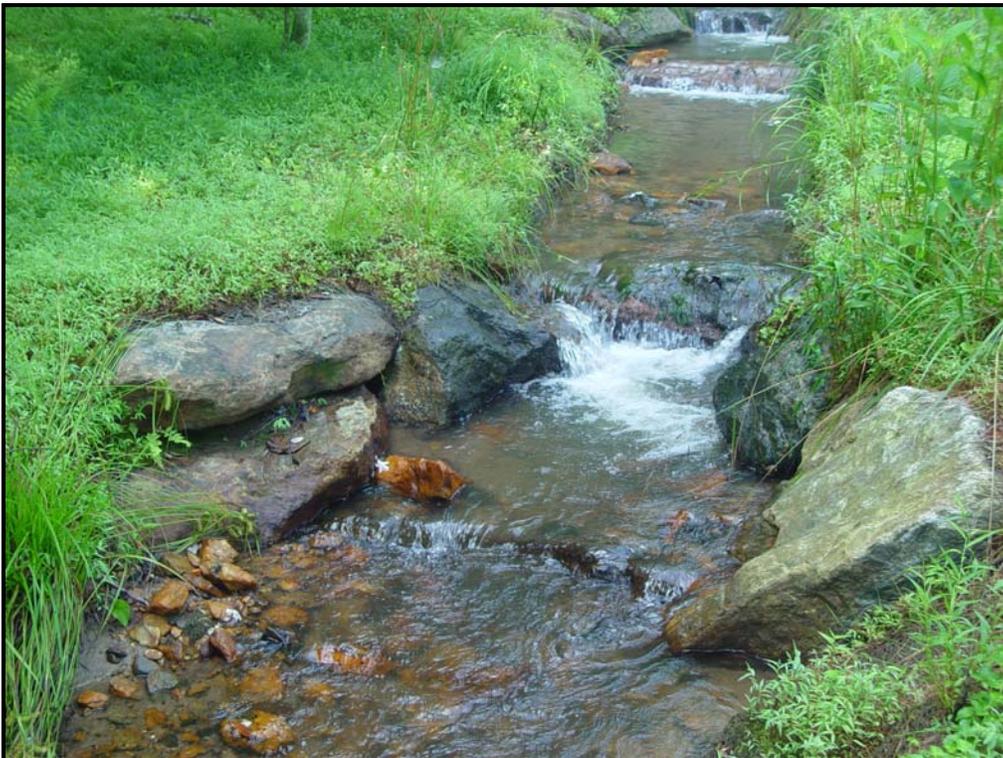
Photograph 11. Example of a rock cross vane.

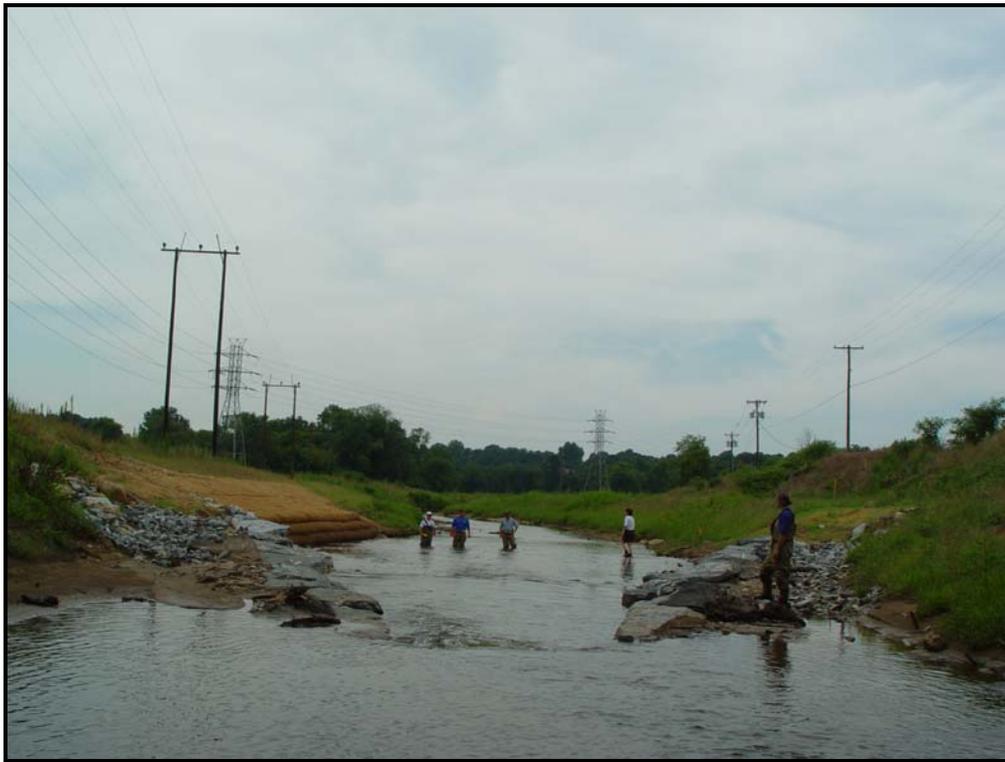
Photograph 12. Example of a rock cross vane and soil fabric lifts.

The soil fabric lifts and rock and log structures alternative is a combination of both restoration methods (Photographs 12). This alternative is typically used for stream restoration projects that have site or restoration objective constraints (*e.g.*, infrastructure and stream confinement.). The benefit to this alternative is that it combines the advantages associated with each of these methods, but design and implementation can be more complex.

The Service recommends the structures and soil lifts restoration alternative for the restoration of Daniels Run. This alternative scored the highest because it was the most successful alternative at
