Hickey Run, Washington, D.C. Watershed and Stream Assessment

CBFO-S05-01
December 2005

HICKEY RUN, WASHINGTON, D.C. WATERSHED AND STREAM ASSESSMENT

By: Richard R. Starr and Tamara L. McCandless

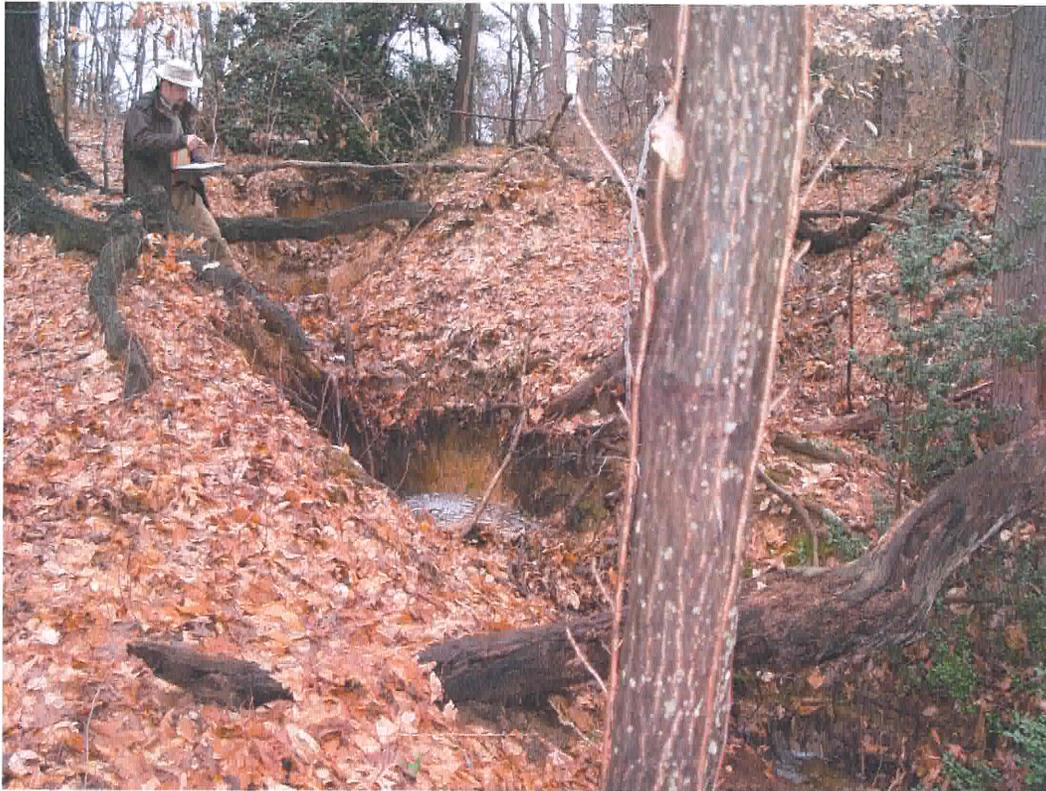
HR-LT-02-RT-01 and 02 – The HR-LT-02-RT-01-01 and 02 are reaches to an ephemeral tributary of HR-LT-02 approximately 200 feet upstream of Valley Road. The existence of this tributary is recent, most likely because of broken drain tiles, and therefore cutting a new channel into the valley floor (Photograph 10). HR-LT-02-RT-01-02 is an unstable Rosgen G5 stream type and HR-LT-02-RT-01-01 is a stable Rosgen E5 stream type both 2 to 3 feet wide. HR-LT-02-RT-01-02 has three major headcuts (totaling 7 to 8 feet in vertical height) actively eroding upstream into HR-LT-02-RT-01-01 (Photograph 11). The head cuts probably formed as the stream's energy increased where the flows drop over the steep valley slopes before entering HR-LT-02. Even though it is a small stream, there are significant impacts to the downstream reaches on HR-LT-02 because of the sediment produced from the eroding headcuts. If not addressed, the headcuts will continue to move upstream farther, degrading HR-LT-02-RT-01 and impacting the HR-LT-02 reaches downstream of HR-LT-02-RT-01.

Photograph 11. Typical HR-LT-02-RT-01 headcut.

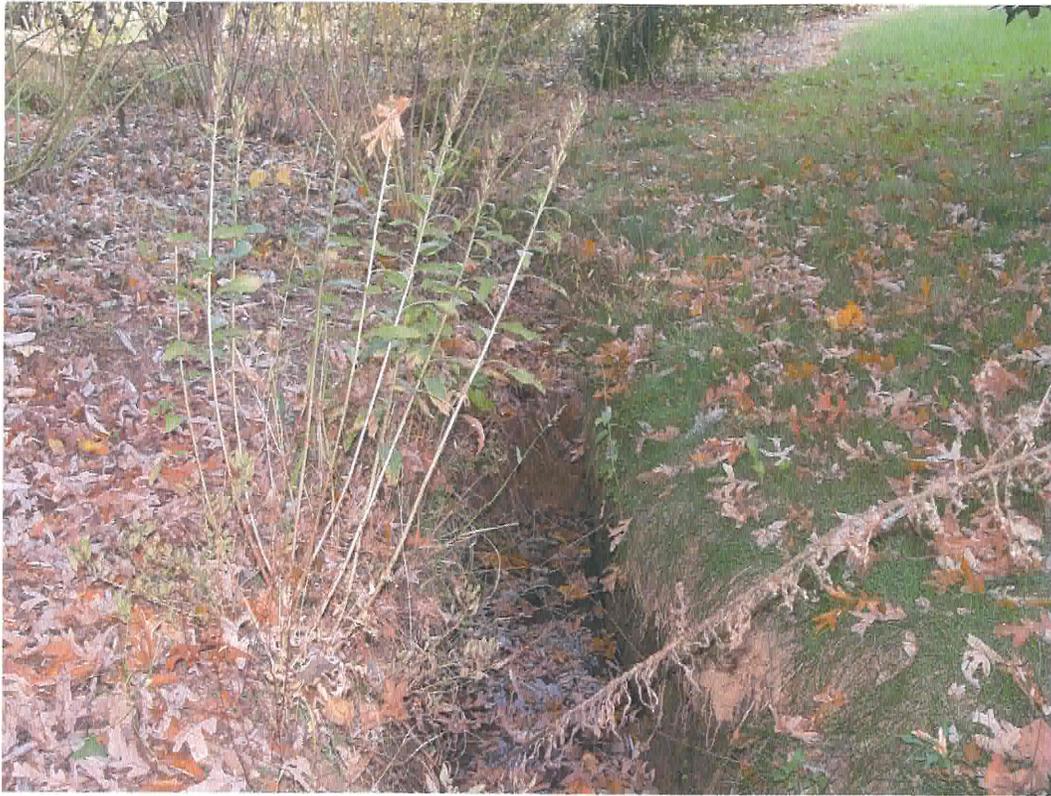
HR-LT-01-04 (the farthest downstream reach) formed before the other three reaches. HR-LT-03-01, HR-LT-03-02, and HR-LT-03-03 formed within the last three to five years, most likely because of a recently broken stormwater pipe. The stormwater runoff that originally flowed through the broken pipe, now flows across the ground and has formed a new open channel. Only 18 percent of the tributary is vertically and laterally unstable. However, the instability is significant because it is associated with three actively eroding headcuts. One headcut (2 to 3 foot vertical height) exists at the downstream end of HR-LT-03-03 (Photograph 13). The other two headcuts (1 to 2 foot vertical height) are on HR-LT-03-01 (Photographs 14 and 15). If these headcuts are not addressed, there will be wide spread instability throughout the majority of the tributary. The tributary has a moderate to very high erosion potential, very high to extreme sensitivity to disturbance and mostly a very poor recovery potential.

Photograph 13. Headcut on HR-LT-03-02.

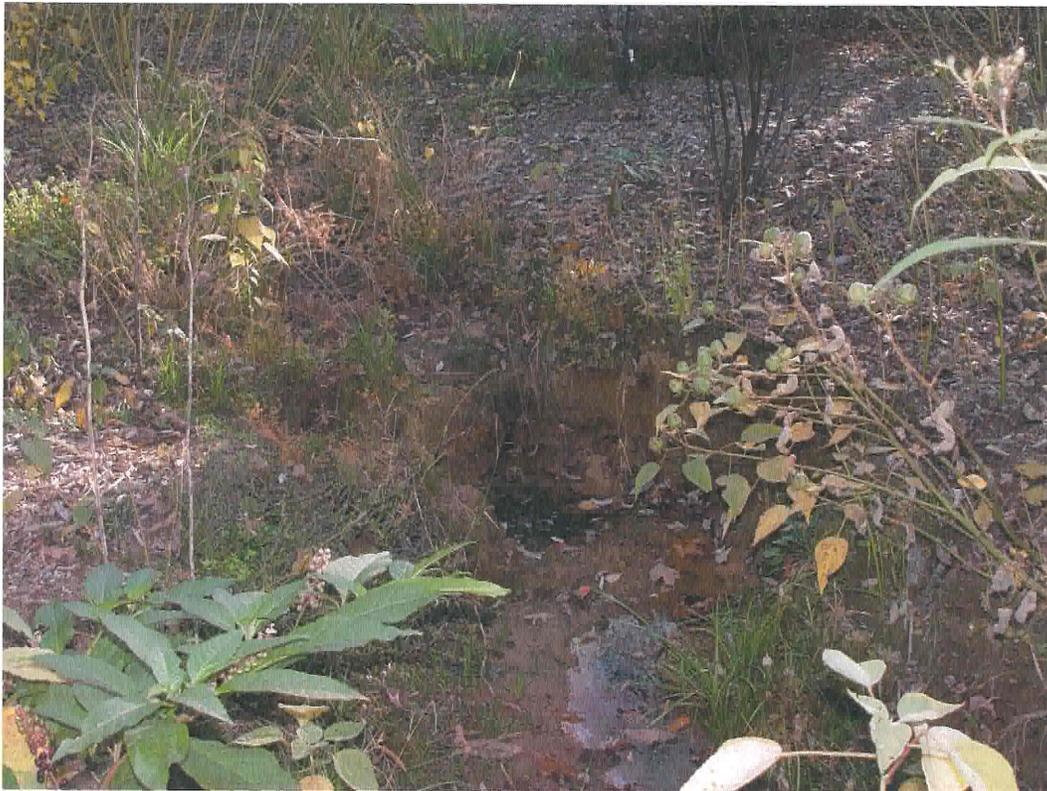
Photograph 14. Upstream headcut on HR-LT-03-04.

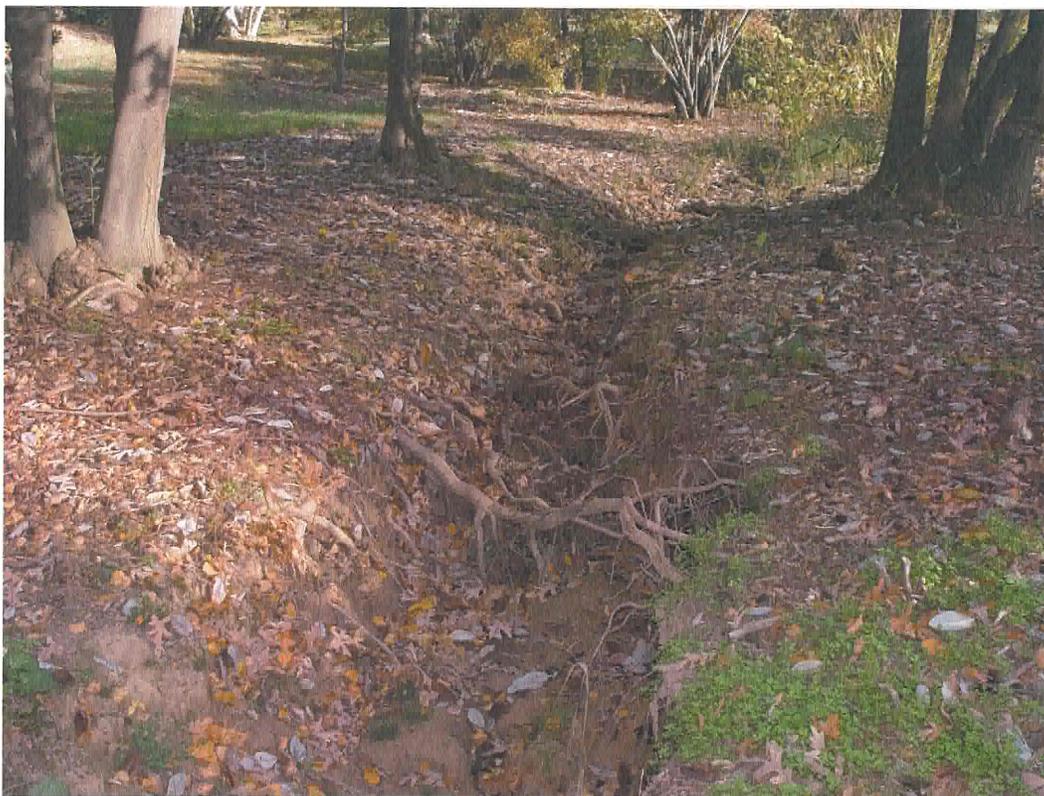
Photograph 15. Downstream headcut on HR-LT-03-04.

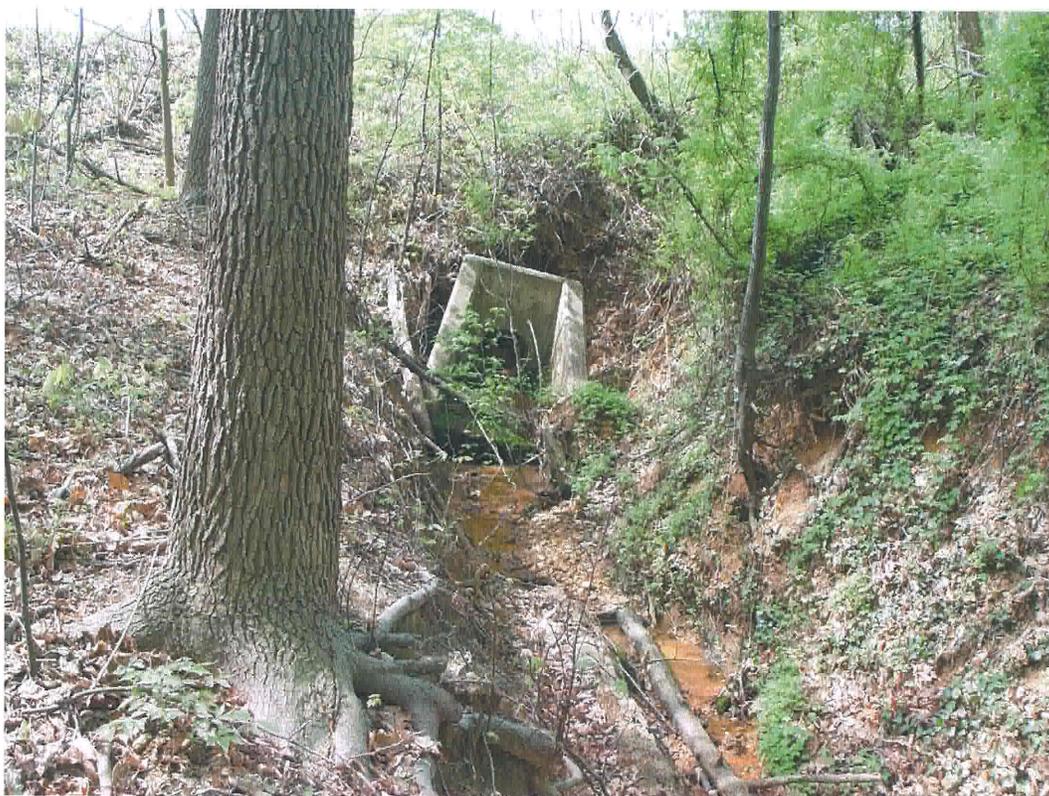
The entire tributary is unstable and has a very high erosion potential, very high to extreme sensitivity to disturbance and poor to very poor recovery potential. The widespread instability is a direct result of urbanization, piping of stormwater flows, and the downcutting of Hickey Run main stem. There is a 10-foot vertically high headcut actively eroding at the start of the tributary caused by the 18-inch outfall, which is now failing (Photograph 16). There are two utility line crossings acting as vertical grade control. The larger one is the District of Columbia, Water and Sewer Authority (WASA) Eastside Interceptor sewer line, which is 72 inches in diameter and encased in concrete. There is a 10 to 12 foot streambed vertical elevation difference between the upstream side of the sewer line to the downstream side.

Photograph 16. Typical HR-RT-01 stream character.

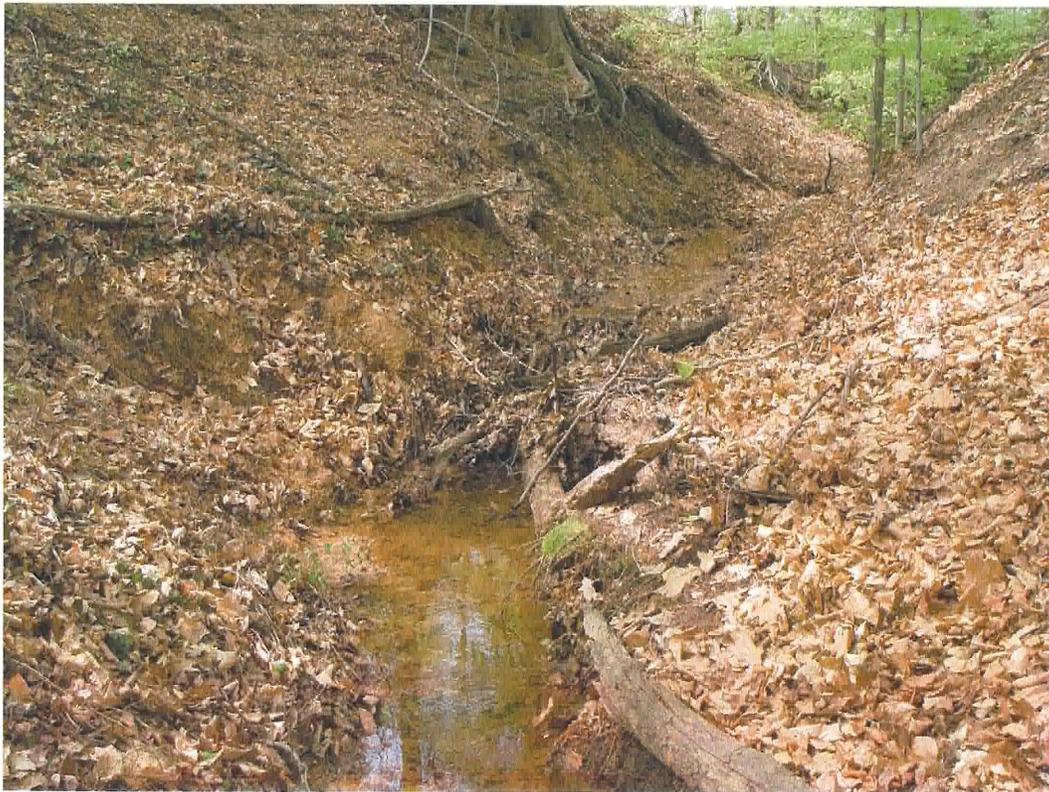
Seventy five percent of the tributary is unstable and has a very high erosion potential, very high to extreme sensitivity to disturbance and poor to very poor recovery potential. In HR-RT-02-01 streambanks are eroding at the toe and experiencing slope failure. There are three headcuts actively eroding: two (12 and 18 inches in vertical height) on HR-RT-02-01 and the third one (48 inches in vertical height) is on HR-RT-02-03 near the upstream end of the reach (Photographs 18, 19, and 20). The widespread instability is also a direct result of urbanization, piping of stormwater flows, and the downcutting of Hickey Run main stem. The only stable section of the tributary (HR-RT-02-02) is a result of the Eastside Inceptor sewer line, which also crosses this tributary, acting as grade control and not allowing the reach to downcut. Below the crossing, the bed of reach HR-RT-02-03 is 7 feet lower than the bed upstream of the crossing.

Photograph 18. Headcut on HR-RT-02-03.

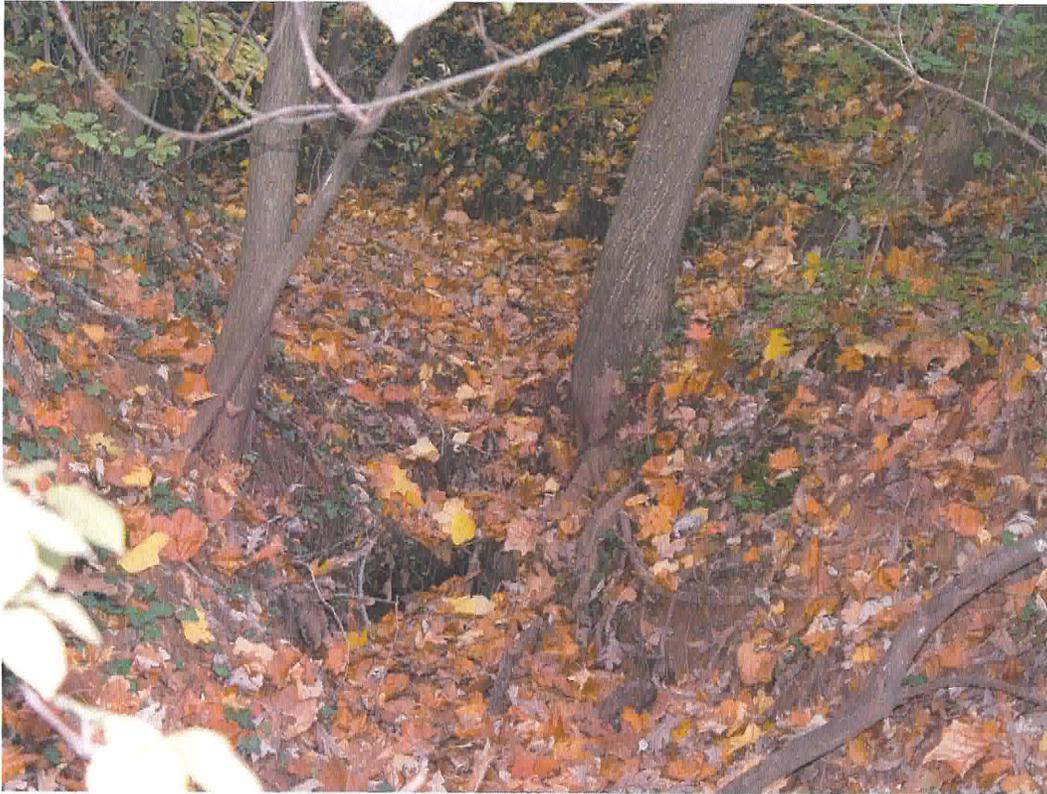
Photograph 19. Downstream headcut on HR-RT-02-01

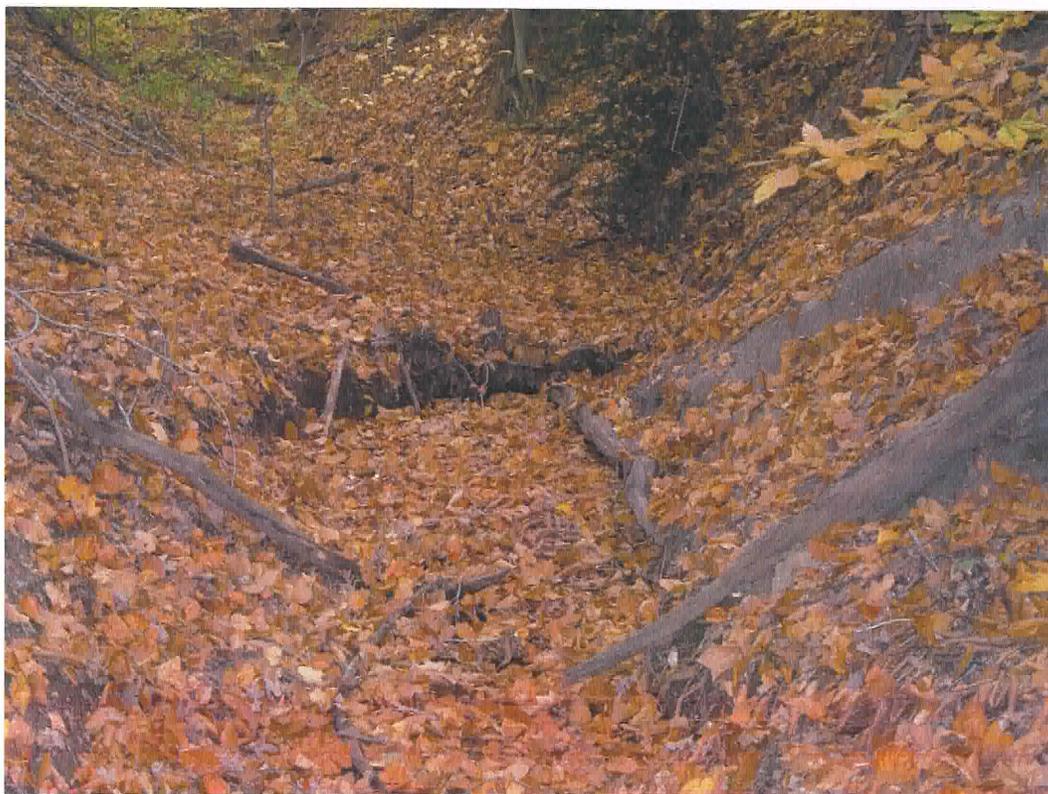
Photograph 20. Upstream headcut on HR-RT-02-03

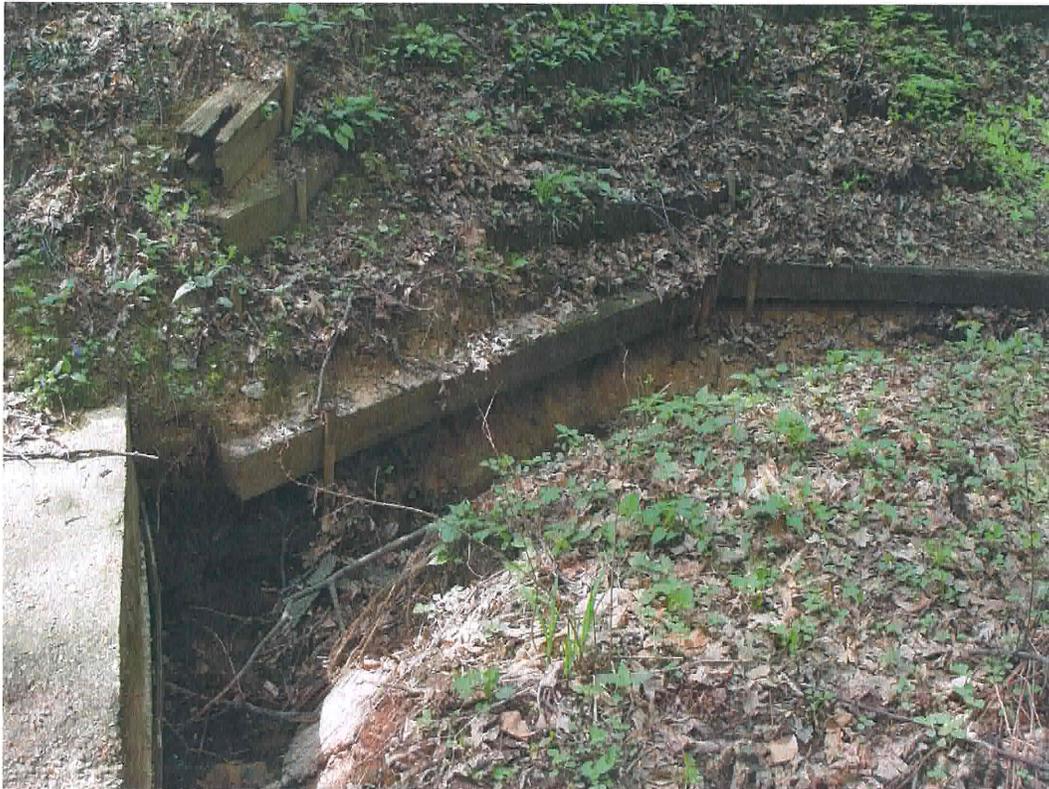
At the upstream end of HR-RT-03-03, where the stream daylights from a pipe, there is a 6-foot headcut that large rip rap was used to stop the erosion. The rip rap does not appear to have any footers and there is a potential for the stream to undercut the rip rap and continue eroding upstream is moderate to high. If the rip rap is able to dissipate the energy of the flows coming from the pipe, then the upward movement of the headcut may be halted. Farther downstream on HR-RT-03-03 there is timber cribbing and a concrete check dam that have the potential to fail and no longer provide bank and bed protection because of current stream undermining (Photograph 22).

Photograph 22. Undermining erosion of crib wall bank protection on HR-RT-03.

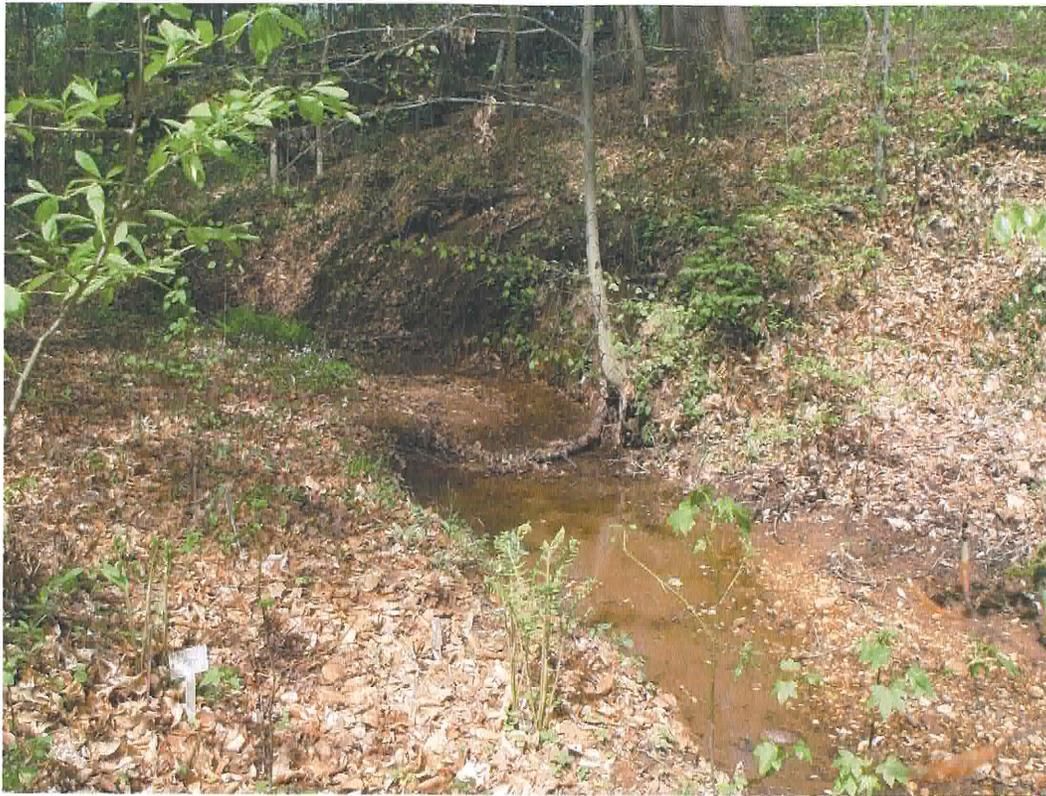
On HR-RT-03-04 there are mortared stone walls and a concrete check dam that also have the potential to fail because of stream undermining. This reach also has some localized bank erosion occurring on the left bank at the upstream end of the reach. The eroding bank is approximately 40 feet long and 5 to 6 feet high and if not addressed will continue to erode until stabilized (Photograph 23).

Photograph 23. Localized erosion on HR-RT-03.

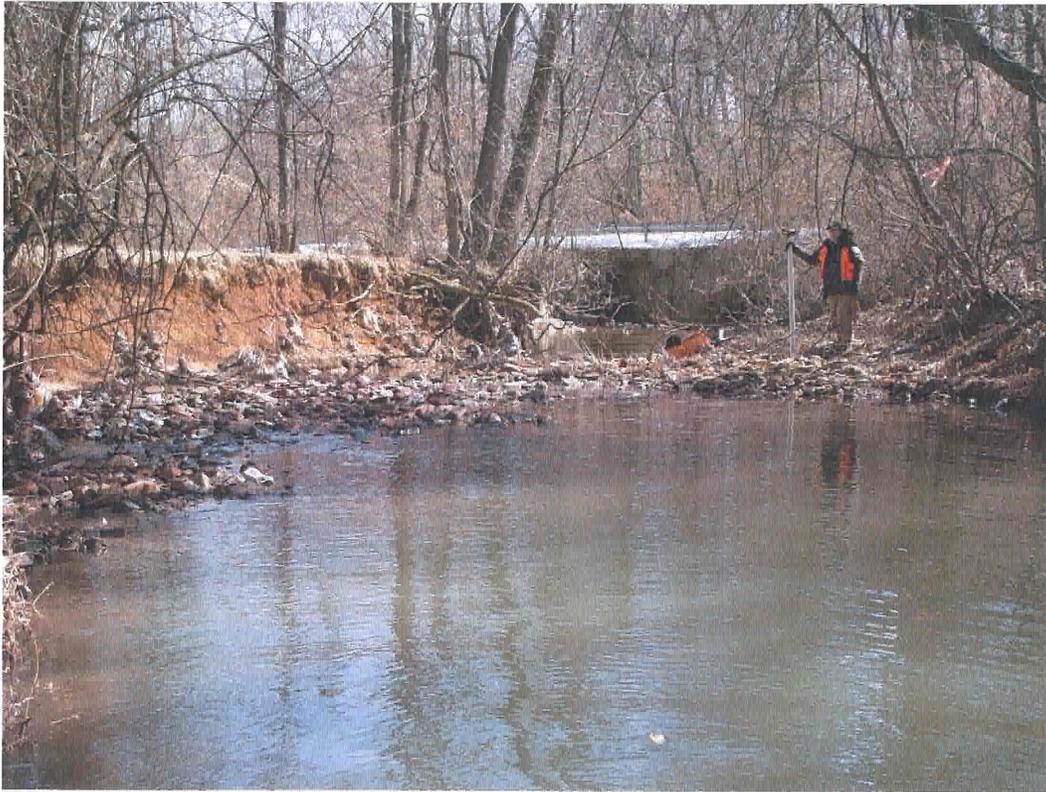
Photograph 29. Severe bank erosion on HR-03 adjacent to Heart Pond.

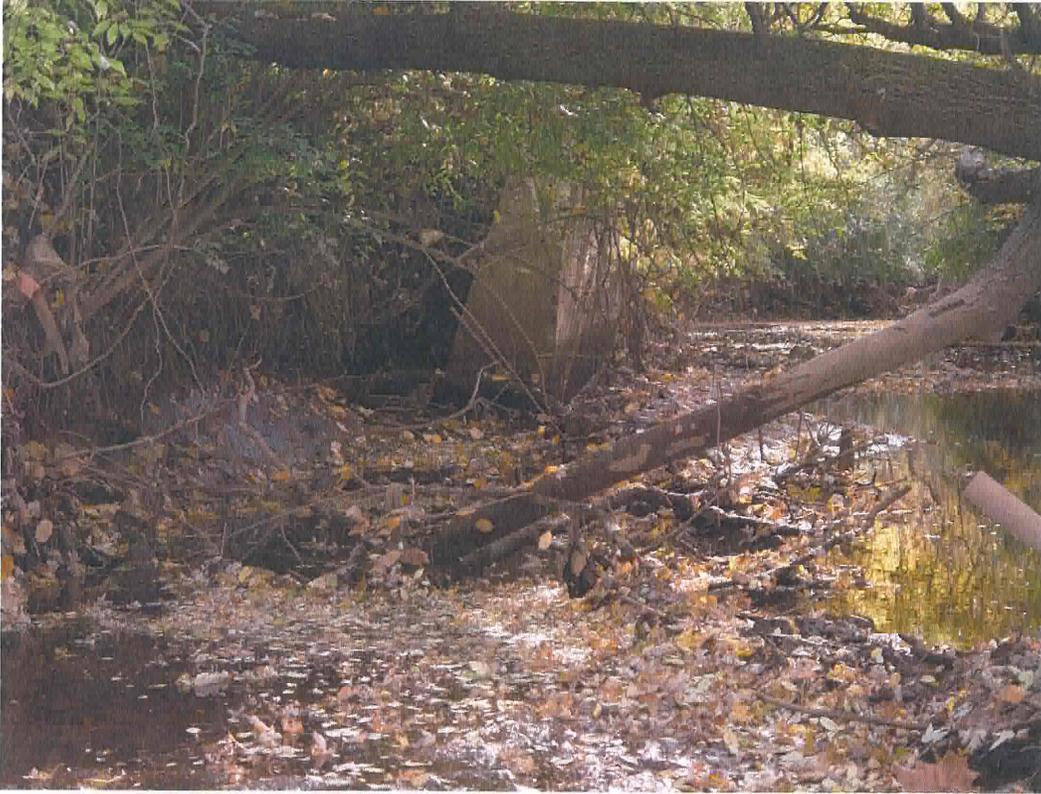
Photograph 33. Failing wall on HR-06.

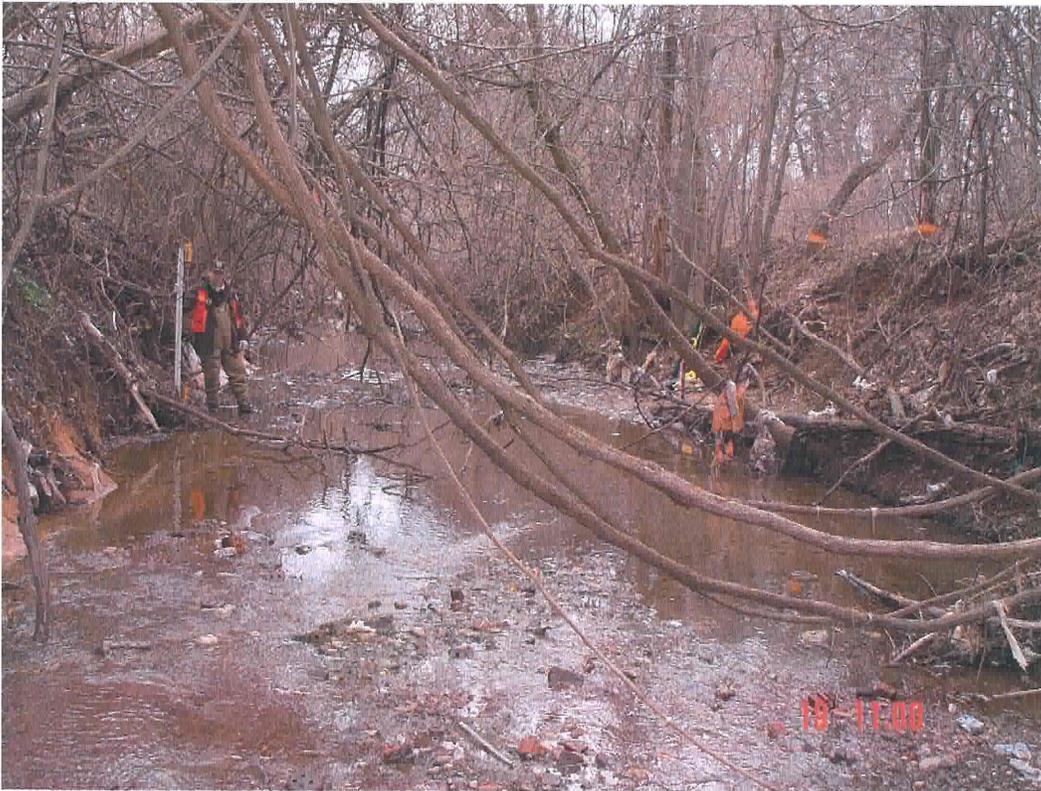
Photograph 34. Example of channel incision (HR-04).

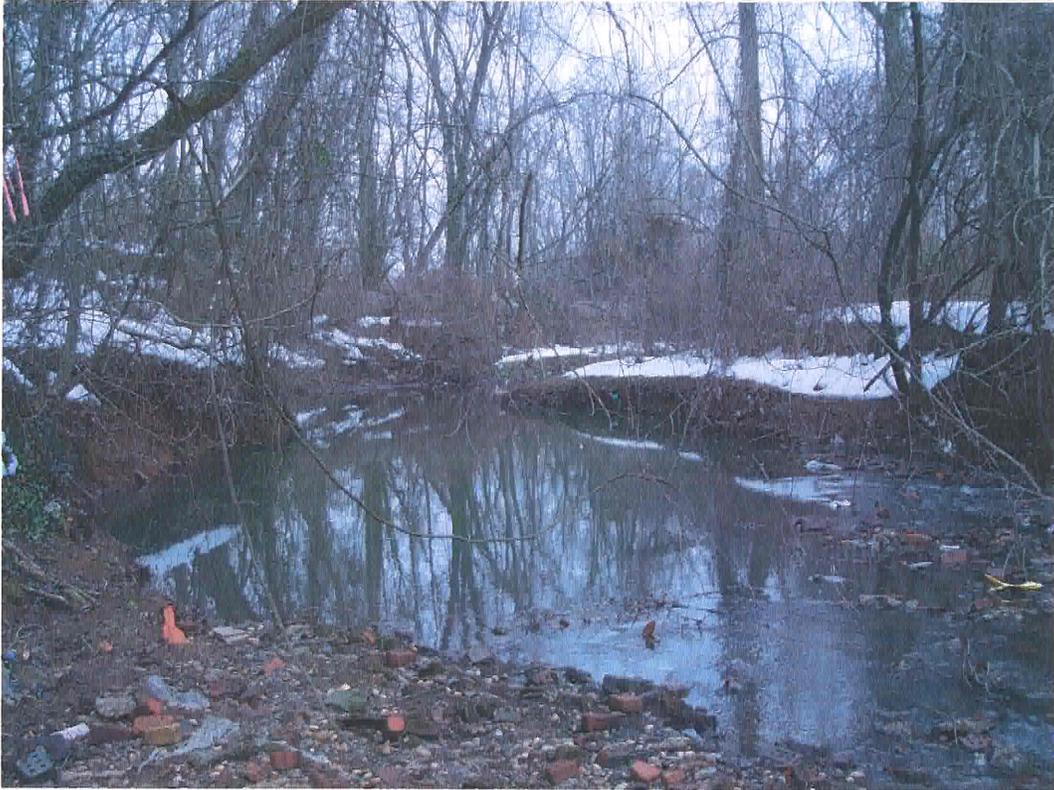
Photograph 35. Example of channel widening (HR-03).

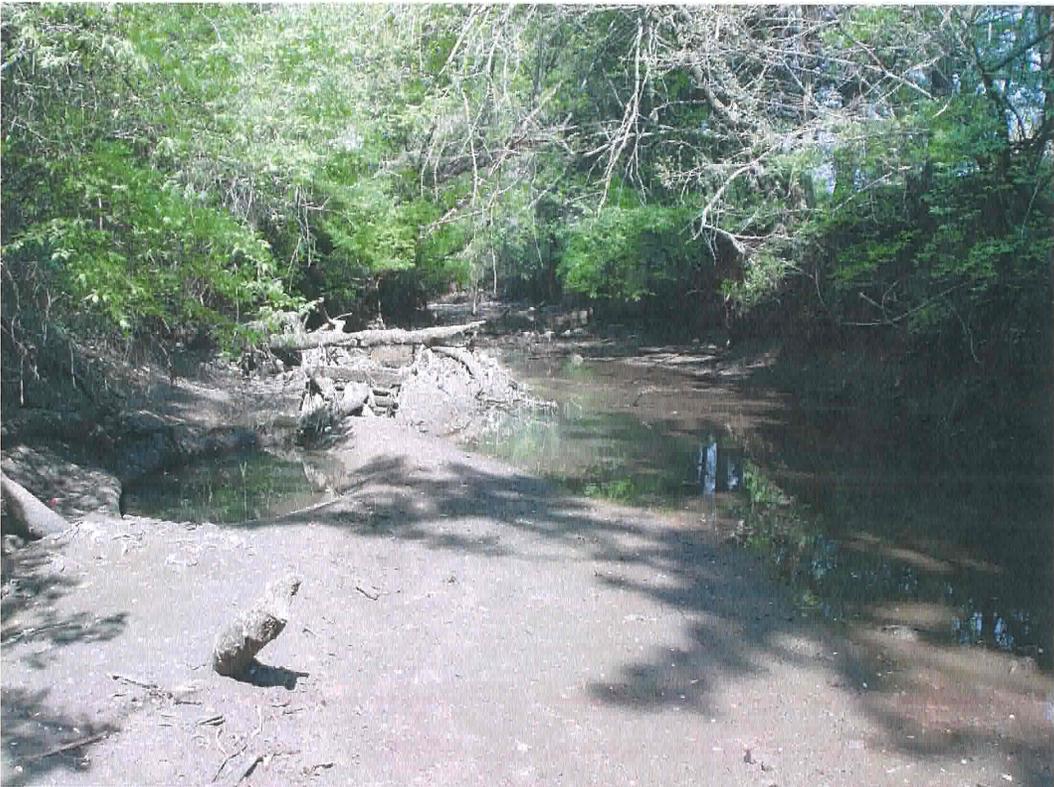
Photograph 36. Example of lateral bar development (HR-06).

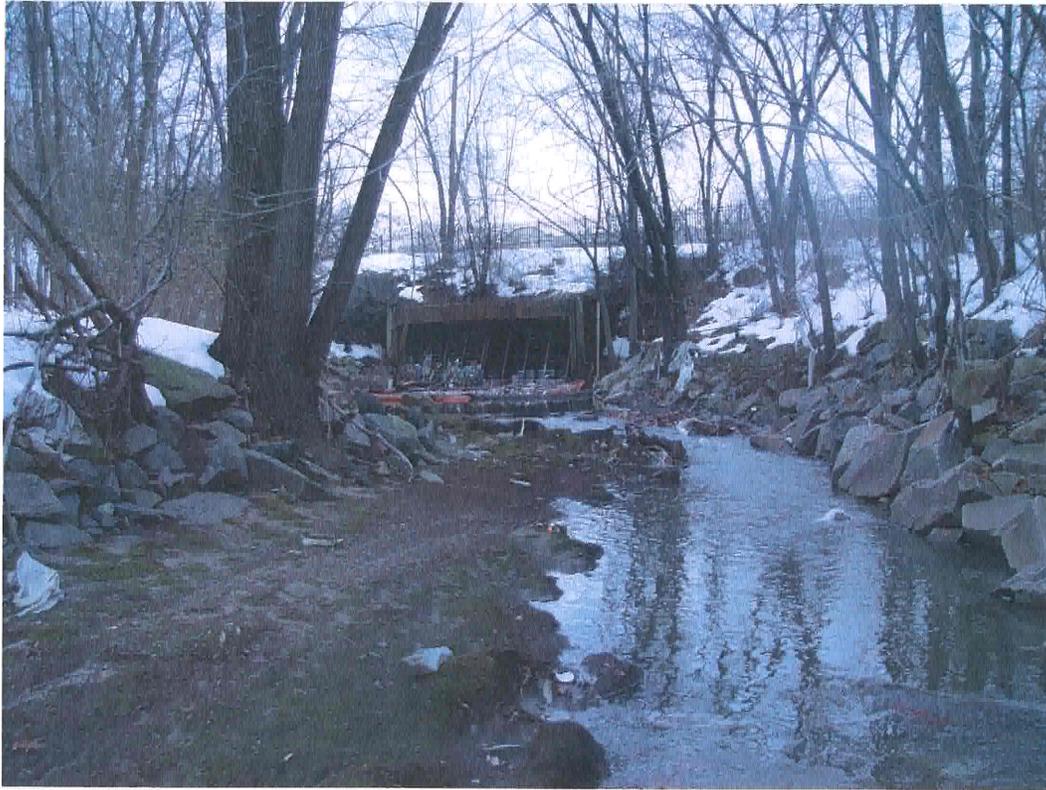
Photograph 37. Outfall where Hickey Run daylights (HR-01).
