# Use of a Rapid Visual Assessment to Monitor In-Stream Structure Success

**Karen Jennings and Sean Crawford**

**Coastal Resources, Inc.  
25 Old Solomons Island Road  
Annapolis, Maryland 21401  
410-956-9000**

# **Case Study: Sullivan Branch**

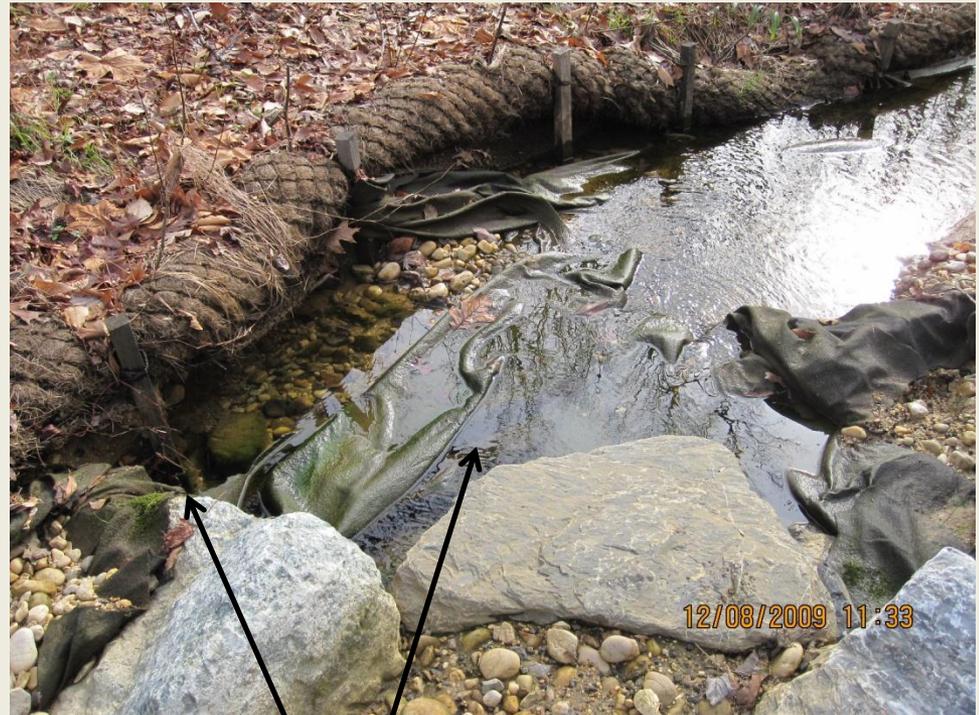
**Bank undercutting and streambed scour.**

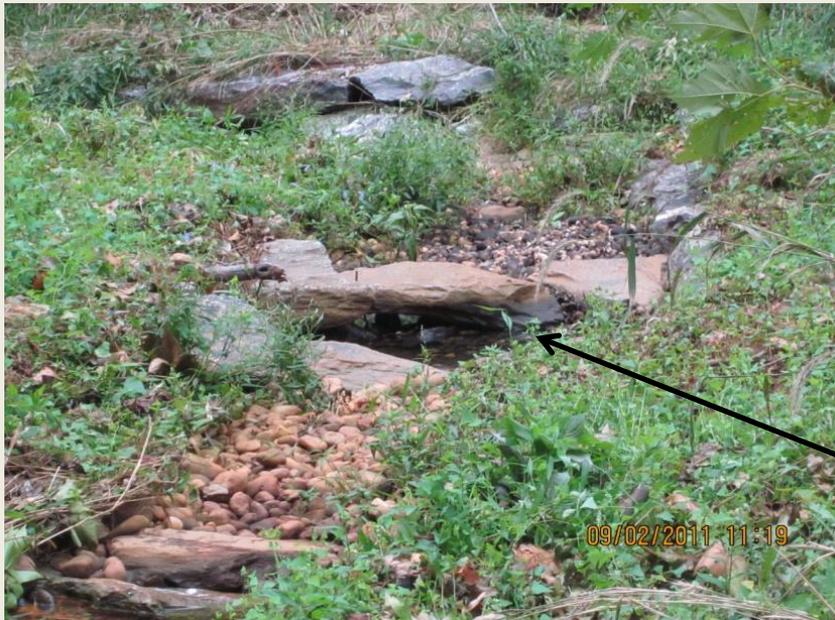
**Piping under structure boulders.**

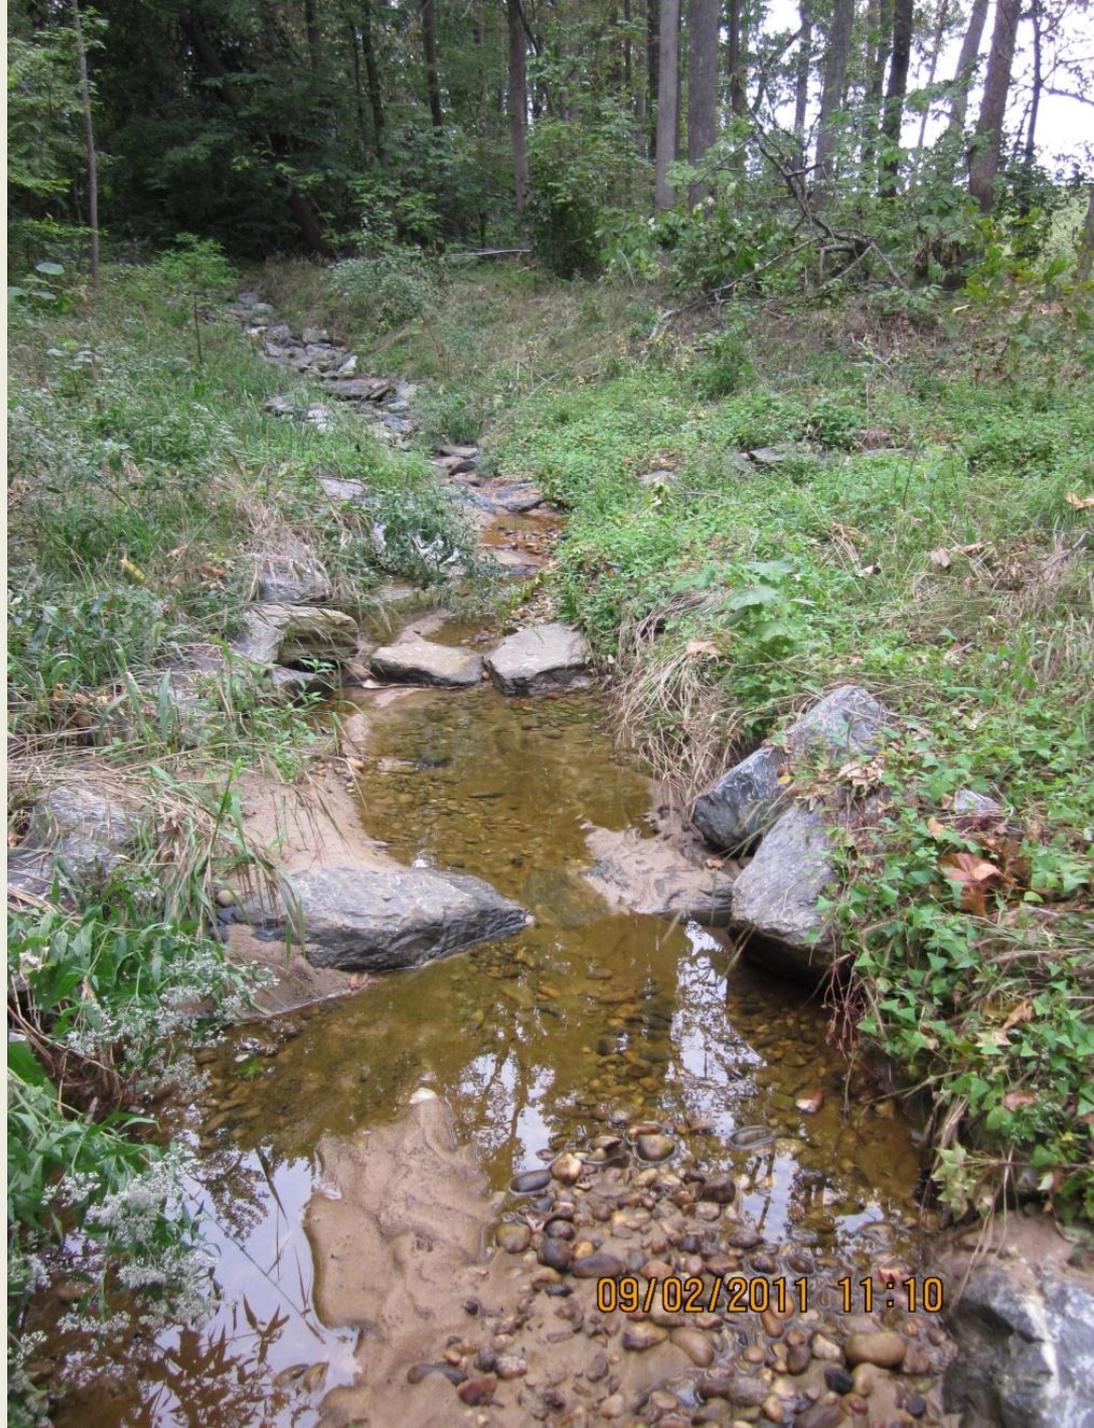
**Buried step pools are no  
longer performing the  
restoration goals of  
dissipating water energy  
or providing pool habitat.**

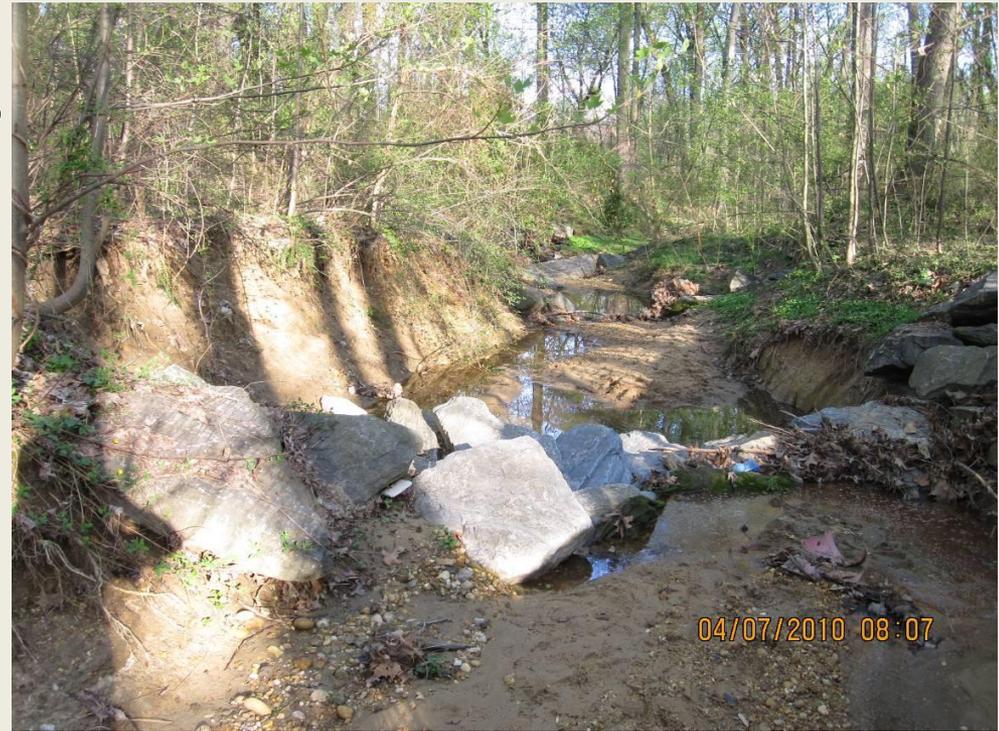
| Structure | Indicator | Failure Score | Primary | Secondary |
| Cross Vane | Arm Washout | 3 | Undercutting | Insufficient Backfill |
| | Bank Erosion at Structure | 5 | Side Cutting | Arms Washed Out |
| | Downstream Bank Erosion | 4 | Side Cutting | Placed in a Bend |

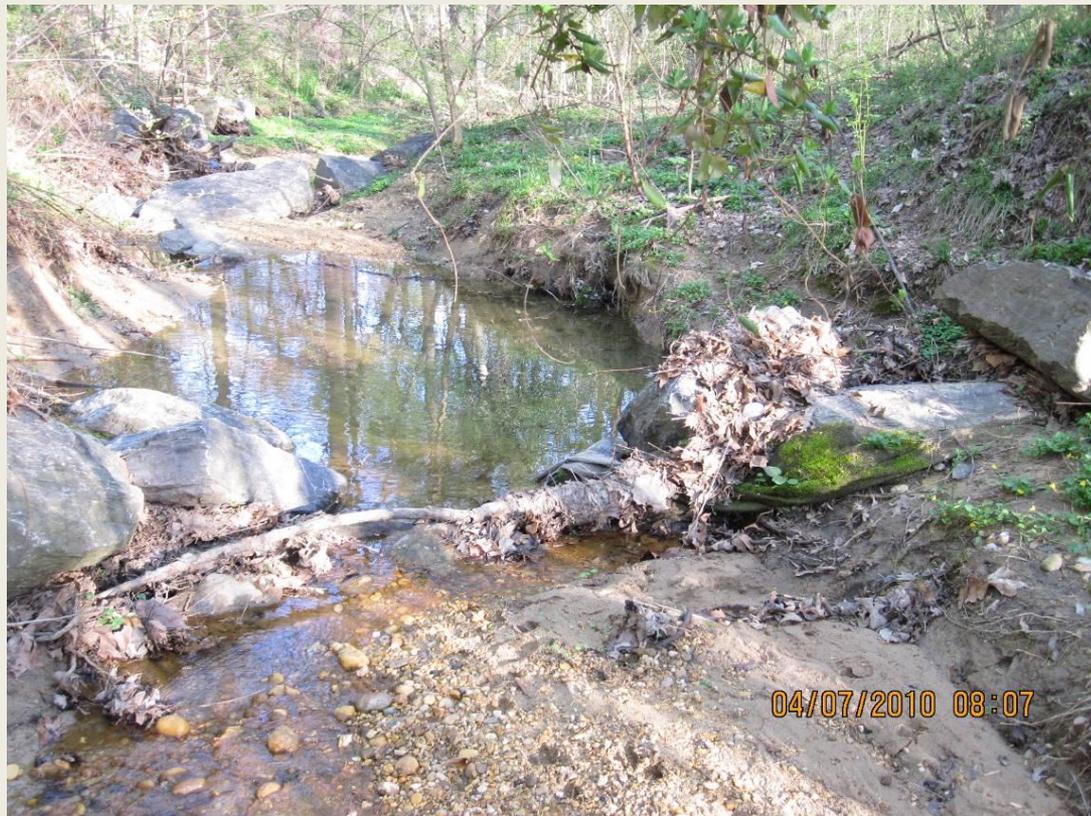
| Structure | Indicator | Failure Score | Primary | Secondary |
| Weir | Boulder Washout | 3 | Drag and Lift or Tipping | Insufficient Backfill |
| | Bank Erosion at Structure | 3 | Side Cutting | Boulders Washed Out |
| | Downstream Bank Erosion | 3 | Flow Directed at Banks | Improper Alignment |

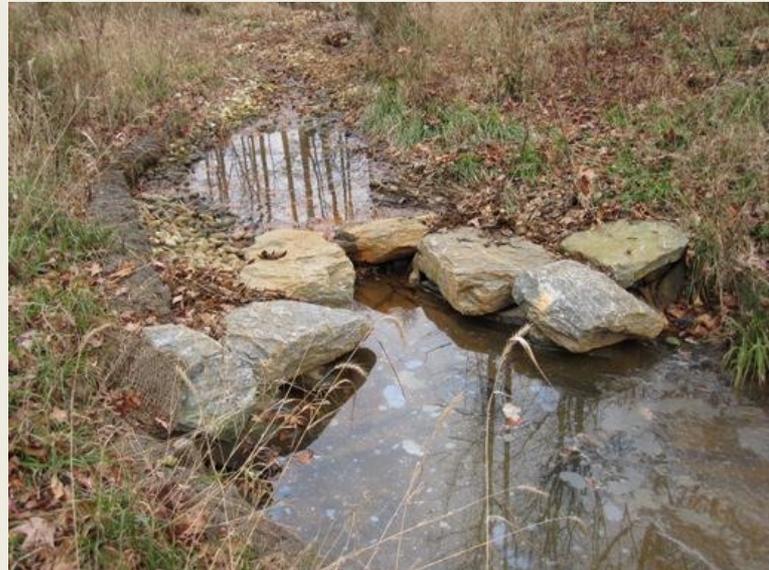
| Structure | Date | Failure Indicators Exhibited | Failure Score (1-5) | Primary Causes Identified | Secondary Causes Identified |
| J-Hook | April 2009 | Bank Erosion at Vane | 1 | Piping | Insufficient Backfill |
| | Dec. 2009 | Bank Erosion at Vane | 1 | Flow Directed at Banks<br>Piping<br>Side Cutting | Placed in a Bend<br>Insufficient Backfill |
| | | Downstream Bank Erosion | 2 | Flow Directed at Banks | Improper Alignment |
| | Dec. 2010 | Bank Erosion at Vane | 3 | Direct Contact of Flow with Banks<br>Flow Directed at Banks<br>Undercutting | Exposed Banks<br>Improper Alignment<br>Placed in a Bend<br>Drop too High |
| | | Downstream Bank Erosion | 4 | Direct Contact of Flow with Banks<br>Flow Directed at Banks<br>Weak Jet | Exposed Banks<br>Improper Alignment<br>Flow not Concentrated in Channel Center |
