WEST CUDDIHY WATERSHED:
STREAM ASSESSMENT

*Patuxent River Naval Air Station,
St. Mary's County, Maryland*

Final Report

December 2001

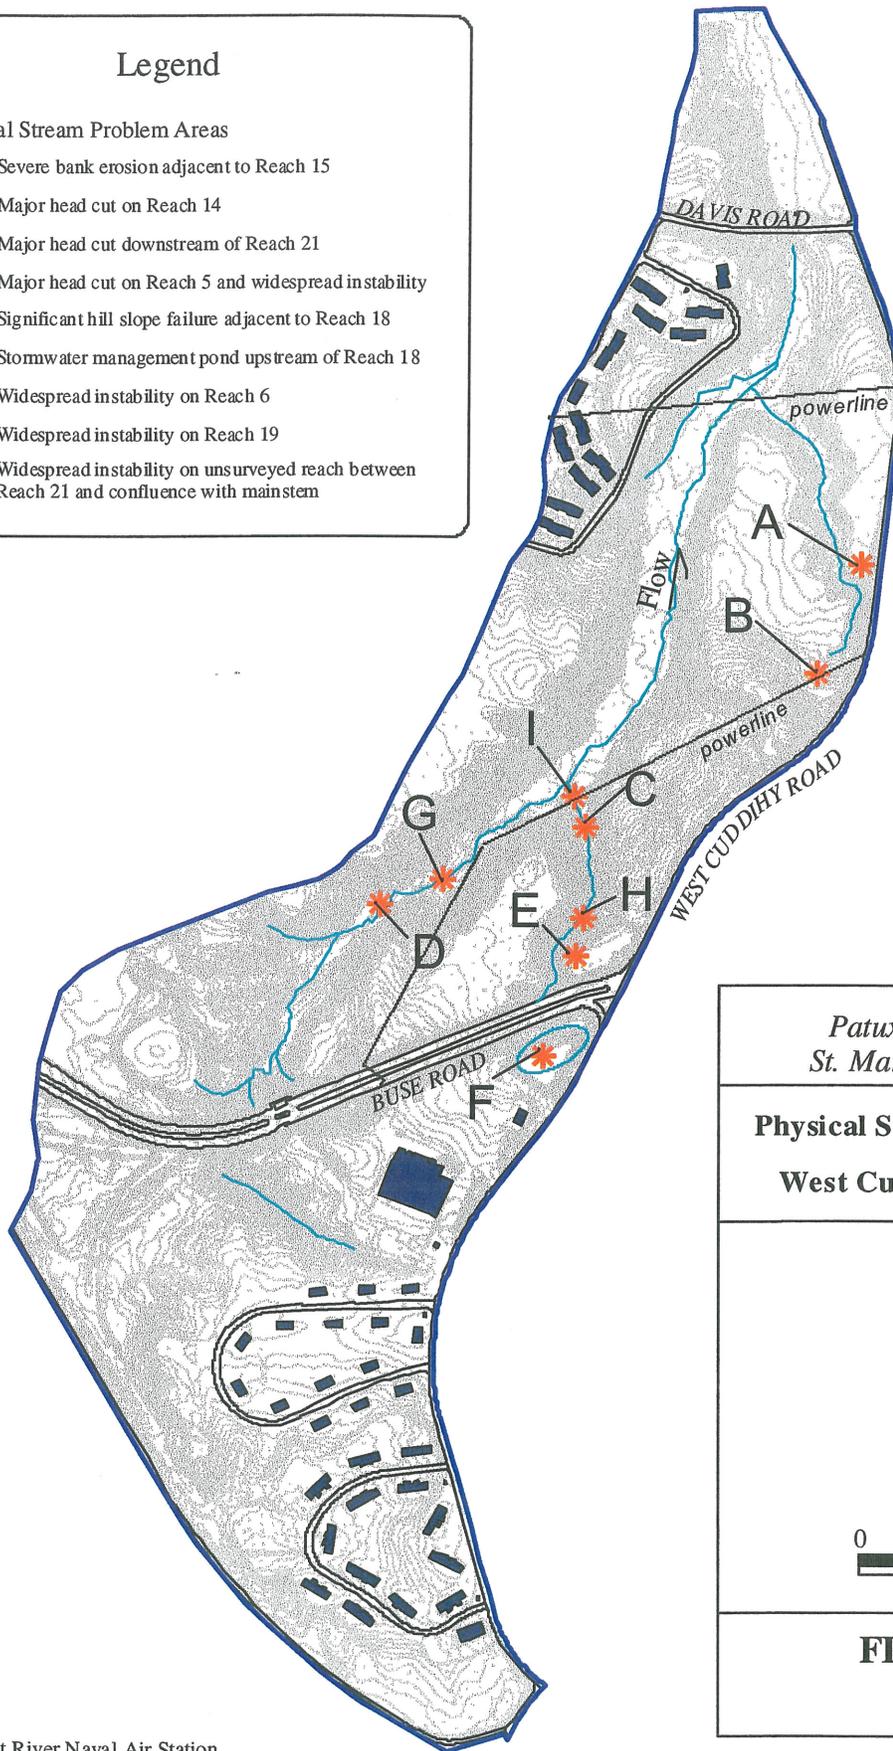
Physical Stream Problem Areas West Cuddihy Watershed

- A Severe bank erosion adjacent to Reach 15
- B Major head cut on Reach 14
- C Major head cut downstream of Reach 21
- D Major head cut on Reach 5 and widespread instability
- E Significant hill slope failure adjacent to Reach 18
- F Stormwater management pond upstream of Reach 18
- G Widespread instability on Reach 6
- H Widespread instability on Reach 19
- I Widespread instability on unsurveyed reach between Reach 21 and confluence with mainstem

Seven significant site-specific problem areas were identified within the watershed (Figure 7). Figure 8 shows both the physical stream problem areas identified by this report and the biological problem areas identified in the biological assessment report prepared by the FWS Contaminants Branch. Four of the problems areas are head cuts on Reaches C2, 5, 14, and the unsurveyed reach between Reach 21 and the confluence with the mainstem. The other three site-specific problem areas include: the hill slope failure adjacent to Reach 18; the erosion occurring adjacent to Reach 15 as a result of runoff from West Cuddihy Road; and the stormwater runoff from the Navy Exchange complex. The existing stormwater pond provides extended detention for 2 and 10-year storm events. Management of a 1-year storm event is necessary to reduce erosive flows to the downstream reaches (e.g., Reach 18). The conversion of the pond to manage a 1-yr storm event is also considered a Best Management Practice.

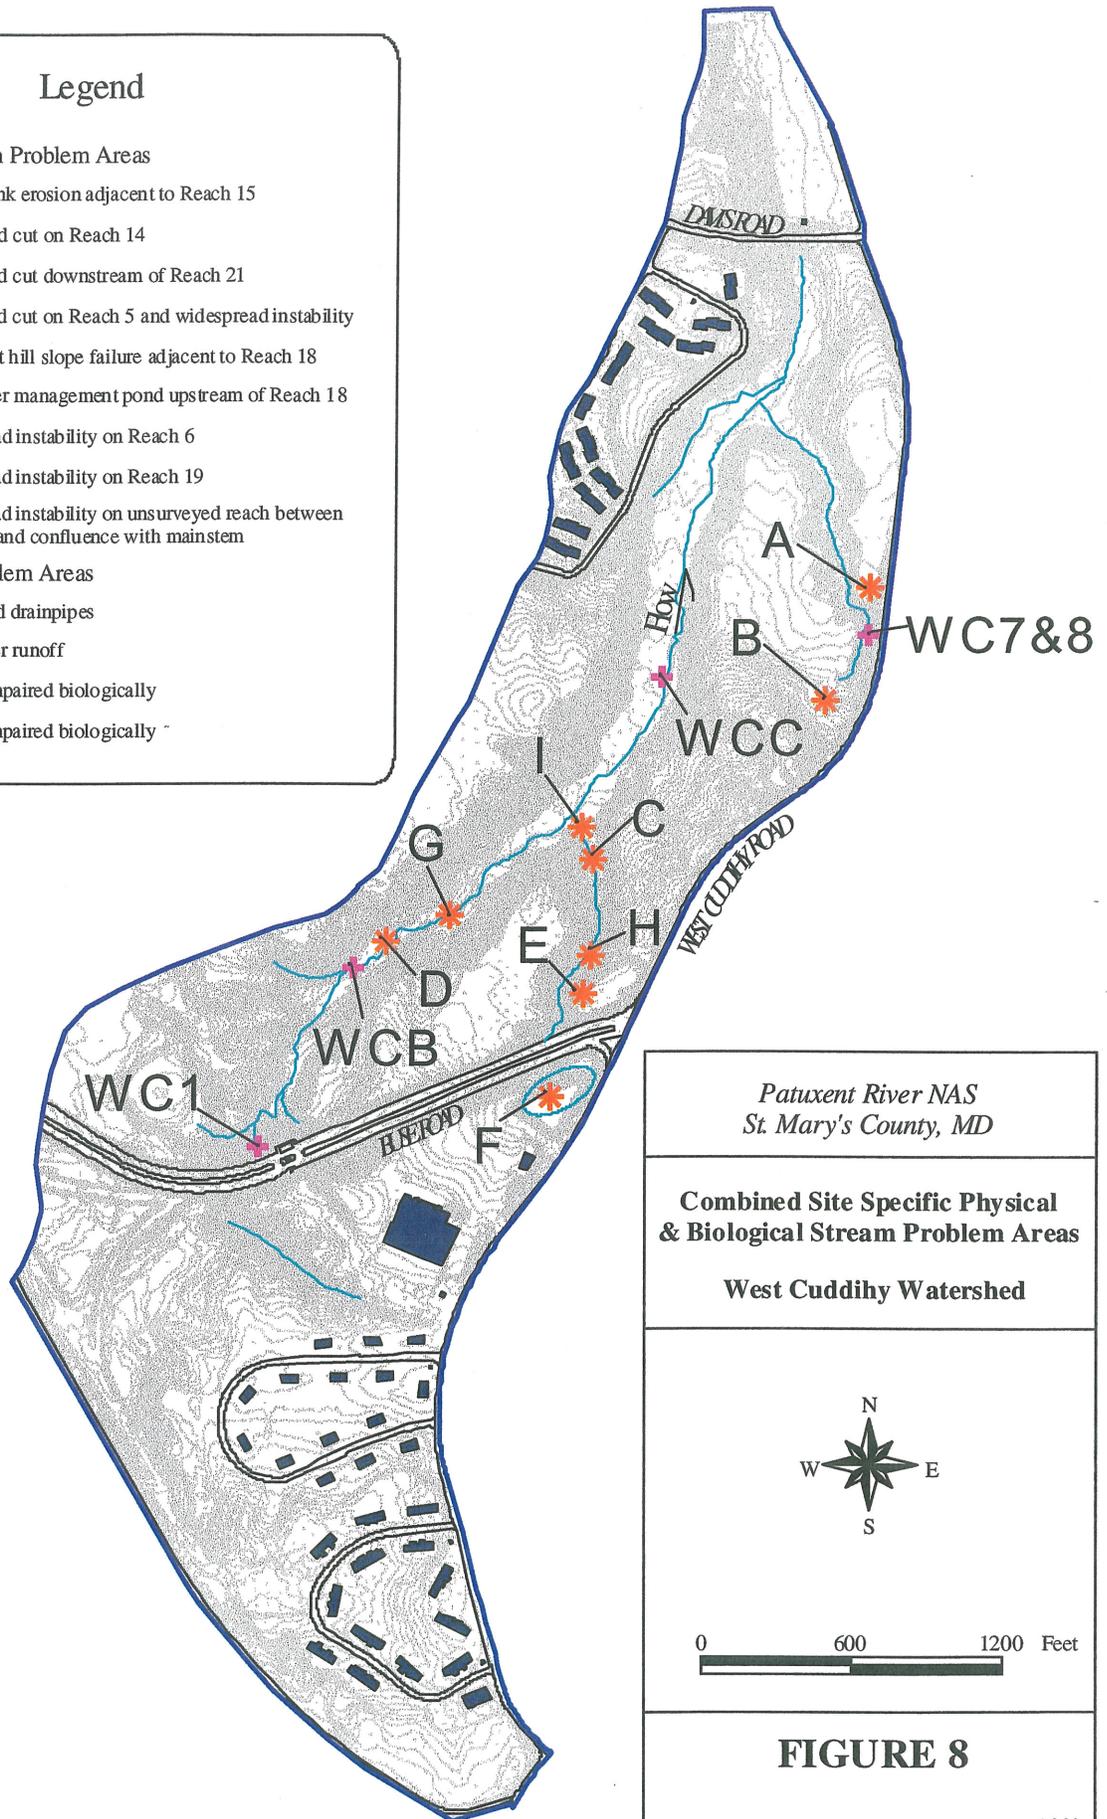
- A Severe bank erosion adjacent to Reach 15
- B Major head cut on Reach 14
- C Major head cut downstream of Reach 21
- D Major head cut on Reach 5 and widespread instability
- E Significant hill slope failure adjacent to Reach 18
- F Stormwater management pond upstream of Reach 18
- G Widespread instability on Reach 6
- H Widespread instability on Reach 19
- I Widespread instability on unsurveyed reach between Reach 21 and confluence with mainstem

- WC1 Corrugated drainpipes
- WC7&8 Stormwater runoff
- WCB Slightly impaired biologically
- WCC Slightly impaired biologically
