**APPENDIX J:
HAZARDOUS TOXIC AND
RADIOACTIVE WASTE
ASSESSMENT**

J3: Appendices F-G

Appendix F

Observed Field Survey Sites
 Mid-Barataria Sediment Diversion
 Phase I Environmental Site Assessment
 Jefferson and Plaquemines Parish

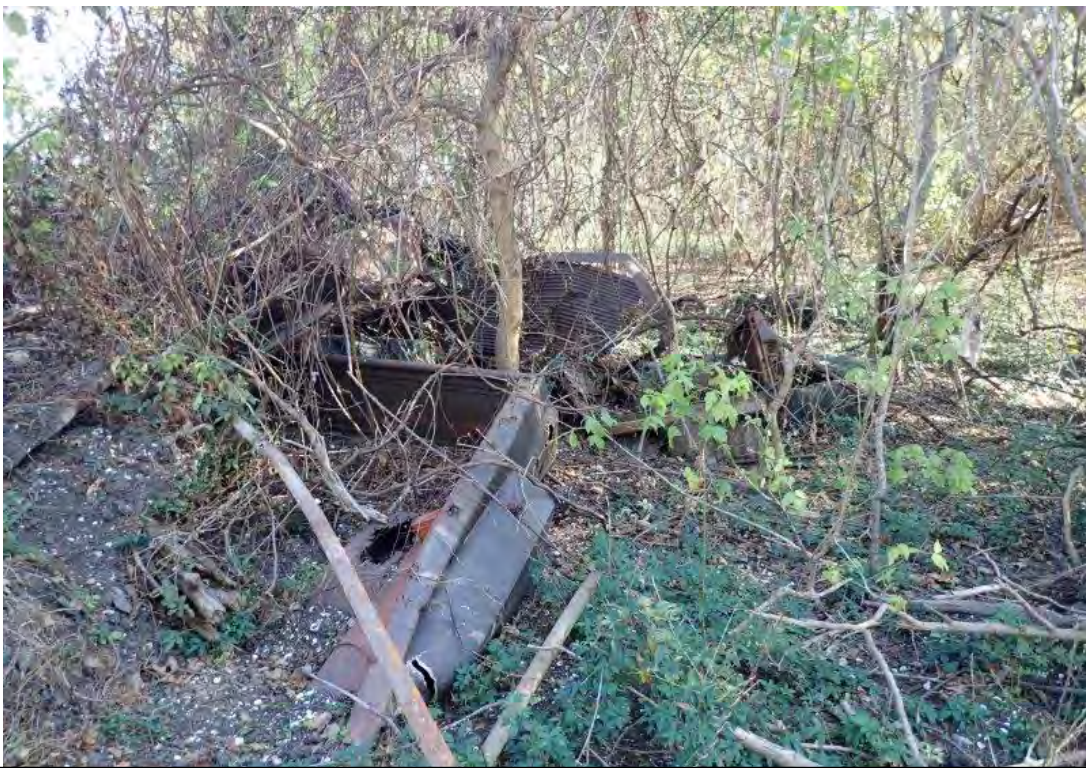
Photograph 71. Destroyed Grain Silo Adjacent to Silo Pad

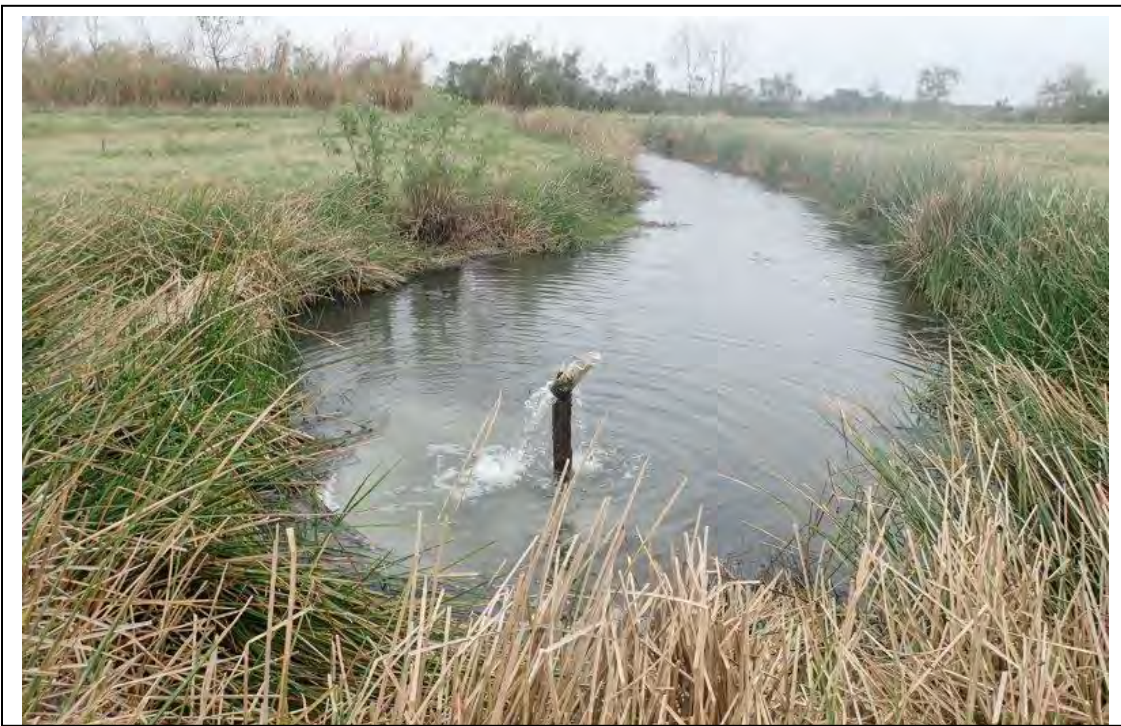
Photograph 81 - Collapsed Windmill with Flowing Water Well
(29°39'5.16"N, 89°58'32.10"W)

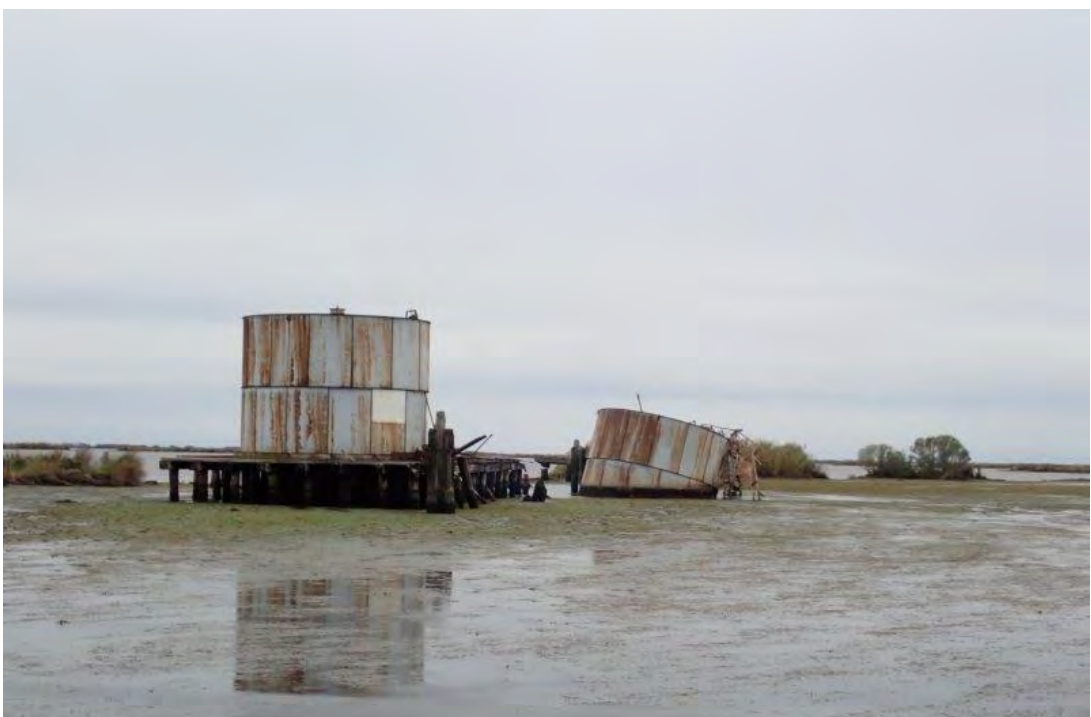
Photograph 86. Site 2: Damaged Oil Field Facility
(29°37'7.93"N, 89°59'32.28"W)

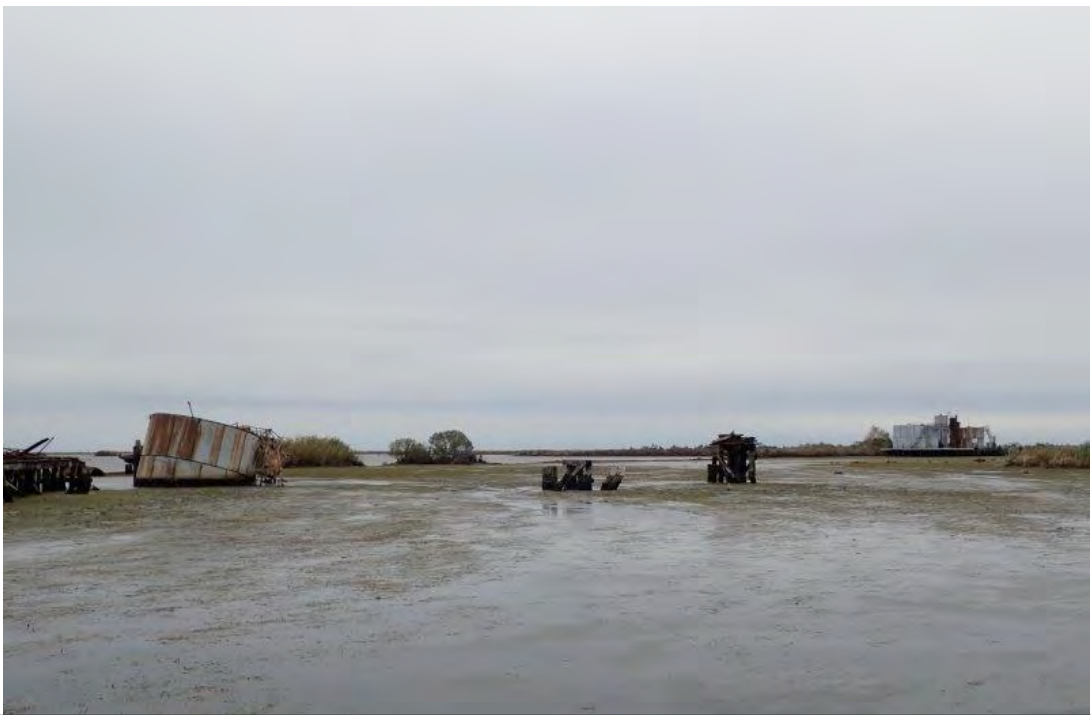
Photograph 87. Site 2: Damaged Oil Field Facility

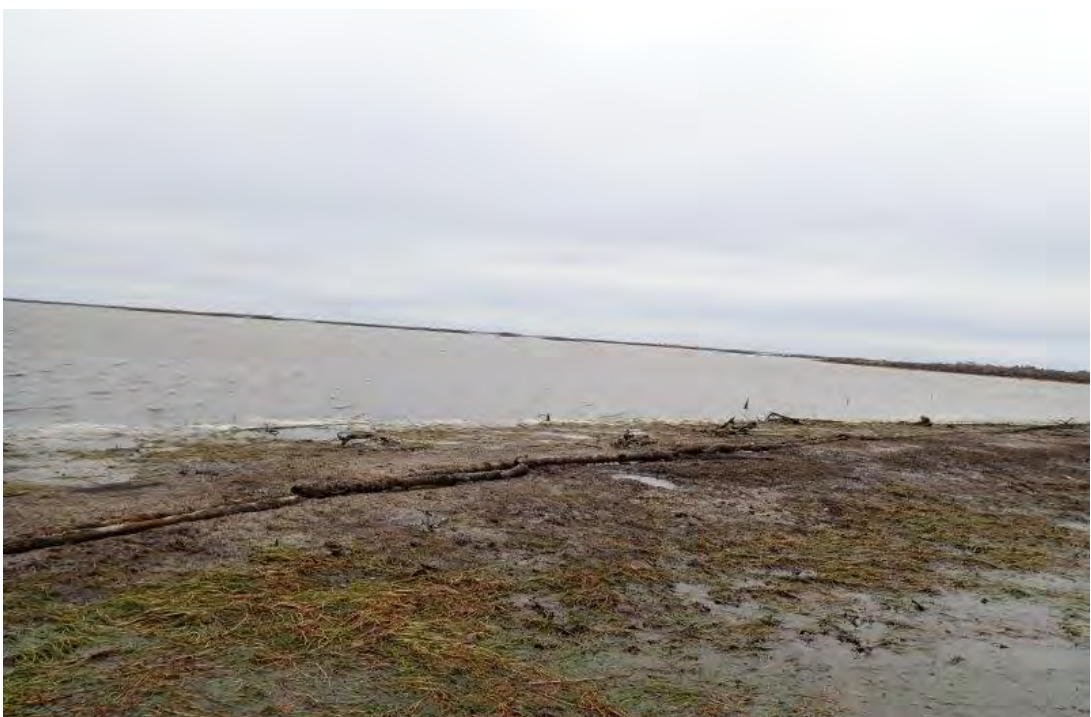
Photograph 88. Site 2: Damaged Oil Field Facility

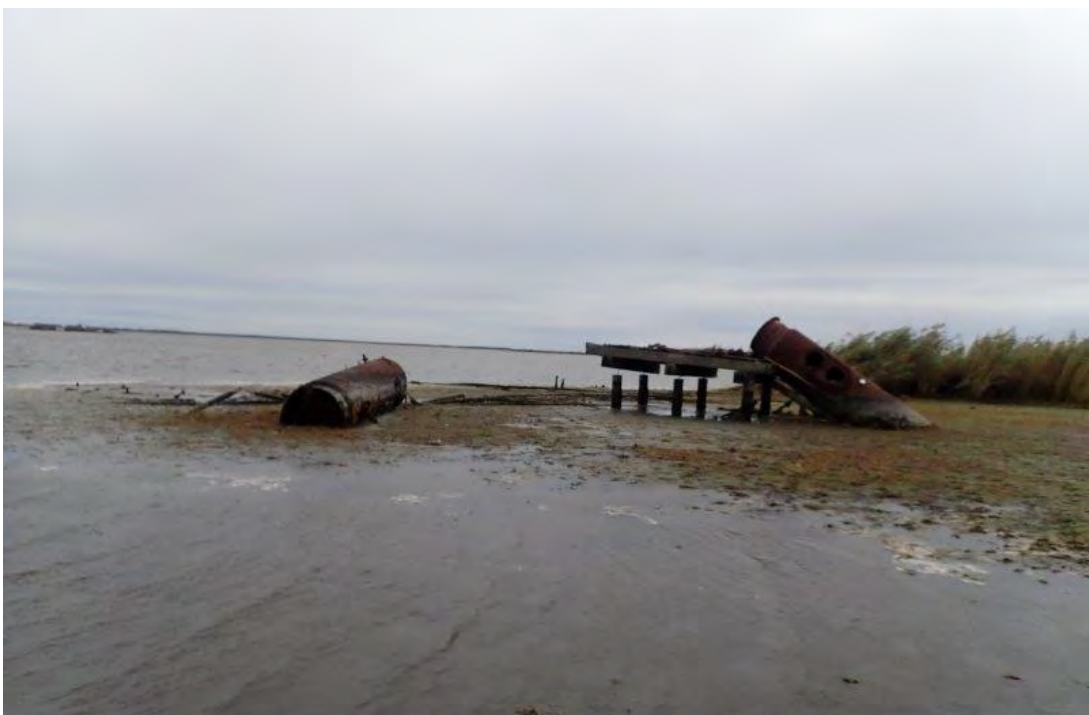
Photograph 89. Site 2: Damaged Oil Field Facility

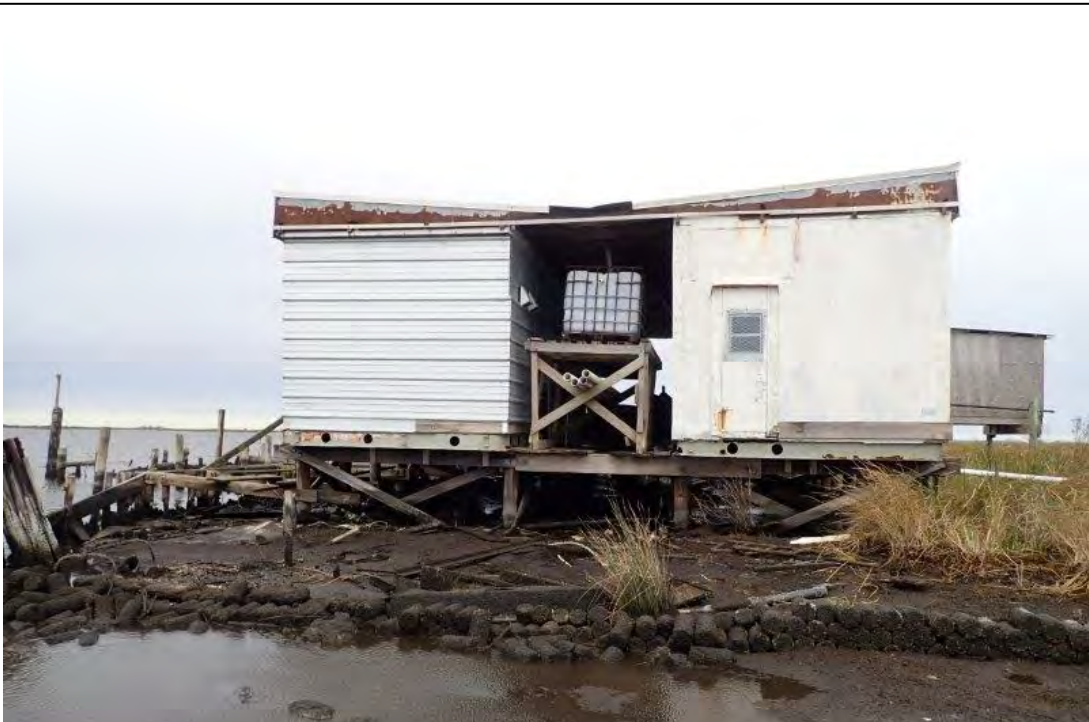
Photograph 90. Site 3: Damaged Camp
(29°36'26.76"N, 89°58'46.52"W)

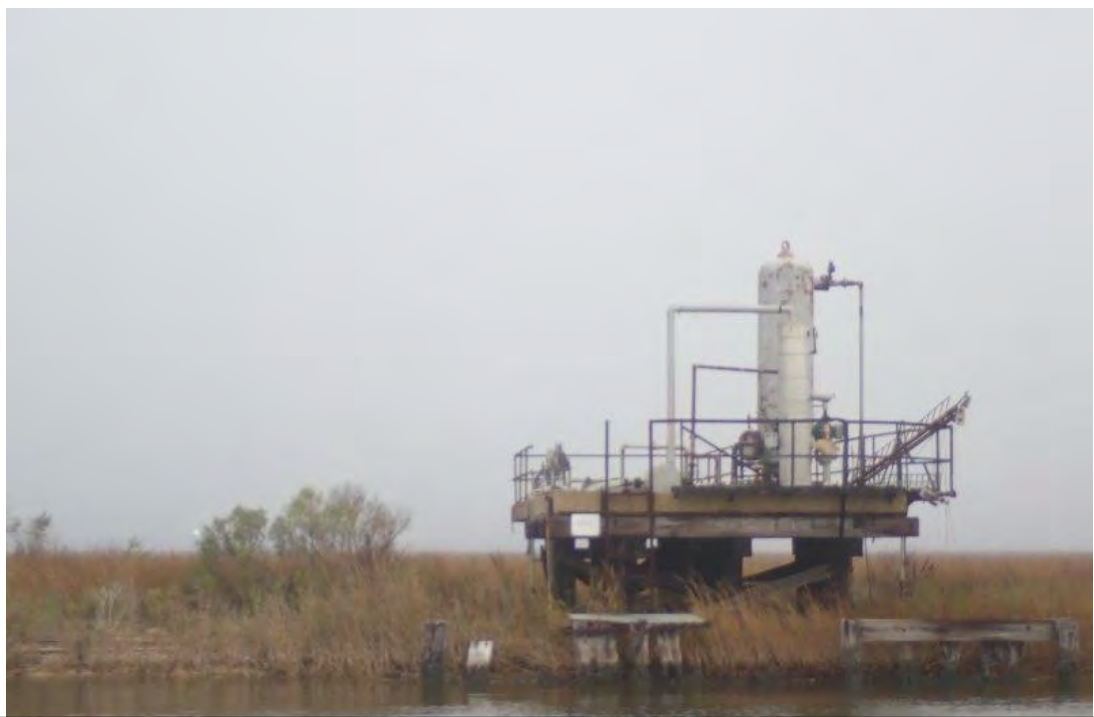
Photograph 108. Site 18: Damaged Oil Field Facility
(29°32'22.89"N, 89°54'16.42"W)

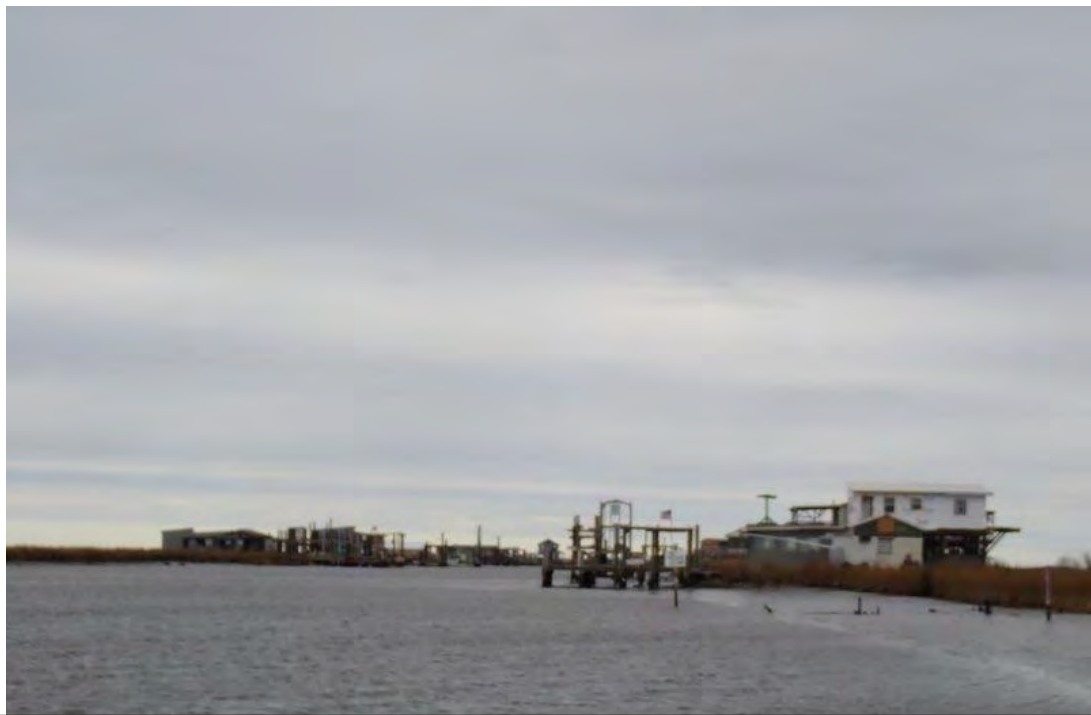
Photograph 110. Site 18: Storm Damaged Floating Shrimp Net Platform (Relocated from Near Site 14)

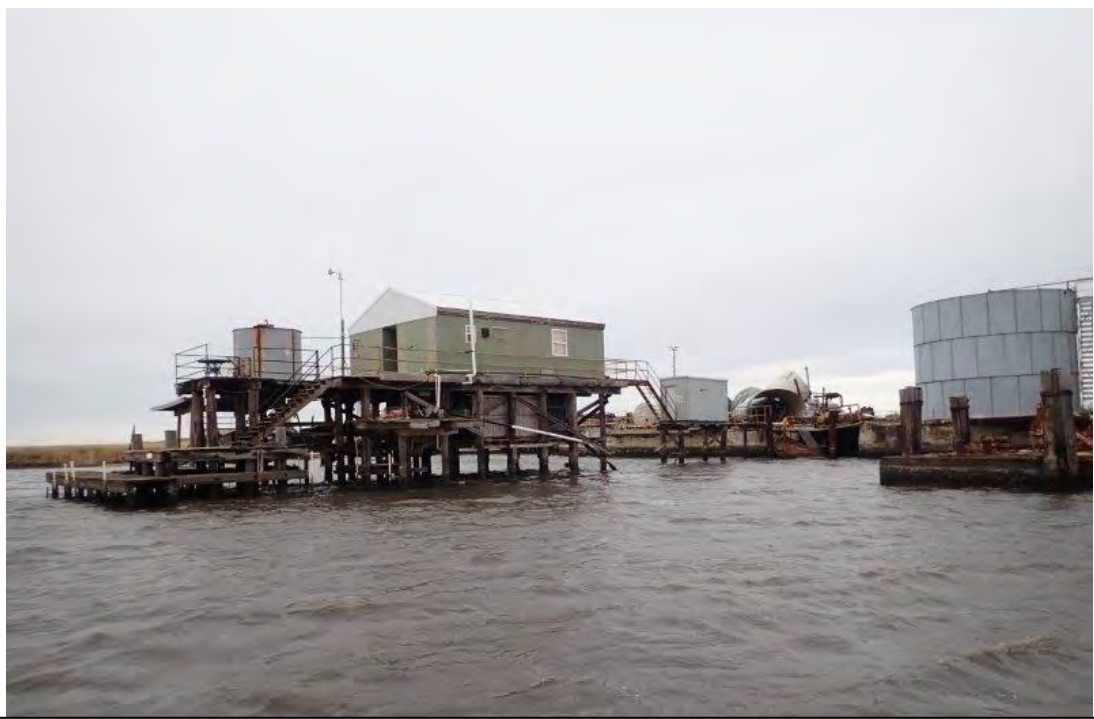
Photograph 114. Site 22: Damaged Oil Field Facility
(29°30'39.01"N, 89°59'9.13"W)

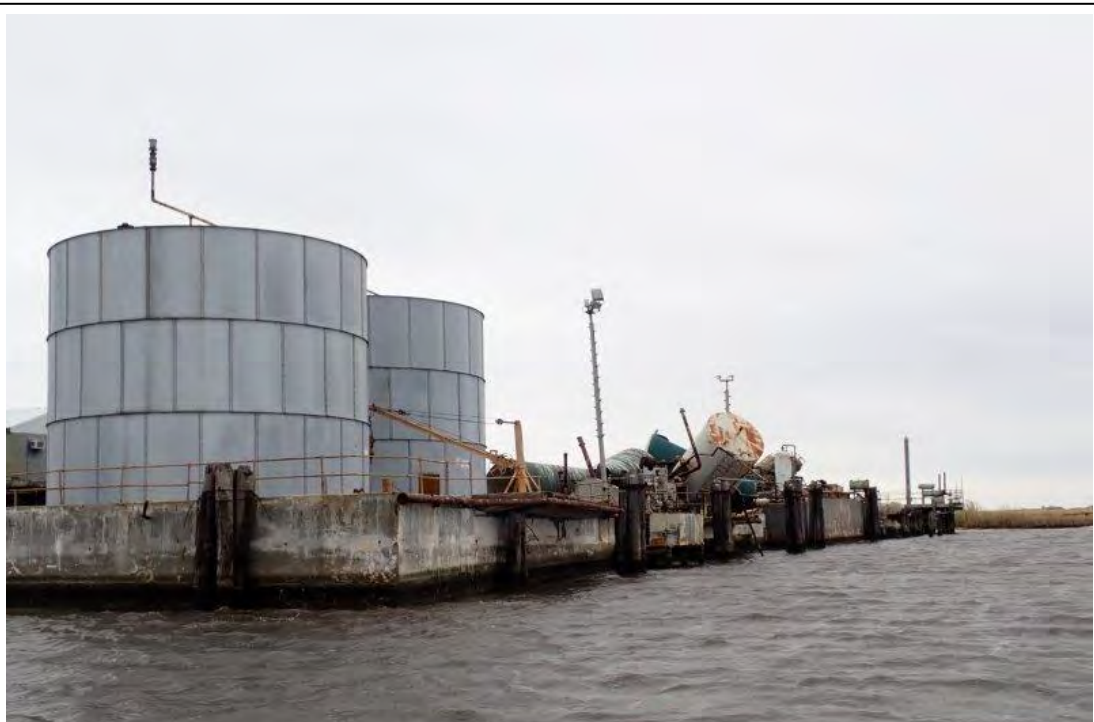
Photograph 115. Site 22: Damaged Oil Field Facility

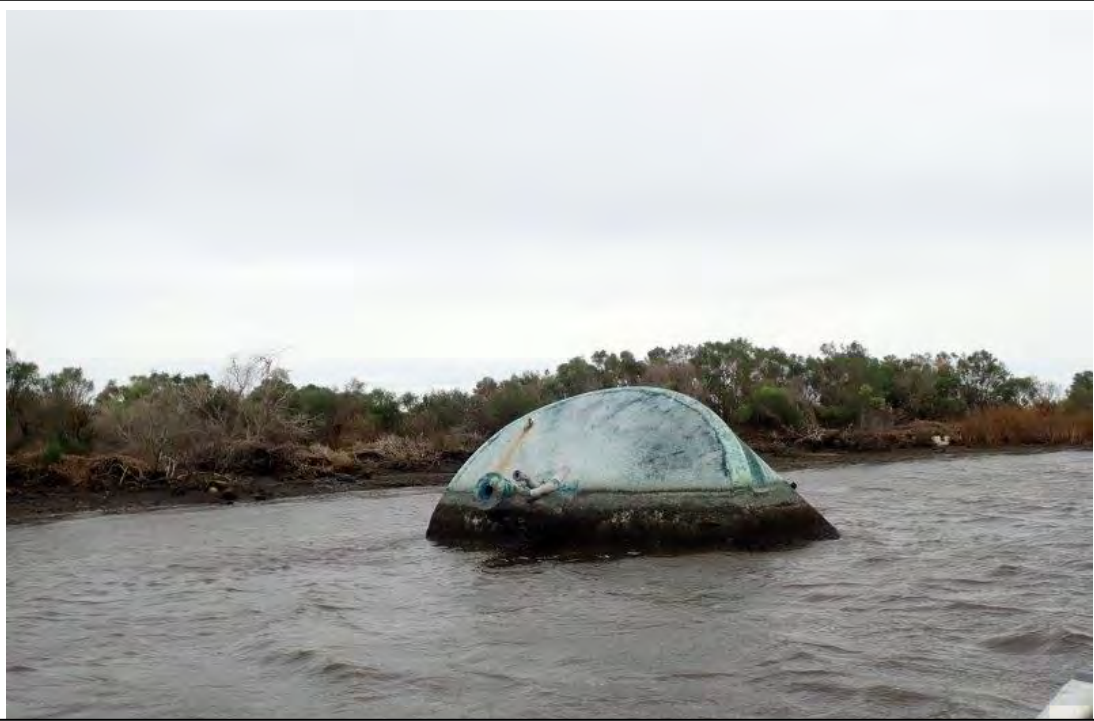
Photograph 116. Site 22: Damaged Oil Field Facility
