HATCHERY MAINTENANCE

Hagerman National Fish Hatchery

Raceway Expansion Joint Project

July 22, 2010

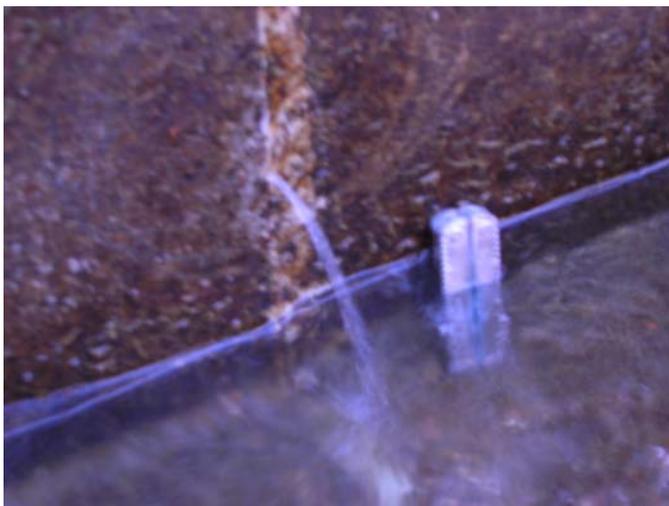
Worn Expansion Joints

In May, 2010 the Hagerman National Fish Hatchery (Hatchery) crew observed water leaking through the expansion joints in several places in the Steelhead Raceways during the annual de-watering. The water had seeped underneath the upper and middle deck raceways and was draining into the bottom deck.

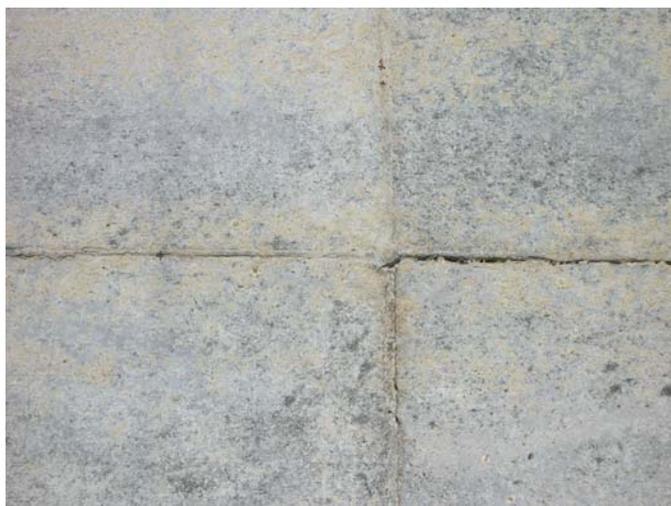
Upon further inspection, the Hatchery found numerous places where the expansion joint caulking was cracked and separated from the concrete which would allow water to seep out below the raceways.

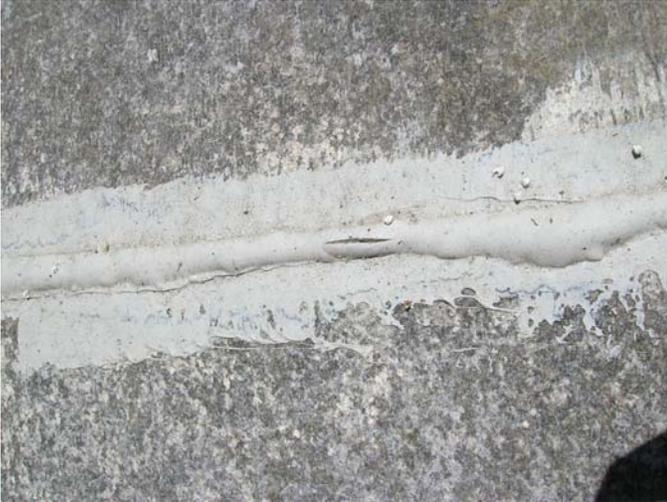
Caulking Bubbling

Within 24 hours, The Hatchery staff observed large bubbles in the caulk. These bubbles were caused by moisture in the concrete. The caulking was applied in the cool mornings. By afternoon, the top of the caulk was dry to the touch, but was still tacky underneath. The hot afternoon sun drew moisture vapor into the tacky component of the caulking where it was trapped by the dry skin over the top; thus creating bubbles in the expansion joints.

Unfortunately, the only repair for bubbled SIKA-Flex 1A is to remove the affected caulking and replace it. Since the SIKA-Flex 1A requires one to two weeks for proper curing, the Hatchery did not have time for this repair before the Steelhead Raceways were filled with water late July.

1. Before application, a moisture vapor test should be conducted by duct taping a heavy mil (4-6 mm) visqueen over the joint. The plastic is left for 18-24 hours and then checked for condensation. If condensation is present, the concrete has >4% moisture and should be further dried.
2. Backer rod should be installed for several reasons: First, the backer rod prevents caulking from sticking to the bottom substrate. This reduces the chance that it will pull away from the sides. Second, it makes a guide to ensure uniform depth between 1/4 and 1/2 inch. Third, it helps ensure an hour-glass shape to the finished product. The hour glass shape is formed on the bottom by the backer rod and on the top by tooling. The hour glass shape ensures extra caulking on the adherence edge and a narrower band of caulking over the gap to

facilitate expansion across the joint. The caulking should be applied at a 2 to 1 ratio of width to depth, i.e. the width should be twice the depth.

3. In circumstances where it is difficult to completely dry the concrete (by the moisture vapor test) two techniques can be attempted to ensure good adhesion and avoid bubbling:
 - A) Apply SIKA-Flex 1A in the early evening after the temperature has started to cool. This will allow the SIKA-Flex 1A to set-up to a rubbery consistency overnight before the heat of the day drives moisture into the product. Once the product is set, the moisture underneath is not a problem.
 - B) Use a two part product like SIKA-Flex 2C SL. This product cures faster before the moisture becomes a problem. However, a **professional** and experienced contractor should install this product.
