Pigg River Restoration at Power Dam Post Construction Monitoring Report

Wetland Studies and Solutions, Inc.
1402 Grandin Road SW, Suite 211
Roanoke, VA 24015
WSSI #22906.01

NOVEMBER 2016

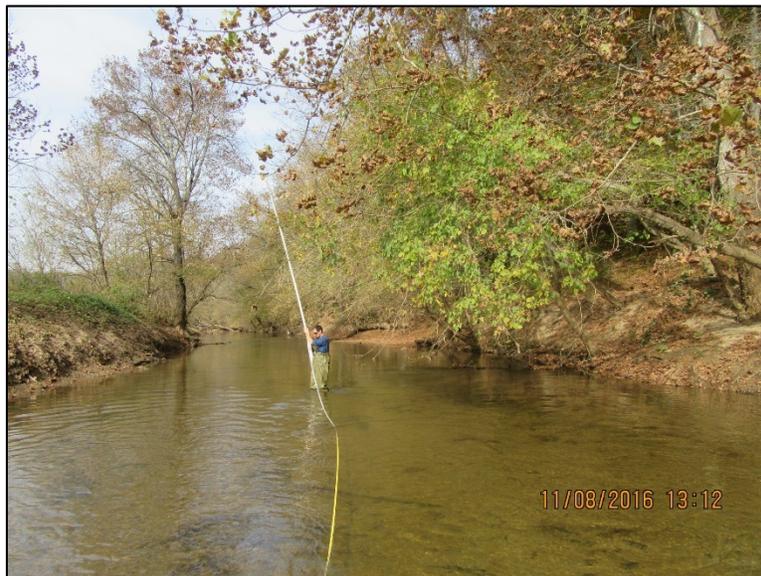
Photo 1-1

Description: View looking upstream from the middle of Cross Section 1

Woody Debris: 7

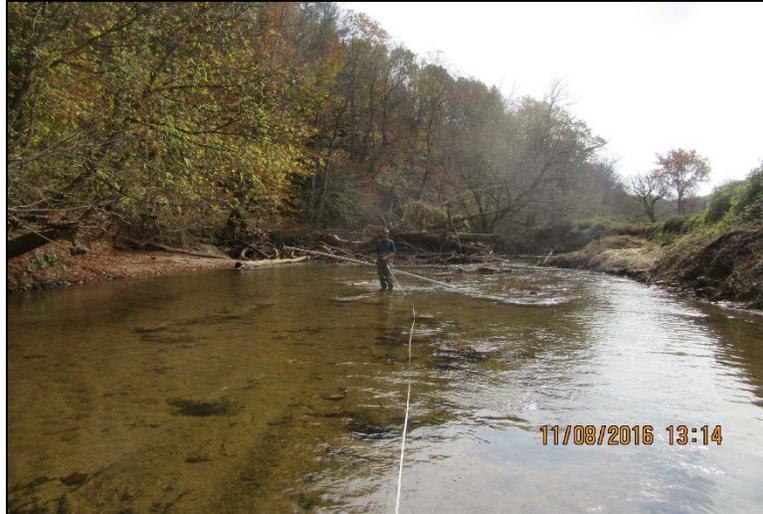
Photo 1-2

Description: View looking downstream from the middle of Cross Section 1

Woody Debris: 7

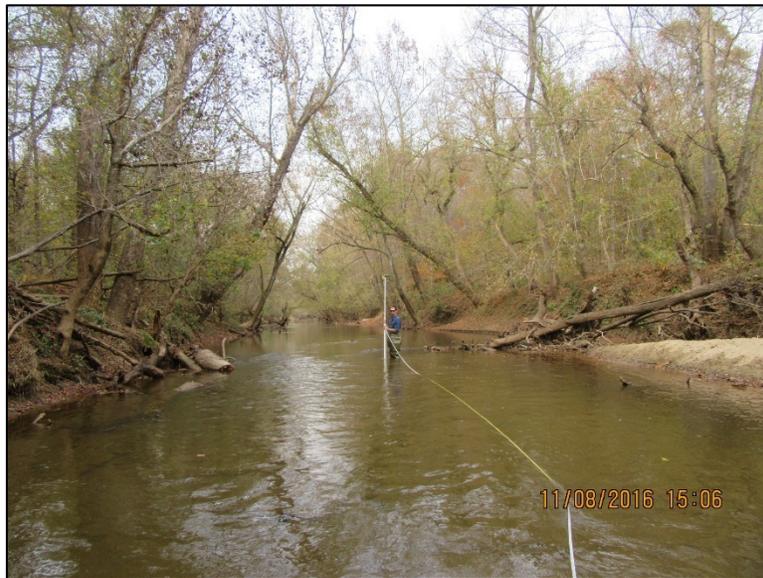
Photo 2-1

Description: View looking upstream from the center of Cross Section 2

Woody Debris: 35

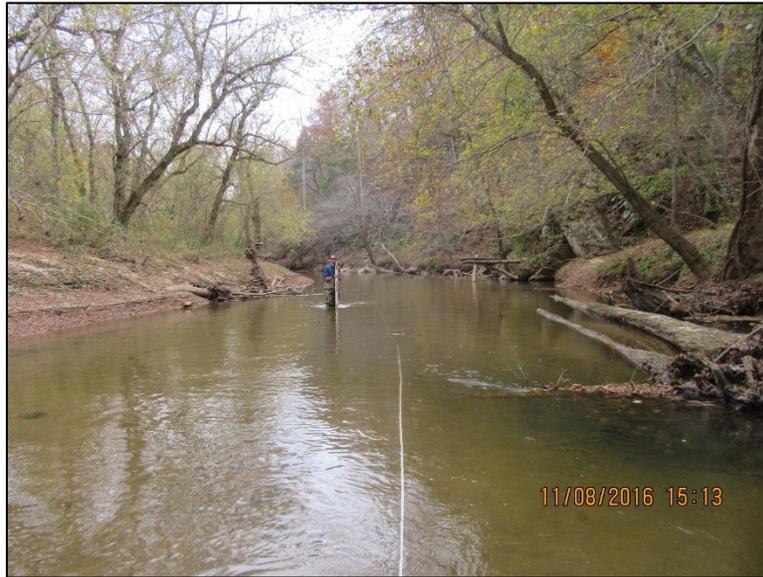
Photo 2-2

Description: View looking downstream from the middle of Cross Section 2

Woody Debris: 25

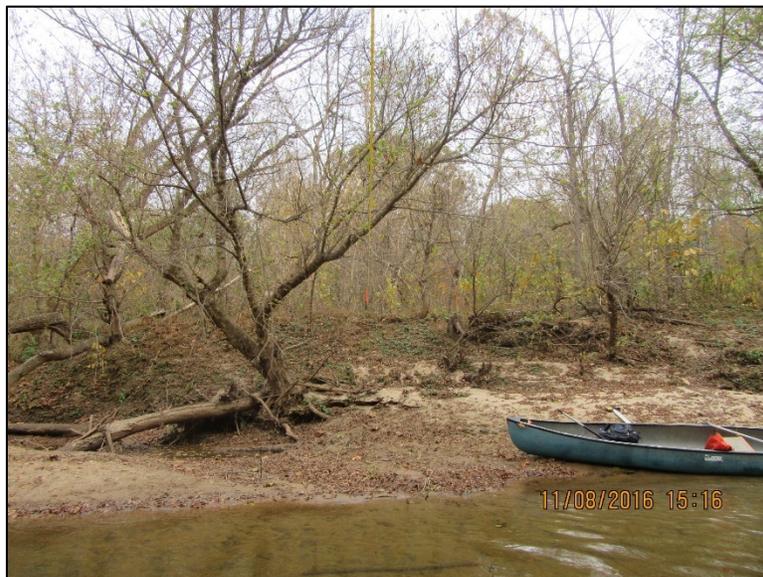
Photo 2-3

Description: View looking left from the middle of Cross Section 2

Vegetation: 40% herbaceous cover, few trees

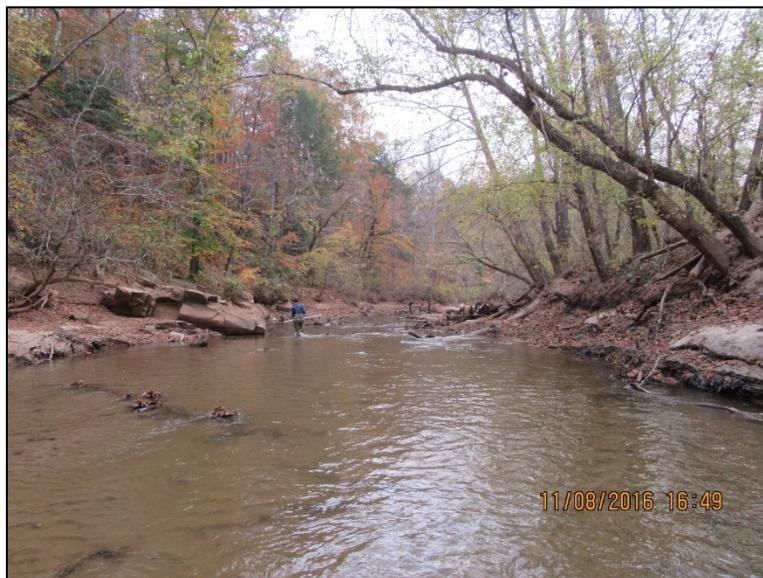
Photo 3-1

Woody Debris: 50

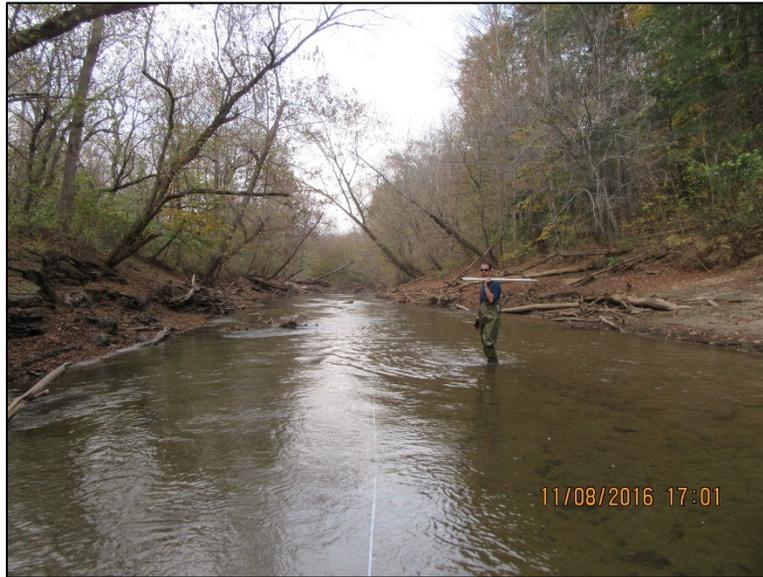
Photo 3-2

Woody Debris: 40

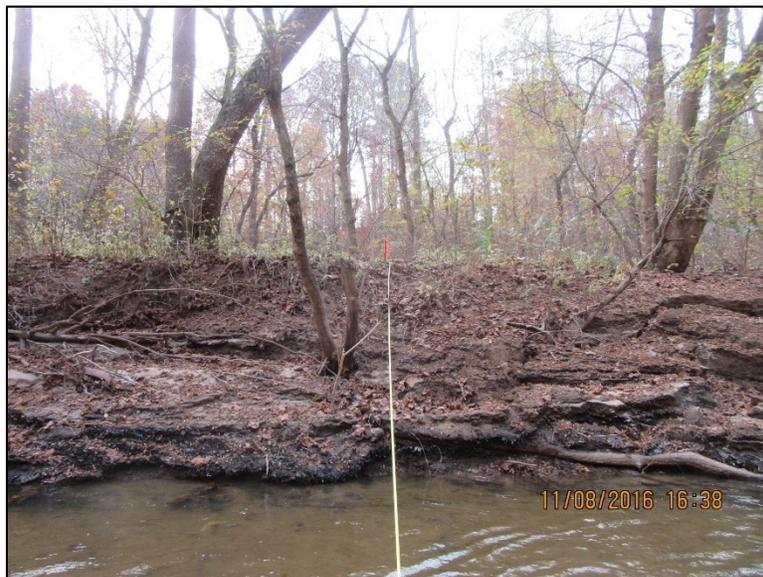
Photo 3-3

Vegetation: 40% herbaceous plants, few trees

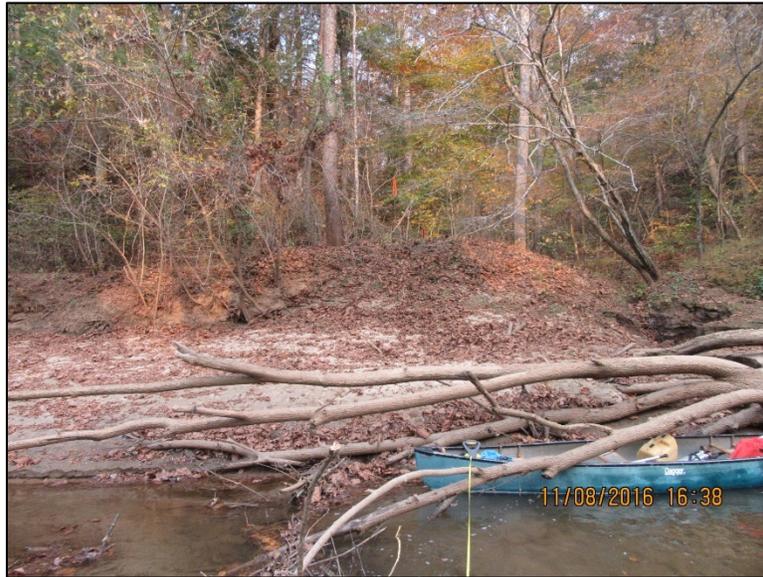
Photo 3-4

Vegetation: 30% herbaceous cover and a few trees at top of bank

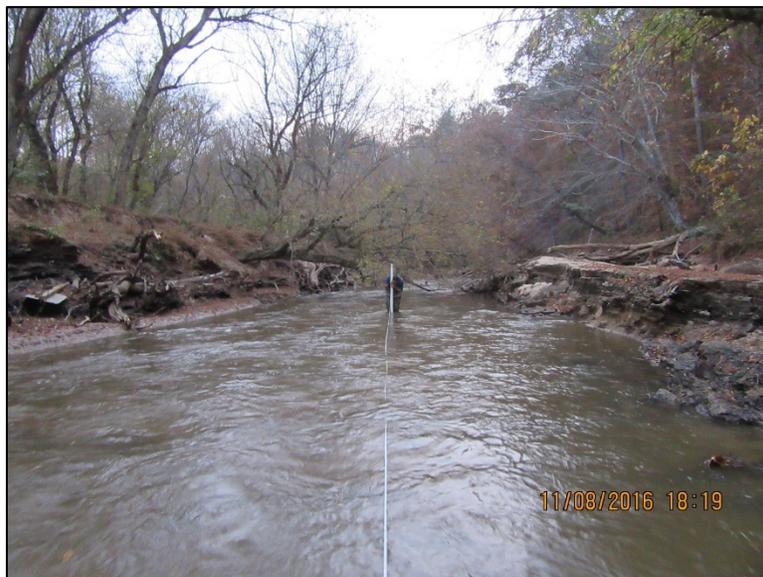
Photo 4-1

Description: View looking upstream from the center of Cross Section 4
Woody Debris: 75

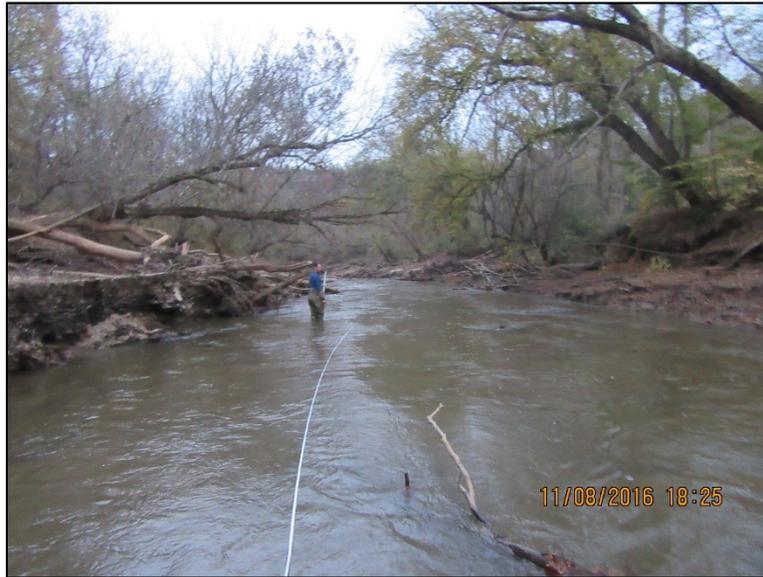
Photo 4-2

Woody Debris: 50

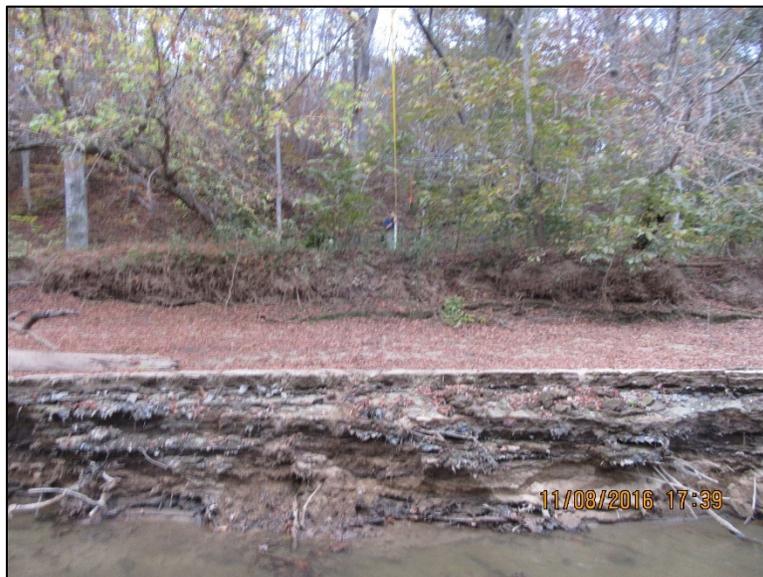
Photo 4-3

Vegetation: 80% herbaceous plants and a few trees at top of bank

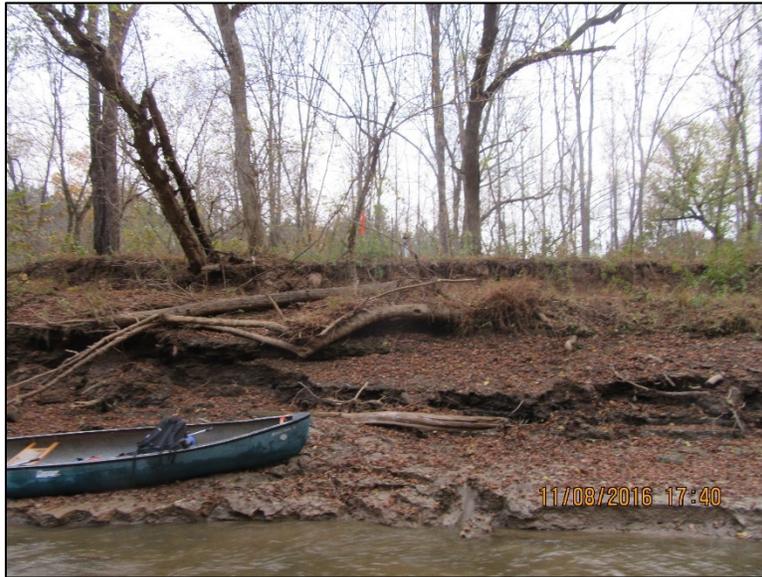
Photo 4-4

Vegetation: 40% herbaceous on lower terrace, small shrubs and a few trees at top of bank

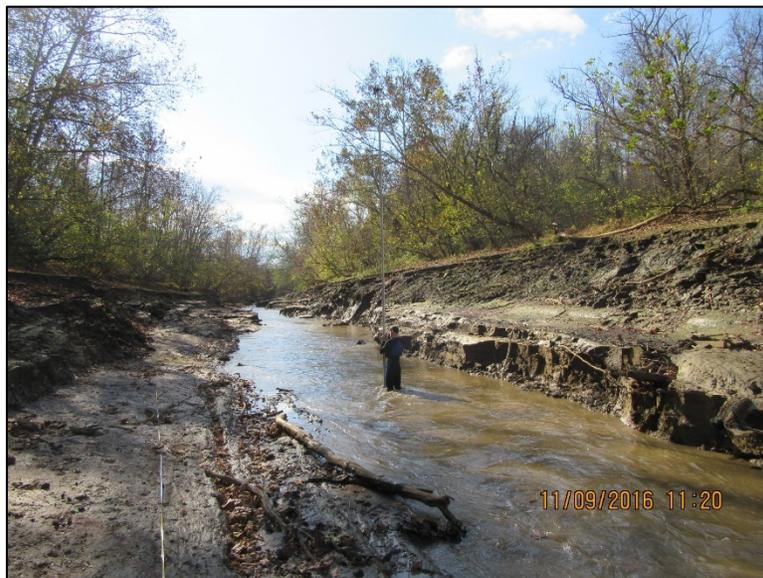
Photo 5-1

Woody Debris: 11

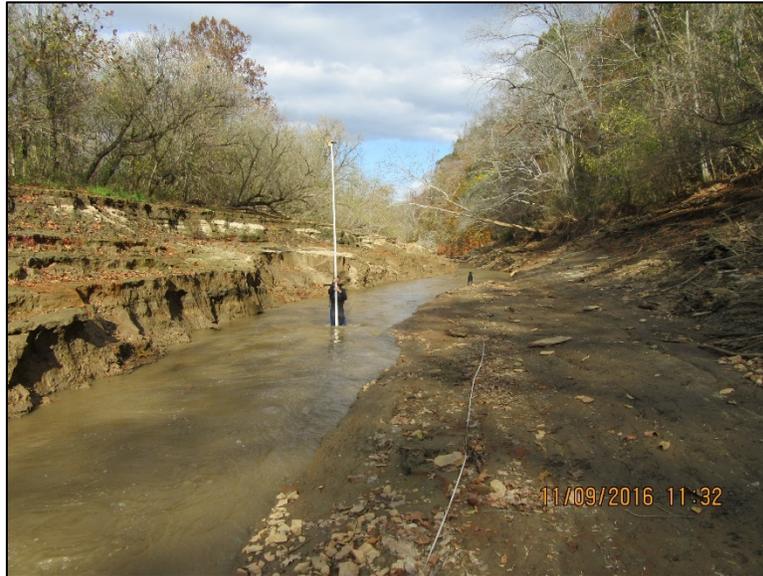
Photo 5-2

Woody Debris: 7

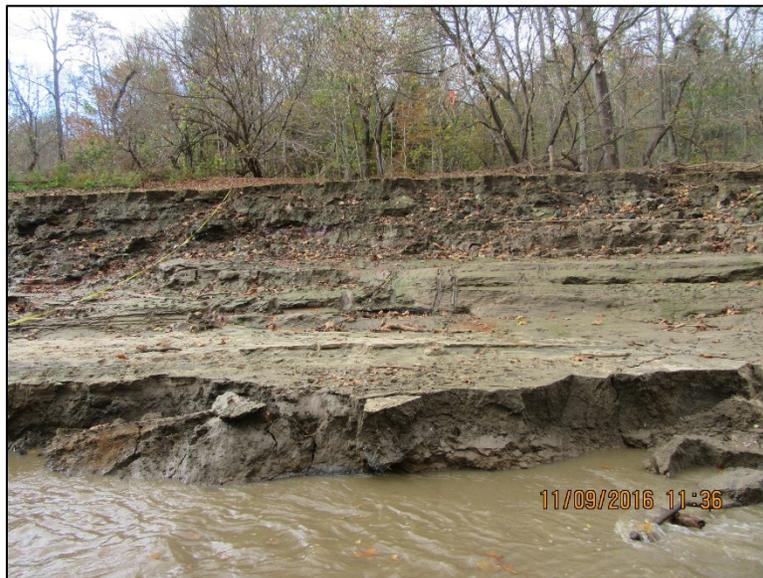
Photo 5-3

Vegetation: Small trees at bankfull, no vegetation below top of bank

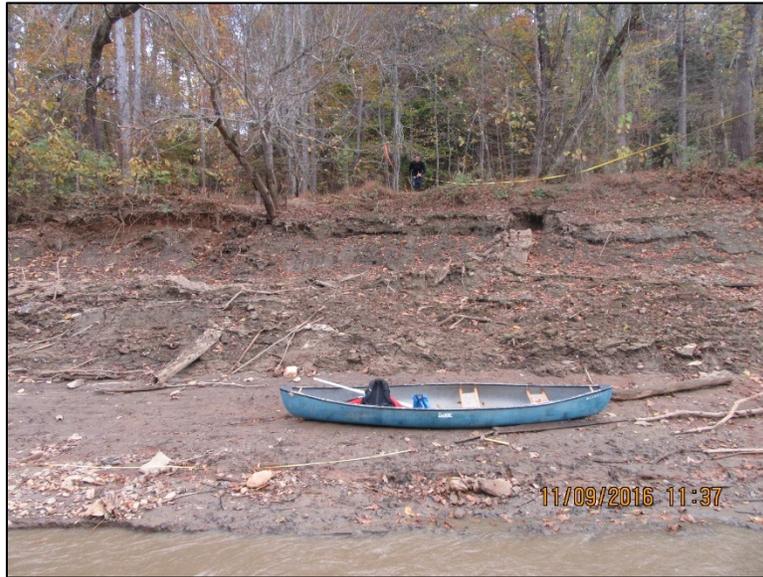
Photo 5-4

Description: Cross Section 5 was located approximately 2,000 feet downstream of Cross Section 4; approximately 800 feet downstream (north) of the power line easement. Access was by canoe from the upstream pumping station. The cross section was bounded on both banks by forested conditions. The significant backwater depth (> 10 ft) created by the dam resulted in the development of a narrow terraced channel, with the confined baseflow channel flanked by wide mudflats. Due to the recent drop in water level associated with dam removal no vegetative establishment was seen inside the top of banks (~15-ft high), or edge of the previous permanent pool water surface. The left inner bank face was vertical, approximately 4-ft high, and showing signs of periodic mass failure (Photo 5-3). The right inner bank was more gradually sloping with signs of cyclical deposition and scour. (Photo 5-4).

Description: View looking right from the middle of Cross Section 5
Vegetation: Small trees and grass at bankfull, no vegetation below top of bank

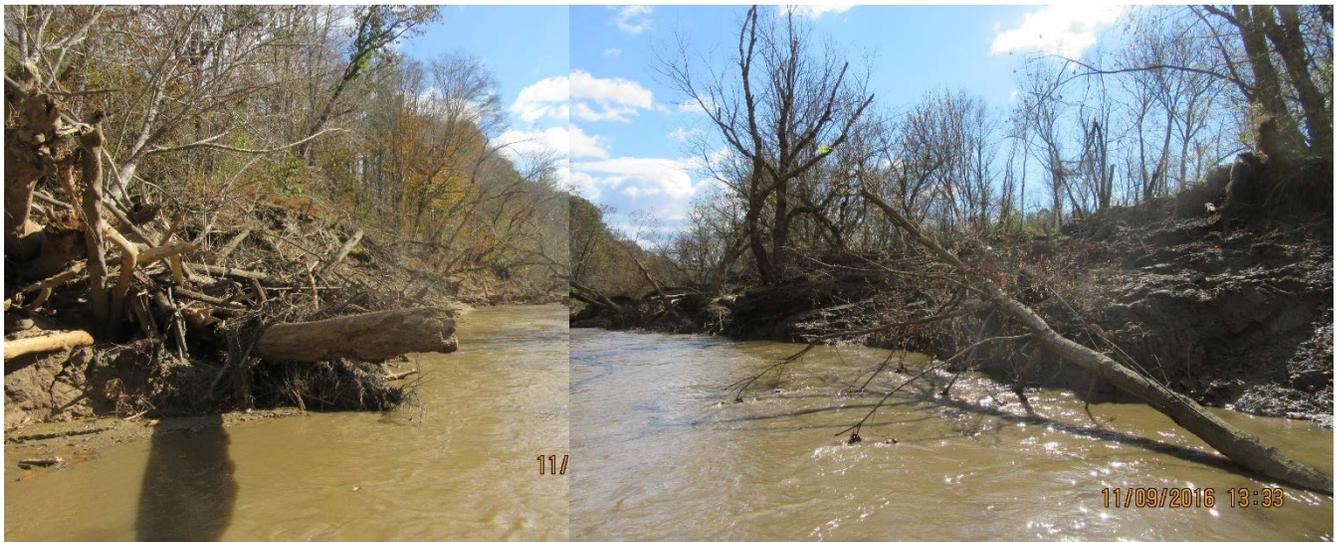
Photo 6-1 (combined image)
 Location, Orientation: XS 6, Looking Upstream
 Permit Number: JPA #15-1551
 Wetland Data Sheet Reference: n/a
 11/9/16, 12:32 PM
 Description: View looking upstream from the center of Cross Section 6
 Woody Debris: 100+

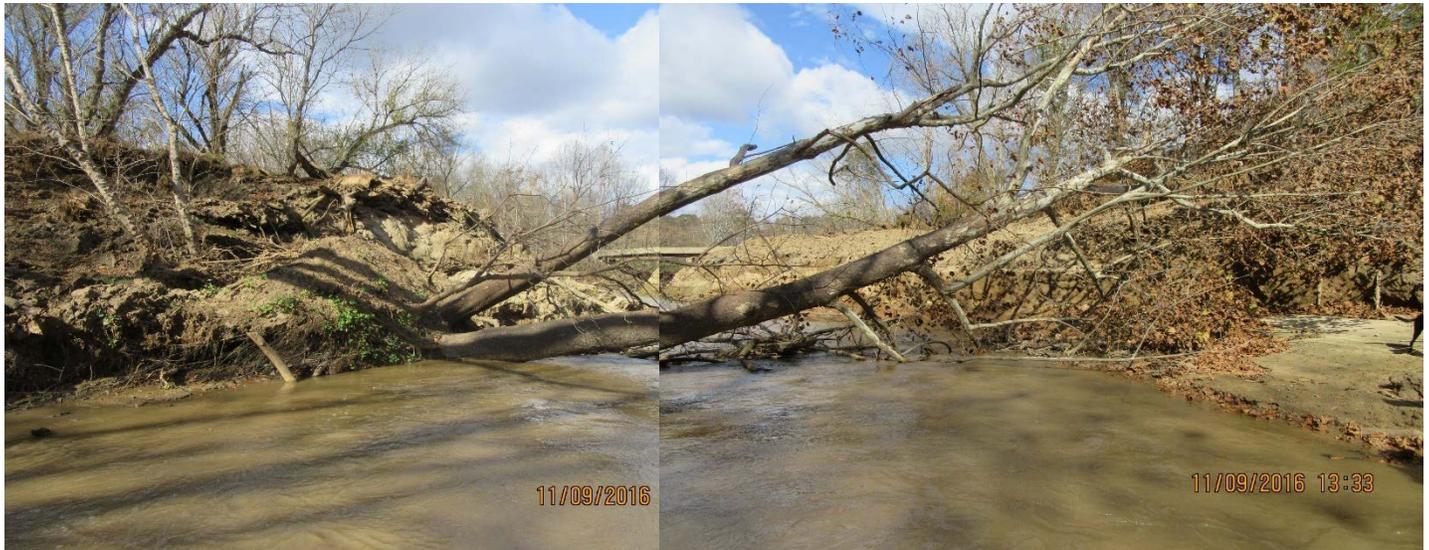
Photo 6-2 (combined image)
Location, Orientation: XS 6, Looking Downstream
Permit Number: JPA #15-1551
Wetland Data Sheet Reference: n/a
11/9/16, 12:33 PM
Description: View looking downstream from the middle of Cross Section 6
Woody Debris: 100+

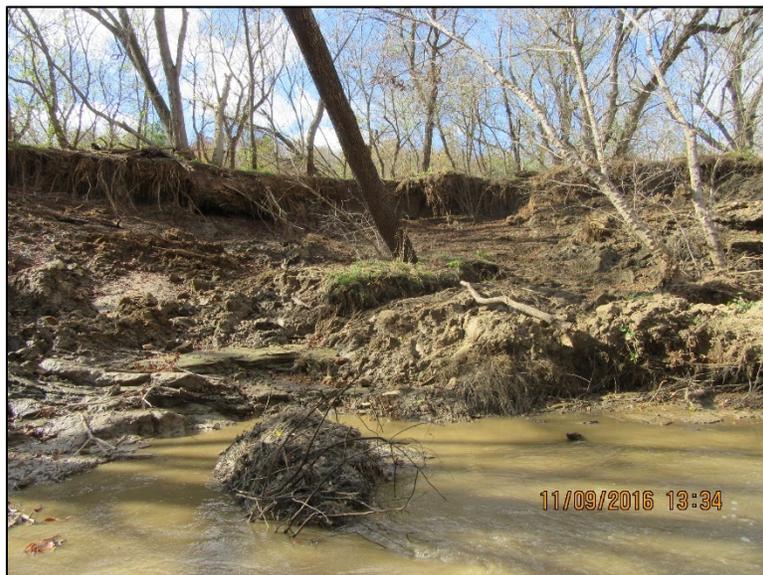
Photo 6-3
Location, Orientation: XS 6, Left Bank
Permit Number: JPA #15-1551
Wetland Data Sheet Reference: n/a
11/9/16, 12:34 PM
Description: View looking left from the middle of Cross Section 6

Vegetation: 10% herbaceous cover, large trees and shrubs at top of bank

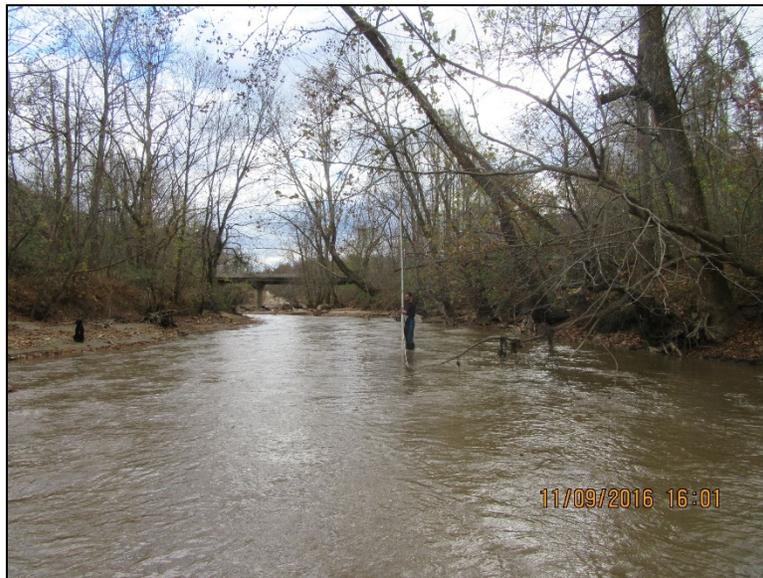
Photo 7-1

Woody Debris: 30

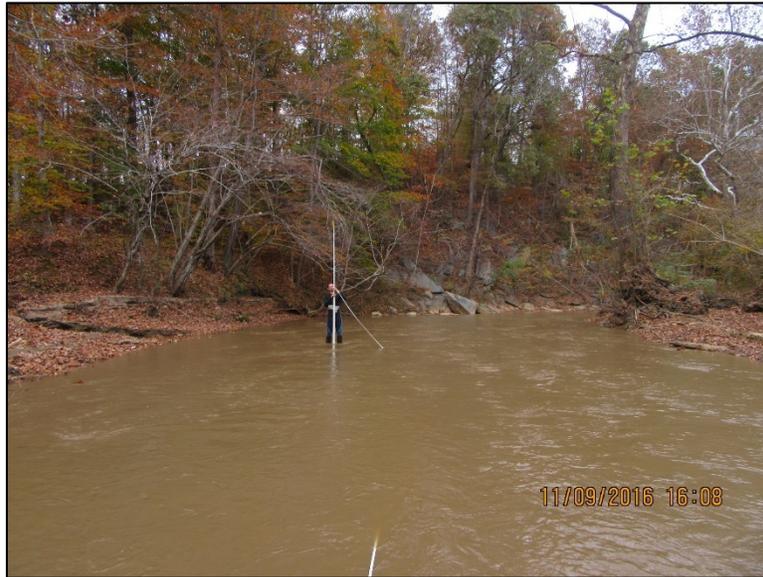
Photo 7-2

Woody Debris: 12

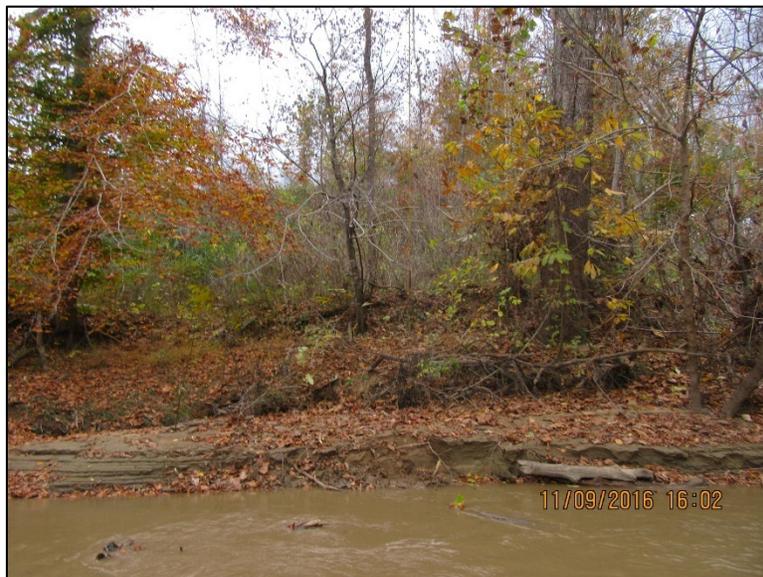
Photo 7-3

Vegetation: 70% herbaceous cover, few trees

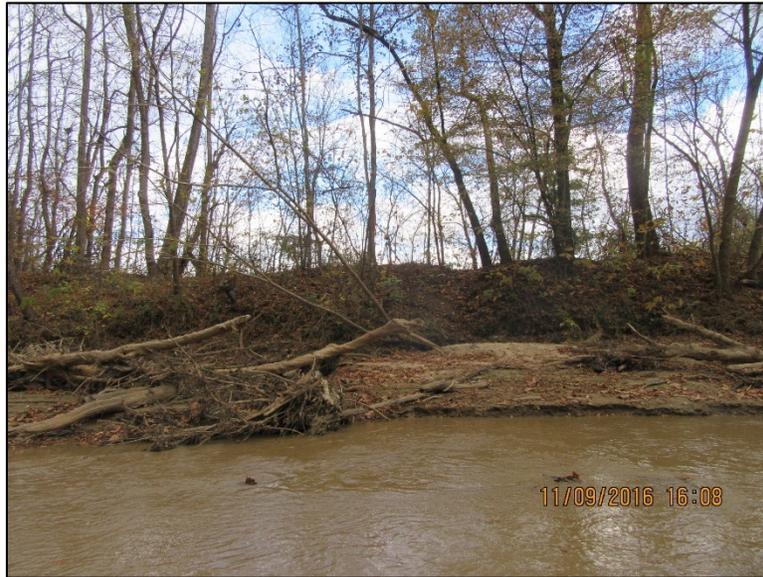
Photo 7-4

Vegetation: 30% herbaceous plants, trees on top of bank

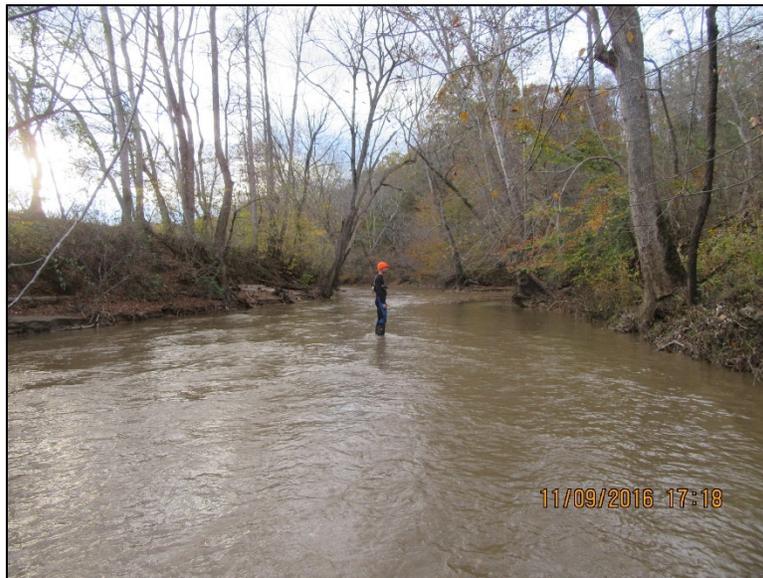
Photo 8-1

Description: View looking upstream from the middle of Cross Section 8
Woody Debris: 10-15

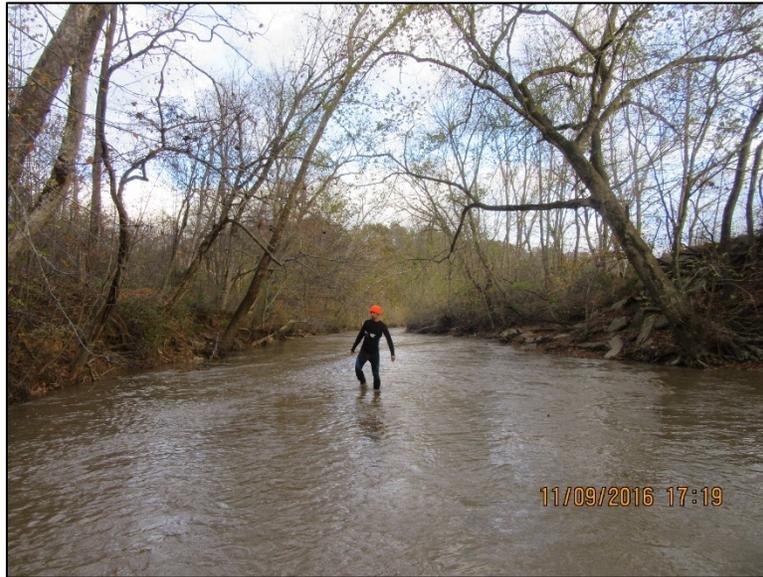
Photo 8-2

Woody Debris: 10-15

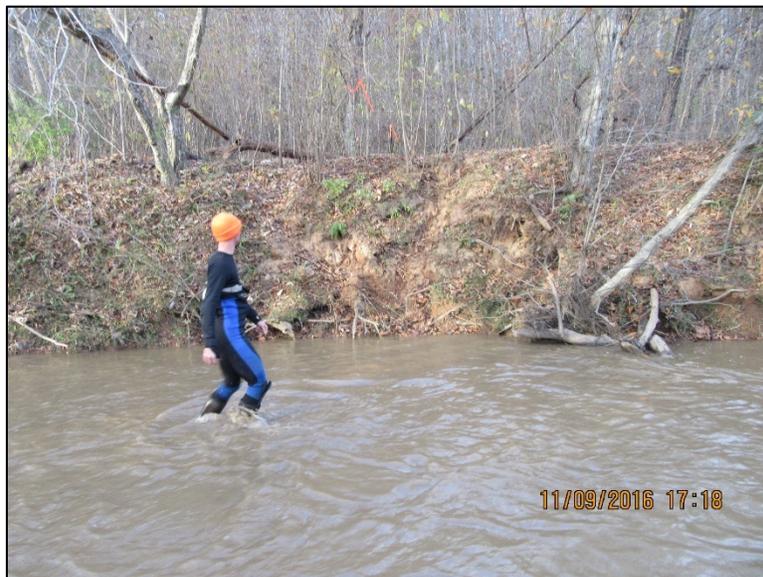
Photo 8-3

Vegetation: 60% herbaceous cover, small trees

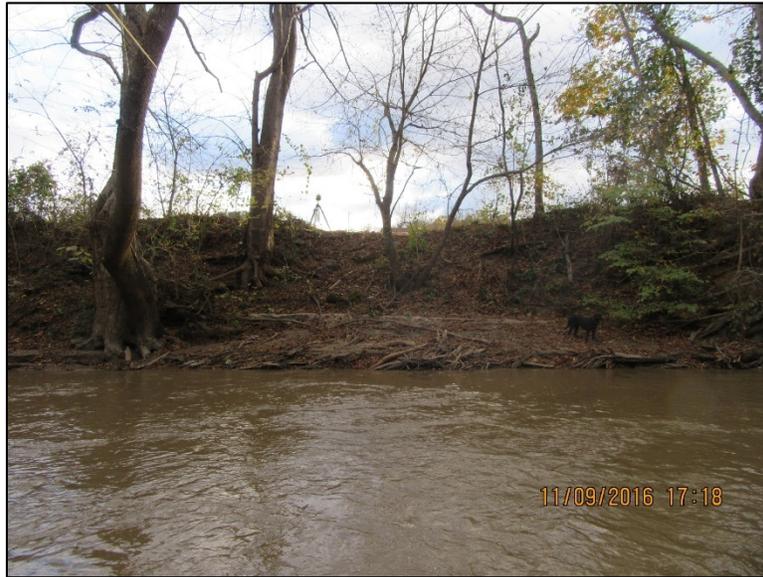
Photo 8-4

Vegetation: 30% herbaceous plants, trees

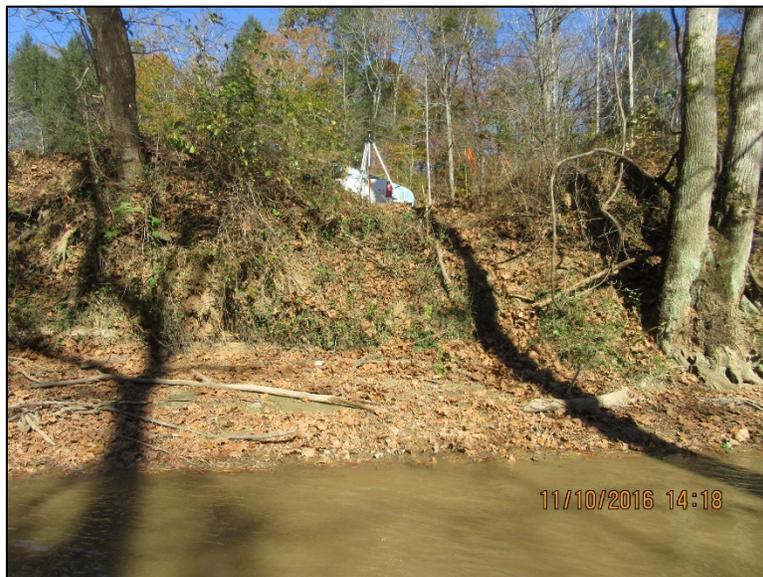
Photo 10-3

Vegetation: 70% herbaceous cover, trees

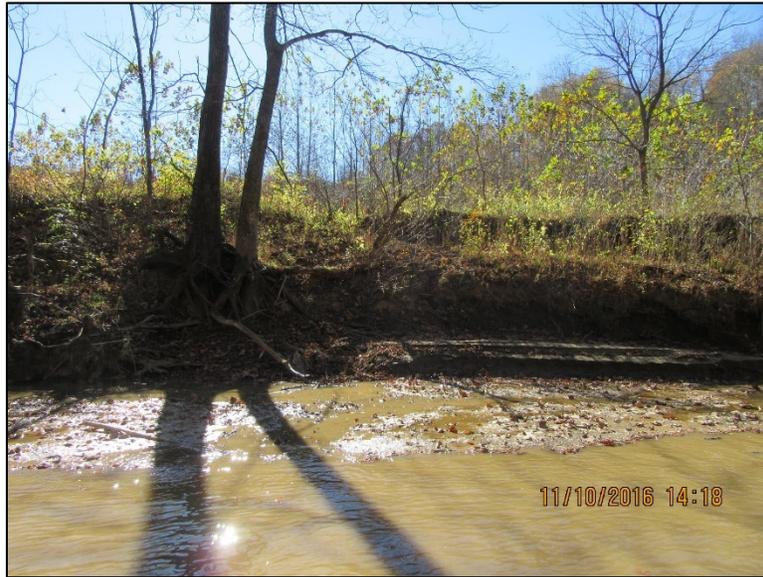
Photo 10-4

Vegetation: 70% herbaceous cover, some trees higher on bank

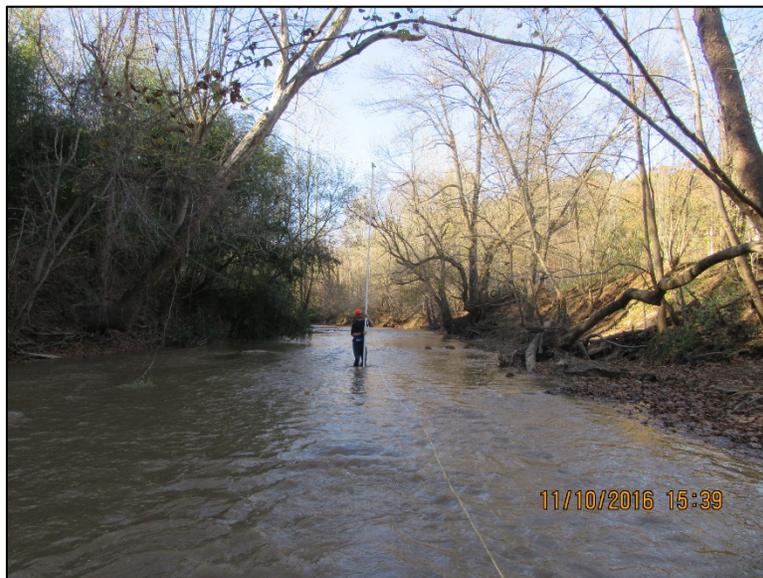
Photo 11-1

Woody Debris: 15

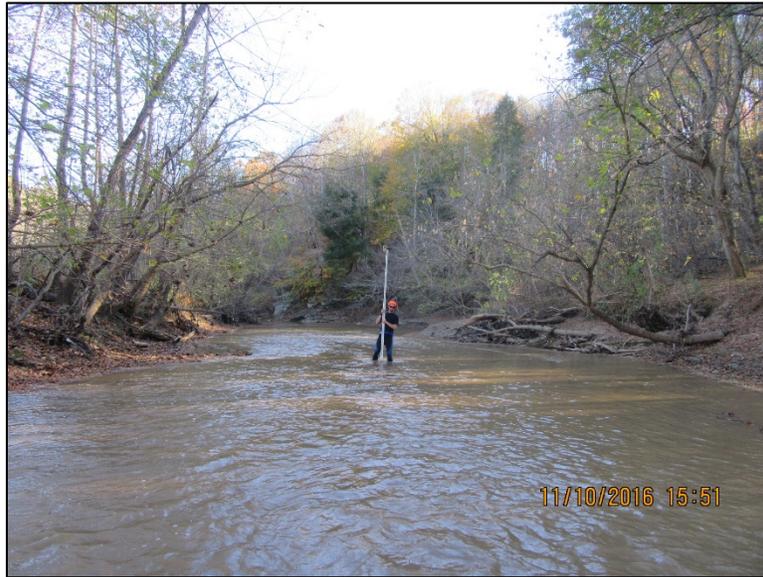
Photo 11-2

Woody Debris: 15

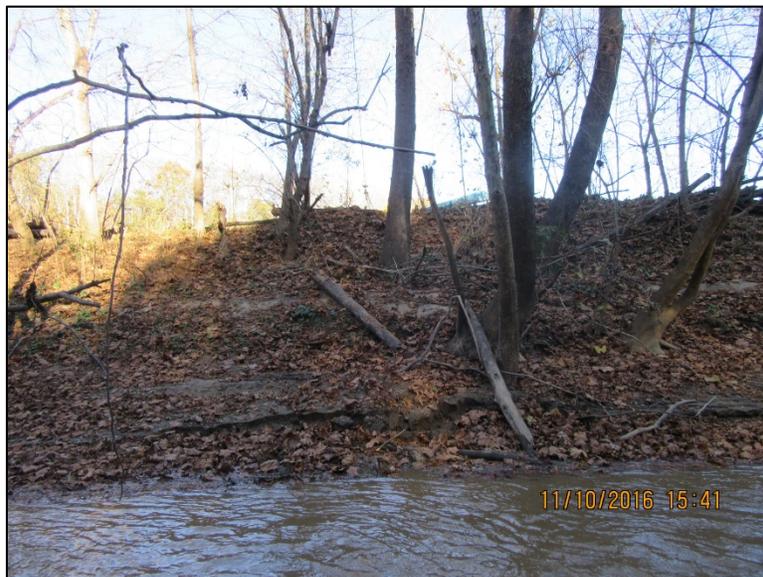
Photo 11-3

Vegetation: 30% herbaceous cover, trees

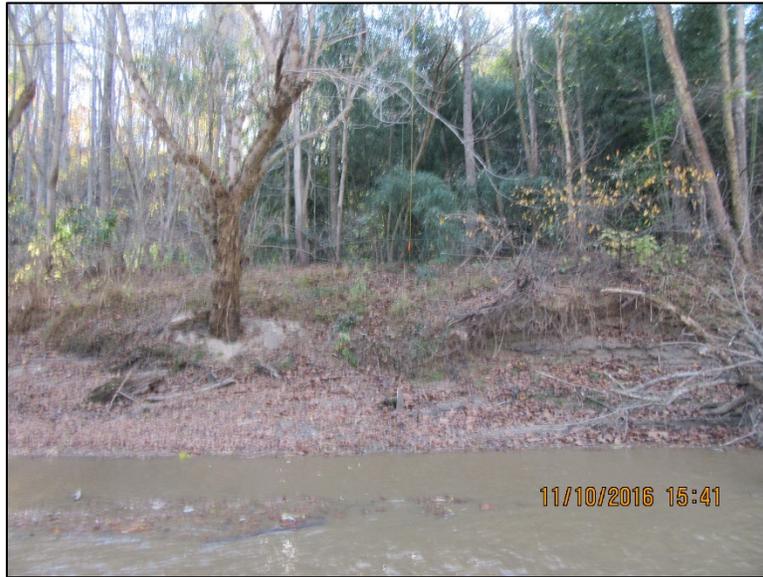
Photo 11-4

Vegetation: 60% herbaceous cover and small trees going up slope, bamboo/forest at bankfull

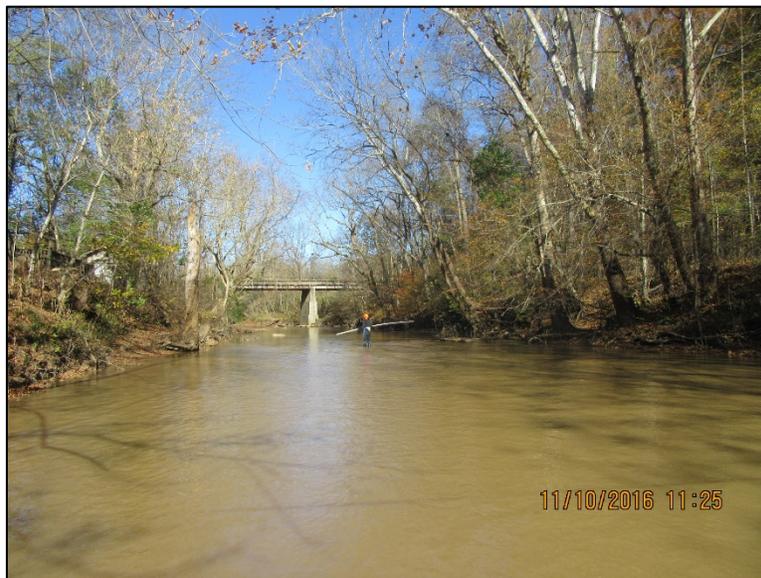
Photo 12-1

Woody Debris: 5

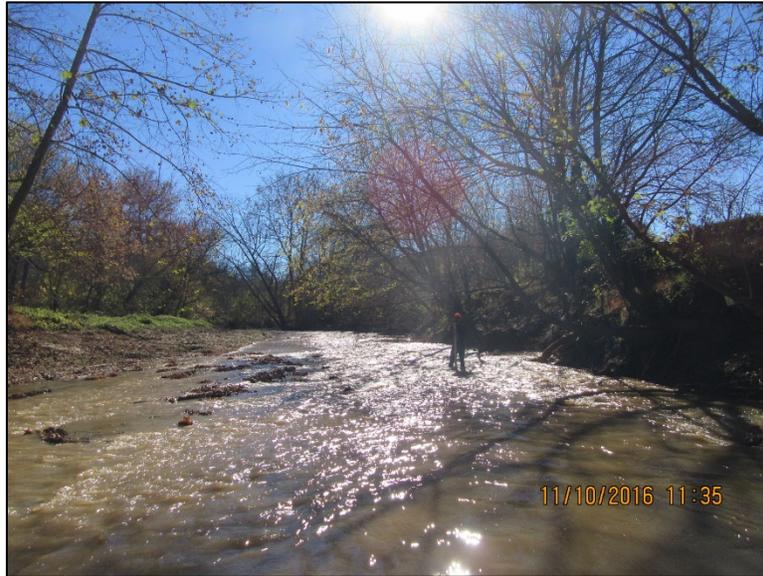
Photo 12-2

Woody Debris: 5

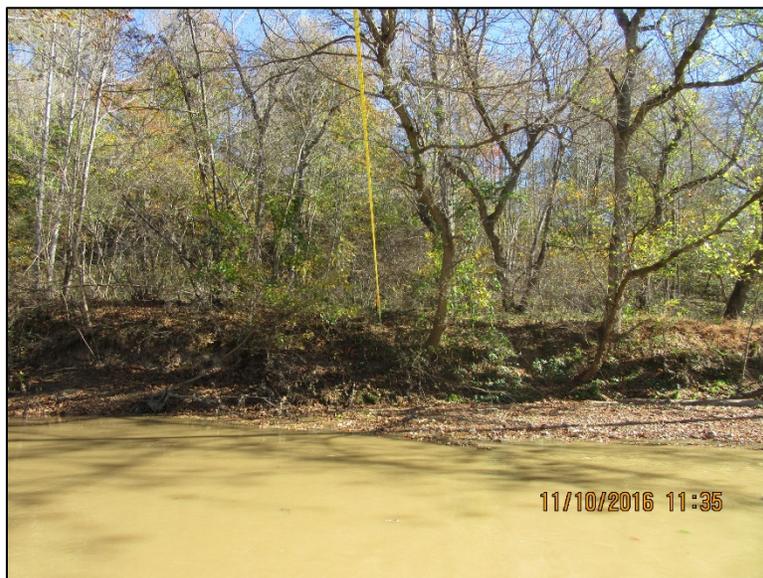
Photo 12-3

Vegetation: 70% herbaceous cover, trees

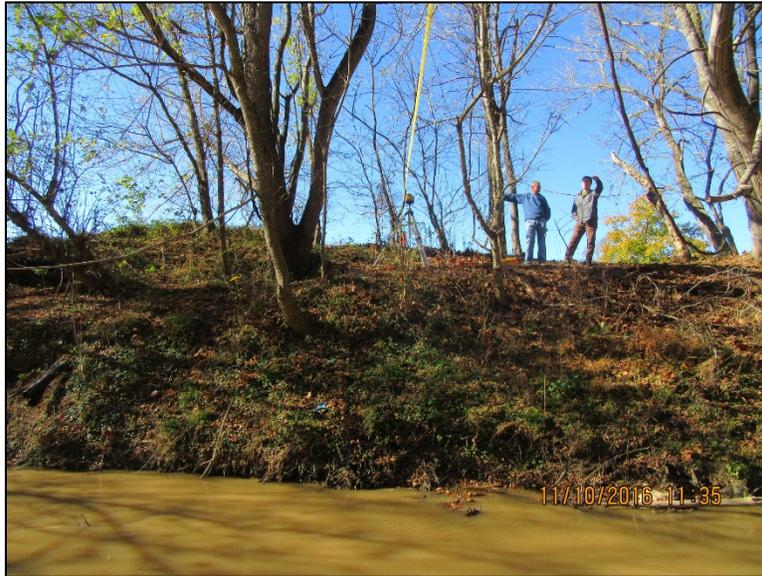
Photo 12-4

Vegetation: 70% herbaceous cover, trees at top of bank
