The Cost of Well Abandonment

Lower Rio Grande Valley National Wildlife Refuge

Abandoned Oil & Gas Equipment

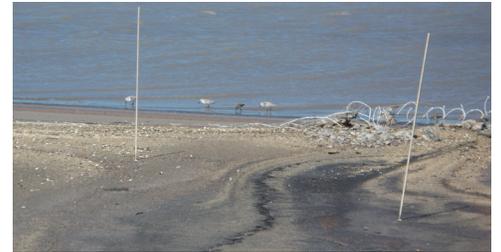
Before clean up, the abandoned production facilities – including storage tanks and sections of rusted pipe – extended into East Lake, threatening contamination of the adjacent wetlands that are piping plover winter habitat. They also posed potential health risks to other native wildlife. Oil sheens were visible in East Lake near one of the abandoned wells.

Leaking fluids from old abandoned well

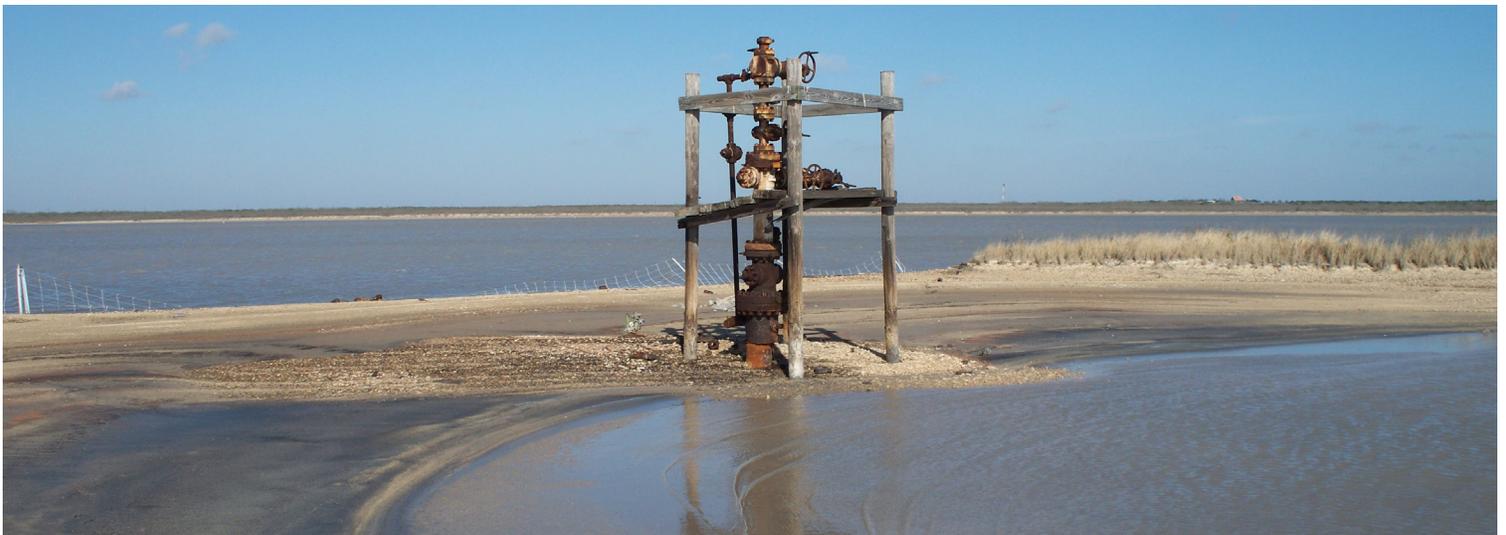
One of the three wells removed from the shore of East Lake by the Texas Railroad Commission/USFWS

Storage tanks, pipes, and other oil production equipment were removed from the three well sites. Metal that could be recycled was taken to a metal salvage yard. Refuge habitat was restored.

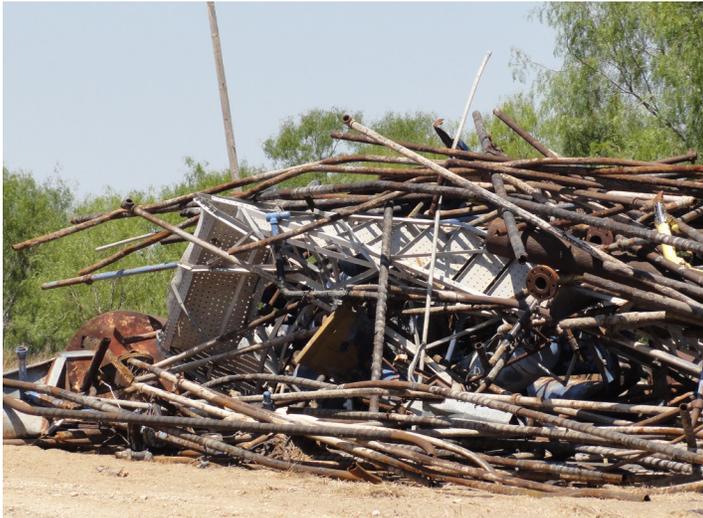
A mass of abandoned equipment was removed from each of the three East Lake well sites/USFWS

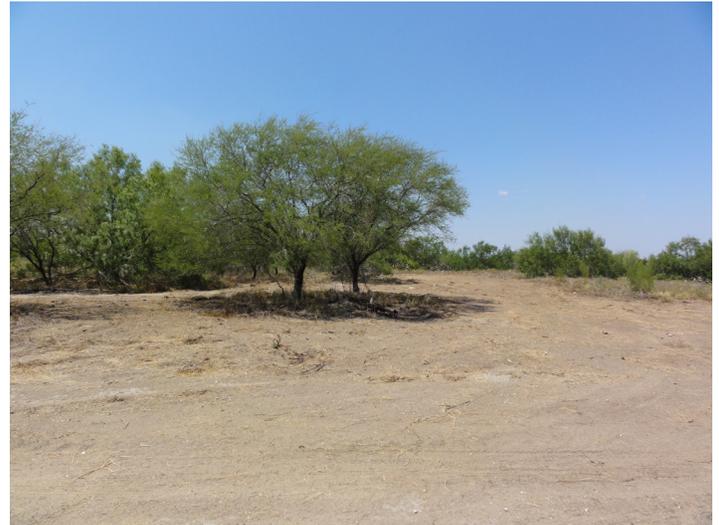
Site after clean up/USFWS

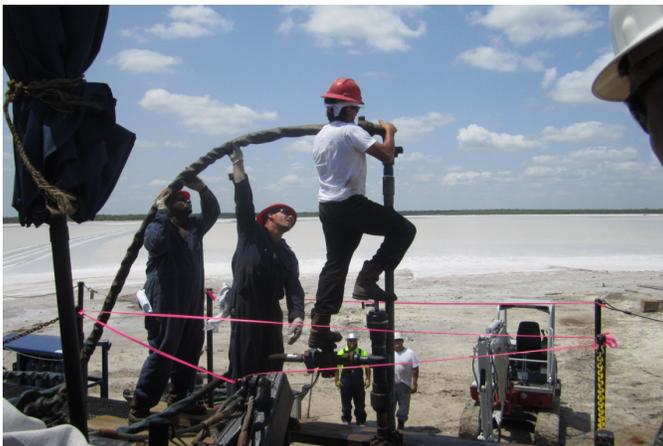
Pumping cement in the well to plug it / USFWS

Corrective Action: abandoned wells plugged, oil & gas equipment removed, June-July 2011
