Pacific Lamprey Passage Evaluations at Hatchery Facilities in Southwest Washington State

Summary Graphic Report: 2022

Joe Skalicky, US Fish and Wildlife Service, Columbia River Fish and Wildlife Conservation Office, January 2022

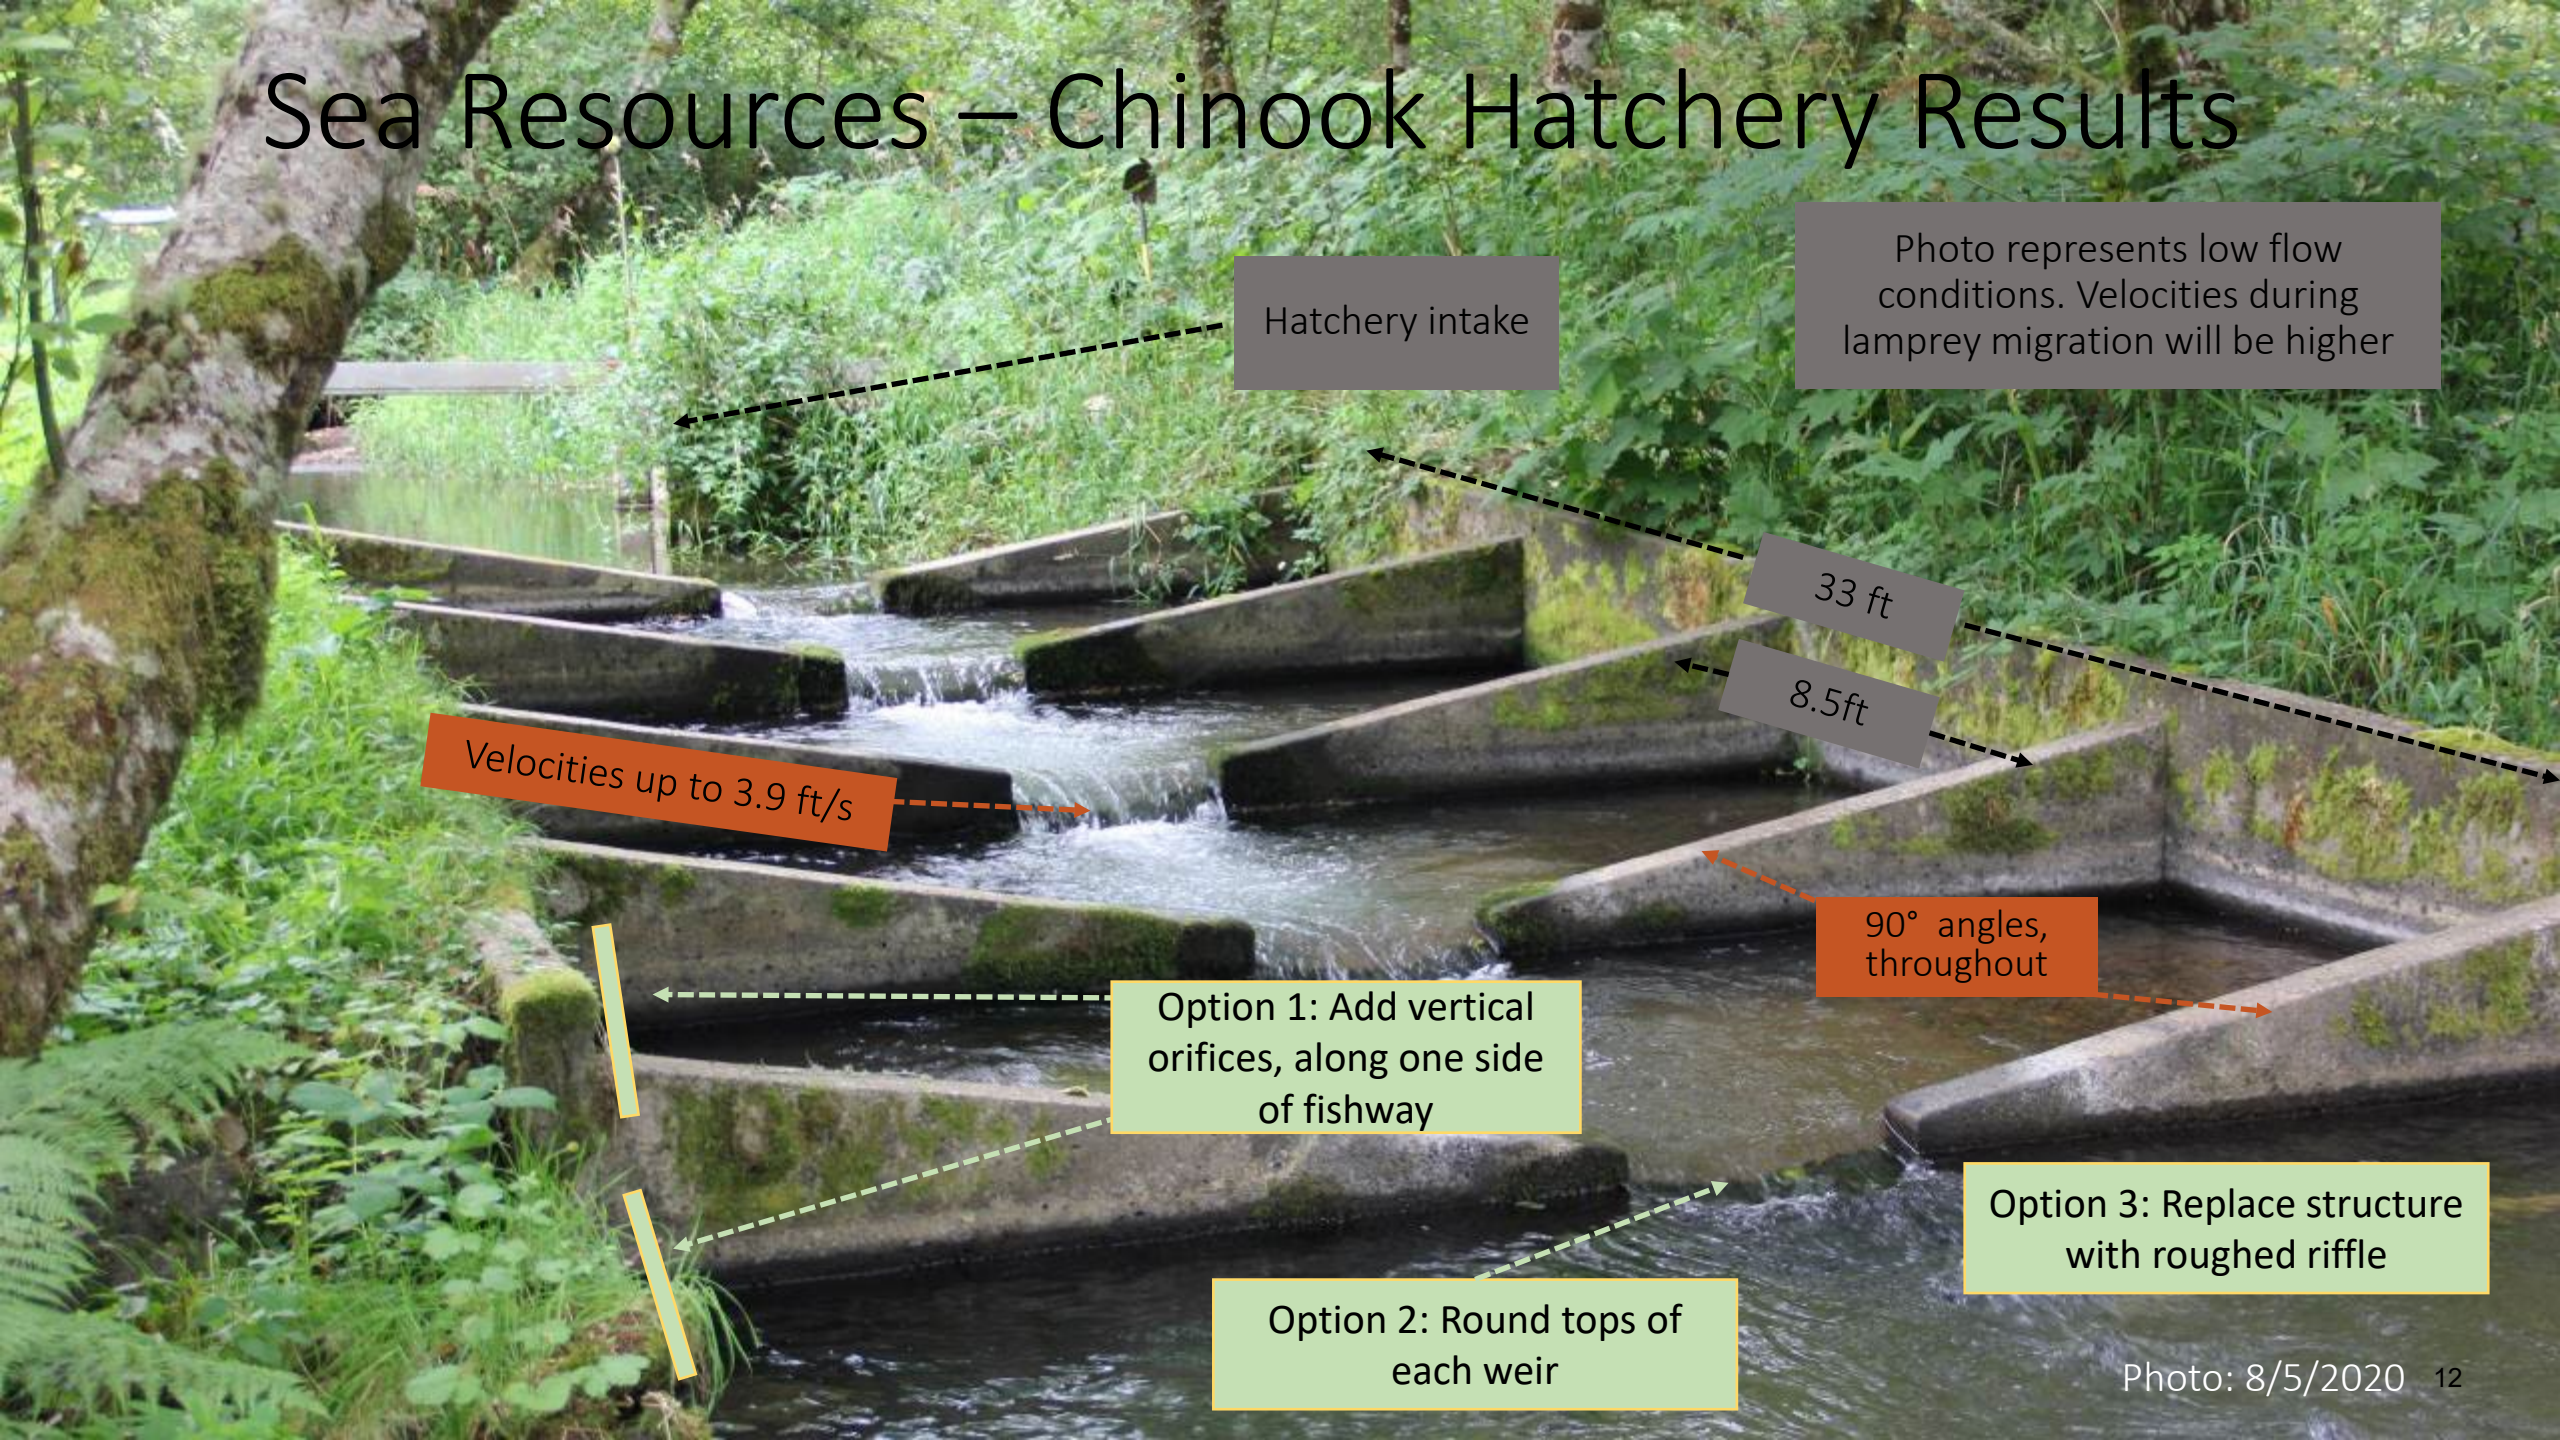
Sea Resources – Chinook Hatchery Results

Hatchery intake

Photo represents low flow conditions. Velocities during lamprey migration will be higher

Velocities up to 3.9 ft/s

90° angles, throughout

- Diversion and intake are located ~2,000 ft upstream of hatchery
- V-notched weirs are used to pond up water for the hatchery water intake
- Passage could be an issue at most flows (90° angles and velocities up to 3.9 ft/s)

- Velocities (8/5/2020) ranged from 1.2 – 3.9 ft/s, with heavy moss on weirs
- Recommend re-assessing at spring flows, during active migration
- Recommend option 1), adding lamprey specific orifices adjacent to weir walls

Option 1: Add vertical orifices, along one side of fishway

Option 2: Round tops of each weir

Option 3: Replace structure with roughed riffle

- Recommend option 2) replace with roughed riffle. Will enable passage of all native fishes
- Larval Pacific and Lampetra species observed above hatchery

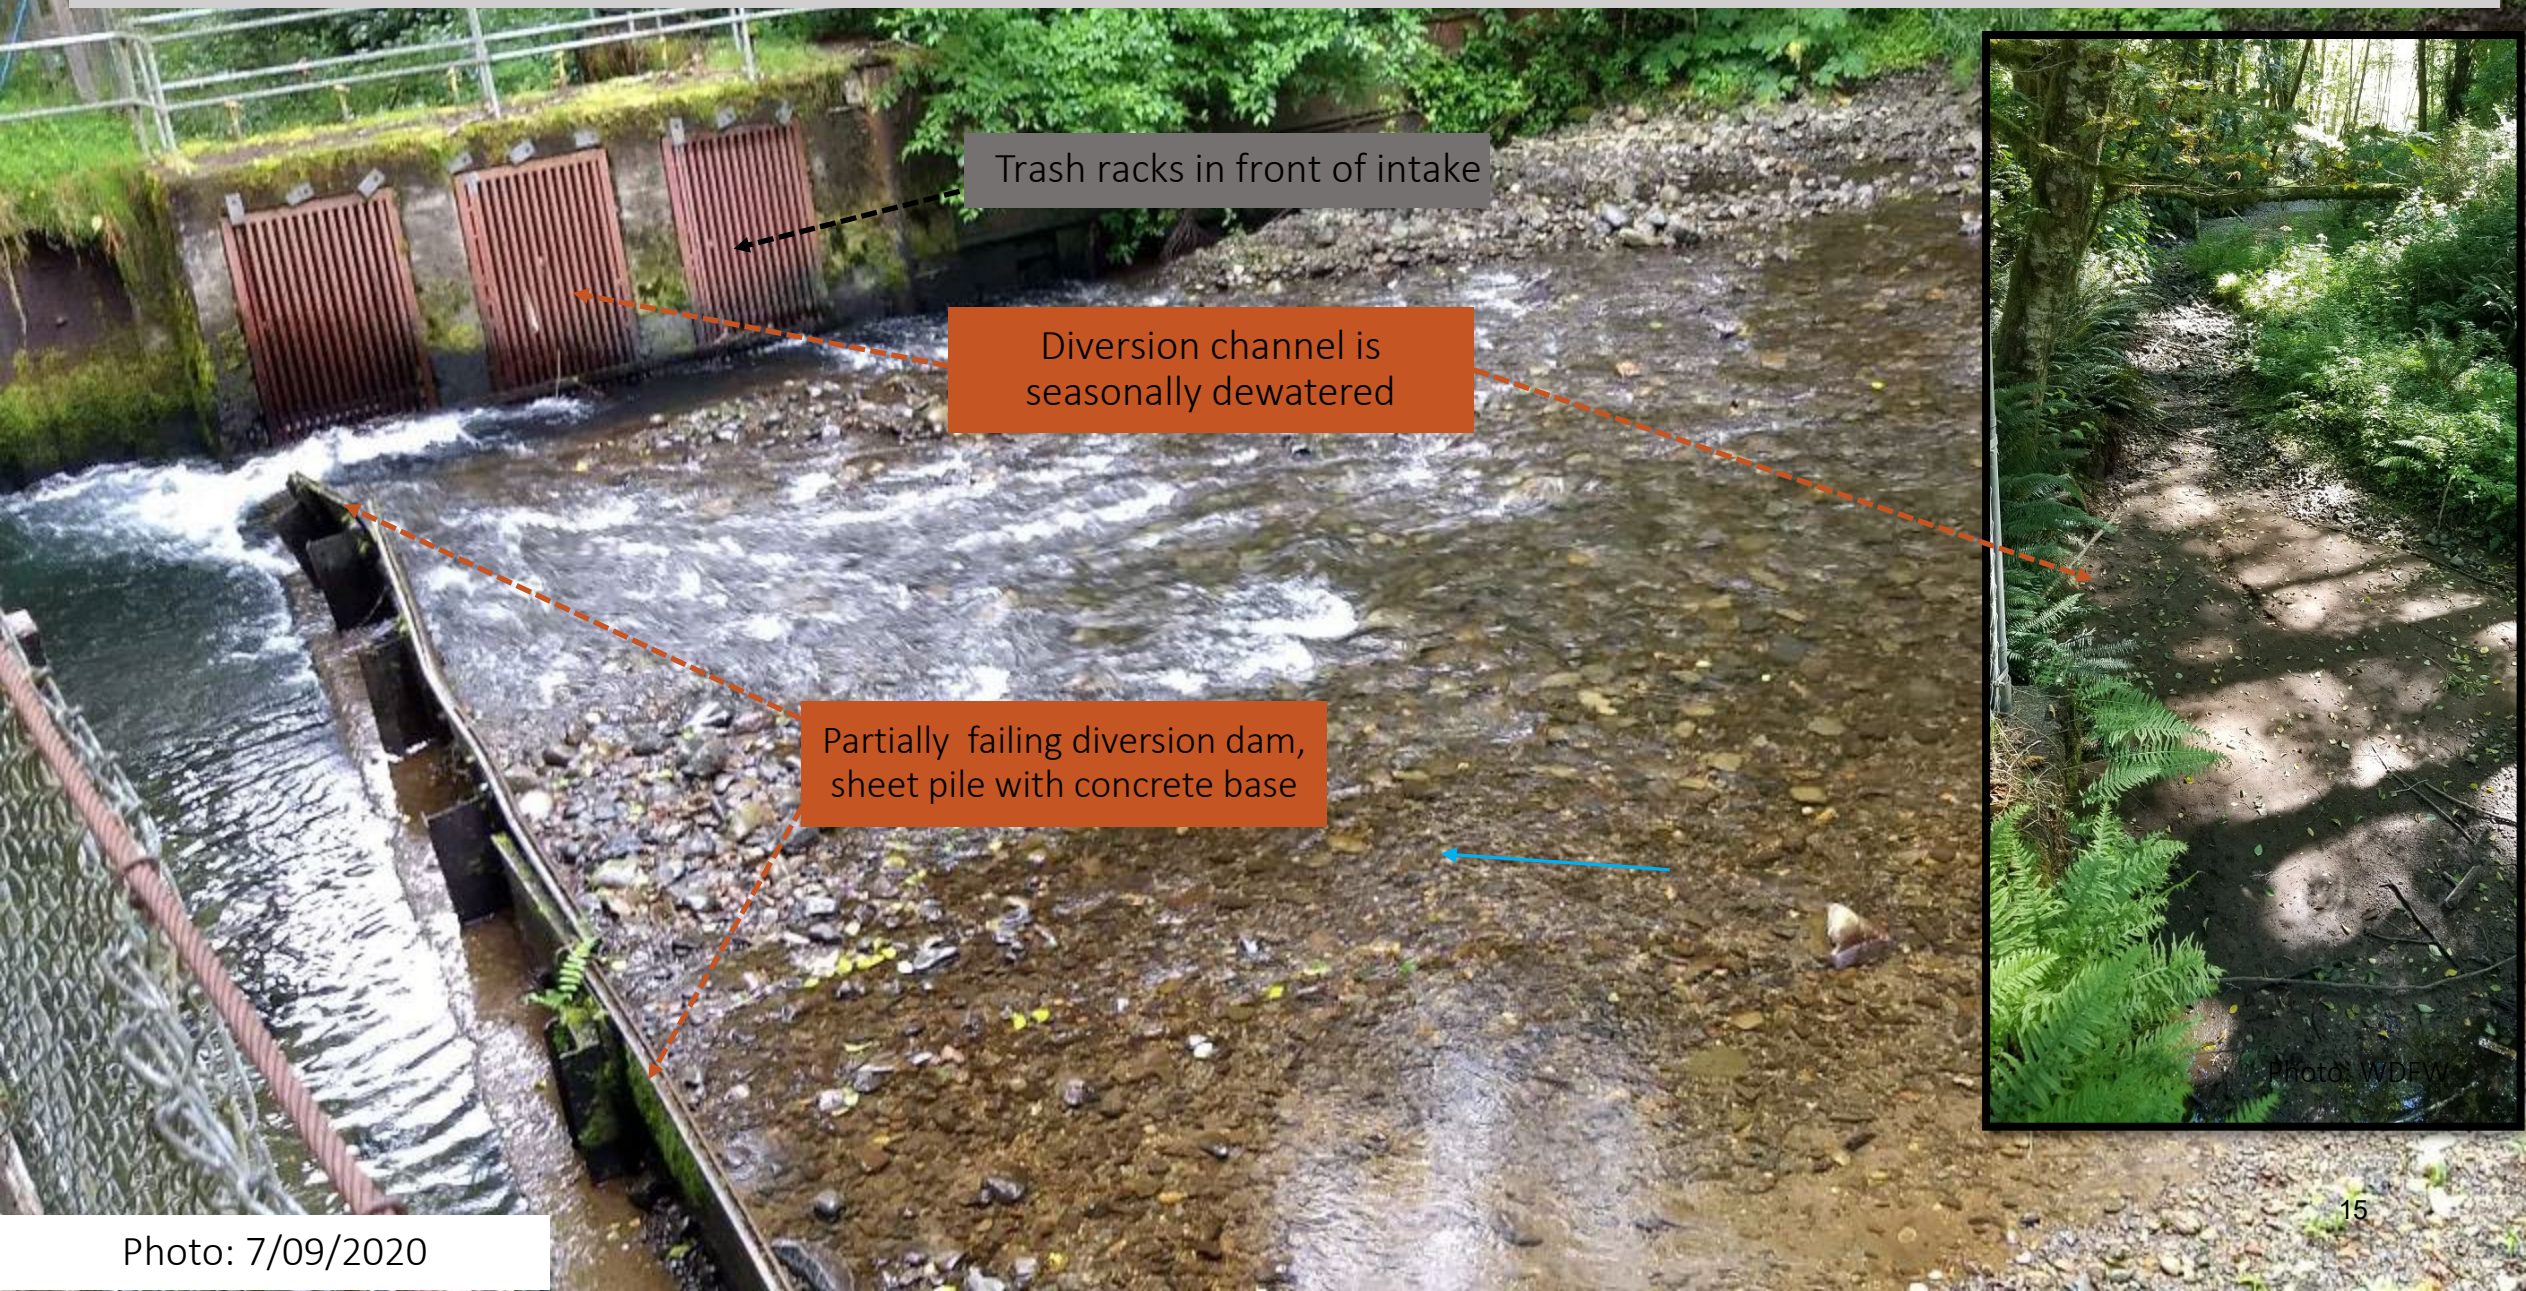
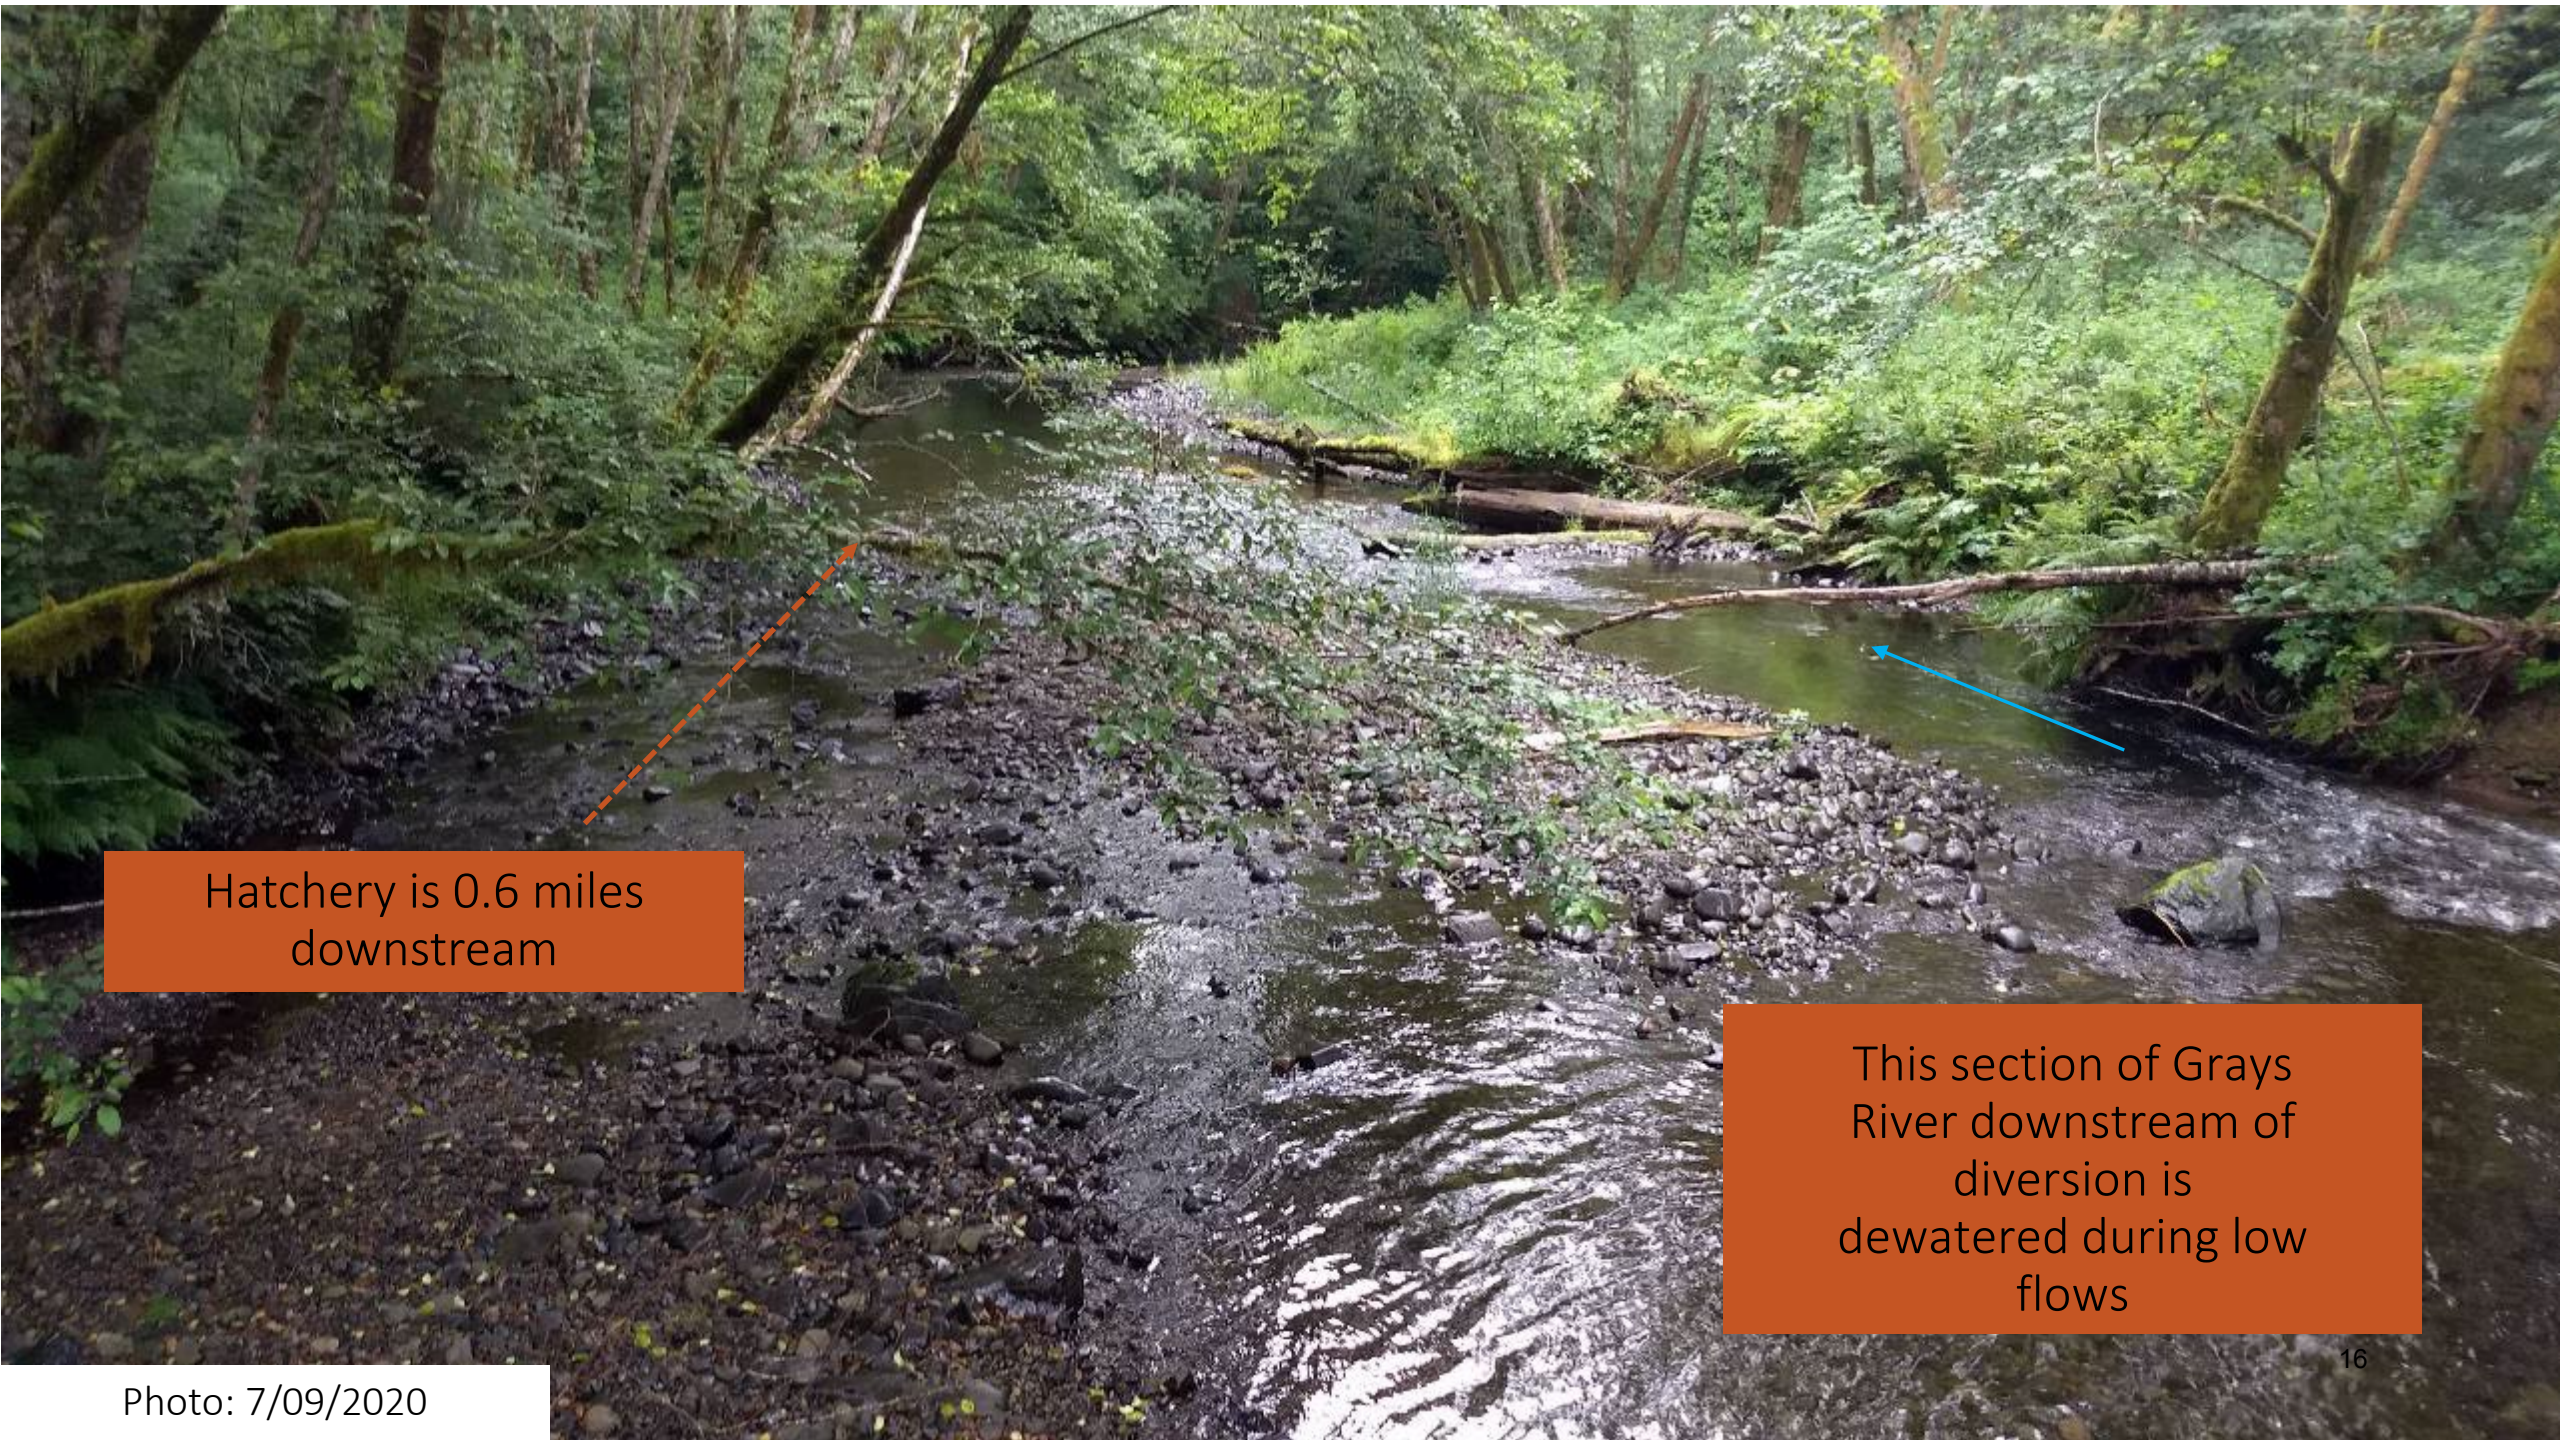
Grays River Hatchery – WDFW – Upstream Diversion & Intake

Hatchery is 0.6 miles
downstream

This section of Grays
River downstream of
diversion is
dewatered during low
flows

- No barrier dam is associated with the fish ladder at the hatchery proper
- Hatchery is currently shut down and scheduled for decommissioning
- Upstream diversion and partial diversion dam are out of compliance
 - River between the diversion and hatchery is dewatered in some low-flow years
 - Diversion channel is dewatered seasonally.
 - Larval Pacific lamprey were observed in the abatement pond
- Cowlitz Tribe is seeking funding (Jan 2022) to remove the diversion structure
 - No recommendations suggested, pending removal

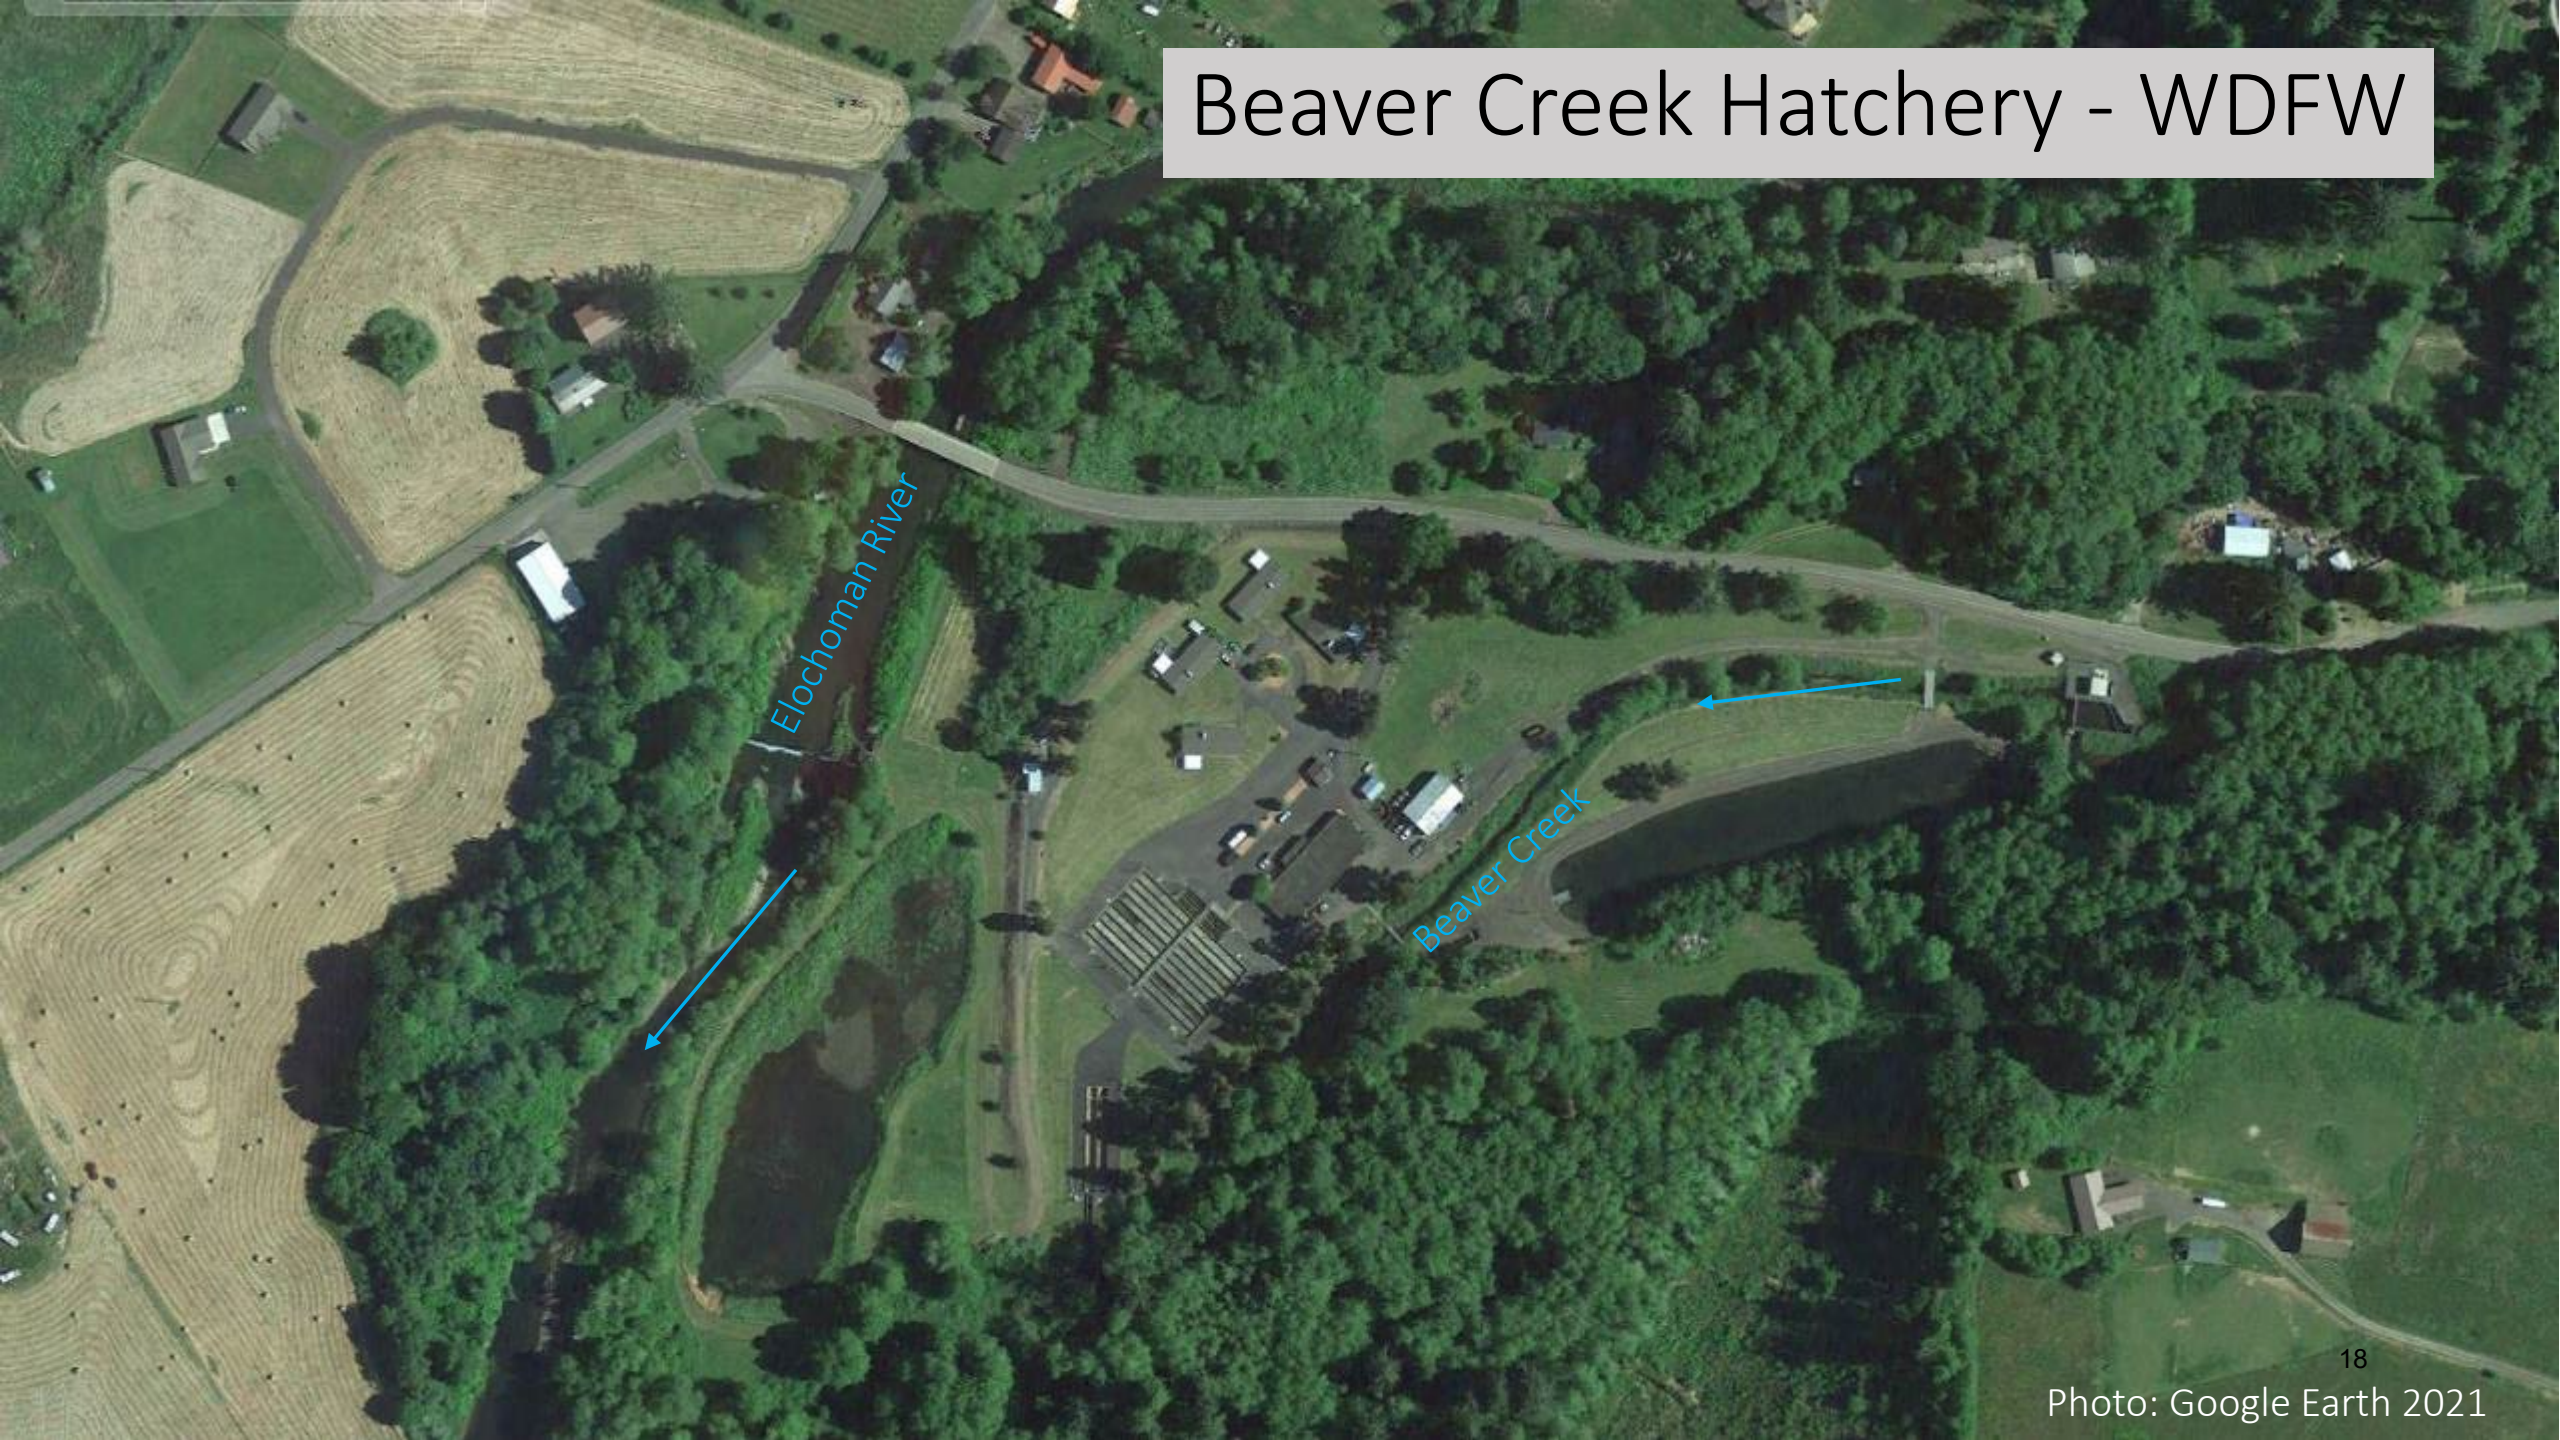
Elochoman River fishway, barrier dam, and pumped intake

Beaver Creek Fishway, Barrier Dam, and intake

- Elochoman fishway suffers from a lack of water (July-Sep.)
 - Dam (head) is not high enough to pond up adequate water.
 - During low flows, the fishway does not function

- Sheet pile dam appears to be failing
 - All 90 angles, no orifices
 - Option to replace with roughened riffle?
- Recommend re-assessing at spring migration flows

- Recommend concrete or aluminum ramps on the sheet pile dam, on both ends.
- Consider adding lamprey-specific orifices, either vertical or horizontal depending on the infrastructure

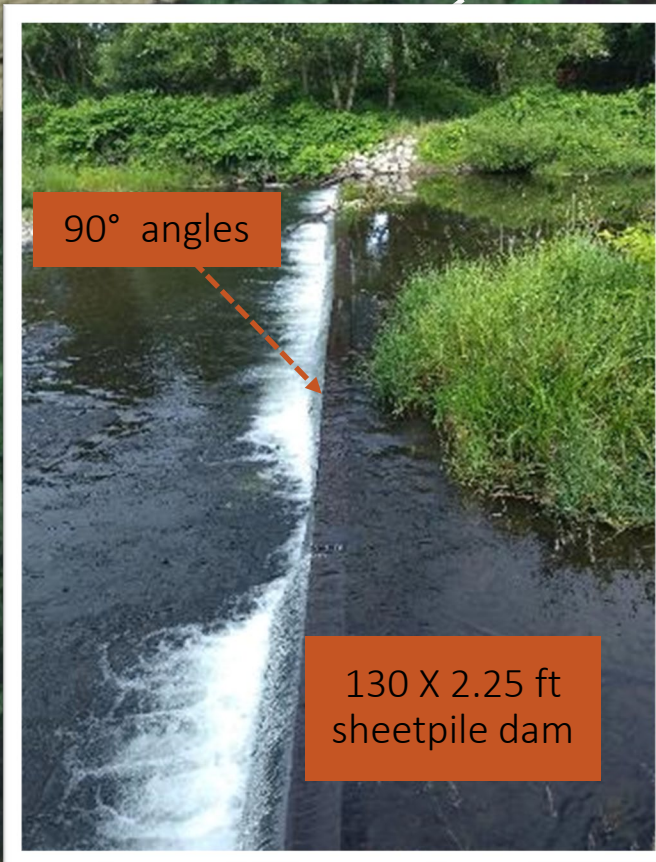
No dam at adult fishway entrance

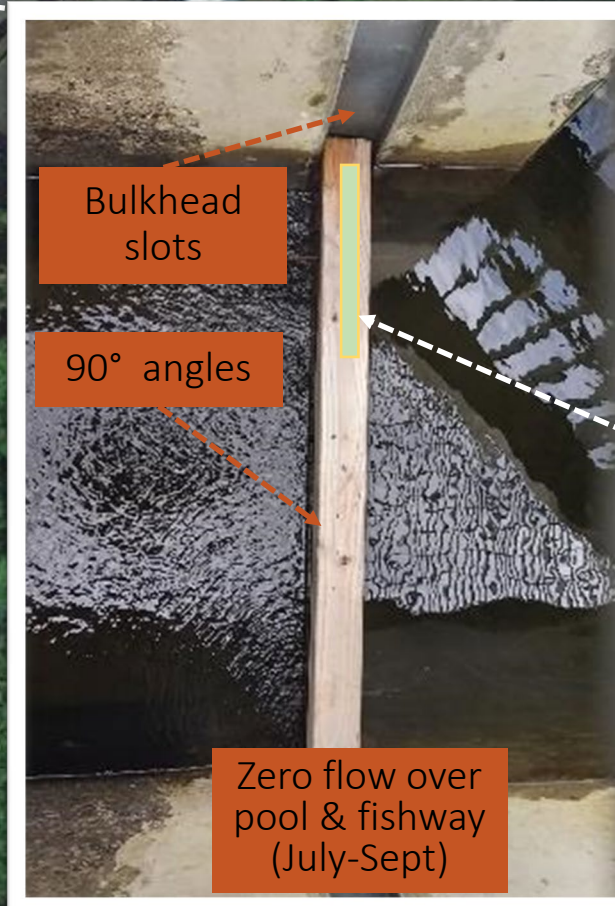
- Beaver Creek fishway(on Beaver Creek) has a new and novel lamprey passage wear
 - Operated seasonally. Not aware of any efficacy assessments
 - Adult salmon ladder downstream adjacent to the hatchery does not have a barrier dam

Options:

- Evaluate passage of lamprey weirs
- Assess velocities during operation

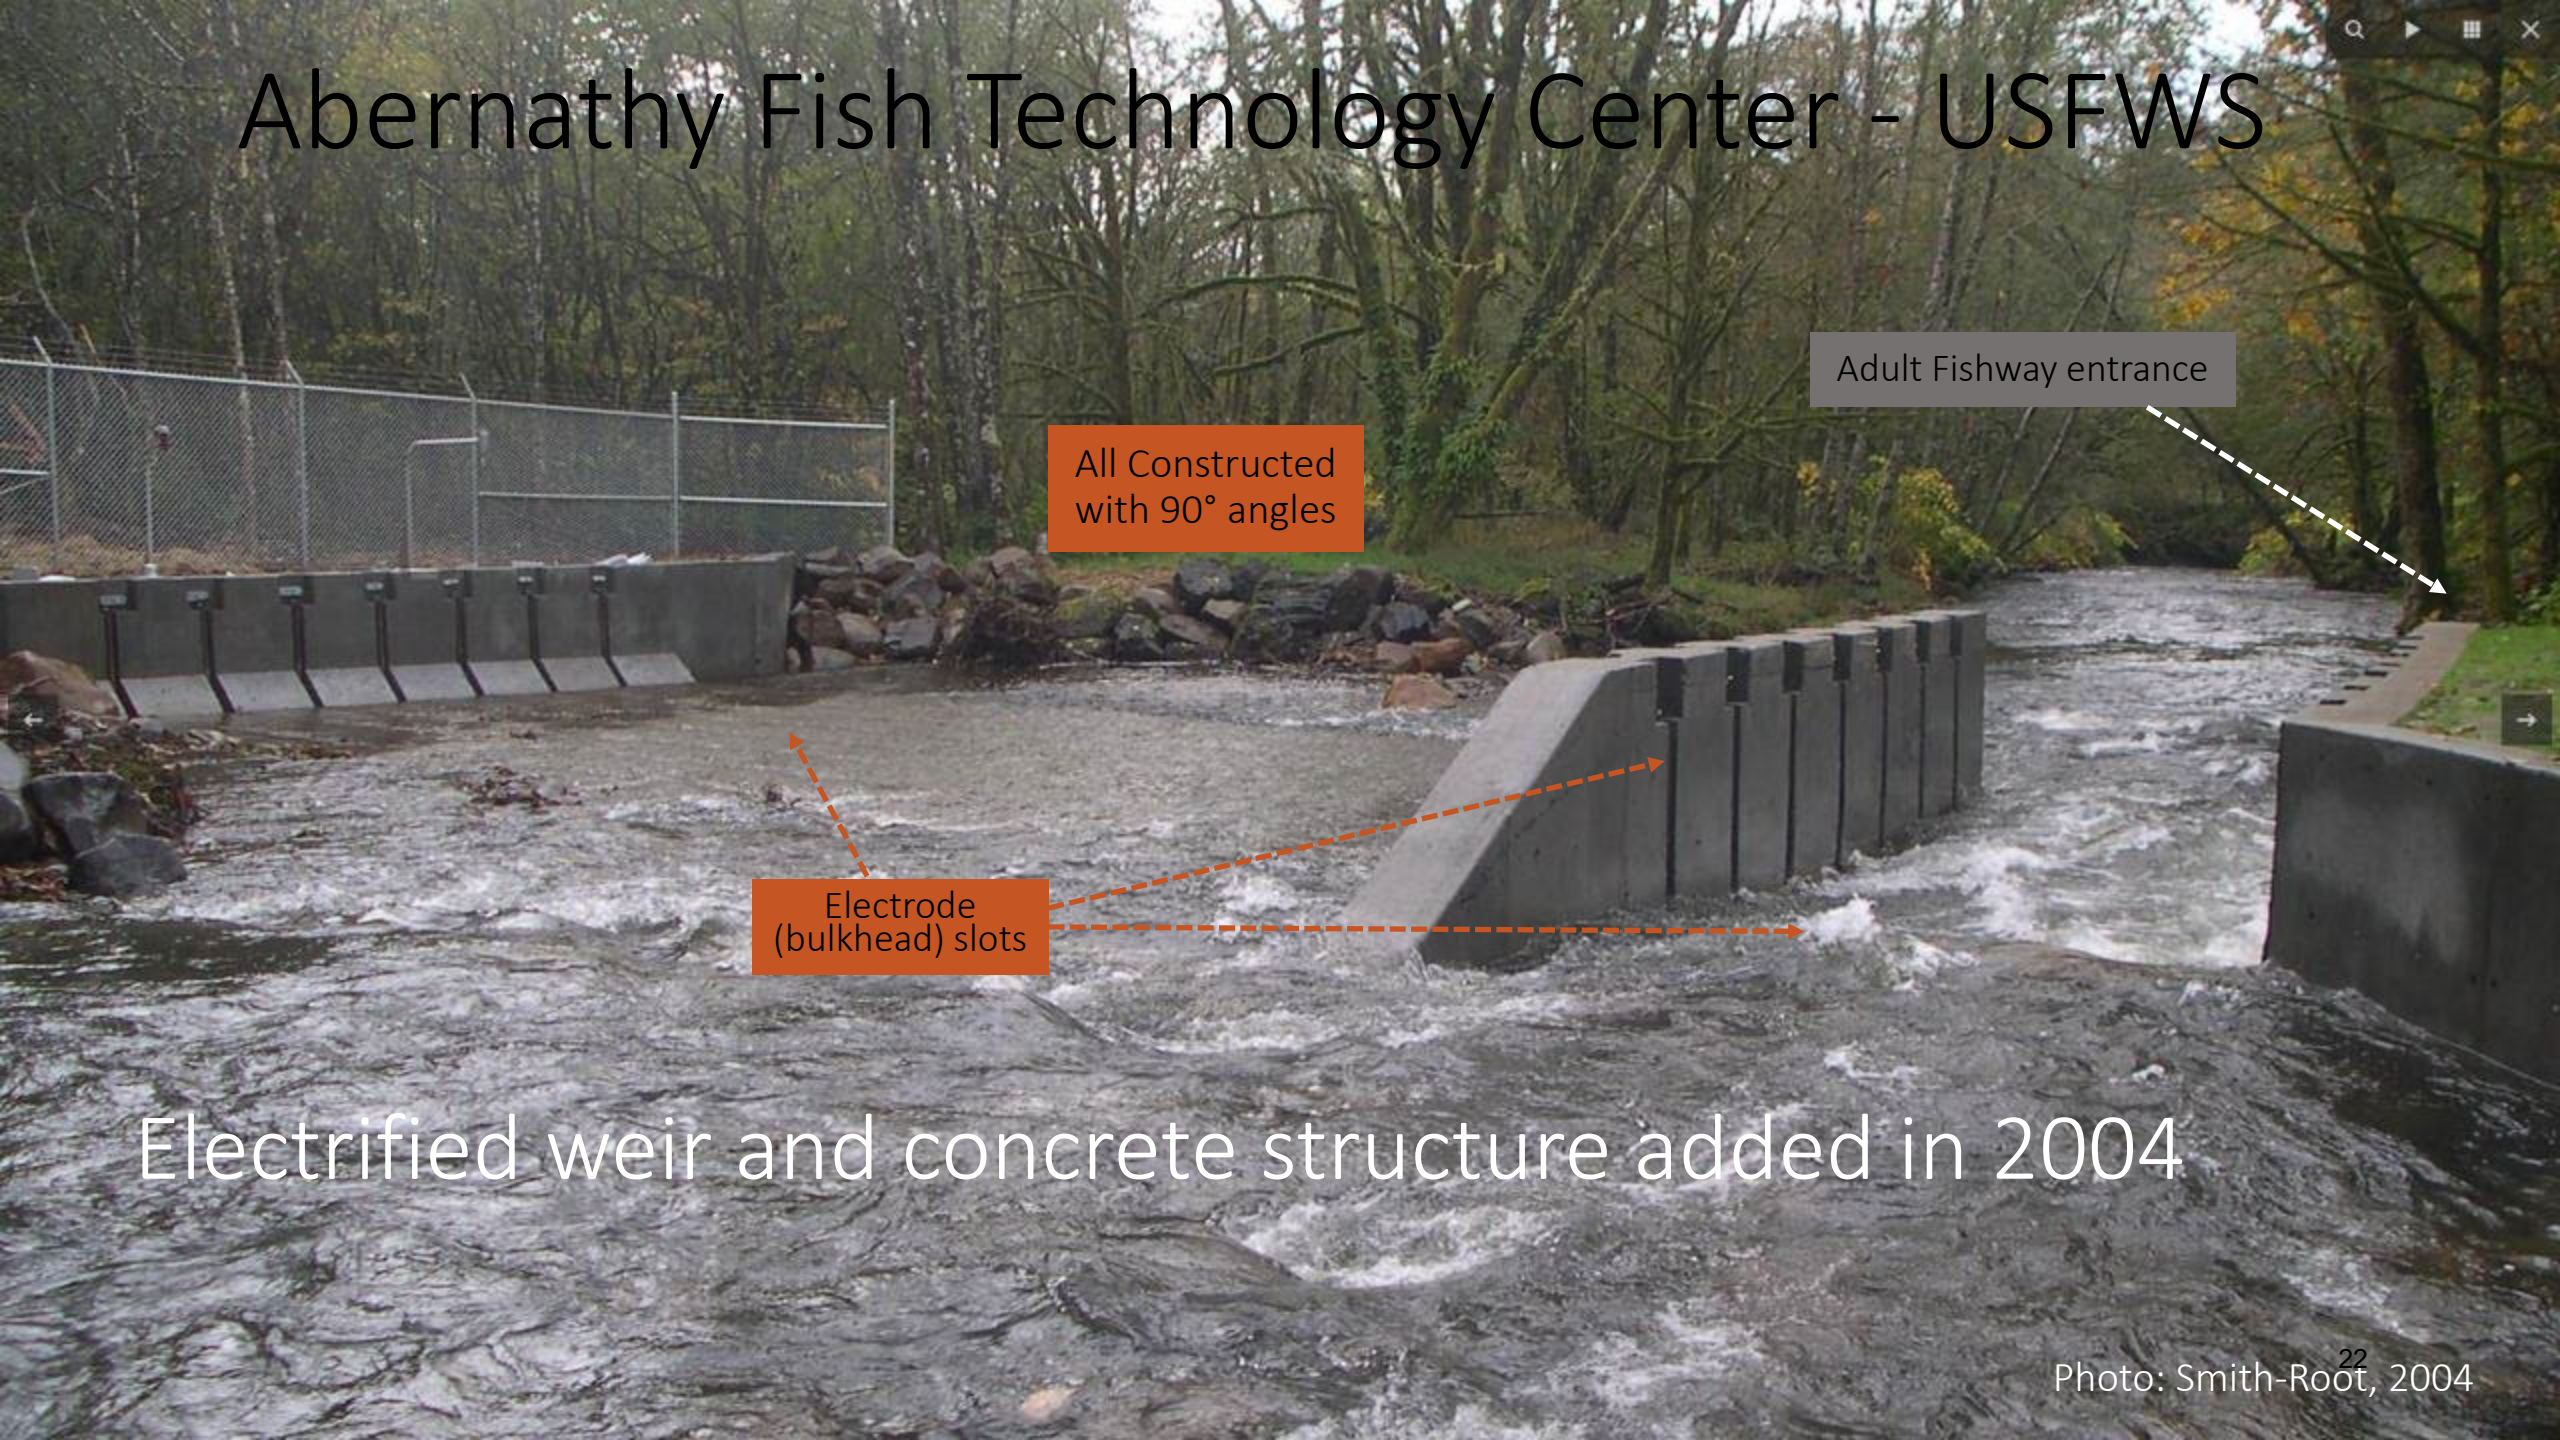
All Constructed
with 90° angles

Adult Fishway entrance

Electrode
(bulkhead) slots

Electrified weir and concrete structure added in 2004

- Downstream electric weir installed in 2004 by Smith-Root
 - Seasonally operated from 2004 – 2019 to intercept and guide fish into the hatchery for sorting. Generally, from Oct – April/May (overlaps lamprey migration)
 - 90° corners and electrode slots could limit passage
 - Increased predation risks below
- Upstream diversion & fishway built into the side of natural falls
 - Fishway is highly eroded and out of compliance
 - New intake and retrofitted fishway planned for 2023
 - Modified falls appear to be passable by lamprey at conducive flows (lower)
 - New fishway retrofits are planned to accommodate lamprey passage elements (Summer 2023)
- Larval Pacific and Lampetra species have both been observed above the upper diversion
