Pacific Lamprey Passage Evaluations at Hatchery Facilities in Southwest Washington State

Summary Graphic Report: 2022

Joe Skalicky, US Fish and Wildlife Service, Columbia River Fish and Wildlife Conservation Office, January 2022

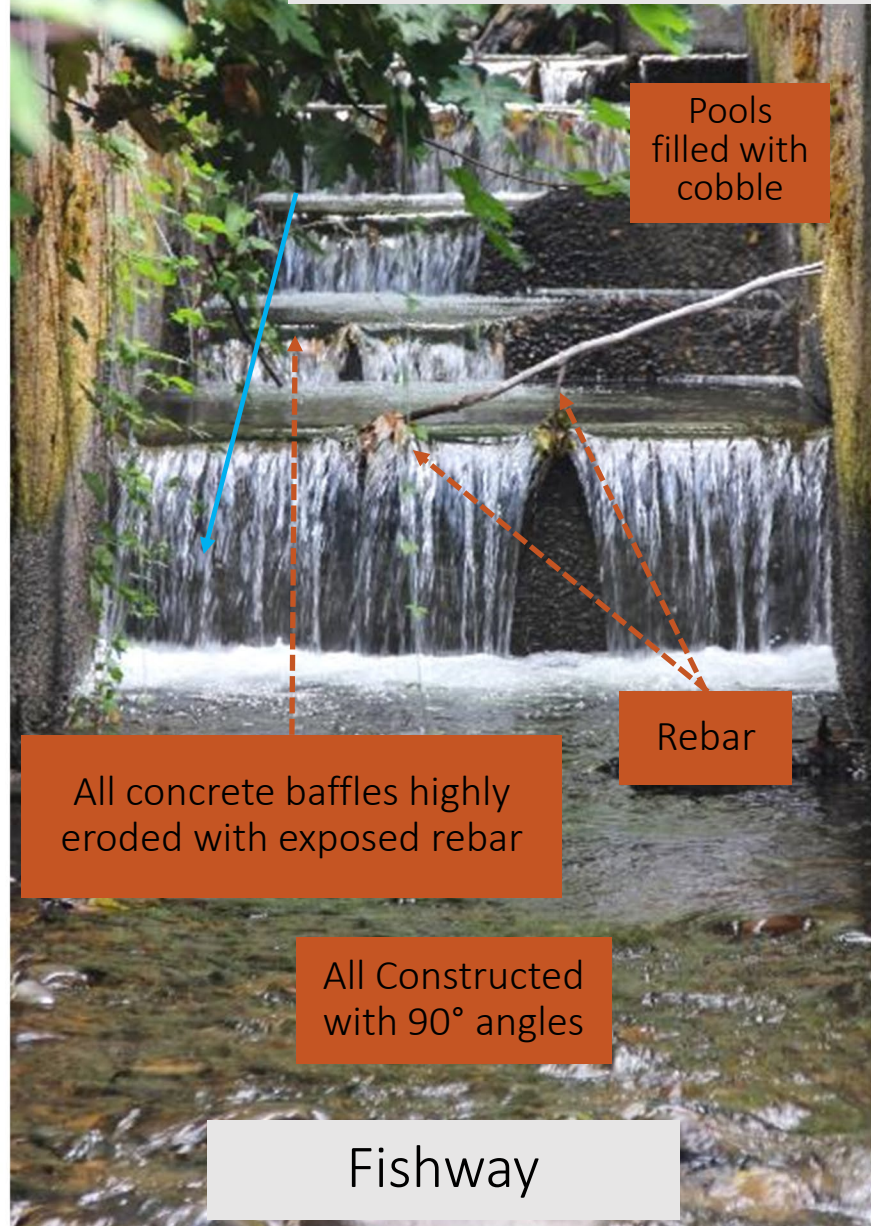
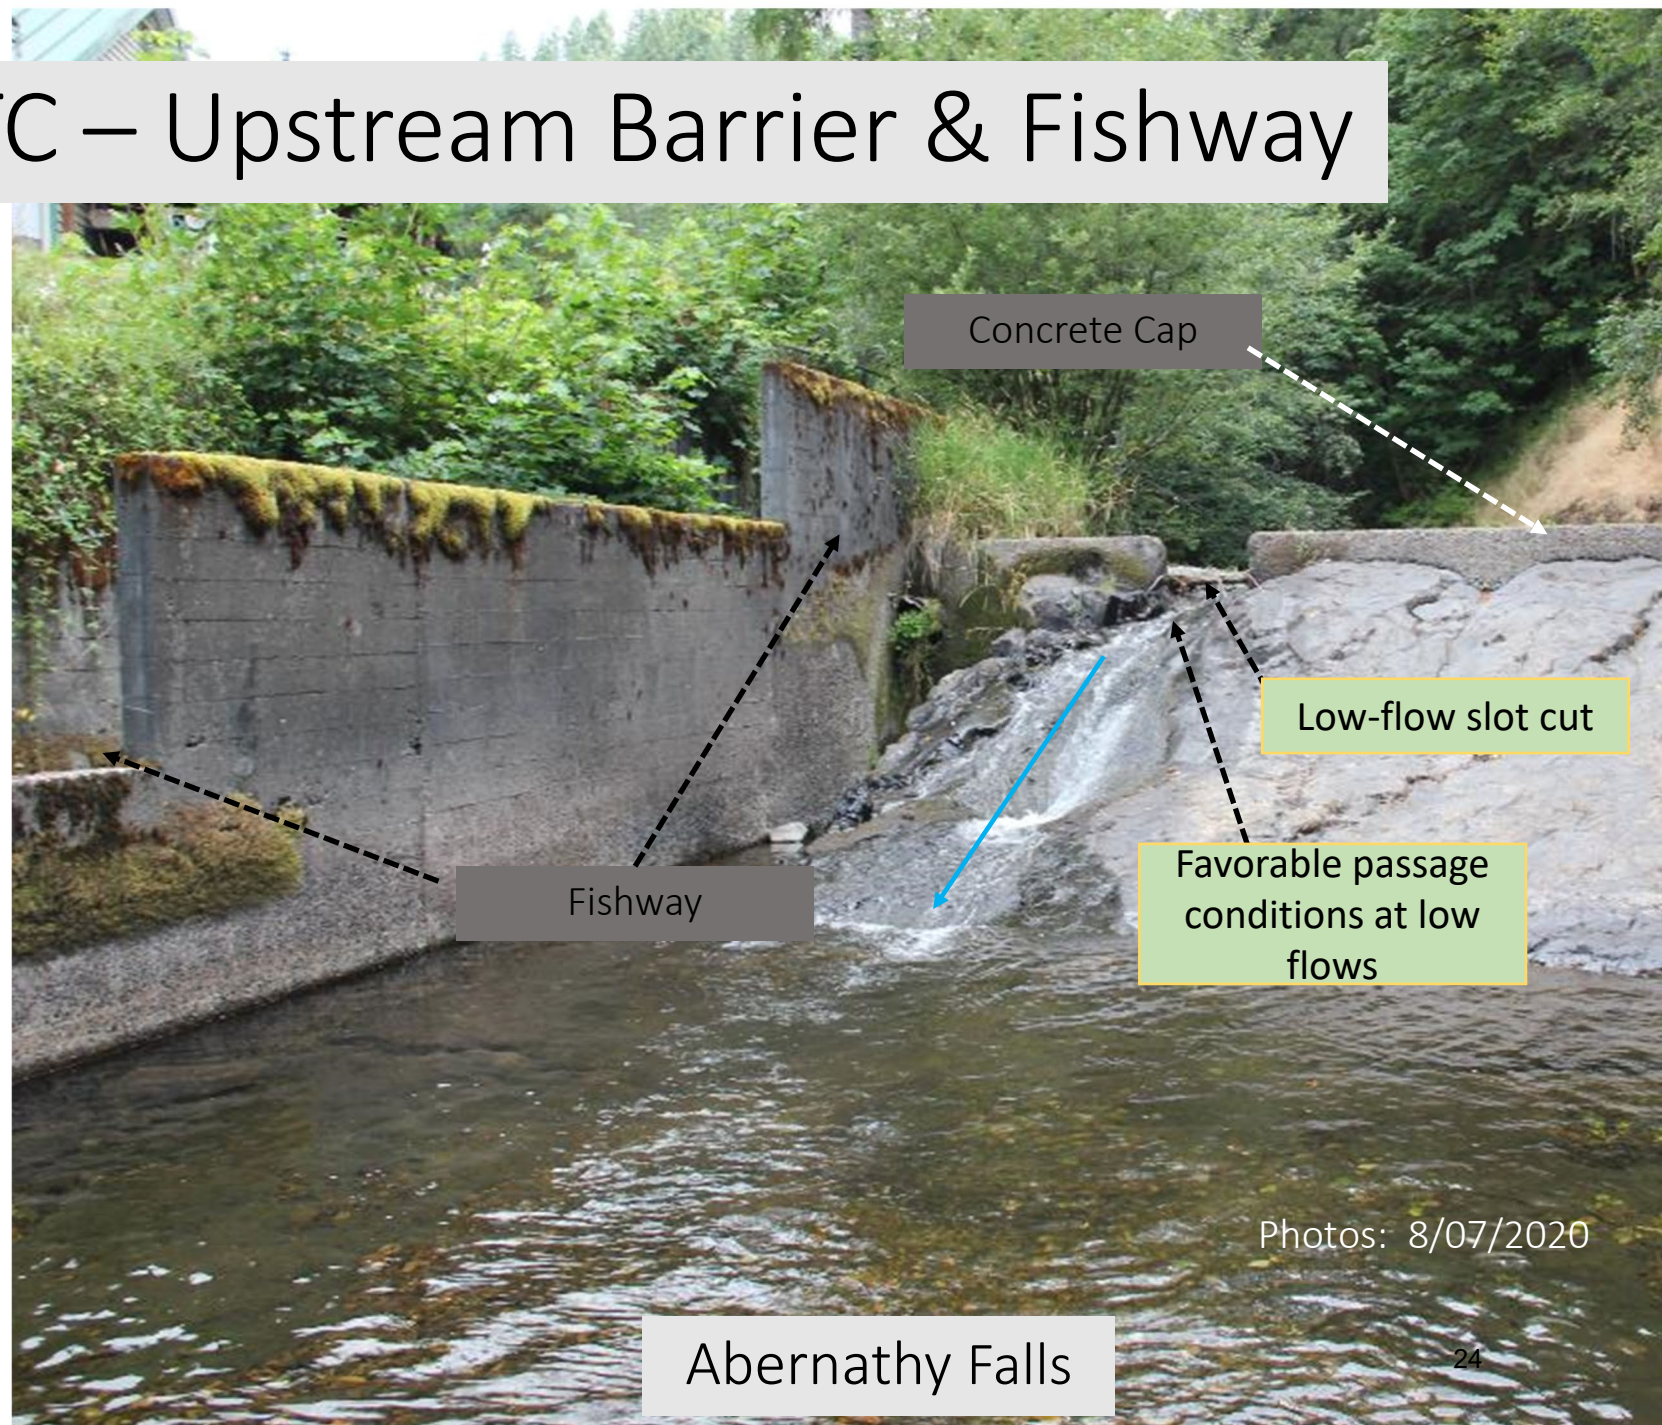
Abernathy FTC – Upstream Barrier & Fishway

All Constructed
with 90° angles

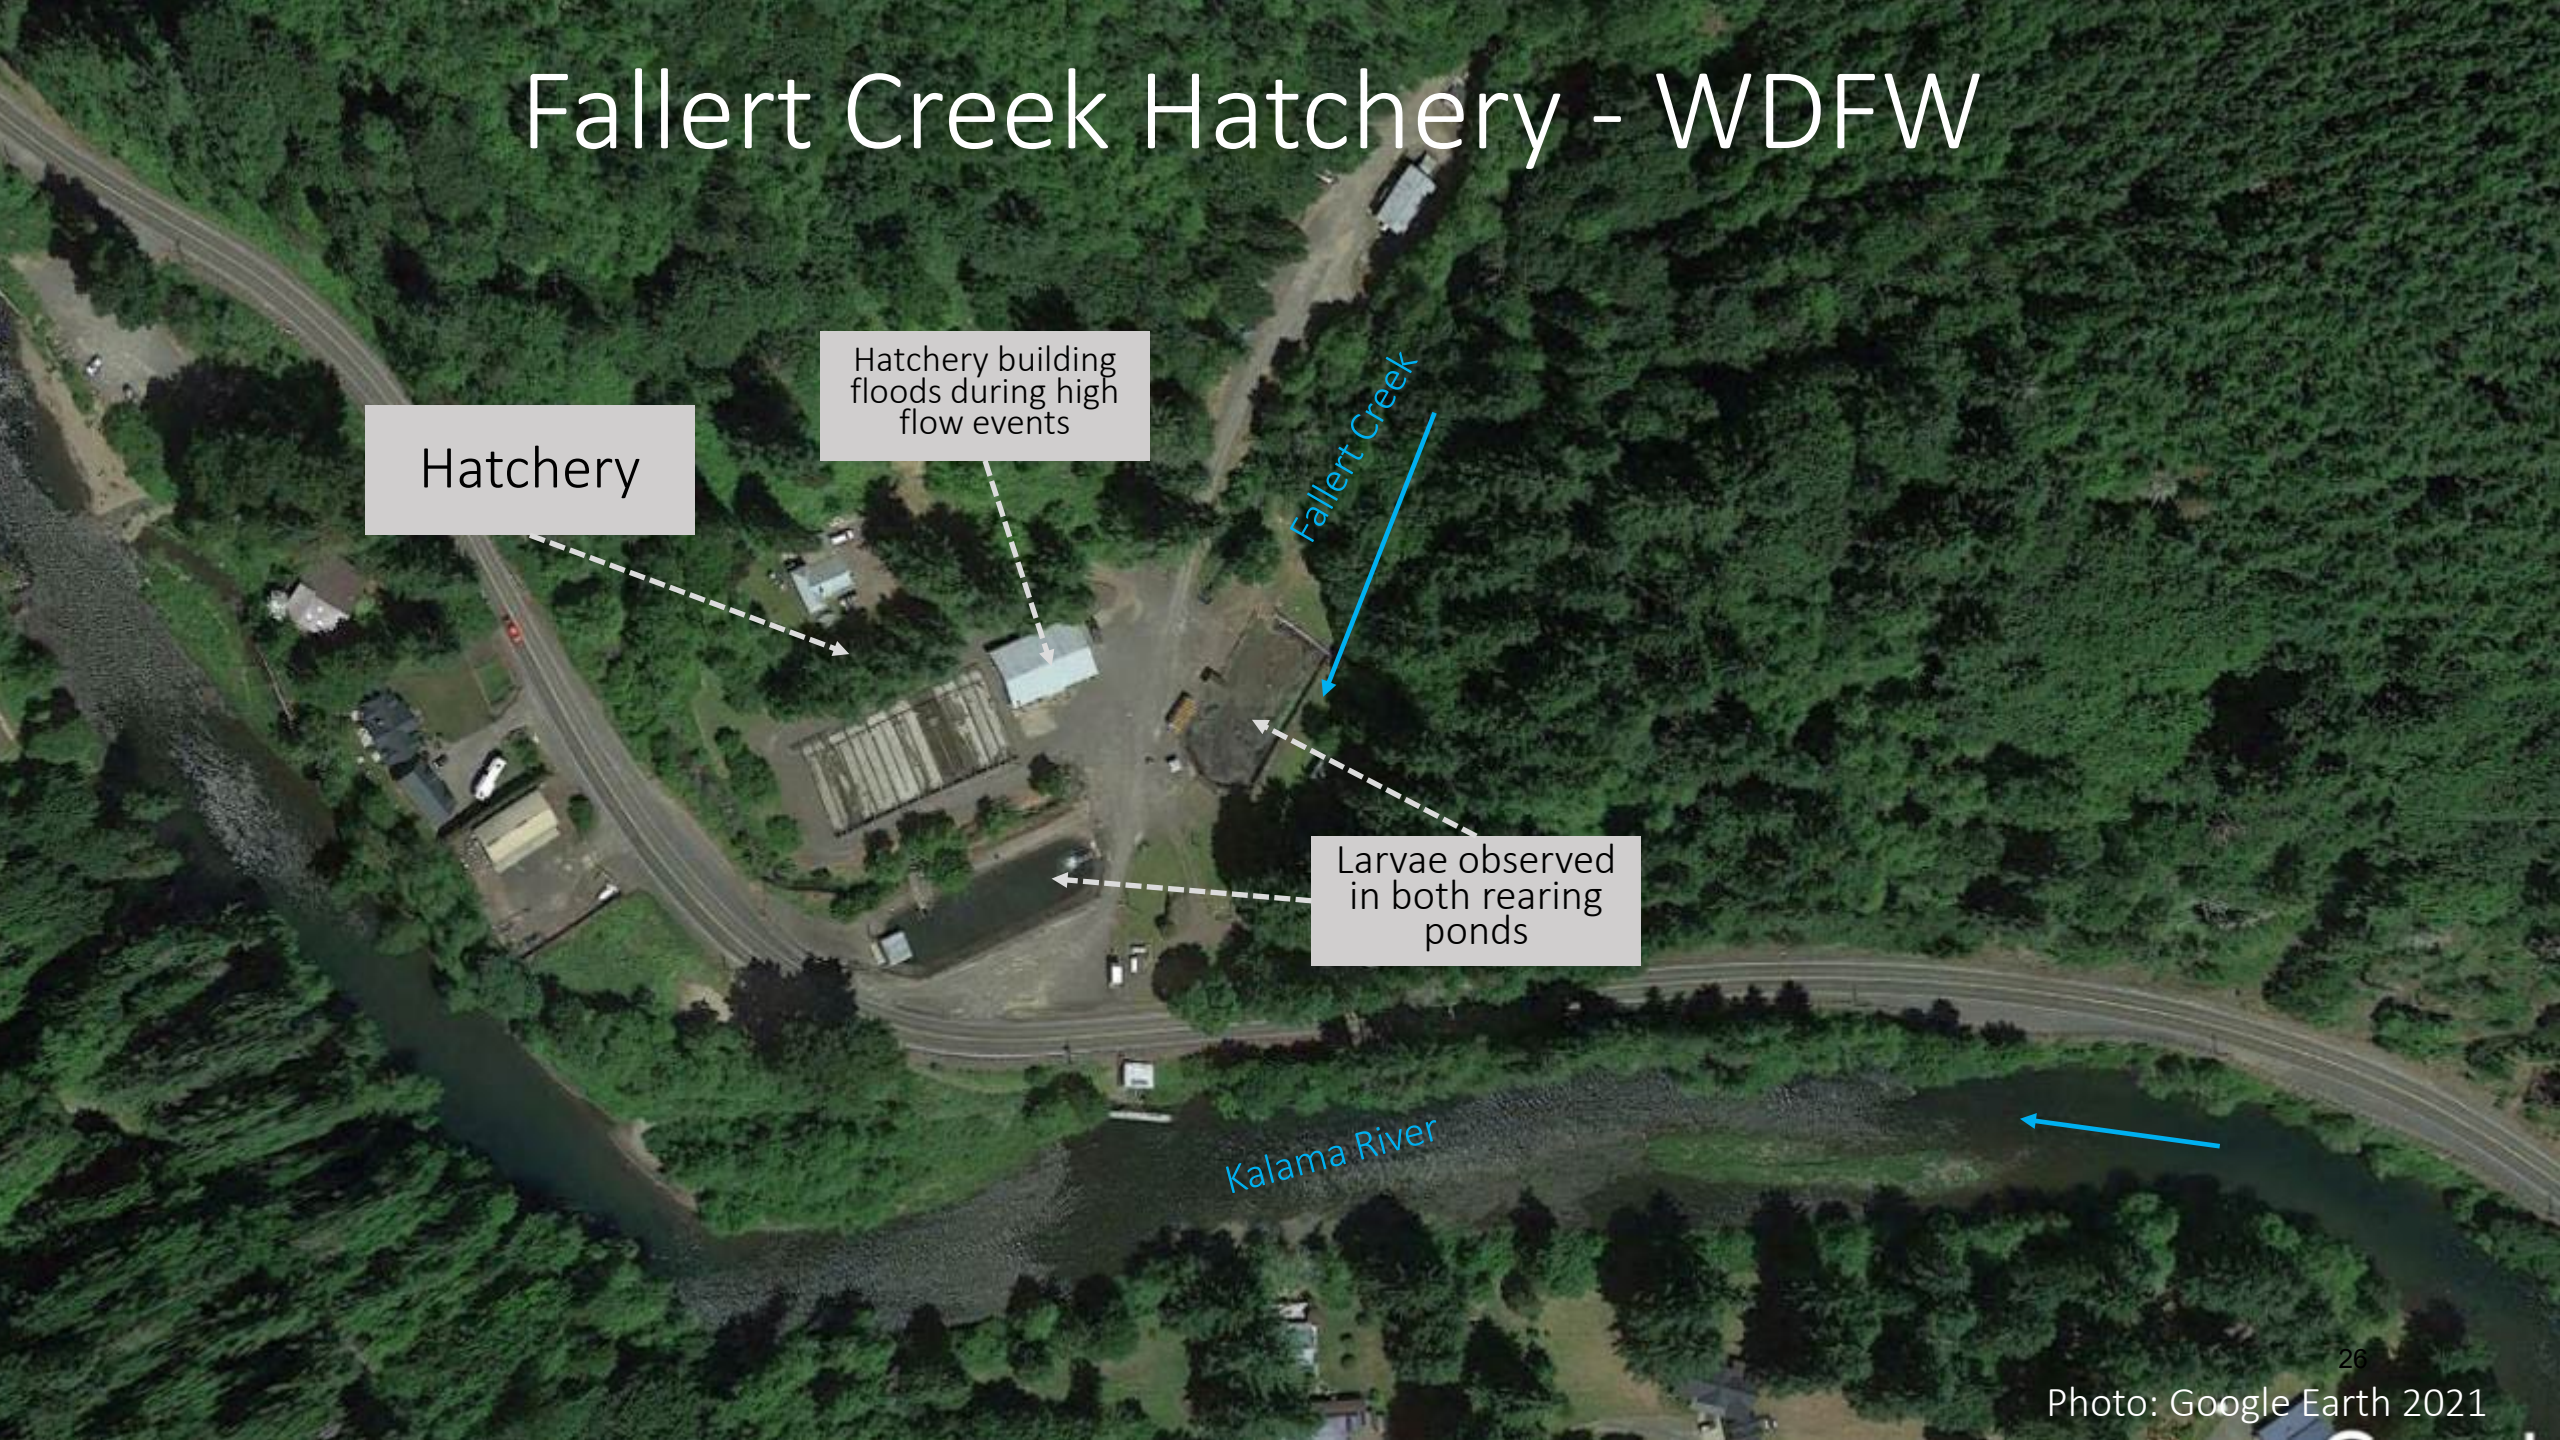
Hatchery building
floods during high
flow events

Larvae observed
in both rearing
ponds

6" Iron weir (railroad tie)

- No fishway or ladder exists at the hatchery. Brood fish are transferred from the Kalama Falls Hatchery to Fallert Creek.
 - Small iron weir does exist at the hatchery and should be replaced with roughed riffle or other – function unclear
 - Larval lamprey (hundreds) have been observed in hatchery ponds
 - Consider new screens with smaller openings (0.75 or 1.0 mm)
- Upstream diversion – No ladder or fish passage
 - WDFW has determined passage is necessary
 - WDFW has requested funds to replace intake (Ten-year plan (2021 -2031))
 - Located 1,700 feet upstream of the hatchery
 - New intake & screen with fishway could accommodate lamprey passage elements. Consider roughened riffle.

Remove or replace
with nature-like
fishway

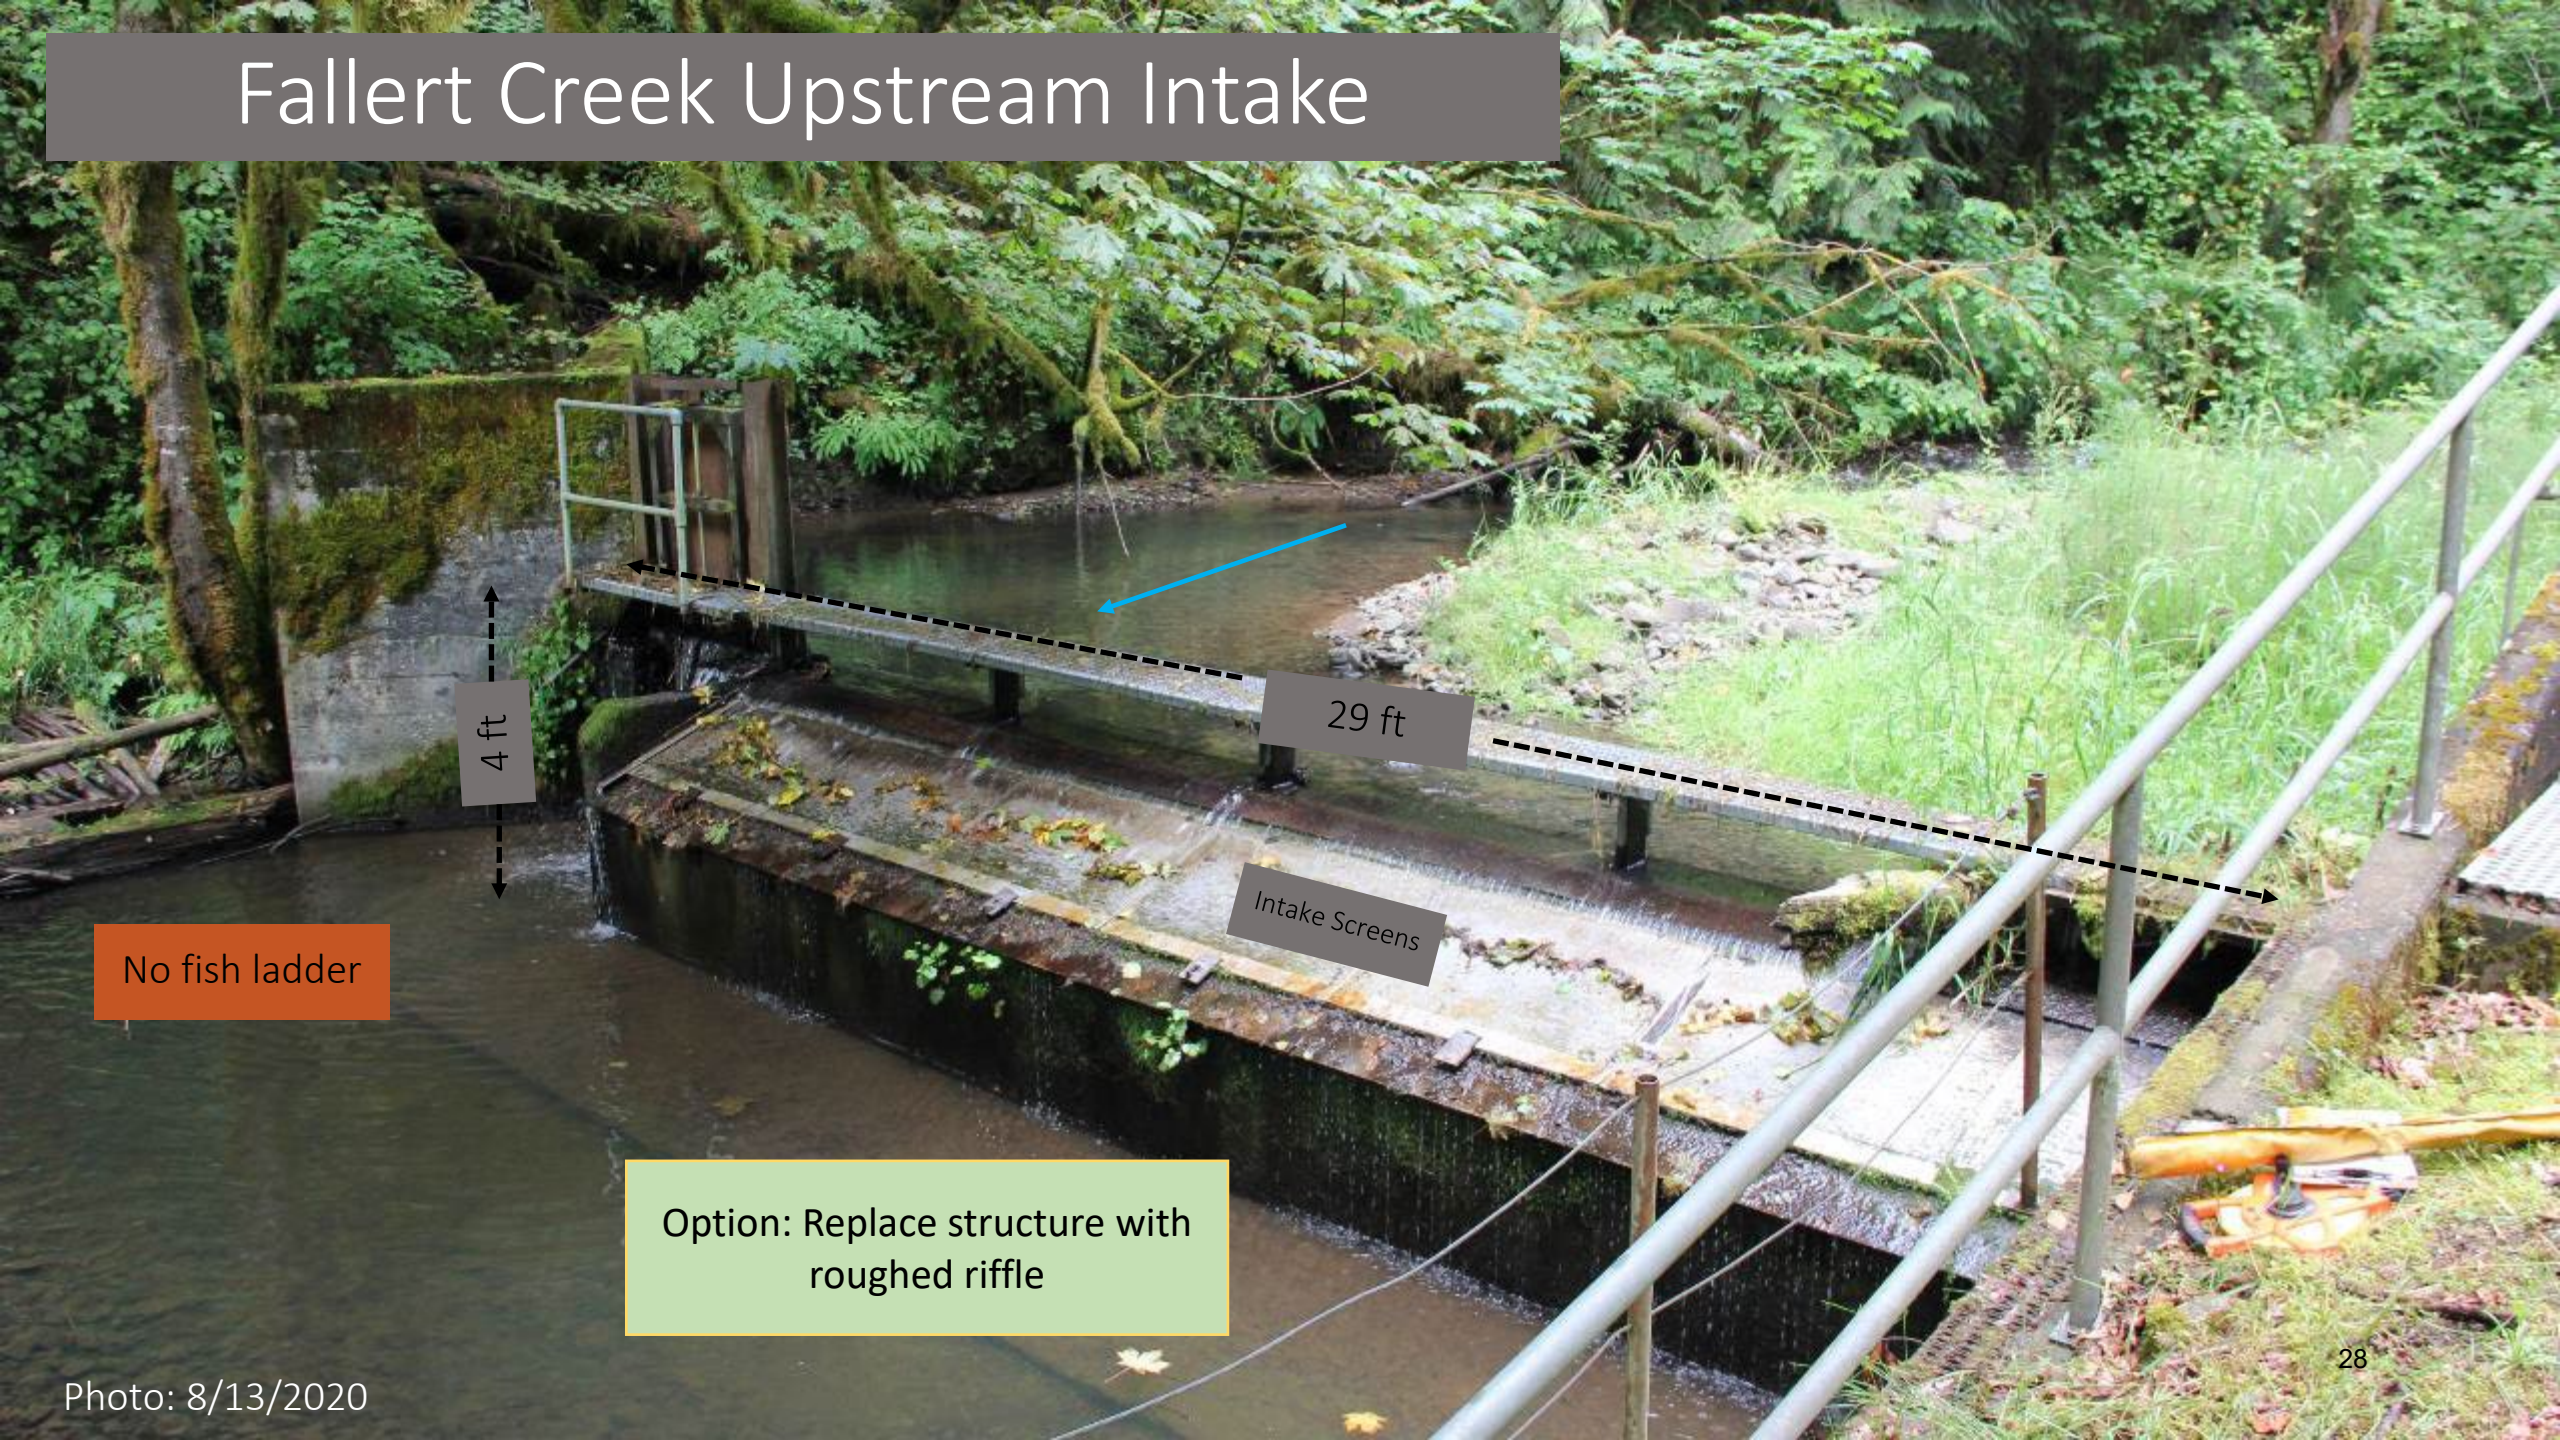
Fallert Creek Upstream Intake

No fish ladder

Intake Screens

Option: Replace structure with
roughed riffle

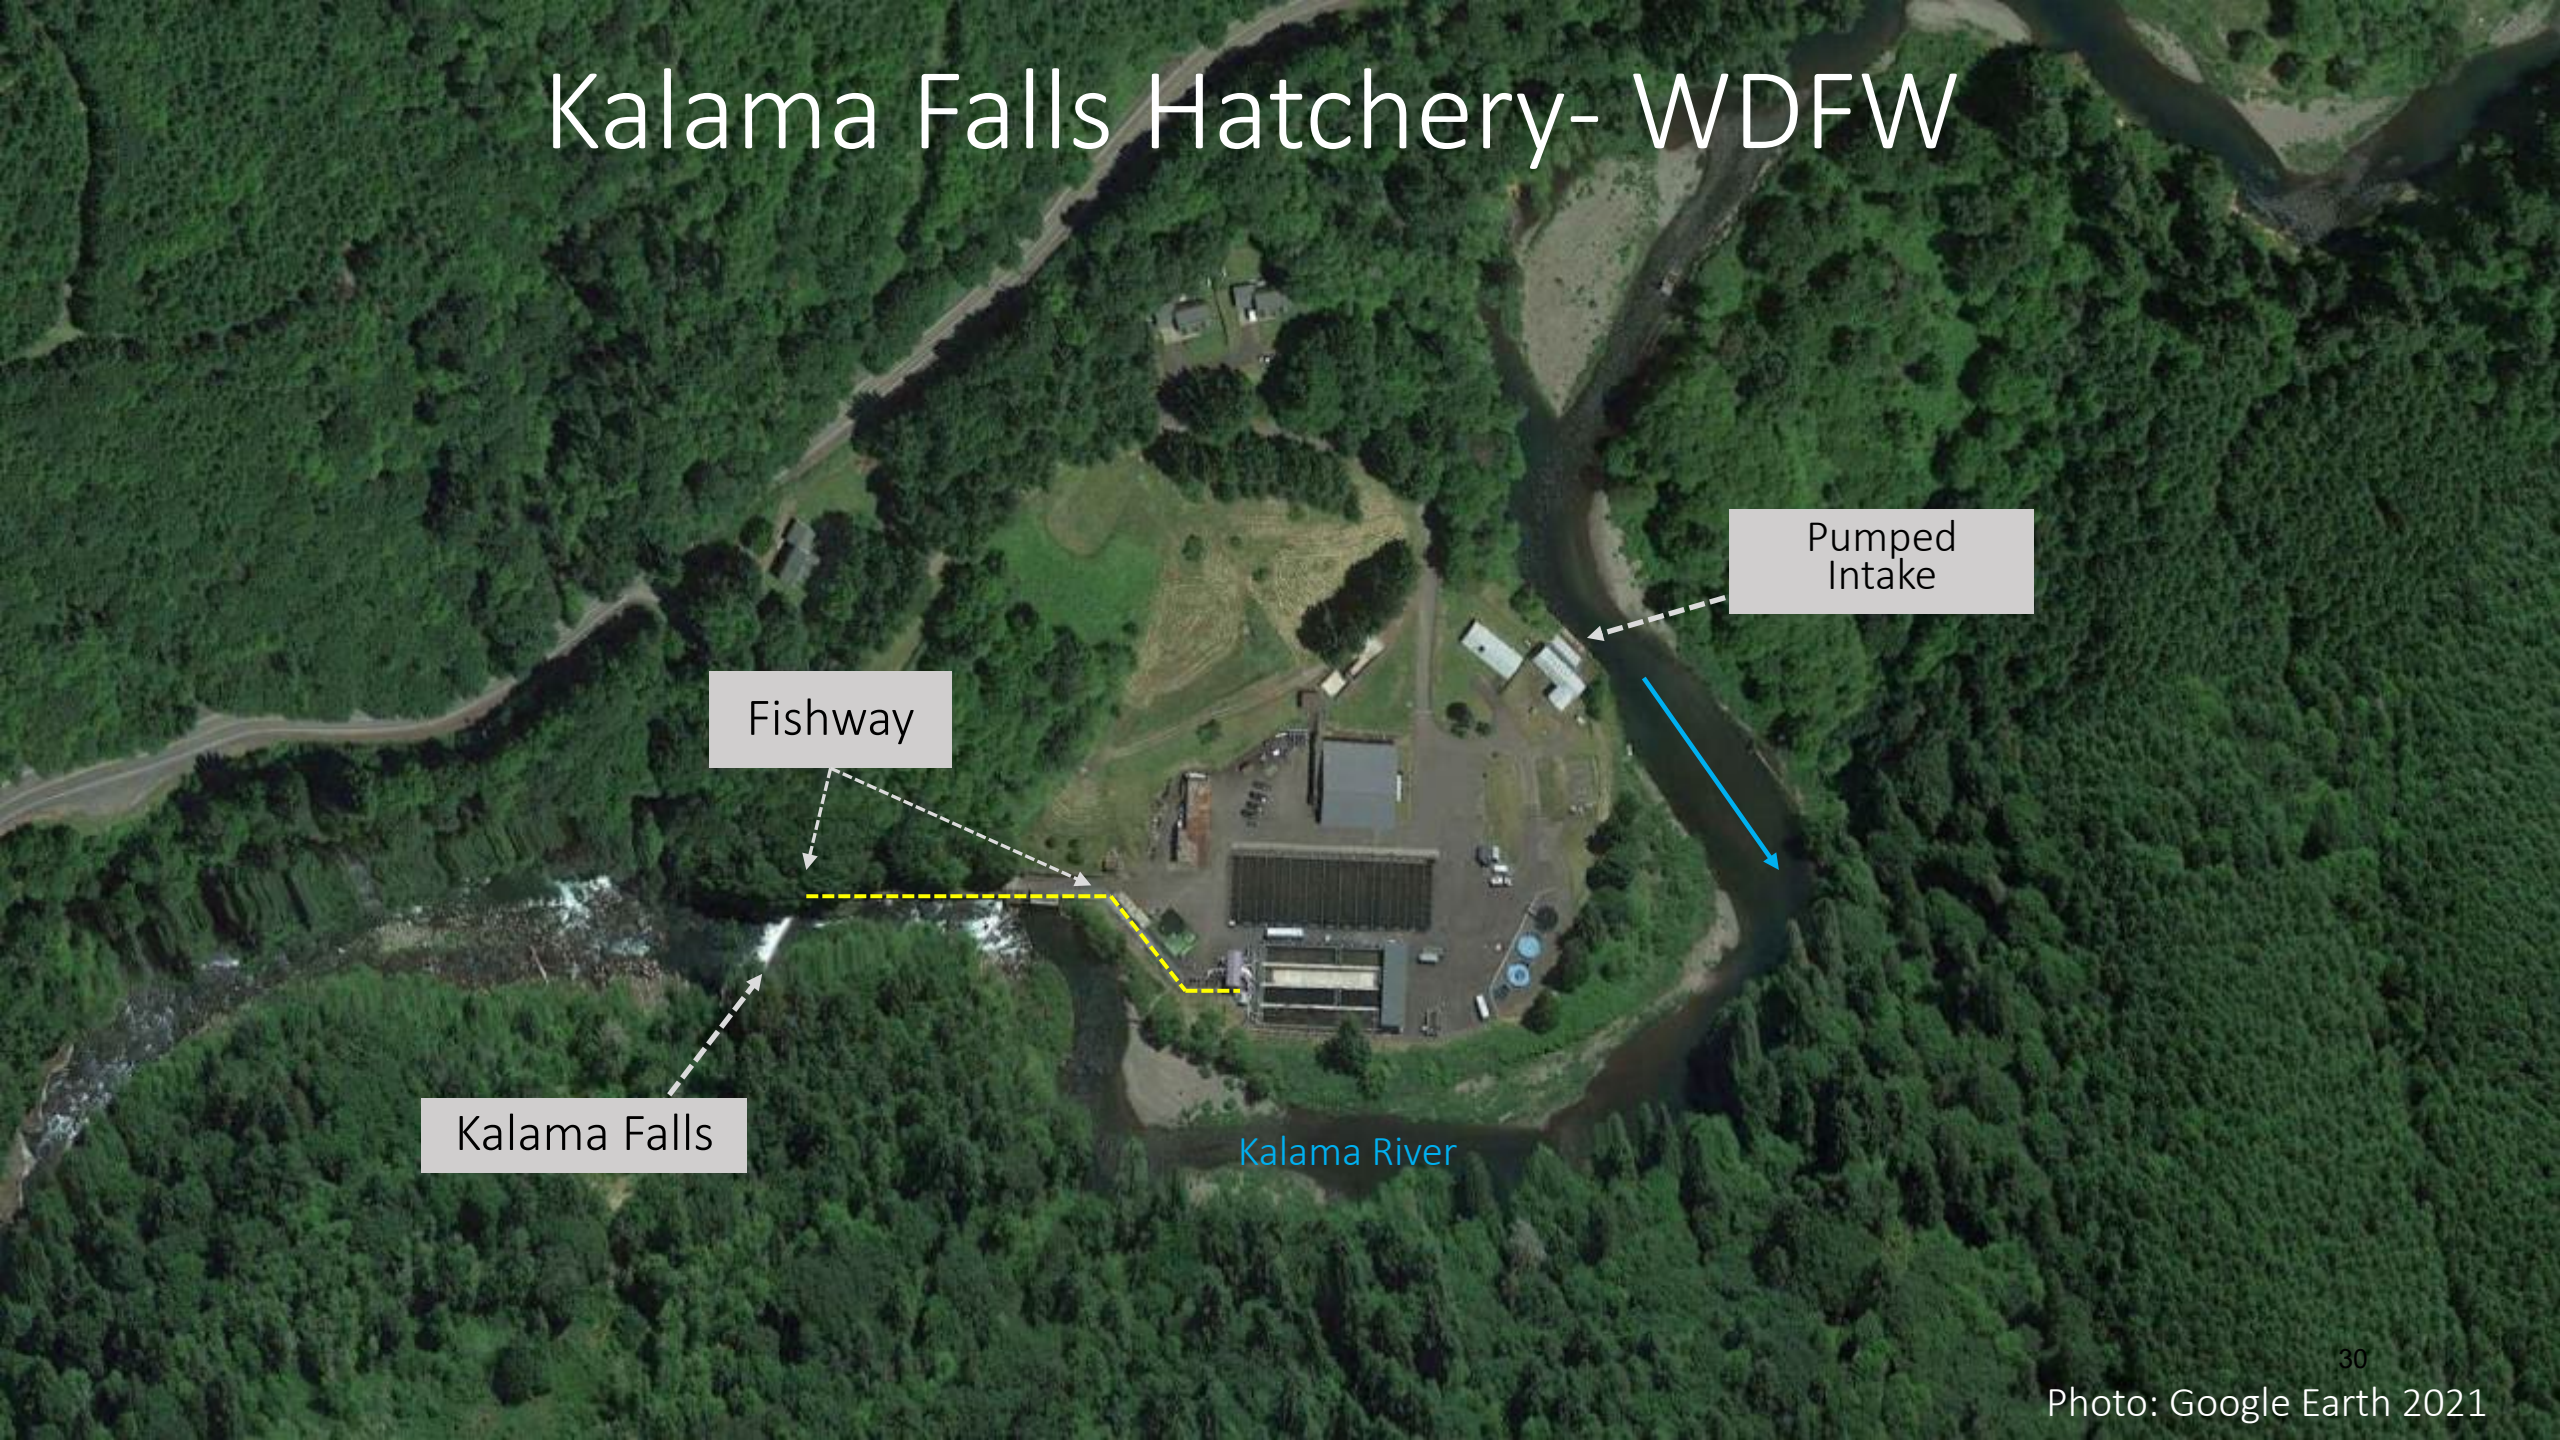
Vertical Slot fishway upstream of entrance

All constructed with 90° angles

Kalama Falls with concrete and steel cap added

Fall height = 10.3 ft

- Concrete cap was added to the top of Kalama Falls to increase the height
- Fishway extends from the base of falls upstream 264 ft to the hatchery
 - Built into the side of the basalt channel wall
 - Not possible to widely assess velocities. Only the upper section was accessible and all were >5ft/s. Velocities in the lower section visually appeared higher
 - Lower 2/3 fishway is old and roughened
 - Fishway entrance is narrow with high velocities
 - 2 adult lamprey were observed in the adult trap in 2019
 - Unidentified larval lampreys in raceways
 - Consider monitoring likely passage at river AWS
- Considering the overall length, head differential, and age of the project, recommend a tagging study of adults before anything structural is done

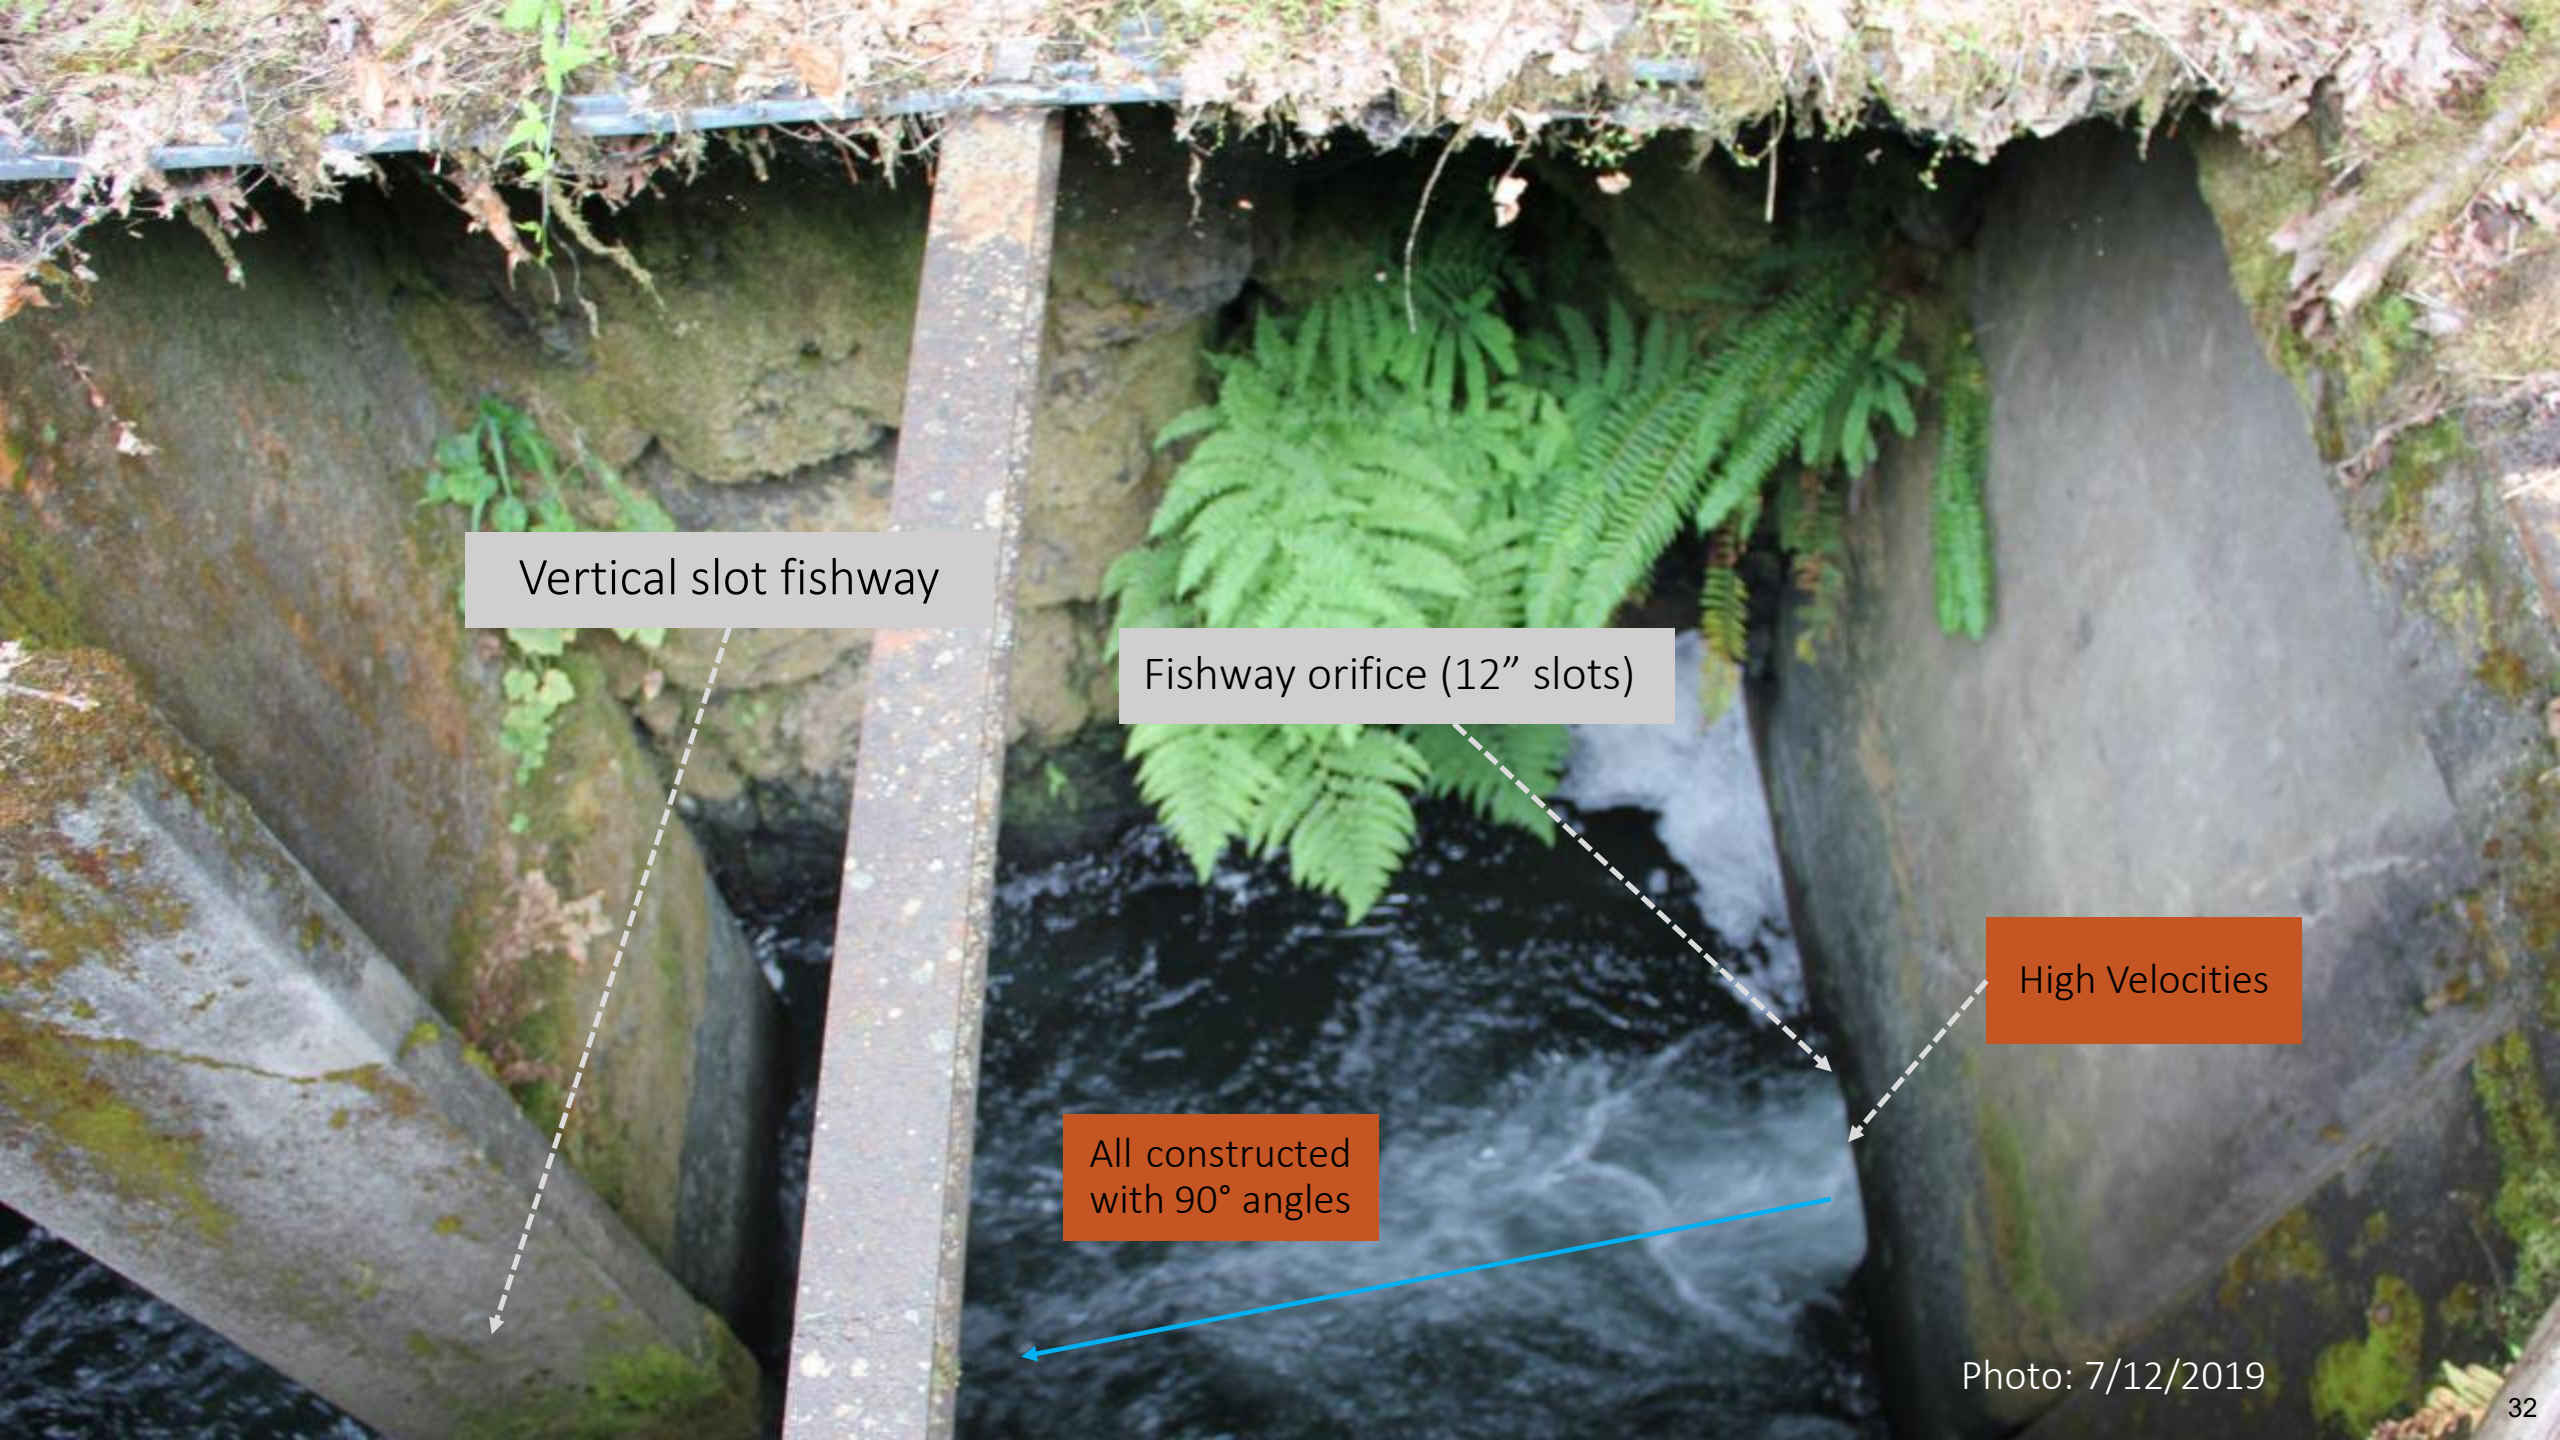
Fishway orifice (12" slots)

High Velocities

All constructed
with 90° angles

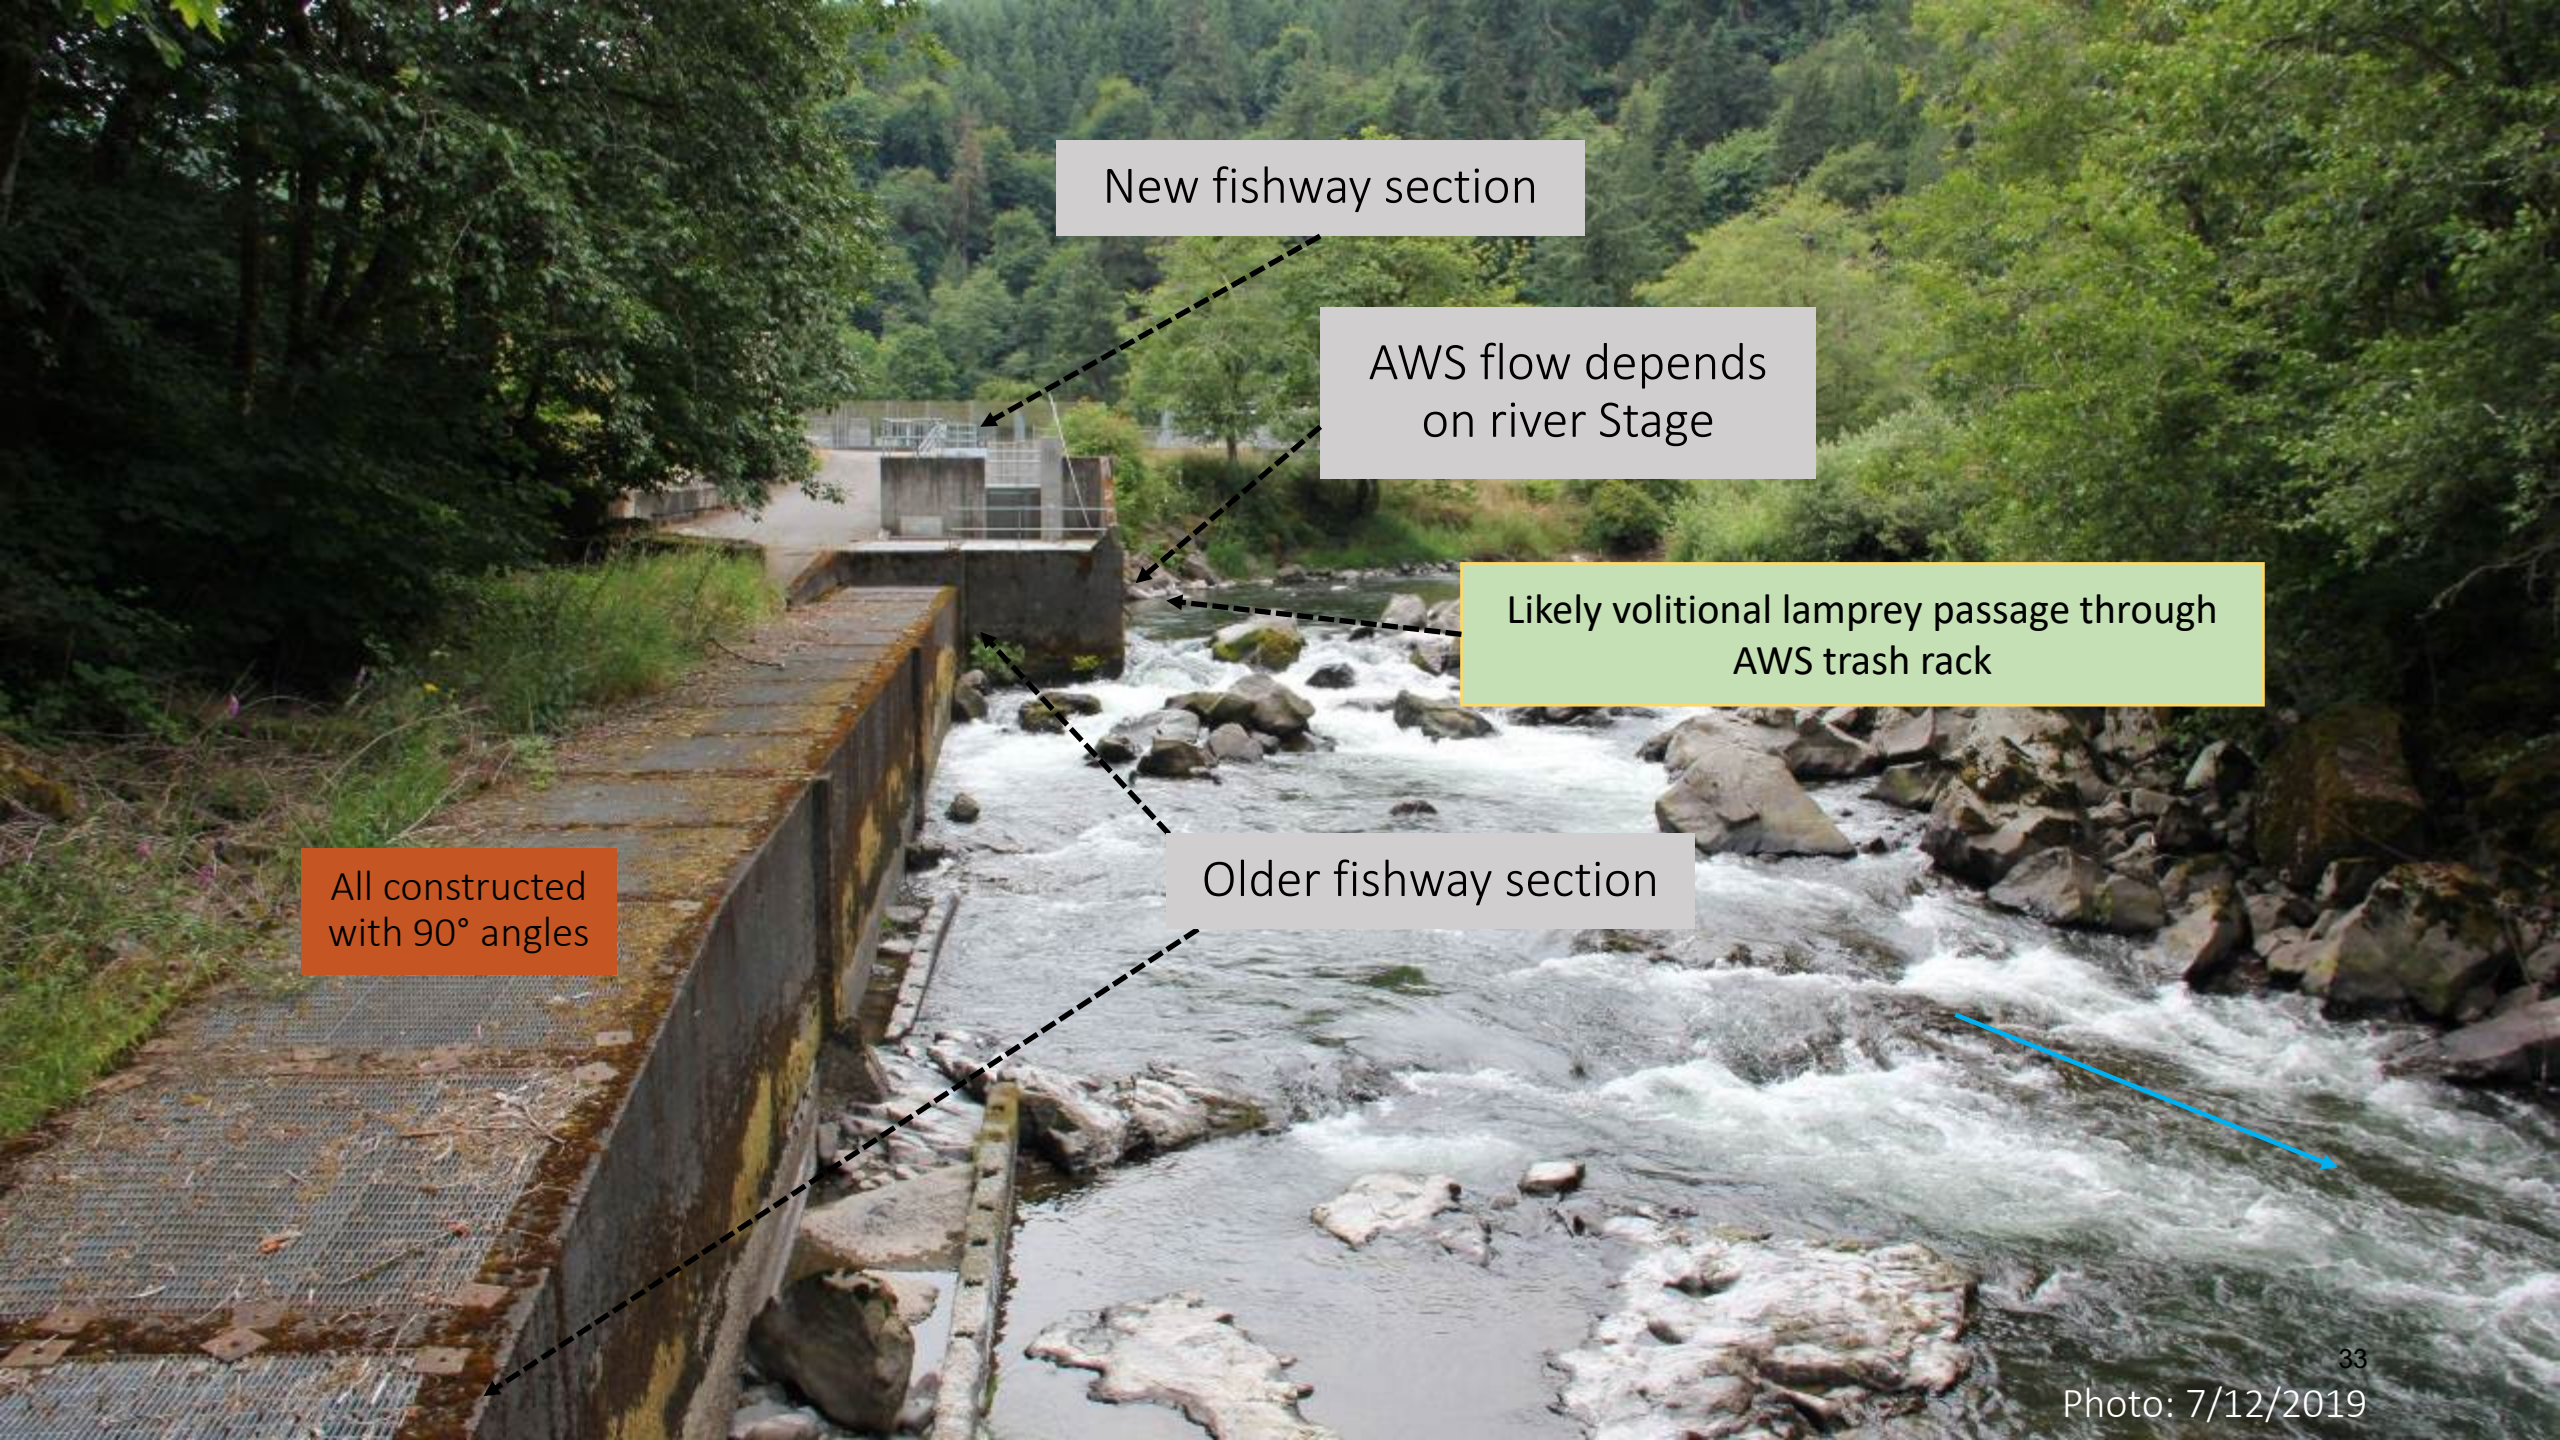
AWS flow depends
on river Stage

Likely volitional lamprey passage through
AWS trash rack

All constructed
with 90° angles
