Pacific Lamprey Passage Evaluations at Hatchery Facilities in Southwest Washington State

Summary Graphic Report: 2022

Joe Skalicky, US Fish and Wildlife Service, Columbia River Fish and Wildlife Conservation Office, January 2022

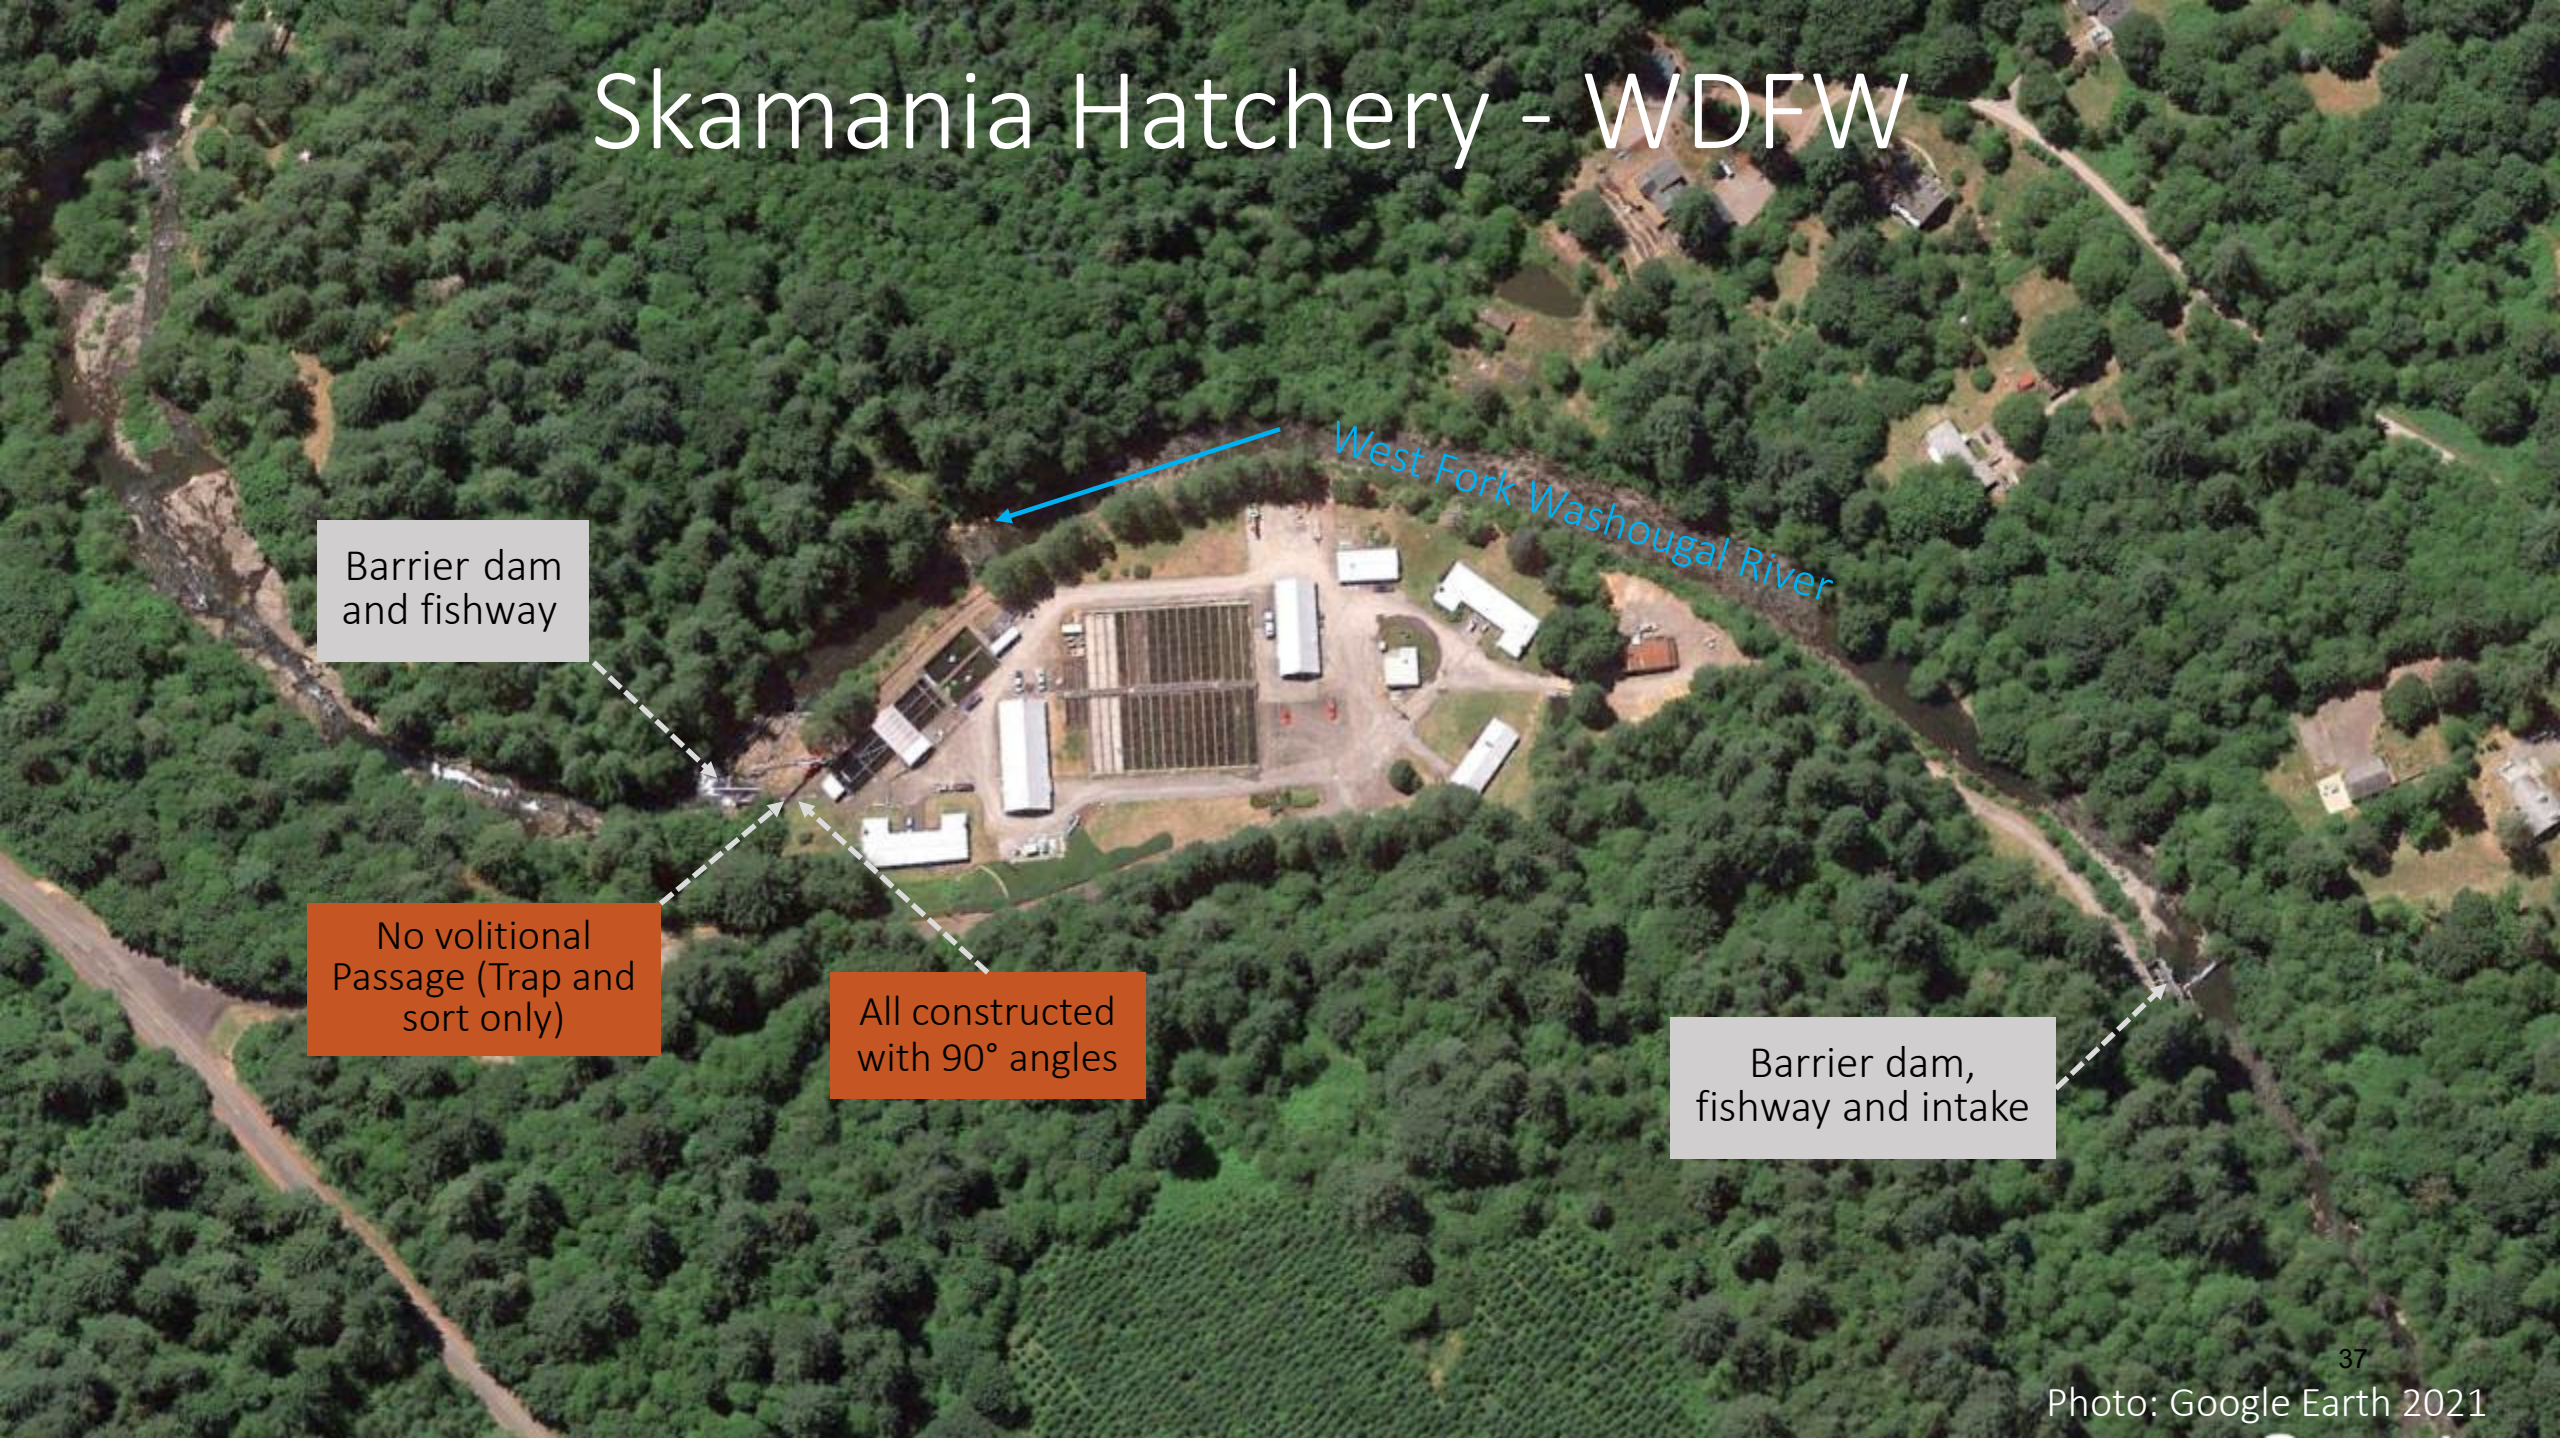
No volitional
Passage (Trap and
sort only)

All constructed
with 90° angles

Possible adult passage
(burst & attach) lower
flows only

Barrier dam
rebuilt in 2017

Possible adult passage
(burst & attach) lower
flow only

Fishway rebuild in 2012
but difunctional at higher
flows. Fishway fills with
cobble.

- Downstream barrier and ladder
 - Possible passage over new barrier dam that was rebuilt in 2017
 - Ladder leads directly into the hatchery. No volitional fish passage
 - Entrance velocities appear high but were not accessible
 - No actions are recommended at this structure for the time being
 - No observations of adults or larvae at the hatchery by staff
 - Larval lamprey occupancy surveys above project resulted in zero lamprey observations
- Upstream barrier and ladder
 - Possible passage over barrier dam at lower flows.
 - Ladder only operated seasonally at lower flows. Likely outside of adult upstream migration
 - Passage through ladder uncertain as it was dewatered during survey

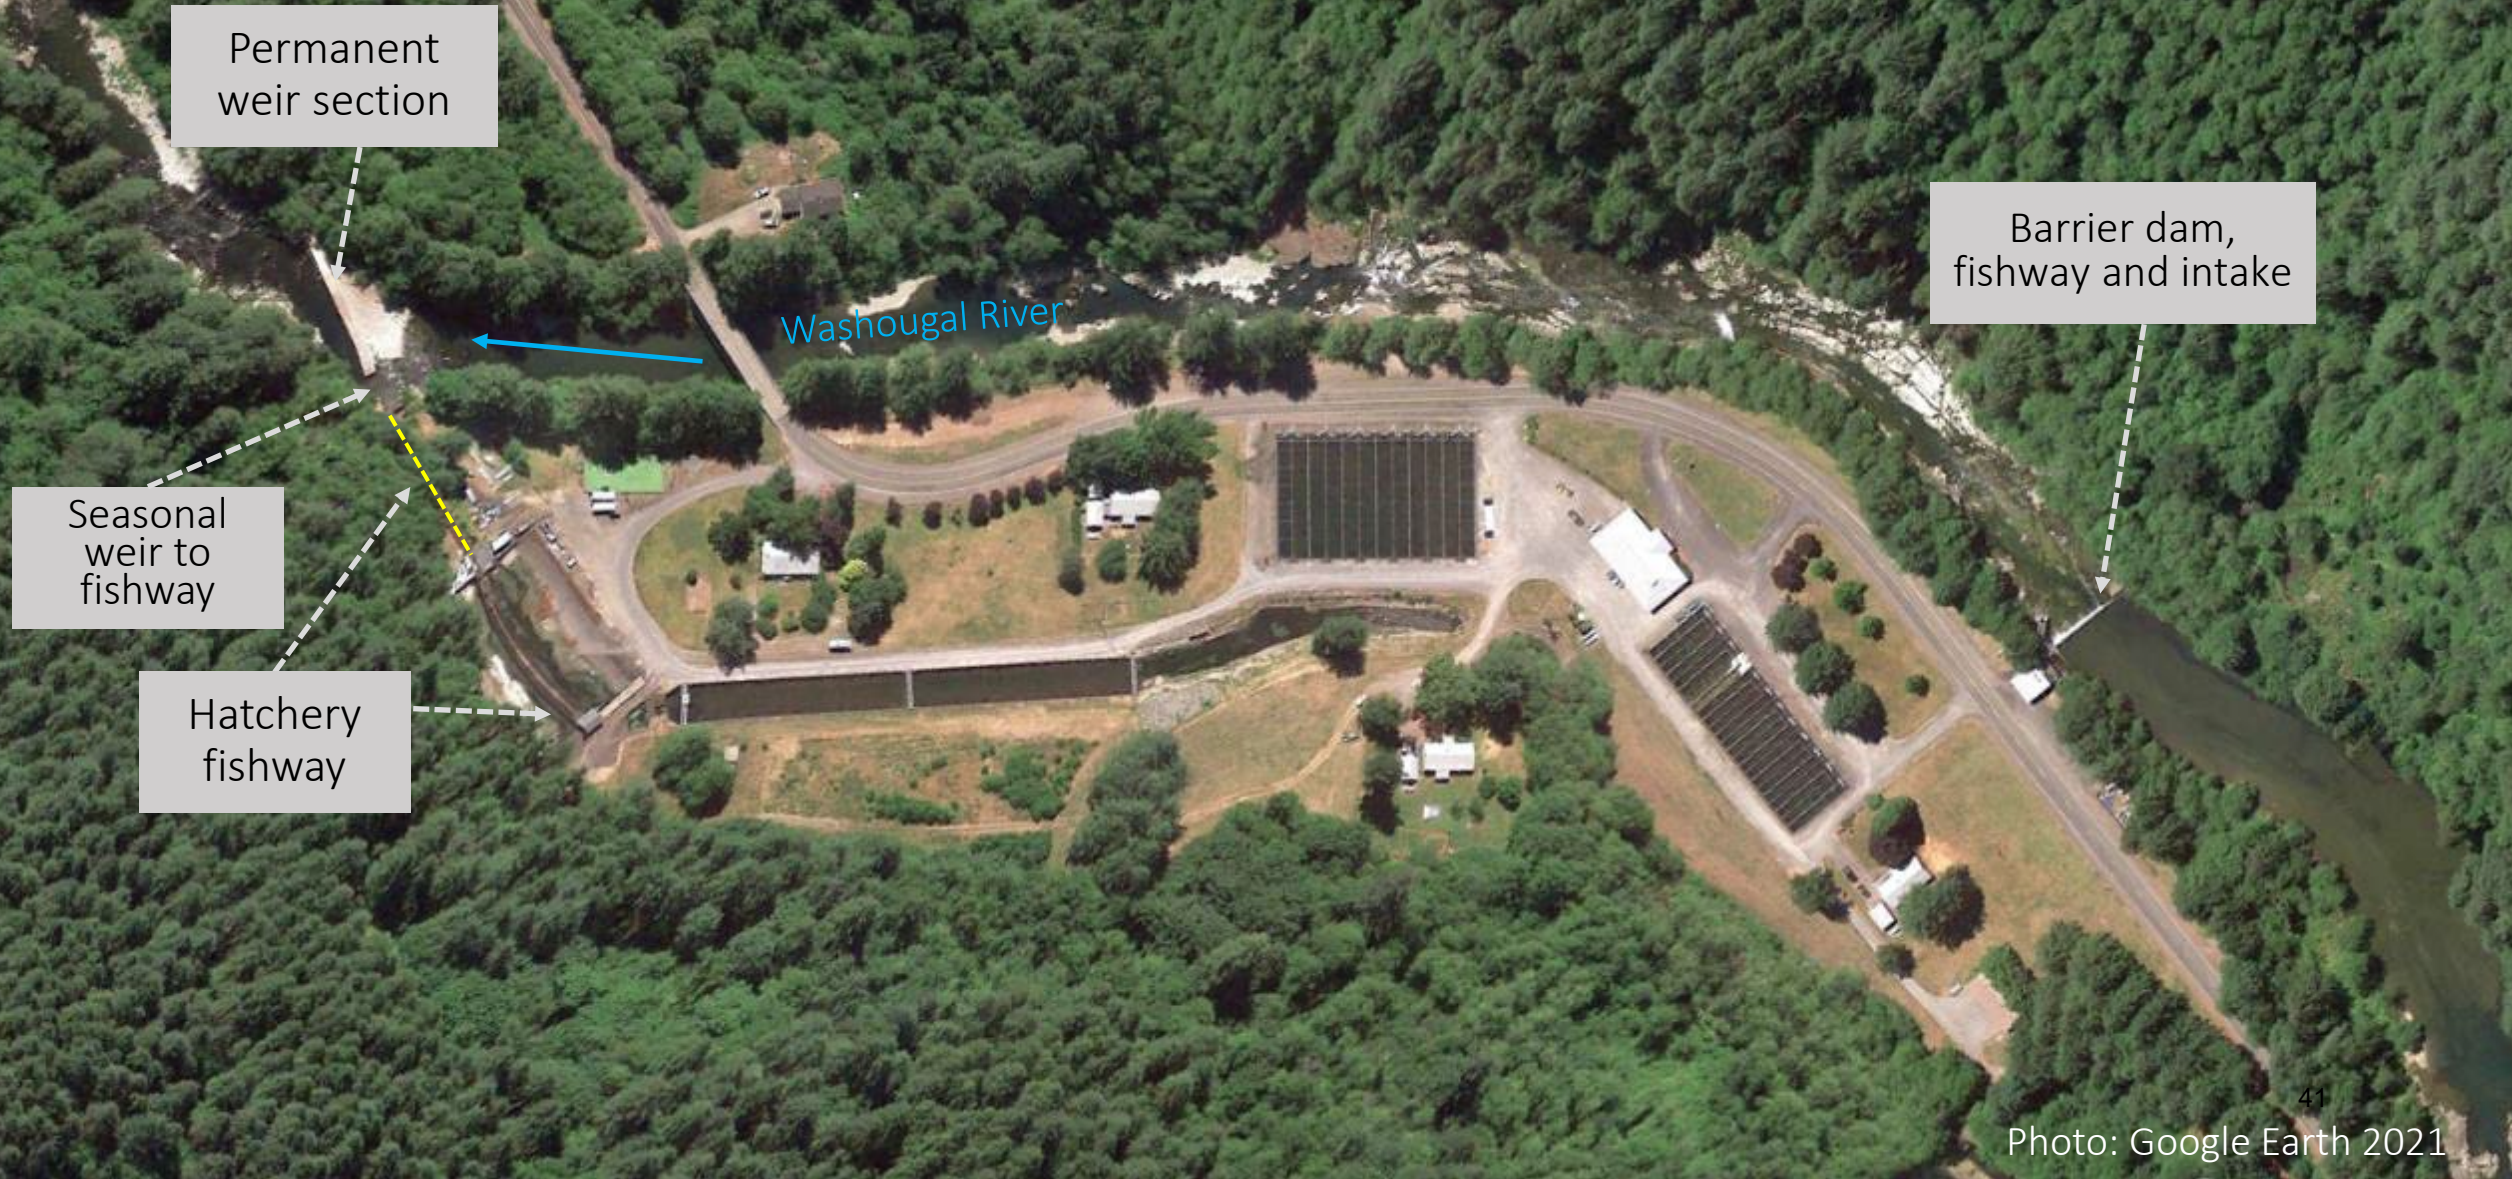
Washougal Hatchery – Downstream Barrier

Permanent
weir section

Seasonal weir
(not present)

Seasonal fishway (Aug
– Feb) not operational
during site visit

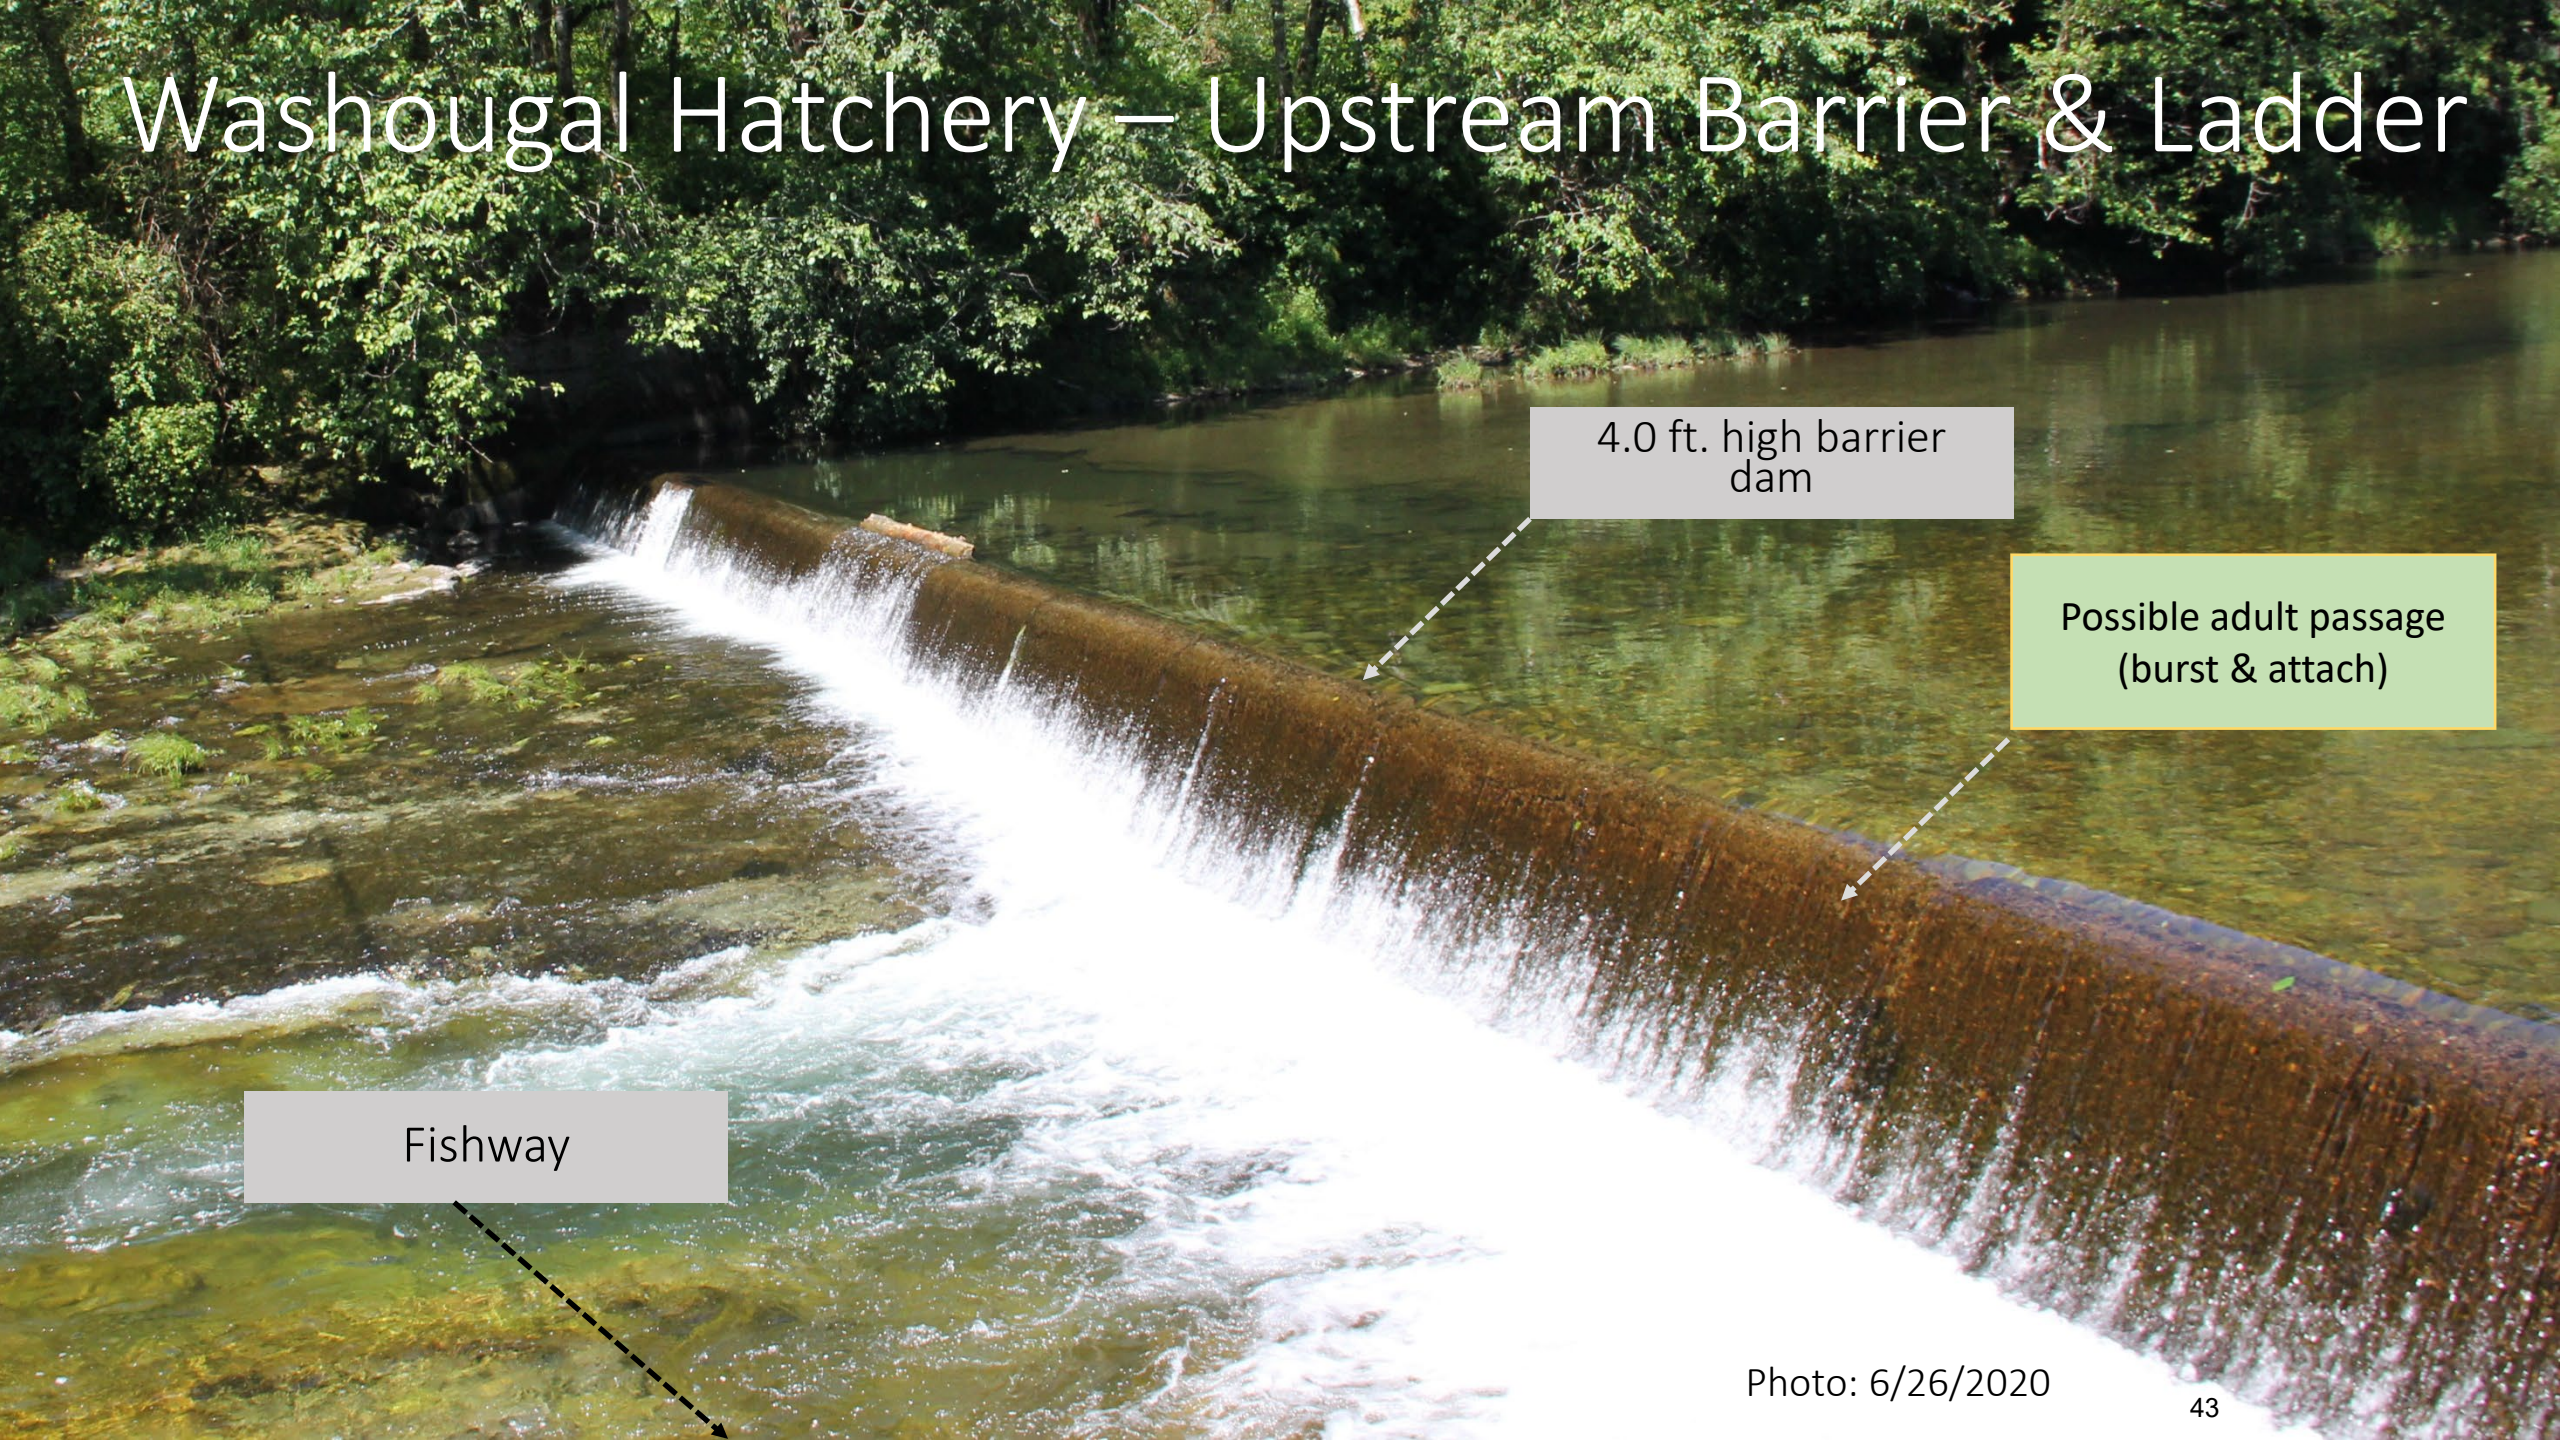
Washougal Hatchery – Upstream Barrier & Ladder

4.0 ft. high barrier
dam

Possible adult passage
(burst & attach)

Fishway velocities
up to 5.15 ft/s
during visit

All constructed
with 90° angles

- Downstream barrier comprised of a permanent weir to guide salmon into the hatchery fishway, and a seasonal weir is added (Aug-Feb) permanent weir to guide hatchery returns into the fishway
 - Weir pickets (1.5-inch spacing) facilitate adult lamprey passage through. These are not installed during active spring adult lamprey migration
 - No actions recommended at the downstream barrier
- Upstream barrier and fishway seasonally operated as a trap
 - Velocities currently limiting passage in the fishway
 - Recommend reassessing during spring migration flows
 - Recommend smoother barrier dam surfaces along both ends
 - Pacific lamprey have been documenting above hatchery

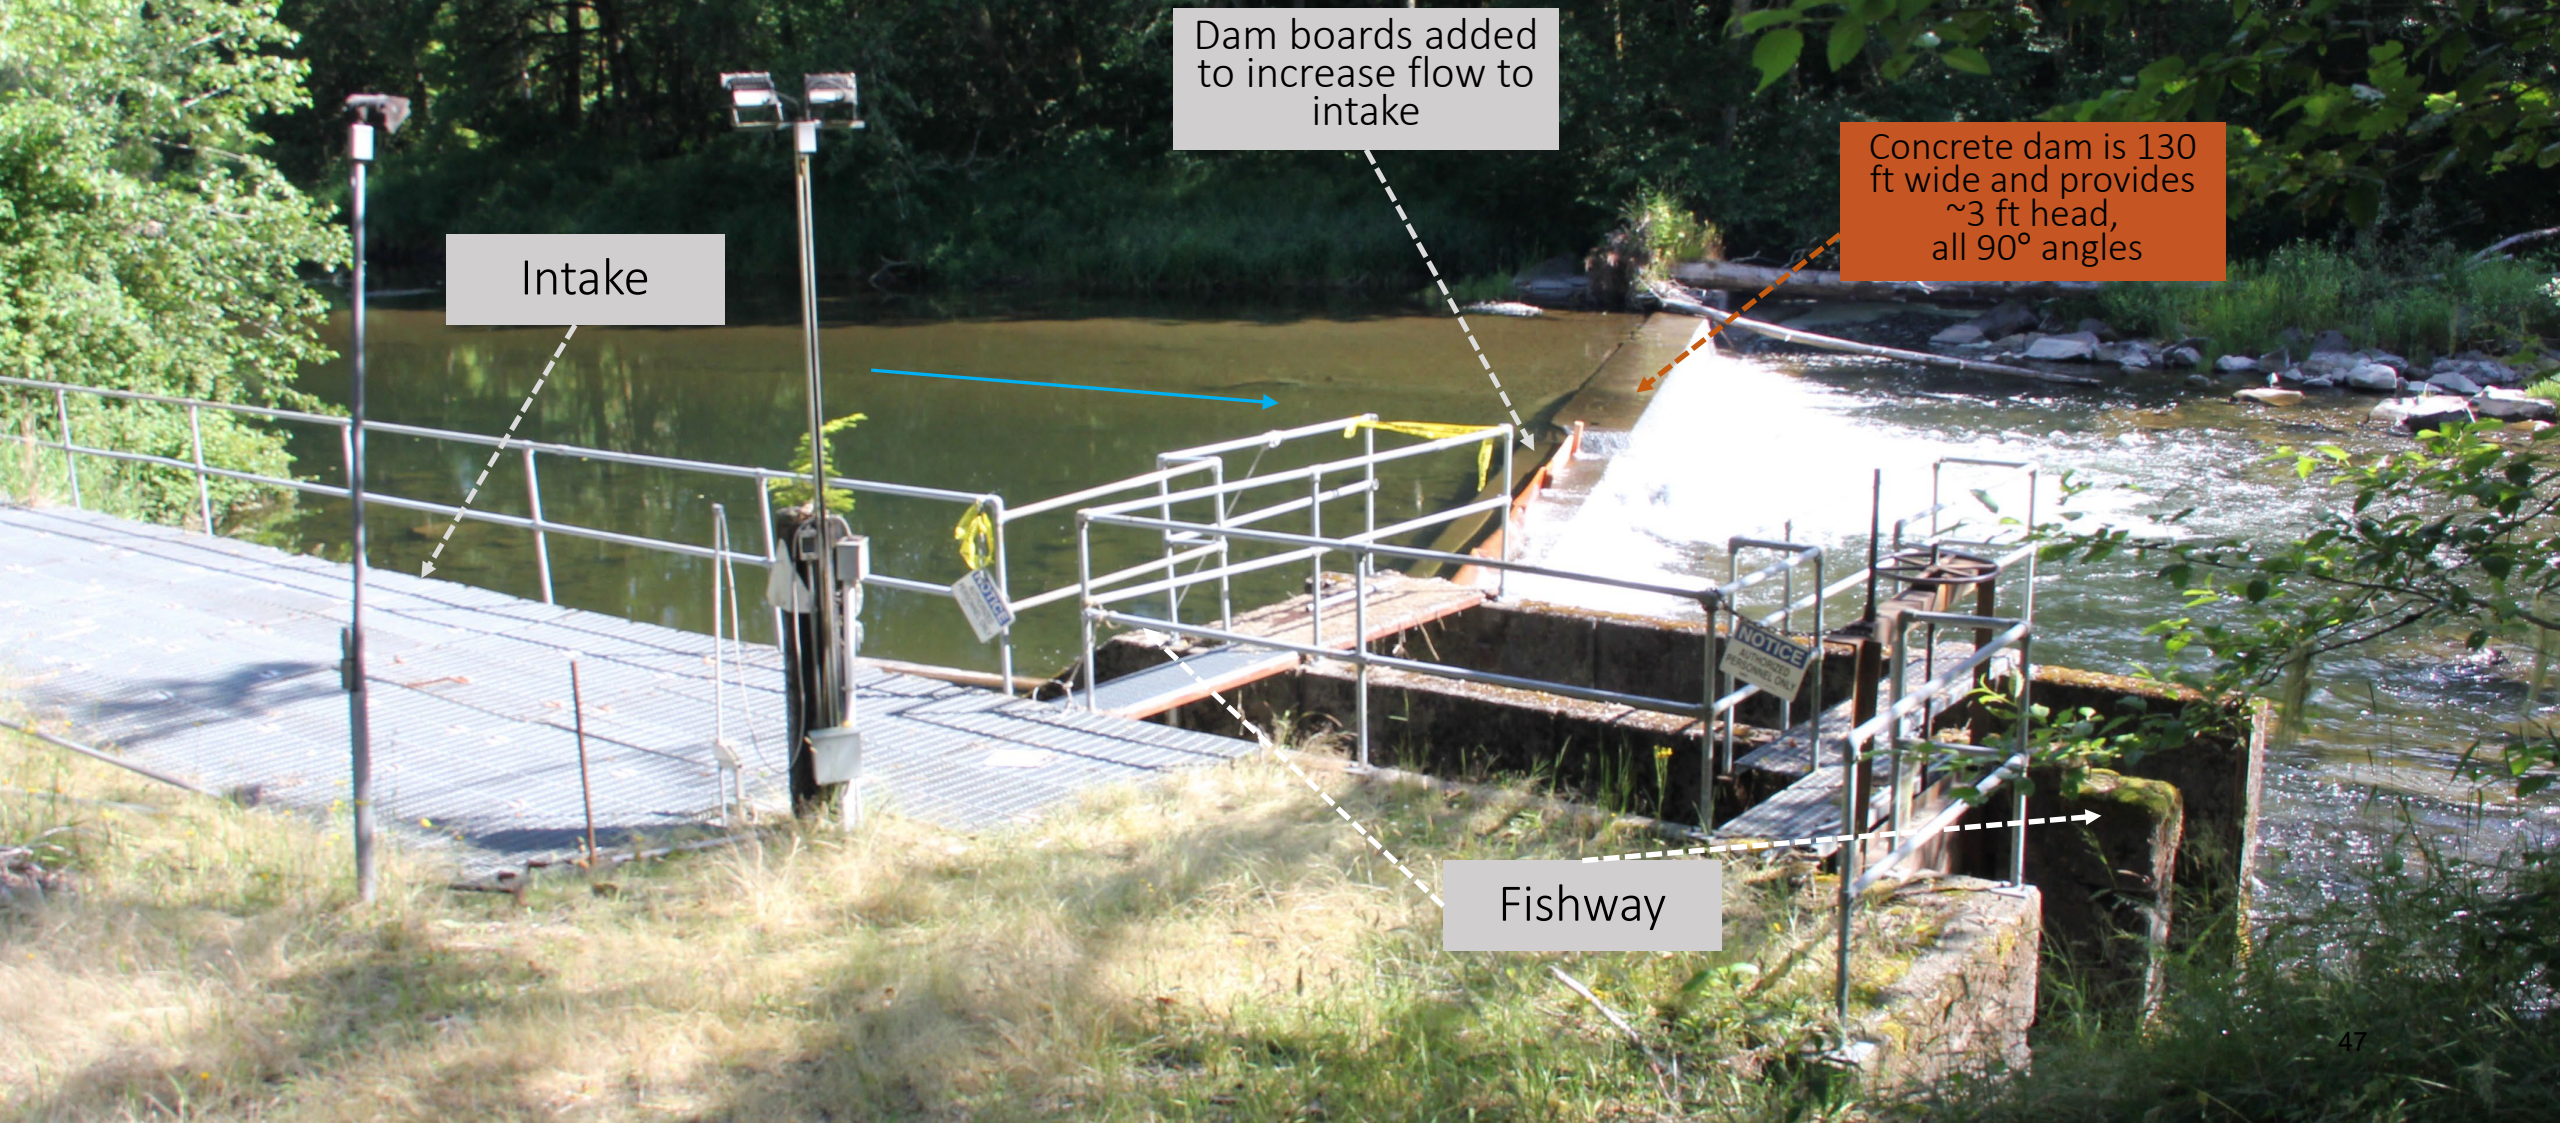
North Toutle - Upstream Dam, Fishway and Intake

- Downstream
 - No barrier dam exists at the hatchery
 - Seasonal weir used to convey fish into hatchery (spacing 1.5’)
 - The downstream was fishway dewatered during the visit
- Upstream barrier dam, fishway, and intake
 - Fishway operates all year with volitional salmon passage
 - Entrance velocities exceed lamprey swimming speeds
 - Recommend ramps on the dam and smoothing surfaces
 - Recommend adding attachment surfaces to the entrance and adding lamprey orifices to the pool and weir fishway baffles
 - Thousands of larval pacific lamprey observed in earthen ponds
 - Recommend reassessing during spring migration flows
 - Replacing the dam with a nature-like fishway could be a viable solution

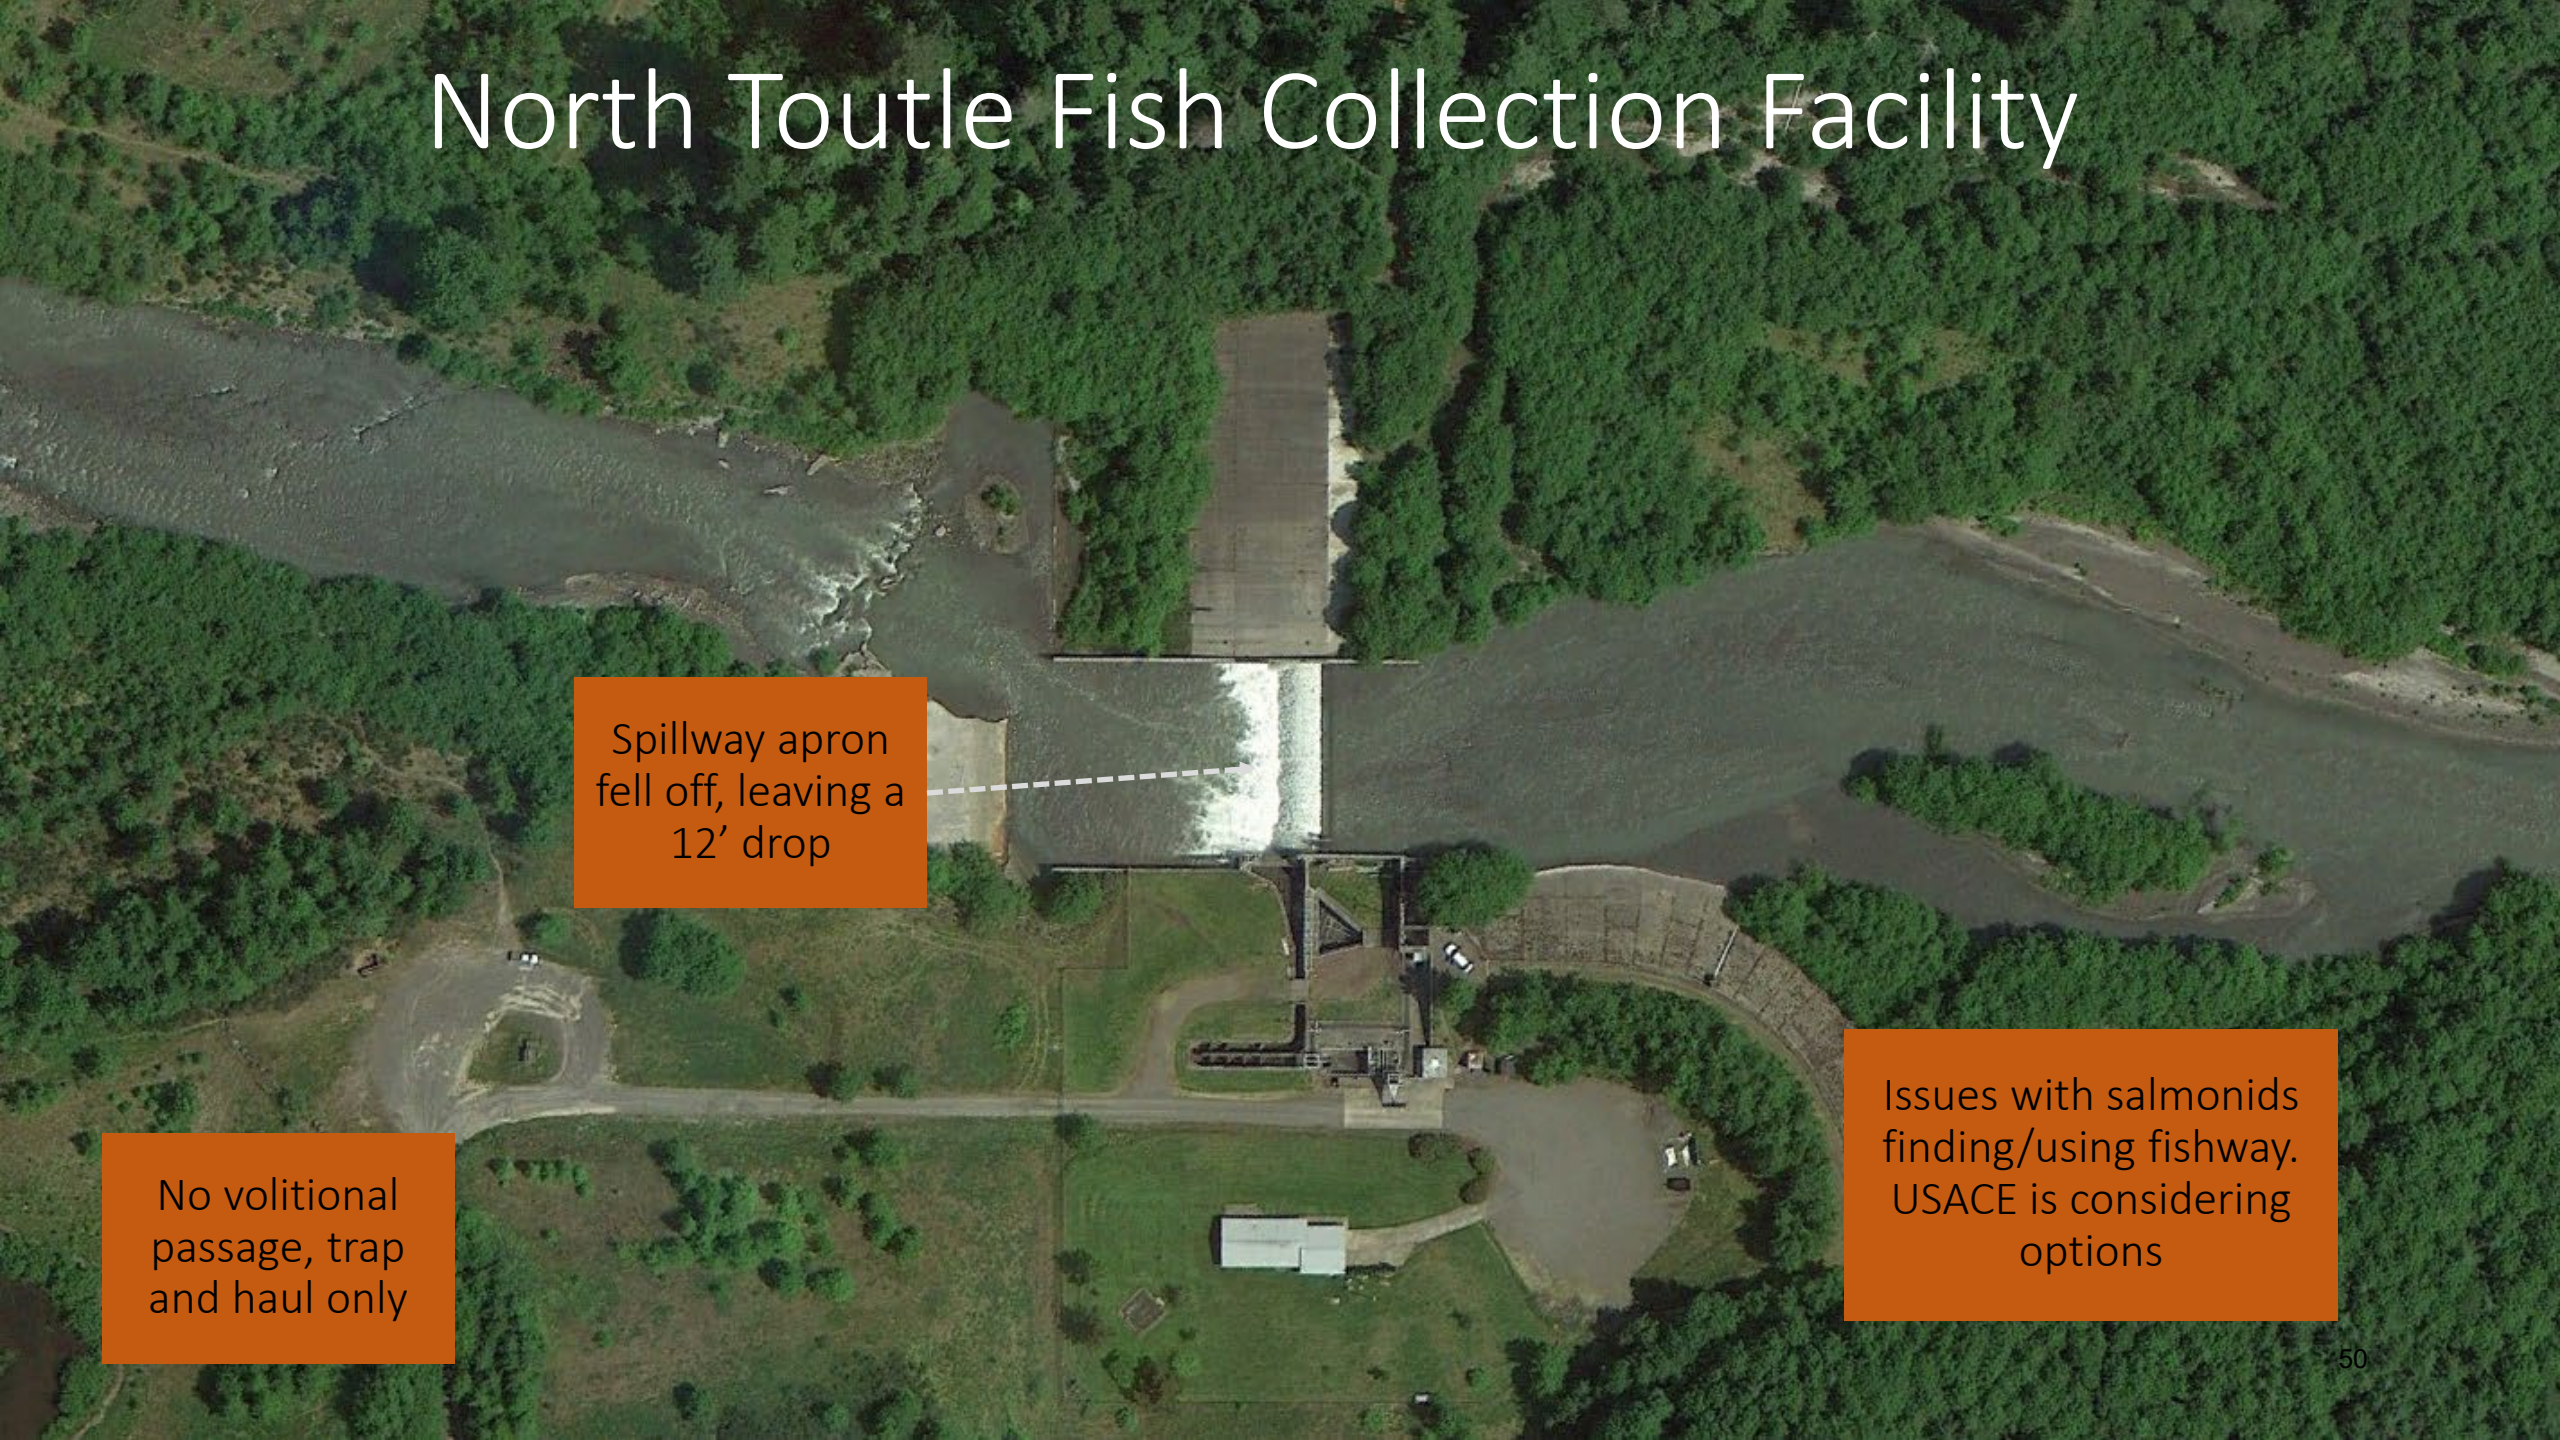
North Toutle Fish Collection Facility

Spillway apron
fell off, leaving a
12' drop

No volitional
passage, trap
and haul only

Issues with salmonids
finding/using fishway.
USACE is considering
options
