**Notes on Raghorn Road # 10802 Geo-Tagged Photos Taken July 28, 2016  
By Keith Hammer**

**CULVERT SURVEY PHOTO LOG:**

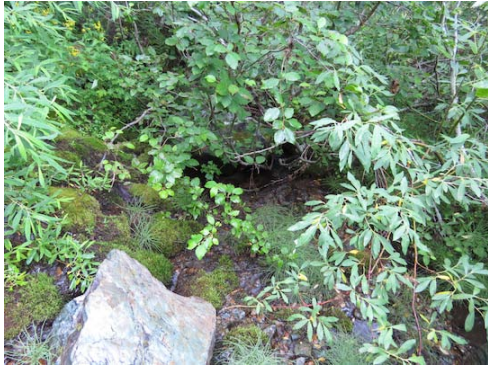
8356: (A) Culvert behind rock at center channels this small stream and seep.

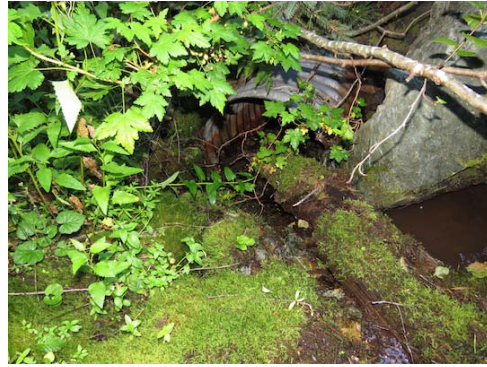
8357: 24" culvert inlet partially blocked by rock and woody debris, channeling stream and seep shown in 8356. Likely 950711 Road 10802 Survey Log at MP 0.03.

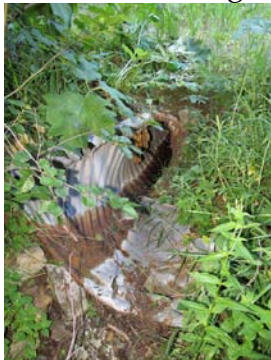
8359: (B) 18" culvert with partially crushed and ripped inlet. Currently dry with rust and signs of flow.

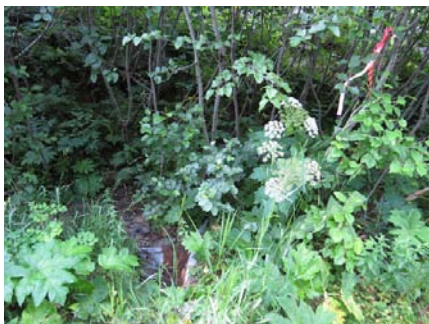
8361: Flagging indicates this culvert with the crushed and ripped inlet is likely known to the Forest Service. Note gravel and culvert rust lines indicate substantial flow at times.

Perhaps 950711 Road 10802 Survey Log at MP 0.15, which notes a damaged culvert that "will need to be removed," although this location is closer to MP 0.21.

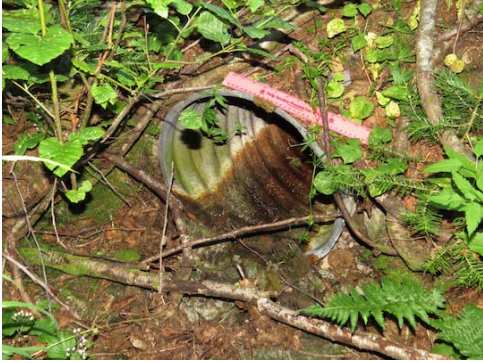
8362: (B) 18" currently dry culvert with rust and signs of flow.

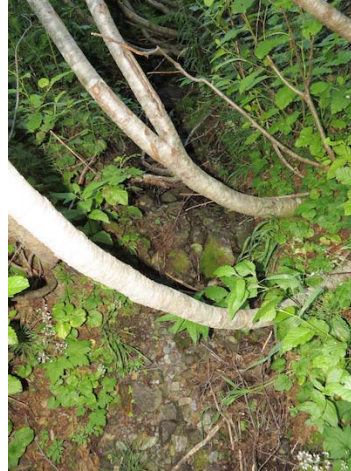
8363: Gravel bed in inboard ditch leading to culvert in 8362 indicates substantial flow at times.

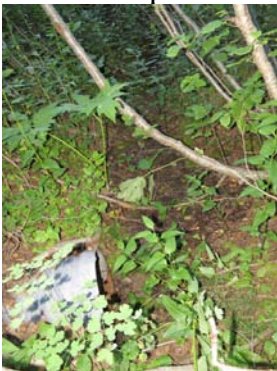
8365: (B) 18" culvert. Currently damp, carries seep from inboard ditch.

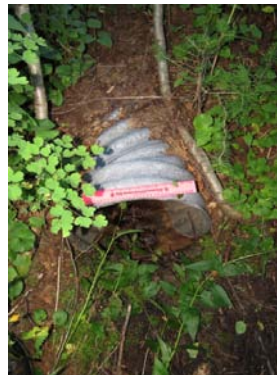
8366: 18" culvert inlet. Same as 8365.

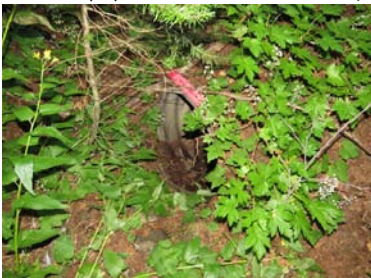
8367: (B) 18" culvert inlet, damp.

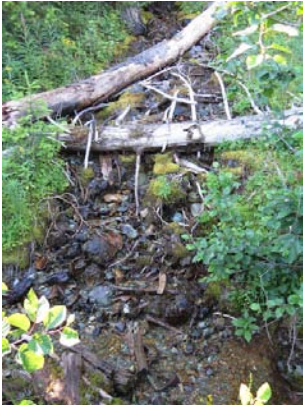
8368: (A) Significant seep and stream ends up in inboard ditch and 18" culvert in 8369.

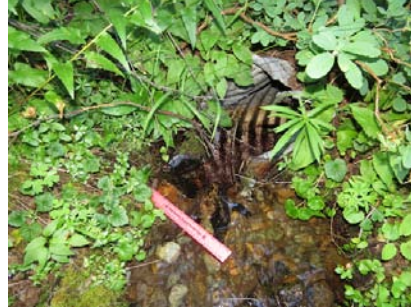
8369: 18" culvert with partially crushed and ripped inlet carries stream in 8368.

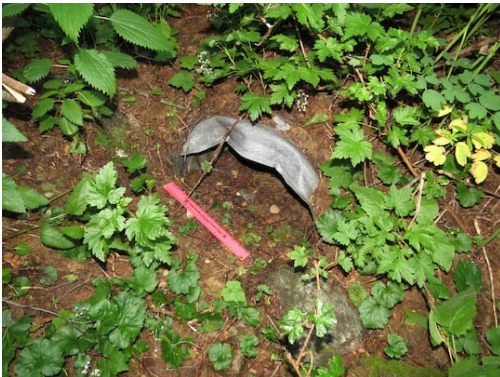
8370: (C) 18" culvert half full of small debris.

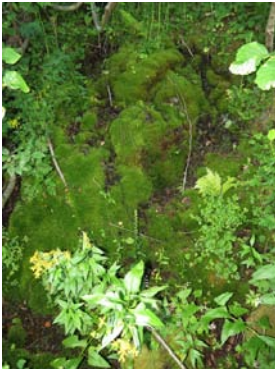
8372: (A) Seep that feeds into inboard ditch and 18" culvert in 8373.

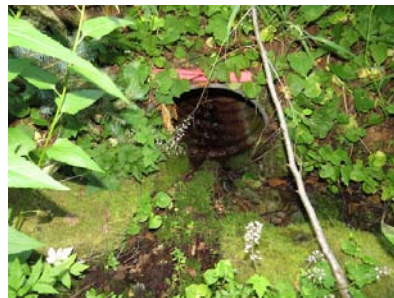
8373: 18" culvert carrying seep in 8372.

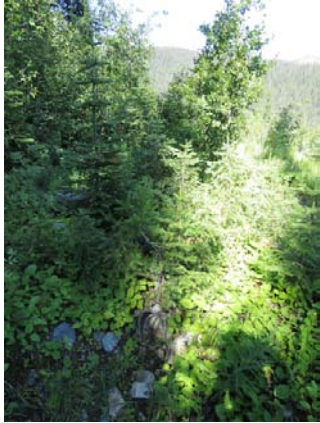
8374: (C) 18" culvert currently dry.

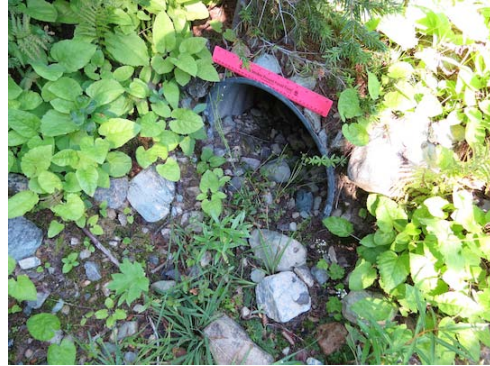
8375: 18" culvert inlet shown in 8374, one-third full of debris.

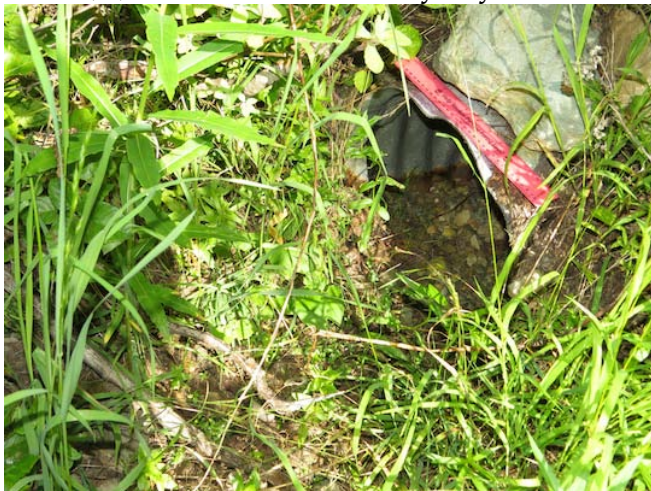
8377: (C) 18" culvert, currently dry.

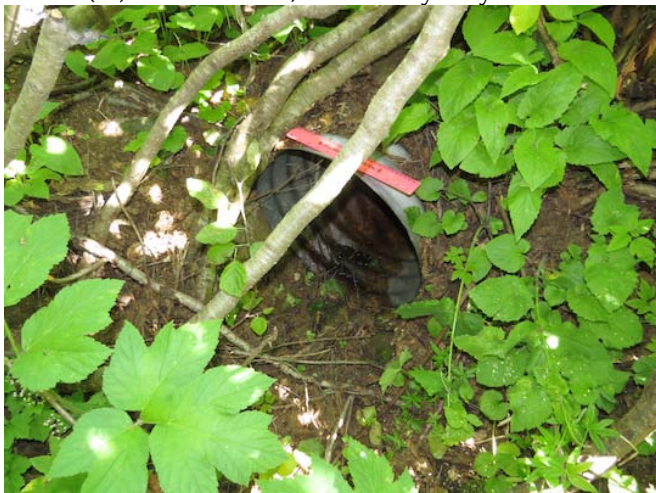
8378: (C) 18" culvert, currently dry.

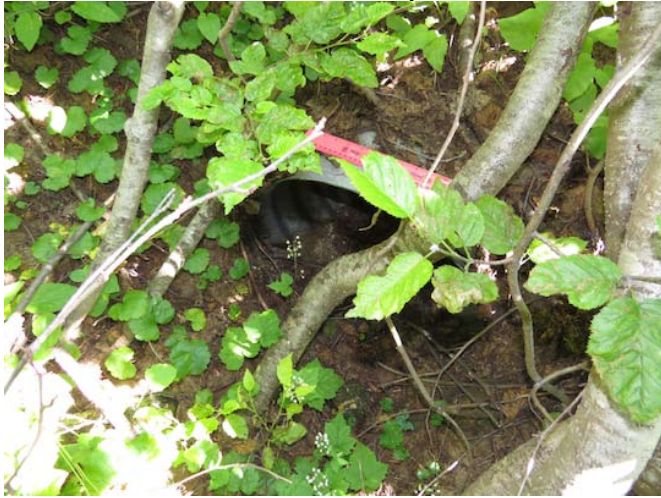
8379: (C) 18" culvert, currently dry.

8380: Same as 8379 but with photo flash.

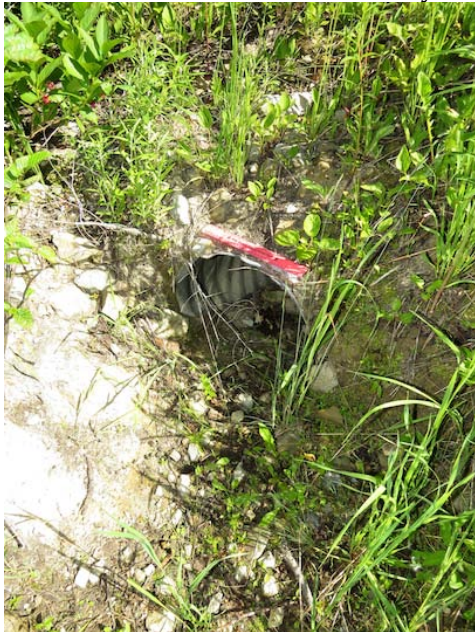
8381: (C) 18" culvert, currently dry.

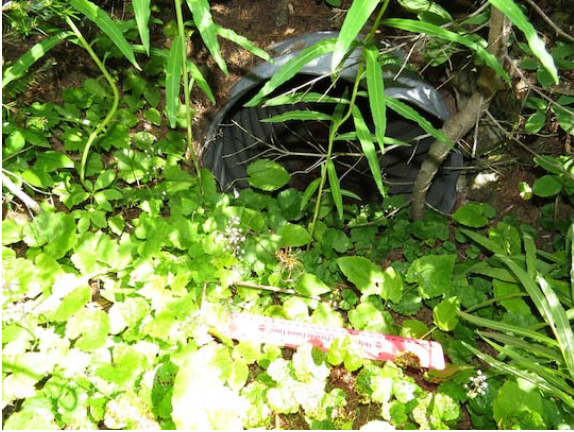
8386: (C) 18" culvert, currently dry.

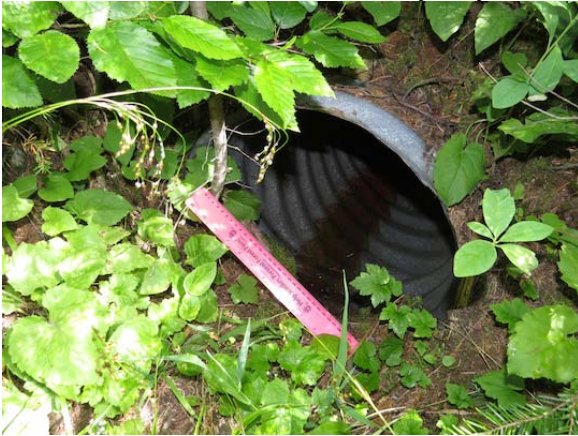
8387: (C) 18" culvert, currently dry.

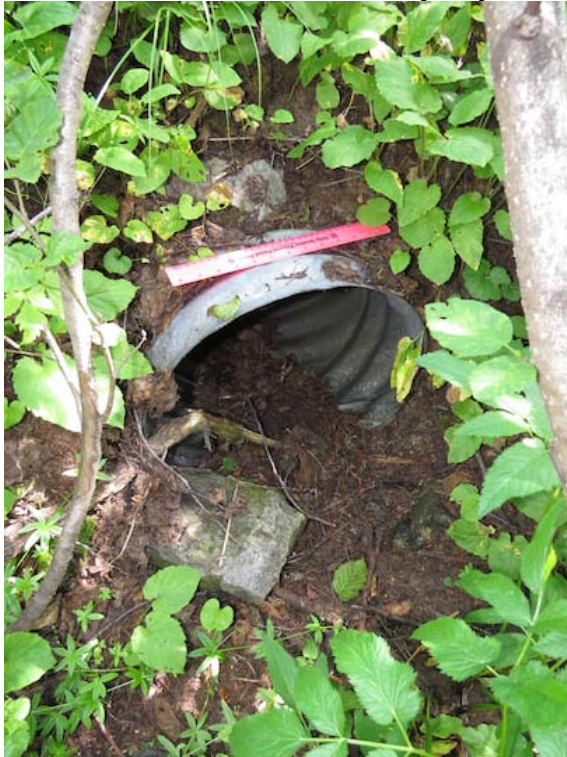
8395: (C) 18" culvert, currently dry.

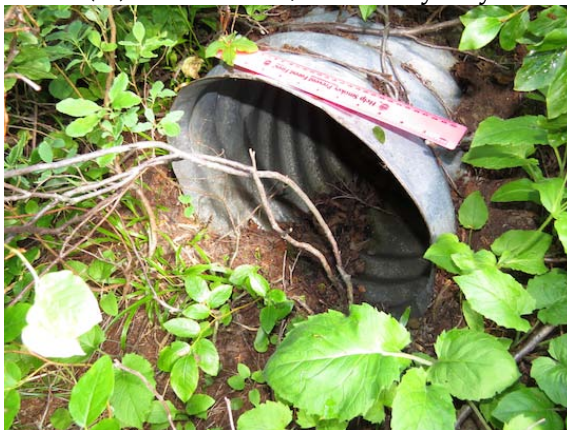
8396: (C) 18" culvert, currently dry.

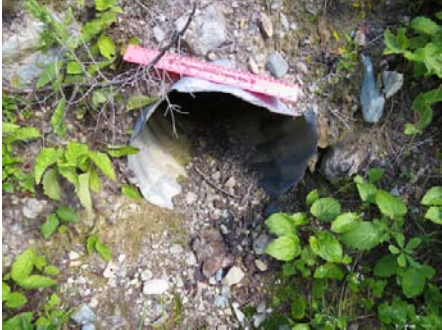
8399: (C) 18" culvert, currently dry.

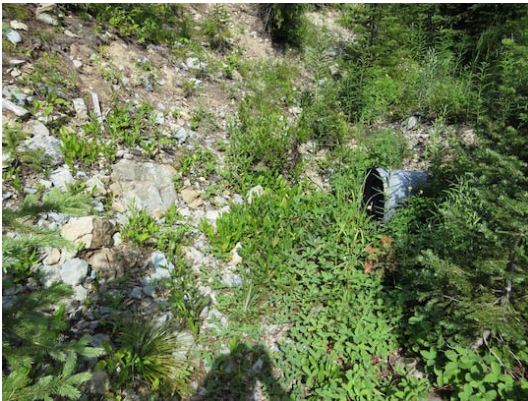
8403: Overland stream feeds into 18" culvert.

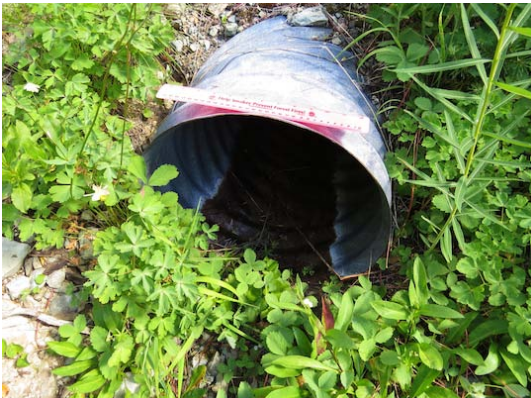
8404: 18" culvert inlet with rust from seasonal flow.

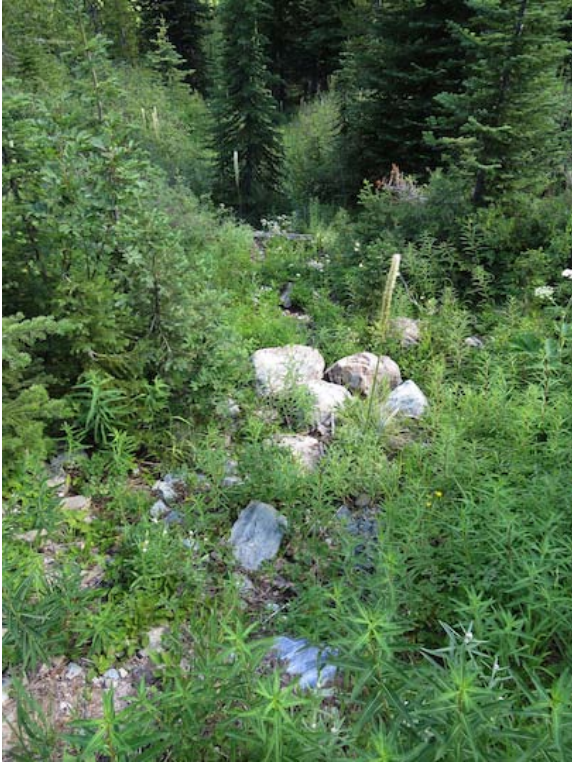
8405: 18" culvert outlet in foreground and aligned, incised stream channel.

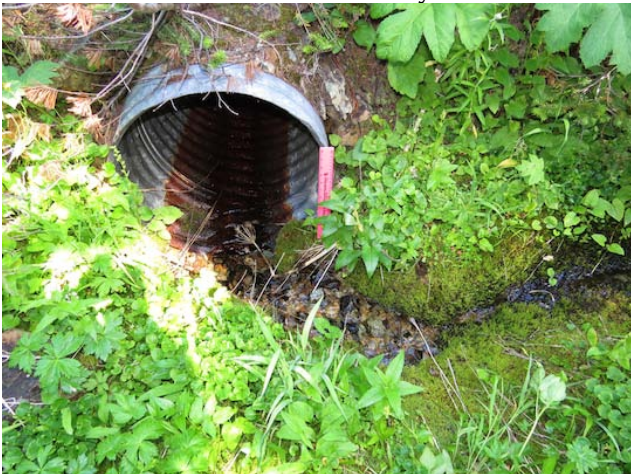
8408: 24" culvert inlet carrying live incised stream channel from above and right, and overland flow diverted by installed berm at left.

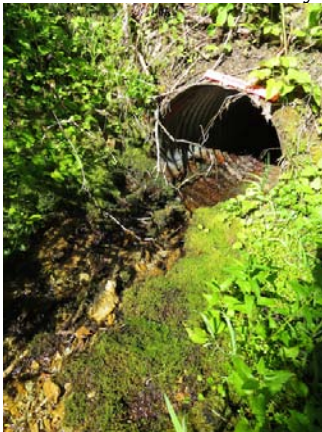
8414: 24” culvert carrying aligned, incised stream channel.

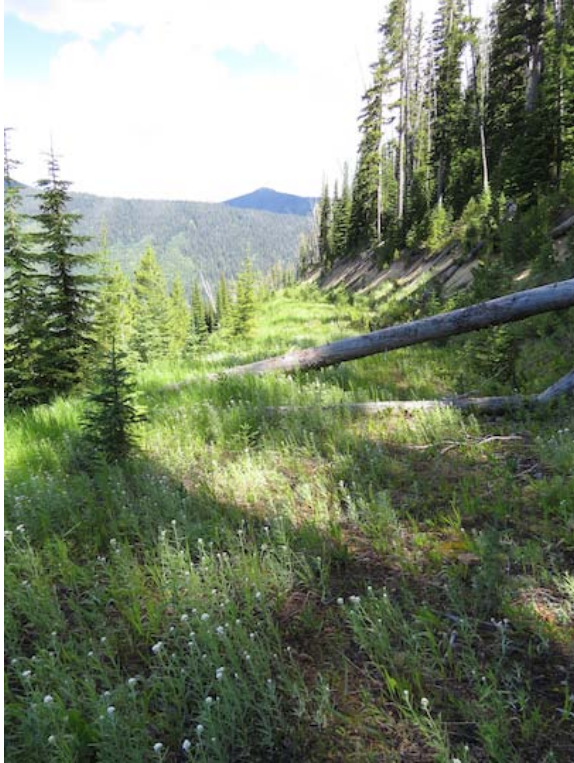
8415: Beginning of road cut section that is heavily slumped and has buried most culvert inlets completely. I could find only a few of the culverts listed in the 950711 Road 10802 Survey Log.

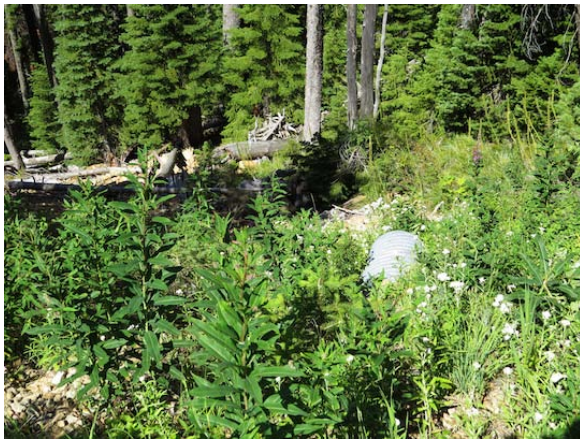
8422: (C) Culvert outlet (likely 18"). Likely connected to culvert inlet shown in 8423 and 8424.

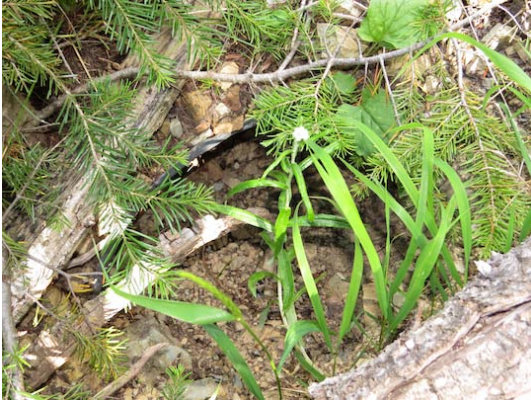
8423: Culvert inlet almost completely plugged with rock and woody debris.

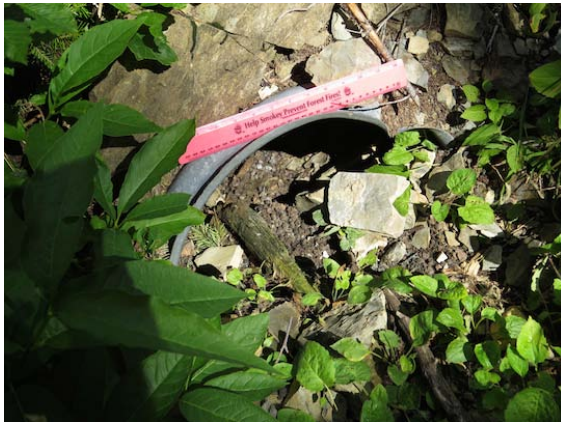
8426: (C) 18" culvert inlet half-full of debris and animal scat.

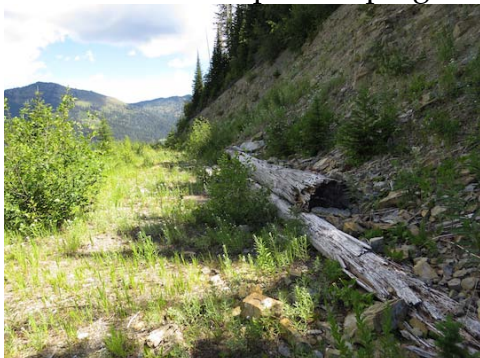
8429: More cutslope slumping and signs of past log decking.

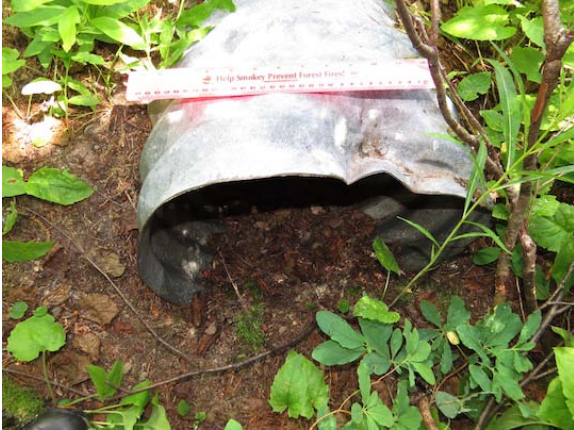
8433: (C) 18" culvert, currently dry.

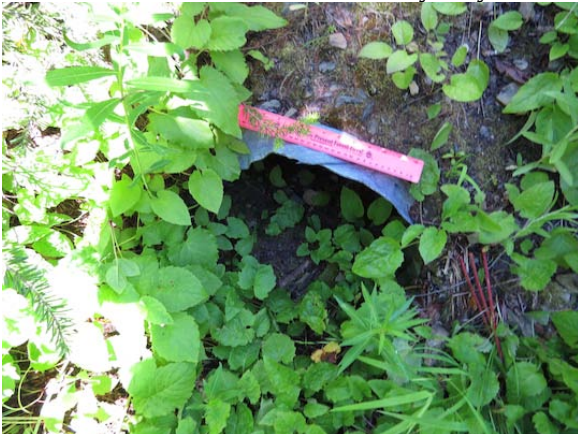
8434: (C) 18" culvert, currently dry.

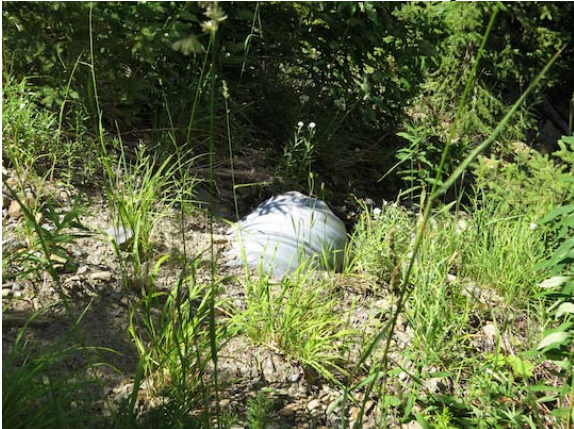
8435: (A) Outlet of culvert (likely 18") carrying live small stream.

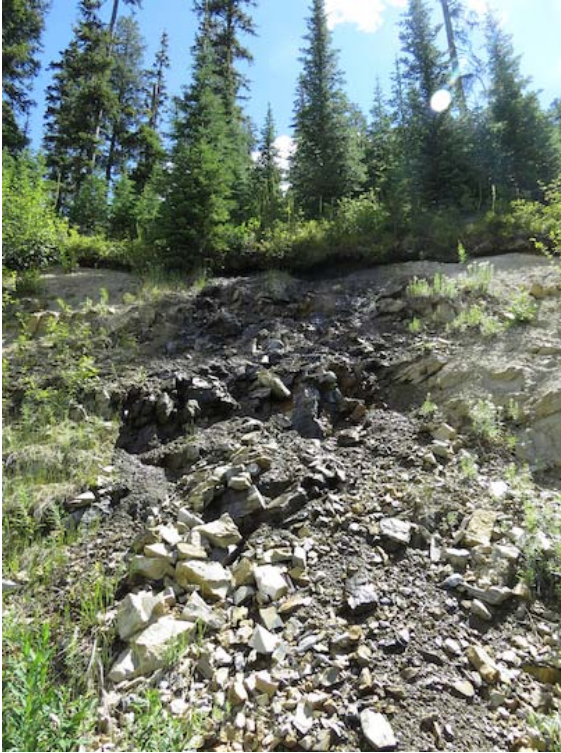
8436: This spring and others to the left feed the culvert shown in 8435.

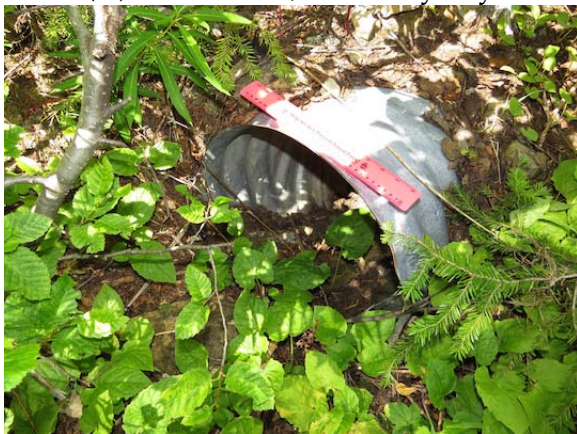
8440: (C) 18" culvert, currently dry.

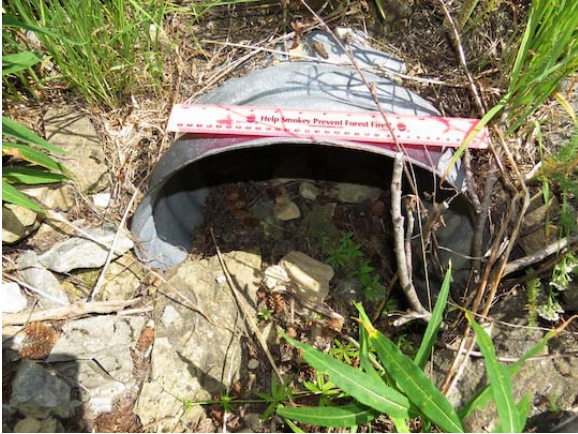
8442: (C) 18" culvert, currently dry.

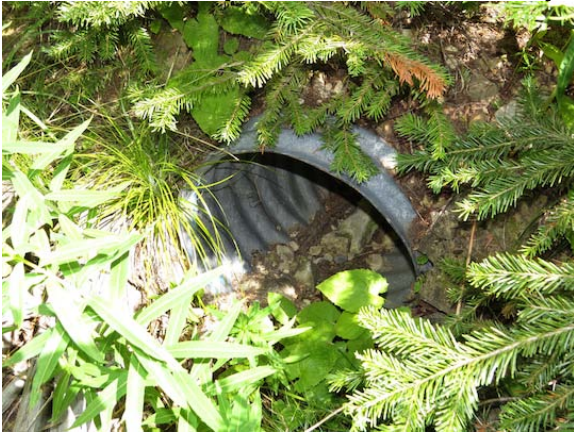
8444: (C) (Likely 18") culvert, currently dry.
