San Juan and Animas rivers Diversion Study

Final Report

Dale Lyons, Michael A. Farrington, Steven P. Platania, and Dave Gori

31 August 2016
Revised 12 December 2016

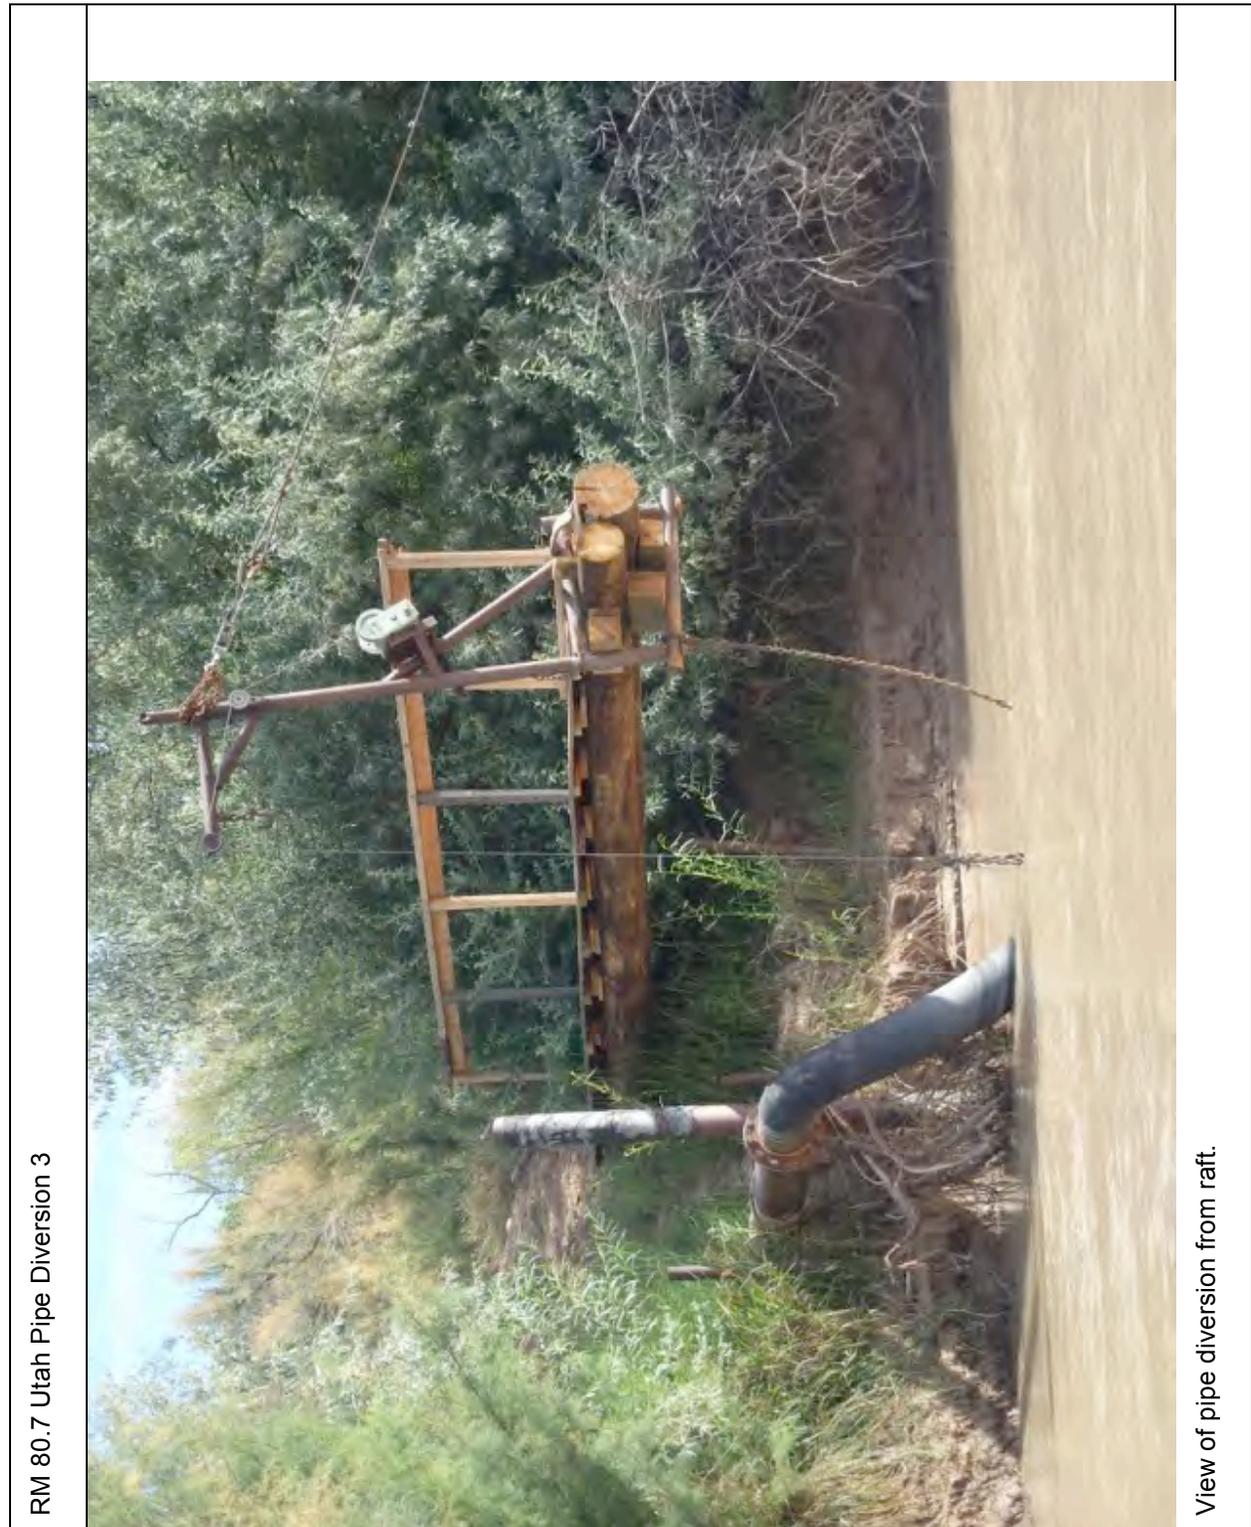
RM 80.7 Utah Pipe Diversion 3

View of pipe diversion from raft.

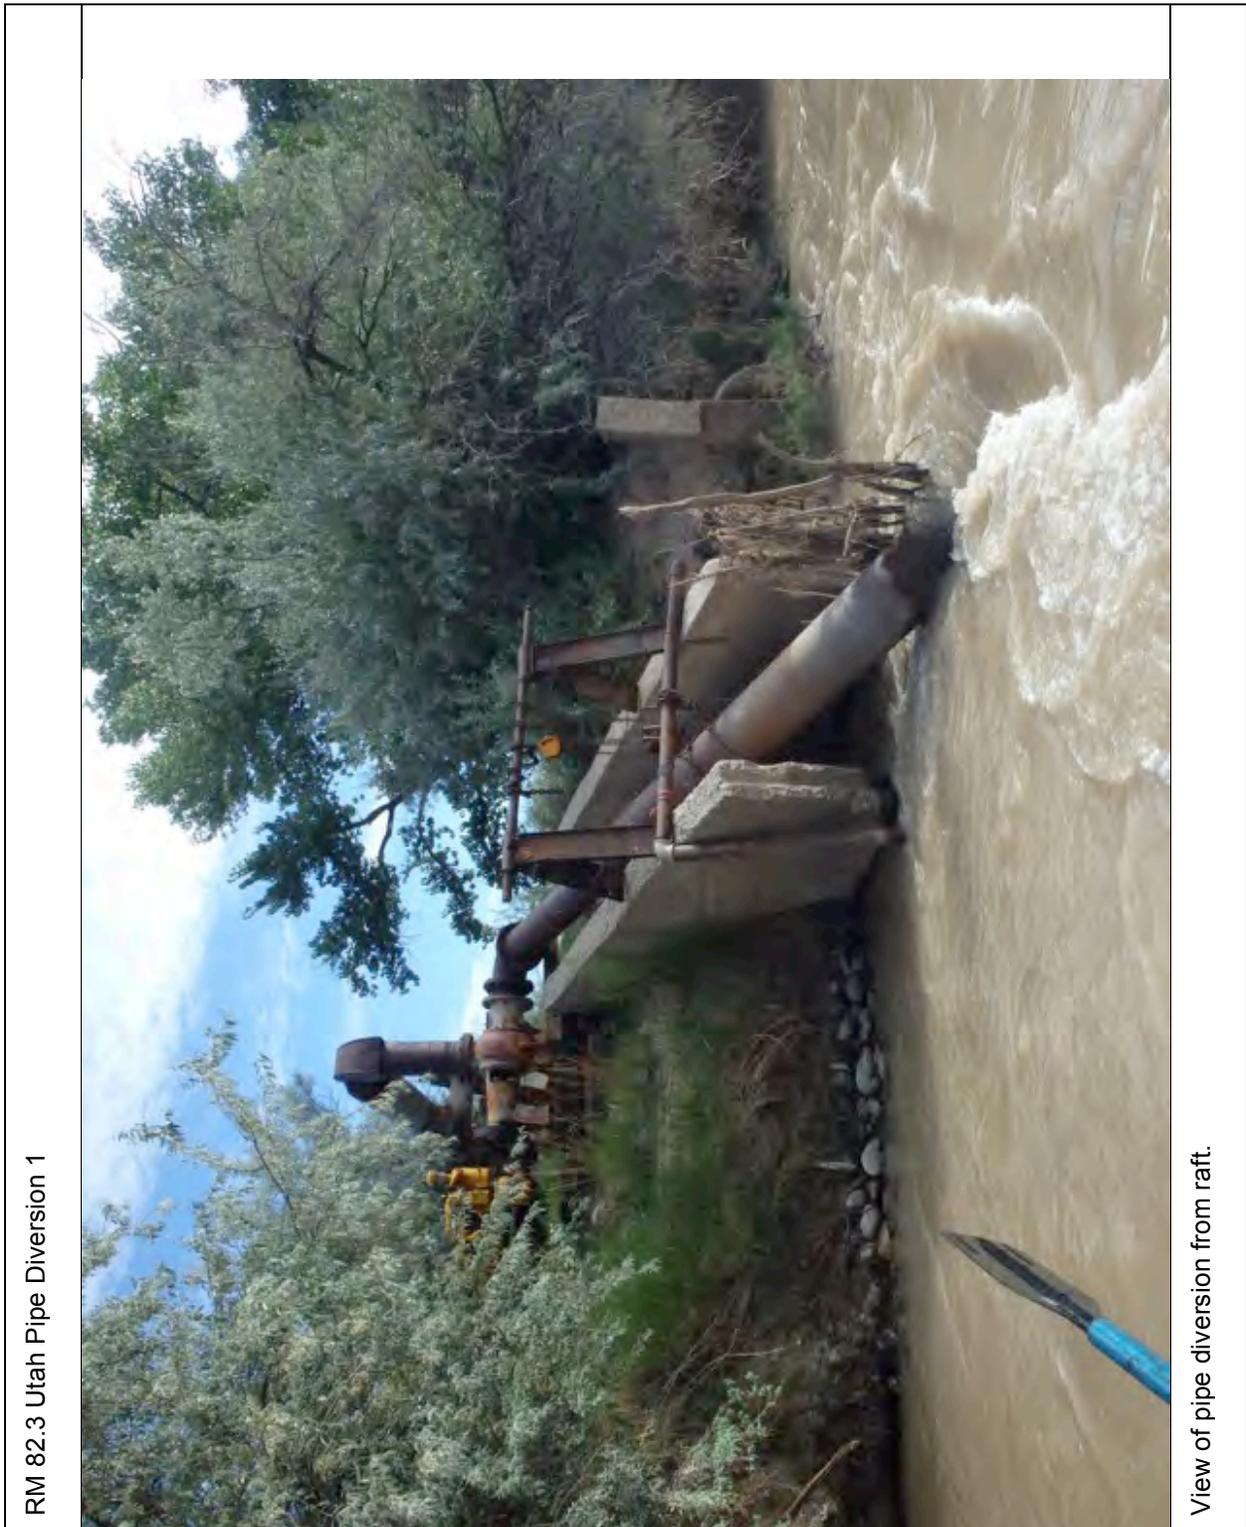
RM 82.3 Utah Pipe Diversion 1

View of pipe diversion from raft.

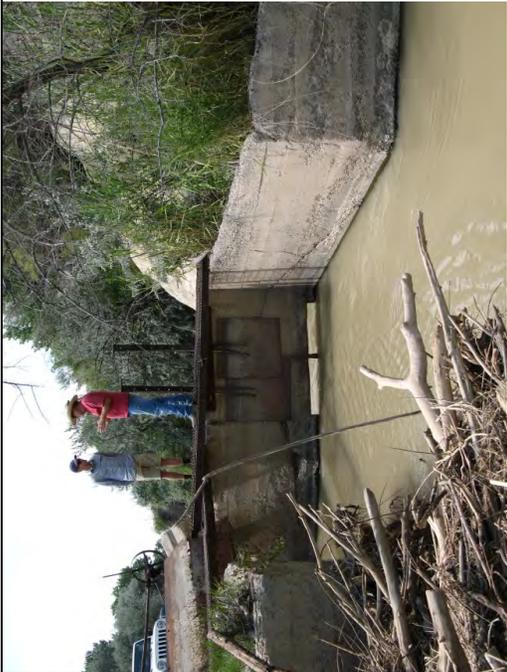
<p>Headgate with non-functioning spillway at left.</p>

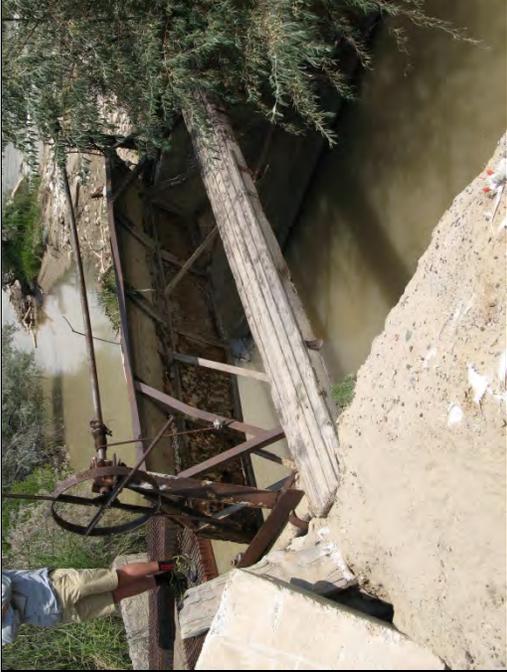
<p>A photograph showing a large, rusted metal structure, likely a spillway gate, situated in a river. The water is brown and turbulent. The surrounding area is rocky and has some green vegetation.</p>	<p>Non-functioning spillway gate at headgate</p>

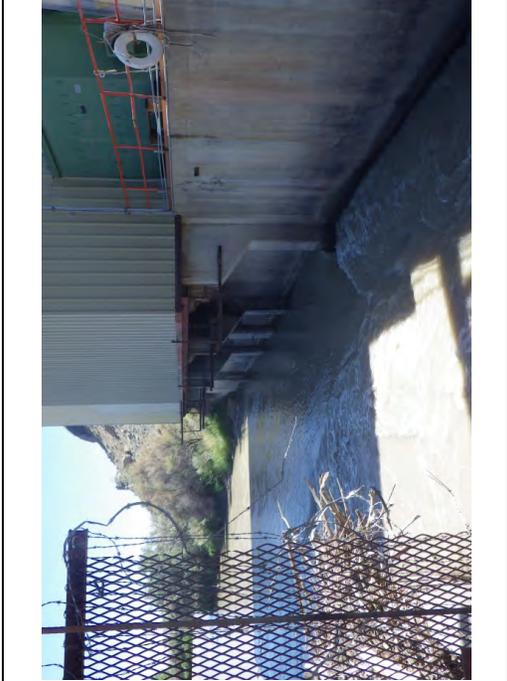
<p>A view of a concrete structure with a metal gate or screen. The structure is situated in a river channel. The water is flowing through the structure. The background shows a rocky hillside.</p>	<p>View upstream of diversion channel outlet gate.</p>	<p>Diversion structure inlet openings with debris/fish screens.</p>

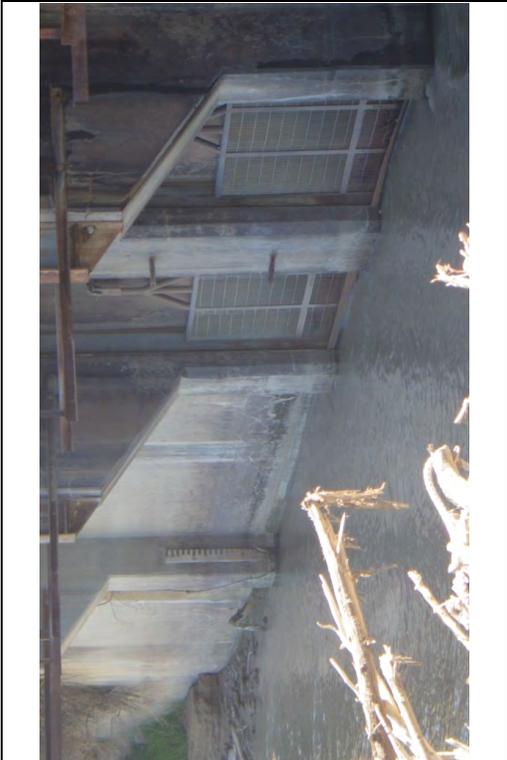
<p>A photograph of a concrete structure with two large, rectangular debris/fish screens. The screens are partially covered with sticks and other debris. The structure is situated in a riverbed.</p>	<p>Debris/fish screens across diversion/pump inlets.</p>

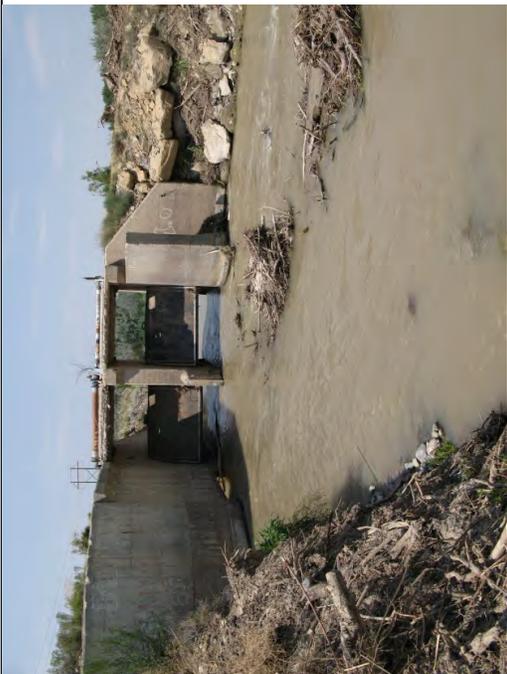
<p>View downstream of headgate structure with gate operators removed.</p>	<p>Headgate structure.</p>

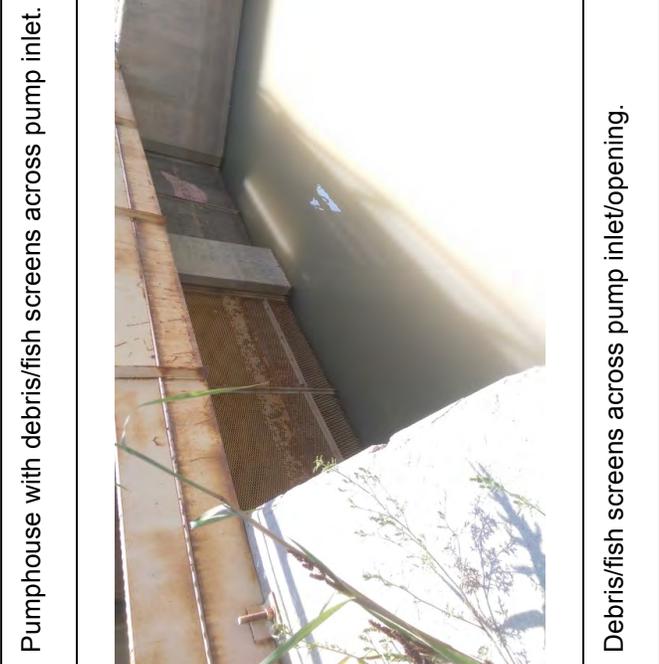
<p>Debris/fish screens across pump inlet/opening.</p>
--	---	--	---	--

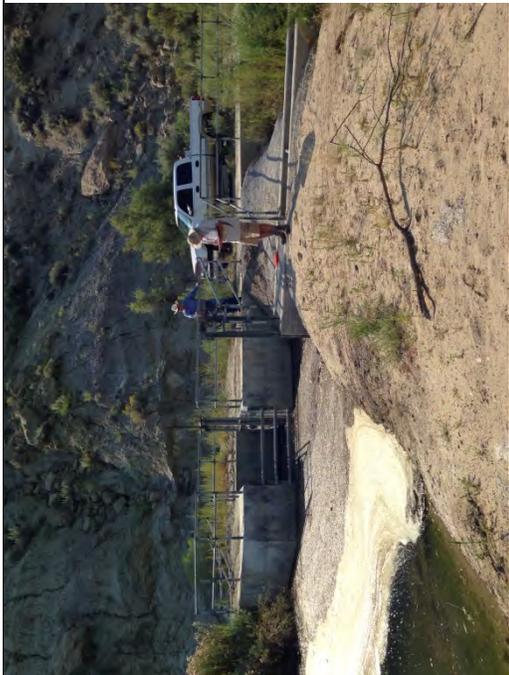
<p>RM 214.4 Turley-Manzanares Ditch (1 of 2)</p>

<p>A wide-angle photograph showing a concrete headgate structure with a spillway. The river flows through a rocky, arid landscape. A white pickup truck is parked on the dirt bank to the right. The background shows a range of mountains under a clear sky.</p>	<p>View downstream of headgate and spillway.</p>
<p>Headgate with trash rack.</p>

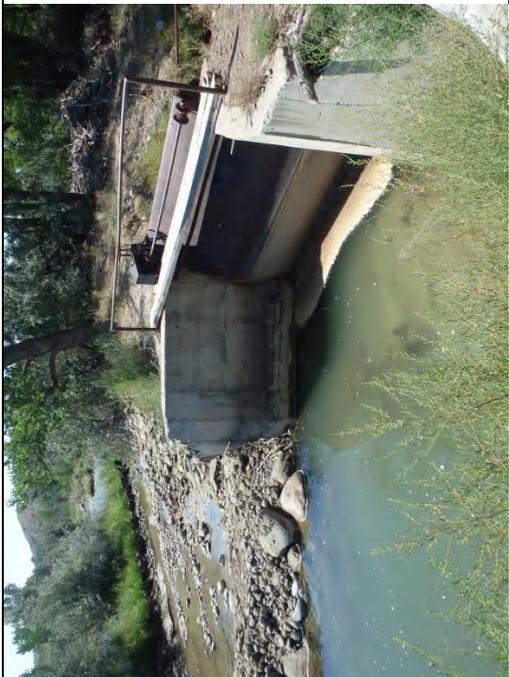
<p>Headgate structure with uncontrolled spillway at left, river return in background.</p>

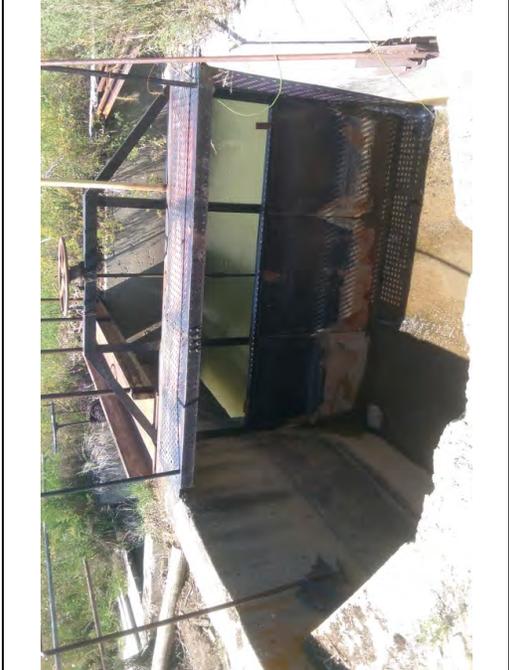
A photograph of a spillway gate. The gate is a large, dark metal structure with a corrugated metal roof. It is situated in a river channel, and water is visible behind it. The structure is supported by concrete pillars.	<p>Spillway gate.</p>

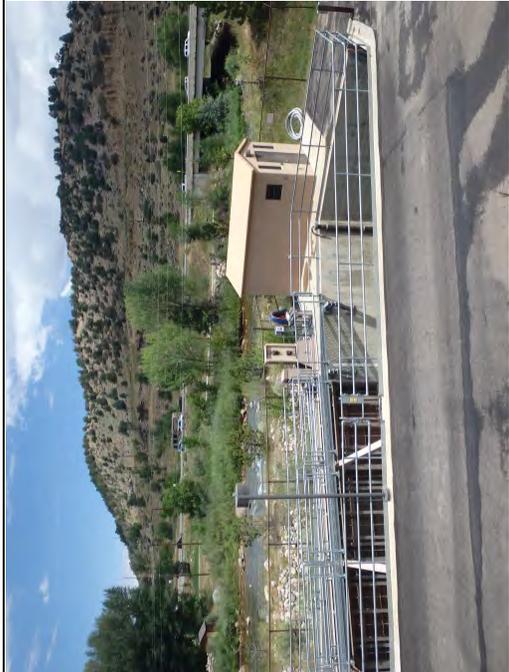
<p>RM 59.8 USBR Animas-La Plata Project/Lake Nighthorse Diversion (2 of 2)</p>

<p>A wide-angle photograph of a large concrete settling pond with a metal fish screen structure extending across its width. The pond is situated in a semi-arid landscape with hills in the background under a blue sky with scattered clouds.</p>	<p>View of settling pond, fish screen sluice structure.</p>
