Card Street Fire Suppression Repair Plan

The following guidelines were developed to help fire managers repair areas damaged or disturbed during fire suppression operations on the Card Street Fire (AK-KIDC-503292). These guidelines are for Wildfire Suppression Activity Damage Repair on areas damaged during the incident and to be financed (charged to the fire incident). Suppression damage repairs are usually completed by fire suppression crews and equipment as directed by the Incident Management Team (IMT) following containment of the wildfire. These guidelines are not for a BAER (Burned Area Emergency Rehabilitation) Plan.

Appendix A: Repair Needs by Division

Appendix B: Repair Prescription by Division

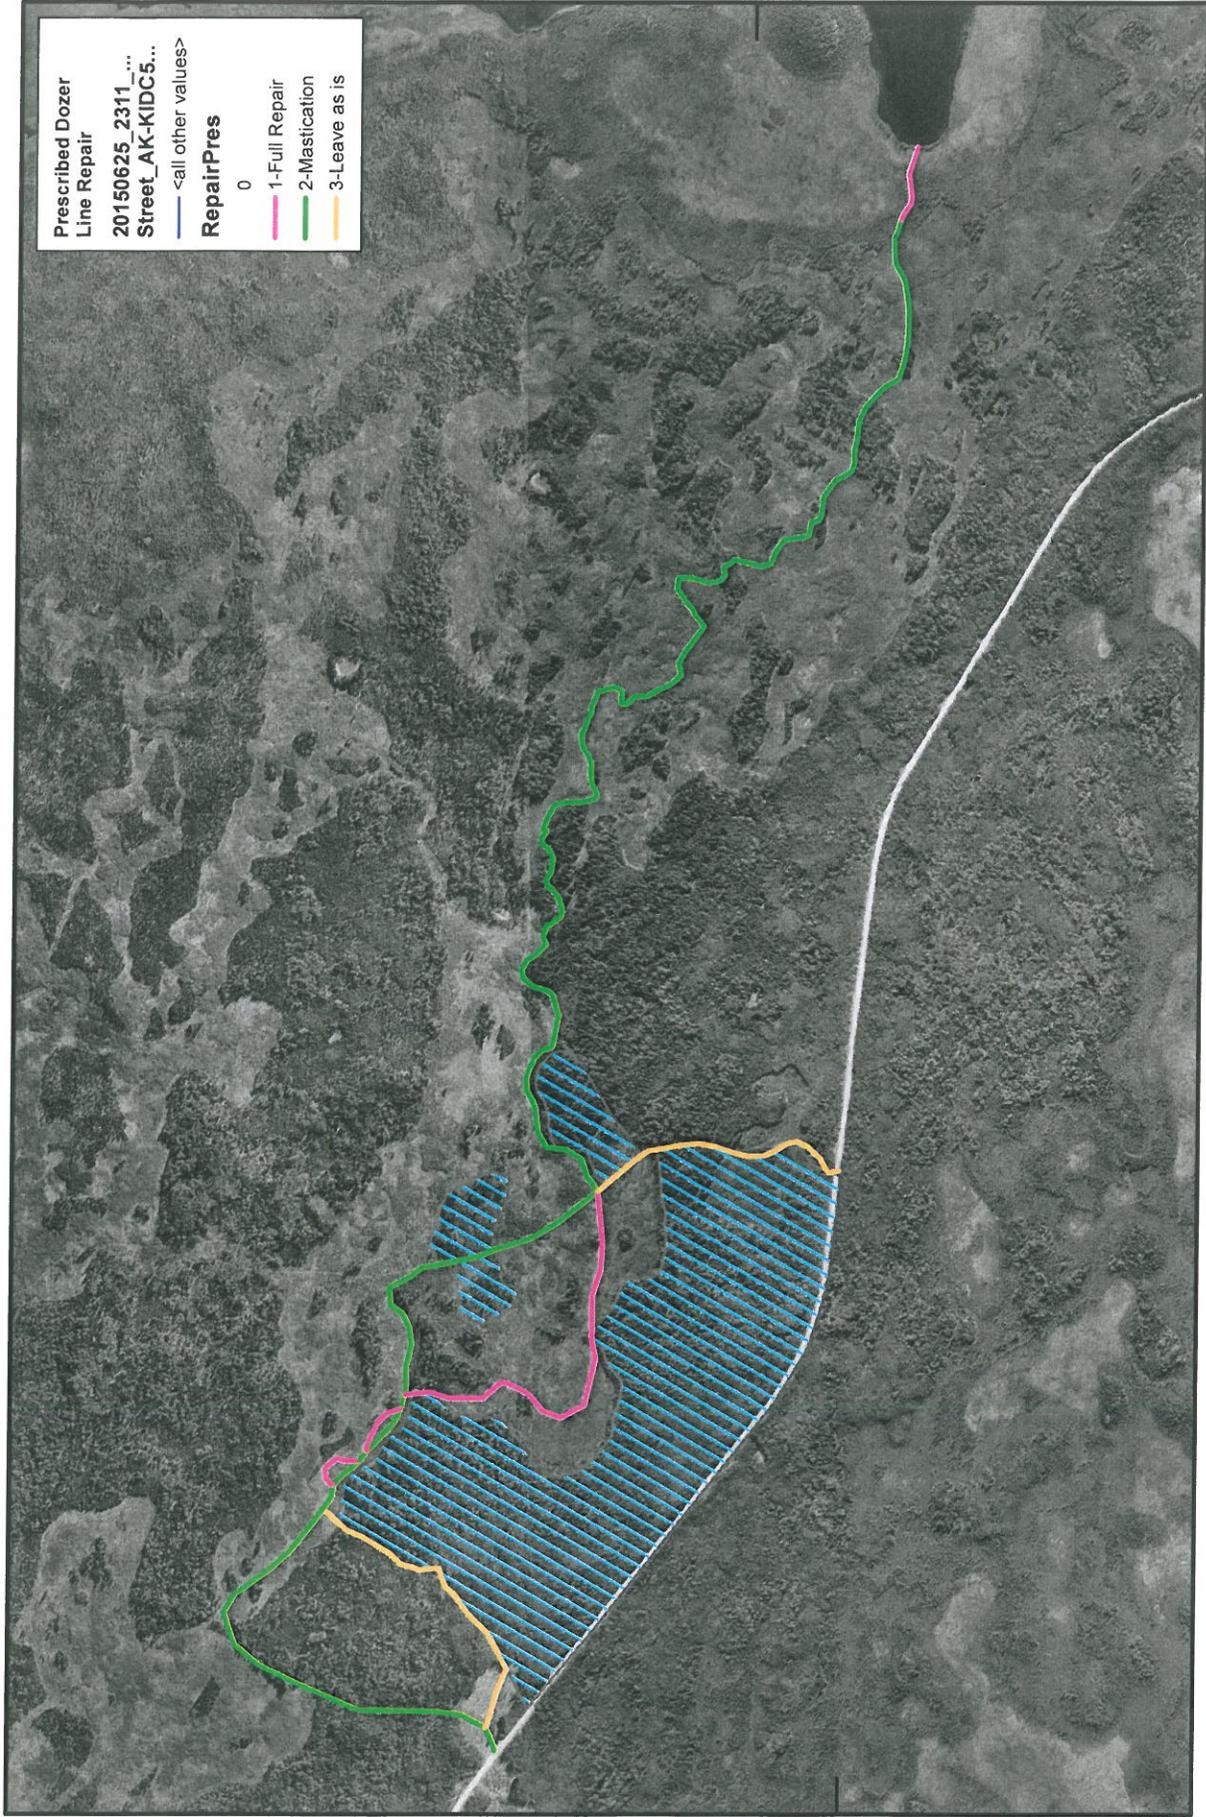
Map of Card Street Fire Suppression Plan of Marsh Lake Dozer Complex

- A minimum of 3.3 miles of dozer line were constructed from Skilak Loop Rd. to Marsh Lake.
- There are several places where there is a main contingency line and the direct attack line as the fire reached the north side of the pre-existing clearing.

- The habitat is a mix of more mature hardwood and spruce and a larger portion of younger mixed hardwood, alder, and spruce resulting from crushing and burning in the 1970's.

- The width of the disturbed zone from the dozer line generally ranges from 5 to 7m wide as it was only cleared one dozer width wide. There are keyholes every few hundred meters where over burden was pushed up a little wider to clear the dozer blade and give an access break for ground crews.

- The terrain is relatively flat until the dozer line heads north away from the pre-existing clearing. From this point on the line is a series of twisting moguls, sharp corners, and moderate sloped hills with elevation gains and falls of 5 to 15m.

- There are three treatment types that should be implemented in this complex of dozer lines.

1. Drag the sphagnum moss and trees back over the line to try and achieve at least 65 percent soil coverage to help control erosion and invasive plant colonization. Use a low impact wide track excavator with a thumb to roll back and place intact chunks of sphagnum across the line. If necessary in wet/boggy areas a small hand crew should assist with attaining coverage and making sure the sphagnum mats landed vegetation side up. This will significantly improve the results of live vegetation taking hold and controlling erosion. Construct water bars on slopes as described on page 5 of this plan.

2. Cut out large timber (10 inch diameter) and pull remaining overburden into the center of the dozer line using a low impact wide track excavator with a thumb. Then bring in a low impact wide track masticator and grind everything to a mix of soil and wood bits. Level the resulting mix across the dozer line. Place water bars at specified distances as described on page 3 of this plan. There are several places where a side hill exists along the dozer line. These areas should be slightly leveled prior to pulling overburden back into the line to assist with reduction of soil movement within and from the line and lessen the need for water bars in these areas.

3. No treatment. Leave dozer lines as they are to re-vegetate naturally .

- Map 2 delineates which section should receive each treatment type.
- There is a considerable amount of slash that has been placed in the ditches on both sides of Skilak Loop Rd. and Lower Skilak Landing Rd. This slash should be moved to Engineer Lake Gravel Pit and run through a chipper with the resulting chips left at the gravel pit for future restoration needs.

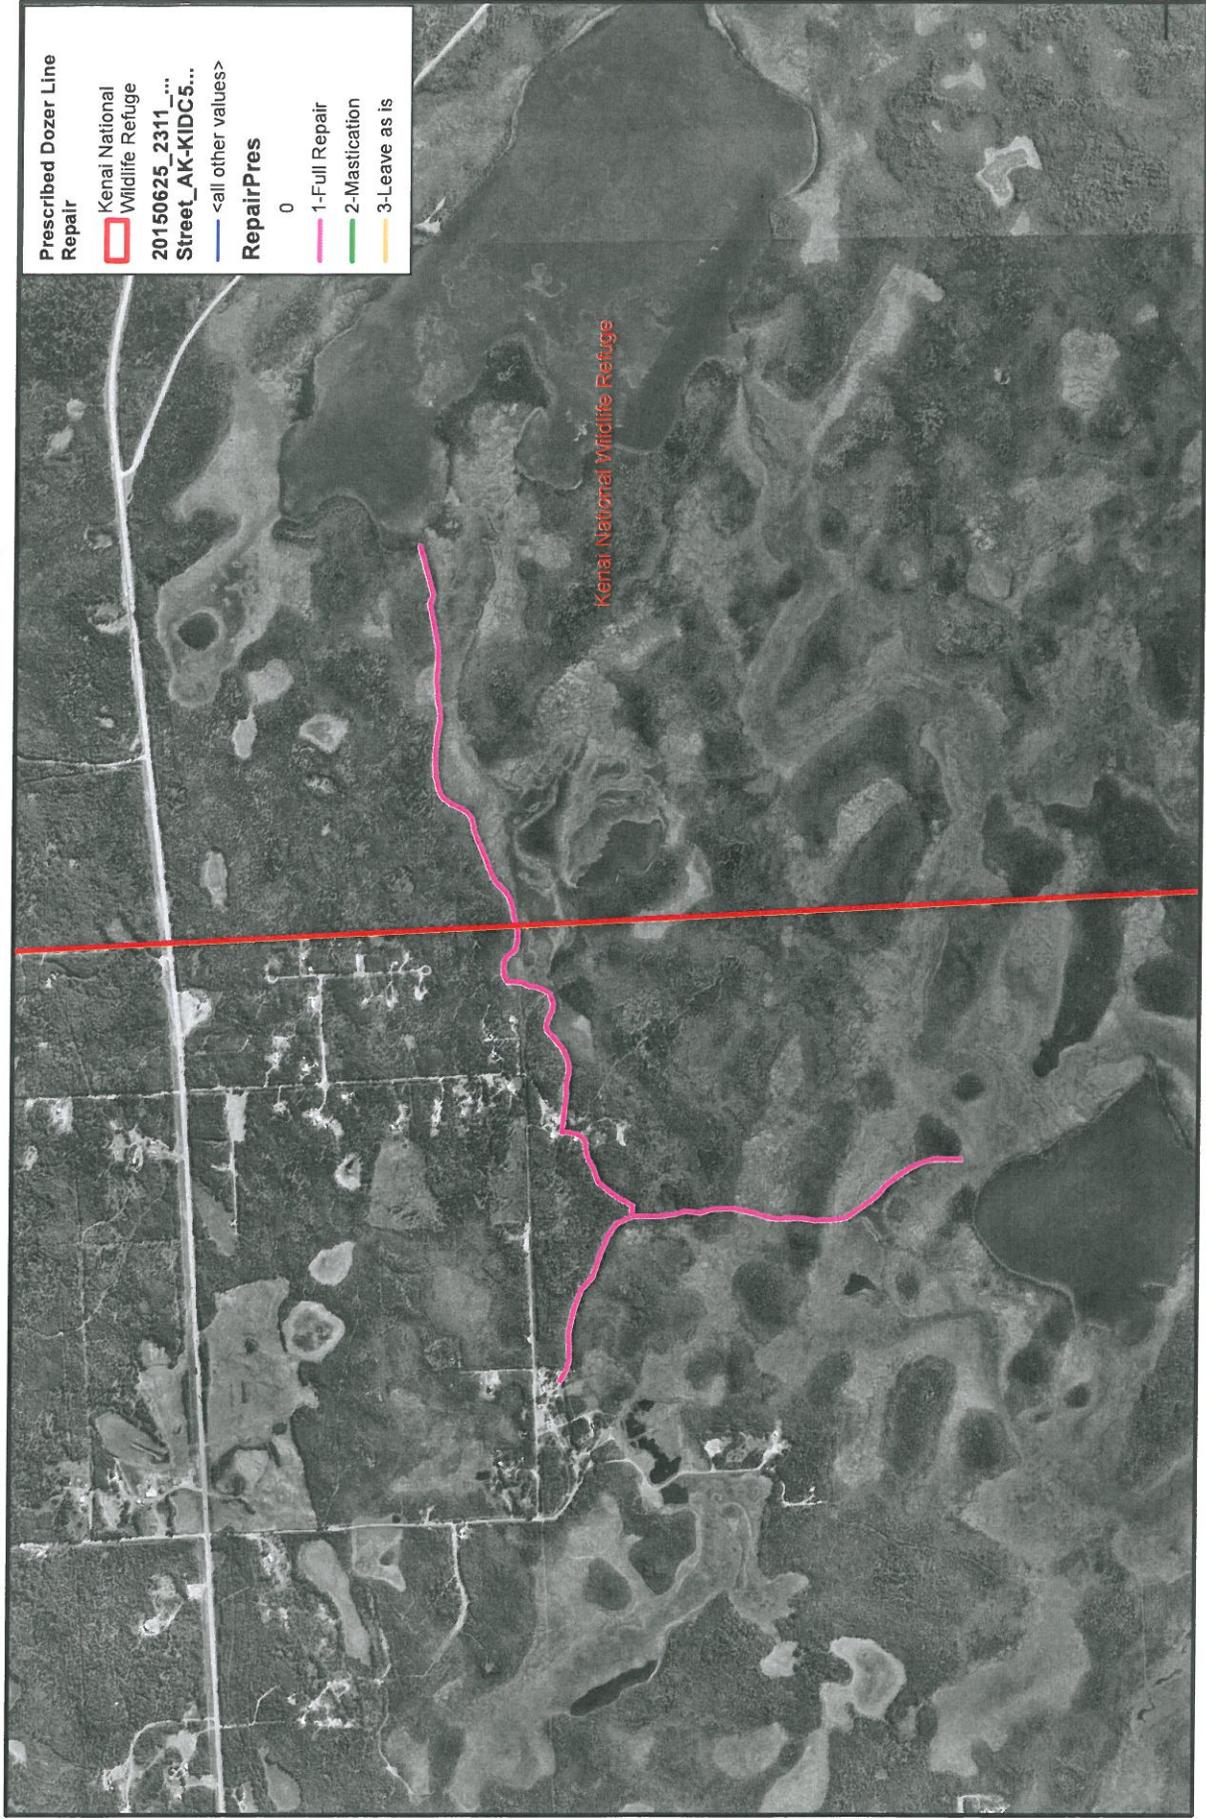
Map of Card Street Fire Suppression Repair Plan of Card Street to Bottenintuin Lake Dozer Line

- A dozer line was constructed from the corner of Lepus Ave to an un-named lake .75 miles south of the origin. A second dozer line was constructed from the first dozer line east to the southerly most residence on adjacent Zenith Street and then continuing east to the northwest corner of Bottenintnin Lake. The eastern .7 miles of this line fall on the Kenai National Wildlife Refuge (Map 1).

- The soils were dominated (75%) by peat and to a lesser degree (25%) silty loam intermixed with gravel and stream rocks.
- The organic layer was pushed to the north side of the line which was mostly the top layer of peat with an occasional black spruce and various shrubs. In many cases the organic layer is rolled and intact and may be used as effective cover for repair use.

- There is virtually 0 slope along the portion of the dozer line to Bottenintnin Lake on the Kenai National Wildlife Refuge so the use of water bars in this region would be ineffective and is not advised.

- Recommend use of a low impact wide track mini-excavator with a thumb if available.
- Pull overburden material from berm on North side of line and spread over exposed soils.
- When possible, spread intact chunks of sphagnum moss across the line to achieve 65% coverage of exposed soil. A small hand crew may be beneficial to assist with placing moss mats vegetation side up.
- The area is flat and no water bars should be needed in this area to control soil erosion.
