**COMBINED
PRELIMINARY ASSESSMENT/SITE INSPECTION
REPORT**

**MIDWAY ATOLL NATIONAL WILDLIFE
REFUGE, SAND ISLAND PROJECT**

**COMBINED PRELIMINARY ASSESSMENT/SITE INSPECTION REPORT
FOR THE
MIDWAY ATOLL NATIONAL WILDLIFE REFUGE
SAND ISLAND.**

**PREPARED BY:
DANIEL T. FORNEY
ENVIRONMENTAL CONSULTANT**

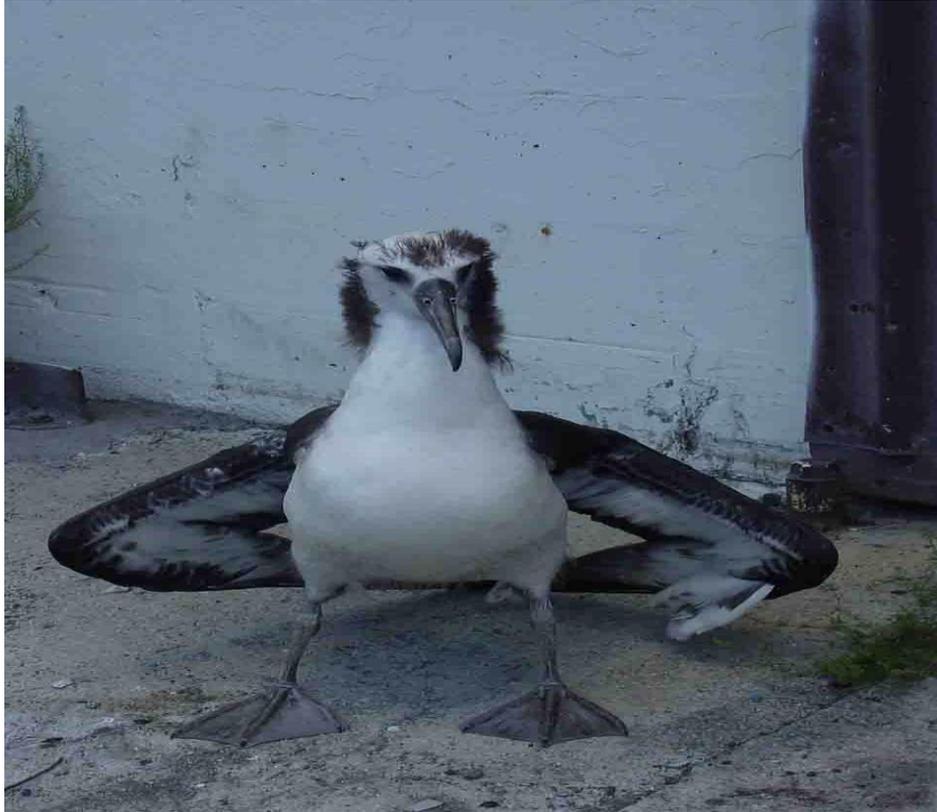
The above mentioned reports have documented that lead levels in some Laysan albatross chicks on Midway are so high that it damages their peripheral nervous systems, leading to a symptom known as “droopwing.” In the syndrome the chicks are unable to hold their wings tucked up against their bodies, and their wings often drag on the ground (Figure 1). It is a classic symptom of lead poisoning, comparable to the “wrist drop” symptom in humans. Chicks experiencing lead toxicity severe enough to cause droopwing may survive as long as their parents are feeding them, but once they reach the fledgling stage and their parents leave, they will starve because they can’t fly to obtain food. According to refuge staff, Laysan albatross chicks with droopwing are common around the buildings on the island.

Figure 1. Droopwing Chick

Thousands of Laysan albatross chicks nesting within five meters of buildings and structures exhibit a condition of peripheral neuropathy referred to as "droopwing," (Figure 1). Droopwing manifests in chicks' inability to raise their wings, which commonly drag on the ground resulting in broken bones and open sores. Chicks with droopwing will never be able to fly, hence they will die. The total number of chicks suffering significant detrimental effect from lead exposure could be thousands more with average blood lead levels of 85 ug/dL, enough to cause immunological, neurological and renal impairment, thus decreasing their chances of survival. Lead paint that is peeling from the buildings and the lead contaminated soil is affecting approximately 6,674 Laysan albatross chicks each year. This number indicates approximately 1.5% of Midway's chicks are affected annually (Klivitter 2004).

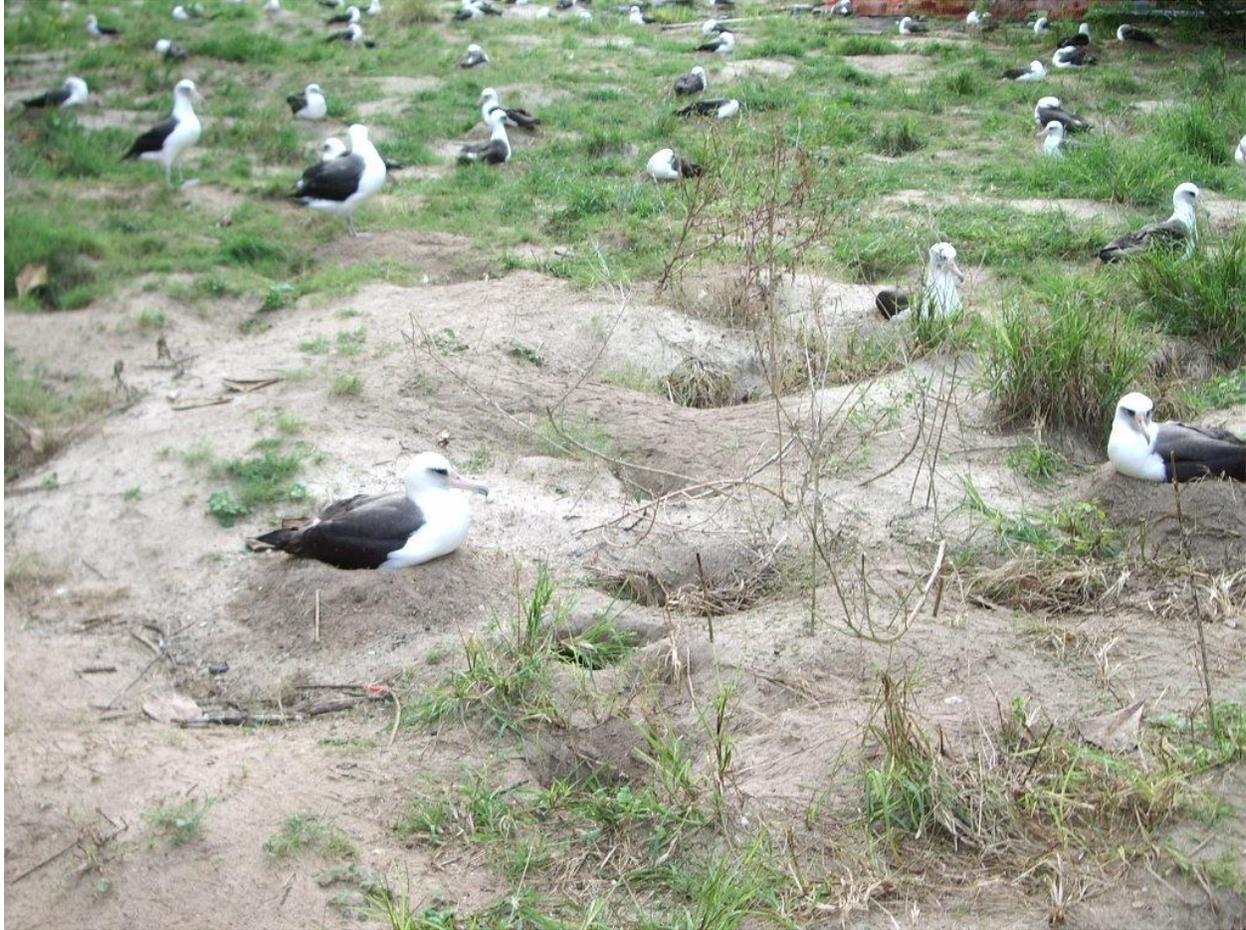
Bonin petrels burrow below ground and there was evidence of soil cycling from below ground to above ground and vice versa. Blood lead levels of some bonin petrel chicks were elevated around buildings with increased lead soil levels but not at reference sites. Additional study is required to determine (a) depth of burrows, (b) effects level for lead in bonin petrel chicks, (c) exposure of adult bonin petrels, and (d) extent of movement of lead through the soil column due to petrel burrowing activity.

Figure 2. Laysan albatross nests and Bonin petrel burrows

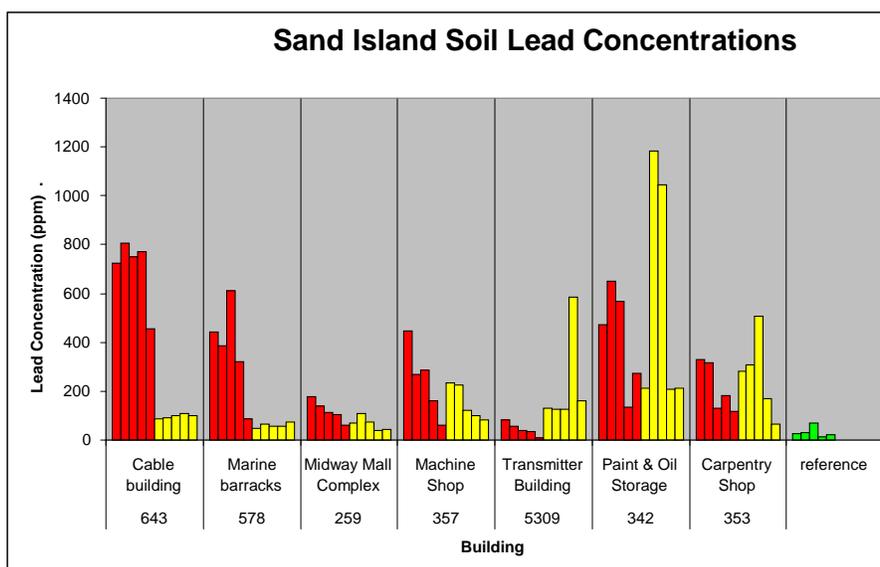
Table 5. Mean soil lead concentrations (ppm) by building, depth (surface to 30 cm) and zone, Sand Island, Midway Atoll National Wildlife Refuge, 2008. Red bars represent inner (0-5m from building) zone; yellow bars represent outer (5-15m from building) zone; green bars represent reference sites.

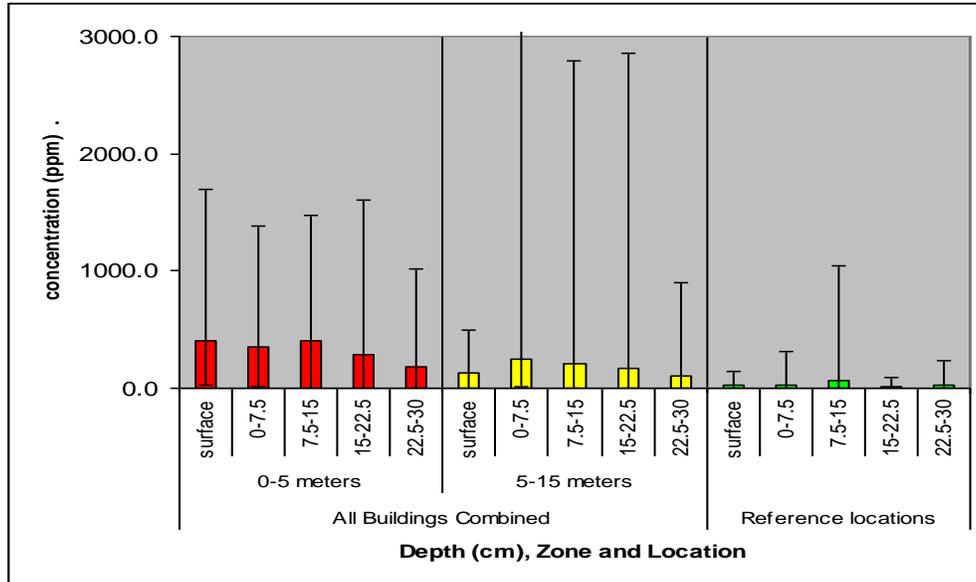
Table 6. Mean soil lead concentrations (ppm) by depth and zone and locations combined, Sand Island, Midway Atoll National Wildlife Refuge, 2008. Red bars represent inner (0-5m from building) zone; yellow bars represent outer (5-15m from building) zone; green bars represent reference sites.

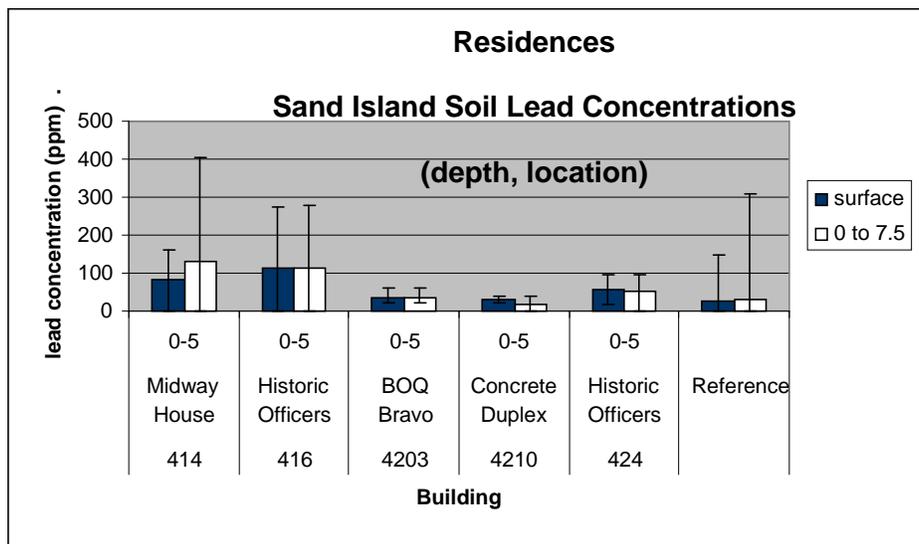
Table 8. Mean soil lead concentrations (ppm) at each residential location, Sand Island, Midway Atoll National Wildlife Refuge, 2008. All soil depths are combined. Bars show minimum and maximum concentrations.

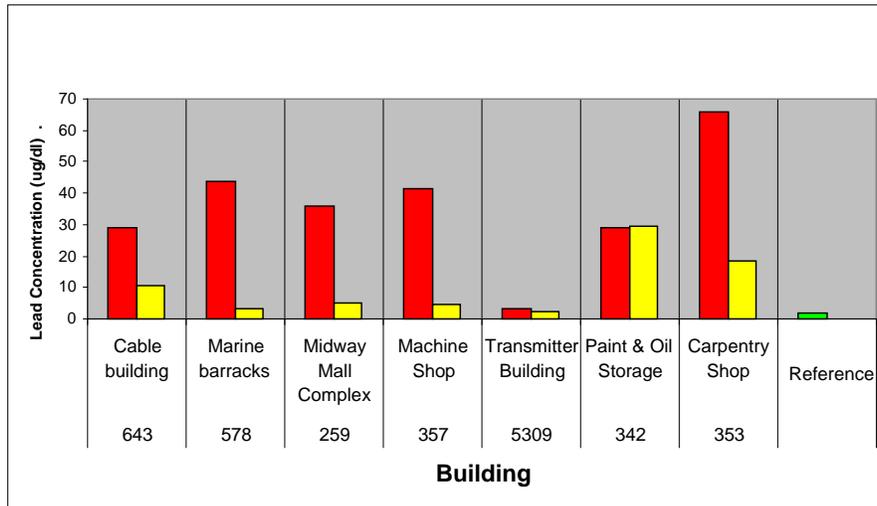
Table 10. Mean Laysan albatross chick blood lead concentrations (ug/dl) by location, Sand Island, Midway Atoll National Wildlife Refuge, 2008. Red bars represent inner (0-5m from building) zone; yellow bars represent outer (5-15m from building) zone; green bars represent reference sites.

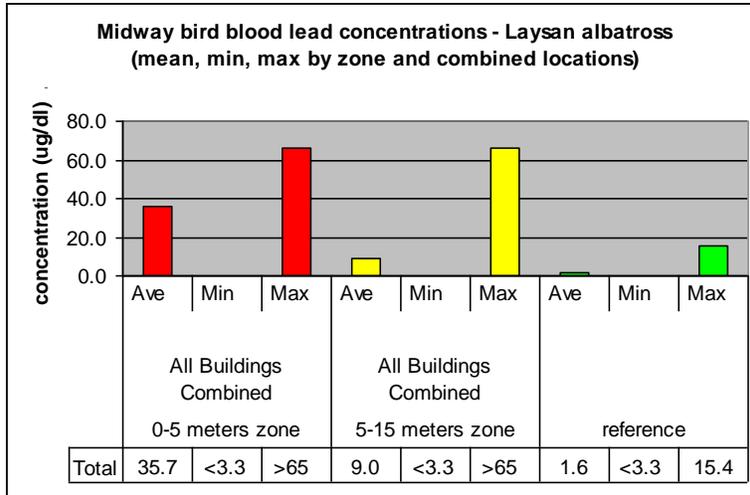
Table 11. Summarized Laysan albatross chick blood concentrations (ug/dl) by zone and reference site, Sand Island, Midway Atoll National Wildlife Refuge, 2008. Red bars represent inner (0-5m from building) zone; yellow bars represent outer (5-15m from building) zone; green bars represent reference sites.

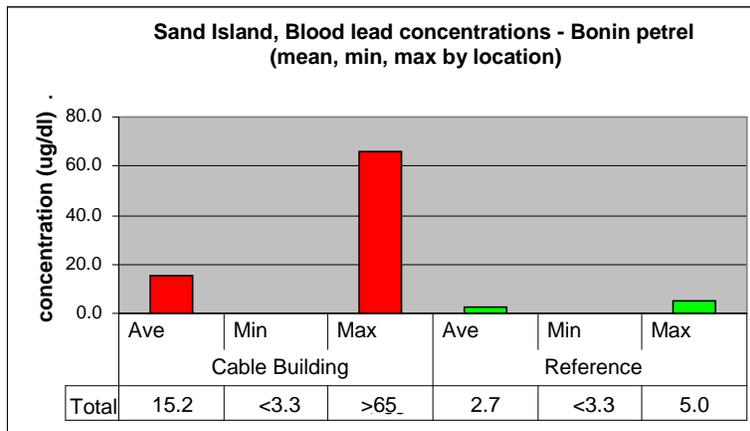
Table 12. Summarized bonin petrel blood concentrations (ug/dl) by zone and reference site, Sand Island, Midway Atoll National Wildlife Refuge, 2008. Red bars represent inner (0-5m from building) zone; yellow bars represent outer (5-15m from building) zone; green bars represent reference sites.
