**COMBINED
PRELIMINARY ASSESSMENT/SITE INSPECTION
REPORT**

**MIDWAY ATOLL NATIONAL WILDLIFE
REFUGE, SAND ISLAND PROJECT**

June 2010

**PREPARED BY:
DANIEL T. FORNEY
ENVIRONMENTAL CONSULTANT**

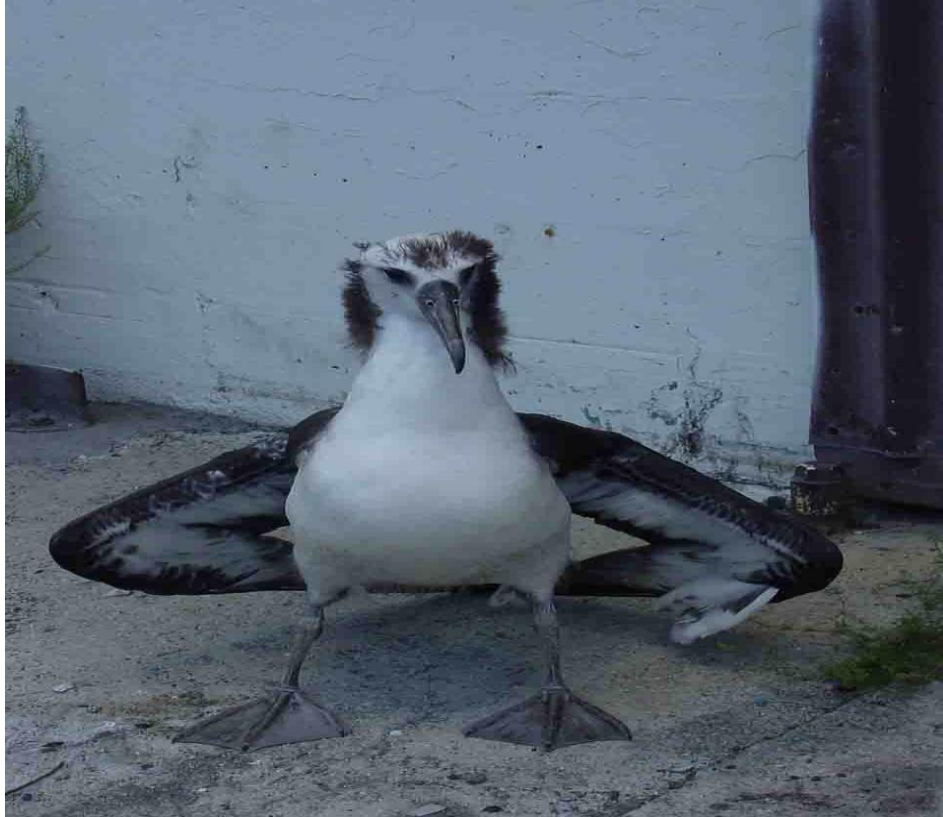
Figure 1. Droopwing Chick

The above mentioned reports have documented that lead levels in some Laysan albatross chicks on Midway are so high that it damages their peripheral nervous systems, leading to a symptom known as “droopwing.” In the syndrome the chicks are unable to hold their wings tucked up against their bodies, and their wings often drag on the ground (Figure 1). It is a classic symptom of lead poisoning, comparable to the “wrist drop” symptom in humans. Chicks experiencing lead toxicity severe enough to cause droopwing may survive as long as their parents are feeding them, but once they reach the fledgling stage and their parents leave, they will starve because they can’t fly to obtain food. According to refuge staff, Laysan albatross chicks with droopwing are common around the buildings on the island.

Thousands of Laysan albatross chicks nesting within five meters of buildings and structures exhibit a condition of peripheral neuropathy referred to as "droopwing," (Figure 1). Droopwing manifests in chicks' inability to raise their wings, which commonly drag on the ground resulting in broken bones and open sores. Chicks with droopwing will never be able to fly, hence they will die. The total number of chicks suffering significant detrimental effect from lead exposure could be thousands more with average blood lead levels of 85 ug/dL, enough to cause immunological, neurological and renal impairment, thus decreasing their chances of survival. Lead paint that is peeling from the buildings and the lead contaminated soil is affecting approximately 6,674 Laysan albatross chicks each year. This number indicates approximately 1.5% of Midway's chicks are affected annually (Klivitter 2004).

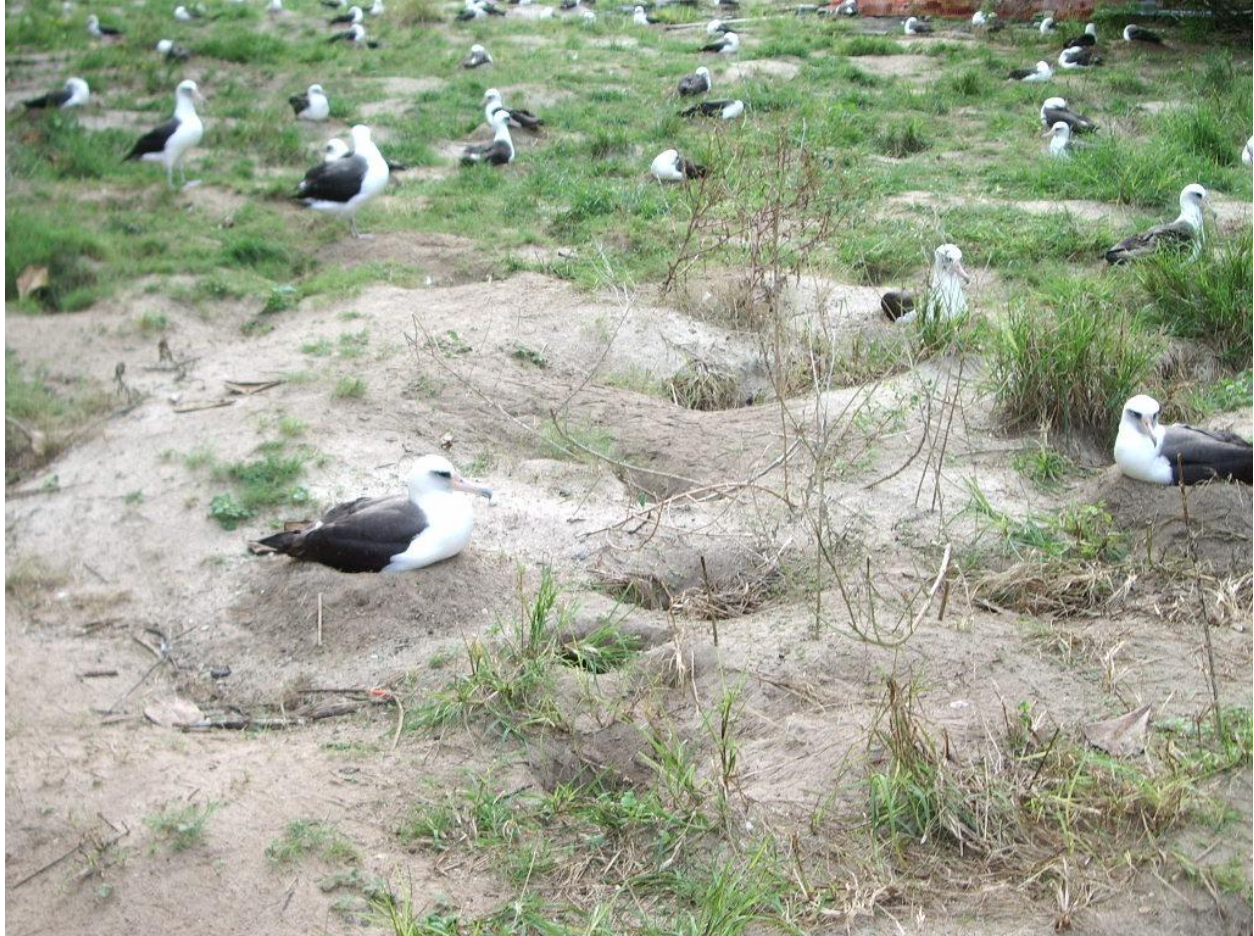
Figure 2. Laysan albatross nests and Bonin petrel burrows

Bonin petrels burrow below ground and there was evidence of soil cycling from below ground to above ground and vice versa. Blood lead levels of some bonin petrel chicks were elevated around buildings with increased lead soil levels but not at reference sites. Additional study is required to determine (a) depth of burrows, (b) effects level for lead in bonin petrel chicks, (c) exposure of adult bonin petrels, and (d) extent of movement of lead through the soil column due to petrel burrowing activity.
