**2011 ANNUAL REPORT**  
**CERCLA Non-time Critical Removal Action**  
**MIDWAY ATOLL NATIONAL WILDLIFE REFUGE**  
**MIDWAY ISLAND**  
**Contract No. F11PC00327**

29 February 2012

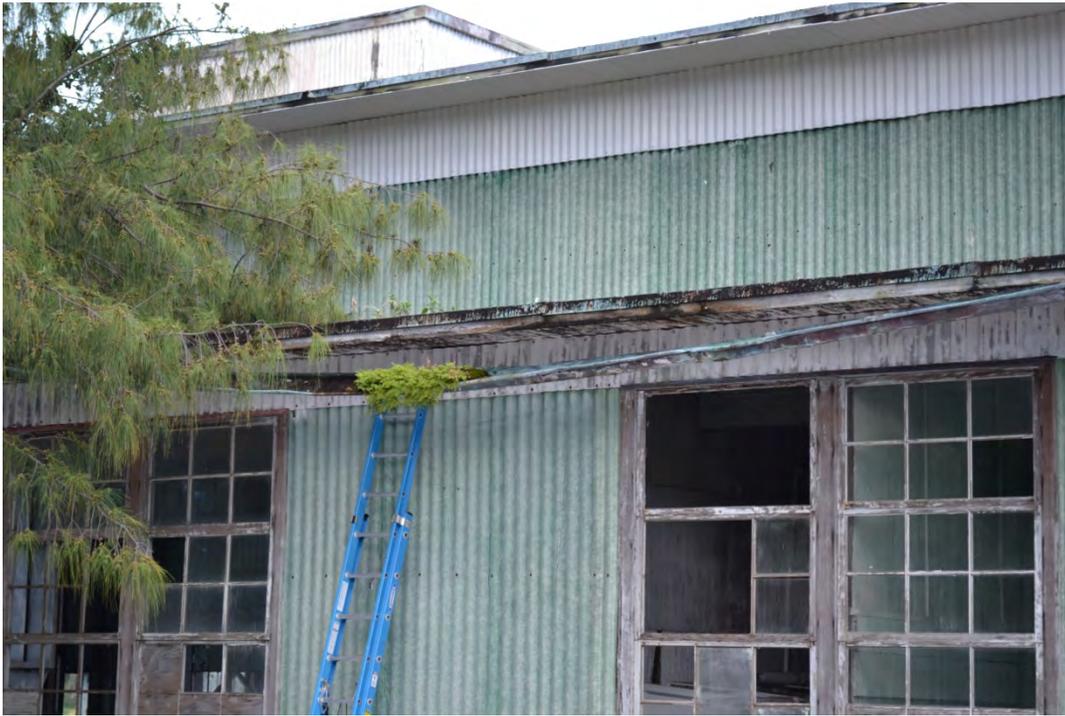
Photo 5: Sagging gutter on west wall (1<sup>st</sup> story) of Bldg 363

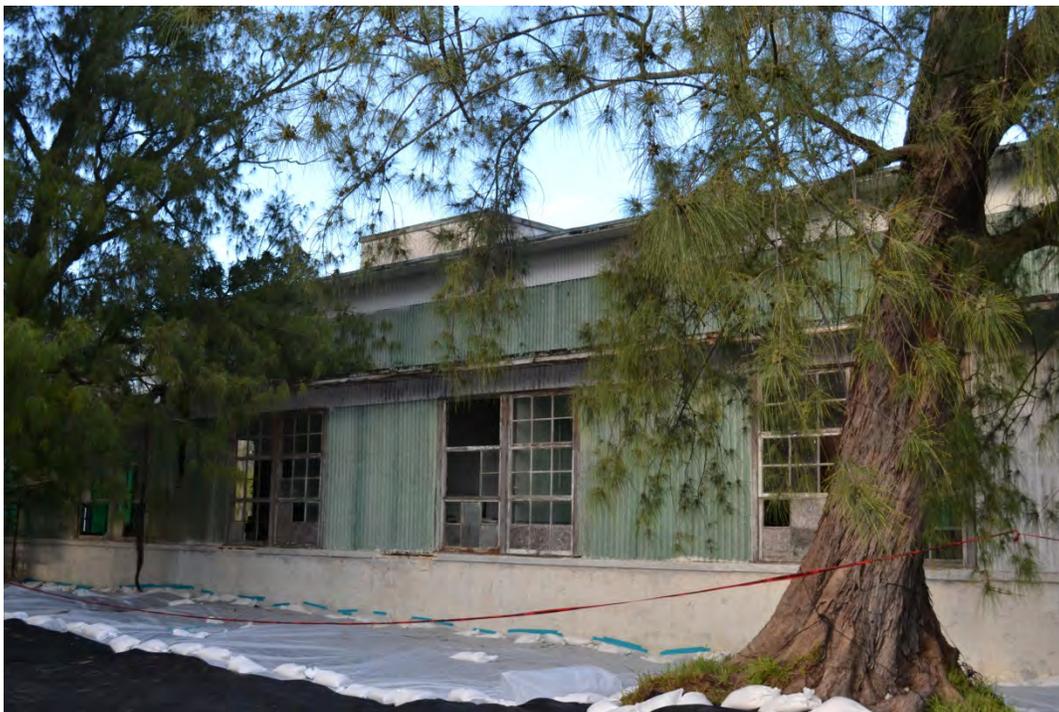
Photo 6: West wall of Bldg 363 after the gutter had been removed.

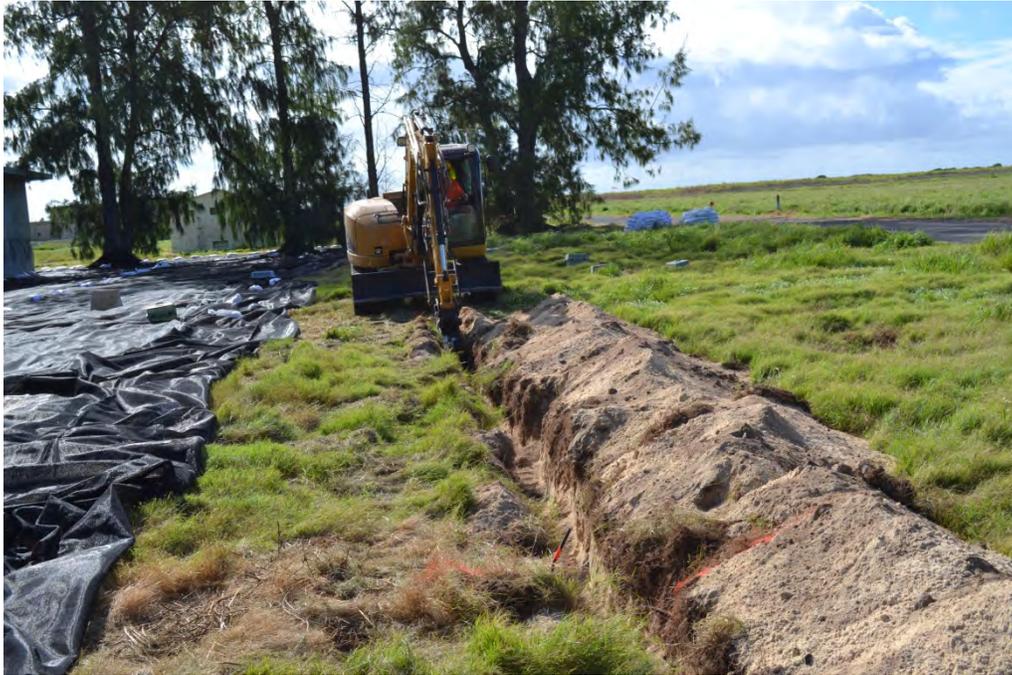
Photo 03: NWDE trenching along west wall of Bldg 393. Note cut phone line in the foreground.

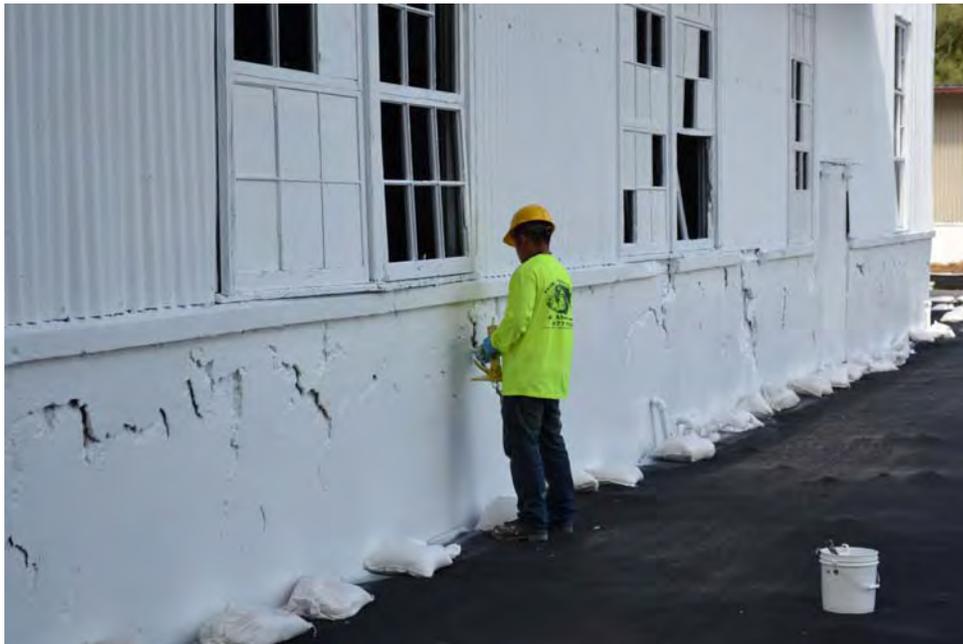
Photo 02 – Iniki is sealing / using caulk on cracks in foundation wall, Bldg 363.

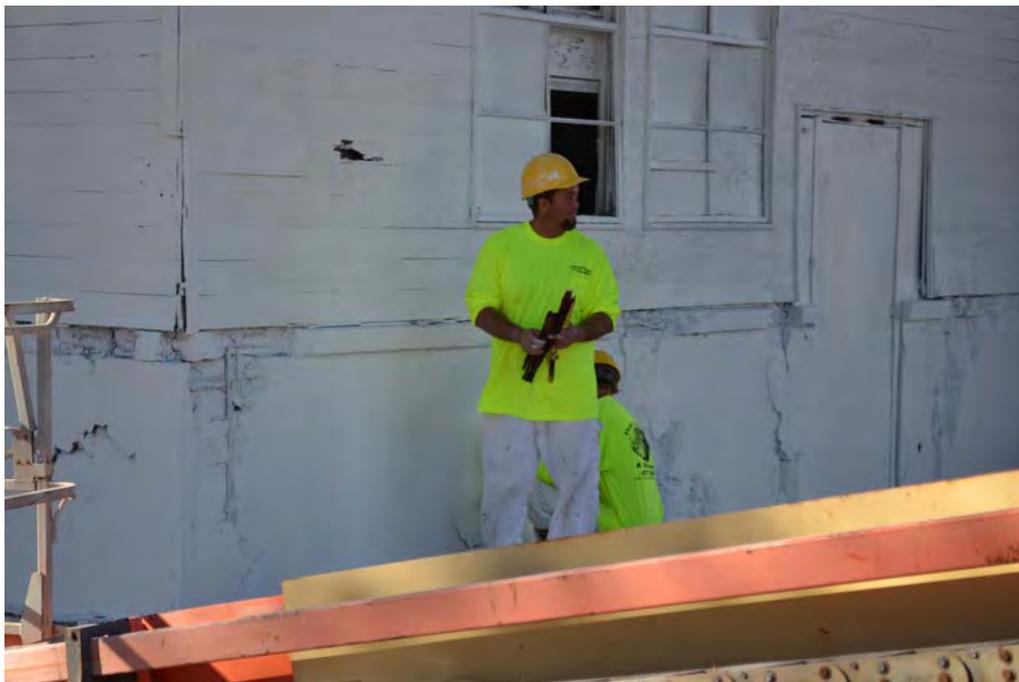
Photo 02 – Iniki is caulking / sealing the foundation wall (north), Bldg 357.

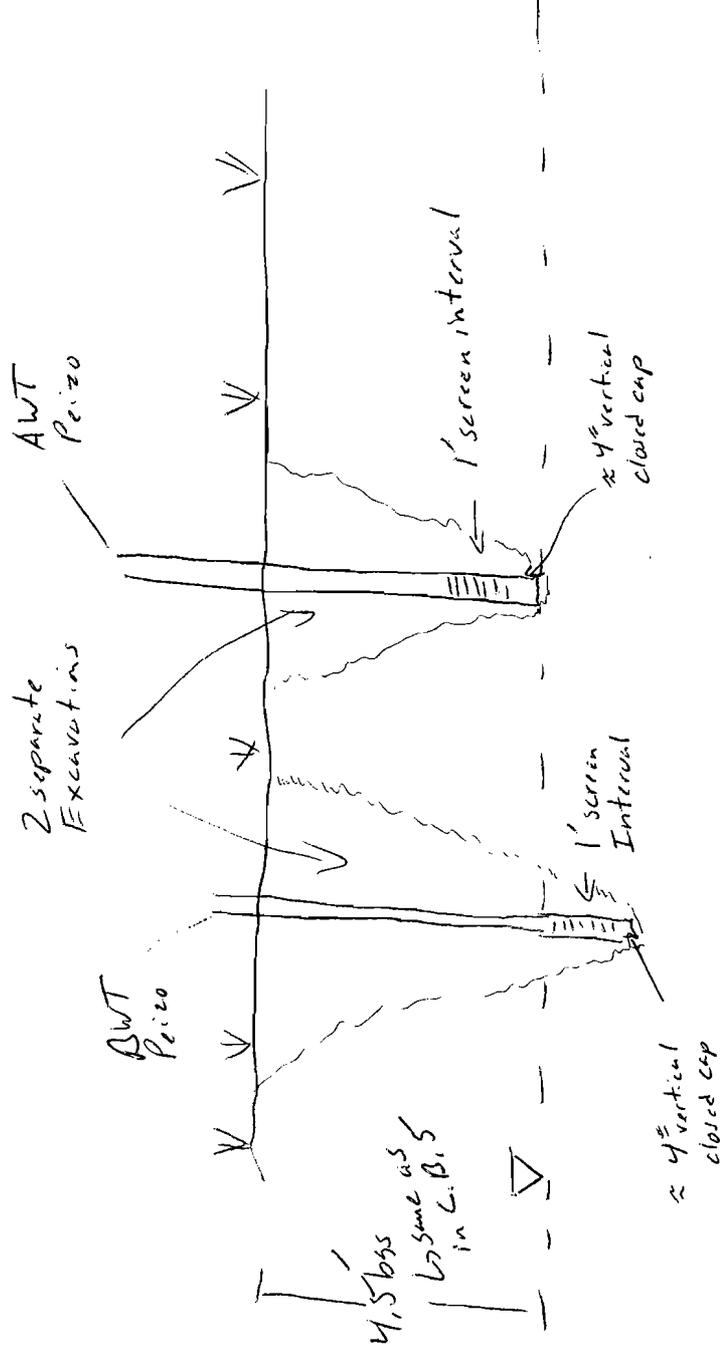
Midway Piezometers installed  
near C.B. #5

- Both are 4"  $\phi$  PVC well casing + screen
- Each was put in a separate hole/excavation by mini-Excavator
- The piezo below the water table is  $\approx 10'$  east of C.B. #5
- The piezo above the water table is  $\approx 6'$  east of that
- Formation is essentially all native sand

- Poured  $\approx 20-25$  gallons of water down both to "develop" or "pre-saturate" then let sit overnight.
