**WDFW Fish Passage and Diversion Inventory Database**  
**Site Description Report**

**Site ID:** 1310034

**Project:** FPGRANT

**WDFW Fish Passage and Diversion Inventory Database  
Level A Culvert Assessment Report**

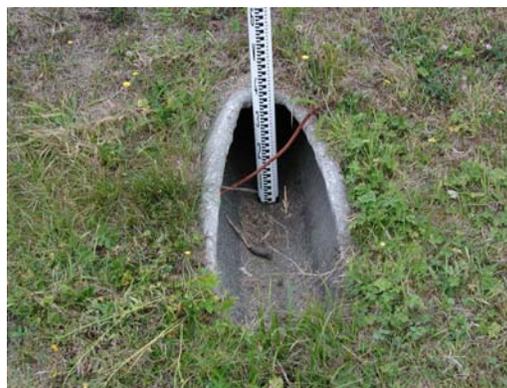
Bevelled US and DS for .75m.

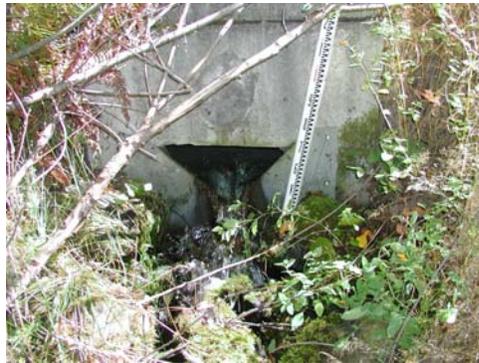
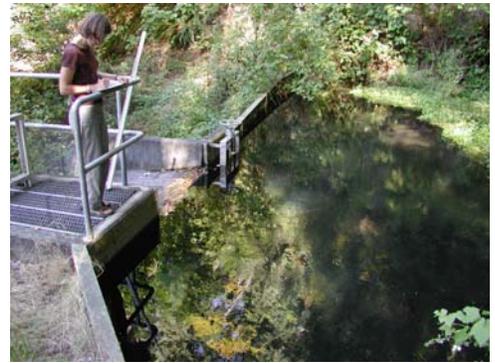
Very steep gradient upstream, 15-20%. 1.53m tall x 1.6m long, pools up on back side- very unlikely any fish in stream. Piped approx 120m DS through .6m diameter pipe that flows out of a concrete box with metal plates that would block most fish access

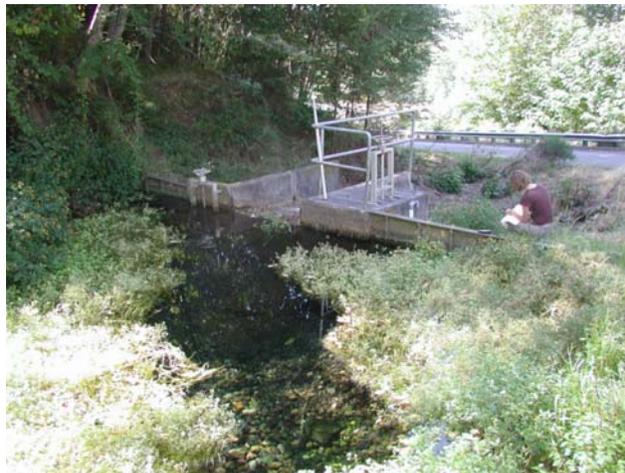
No stream channel US or DS. 1.55m x 1.55m screen size. Dam is 8m long/2m high. Backwatered pool above dam. No flow information, water rights are all tribal for the hatchery.

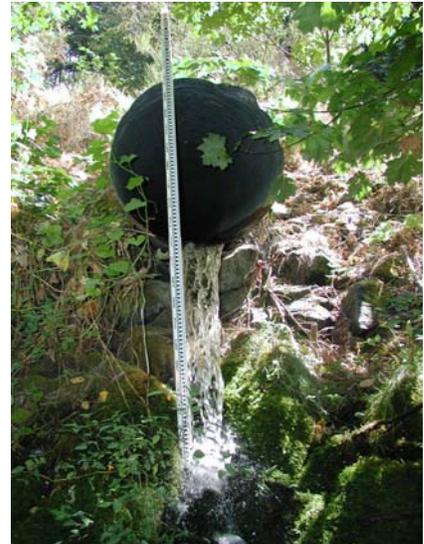
DS end of pipe sticks straight out from hillside approximately 4m.

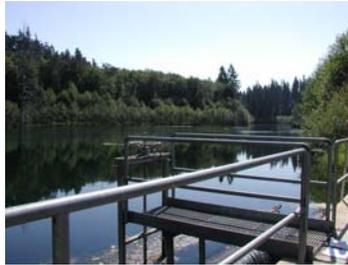
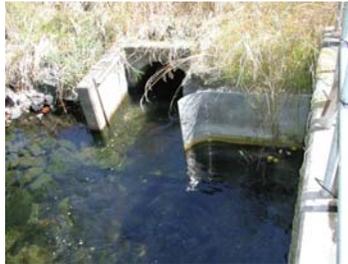
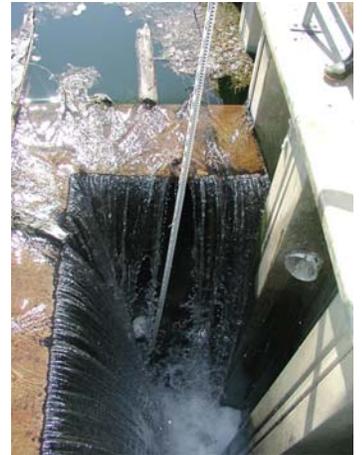
Length (m): 50.00  
 Height (m): 5.20  
 Water Surface Difference (m): 3.50  
 Plunge Pool Depth (m): 0.80

Barrier: Yes Passability (%): 0 Repair Status: UD  
 Problem: Drops off into concrete box, and then flows through a culvert at the base of the dam.  
 Current water levels are topping the dam- it is also held in by the road. Outlet pipe is

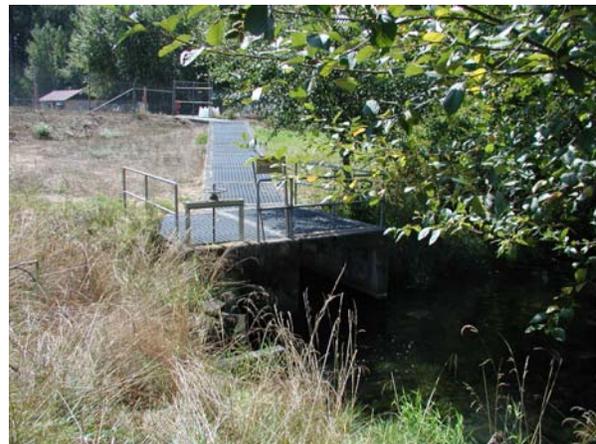
Managed for hatchery fish only! No plunge pool,  
Flows directly into Clear Creek.

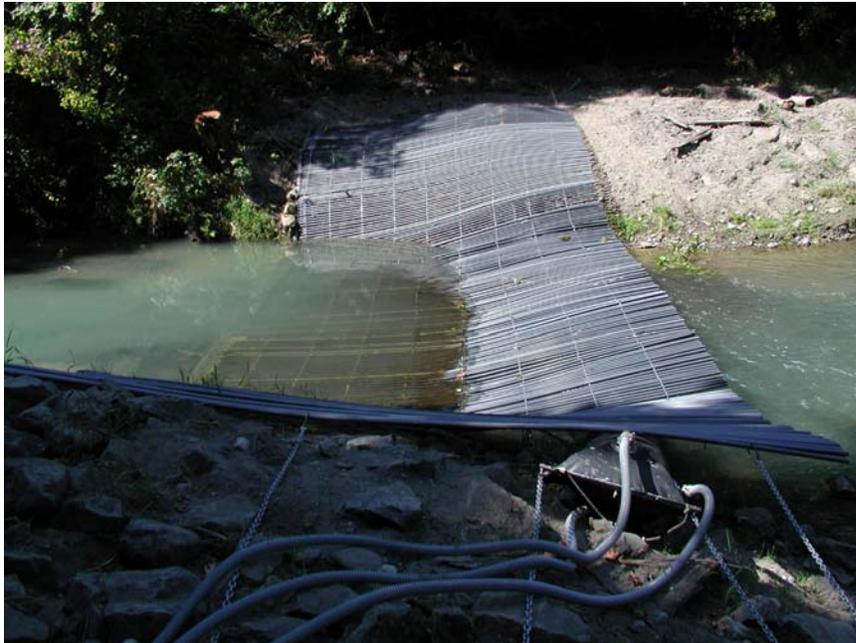
Floating weir made of pvc pipes spaced .04m apart lashed together and chained to the banks, air hoses inflate a bag at the DS side that raises or lowers the end of the weir, always 3.5 feet above water surface. Juv fish can pass through. 60 feet across.

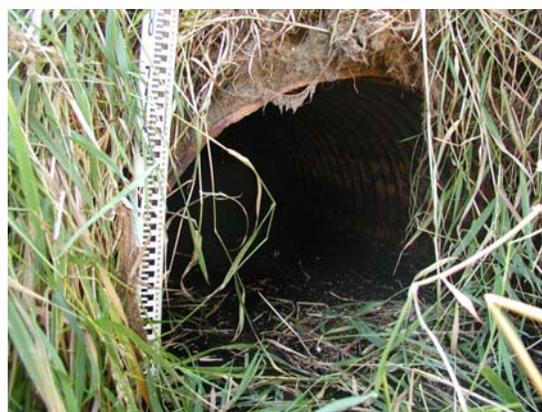
US side of culvert is a little bent and rusted. We cannot get a downstream control, so the culvert passability is unknown- however it looks to be fully passable. Managed to provide migratory bird habitat.

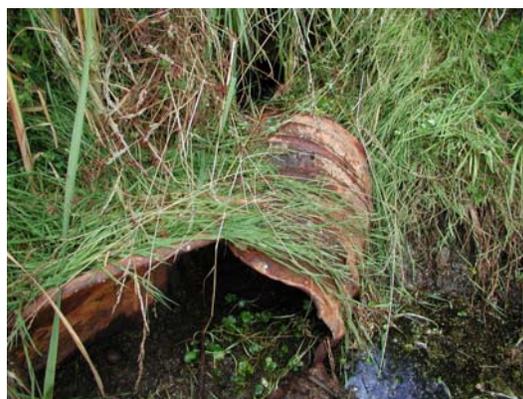
Apron approx .5m long. DS a small piece has broken off, and is laying below the culvert. Managed to provide migratory bird habitat.

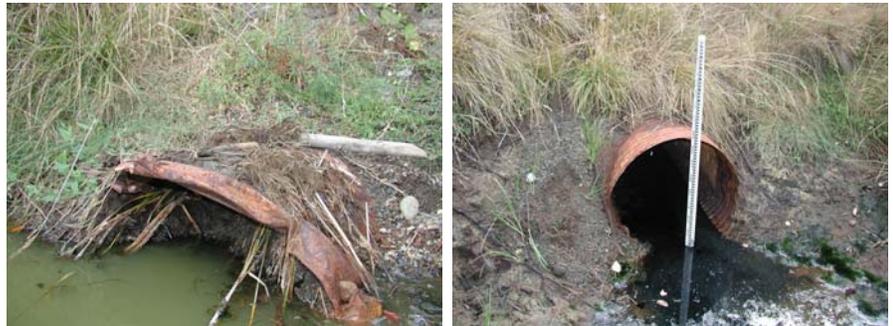
US end crushed and filled with debris, requires maintenance. Some water seeps through. Unknown barrier status since downstream control is inaccessible. Debris is temporary barrier. Culvert could be broken within, can't see through. Managed to provide migratory bird habitat.

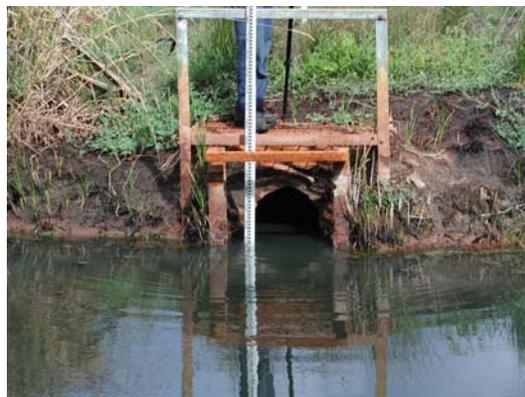
Similar water control structure visible, but no culvert to be found- looks like it is sedimented in. Dike has been breached 5m away so water is fully passable. Wetland US flows to inner slough channel.

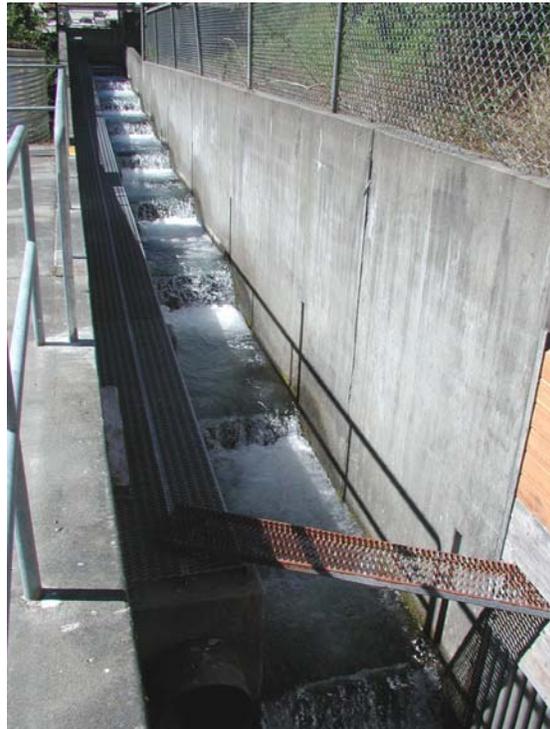
Any adult fish passed from the hatchery fish ladder have to be taken by hand back to the Quilcene R once quotas are met.

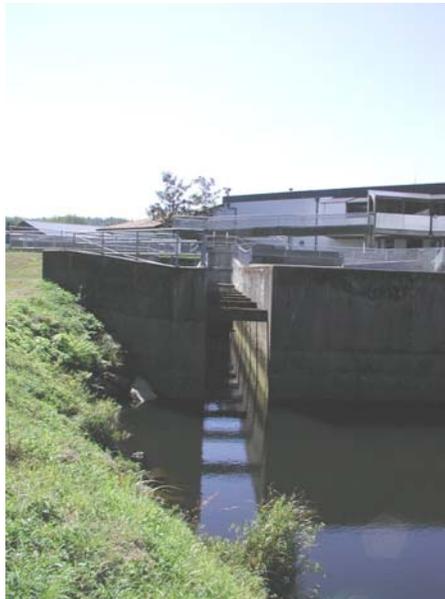
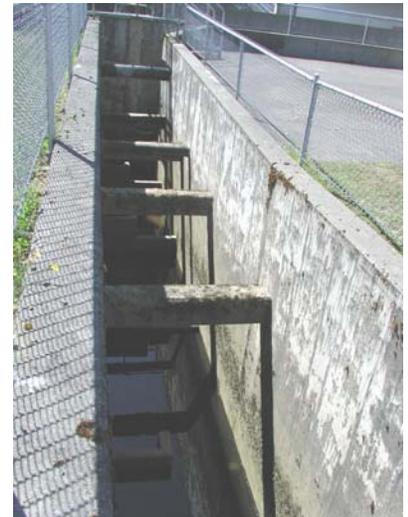
Electric weir next to fish ladder is a physical barrier at low tide, as well as when it is electrified. Otherwise fish can pass freely at higher tides.
