# WDFW Fish Passage and Diversion Inventory Database

## Level A Culvert Assessment Report

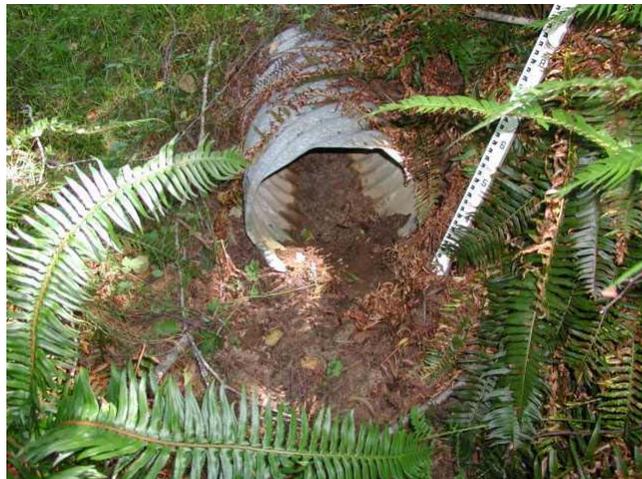
<b>Comments:</b>
no stream channel DS

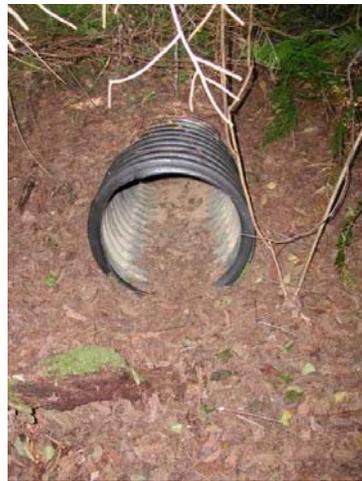
<b>Comments:</b>
no stream channel

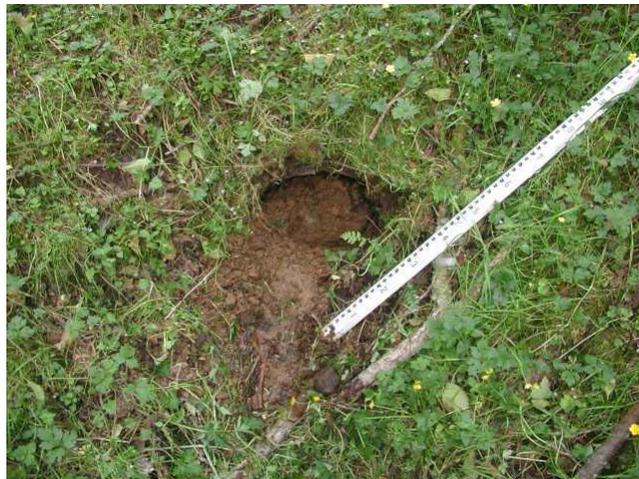
Culvert buried approximately 45% on DS end.

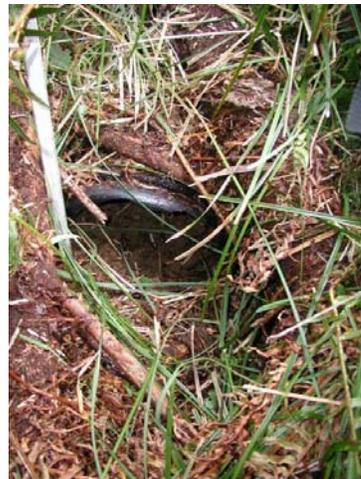
<b>Comments:</b>
40% filled in at DS end with sediment.

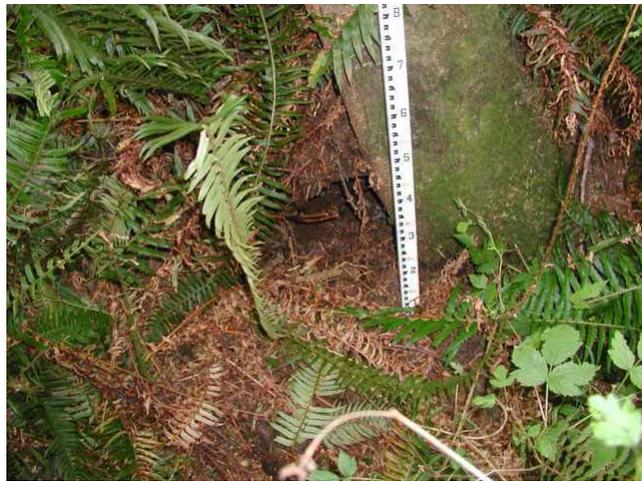
Tree roots covering DS end, which is also rusted out, and US end is crushed. No slope shot (extra information for the refuge.)

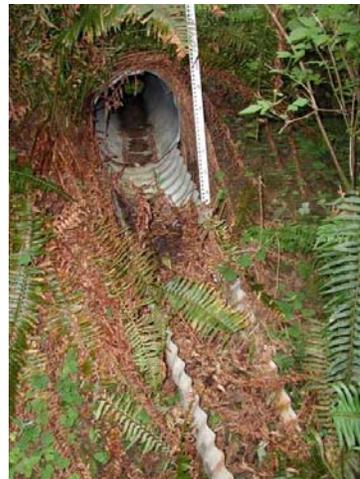
DS bottom of culvert rusted out. Flume on DS end 3m long.

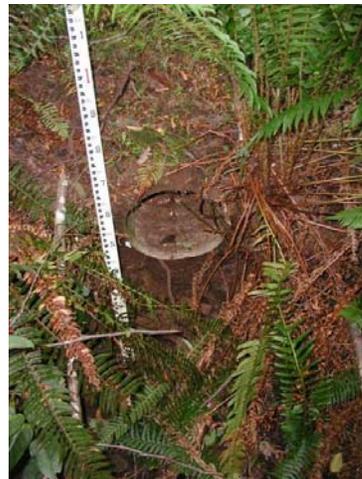
<b>Comments:</b>
US end crushed and covered with log, DS end a bit smashed.

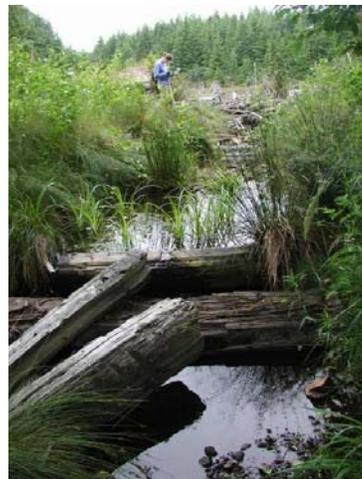
<p>Wetlandish DS, pieces of LWD in channel.</p>
---

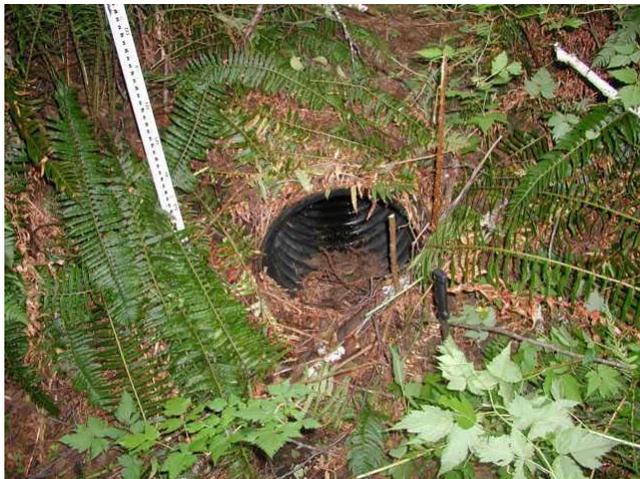
This is probably the replacement culvert for 1310104, since it looks newer, and the other is buried at the US end.

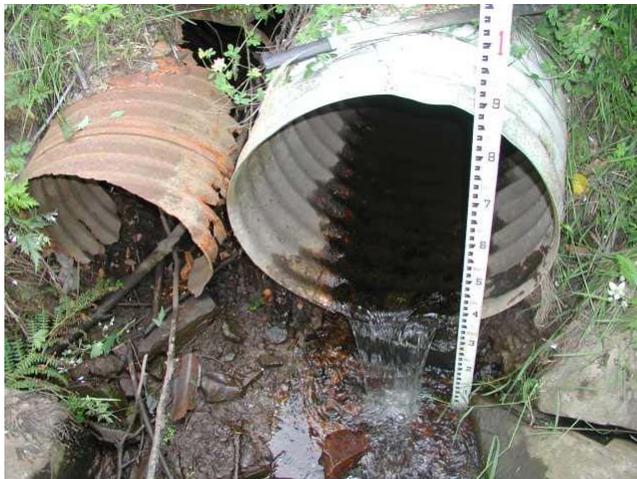
There is an old rusted out culvert buried next to this one- no longer useable. This is the newer replacement culvert.
