# **HIPPY FIRE**

## **ACCOMPLISHMENT REPORT**

**U.S. FISH AND WILDLIFE SERVICE  
CIBOLA NATIONAL WILDLIFE REFUGE  
October 3, 2006**

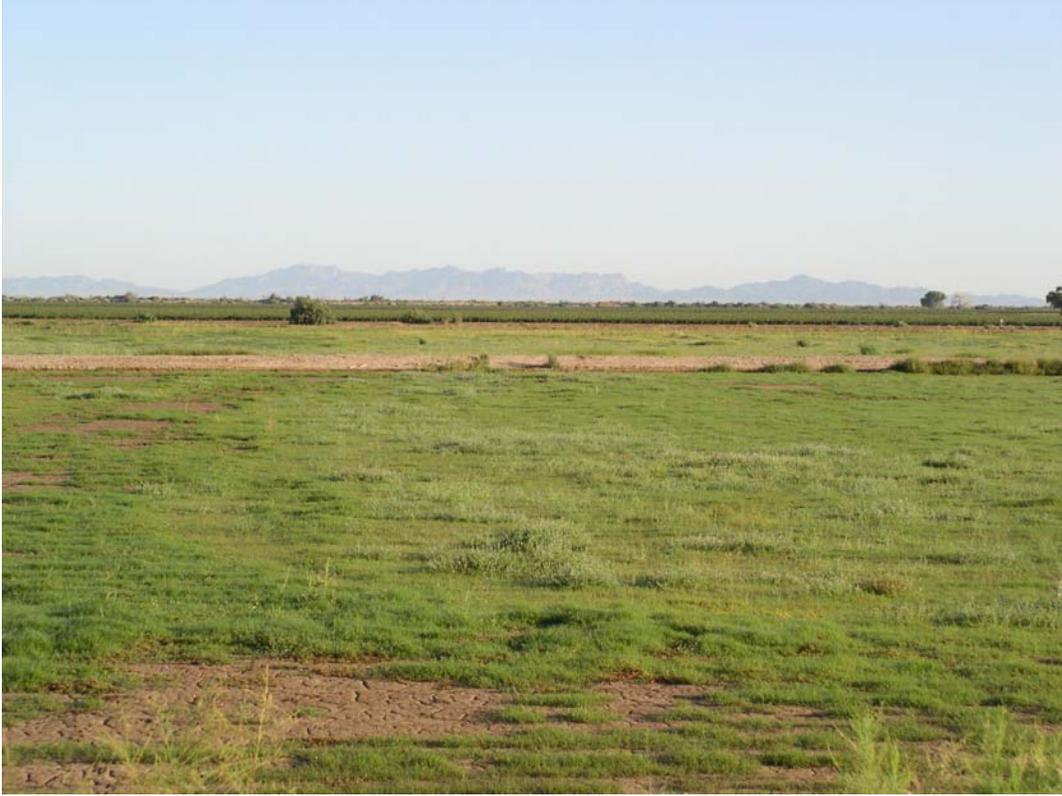
Site Recovery

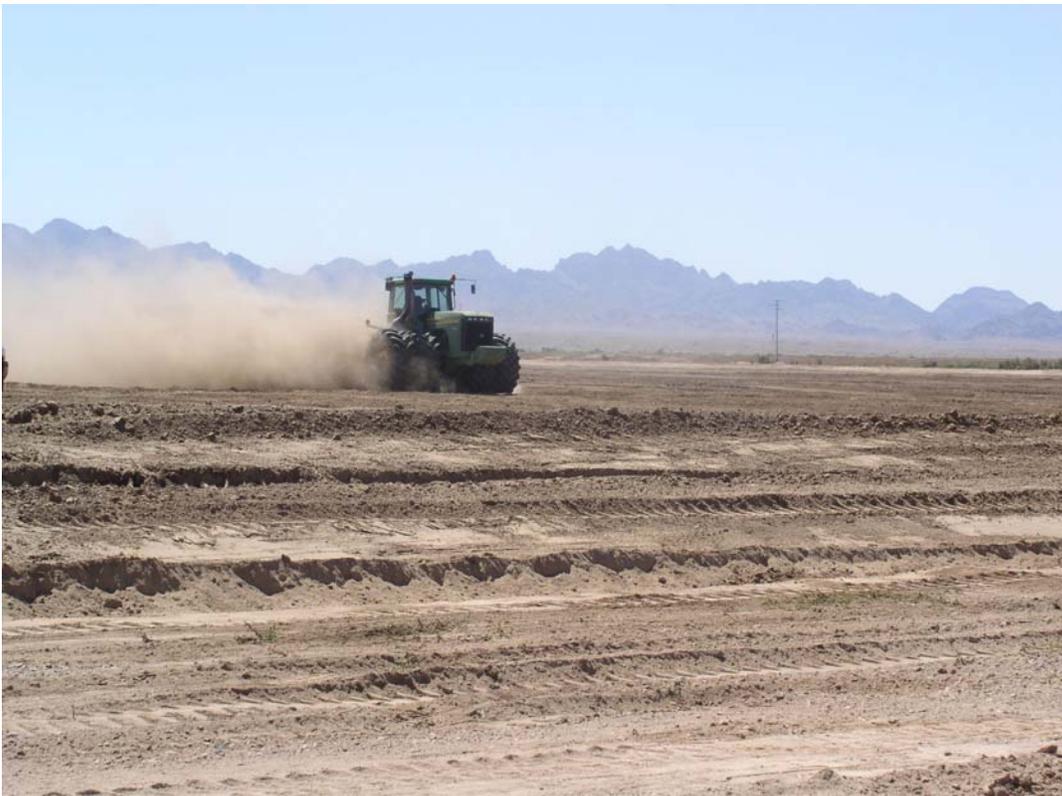
Site preparation

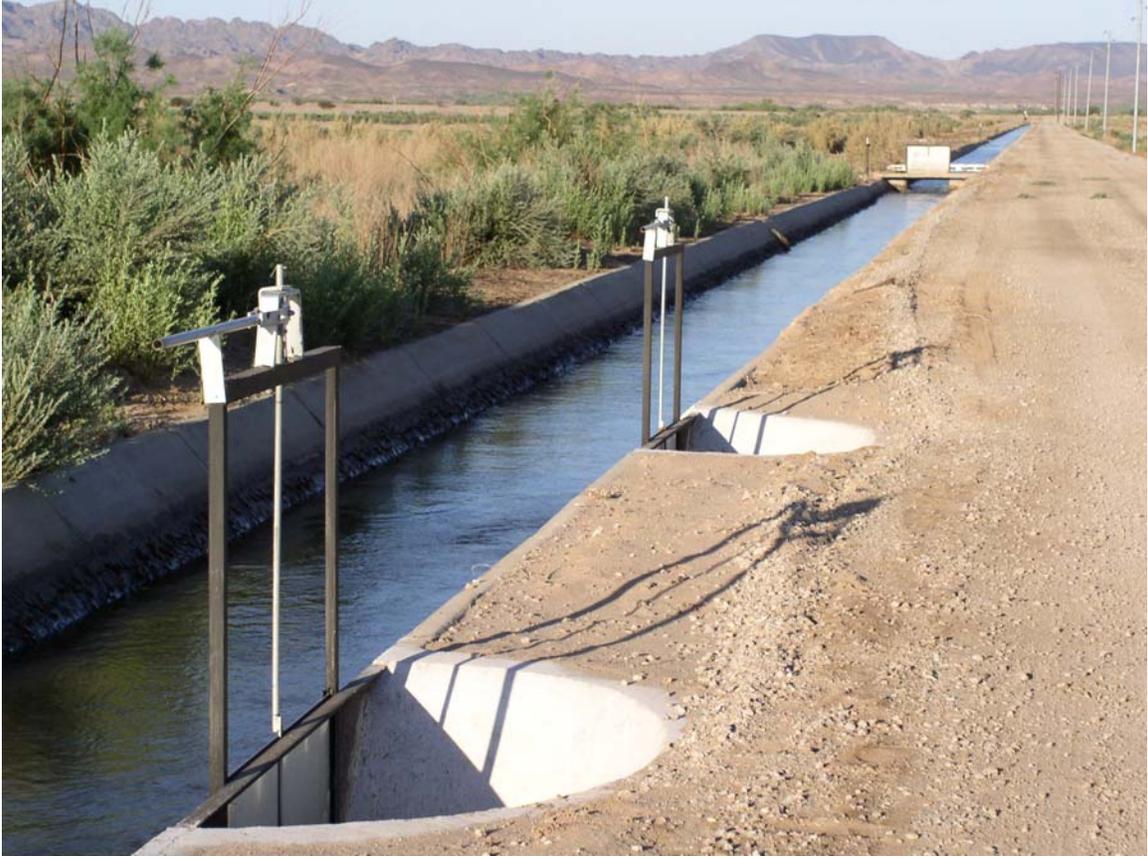
Water control structures
