Lake Champlain Aquatic Habitat Connectivity

Fish Passage in the Lamoille River Watershed

Morrill Brook, Bayley Hazen Rd, Walden, Vermont
Longitude: -72.28900 Latitude: 44.49580

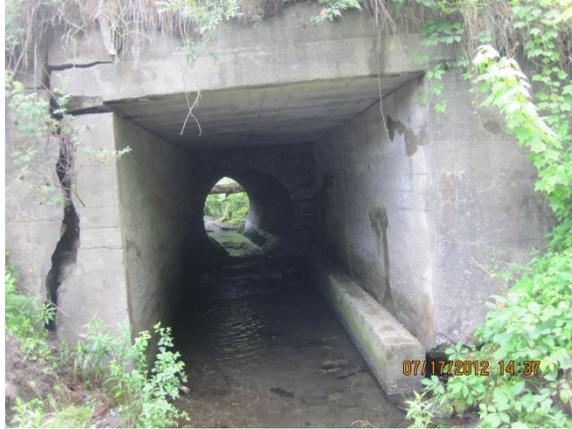
Before

Left: A view of the Morrill Brook culvert on Bayley Hazen Rd. **Right:** Morrill Brook after new culvert installed.

Problems / history: The problem with this barrier is that it is located at a strategic location between rearing and spawning habitat.

Methods: Restore passage to all life stages of brook trout and allowing brook trout refuge in cooler waters of the upper Lamoille River. Replace the culvert with an appropriately sized and placed culvert, designed to pass all life stages of brook trout.
