# August 2000 Monitoring of Natural-Process Restoration at the Runyon Site, Mill Creek

A report to the Mill Creek Conservancy and  
the U.S. Fish and Wildlife Service

Prepared by The Nature Conservancy  
August, 2000

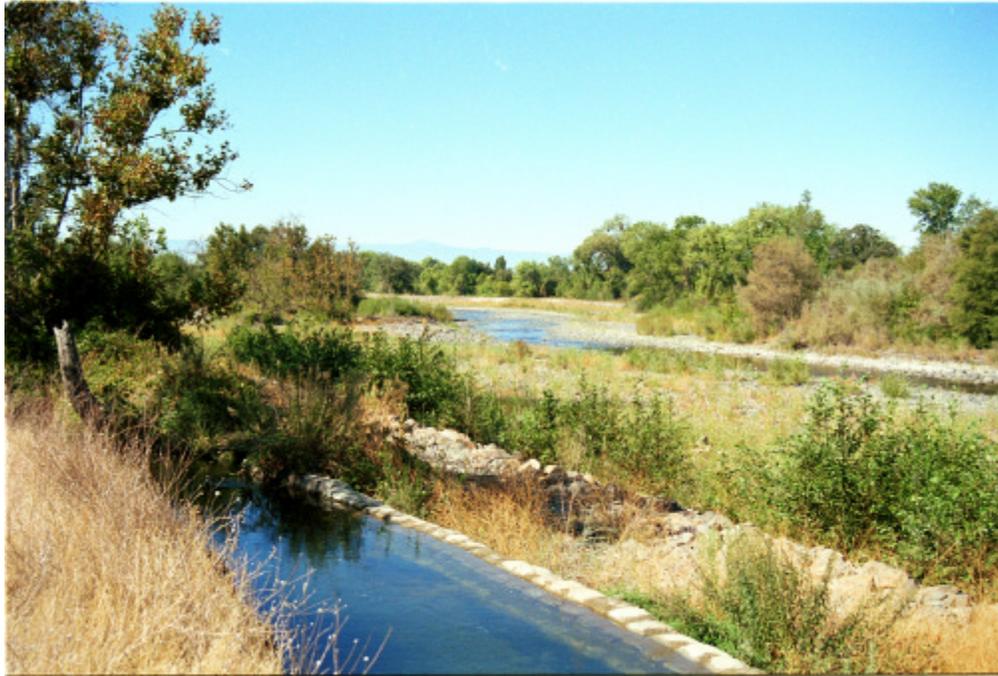
A. View of site. October 1999.

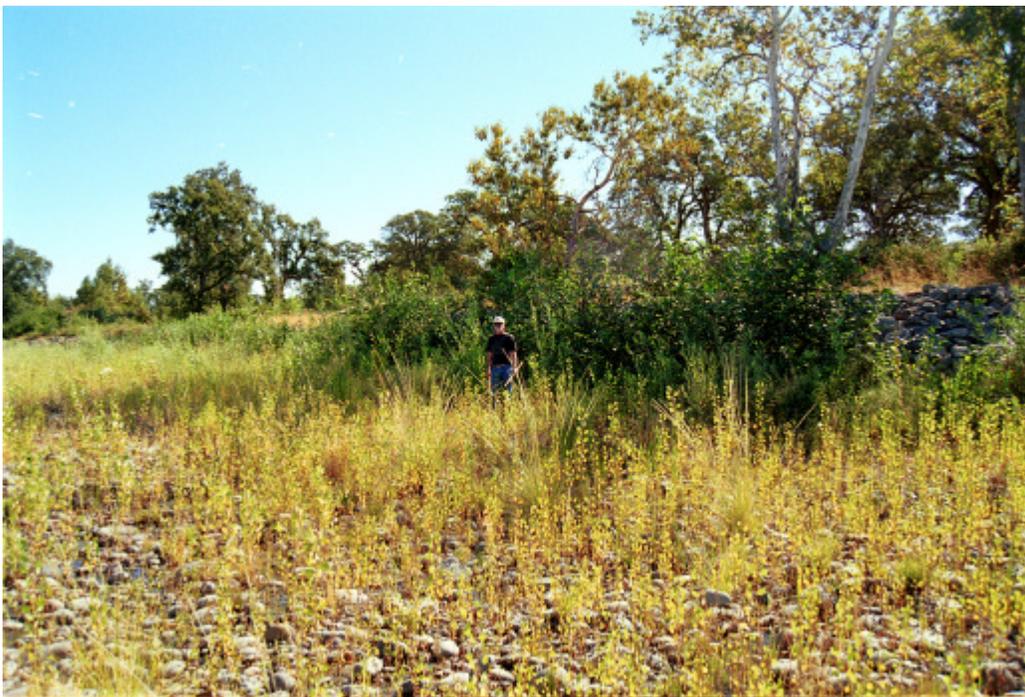
D. White alder stand at base of rip-rap bank (Zone 1). October 1999.

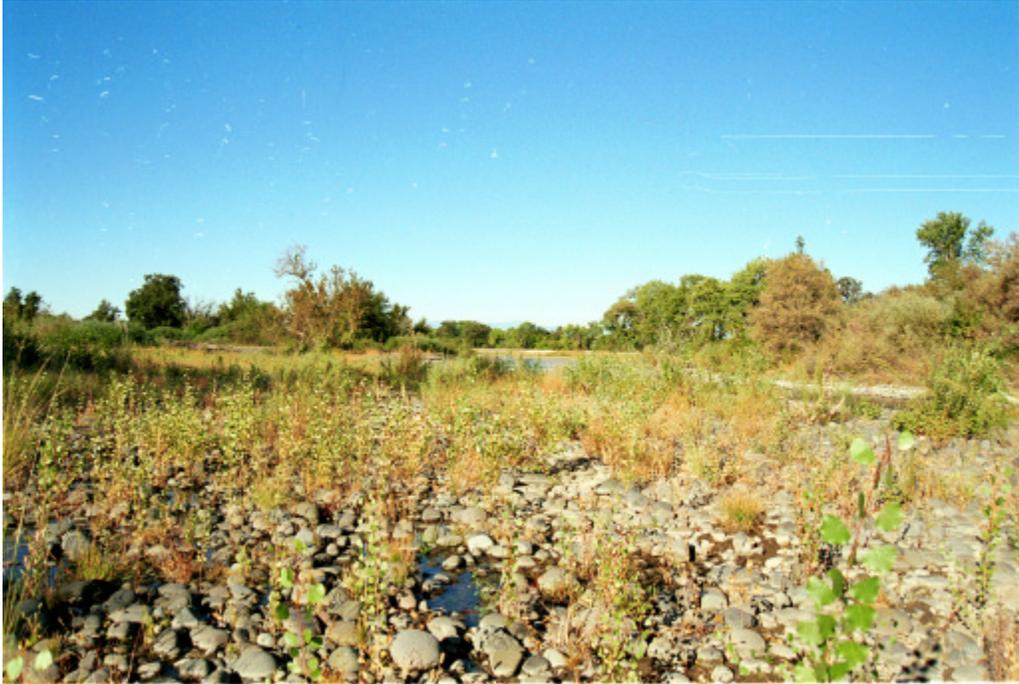
G. Cottonwood and willow saplings (Zones 2-5). October, 1999.
