East Branch Ausable River -- Restoration with Onsite Materials Keene Valley, NY -- Tropical Storm Irene Flood Devastated Area

East Branch Ausable River 2012 Restoration: TU & USFWS (Partners and Fisheries Programs)

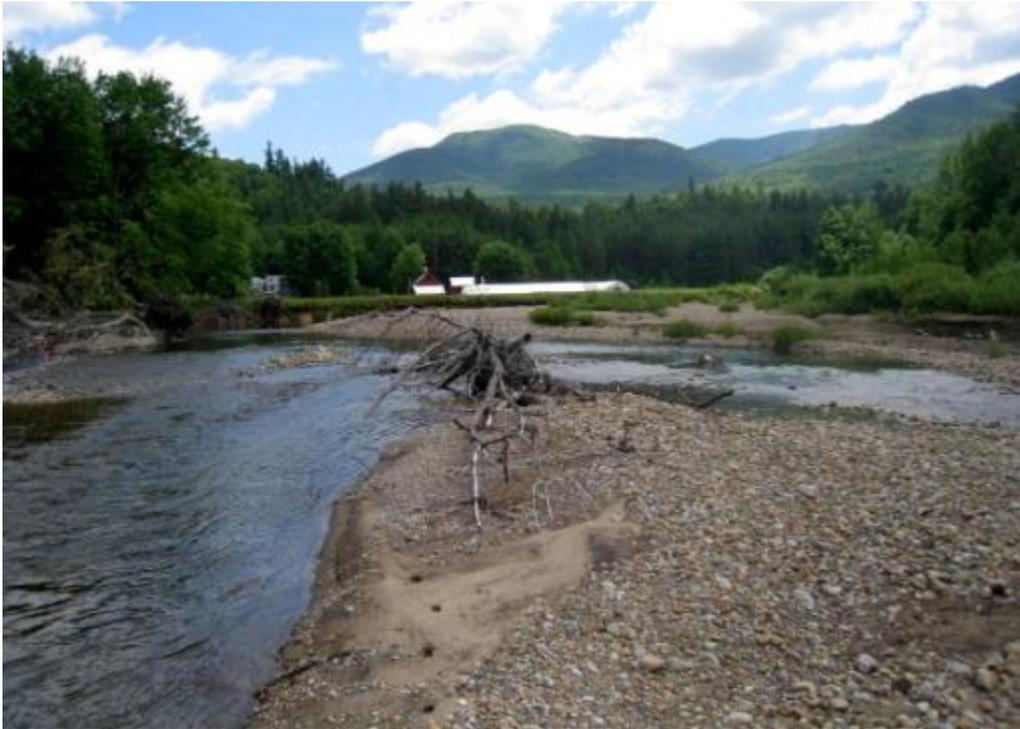
BEFORE
RESTORATION:

245 ft wide
sediment choked,
braided channel
post Tropical
Storm Irene (June
2012)

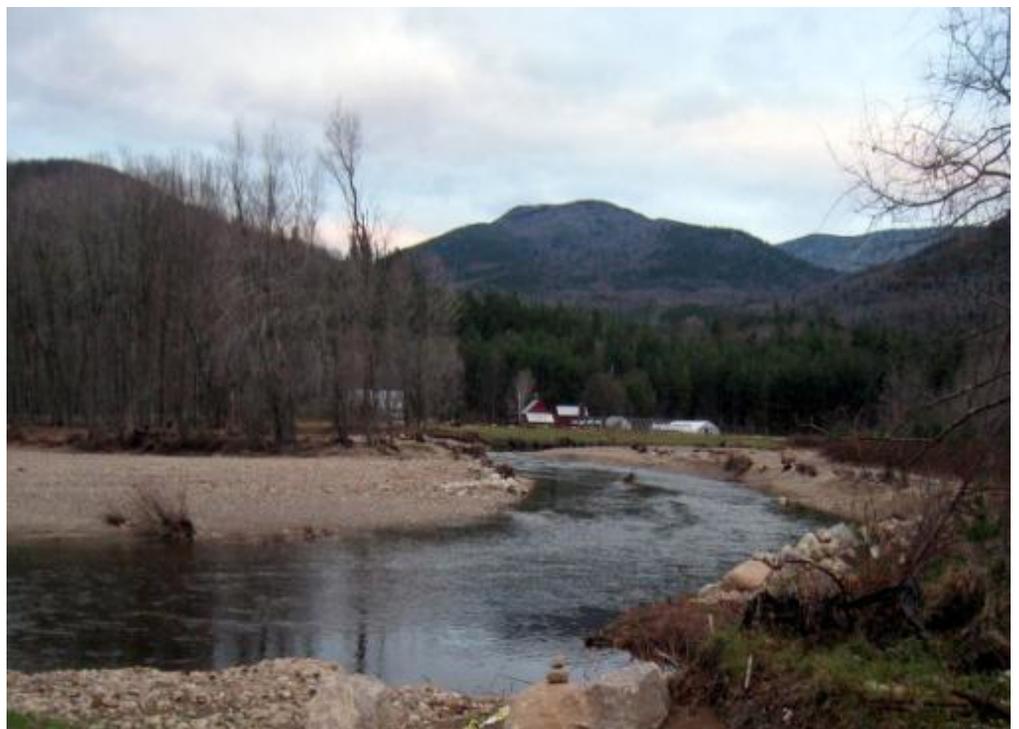
AFTER RESTORATION:
Stream narrowed to 90 ft
wide single channel,
3 months & 3 floods post
construction (Nov 2012)

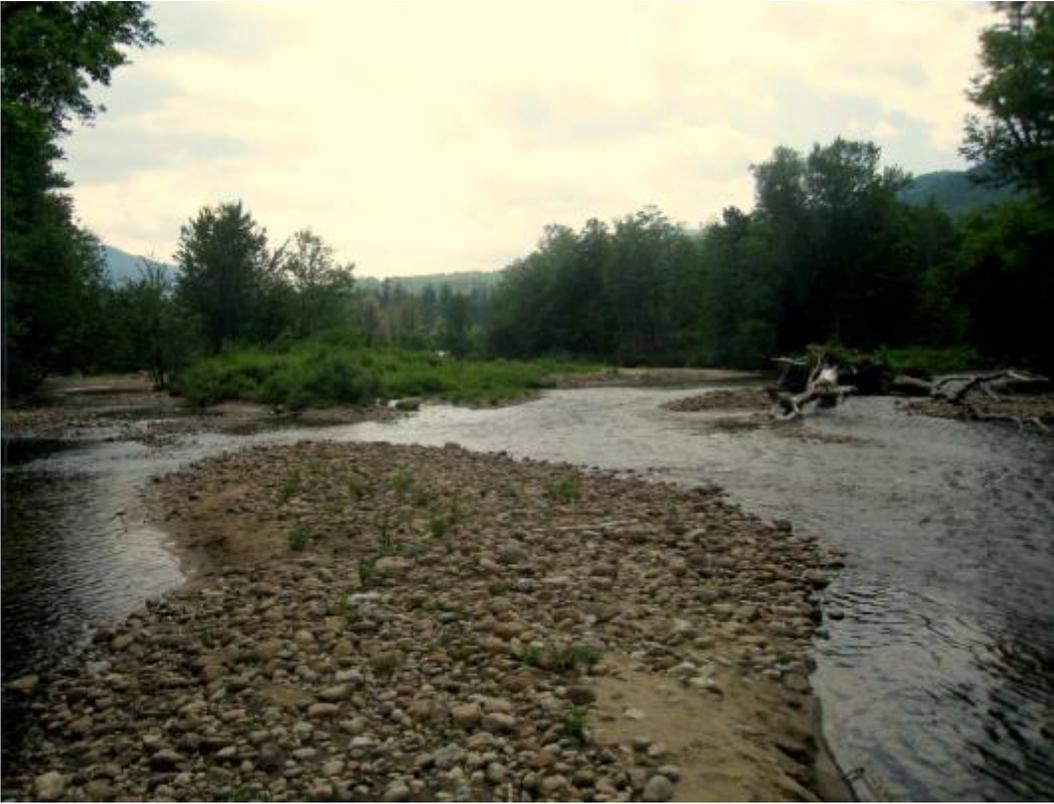
BEFORE
RESTORATION:

185 ft wide stream,
barren, braided
channel post-Irene

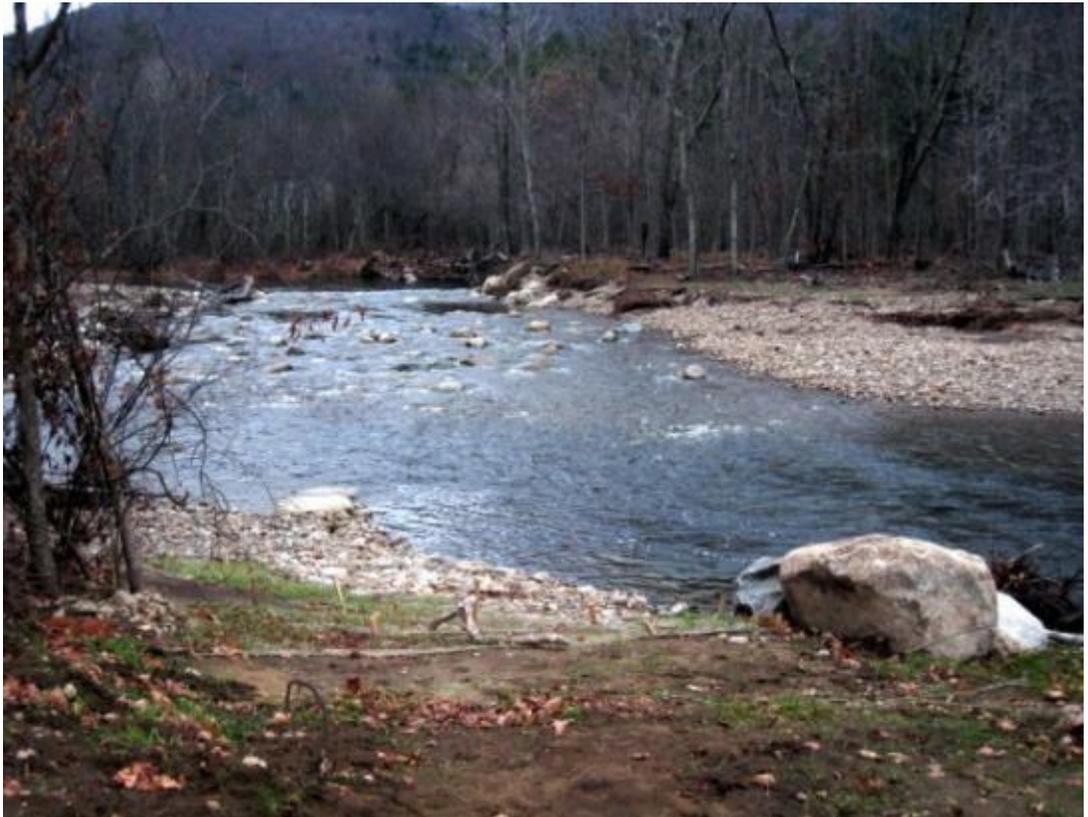
AFTER RESTORATION:

Narrowed stream,
boulder studded riffle
(acting as grade control
and fish habitat)
Nov 2012

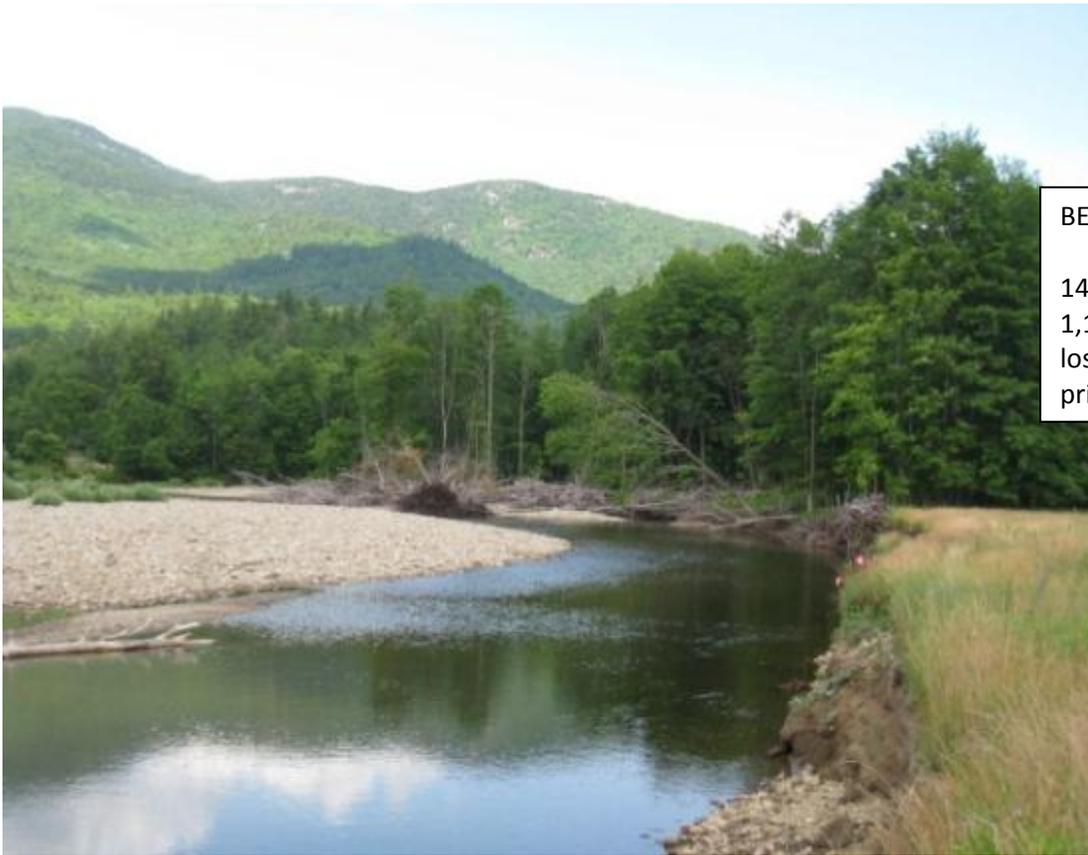
BEFORE RESTORATION:

145 foot wide, barren,
1,100 ft of collapsing bank,
losing 15,000 cu yds of
prime farm soil per year

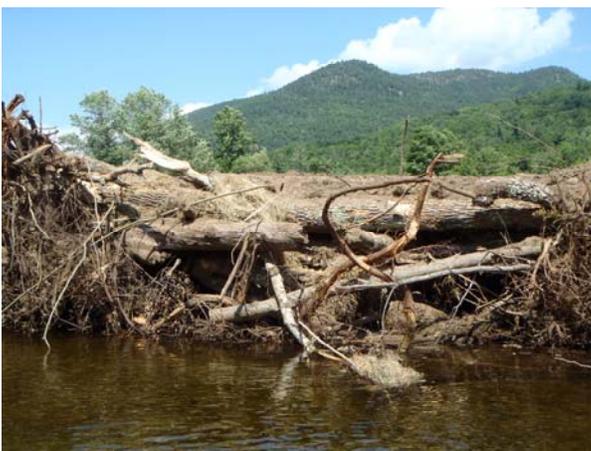
Toe Wood Structure - layered, tangled wood at the base of the bank up to bankfull elevation covered with soil on the top for fish habitat and bank stabilization.

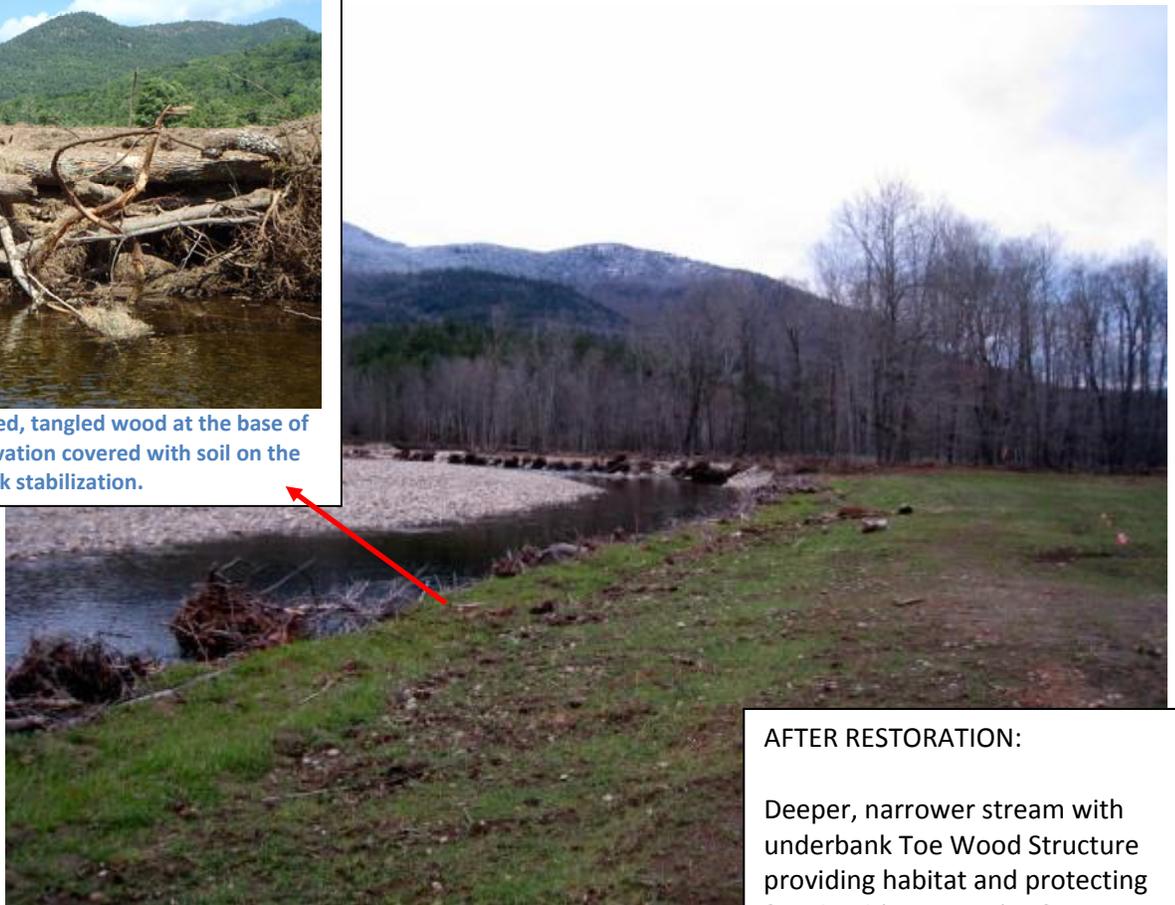
AFTER RESTORATION:

Deeper, narrower stream with
underbank Toe Wood Structure
providing habitat and protecting
farmland (Nov 2012). After 3
over bankfull events.

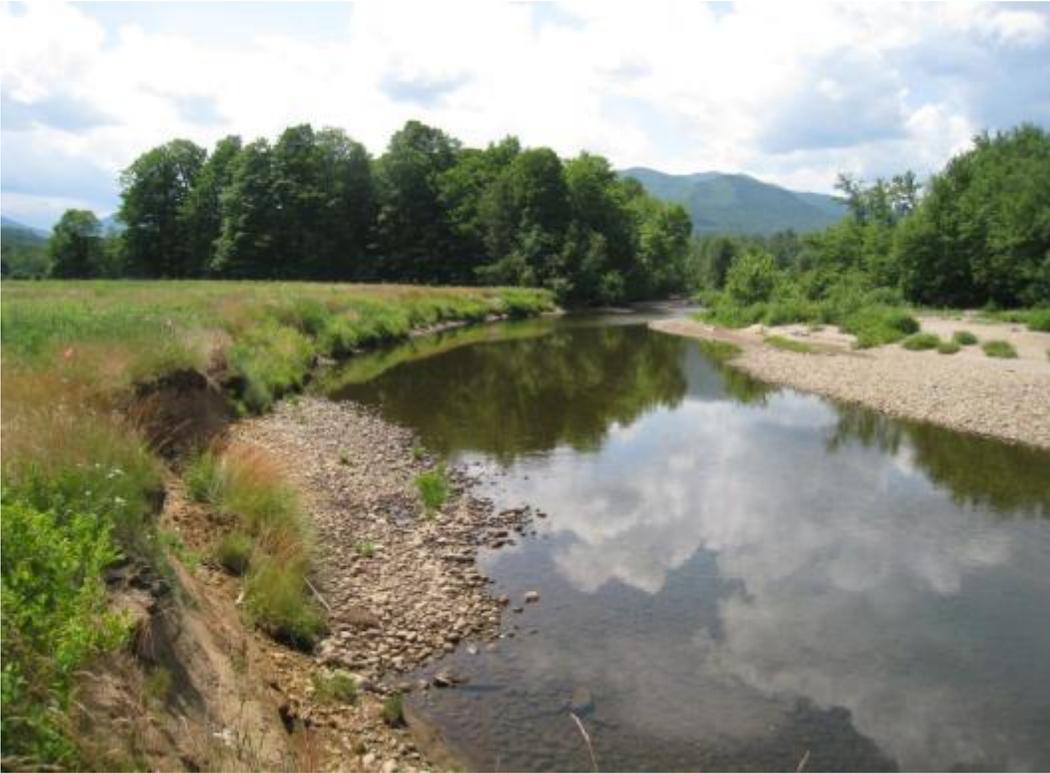
BEFORE RESTORATION:
Upstream view – wide shallow, barren, warm. Rapidly eroding farm field, 6 ft bank by 750 ft long

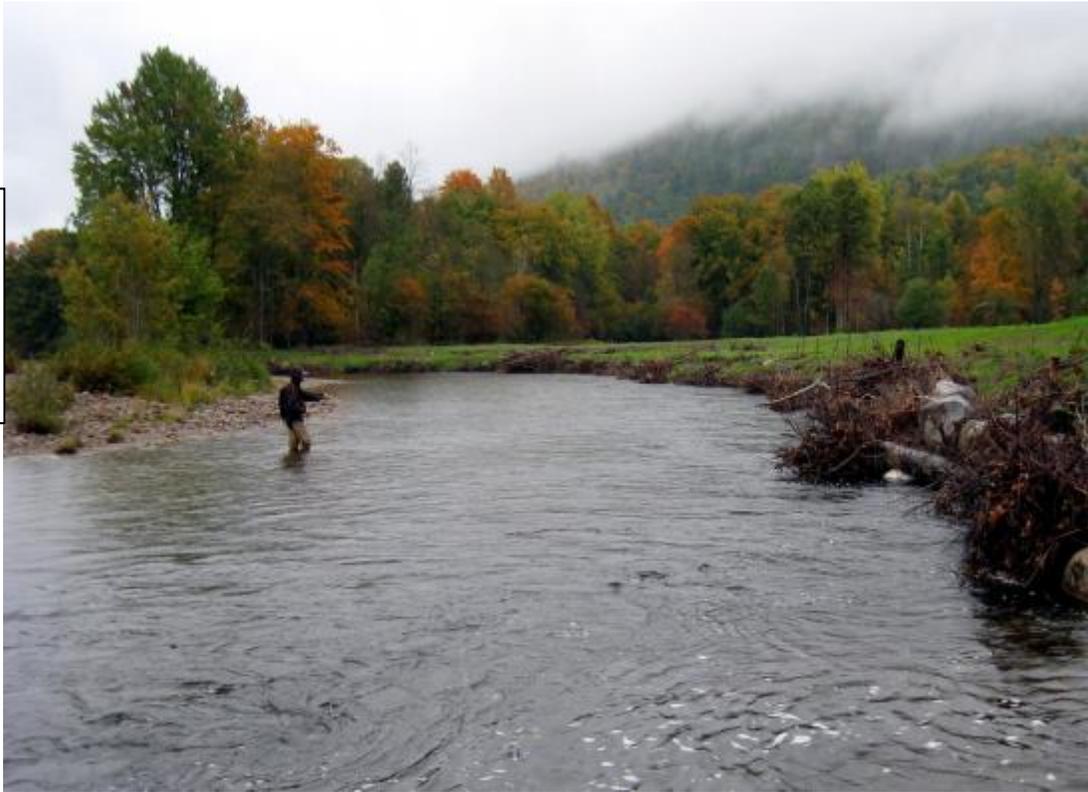
AFTER RESTORATION:
Downstream view, same bend, angler works underbank toe wood structure (Sept 2012)

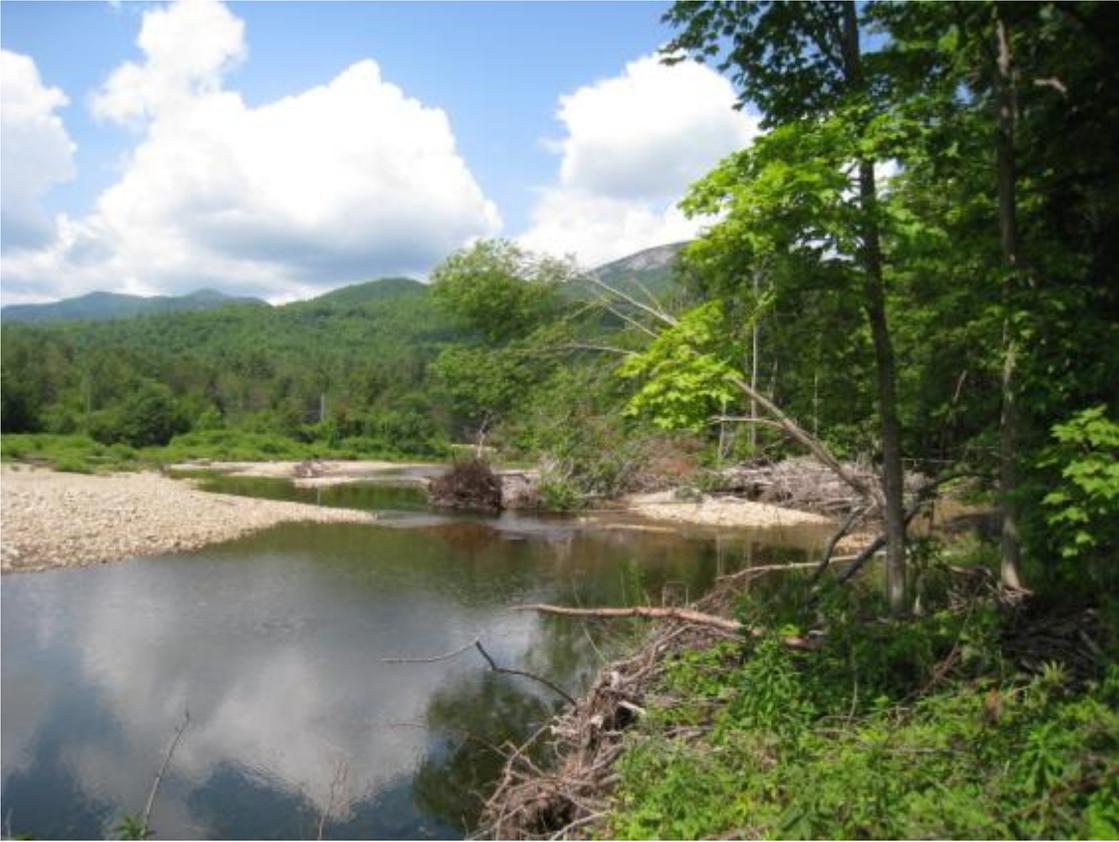
BEFORE RESTORATION:

Unstable stream, flood deposited gravel, trees uprooted

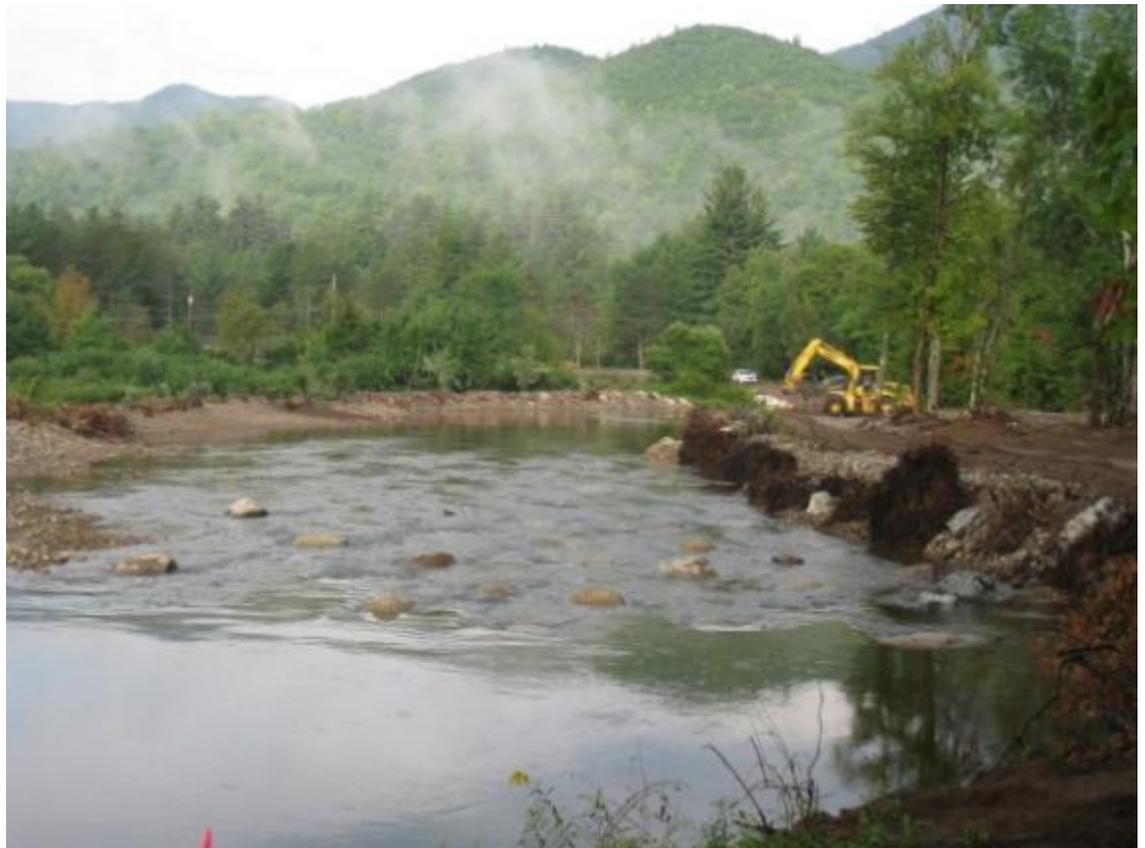
AFTER RESTORATION:

Rootwads with trunks in reconstructed bank, restored boulder studded riffle, bank on left not yet restored.

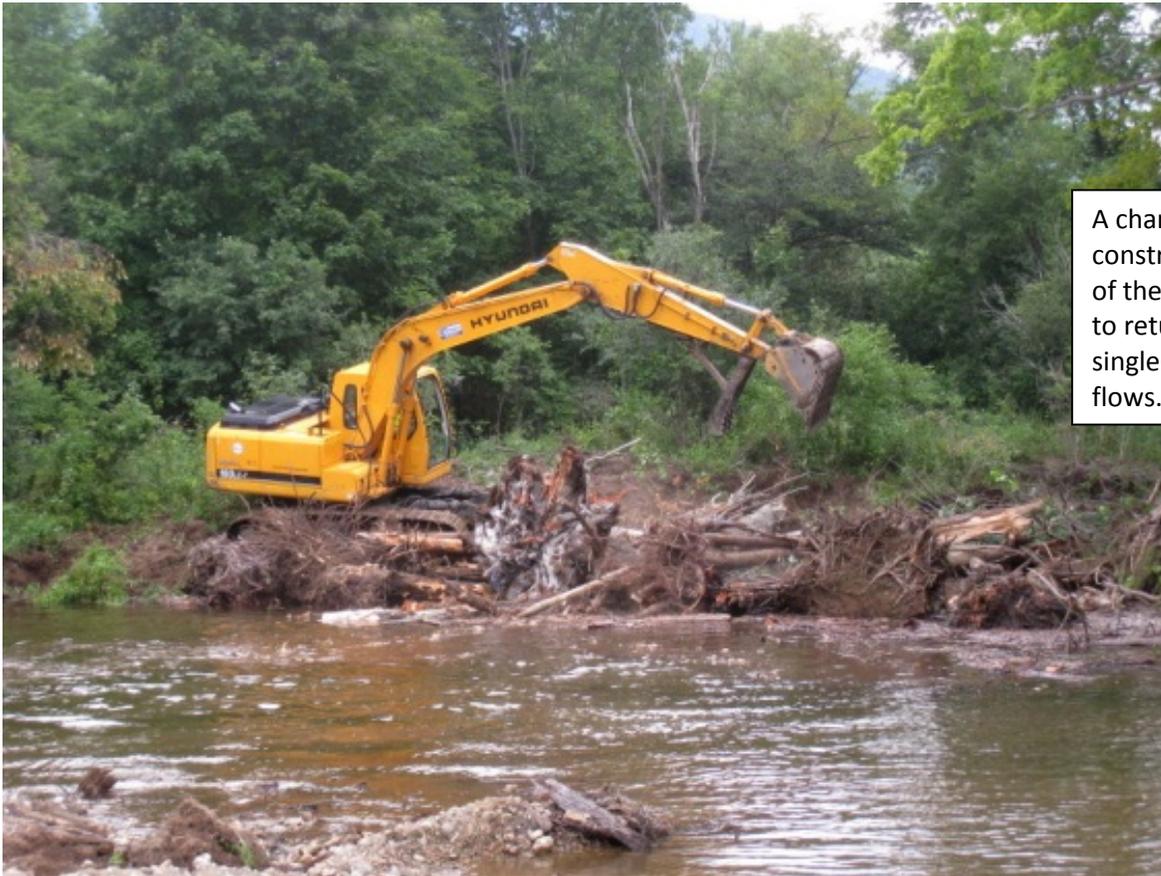
A channel block being constructed at the top of one of the braided cutoff channels to return the stream to a single channel during normal flows.
