Mill Creek

seven miles northeast of Vancouver city center, overlooking Salmon Creek; along the lower part of Mill Creek corridor, a tributary of Salmon Creek

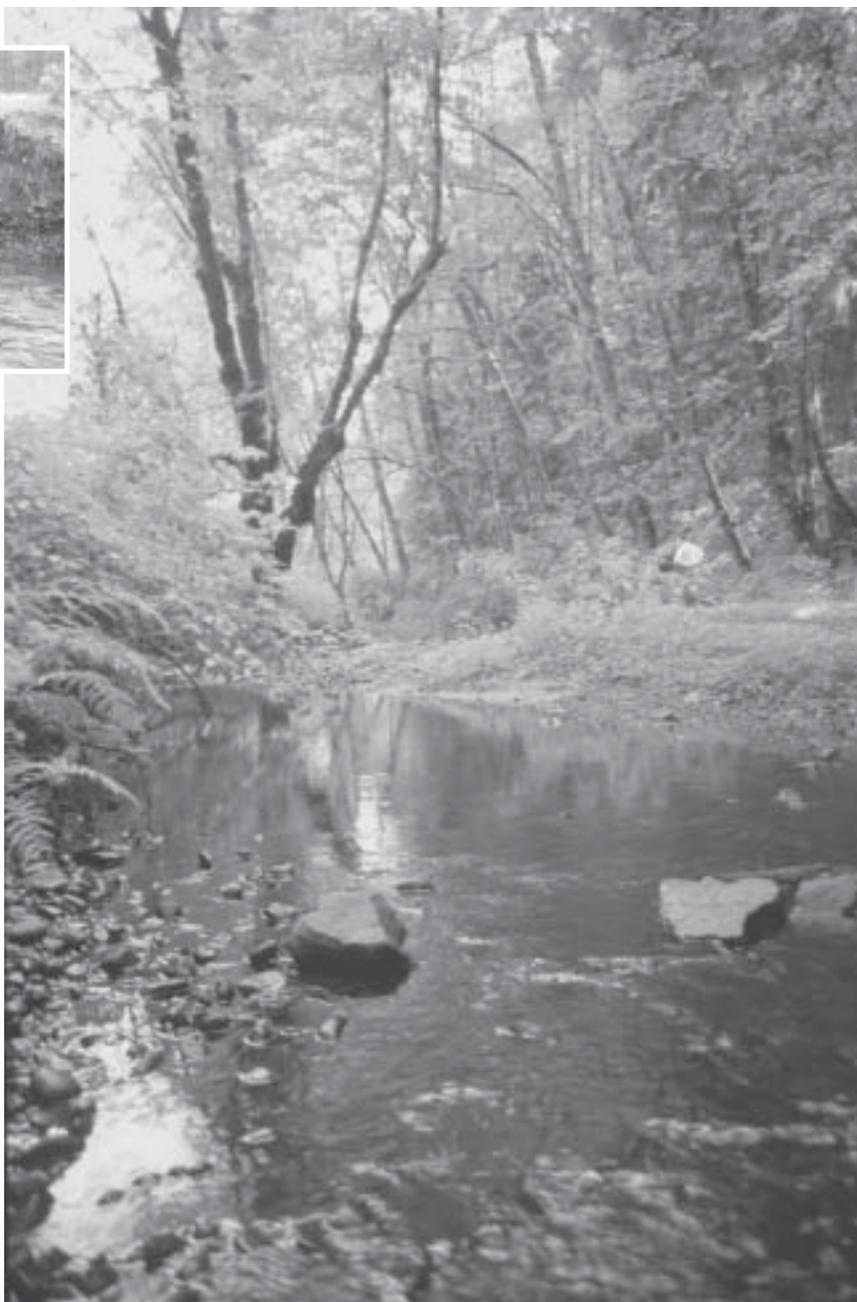
AFTER

(Above) Crib walls and plantings added to support banks

BEFORE

(Upper left) Eroding banks

Rehabilitation on the hillsides and floodplain included the elimination of invasive plant species such as holly and ivy by cutting and uprooting. Streambank erosion prevention devices included the use of log cribwalls; brush, tree or root wad revetments; log brush barriers; and rock or log current deflectors. In addition, soil bio-engineering techniques were used for slope and gully erosion control that included straw secured with jute/coir fabric and stakes, brush mattresses, contour trenches or waterbars, brush/wire dams, woven hurdle fences and log checkdams.
