Shorebird nest fates at Boca Chica after rocket test launch

Prepared by Justin LeClaire, David Newstead
Coastal Bend Bays & Estuaries Program
June 6, 2024

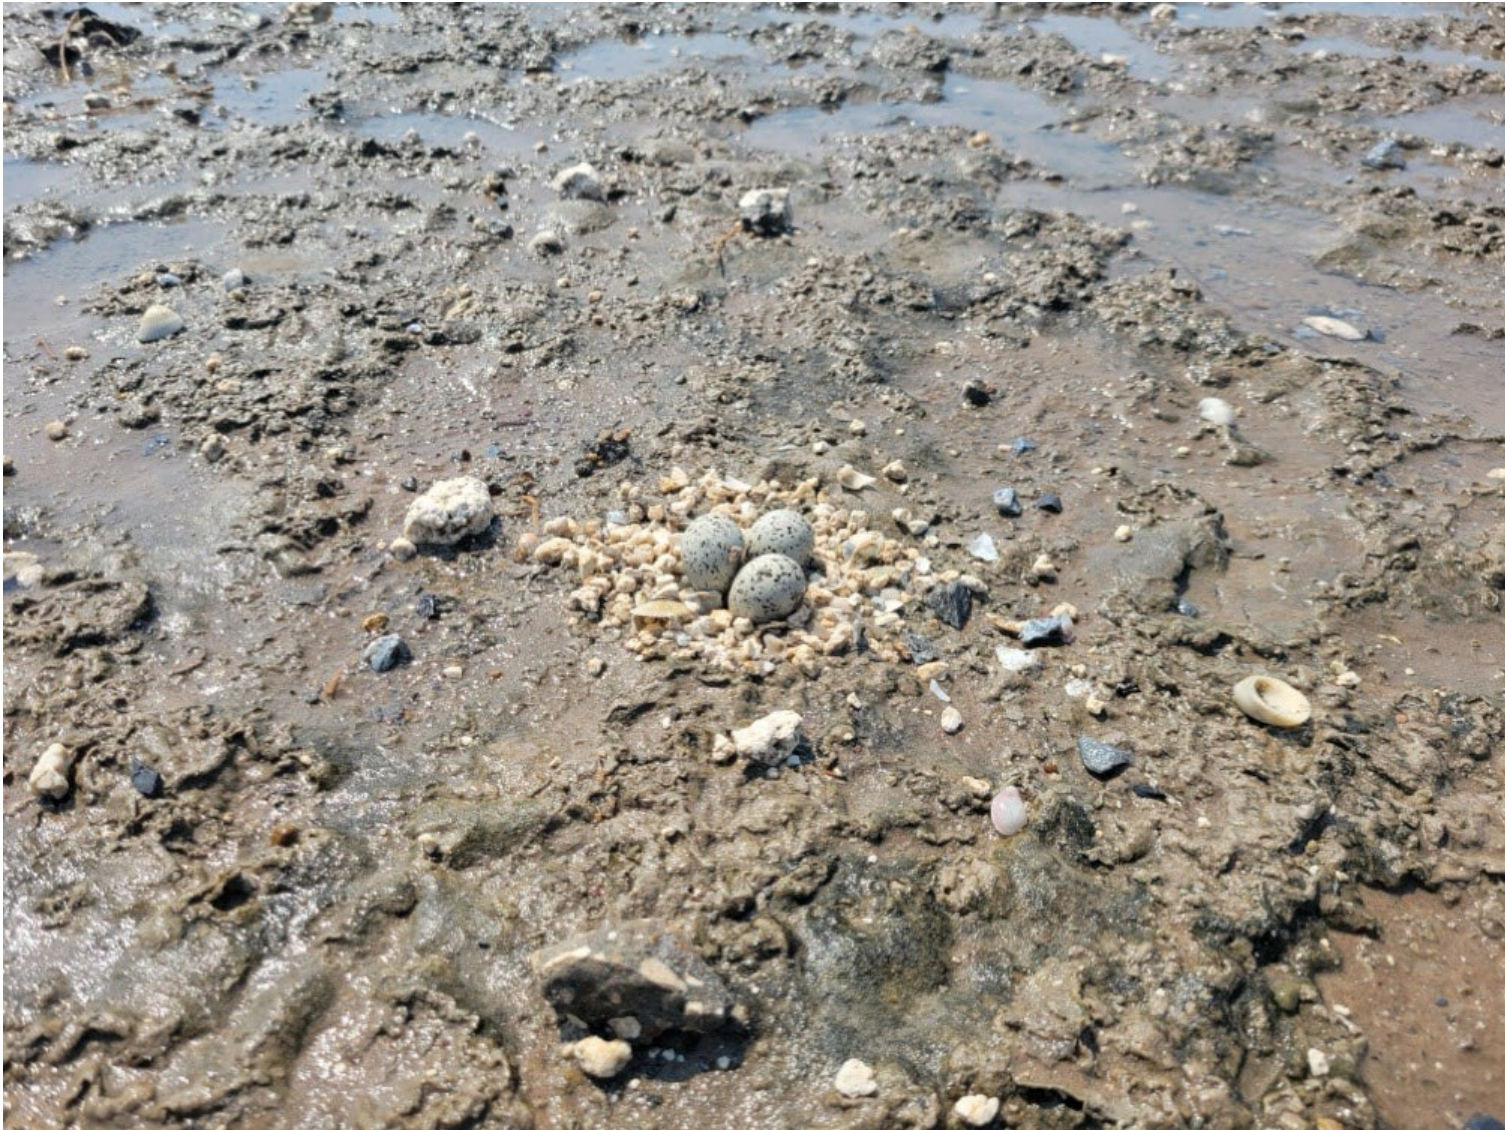
Figure 2. SNPL 1 nest intact and with 3 eggs on June 5, the day before the rocket test launch.

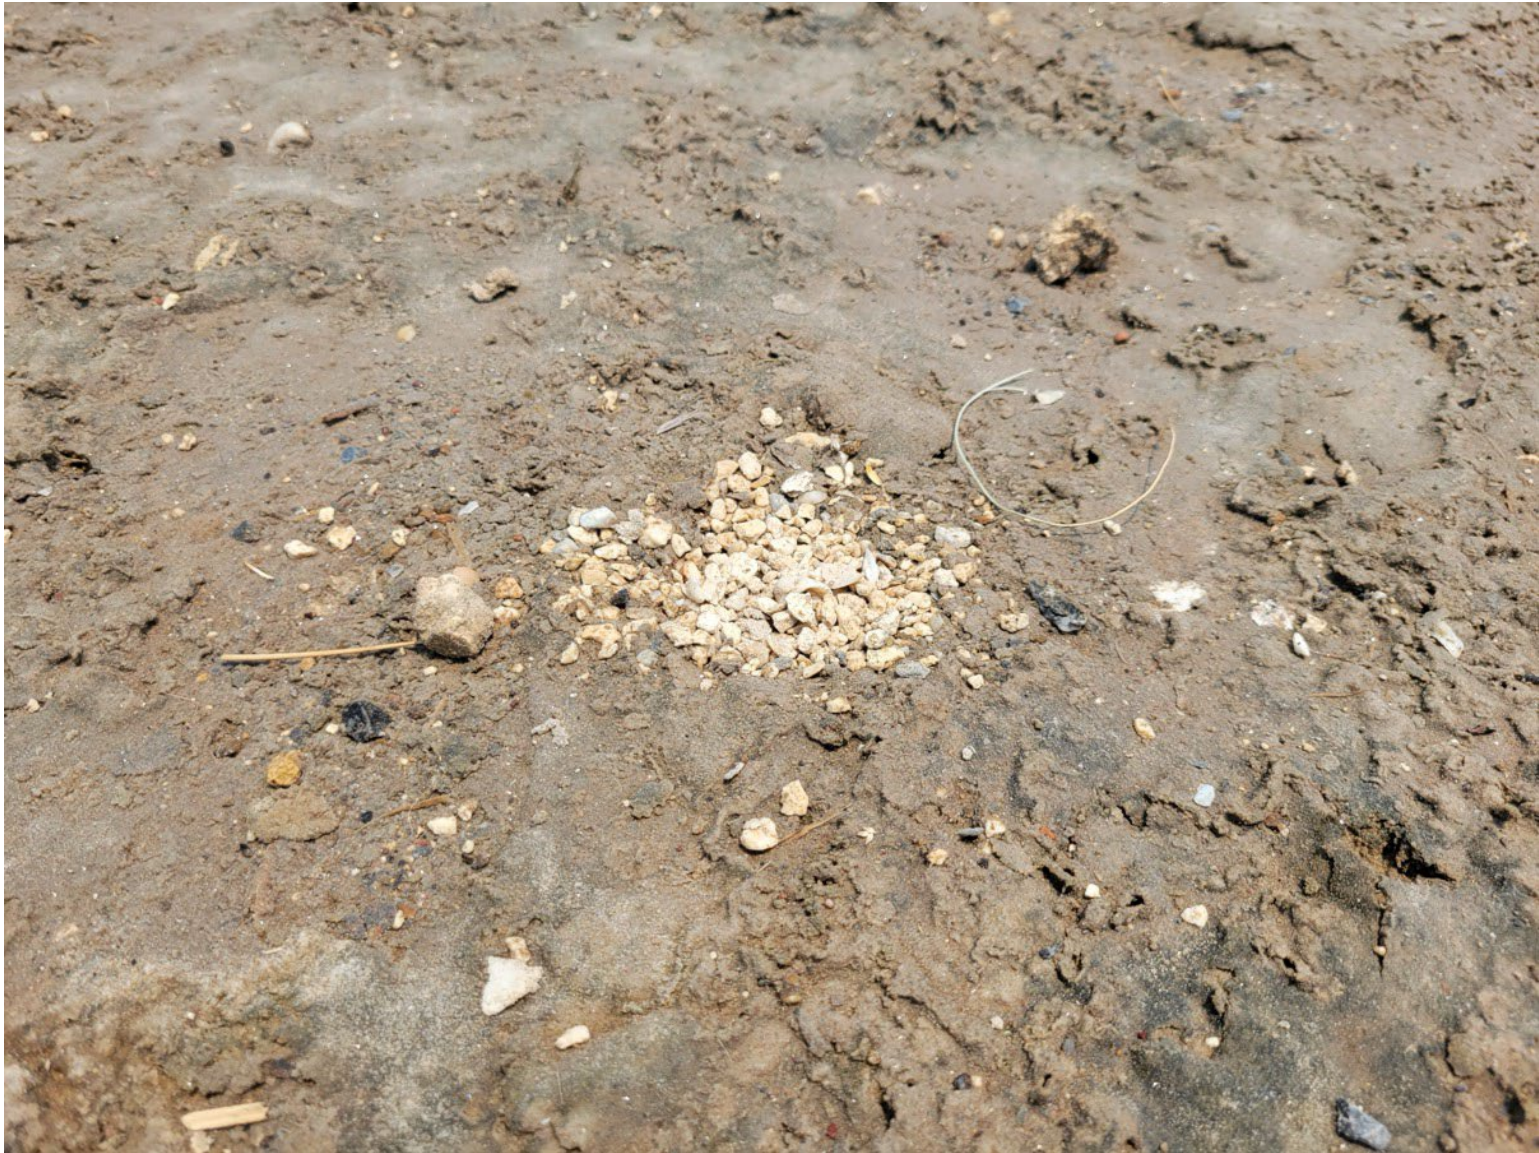
Figure 3. SNPL 1 nest with 0 eggs and no signs of predator tracks despite moist ground that would be highly impressionable by any predators on June 6, 2024.

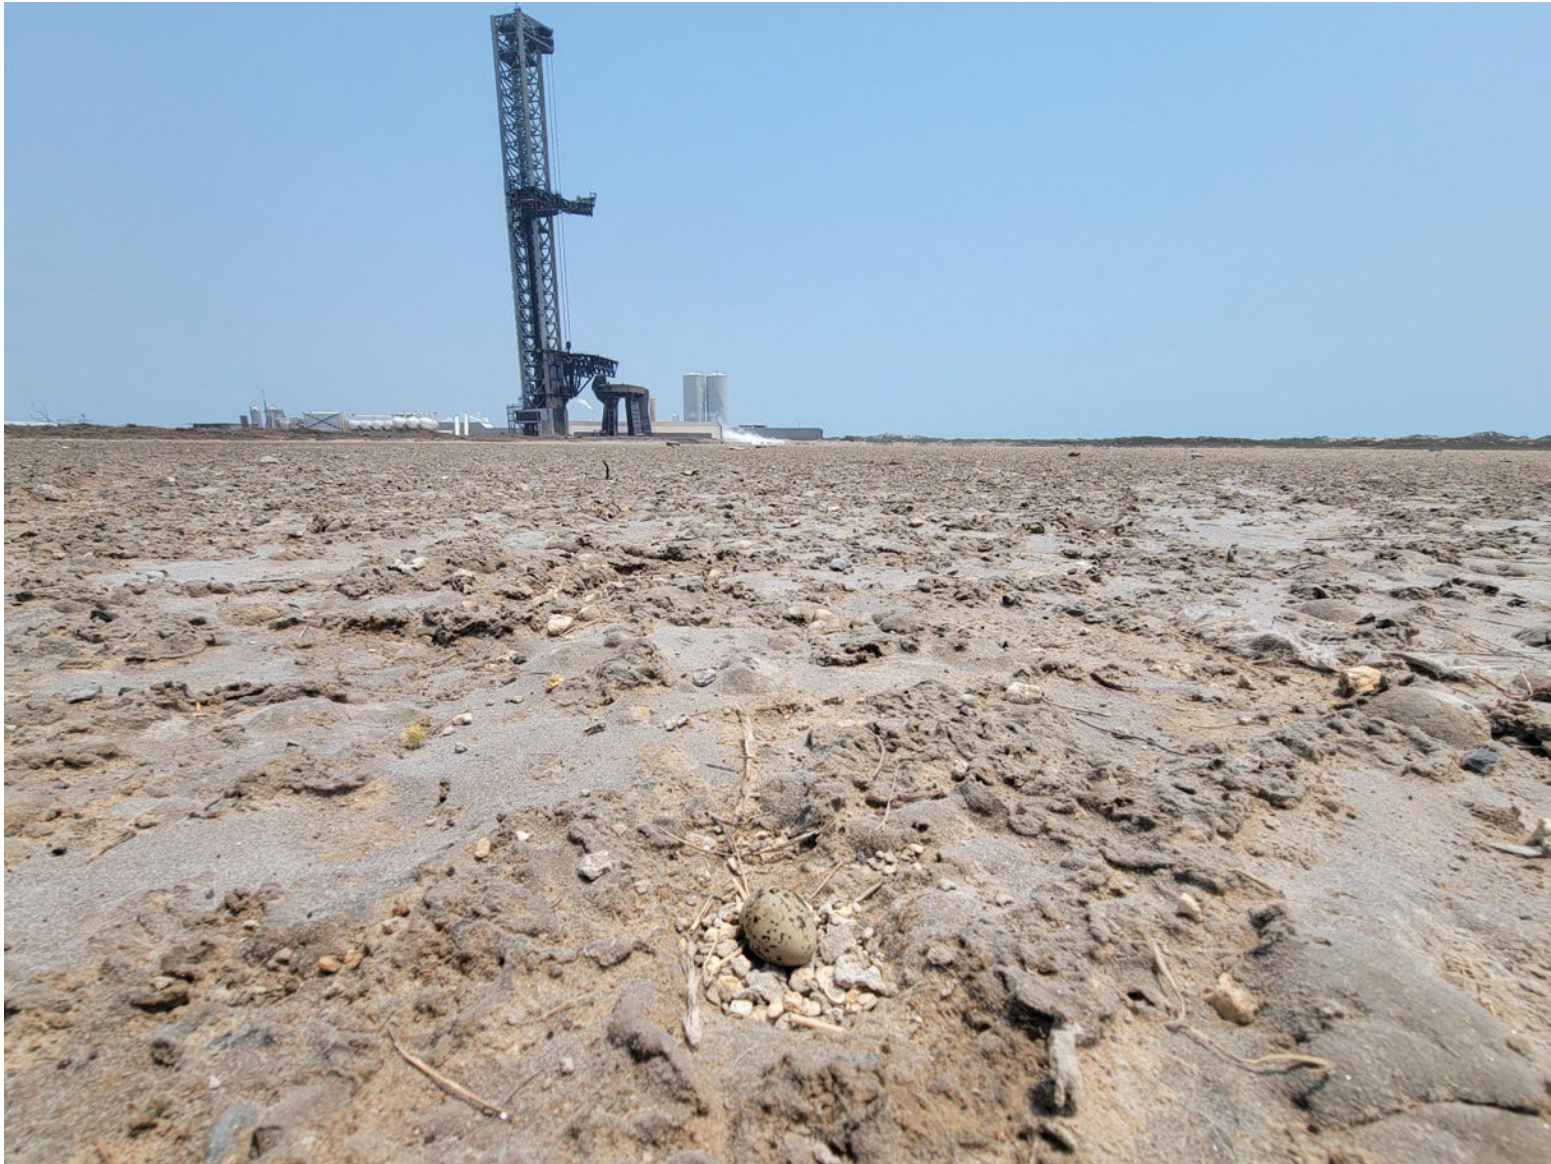
Figure 4. SNPL 2 nest with only one egg remaining and the rocket launchpad in the background on June 6, 2024.

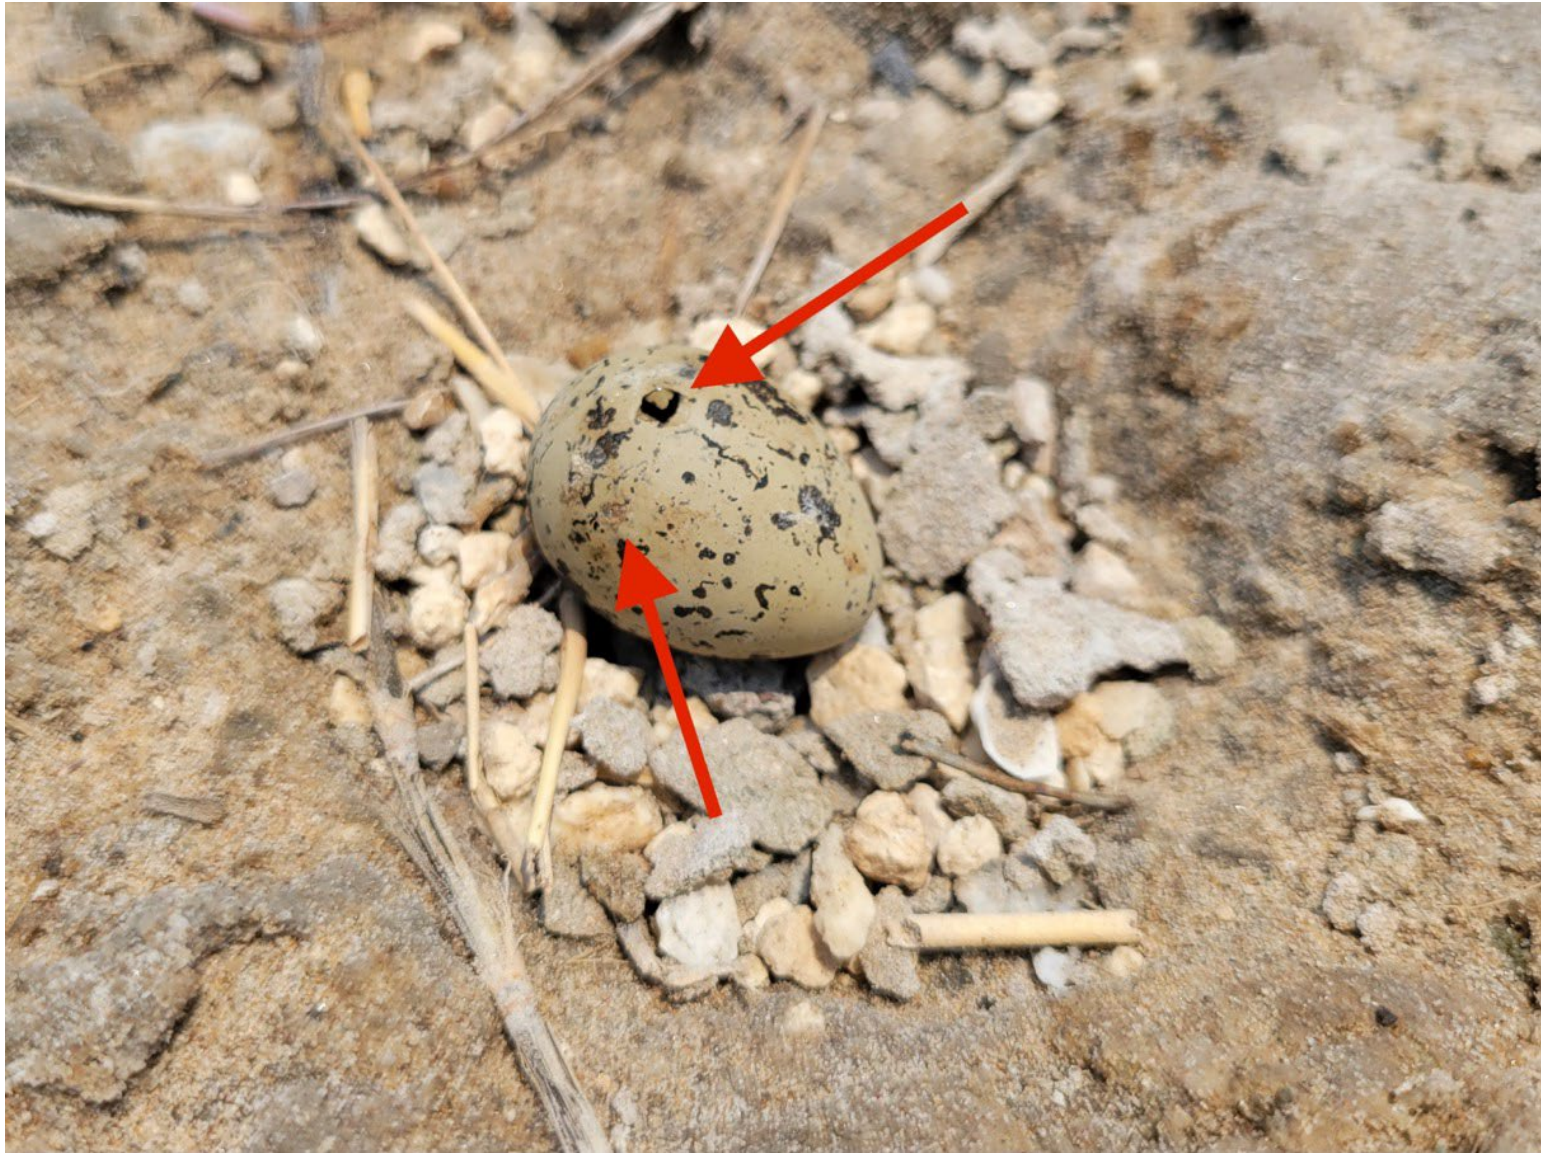
Cracks/holes in eggs ranged from relatively small cracks/notches up to fully penetrated pea-sized holes. Bloody egg contents were found on several egg exteriors near holes within them.

Figure 5. SNPL 2 close up photograph with arrows showing damage on single egg on June 6, 2024.

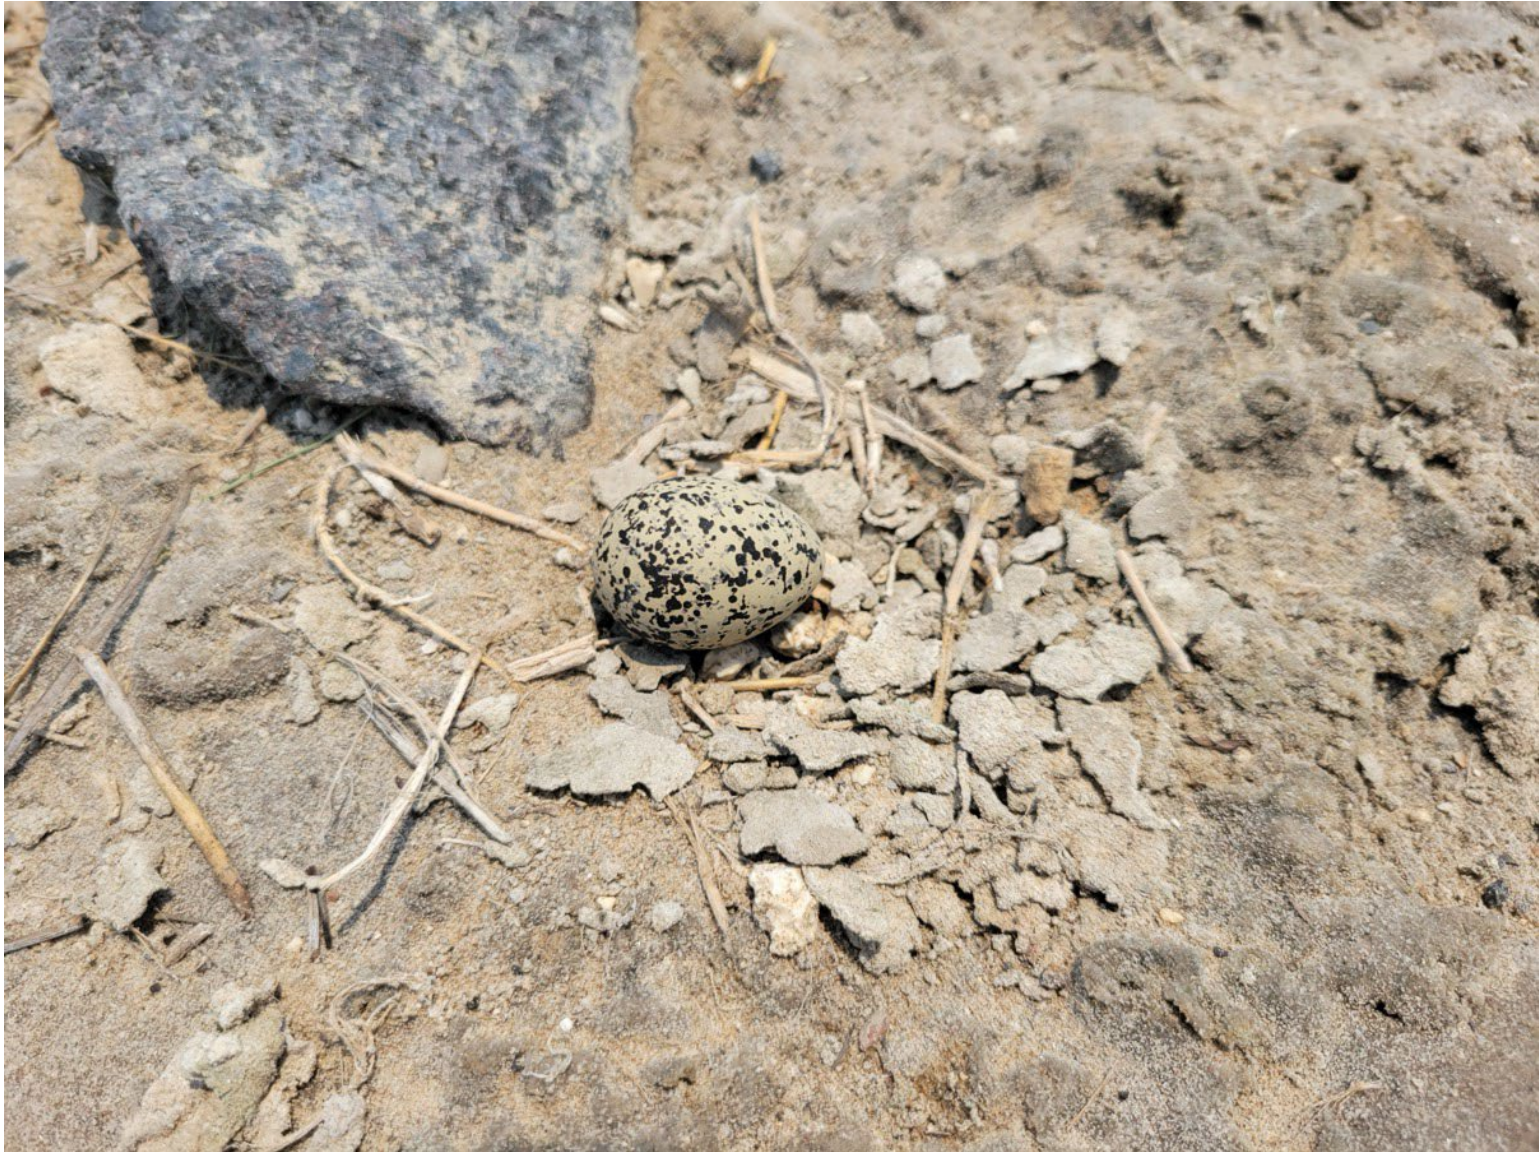
Figure 6. WIPL 1 with only a single intact egg remaining on June 6, 2024.

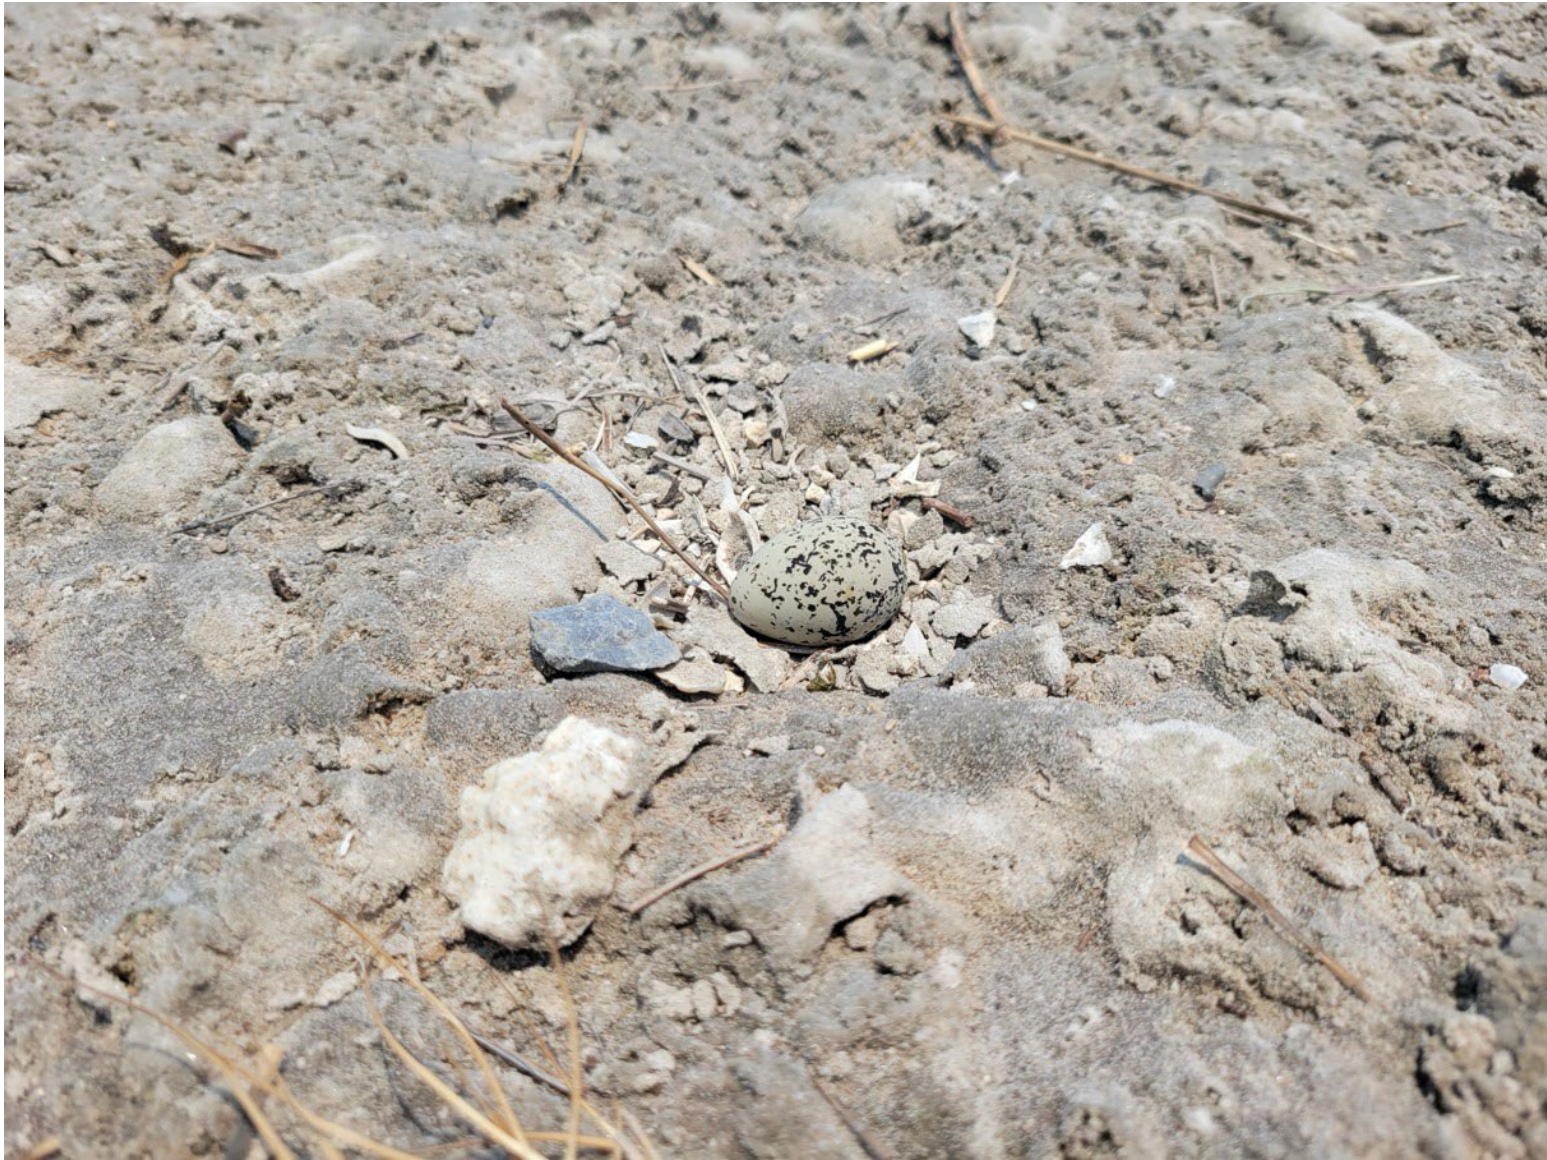
Figure 7. SNPL 3 with only a single egg remaining on June 6, 2024.

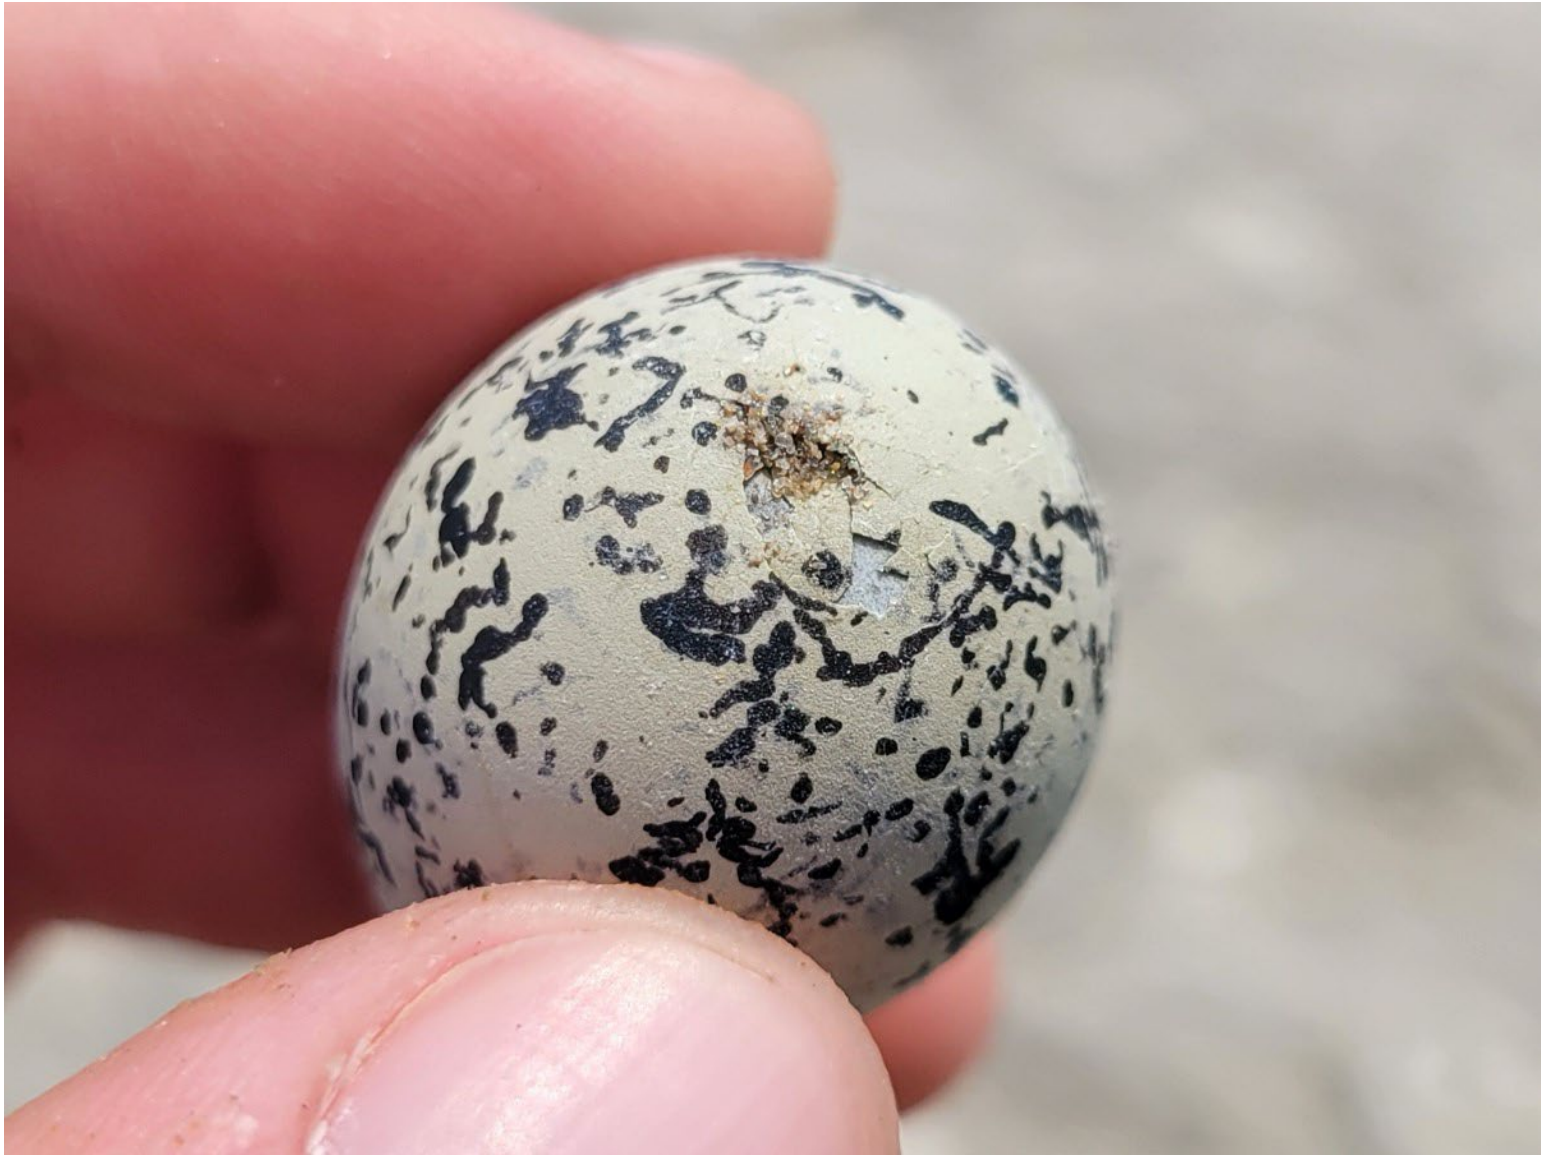
Figure 8. Lone egg from SNPL 3 with large cracks in it on June 6, 2024.

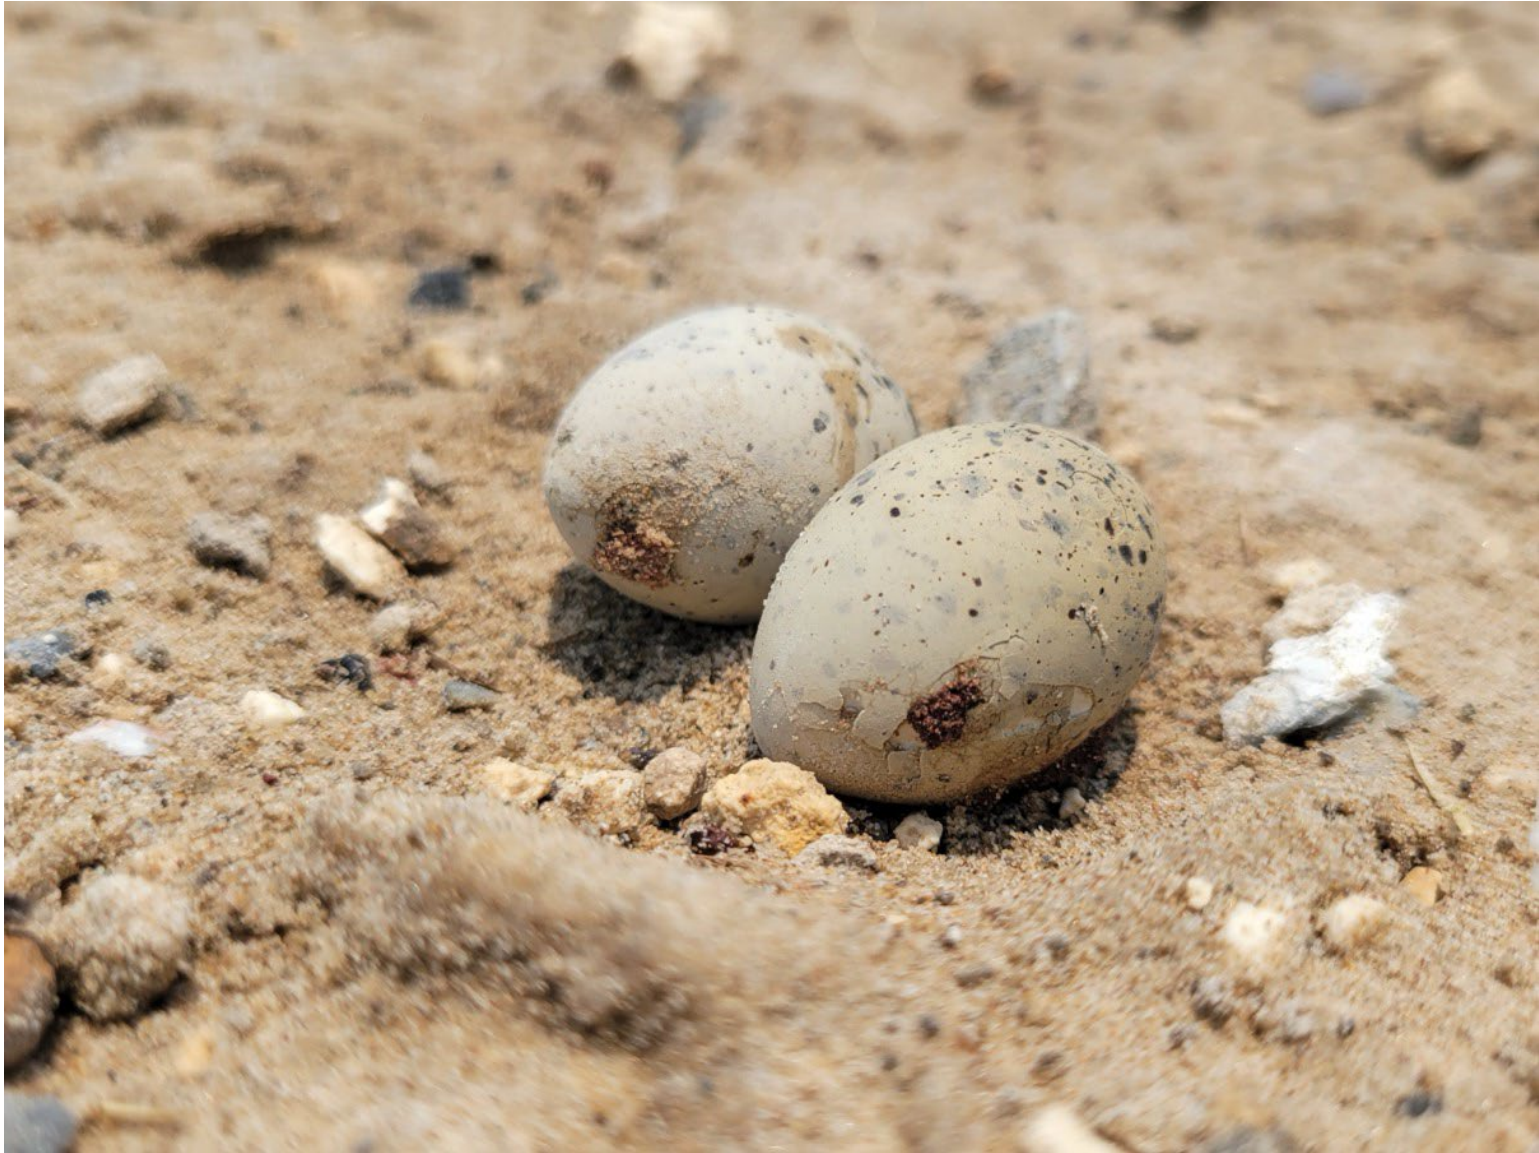
Figure 9. LETE 1 showing both eggs with large holes/cracks and dried egg contents emerging on June 6, 2024.

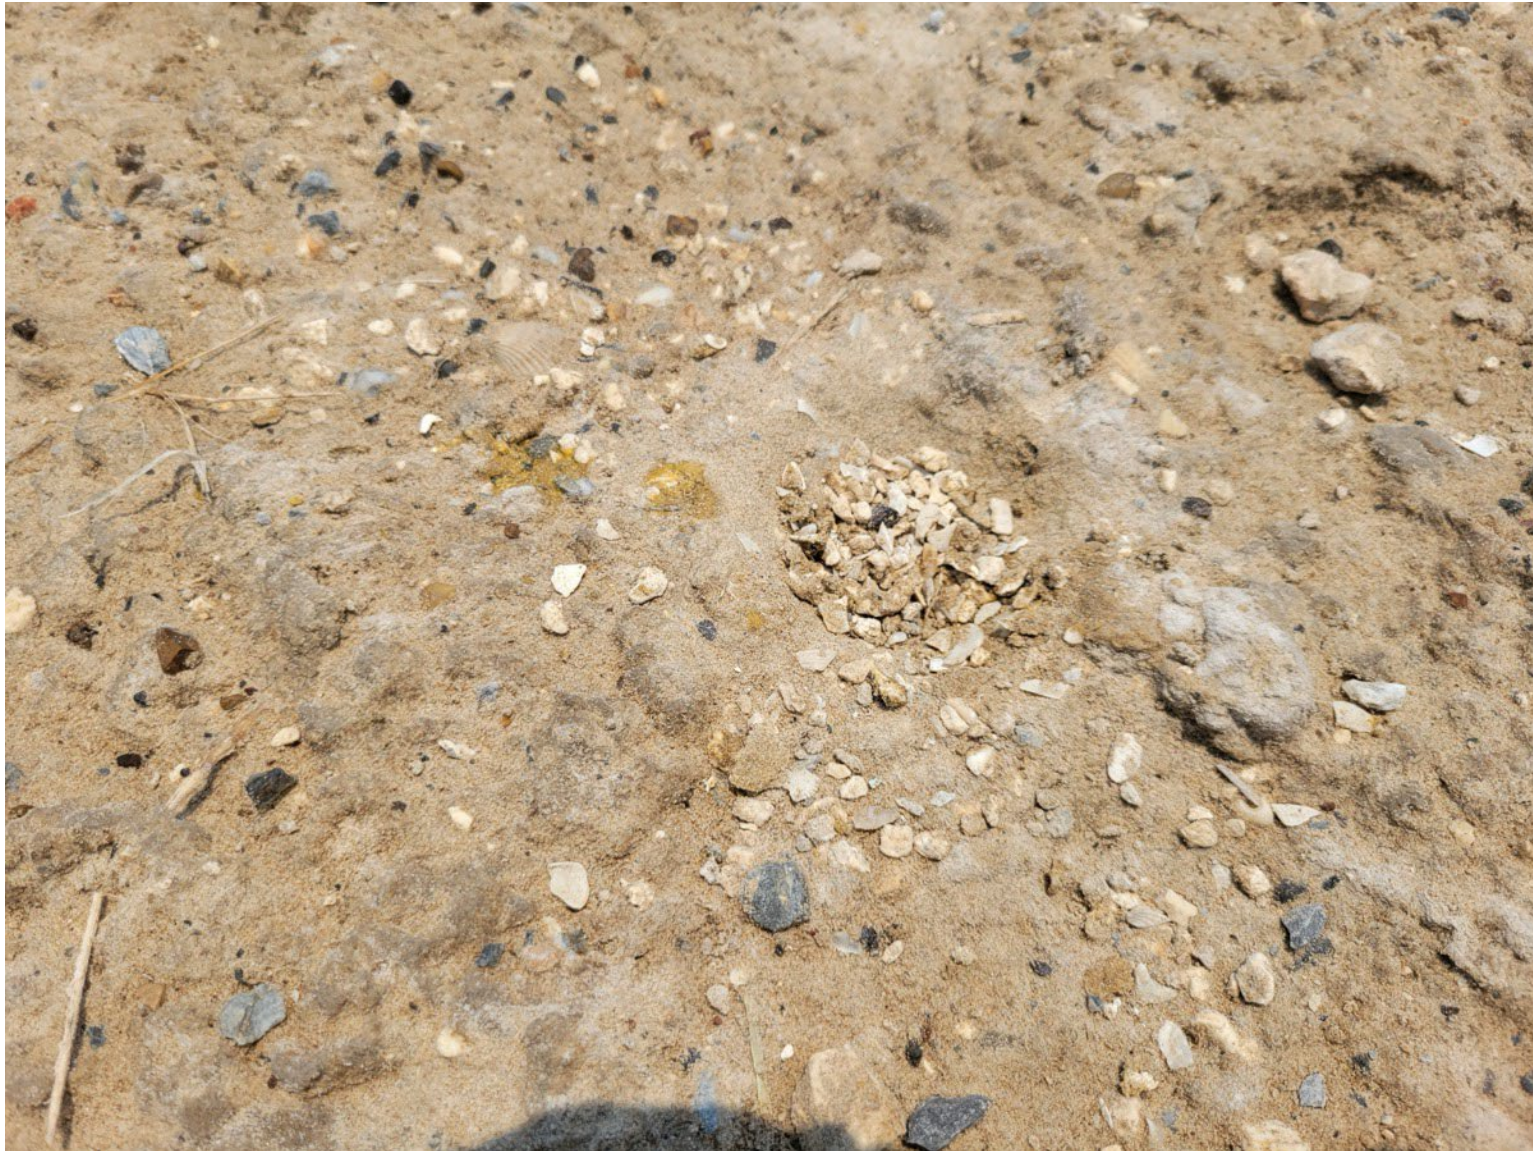
Figure 9. SNPL 4 with dried egg contents spilled in the nest cup and droplets moving away from it in a straight line on June 6, 2024.

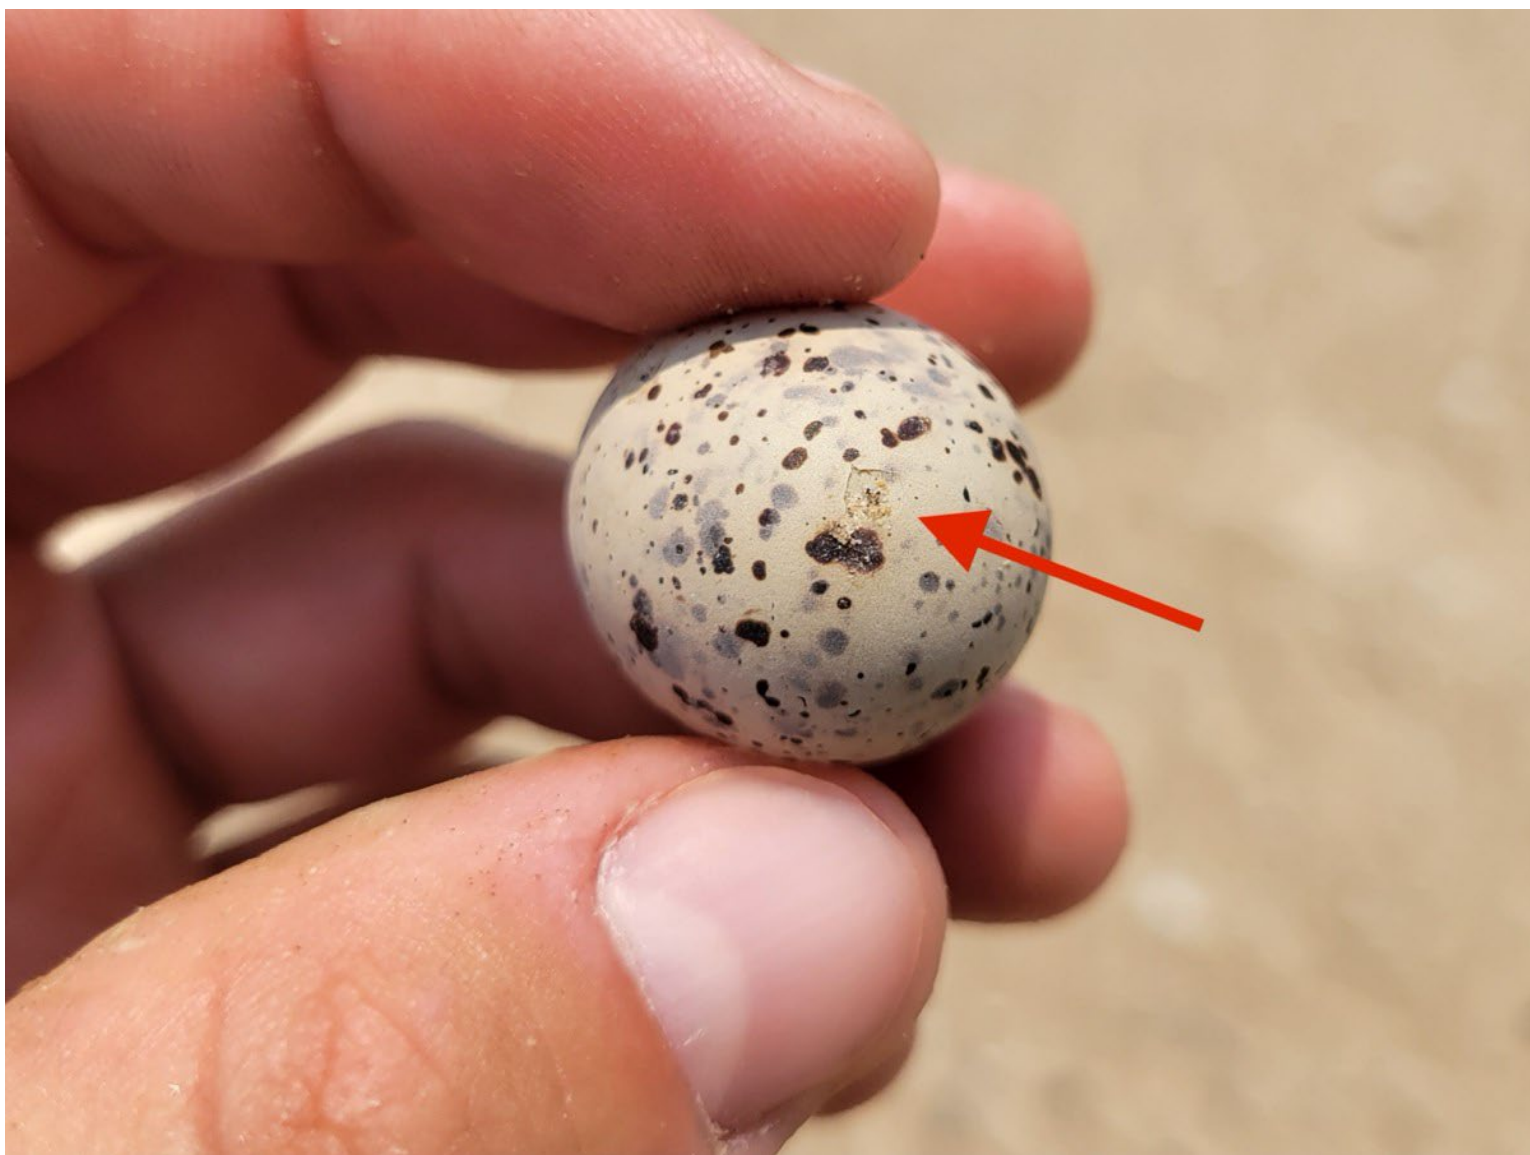
Figure 10. Lone egg from SNPL 5 with a small but significant depressed crack on June 6, 2024.

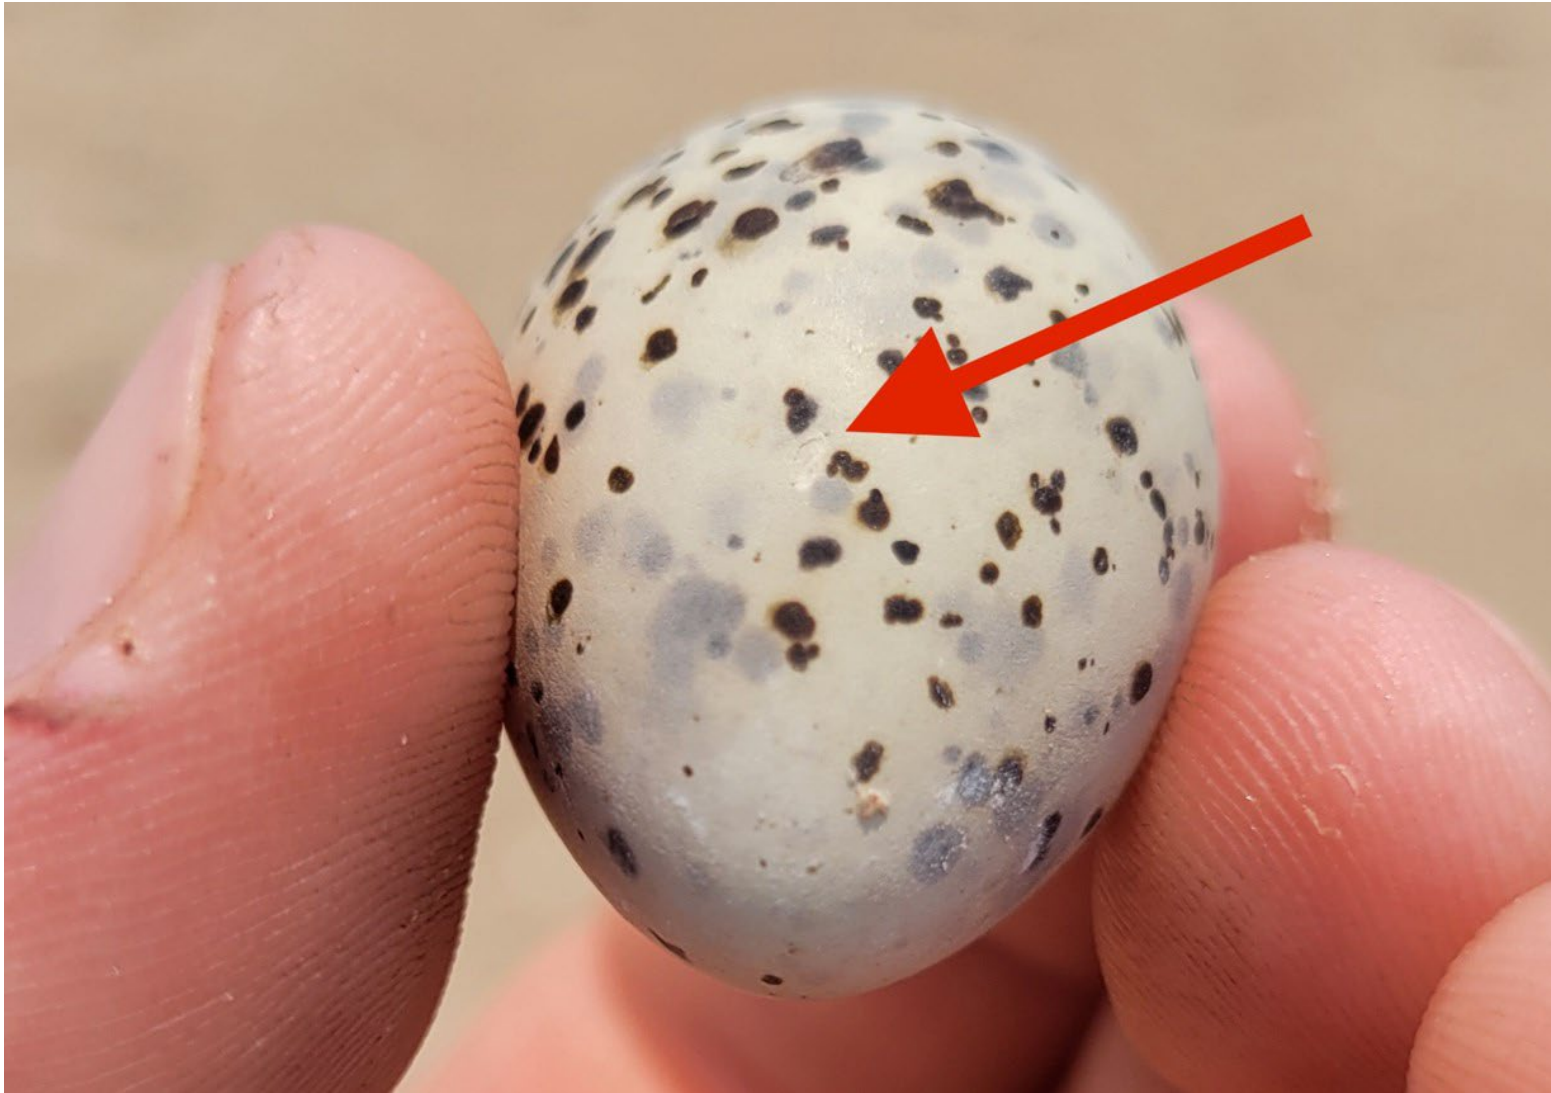
Figure 11. Small but noticeable crack on egg from LETE 2 on June 6, 2024.

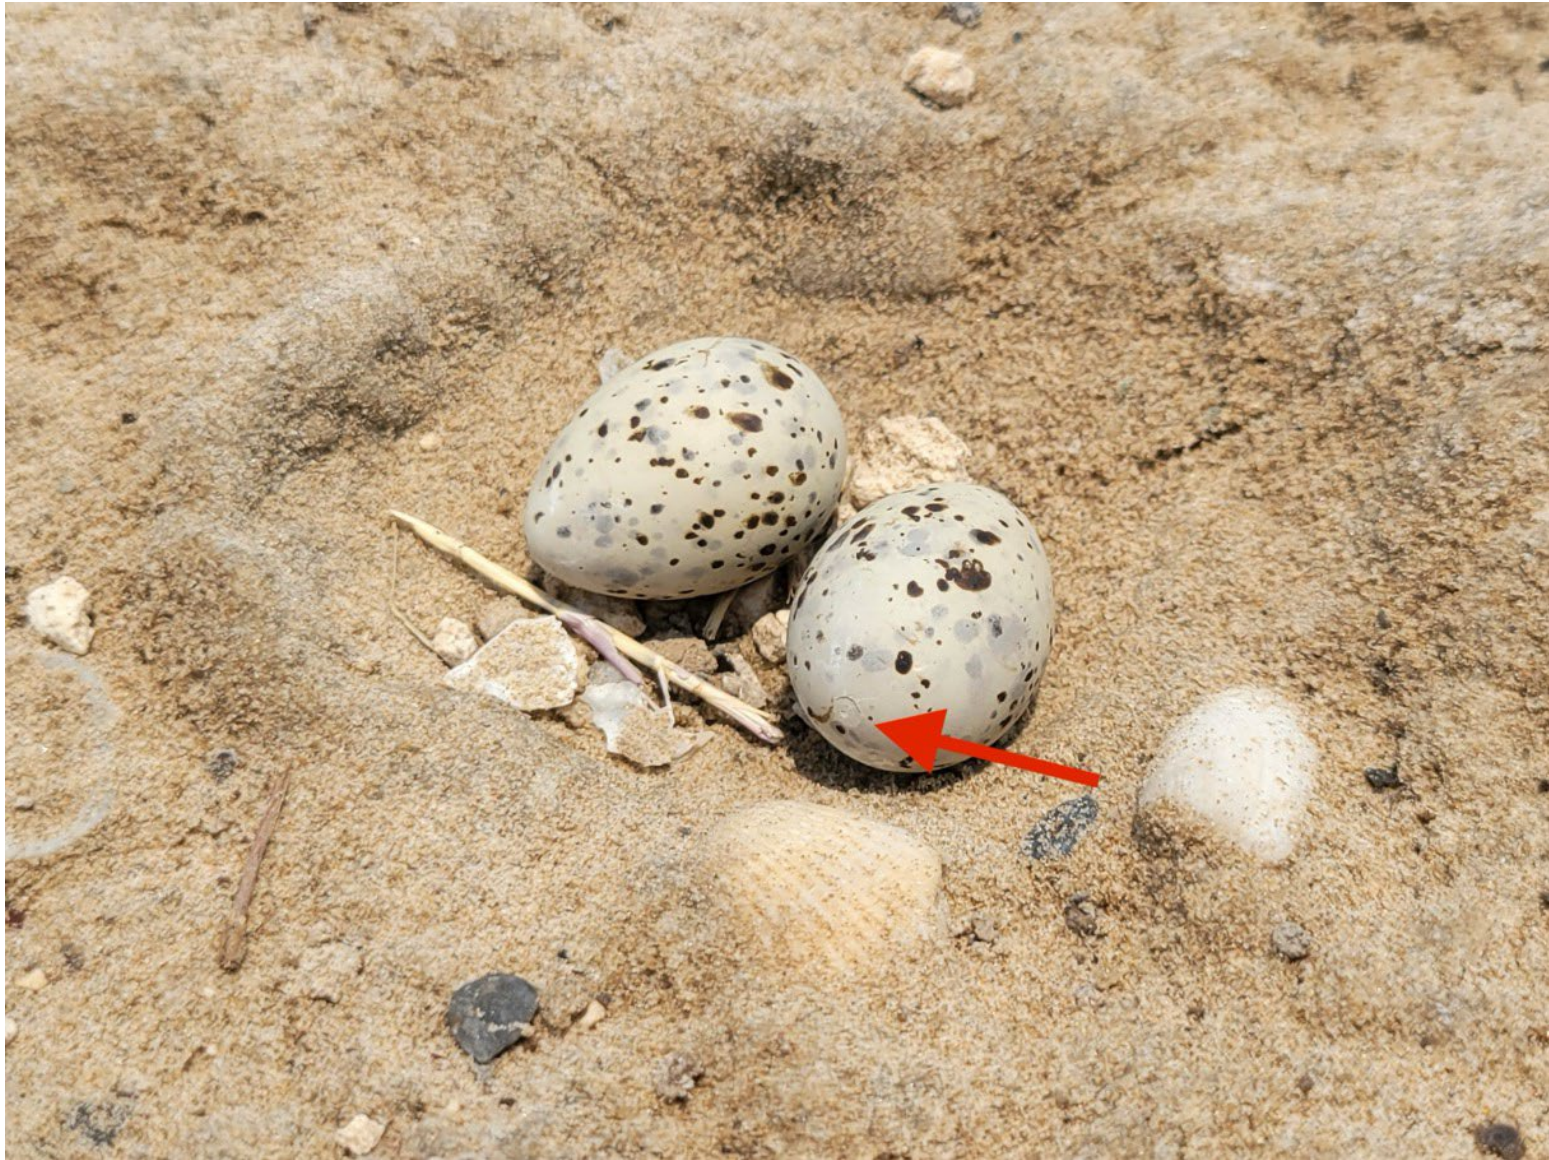
Figure 12. Small but noticeable depressed crack on egg from LETE 3 on June 6, 2024.
