Shorebird nest fates at Boca Chica after rocket test launch

Prepared by Justin LeClaire, David Newstead
Coastal Bend Bays & Estuaries Program
June 6, 2024

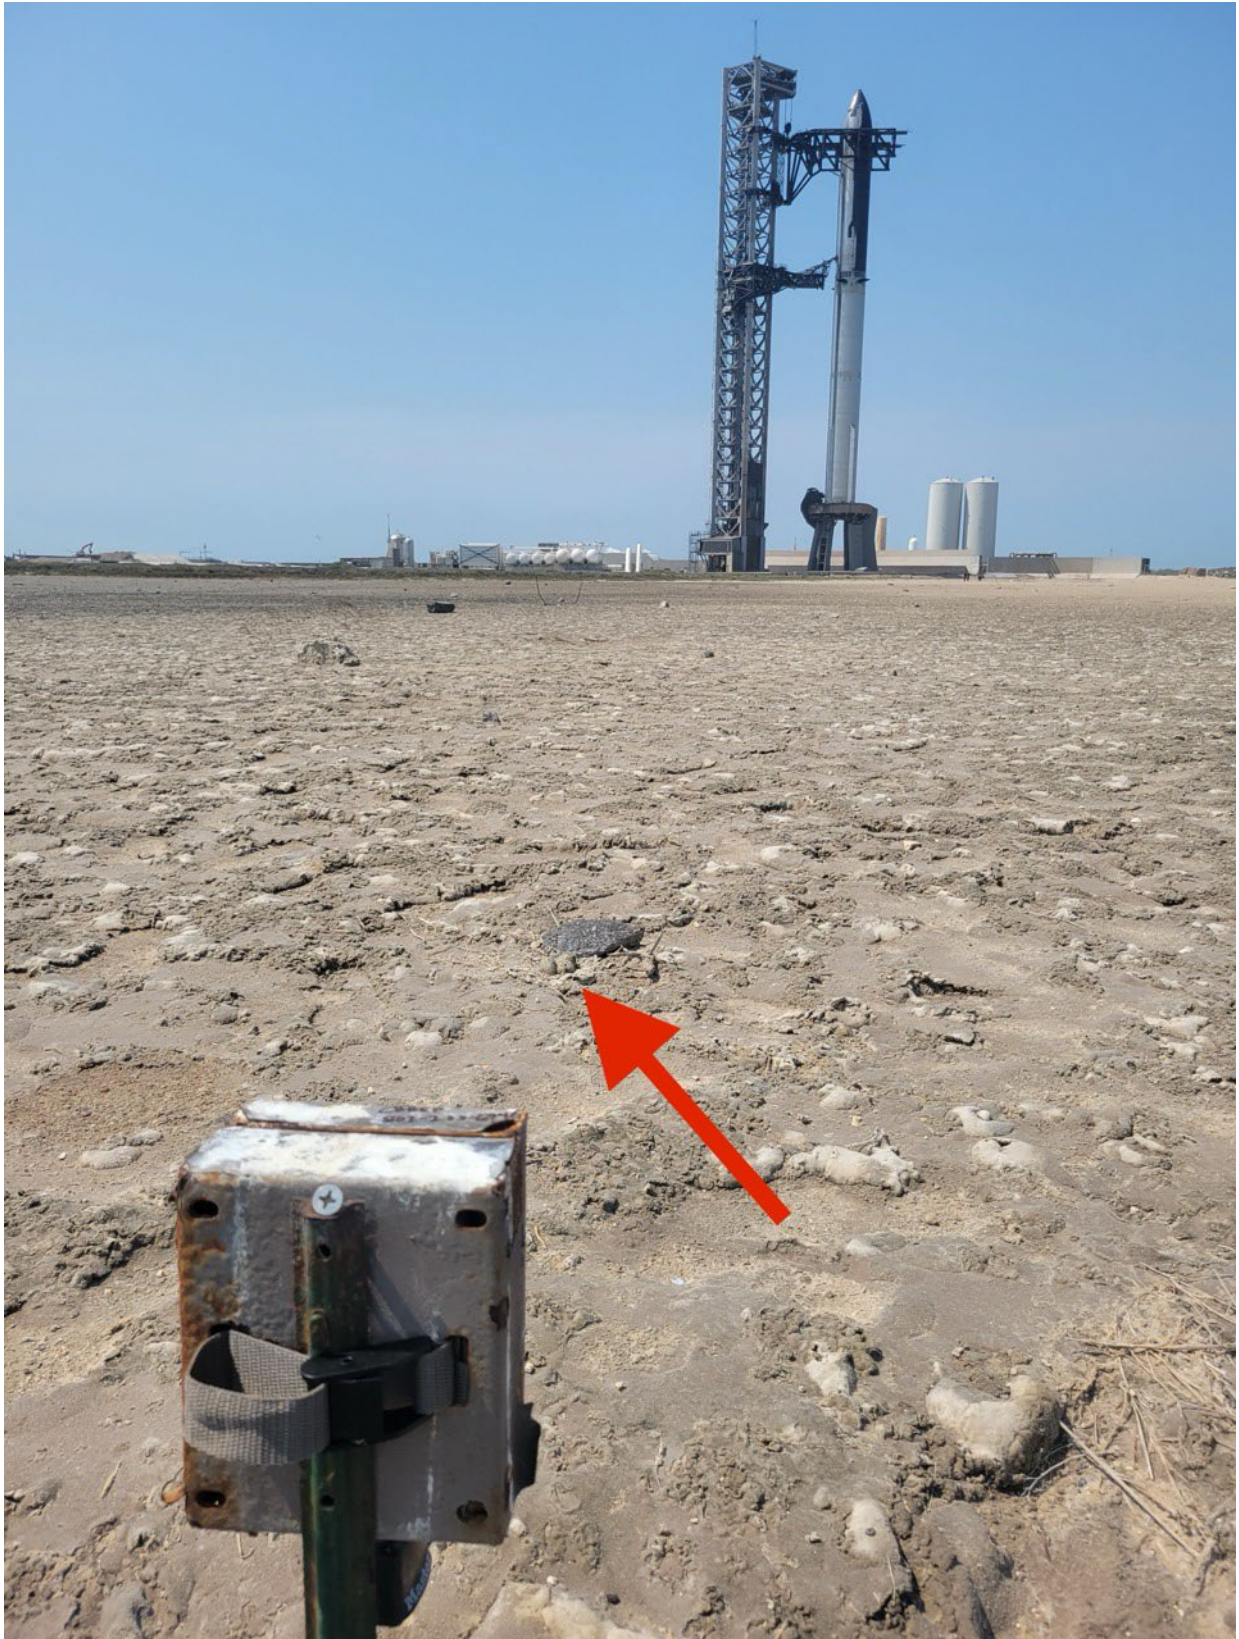
Figure 13. WIPL 1 as referenced by red arrow with game camera installed nearby facing north pre-launch on June 5, 2024.

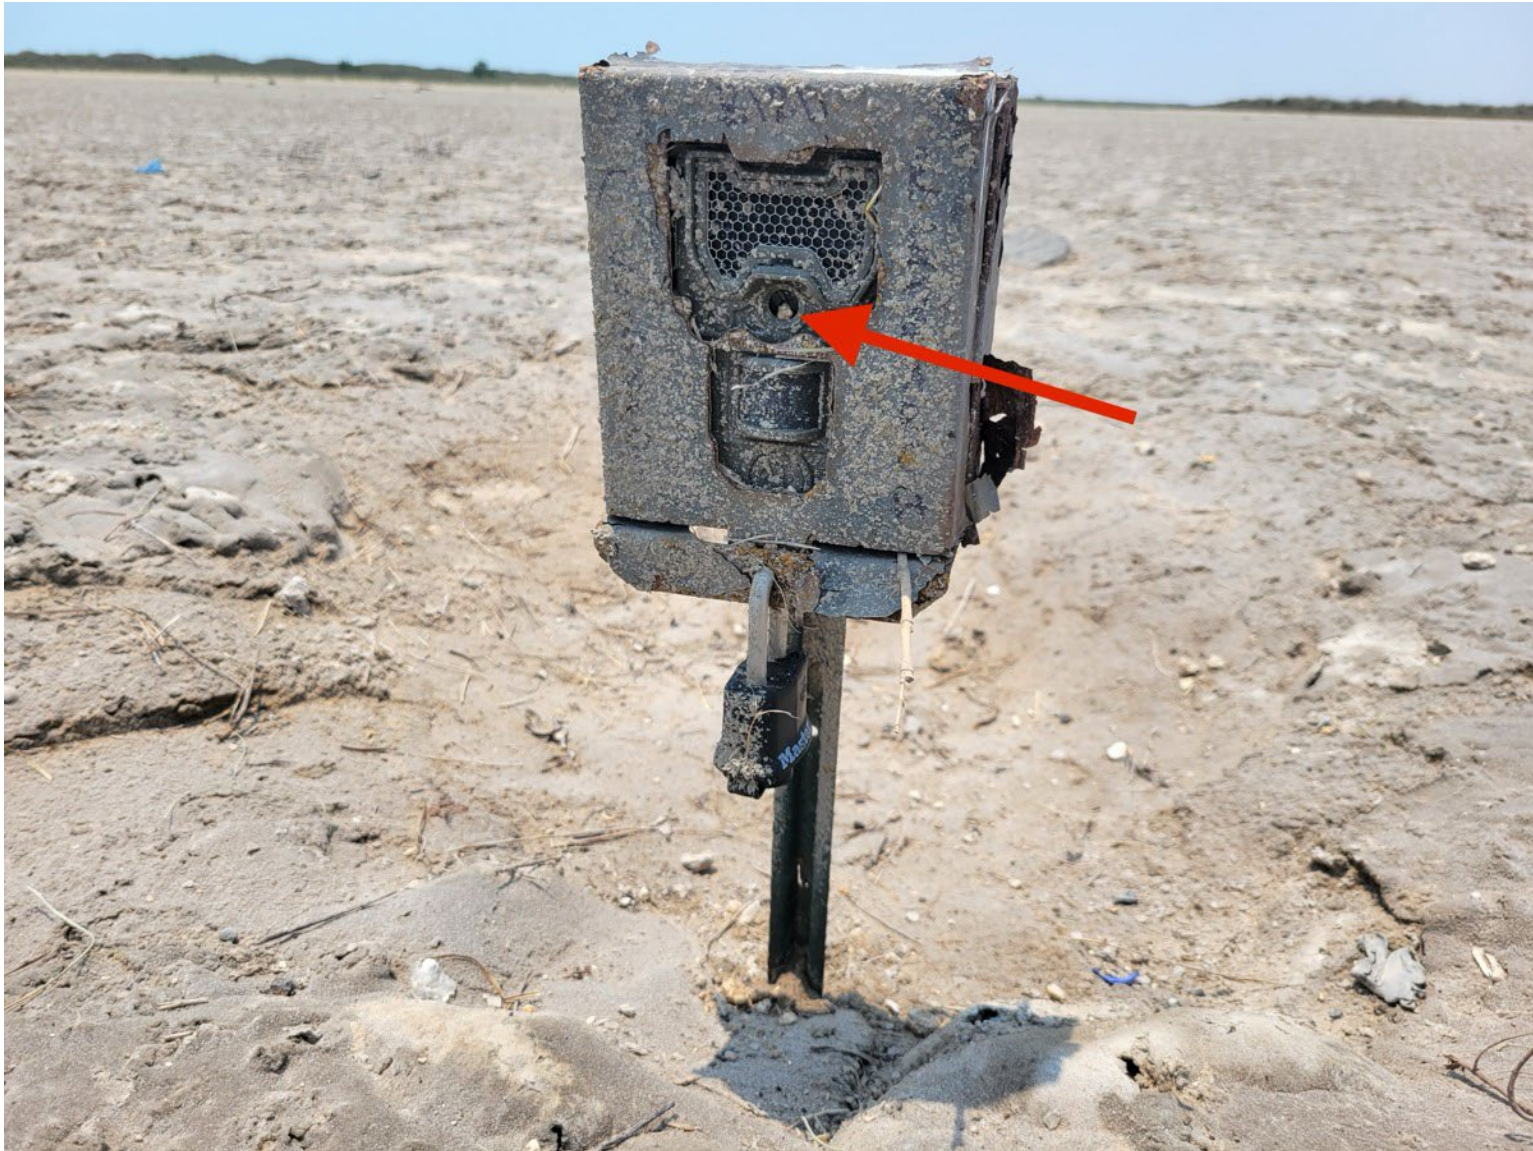
In the post-launch monitoring, both CBBEP game cameras that were placed near nests were found to be heavily coated in clumped sand/mud on their launchpad-facing sides (the camera face). Additionally, the lens on the camera set up at WIPL 1 had been shattered by a pea-sized piece of concrete debris that was found wedged between the game camera and its protective metal housing. Game camera photographs explained below.

Figure 14. Game camera from WIPL 1 showing the launchpad-facing side covered in mud as well as a concrete pebble sitting in front of the camera lens post-launch on June 6, 2024.

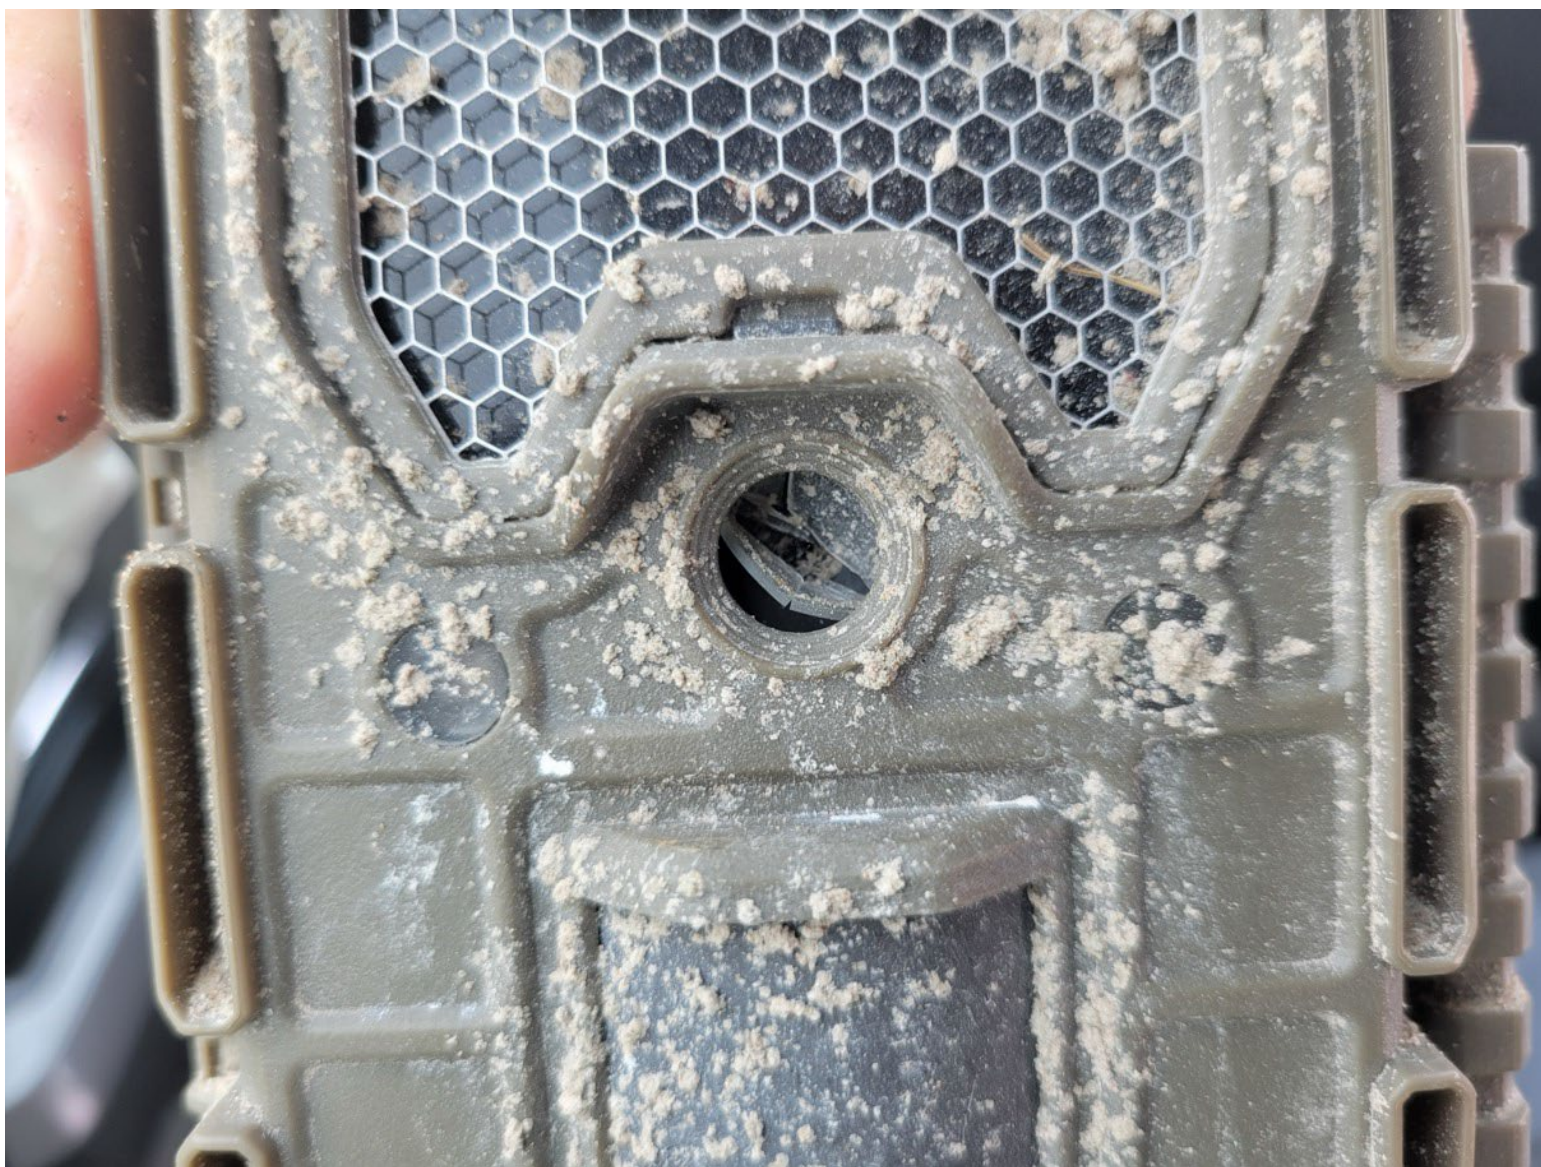
Figure 15. Game camera from WIPL 1 showing completely cracked camera lens after pebble was removed post-launch on June 6, 2024.

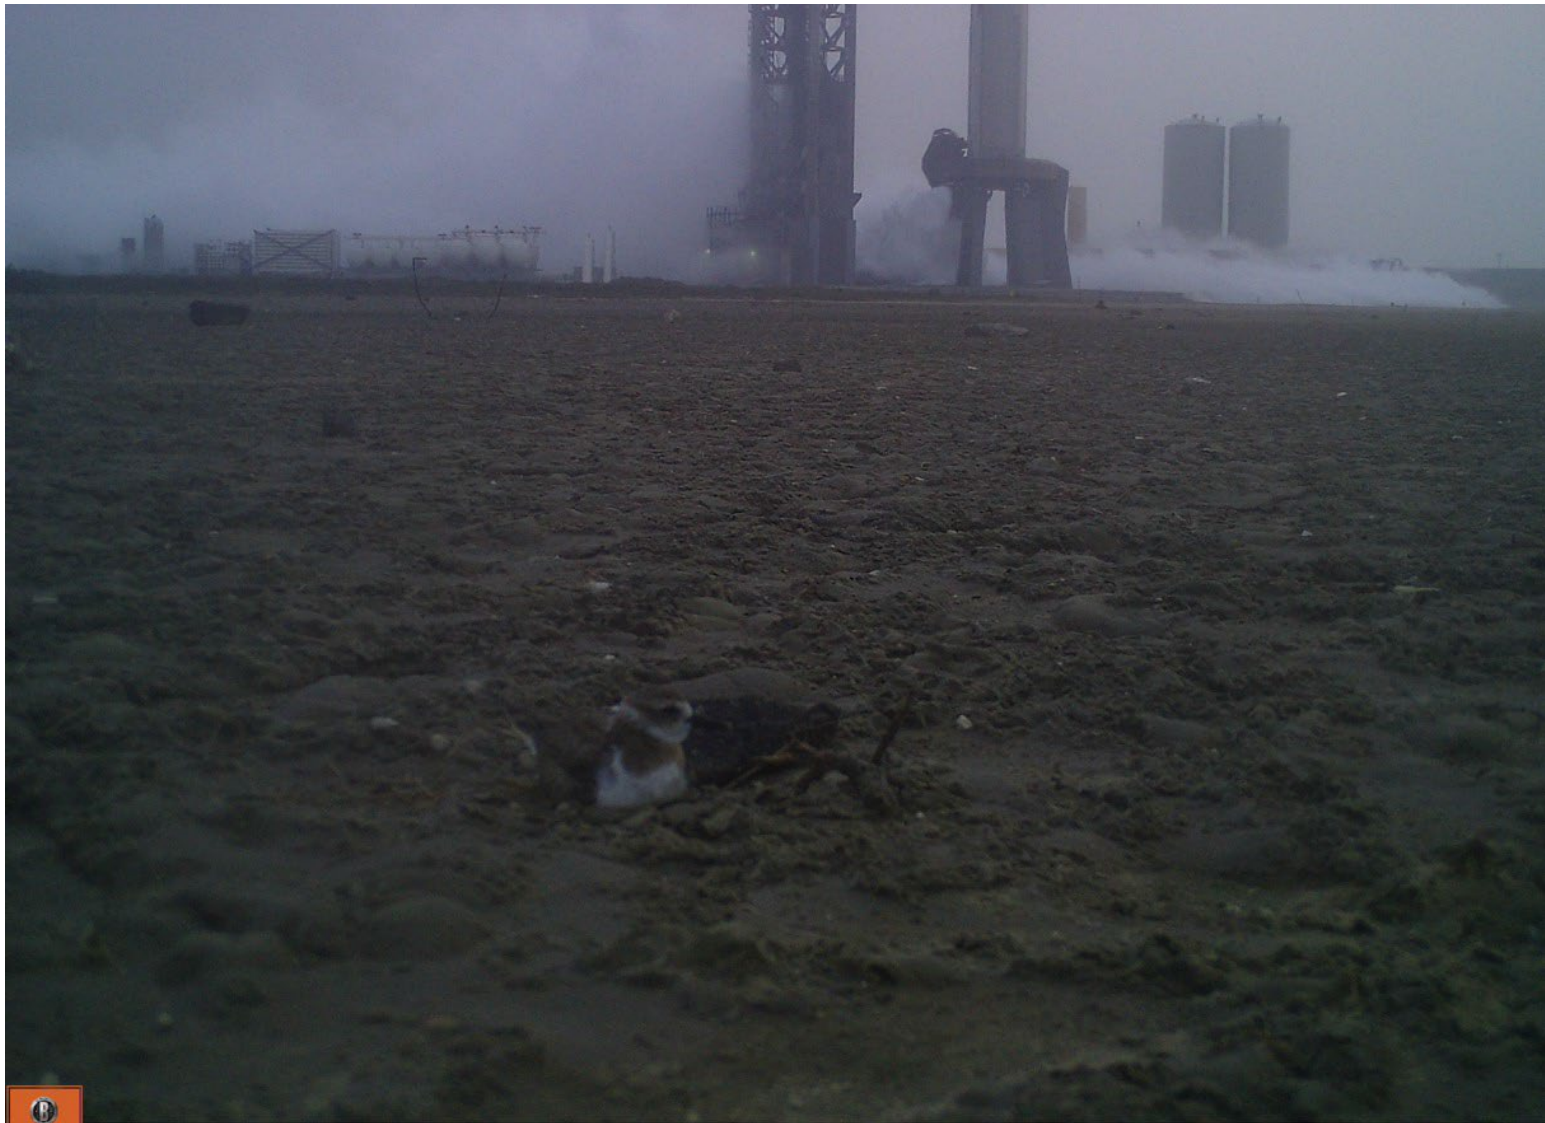
Figure 16. WIPL 1 game camera showing adult female WIPL incubating nest at 6:59am on June 6, 2024, 50 minutes before rocket launch.

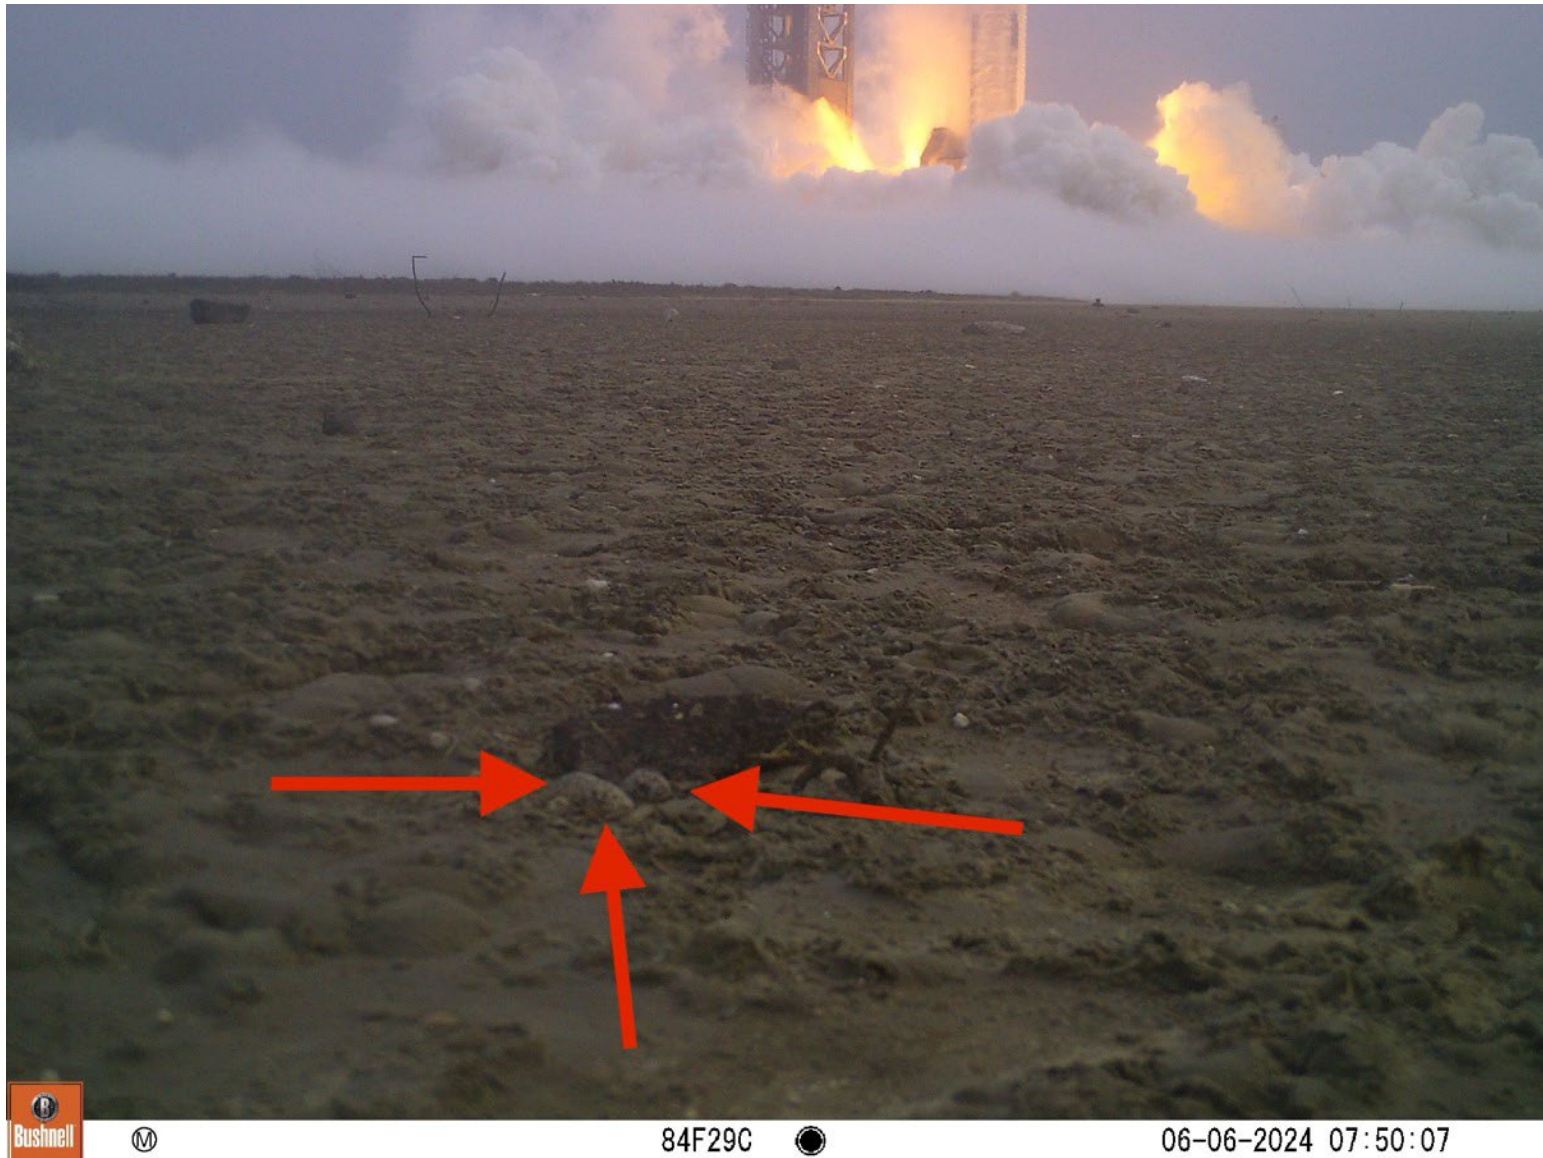
- WIPL 1 camera: camera images clearly show all 3 eggs as well as one or both WIPLs incubating the nest through the rest of June 5 and the proceeding night. Flames are seen from under the rocket at 7:50am on June 6 and at that point the adults are no

Figure 17. WIPL 1 game camera showing 3 eggs in nest cup with rocket engines firing in the background on June 6, 2024.

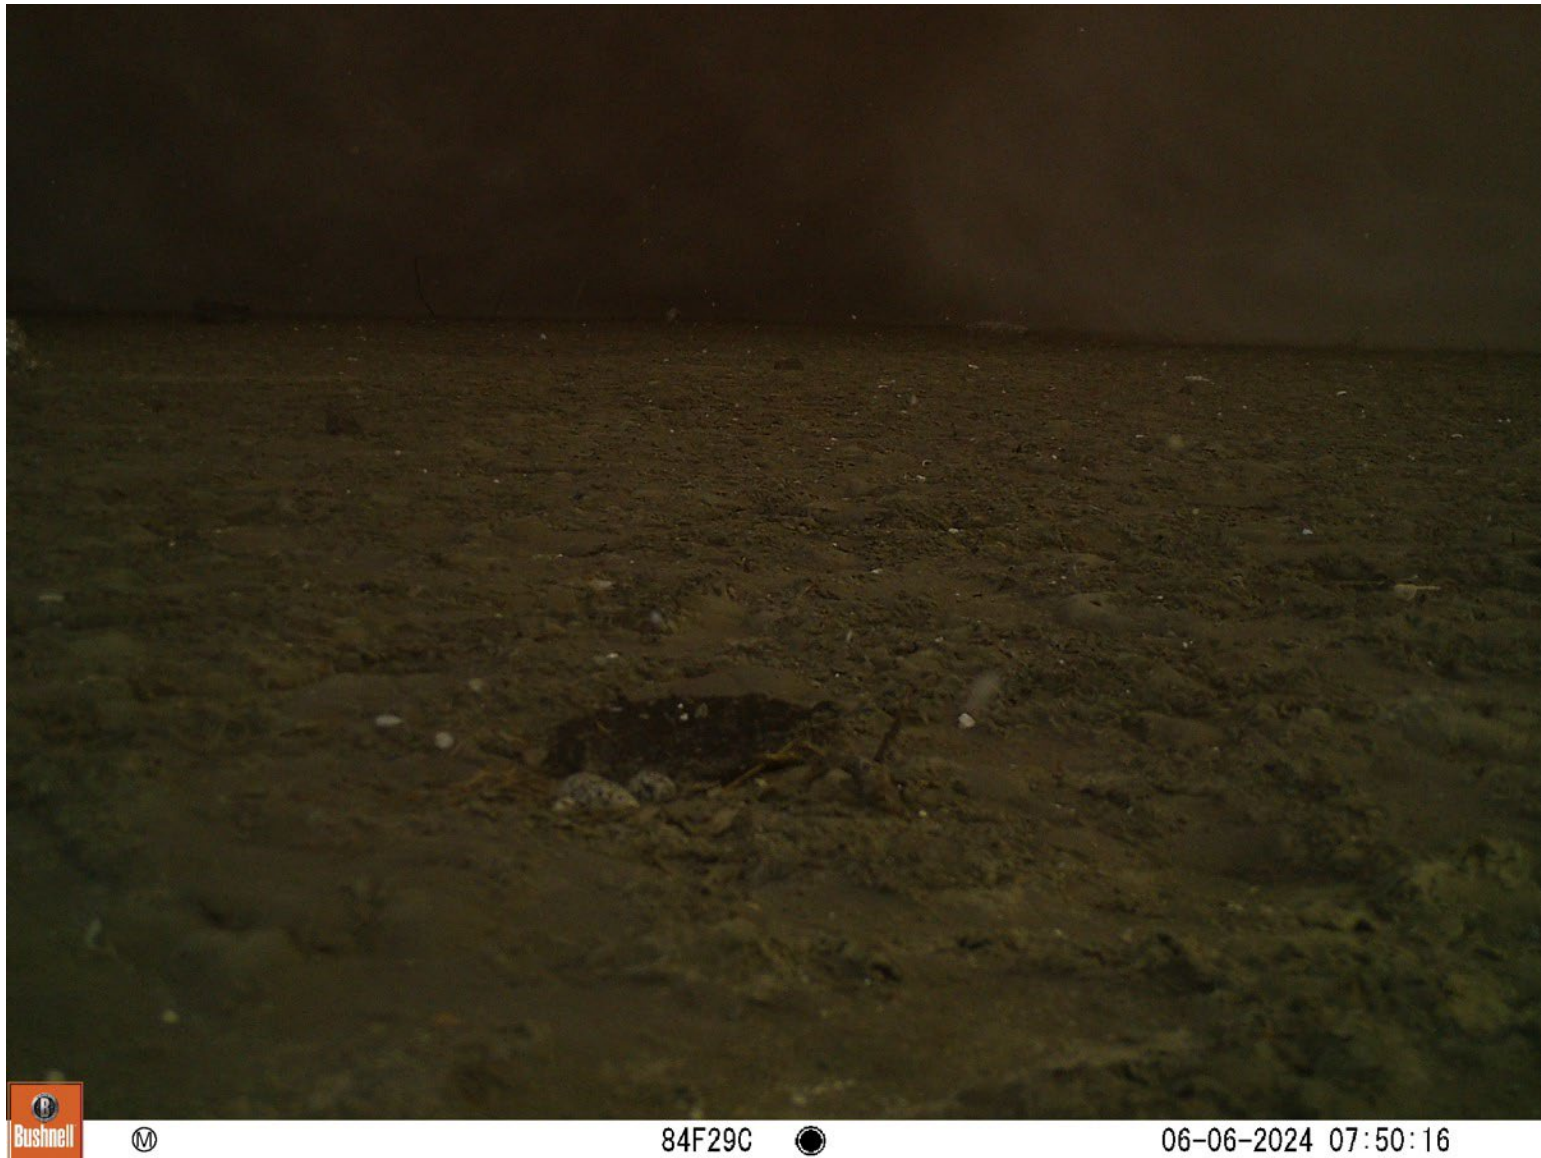
longer in sight but 3 eggs clearly remain. Subsequent images show the thick cloud of dust and small debris approach the camera at a very high rate of speed (estimated minimum 100 ft/sec based on location of leading edge of cloud between photos less than 1 second apart). Within 18 seconds of the engines firing the dust began to clear and all subsequent images appear in a pinkish hue, possibly due to wet sand/mud coating the camera and sensors. It also became apparent that the concrete pebble had broken camera lens and lodged in front of the lens, blocking any view of the nest towards the bottom of the images. The next images taken were 2.5 hours after launch, at which point the WIPLs can be seen switching places incubating the nest, though the nest contents still cannot be seen in the photos. The nest was found at 12:42pm by CBBEP staff with only one egg remaining in it and no signs of predators or egg pieces around.

Figure 18. WIPL 1 game camera showing dust/smoke and small pale-colored debris moving toward the nest and camera at a high rate of speed during the rocket test flight launch on June 6, 2024.

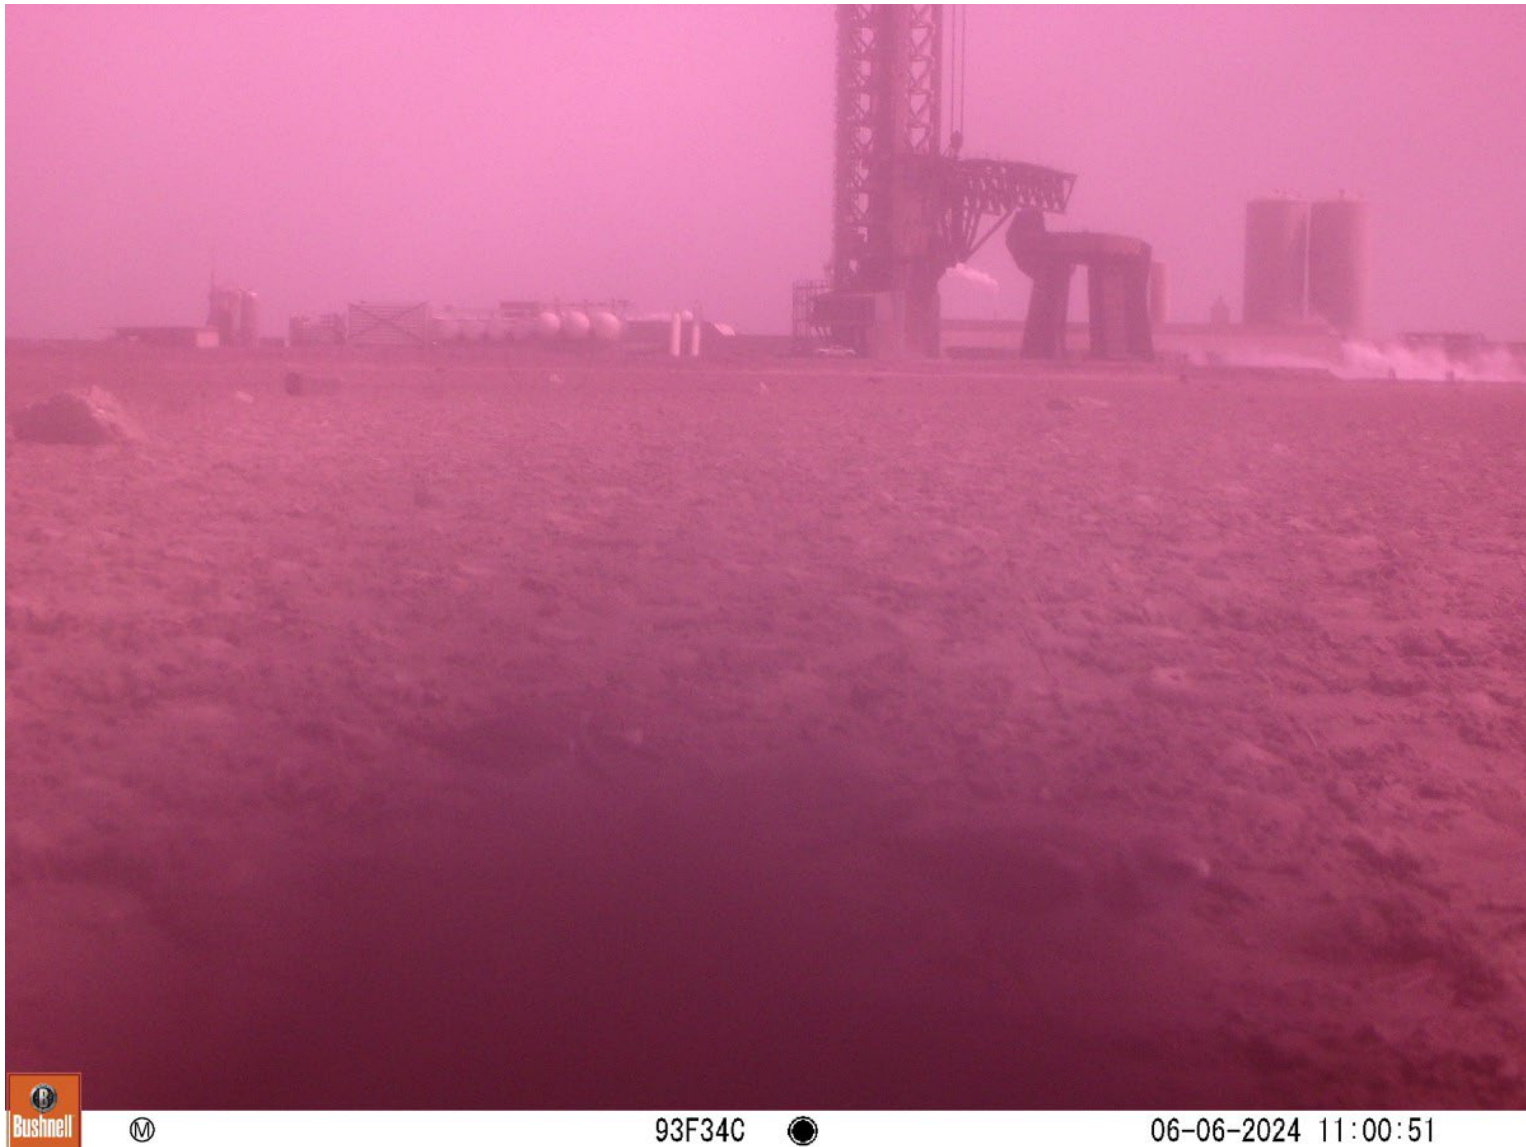
Figure 19. WIPL 1 game camera showing both WIPL adults in attendance but nest cup not quite visible due to pebble lodged in camera lens and overall pinkish hue post-launch on June 6, 2024.

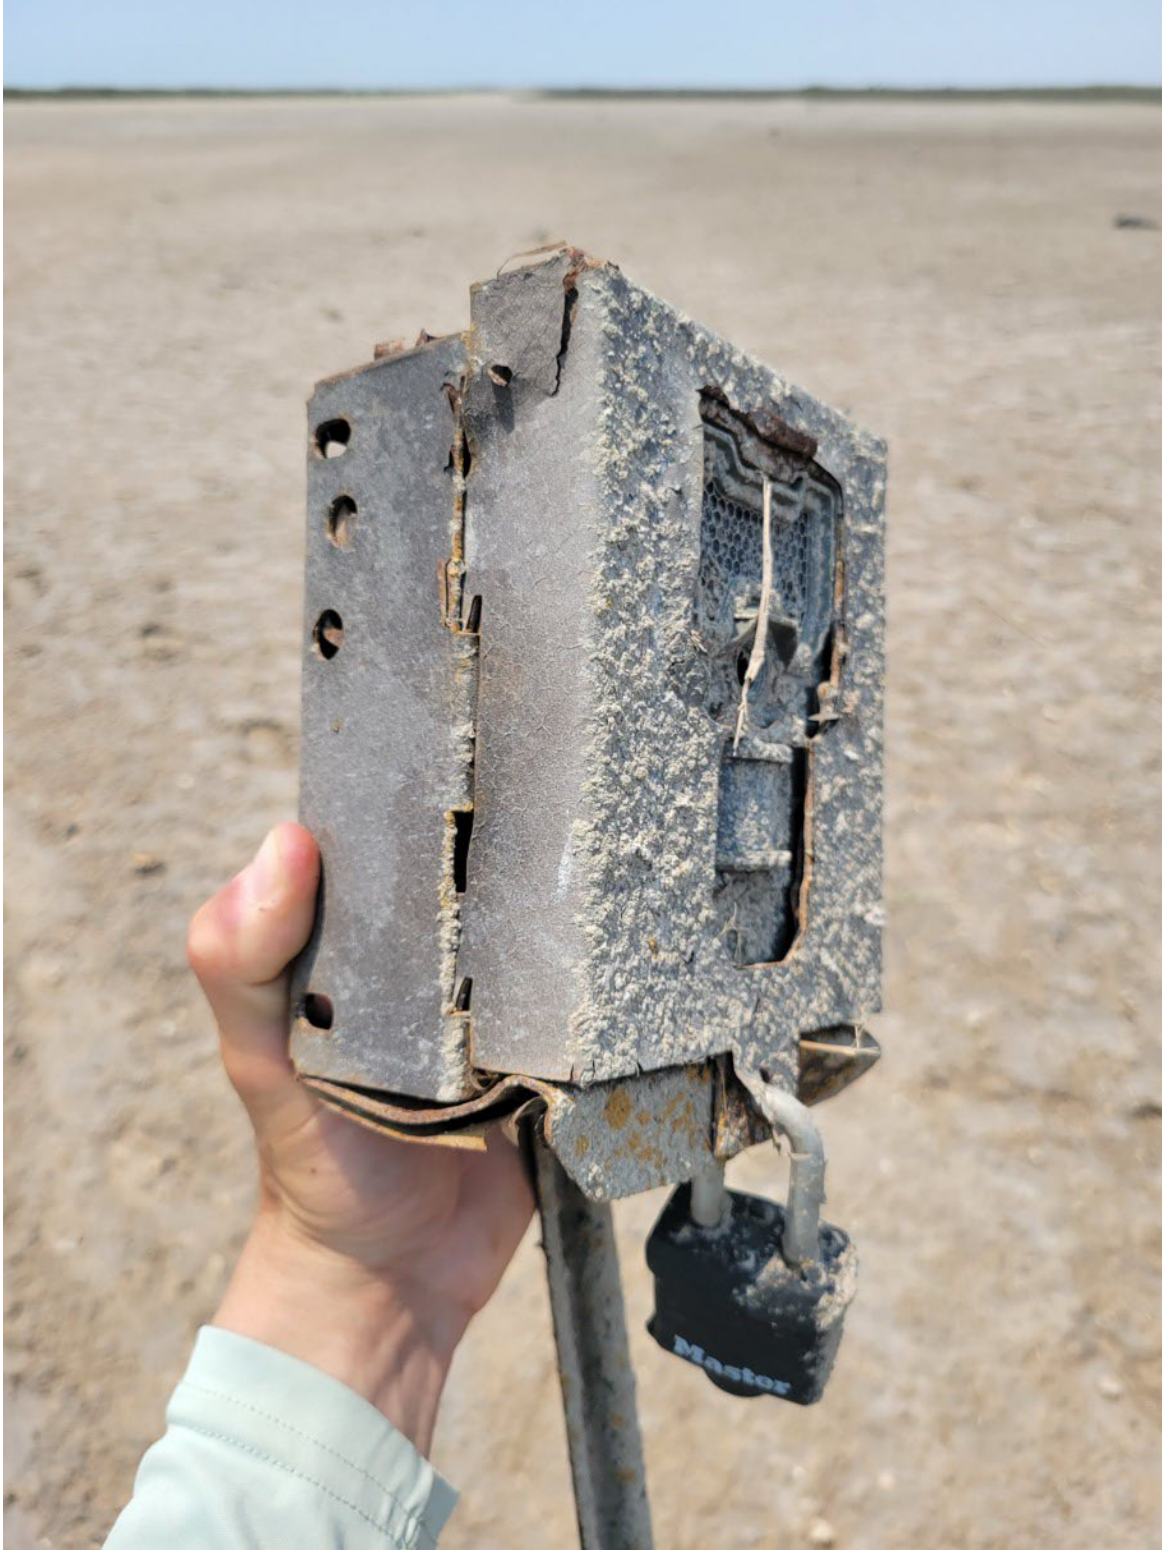
Figure 20. Game camera from SNPL 2 showing the launchpad-facing side completely covered in mud as compared to a clean side post-launch on June 6, 2024.

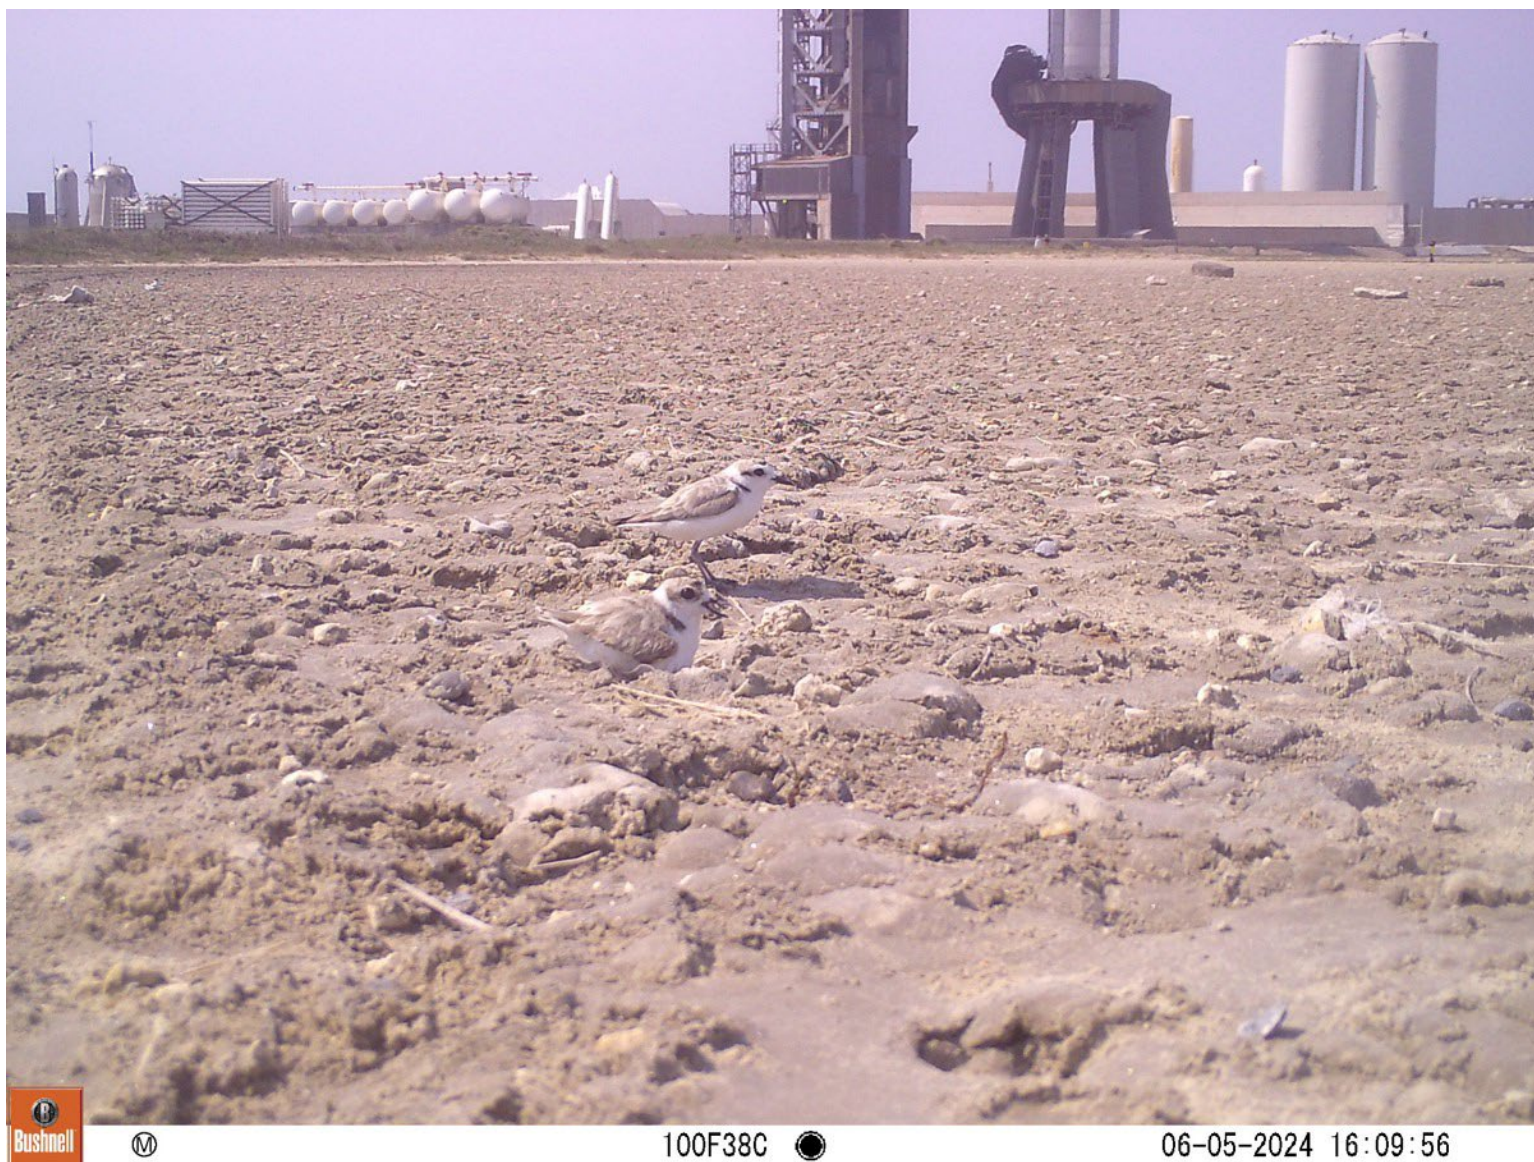
Figure 21. SNPL pair incubating SNPL 2 shortly after the game camera was set up pre-launch on June 5, 2024.

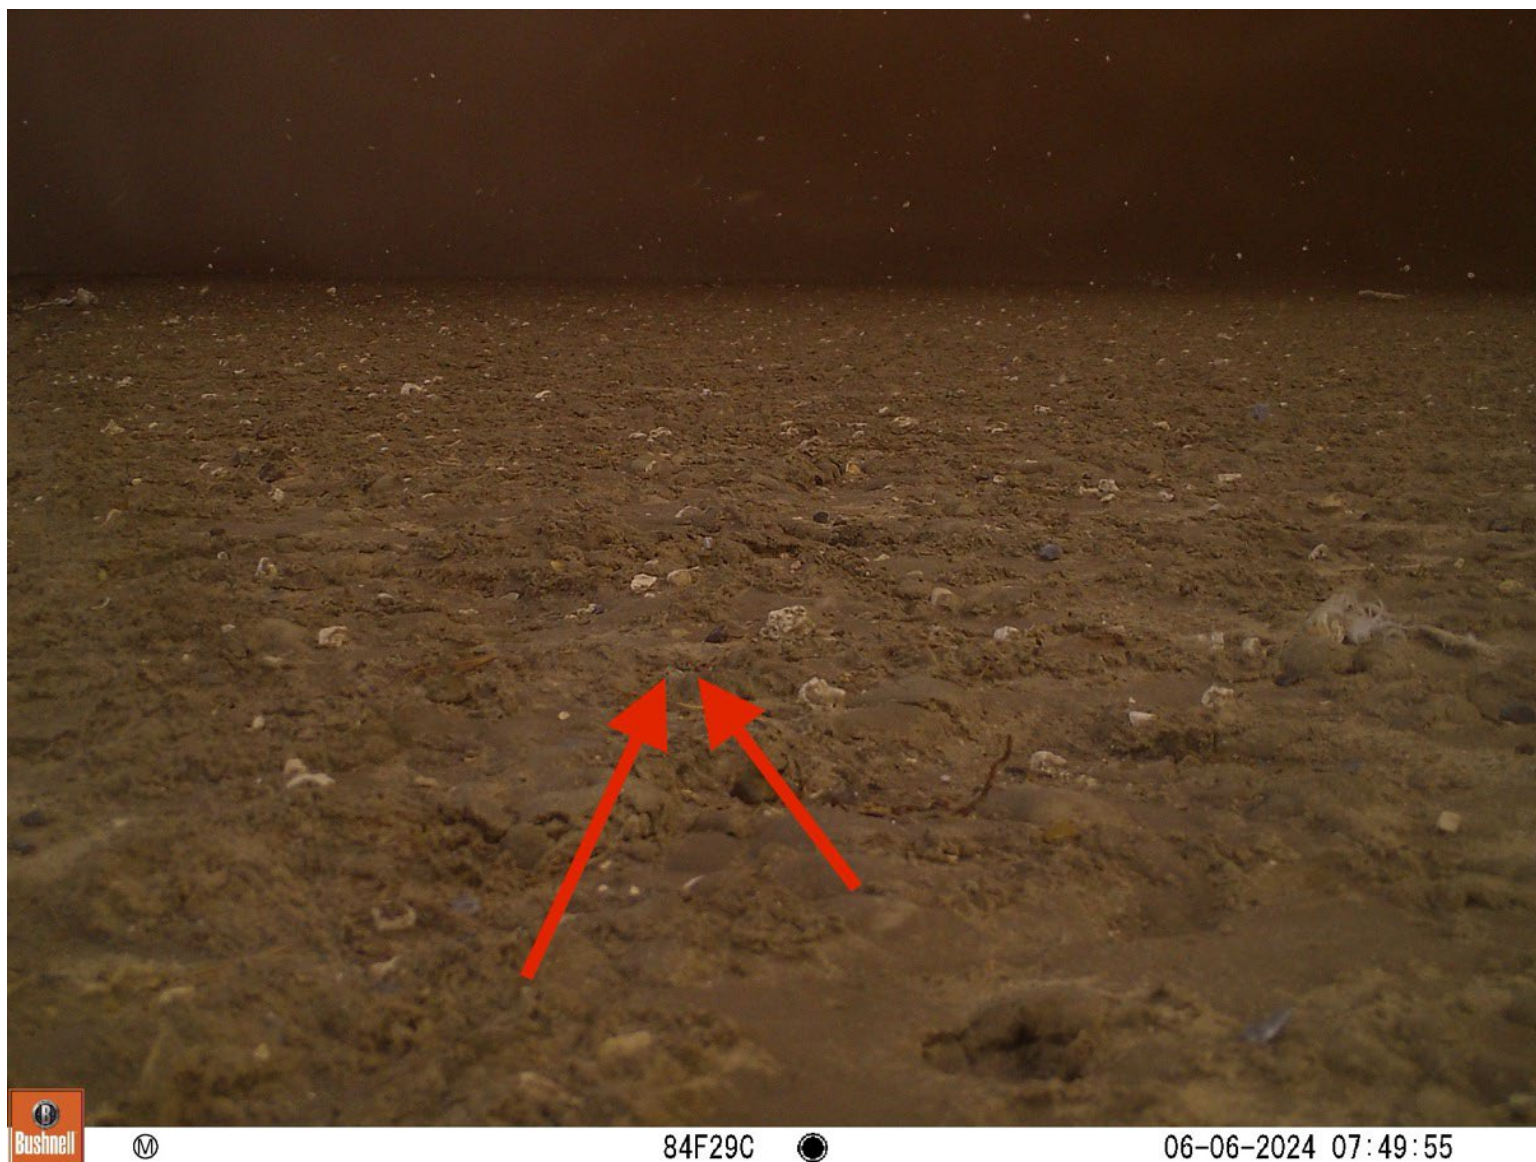
- SNPL 2 camera: camera angle did not allow for clear viewing of nest contents, but the SNPL pair did return to incubate the 3-egg nest after camera installation for a few photos. No other photographs were taken until 7:50am on June 6, just after the rocket launch when the dust cloud and debris can again be seen rapidly moving towards the camera. Nest contents are not perfectly clear in the images but the edge of at least two eggs appear to be visible in the nest cup. The images turn a yellowish hue after the dust settles and no more photographs were taken until CBBEP staff checked the nest at 12:28pm. The nest was then observed with just a single egg in it that was cracked and no longer viable, though the attending SNPLs were still incubating the nest.

Figure 22. SNPL 2 game camera showing dust cloud and small pale-colored debris moving toward nest and game camera at a high rate of speed, with nest cup and at least two eggs possibly visible as referenced by red arrows on June 6, 2024.

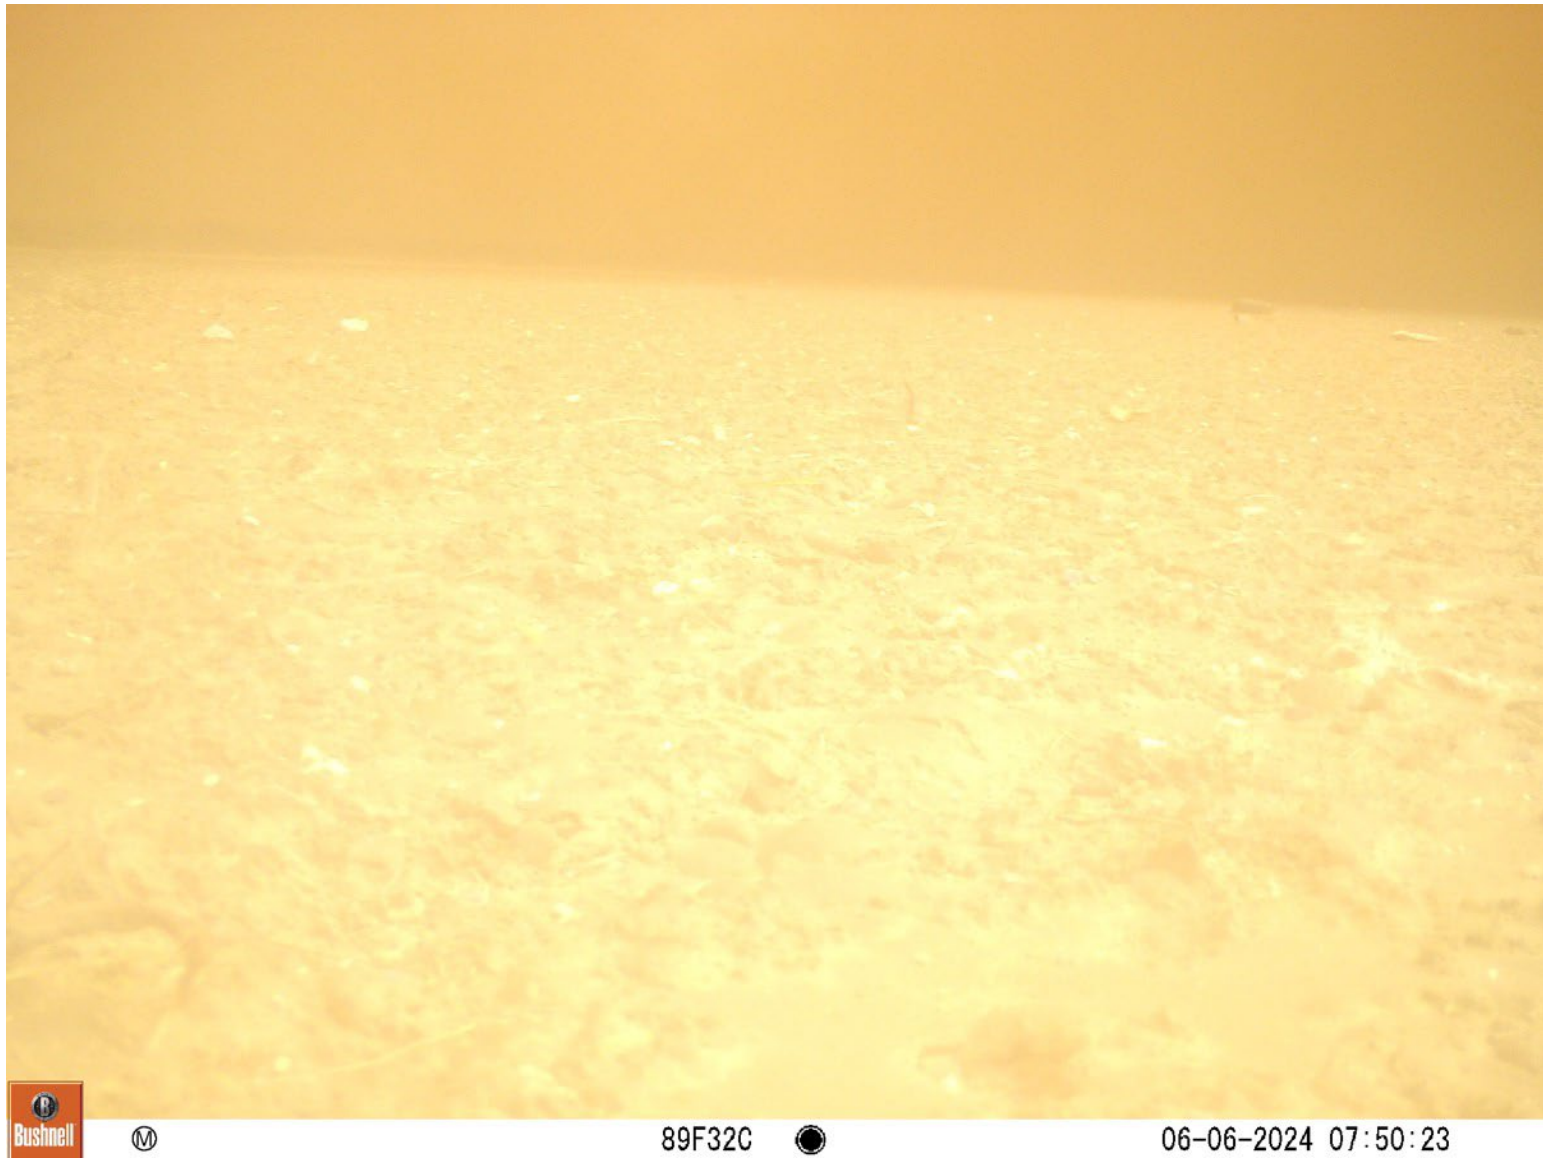
Figure 23. The last SNPL 2 game camera photograph taken post-launch until CBBEP staff checked the nest 4.5 hours later on June 6, 2024.

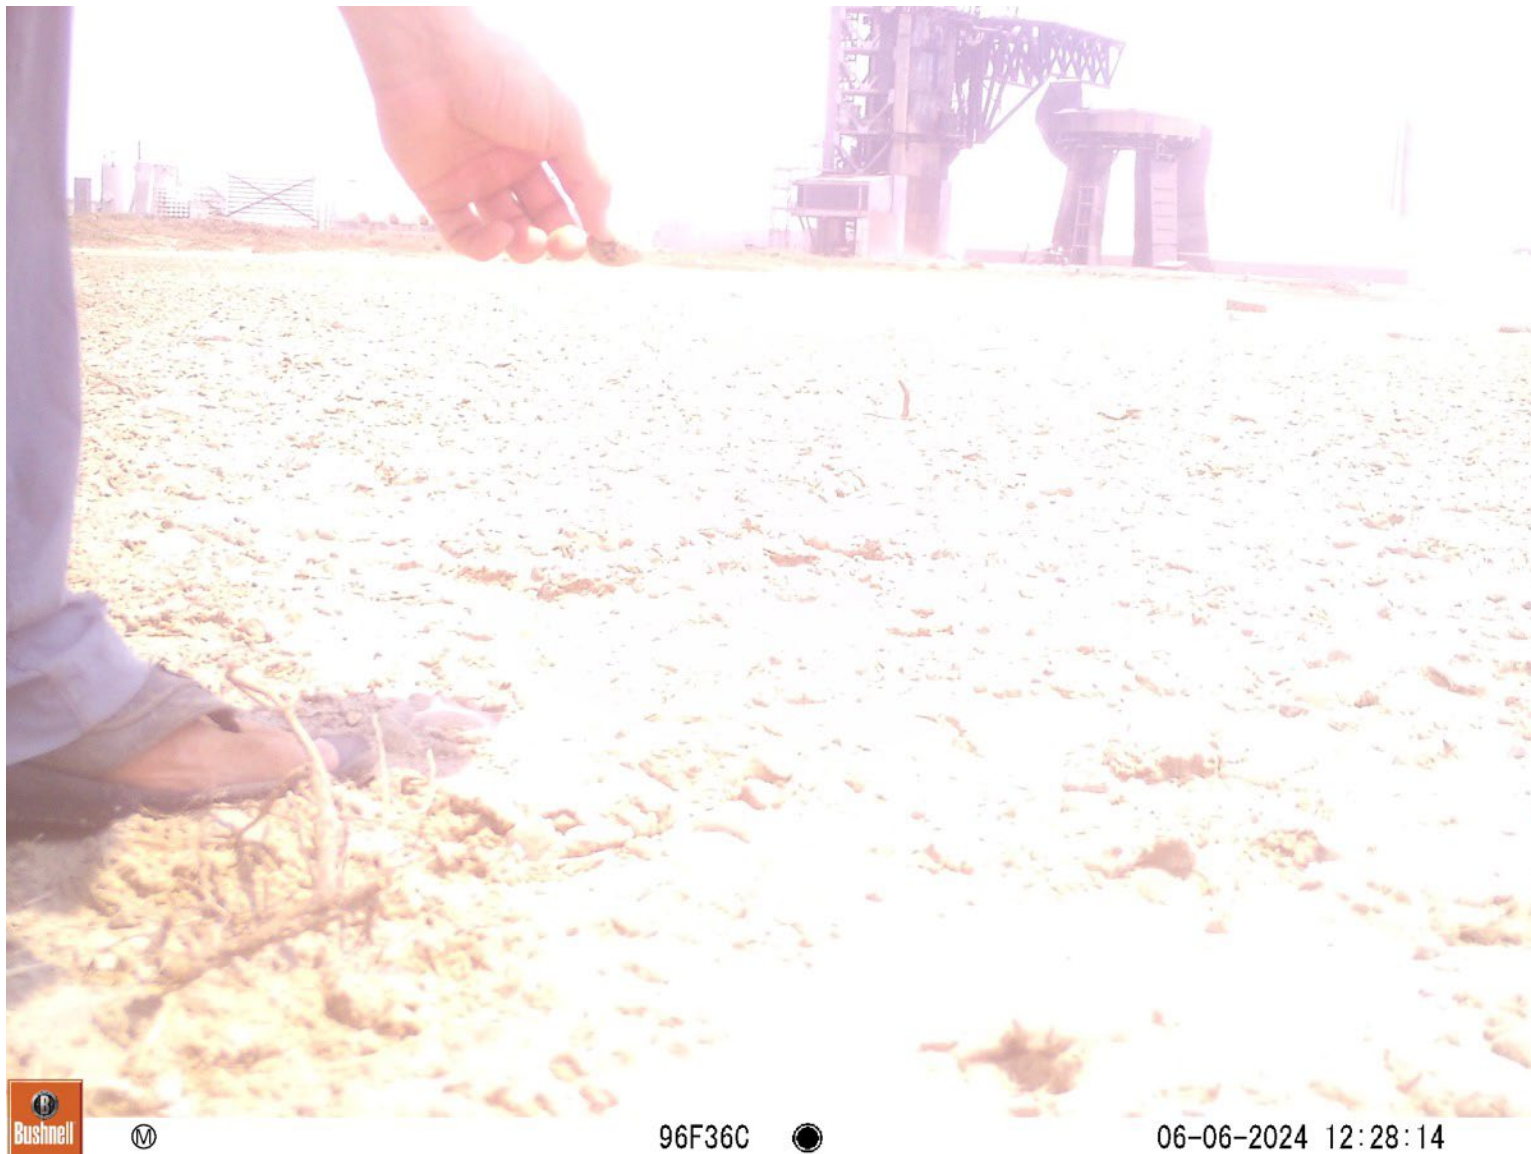
Figure 24. SNPL 2 game camera with CBBEP staff checking SNPL 2 nest post-launch on June 6, 2024, proving camera is still operational despite limited clarity.
