FW: 12-20-16 Endicott Den Update

Subject: 12-20-16 Endicott Den Update

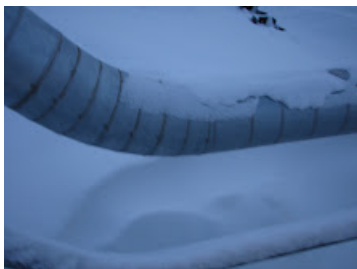
12-20-16 Photo.jpg
1463K

The first attached Photo is of the den area looking directly towards the entrance. The second attached photo is from the Northeast corner of the bridge looking over the den. The last one is of the FLIR shot from the same perspective, which shows the potential heat source (showing as a lighter area), just above the green dot in the center of the screen on the image. As indicated previously the winds and drifted snow would also be affecting the heat signature.
