Pacific Lamprey and Bull Trout Passage Assessment at Warm Springs National Fish Hatchery

2014 Report

> Final June 20, 2014

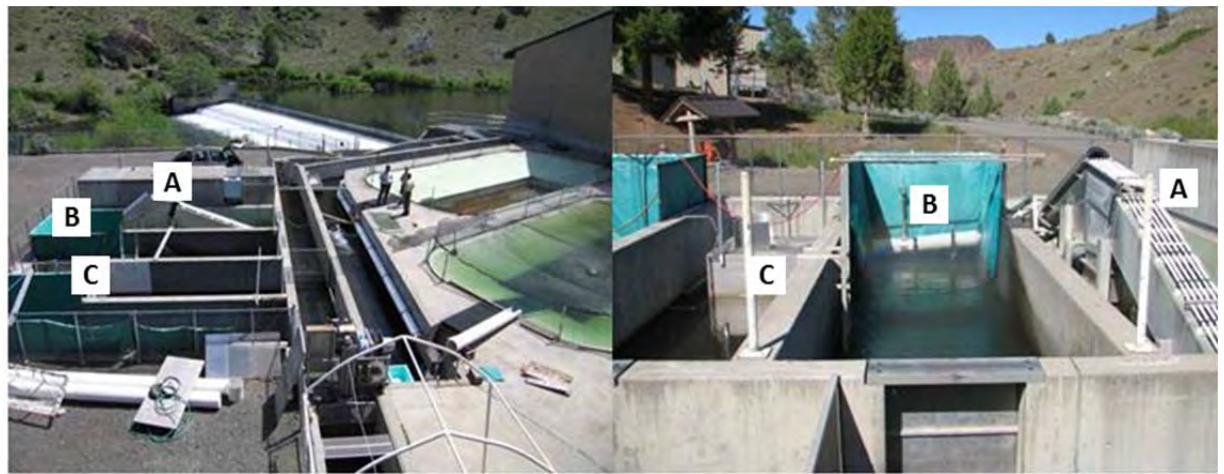
Figure 12. Oblique photo (left image) and lateral photo (right image) of the WSNFH fish counting station which consists of a Denil-steeppass ladder[A], drop tube [B], and a camera box [C].

Archibald (2013) identified specific problems with the equipment used in the fish counting station at WSNFH that could increase delay or jeopardize the goal of limiting upstream migration of hatchery adults. The counting station was not operational during our site visit so a hydraulic assessment was not possible. Therefore, our assessment focused on pool length and orientation upstream and downstream of the counting station. The recommended pool length downstream of the counting station should be 2x the standard pool length. The recommended pool length upstream of the counting station should be 1x the standard pool length. The upstream and downstream pools should be in a straight line with the station.

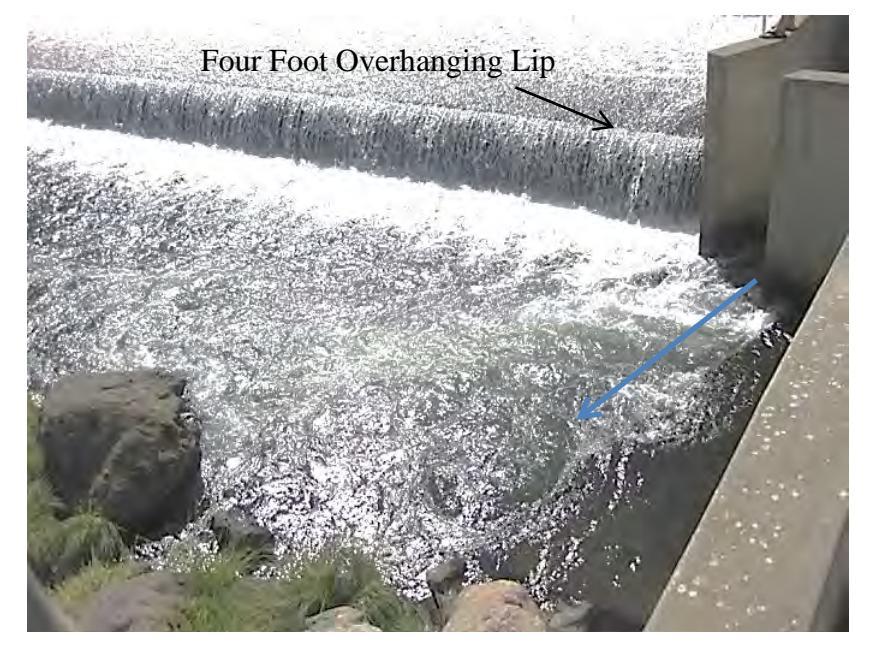
The barrier dam (Figure 14) spans the entire width of the river and has a 4 foot lip or overhang. We measured the overhang and cross referenced the length in the original design drawings. The overhang is likely a significant passage barrier for lamprey and the corner edges of the lip are approximately 90 degree angles further limiting lamprey passage. Lamprey could spend a significant amount of time and energy trying to ascend the barrier dam with little likelihood of passing. We interviewed three hatchery staff about visual observations of lamprey passing the barrier dam at either end, and no observations could be recalled by any of the staff. To minimize any delay or injury that might occur at the barrier dam and the entire fishway, a Lamprey Alternative Passage System (LAPS) may need to be installed that would allow lamprey passage over the barrier dam. A LAPS could be installed adjacent to and on the existing fishway near the entrance, and on one or both sides of the barrier dam. Figure 15 depicts a LAPS installed on the Washington shore ladder of Bonneville dam. Upstream passage of bull trout is likely blocked by the barrier dam. The amount of time and energy bull trout spend trying to ascend the barrier dam before finding the fishway entrance is unknown.

Figure 14. Barrier Dam with four foot overhanging lip and fish ladder entrance looking upstream at WSNFH.

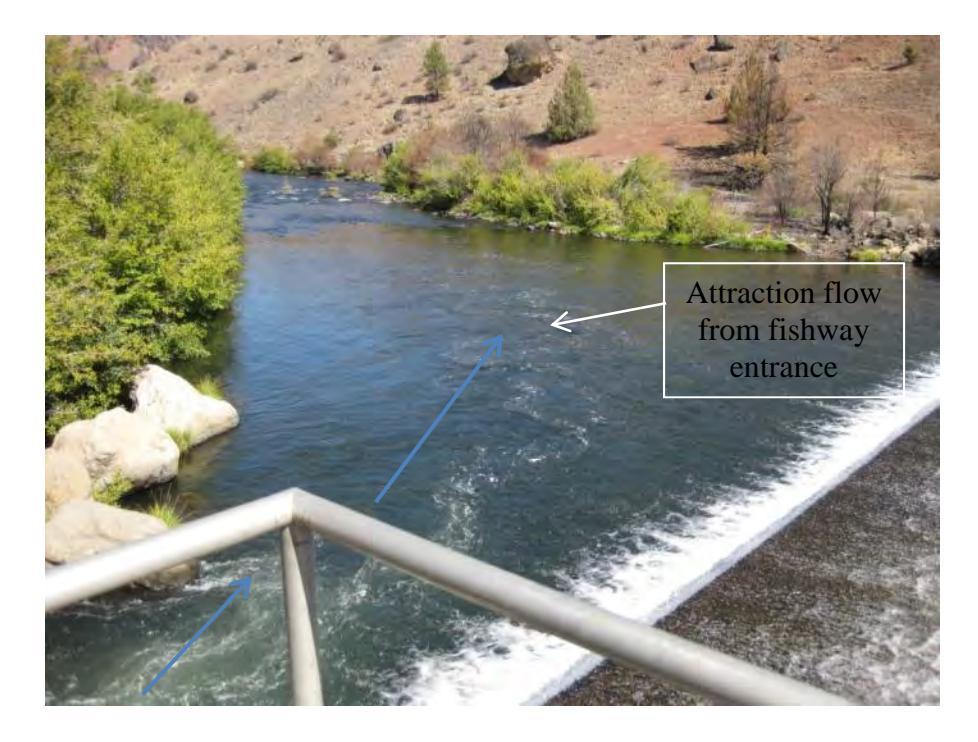
Based on a visual inspection only, the approach to the ladder for both Pacific lamprey and bull trout appeared to be acceptable at the streamflow levels observed during the 2013 field visit. A relatively deep channel led to the ladder entrance and a deep pool was present downstream from the ladder entrance. Water velocities were not tranquil within the pool immediately downstream of the entrance, but they appeared to be slower than velocities in the main channel of the river which were not measured (Figure 14 and Figure 16). Discharge from the ladder entrance flowed diagonally across the channel downstream, which should attract fish throughout the tail race toward the ladder.

Figure 16. View looking downstream from the barrier dam at WSNFH. The blue arrows depict the flow pattern of water exiting the fishway entrance at the lower left.

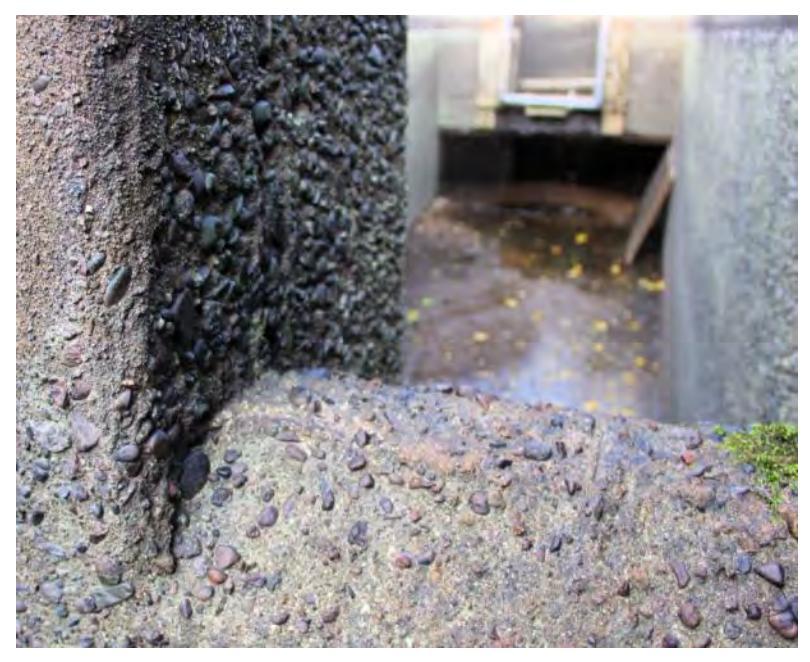
The larger top orifice in the orifice weir section of the ladder is approximately 18 inches wide and 6 feet tall, meets the recommended minimum width and height. The top orifice did not have 4 inch rounded corners or edges on the top or sides as recommended for lamprey passage. The bottom of the top orifice was slightly rounded (Figure 17). The bottom orifice measured 9 inches wide and 15.5 inches tall which does not meet recommended width of 12 inches. In the bottom orifice, where lamprey are more likely to be passing, the sides and top of the orifice are slightly rounded (Figure 8 plate B). The bottom is completely open and flush with the fishway floor, allowing lamprey to move along the bottom of the ladder unimpeded. However, on both the top and bottom orifices the roughened aggregate surfaces may limit lamprey ability to maintain suction (Figure 17).

Figure 17. Detail of the slightly rounded bottom edge of top orifice.

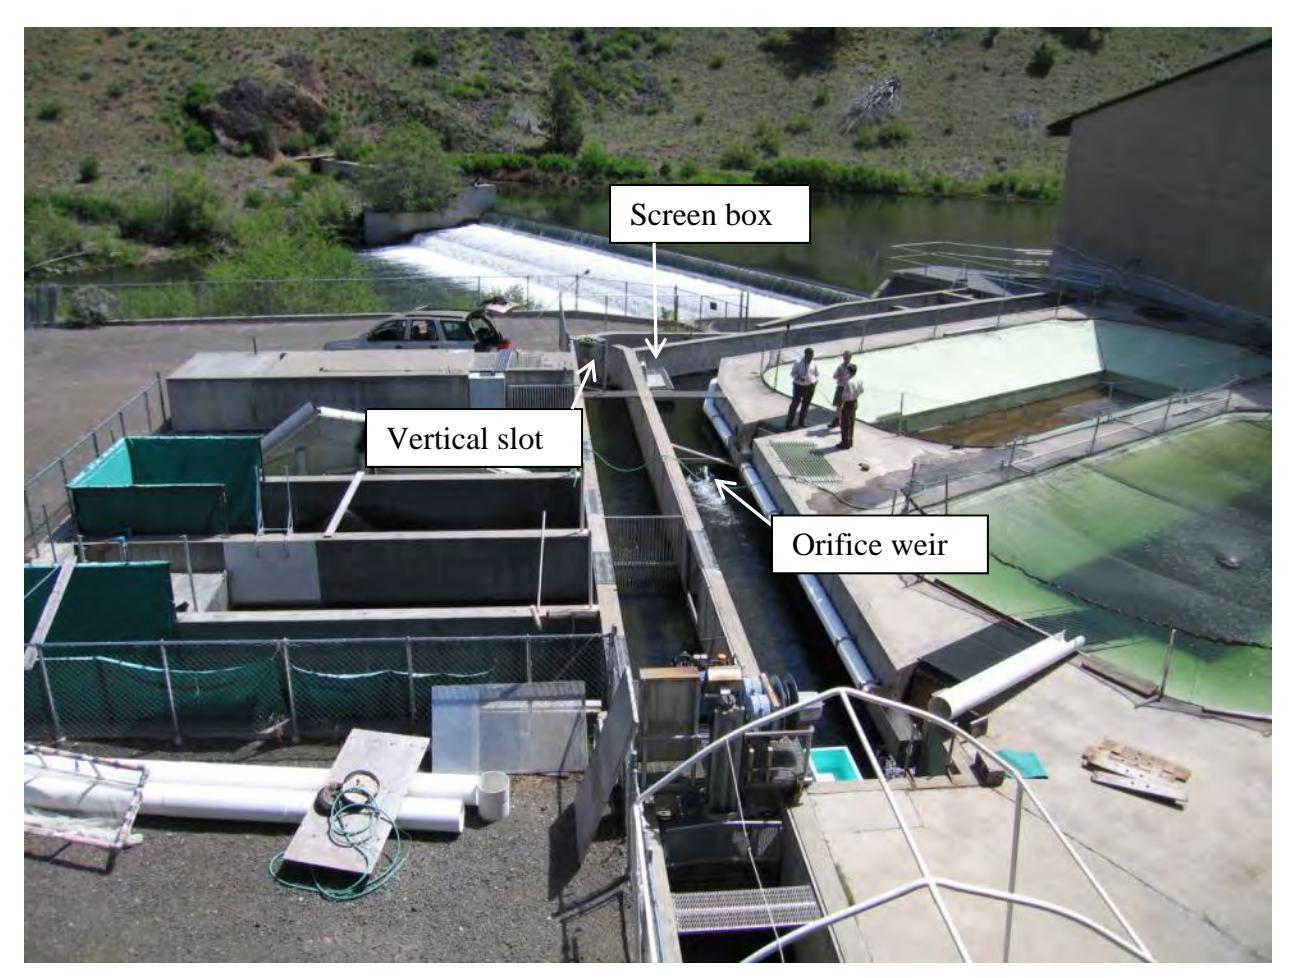
Figure 18. Location of passage impediments in transport channel.

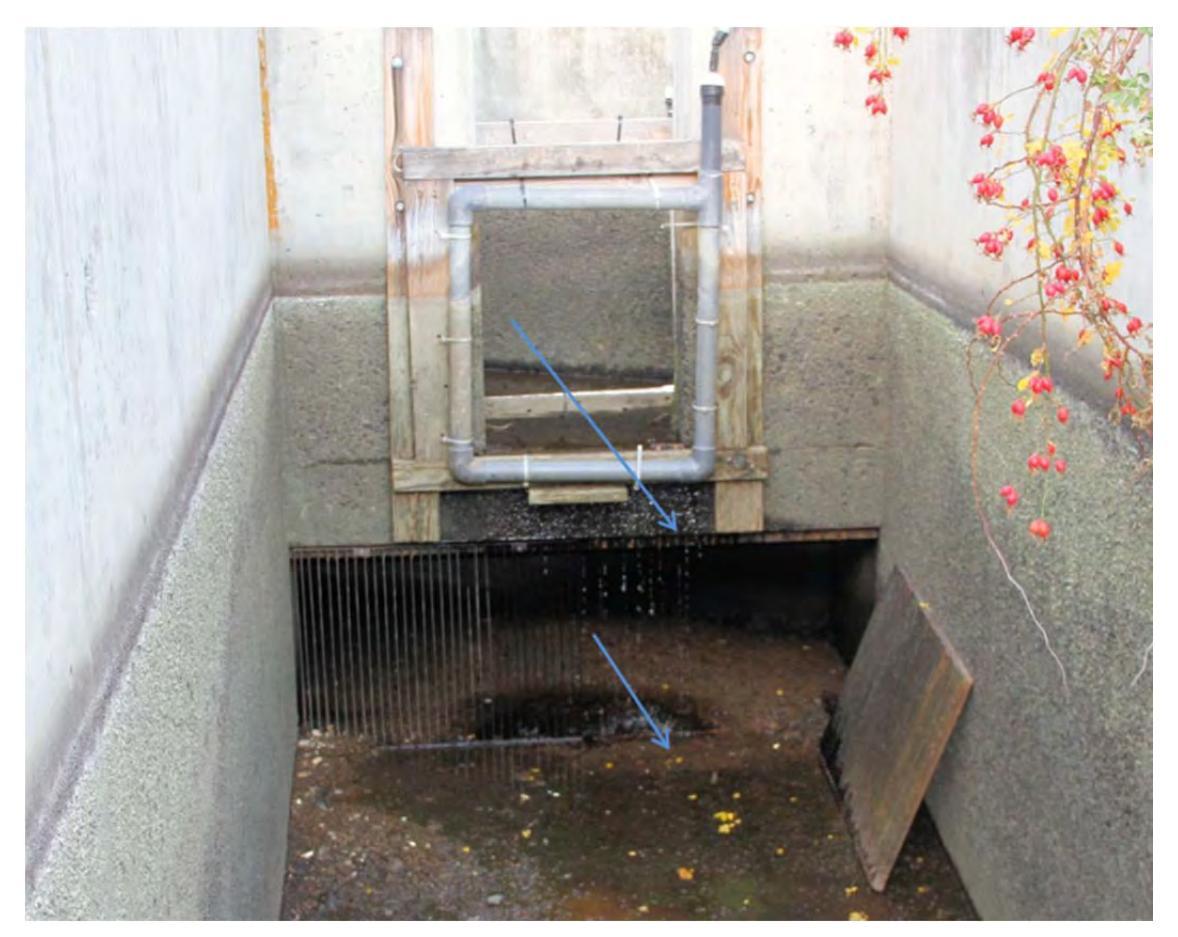
As fish move upstream from the orifice weir section of the ladder through the fish transport channel, the first obstruction encountered is approximately a 3 foot step (Figure 19). The face of the step is constructed of steel grating with 1 inch spacing which allows water to flow from the screen box to below the PIT antenna. Above the step is a vertical slot where a PIT antenna has been installed. Nose velocity was 2.93 ft/s and mean column velocity was 3.34 ft/s on the vertical slot. No velocities were measured through the grating. Water velocities are within NOAA's recommended range of 1.5-4.0 ft/s for transport channels. The steel grating was damaged and has recently been repaired. Apparently, adult fish attracted by the flow coming through the grate were ramming the grating (Mary Bayer, USFWS personal communication.). Grate spacing of 1 inch and greater allows lamprey passage (David Wills, personal communication). If lamprey pass through the grating, they would hit a dead end in the screen box. If they don't pass through the grating and attempt to pass through the elevated vertical slot and PIT antenna, there is no substrate for attachment. The corners/edges of the vertical slot are not rounded with a 4 inch radius, but are beveled. The corners/edges of the vertical slot are covered by the PIT antenna. The grating potentially delays both lamprey and bull trout passage and could cause injury to adult salmonids and impinge lamprey. It is unknown if the elevated vertical slot, the lack of rounded corners/edges or the presence of the PIT antenna results in delayed passage. The antenna should be removed and installed on the upstream side of the

Figure 19. Vertical slot weir leading to the transport channel with PIT array and 3.0 foot step at WSNFH. The blue arrows depict the direction of water flow.

vertical slot to provide a continuous and smooth surface to navigate over the weir. Further investigation may be necessary.

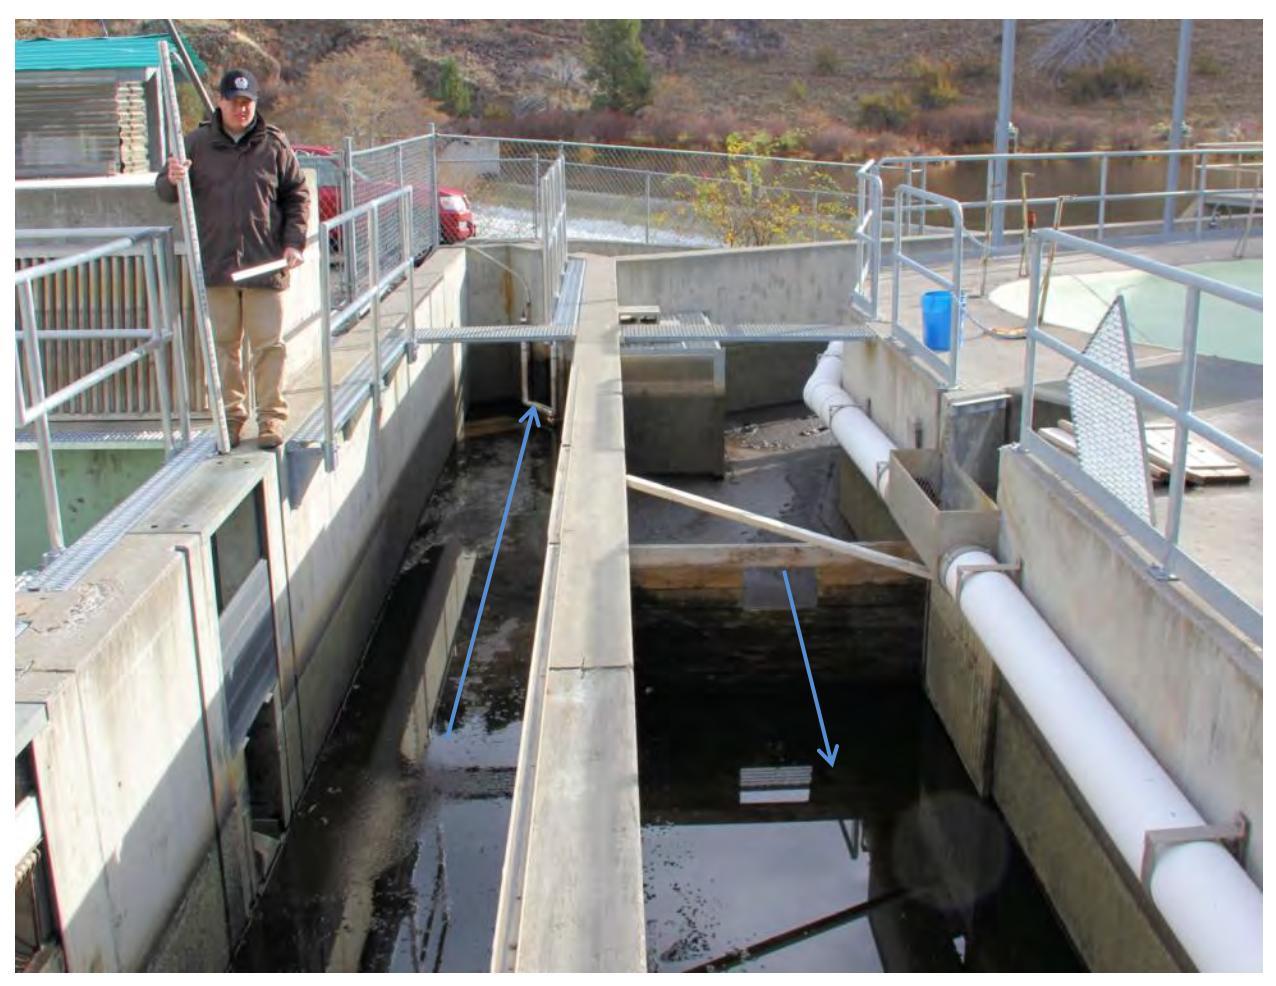
The second obstruction within the transport channel is an orifice weir constructed of dam boards (Figure 20). The bottom of the orifice is 1.8 feet above the bottom of the channel. The height of the orifice is 9.6 inches, with a width of 1.0 feet and mean column velocity in the orifice opening is 2.75 ft/s. Water velocity is within the recommended range of 1.5 to 4.0 ft/s and orifice width meets the recommended 1.0 feet, but the orifice height of 9.6 inches does not meet the recommend orifice height of 15 inches.

Figure 20. Orifice weir in the transport channel at WSNFH. Blue arrows depict direction of water flow.

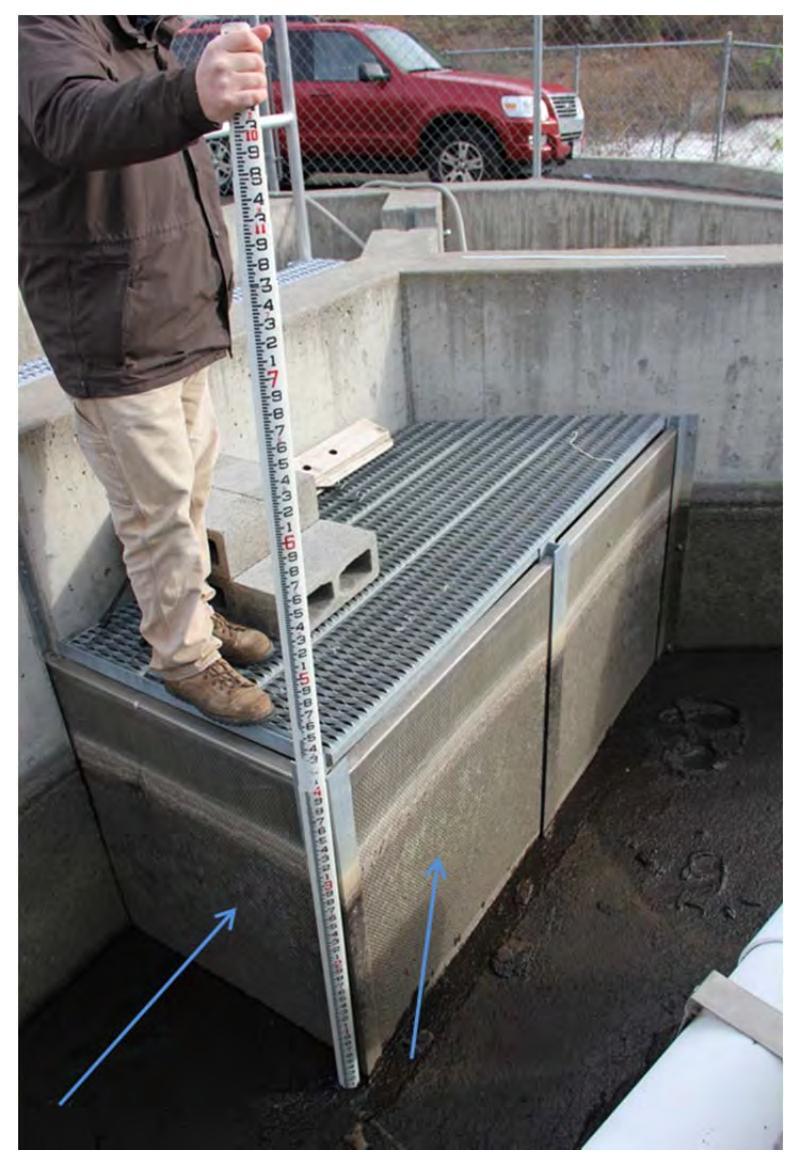
The last obstacle within the transport channel is the screen box (Figure 21). The screen box allows water to flow between the upper and lower transport channel. The purpose of having flow between the upper and lower transport channel is unclear. The screen box has exposed edges within the transport channel, which is not recommended by NOAA.

Figure 21. Screen box in the WSNFH transport channel. Blue arrows depict direction of water flow.

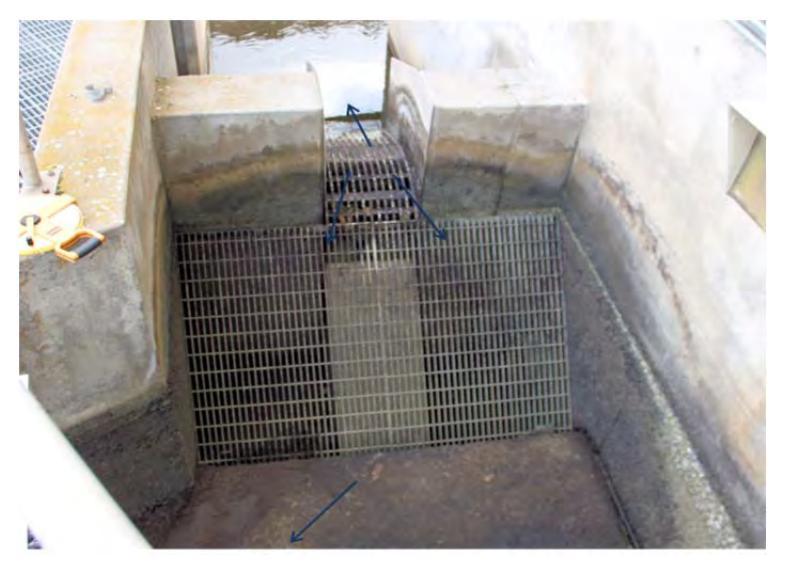
It is likely difficult for lamprey to pass through the fishway exit weir notch. The approach to the notch and the bottom of the notch is constructed of steel grating that lamprey cannot attach to (Figure 22). The lack of rounded corners/edges also makes it more difficult for lamprey that attempt to pass the notch if attempting to do so lateral to the grating. A perforated or partially perforated slide rather than a solid exit slide on the forebay side of the fishway exit would also make it difficult for lamprey to attach to the slide and thus force them into the forebay and prevent them from possibly re-ascending the slide.

Figure 22. Fishway exit dewatered. The arrows depict the direction of water flow.

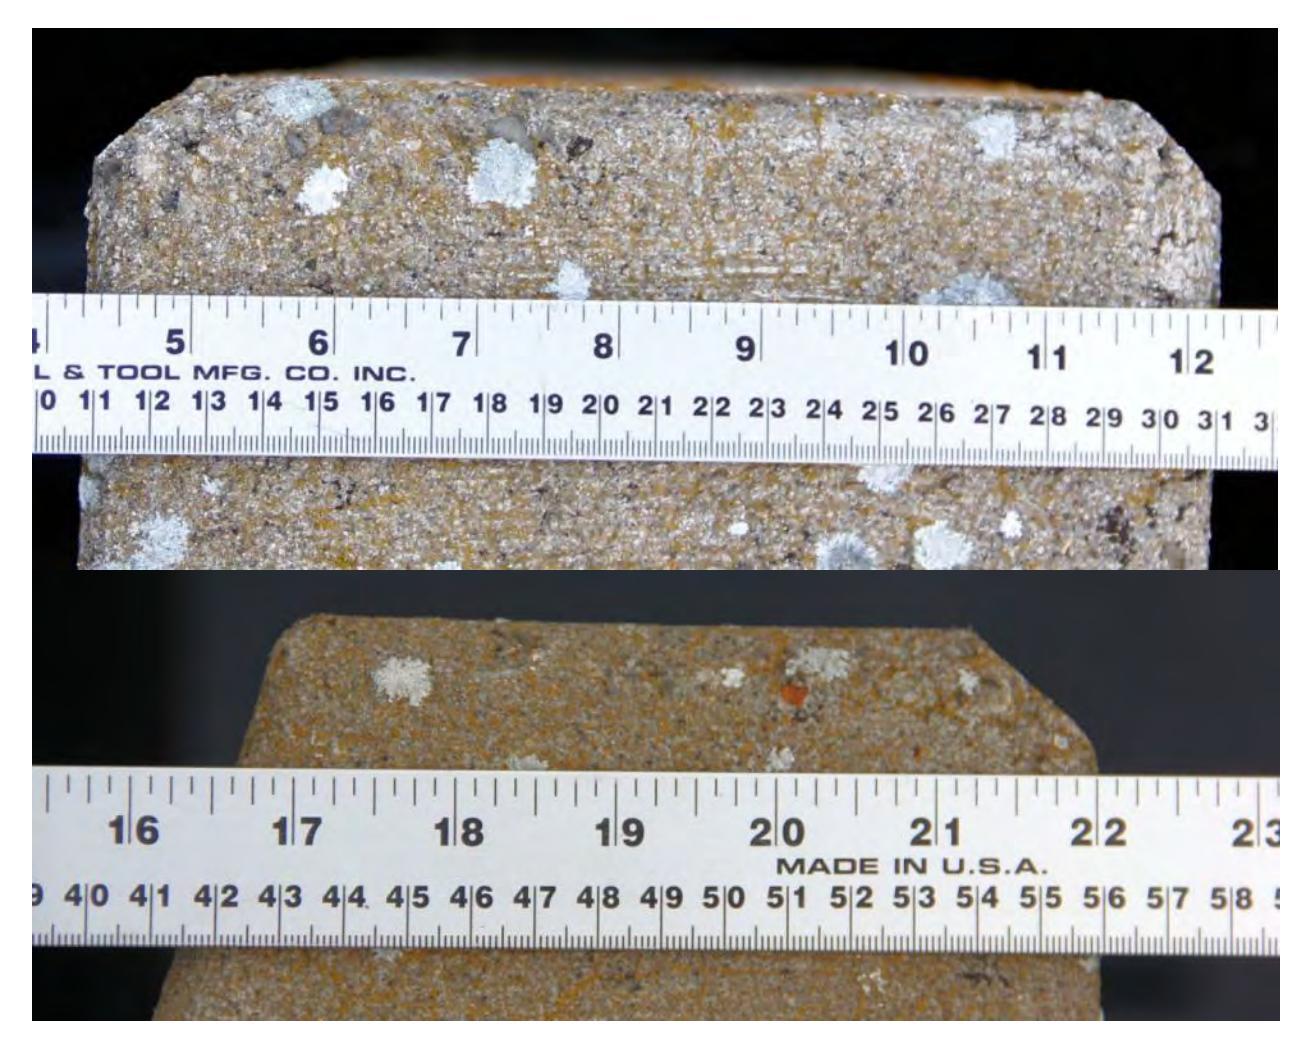
Throughout the entire fishway, no 4 inch radius corners or edges were observed. The fishway was constructed before this criterion was established for lamprey. Most corners and edges were close to 90 degrees and almost all were built with a 0.75 inch chamfer (Figure 23).

Figure 23. Two examples of corner and edge construction angles used throughout WSNFH.

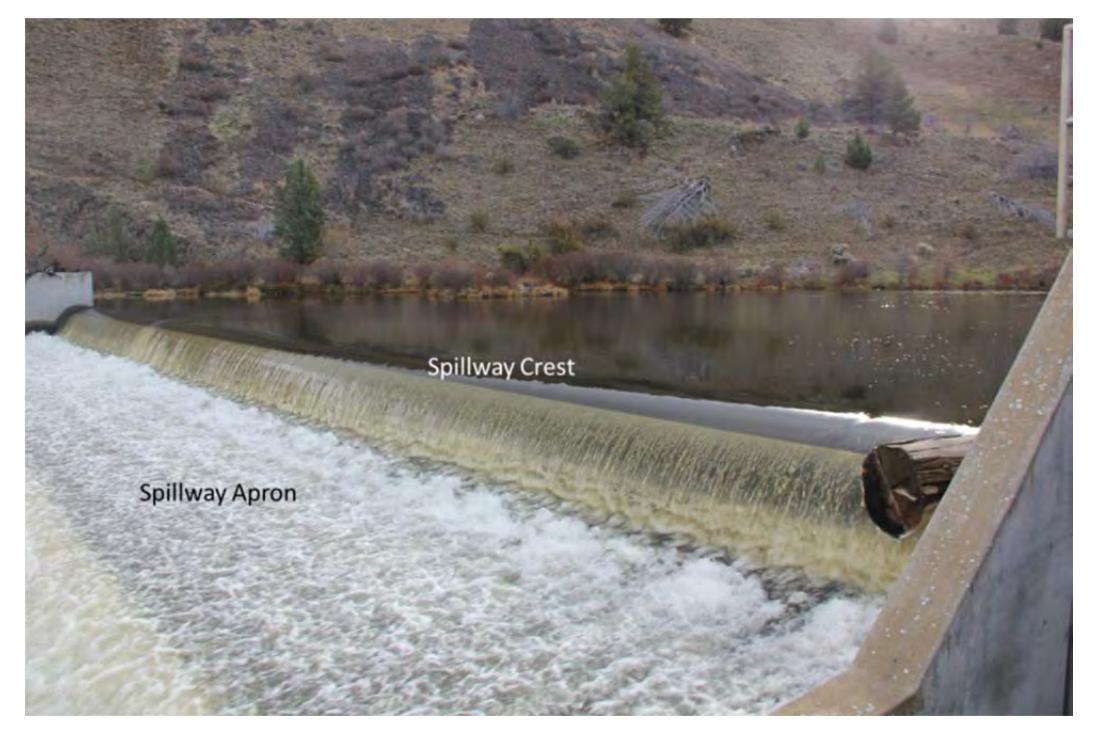
The most likely route past the WSNFH for downstream migrants, including bull trout and lamprey, is over the barrier dam spillway (Figure 24). During our site visit the daily discharge was 233 cfs and approximately 65% of the total streamflow went over the spillway. The vertical drop from the spillway crest to the spillway apron was 3.50 feet and the water depth on the spillway apron was approximately 0.17 feet. The depth on the spillway apron will increase with increasing flow. The drop from the spillway apron to the substrate in the tailrace was inferred

from the original design drawings (about 6 feet). When trying to minimize impacts to downstream migrants, subjecting them to a 3.5 feet drop onto a concrete apron with a water depth of 0.17 feet is less than ideal. The conditions we observed are typical between July and October. July and August are near the end of the downstream migration period for bull trout and lamprey. Downstream migration of bull trout and lamprey is probably more predominant during March-June when streamflows are higher. The drop from spillway crest to the spillway apron, and apron water depth under high flow conditions were not measured, but undoubtedly are more favorable to downstream passage survival. This design, which appears to be less than ideal for downstream passage of lamprey and bull trout under typical summer flows, may be necessary to ensure blocking upstream passage of salmonids at higher streamflows.

Figure 24. Spillway crest and apron at the WSNFH barrier dam.
