**EVALUATING THE POTENTIAL FOR CONSTRUCTING BACKWATERS
IN THE SAN JUAN RIVER FROM RM 158 TO RM 180**

**Final Report to the San Juan River Basin Recovery Implementation
Program**

June 18, 2007

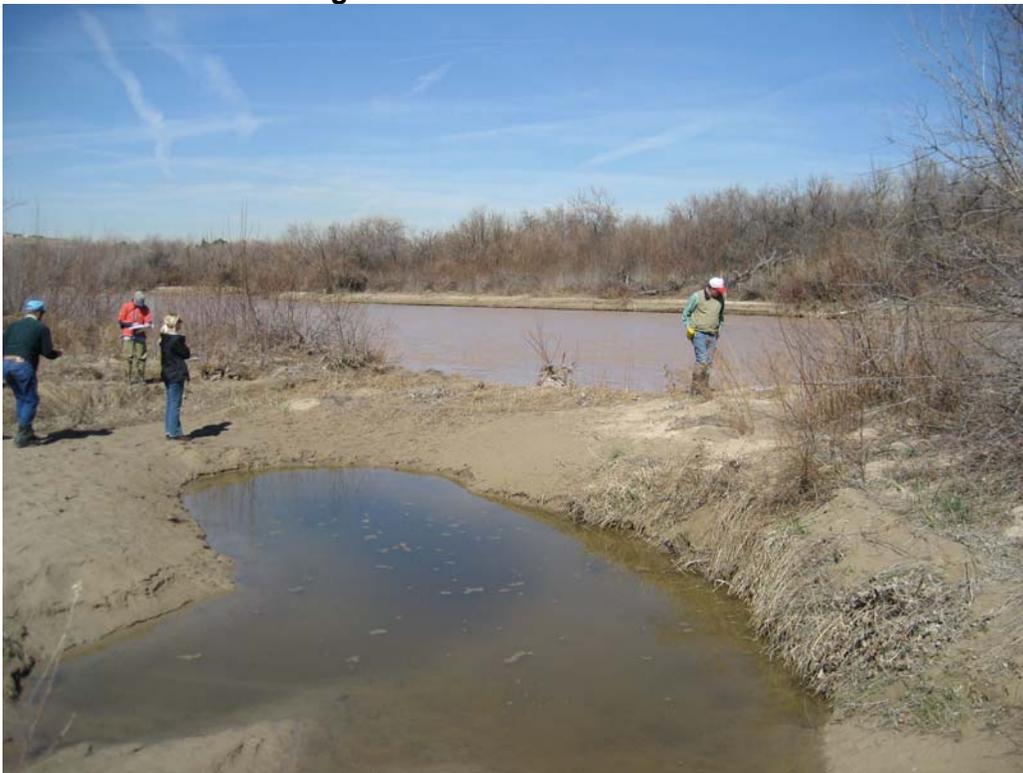
Figure B.8. Site 4.3 sand-filled mouth

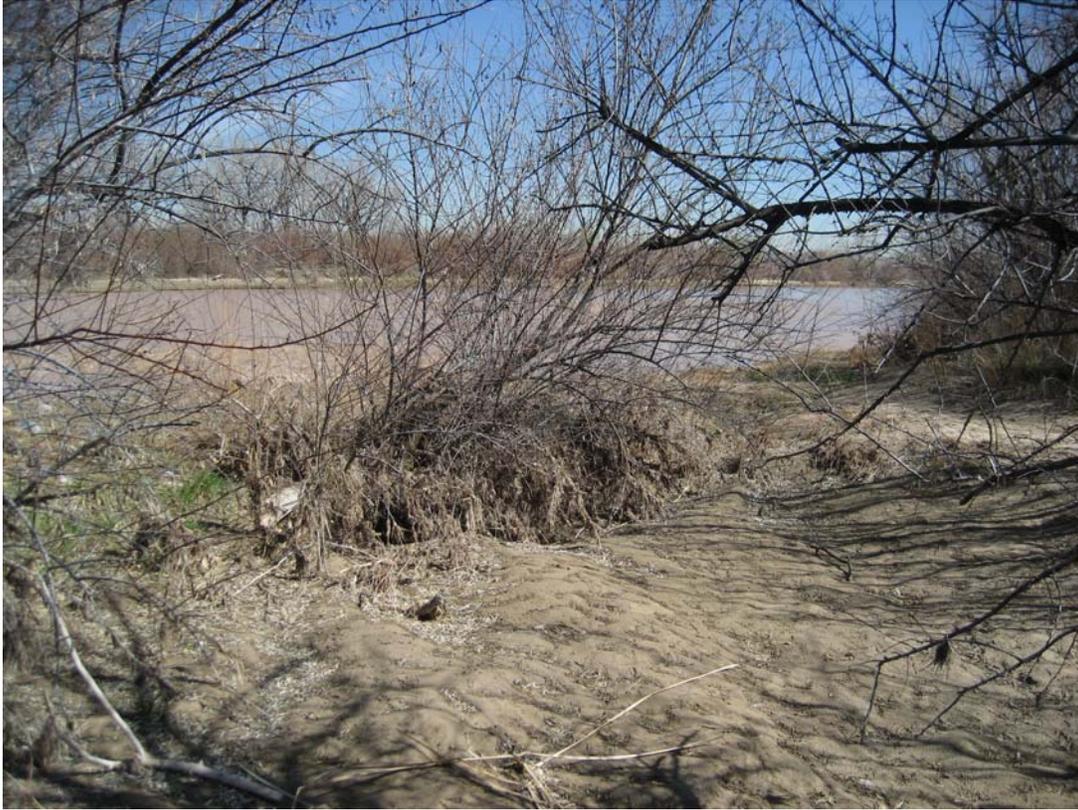
Figure B.9. Site 4.3 clogged secondary inlet

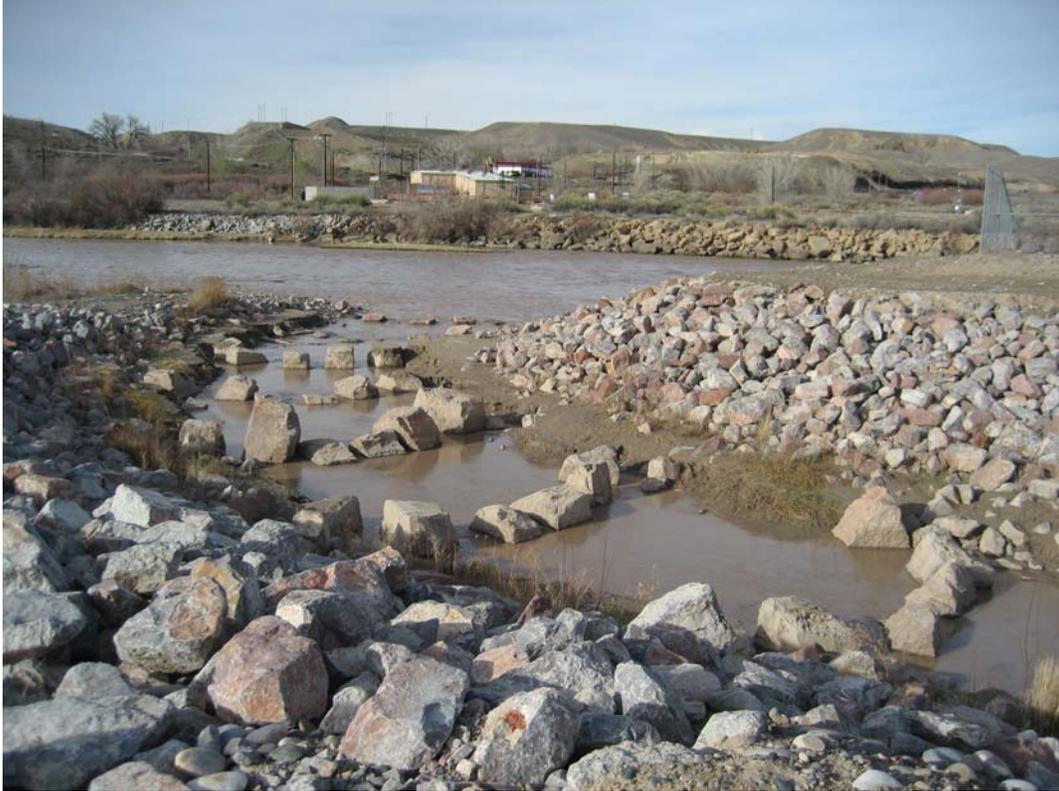
- PNM Fish Passage (RM 166.7). The PNM fish passage consists of a series pools and riffles of sufficiently low velocity to allow passage by native fish. The structure could be blocked with a net at the mouth and used as a stocking site by regulating flows to provide low velocity locations. The advantage of the site is that it could provide a range of habitats suitable for conditioning fish for river conditions. It is about 120 m long and 5 m wide. Only about ½ the gross area is pool area suitable for the stocking density target, therefore the net area is estimated to be 300 m². While this site has good potential, some tests are recommended prior to stocking. A range of flows should be tested to characterize velocities and depths and potential operating scenarios. The flow rate will also be critical to the ability to maintain a block net at the mouth as debris accumulates in direct proportion to flow rate. Block net testing should accompany the flow rate testing. Bird predation could be a problem if depths are shallow. It is immediately upstream of the Jewett Valley canal diversion which is on the opposite site of the river. During autumn stocking, the canal will not be diverting water. However, if the intake gate is open, the canal could provide habitat for predators upstream of the sluice and impact survival if stocked fish that may enter the canal.

Figure B.11. PNM fish passage

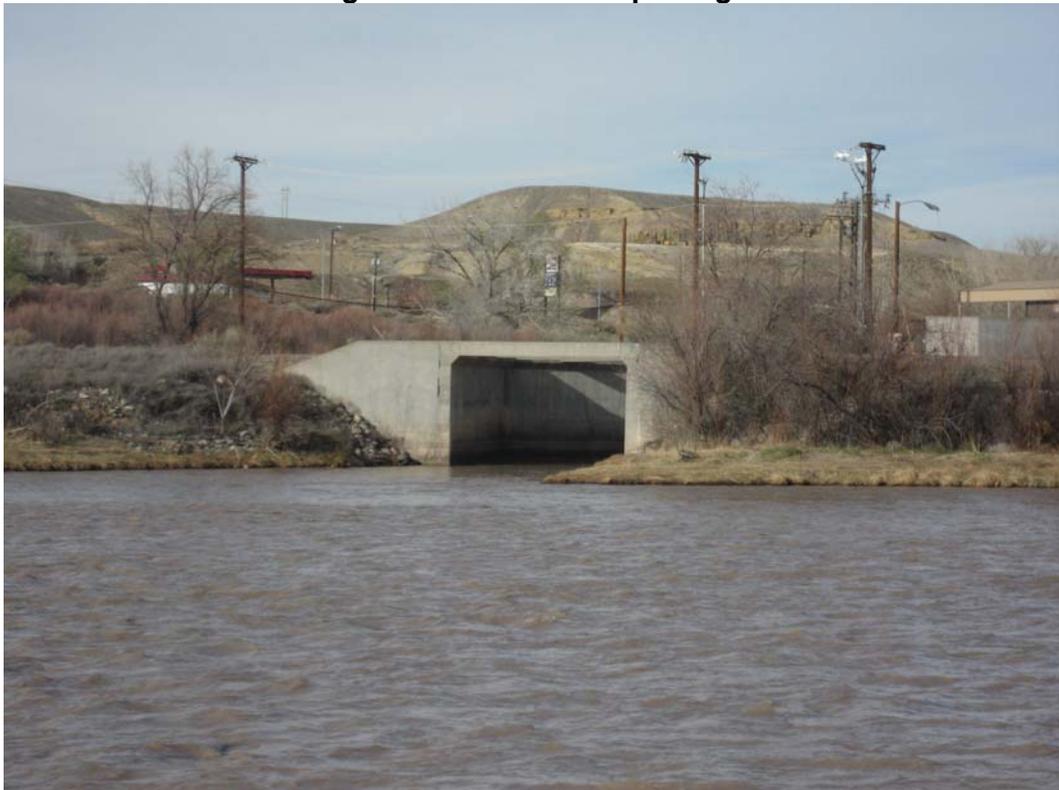
amount of excavation will be required to fully connect the sluiceway to the river, which will lower the water surface elevation in the sluiceway by about 0.1 m. The connection to the river may require maintenance annually, but it will be minor. The channel receives seepage water and should be checked for nutrients and bacteria. The site can be maintained with near zero velocity or with increased velocity with some release from the canal if desirable for conditioning. The site is located in a city park and near a housing subdivision, which could increase the potential for human disturbance during acclimation.

Figure B.12. PNM sluiceway at San Juan River interface

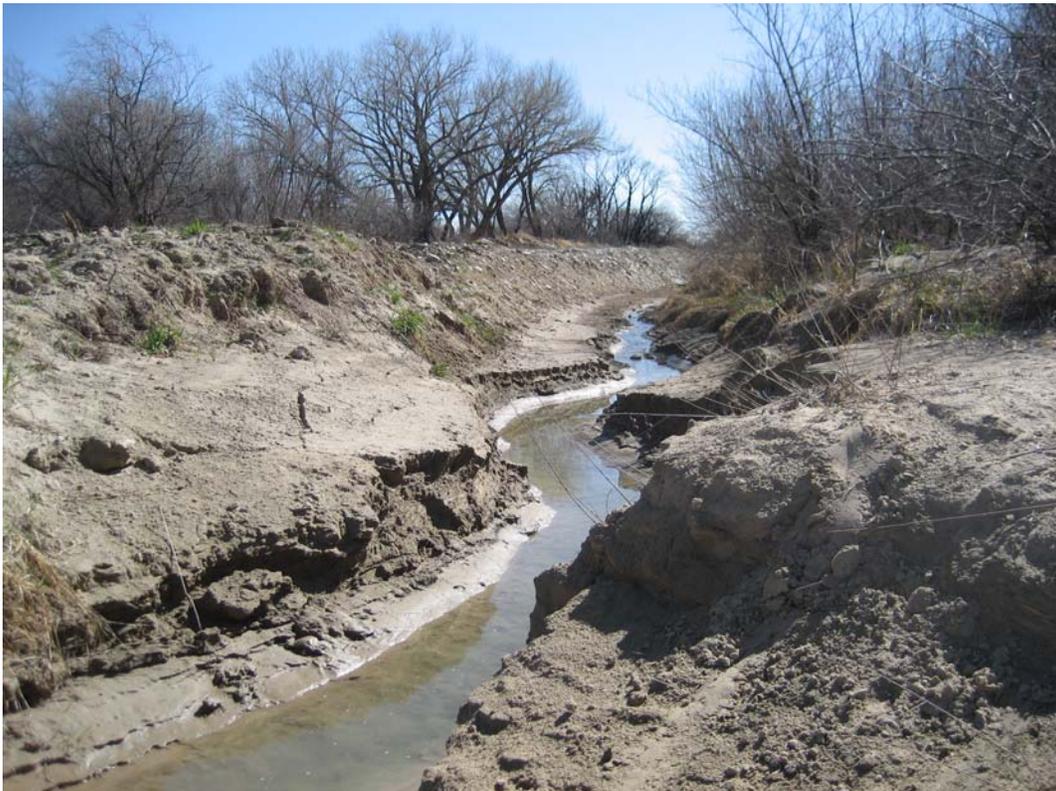
Figure B.16. Site 5.3, drain #3 recently cleaned
