TRIP REPORT OF SITE VISITS TO BASIN CREEK, DURANGO, COLORADO  
12 MAY 2014 AND 9-10 JULY 2014

30 JULY 2014

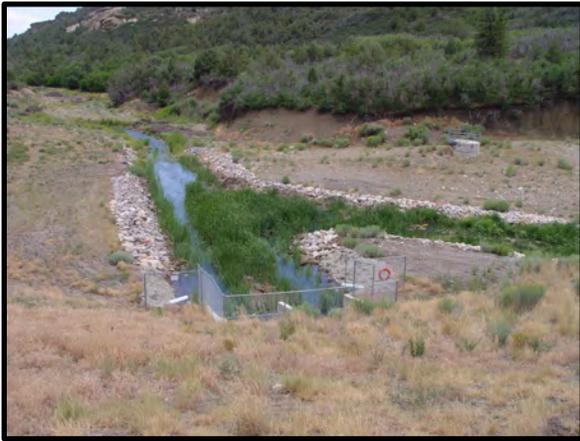
Figure 9. Backwater formed to the right of the concrete dissipation structure.

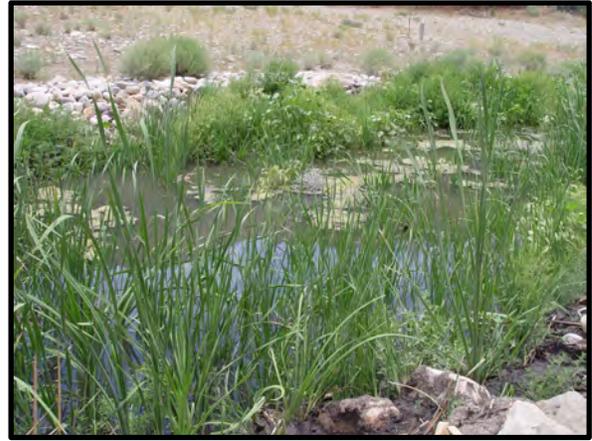
Figure 10. Backwater habitat formed immediately downstream dissipation structure.

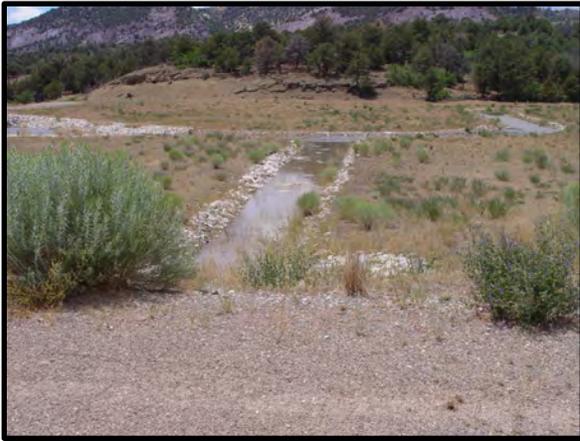
Figure 11. Backwater formed above Drop Structure 4 at 70 cfs

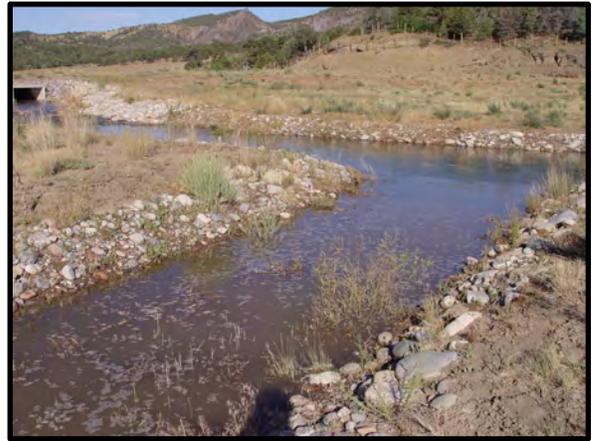
Figure 12. Mouth of backwater formed above Drop Structure 4 at 30 cfs.

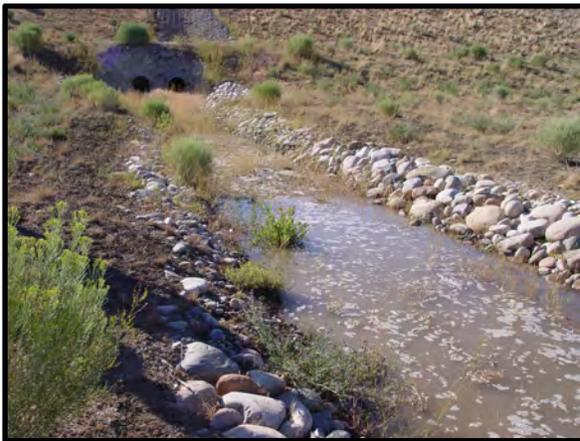
Figure 13. Terminal portion of backwater at 30 cfs.

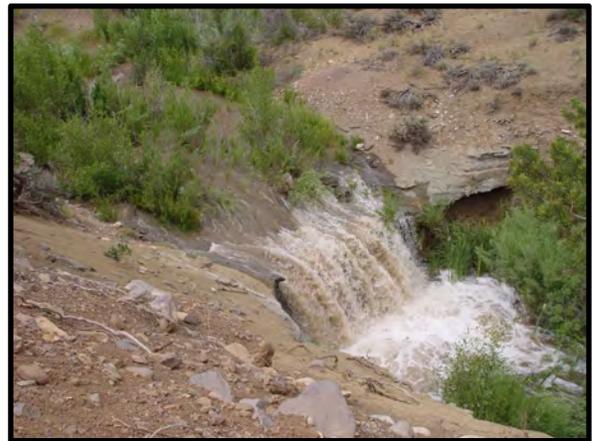
Drop Structures 13, and 1-8 were visually observed at 70 cfs discharge on 9 July 2014. During these flushing releases the water was turbid and carried a significant amount of suspended woody and particulate debris. At 70 cfs water backed-up into several off channel washes creating low velocity habitats. These off channel backwaters were observed immediately below the concrete dissipation structure at the dam outlet, upstream of Drop Structure 1 (about 0.32 miles downstream of the concrete water-energy dissipation structure), downstream of Drop Structures 2 and 3, upstream of Drop Structure 4 and between Drop Structures 6 and 7. When flows were reduced to 30 cfs the only notable off channel habitat that remained were the backwater formed immediately below the concrete water-energy dissipation structure at the dam outlet and in a drain on river left immediately upstream of Drop Structure 4 (Figures 9-13). Also observed during the release at 70 cfs was a waterfall that formed downstream of Drop Structure 8 (directly across from the USBR access gate). The spill over the falls was at least 2 m high and the base of the falls was deeply undercut. The waterfall appeared to pose a barrier to upstream fish movement (Figure 14).

Figure 14. Waterfall formed downstream of Drop Structure 8.

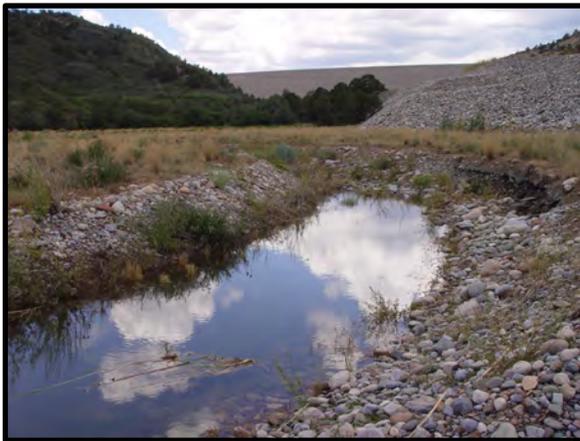
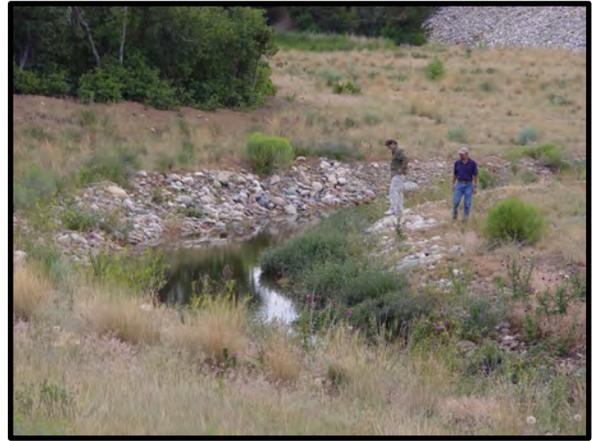
During the visual survey three hours after the release had been terminated, above Drop Structure 6, numerous pools had formed at the base of the drop structures as well as in the bend pools in Basin Creek (Figure 15). While these pools had lower velocities than during the release at 30 cfs, water continued to drain reducing the size of the pools while still allowing for downstream movement of aquatic organisms if present. Water continued to drain from Basin Creek after 1700 hours 10 July 2014.

Figure 15. Remnant bend pools formed about four hours after termination of the 30 cfs release. Bend pools were draining downstream and were not isolated. Bend pools (a) and (b) located upstream of Drop Structure 1.

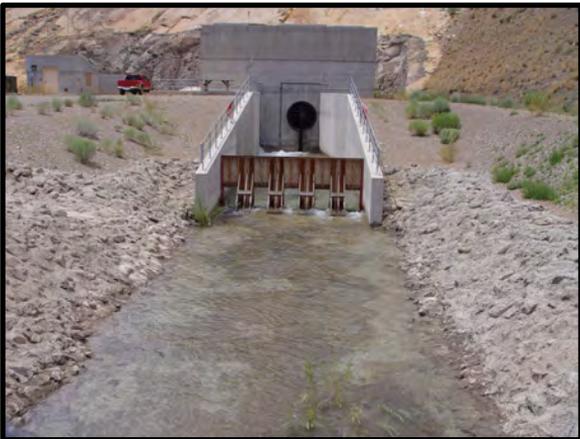
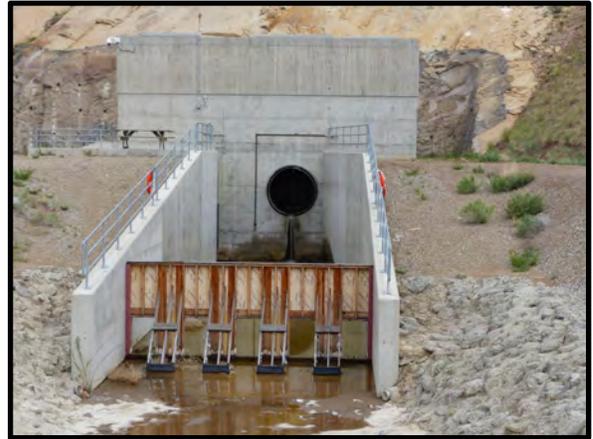
The outlet of Ridges Basin Dam retained water after the release had terminated in the concrete dissipation structure downstream of the outlet and in a small portion of Basin Creek including the backwater that is formed in the drainage channel from the dam itself. The outlet of Ridges Basin Dam has been modified with a temporary wooden wall suitable for setting up five plankton nets. This design was previously used to assess passage of fish from the reservoir to Basin Creek. It is capable of sampling the entire outflow of each release thereby providing a precise determination of escapement from the reservoir (Figure 16).

Figure 16. Outlet of Ridges Basin Dam: (a) release from Lake Nighthorse at 30 cfs (9 July 2014) and (b) termination of the release (10 July 2014). Note the temporary structure in place downstream of the release gate where plankton nets were previously set to sample escapement of fish from Lake Nighthorse.

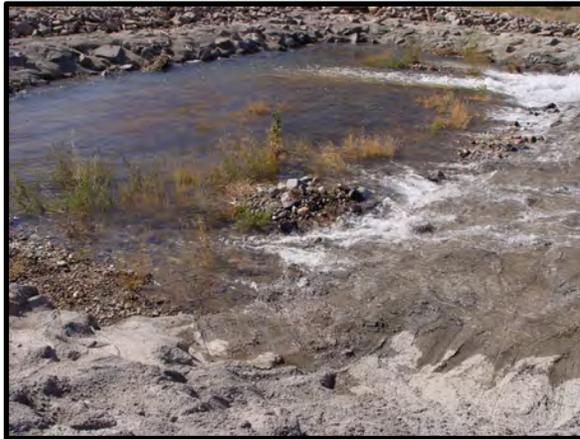
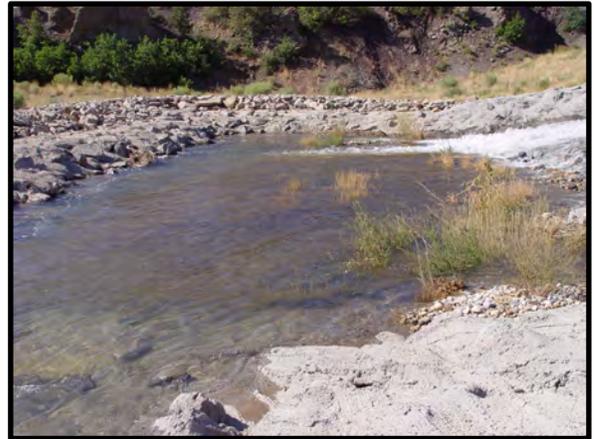
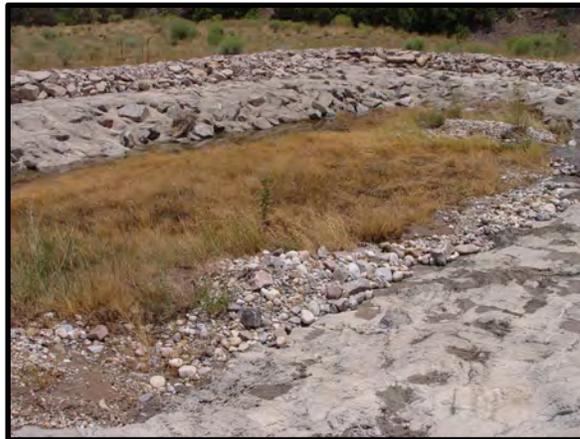
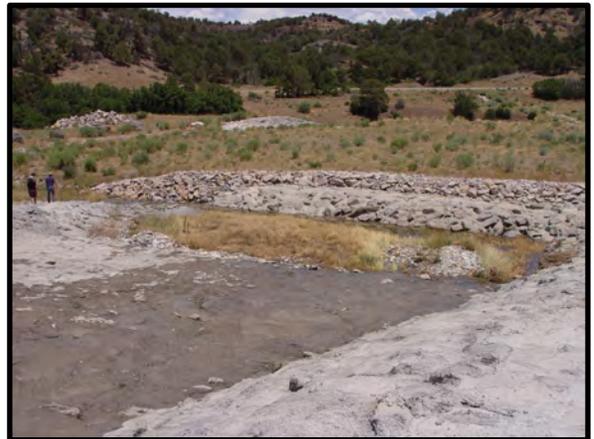
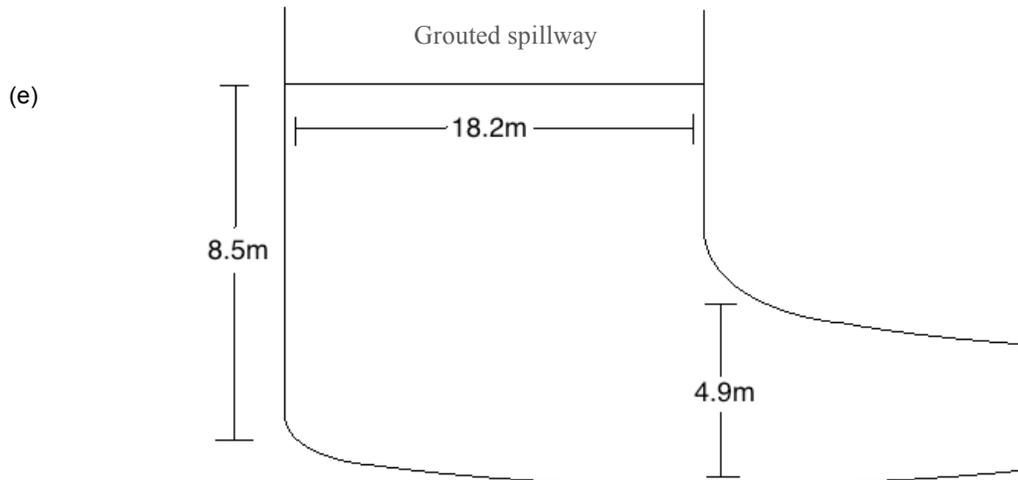
Figure 17. Drop Structure 1: Photographs (a) and (b) at the 30 cfs release, photographs (c) and (d) three hours after termination of release. Diagram (e) wetted area of Drop Structure 1 at 30 cfs release.

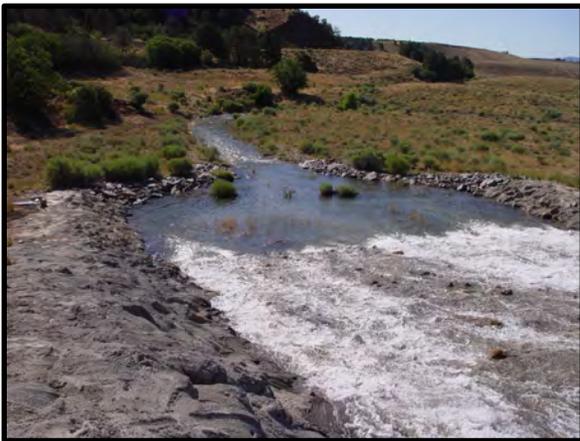
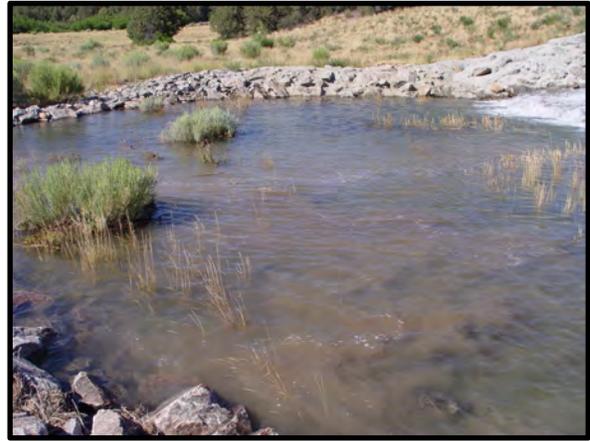
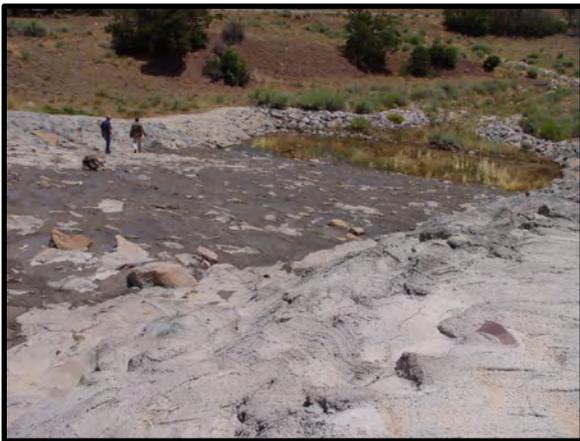
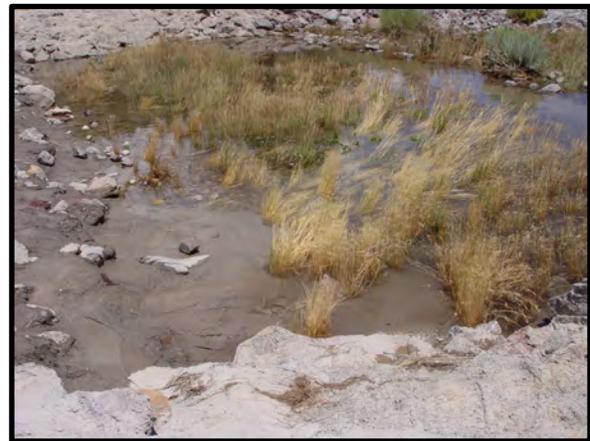
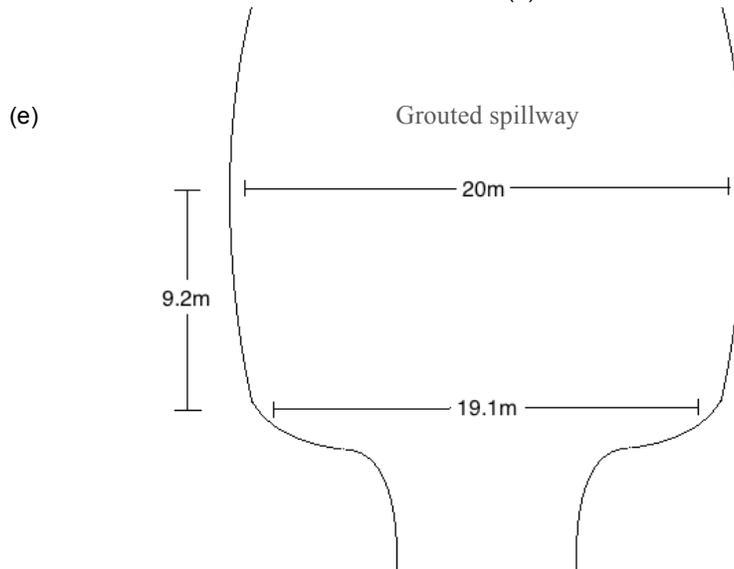
Figure 18. Drop Structure 2: Photographs (a) and (b) at the 30 cfs release, photographs (c) and (d) three hours after termination of release. Diagram (e) wetted area of Drop Structure 2 at 30 cfs release.

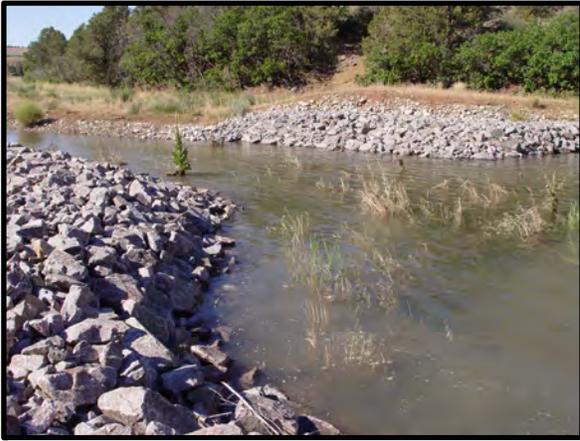
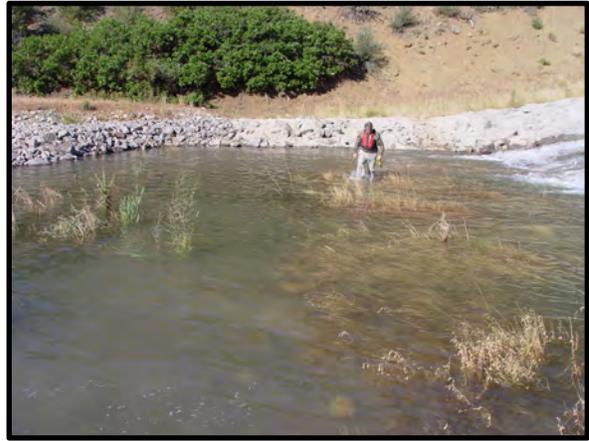
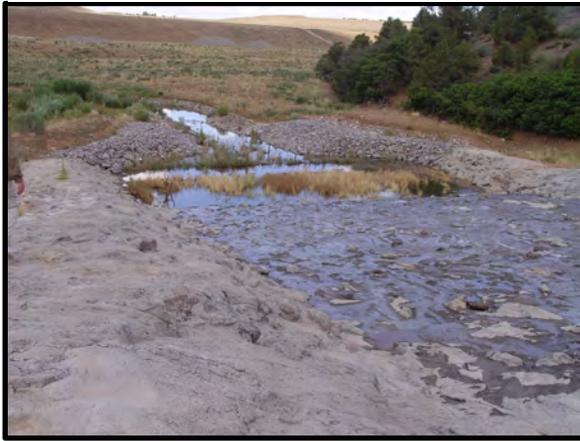
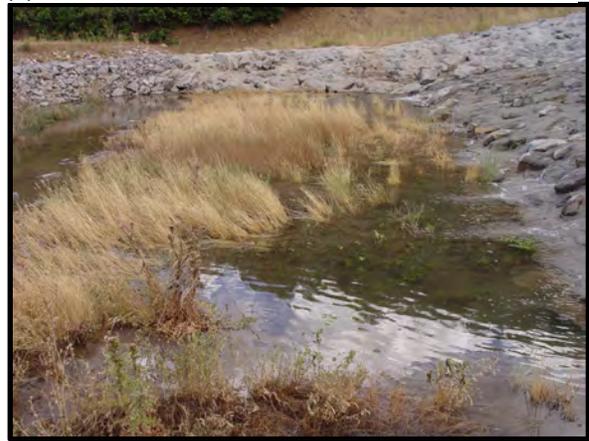
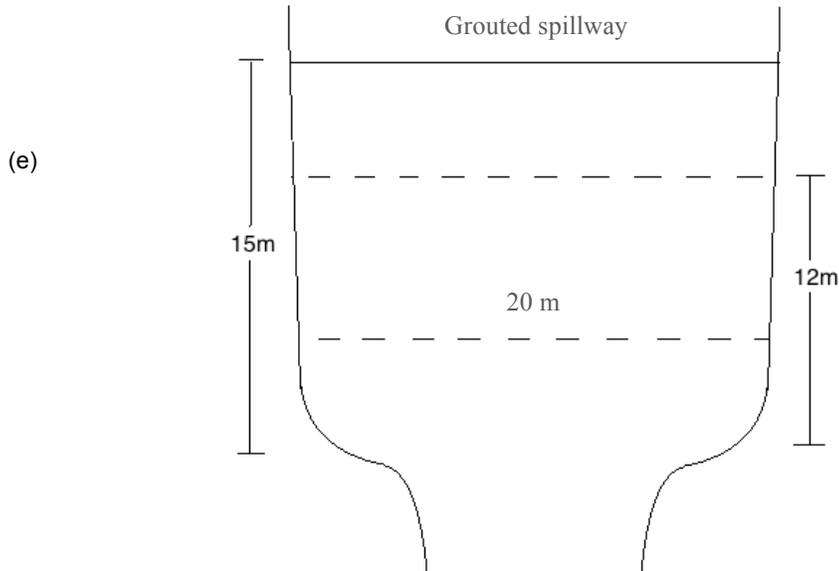
Figure 19. Drop Structure 3: Photographs (a) and (b) at 30 cfs release, photographs (c) and (d) three hours after termination of release. Diagram (e) wetted area of Drop Structure 3 at 30 cfs release.

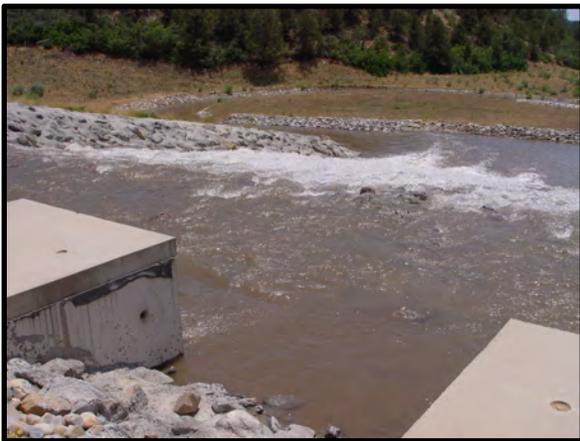
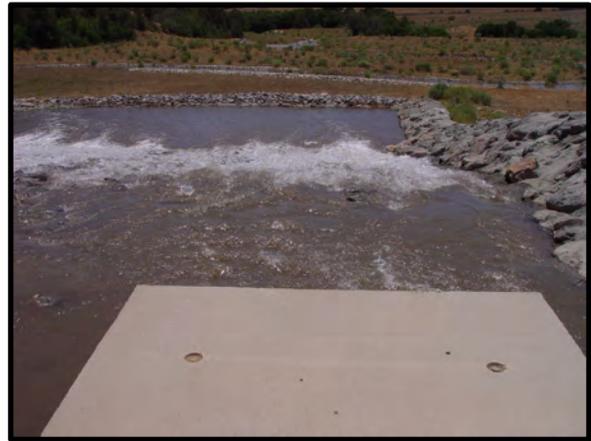
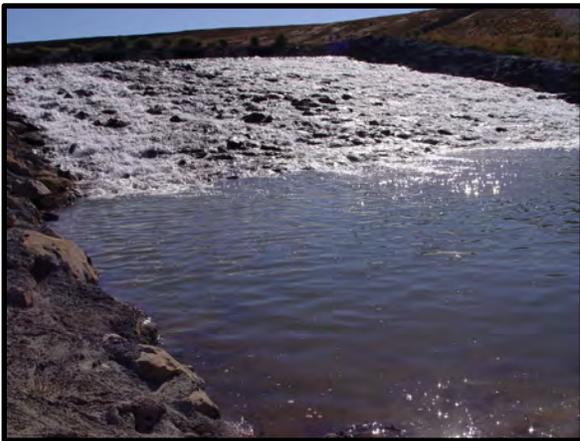
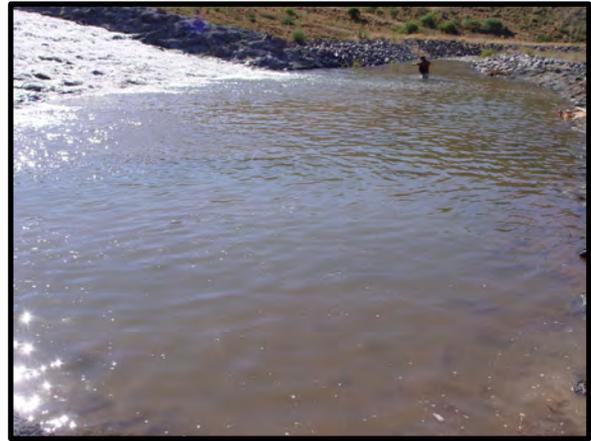
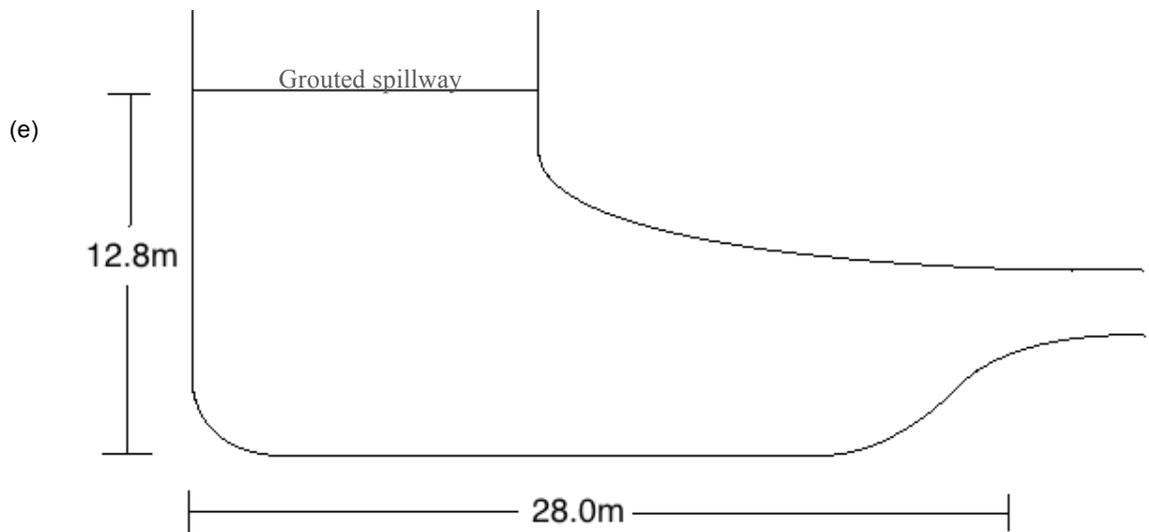
Figure 20. Drop Structure 4: Photographs (a), (b), (c), and (d) at the 30 cfs release. Diagram (e) wetted area of Drop Structure 4 at 30 cfs release.

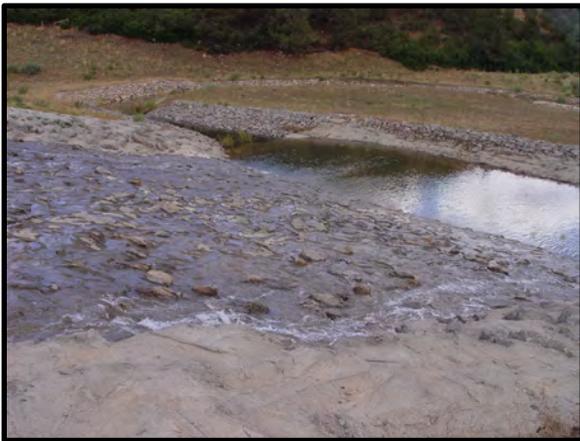
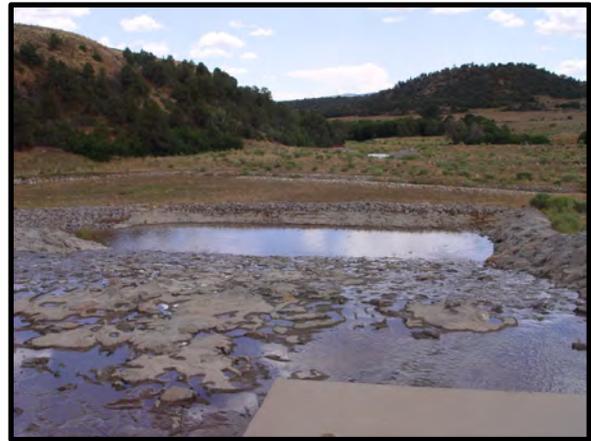
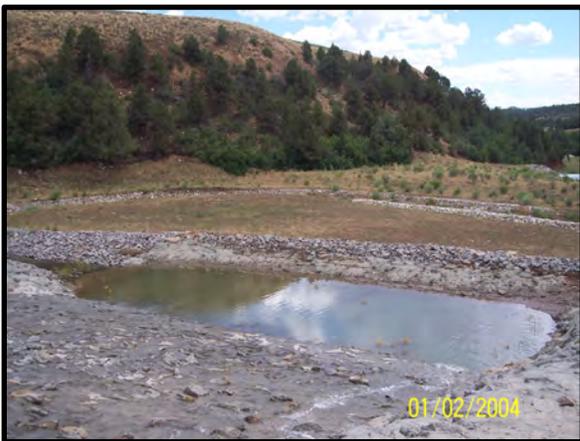
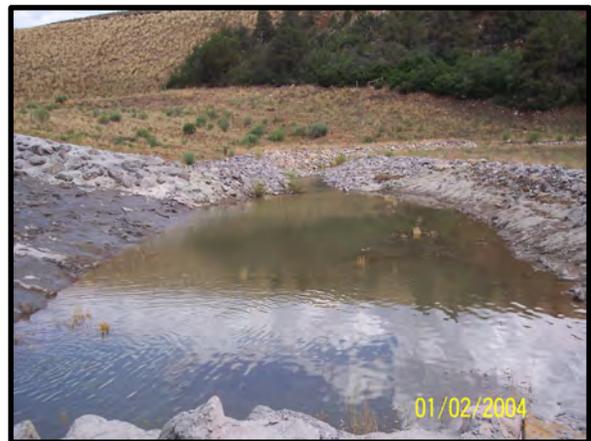
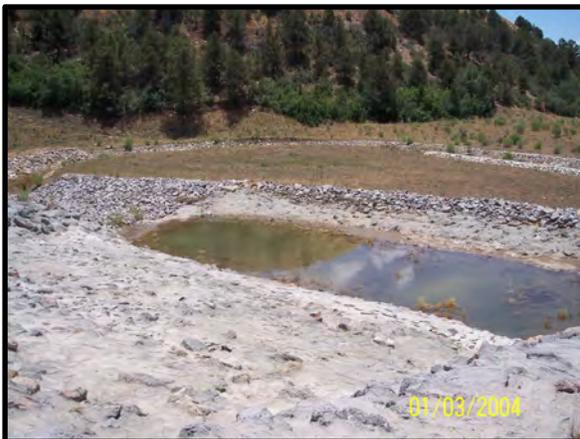
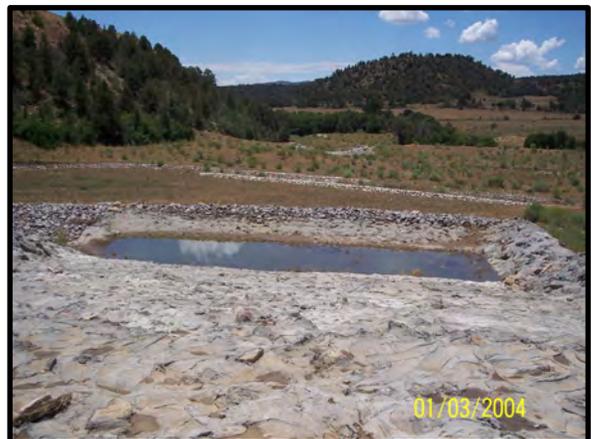
Drop structures, versus the main channel or off channel pools, appeared to hold the greatest volume of low velocity pool habitat after the release was terminated. Of the available pool habitat upstream of Drop Structure 6, Drop Structures 1-4 had the largest surface area of pool habitat type. The drop structures varied in wetted area, draining rates, and water retention times. Drop Structures 1 and 2 had the smallest pools and tended to drain fastest with the least amount of low velocity habitat (Figure 17 and 18). Drop Structure 3 held the second greatest volume of water after the release was terminated and low velocity habitats were formed on either side of a berm bisecting the 20 meter wide pool (Figure 19). Drop Structure 4 held the largest volume of water of all the drop structures upstream of Drop Structure 6 (Figure 20) as a large pool formed in its settling basin. The pool at Drop Structure 4 was still draining water seven hours after the termination of the release and 28 hours after the release (14:00 hours 11 July 2014) a large isolated pool remained (Robert Waldman, USBR, Durango, personal communication; Figure 21). Drop Structure 5 had negligible retention of water and low velocity habitat was minimal.

Figure 21. Drop Structure 4 after termination of release. Photographs (a) four hours after termination of release, (b) seven hours after termination of release, and (c) 28 hours after termination of release. Photographs (b) and (c) provided by Robert Waldman (USBR, Durango).
