**SCOTT RIVER RIPARIAN WOODLAND
RESTORATION PROJECT**

Final Report FY 1996

*"Scott River Riparian Woodland Revegetation III"
Project 96-HR-06*

Cal Forest Nursery, Project Subcontractor

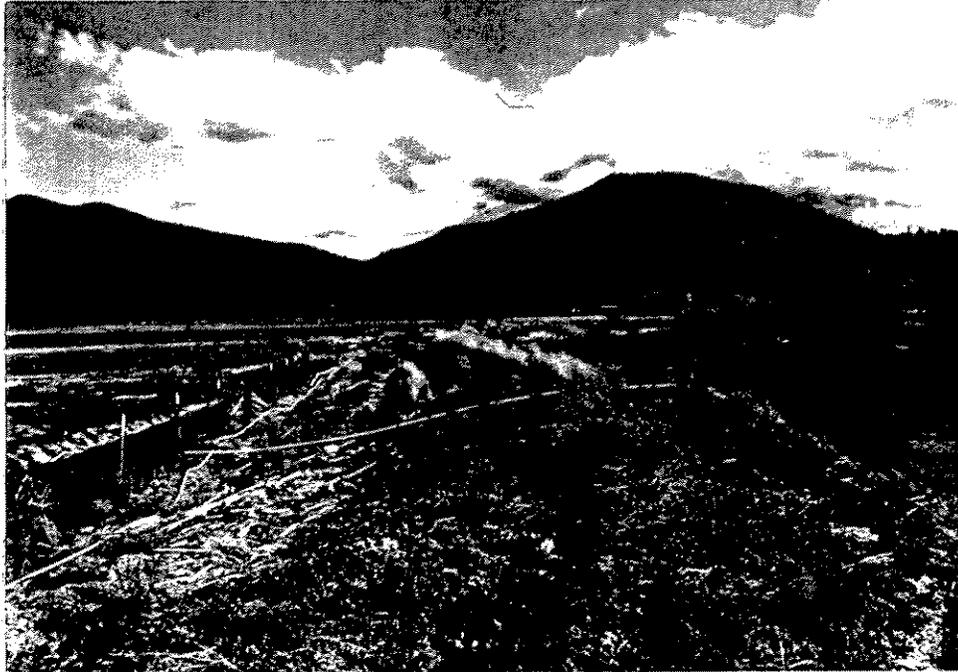
North end of the Hansen Ranch, Spring of 1997 after flooding. This site was not irrigated in the second year of planting, and trees survived (good soils, wet years, browse protection from weeds.)

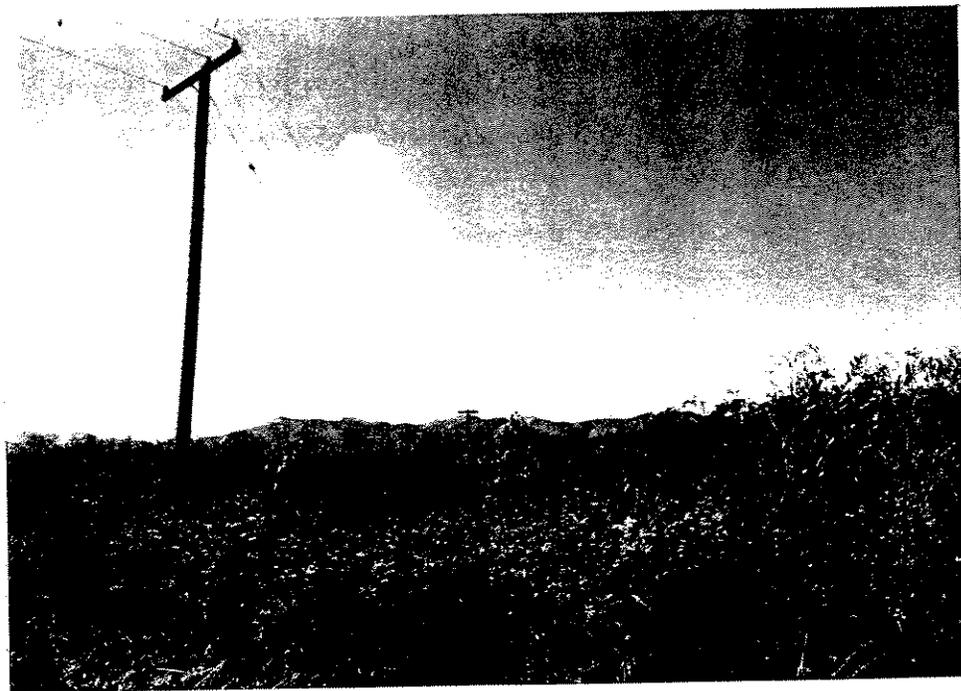
Cottonwoods and Willow (tree on right) above the hemlock and starthistle at Hansen's levee site.

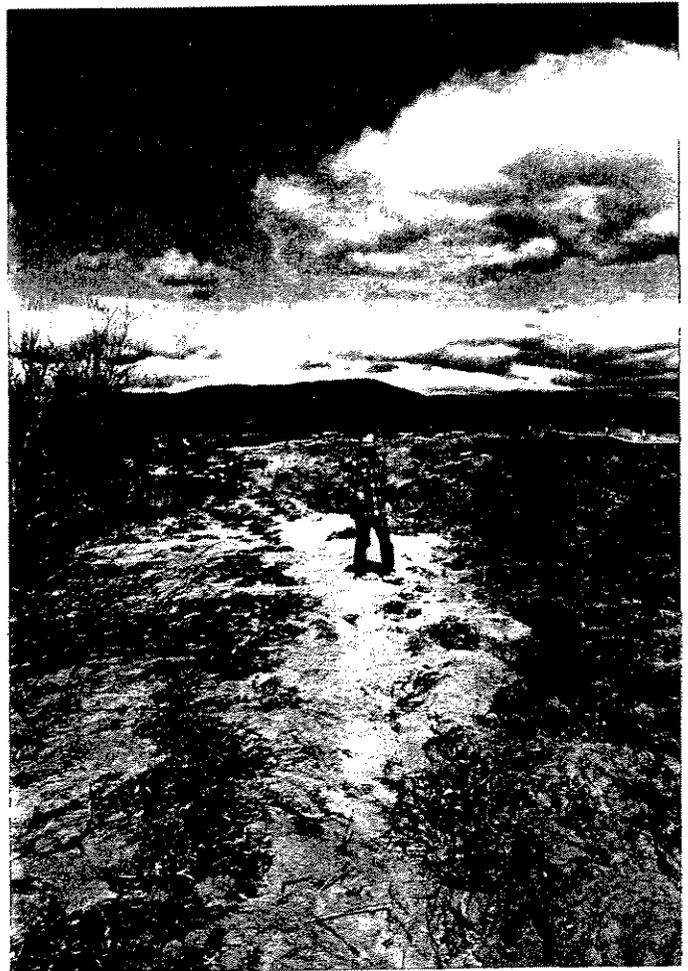
Shot taken at approximately the same location as the above picture. 1997 flood deposited fines along this row. This site has good soil, consistent watering - and good success

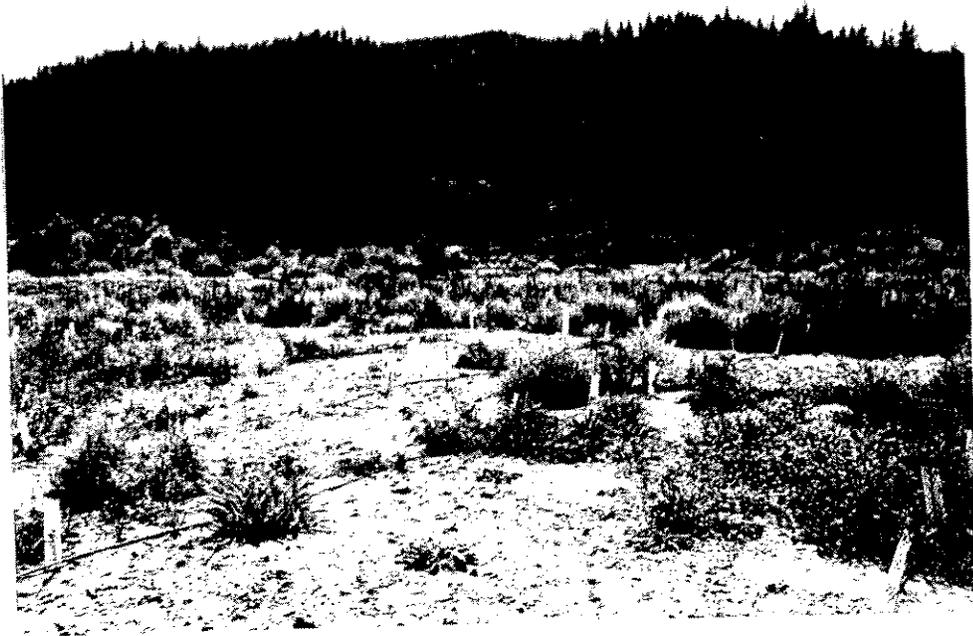
Site conditions on the North portion of the Eiler's Ranch, this area was replanted in 1997 after the "New Years Eve Flood" had covered the site and deposited silt and sand.

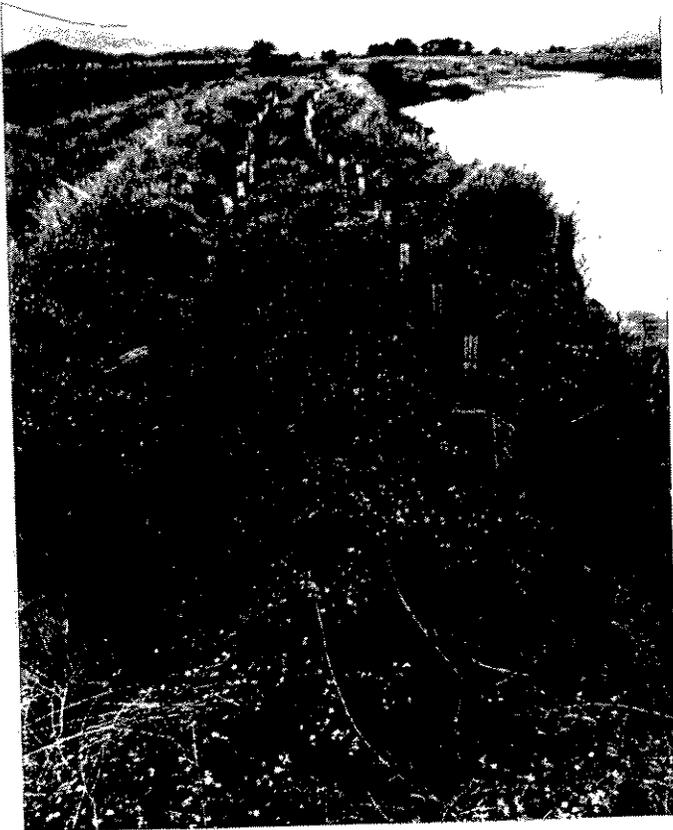
Levee shot at the Davidson Ranch looking north towards Blacks. Starthistle, plant protectors, and scalped rows visible (Scott River on right)
