**Preliminary Floodplain Restoration Plan  
For a 1-Mile Portion of the Scott River  
Degraded By Past Gold Dredging**

**Tom Hesseldenz and Associates**

**February 1999**

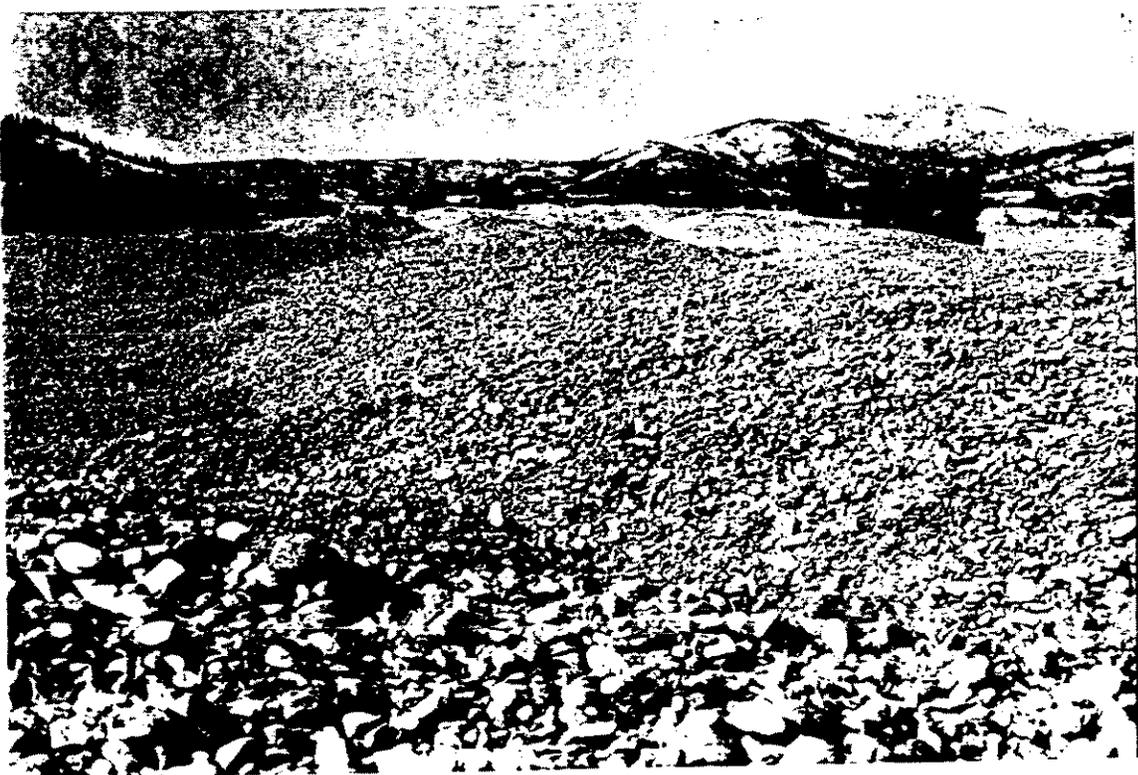
Photo #2. Panorama of tailings looking north beyond limit of pilot project site

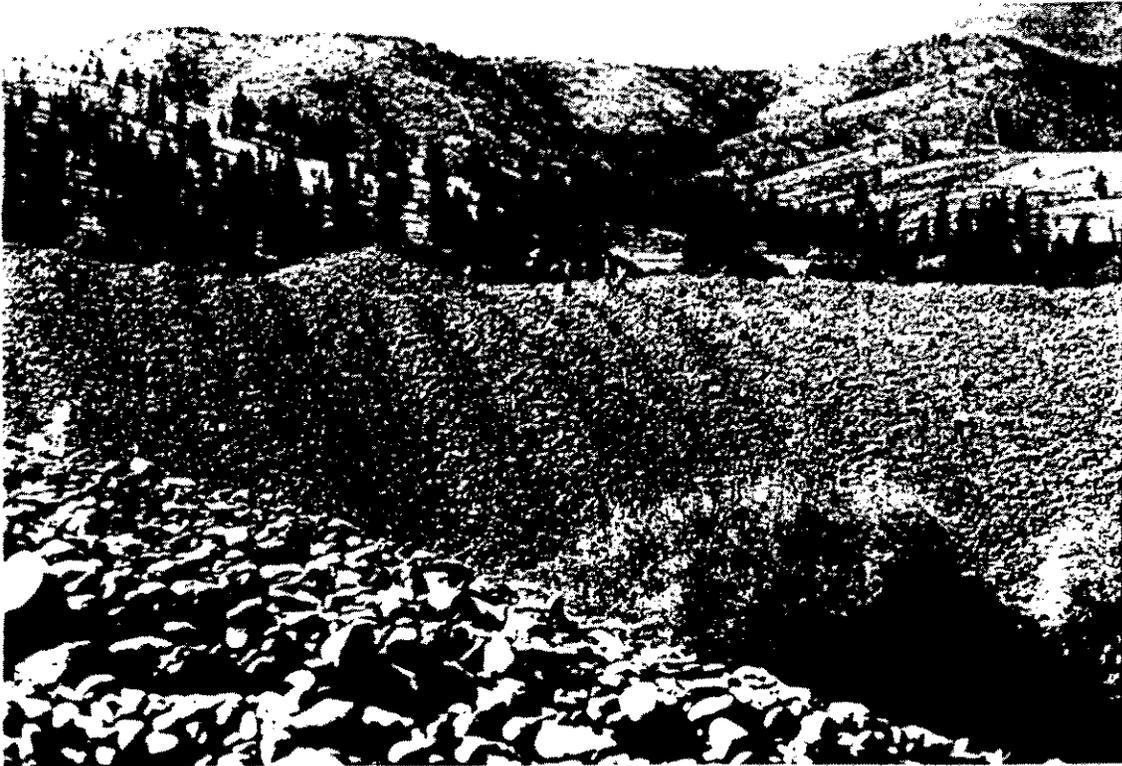
Photo #7. Largest tailings piles with people shown for scale, looking west.
