HORSE CREEK RESTORATION PROJECT

Project #94-HR-10
1994-95

FINAL REPORT

KLAMATH NATIONAL FOREST

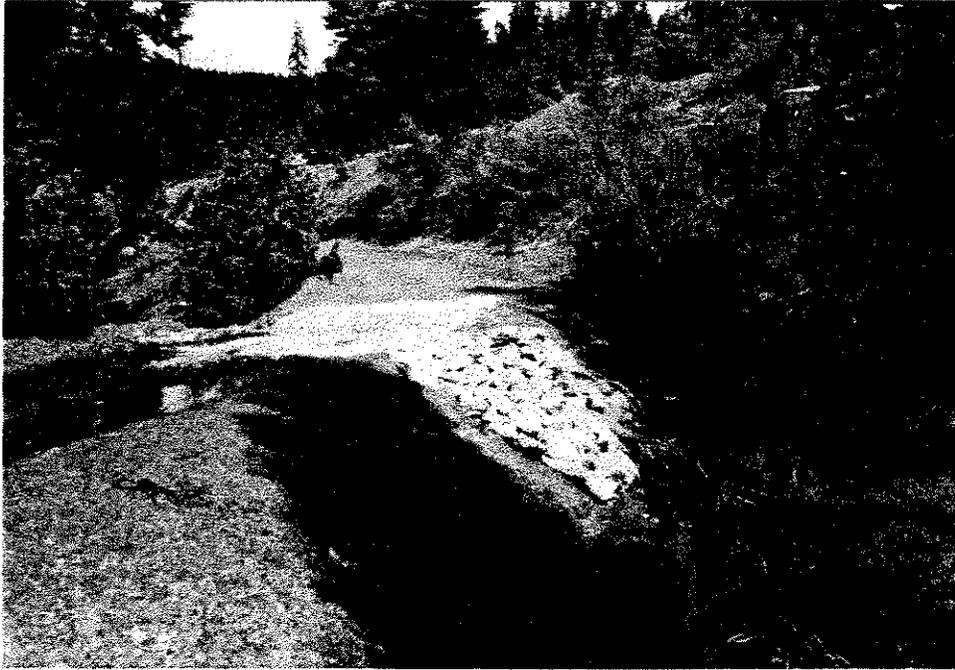
#EF6R

EF-6-R, gully stabilization by installing rock armor, installing dissipators below gully, an armored rolling dip at the stream crossing and rock rip-rap on the upstream side of the stream crossing.

Upstream

Gully stabilization-installation of rolling dip, rock armouring fill slope and culvert outlet and dissipators in gully.
