REFUGE PERIOD, 1939 - 1953

Civilian Conservation Corps at Corn Creek, 1939-1941

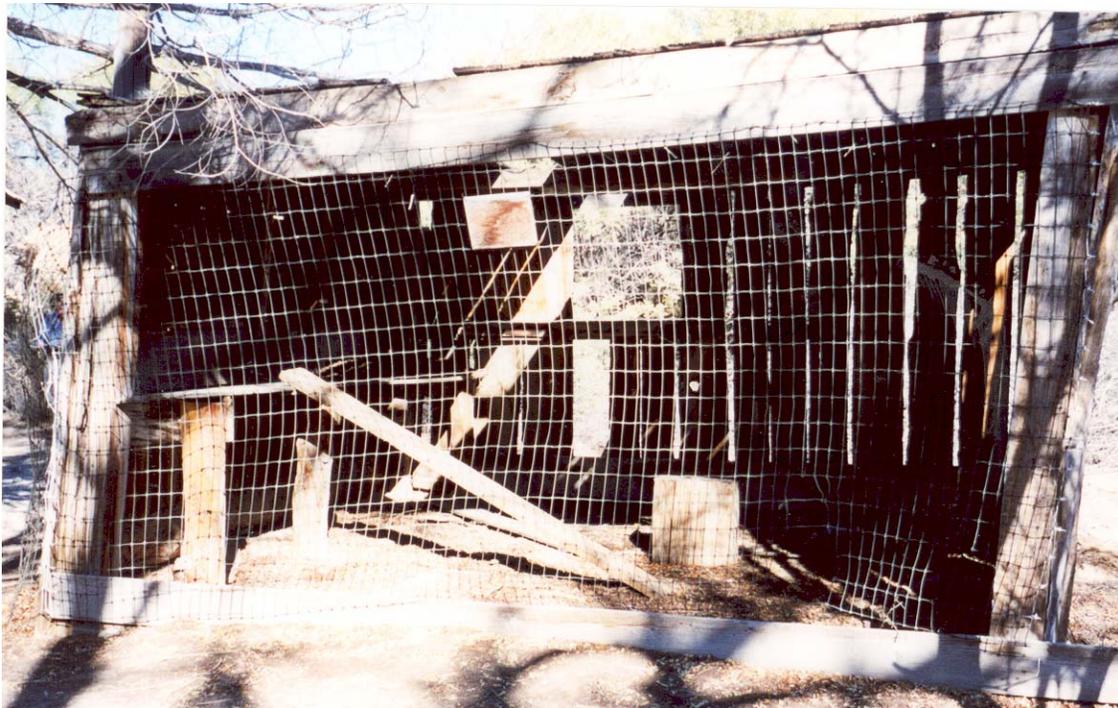
Figure 6.22. The “Blacksmith Shop” in 2002 (HRA photo).

At Corn Creek Ranch, according to Bob Worts, there was a shed located just out of the picture, behind the engine. He did not recollect if that shed was the one still standing near the Tie Building, now known as the Skull House. This shed, now called the “blacksmith shop,” is made of Ponderosa pine puncheons (vertically set lumber) with the bark left on (Figure 6.22).

Recent investigations including test excavations and archival research by FWS architectural historian Lou Ann Speulda-Drews and archaeologist Kathleen Sprowl suggest the structure was probably built after 1960. The “Blacksmith Shop” was found not to be a contributing element to the Corn Creek National Register District in 2007 based upon FWS archival research and excavation. FWS maps narrowed down its construction to the mid-1960s and its use as a shed. Thus, it is not considered historic or eligible.

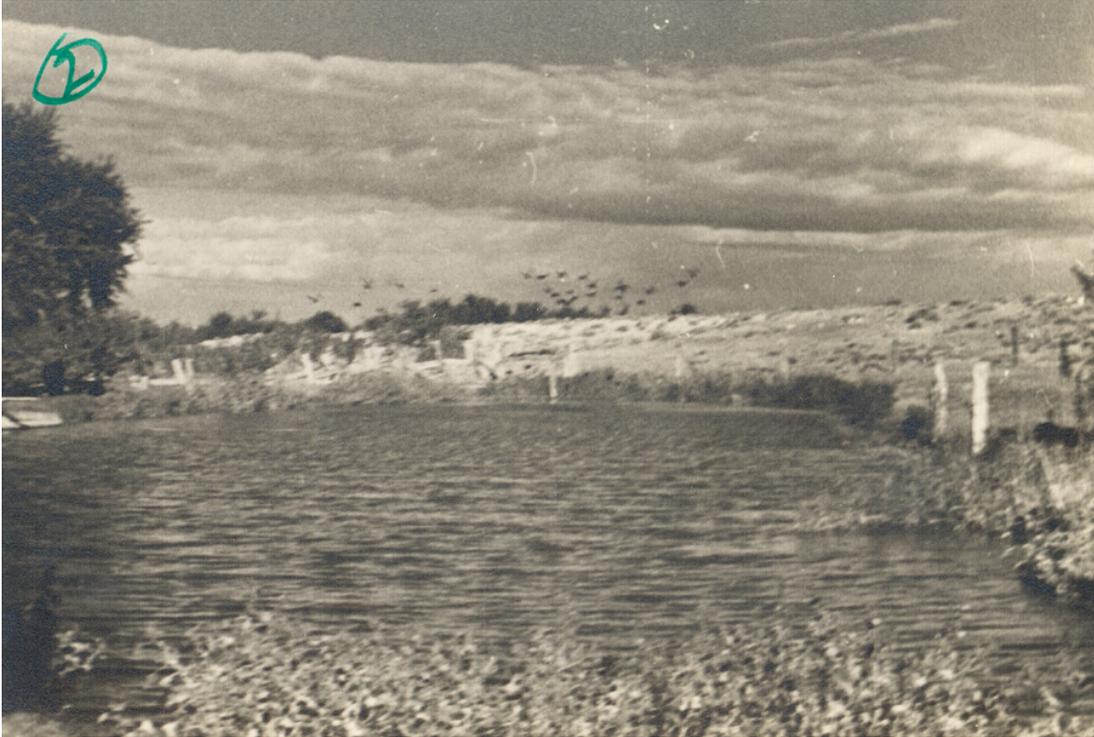
Figure 6.23. Reservoir above the Corn Creek Ranch. Fed from the Corn Creek Spring located at the right, 1936 (Worts Collection).

The entrance to the ranch was on the east, from the wagon road that originally linked Corn Creek to Las Vegas to the south and Indian Springs to the north. By the time Worts bought the property, a rough road had been broken through that connected the old Corn Creek Station on the LV&T and Corn Creek Springs, and another to US 95, the Tonopah Highway. The Richardsons had built a ditch to carry the water from the springs to a reservoir built up slope to the east, and an irrigation ditch to water an orchard and pasture (Figures 6.23 and 6.24).

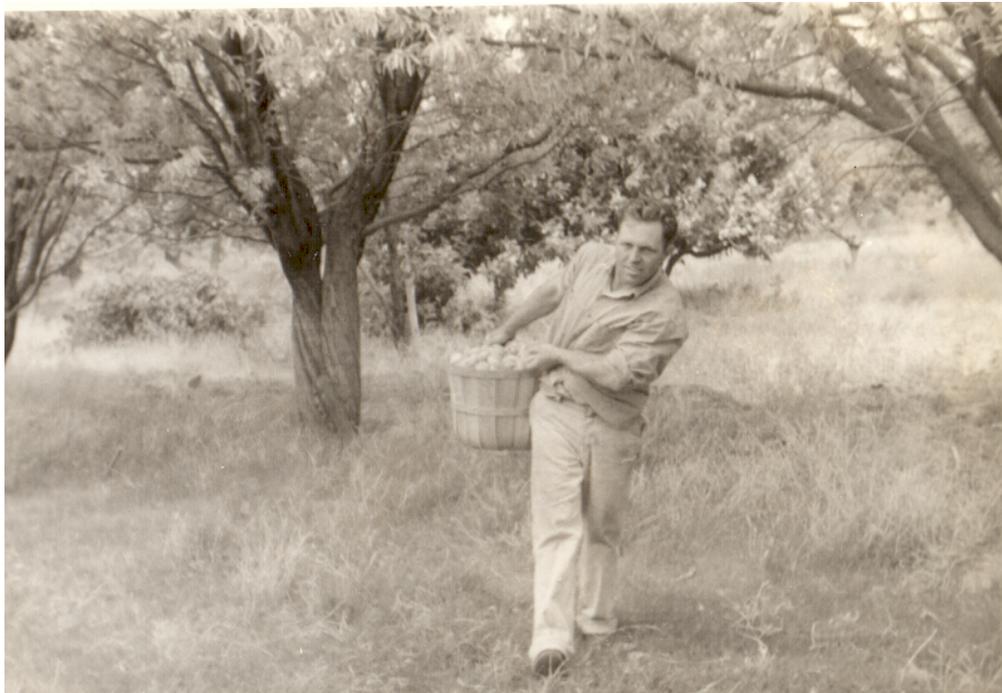
Figure 6.24. Tom Allen harvesting peaches at the Corn Creek Ranch, 1938 (Worts Collection).

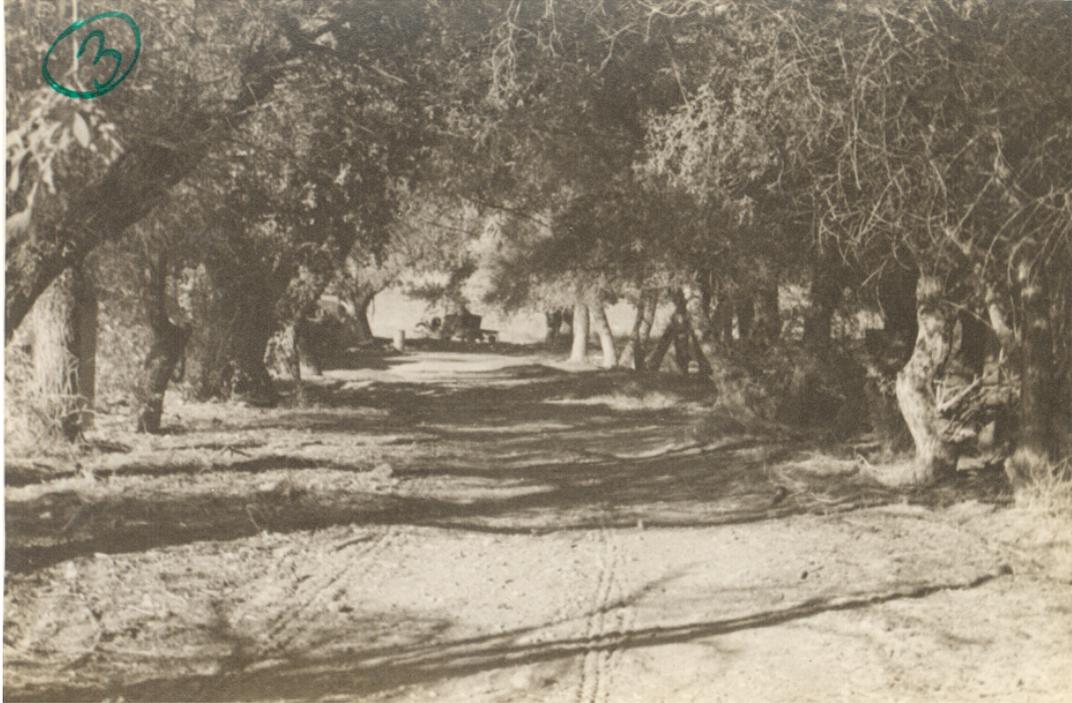
Figure 6.25. Tree-lined lane leading to the Ranch House at the end and to the right, 1936 (Worts Collection).

Cottonwoods and willows shaded the lane leading to the ranch house (Figure 6.25), and along the south side of the drive there were three crude buildings, still in use when the ranch changed hands in 1936 (Figure 6.17). The center one of these was “habitable,” according to Bob Worts, but the others were too shaky and eventually were torn down. The structure located to the west of the cabin shown in Figure 6.17 was the blacksmith shop, and the one to the east was a tack shed. The cabin was remodeled and upgraded in 1936 to become the “cook’s house” (Figure 6.26). The plastering was done by Ted Munson, a friend of Tom Allen, who worked for Worts on the ranch (Worts 2002).

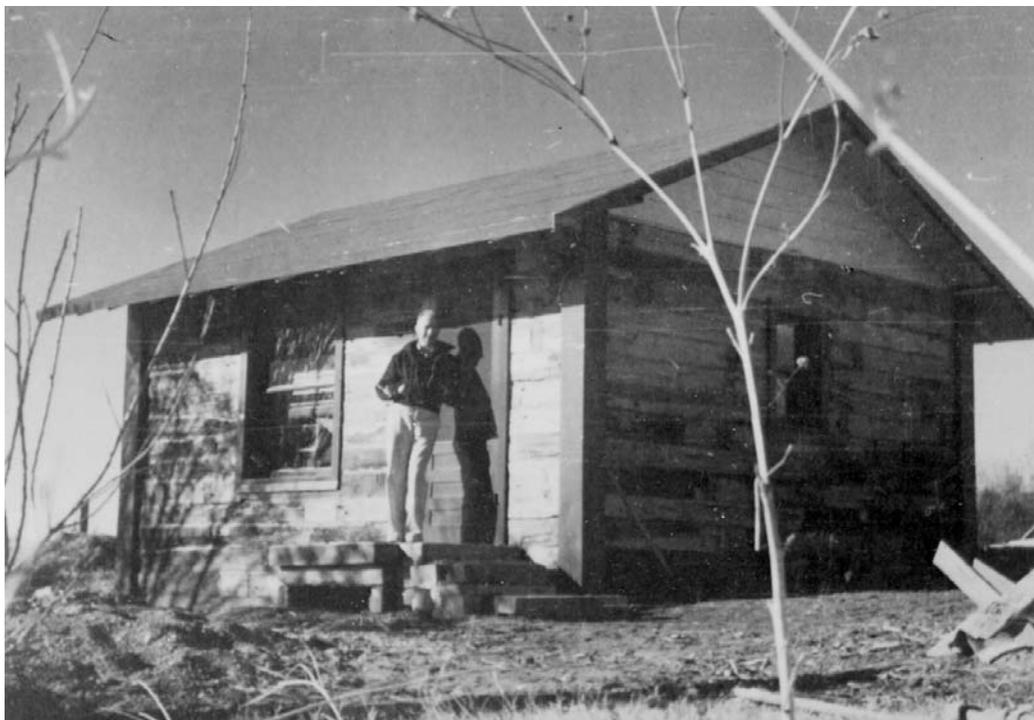
Figure 6.27. George F. Worts’ new study that he built at the Corn Creek Ranch, 1937 (Courtesy of Worts Collection, Special Collections, Lied Library, UNLV).

Because Worts was a writer, he required a place to work, and the small ranch house had no suitable space. To fill this need, in 1937 he built a “study” out of the railroad ties so conveniently stacked along the west side of the pasture (Figure 6.27). This building underwent a series of transformations in later years, when it was remodeled to become a refuge residence; eventually it was demolished. A new and relatively capacious workshop, bunkhouse, and tack room (rooms identified in order, from east to west) also was constructed to the south of the old ranch buildings. Skip Worts and some fellow students from Stanford erected this building in 1938 (see Figure 6.18). Skip is captured in a photo taken in 1938 next to the east end of the newly finished structure, posing with a surveying instrument he made himself (Figure 6.28).

Cottage (K) measured $16 \times 19 \times 8$, a shingle-roofed frame building with no foundation, but still listed in fair condition. It was a one-room structure with “stained soft floors” and was wired. Its value was \$250. This building probably was the “Study” built by George Worts in 1937 (see Figure 6.27).

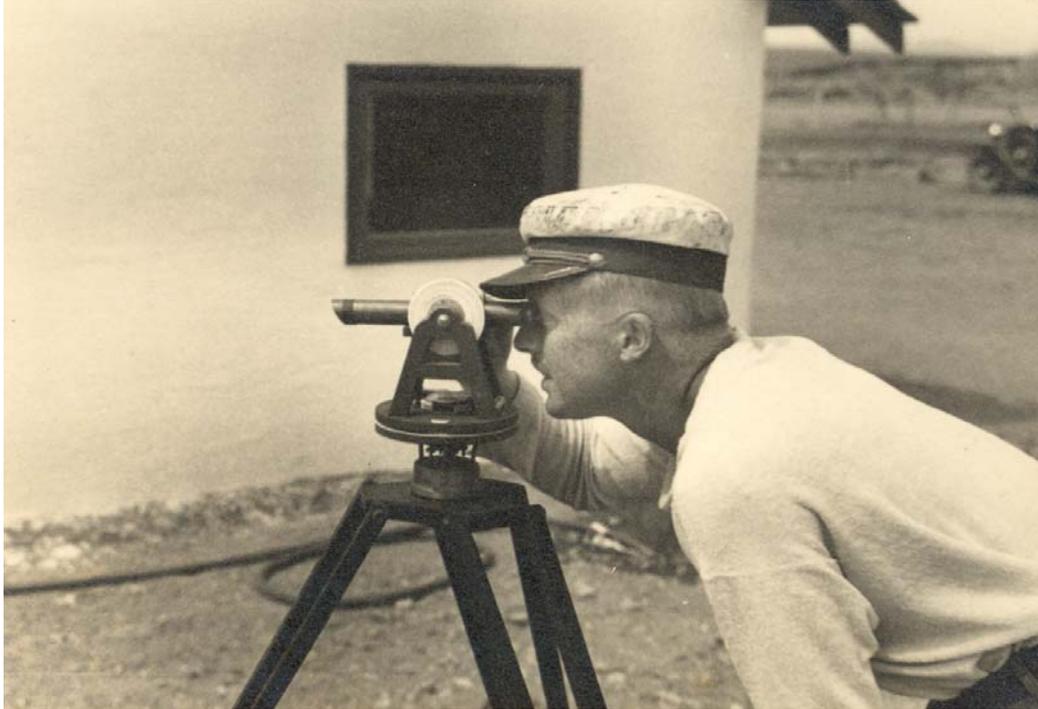
Figure 6.28. Skip Worts surveying at the east end of the workshop, ca. 1938 (Worts Collection).

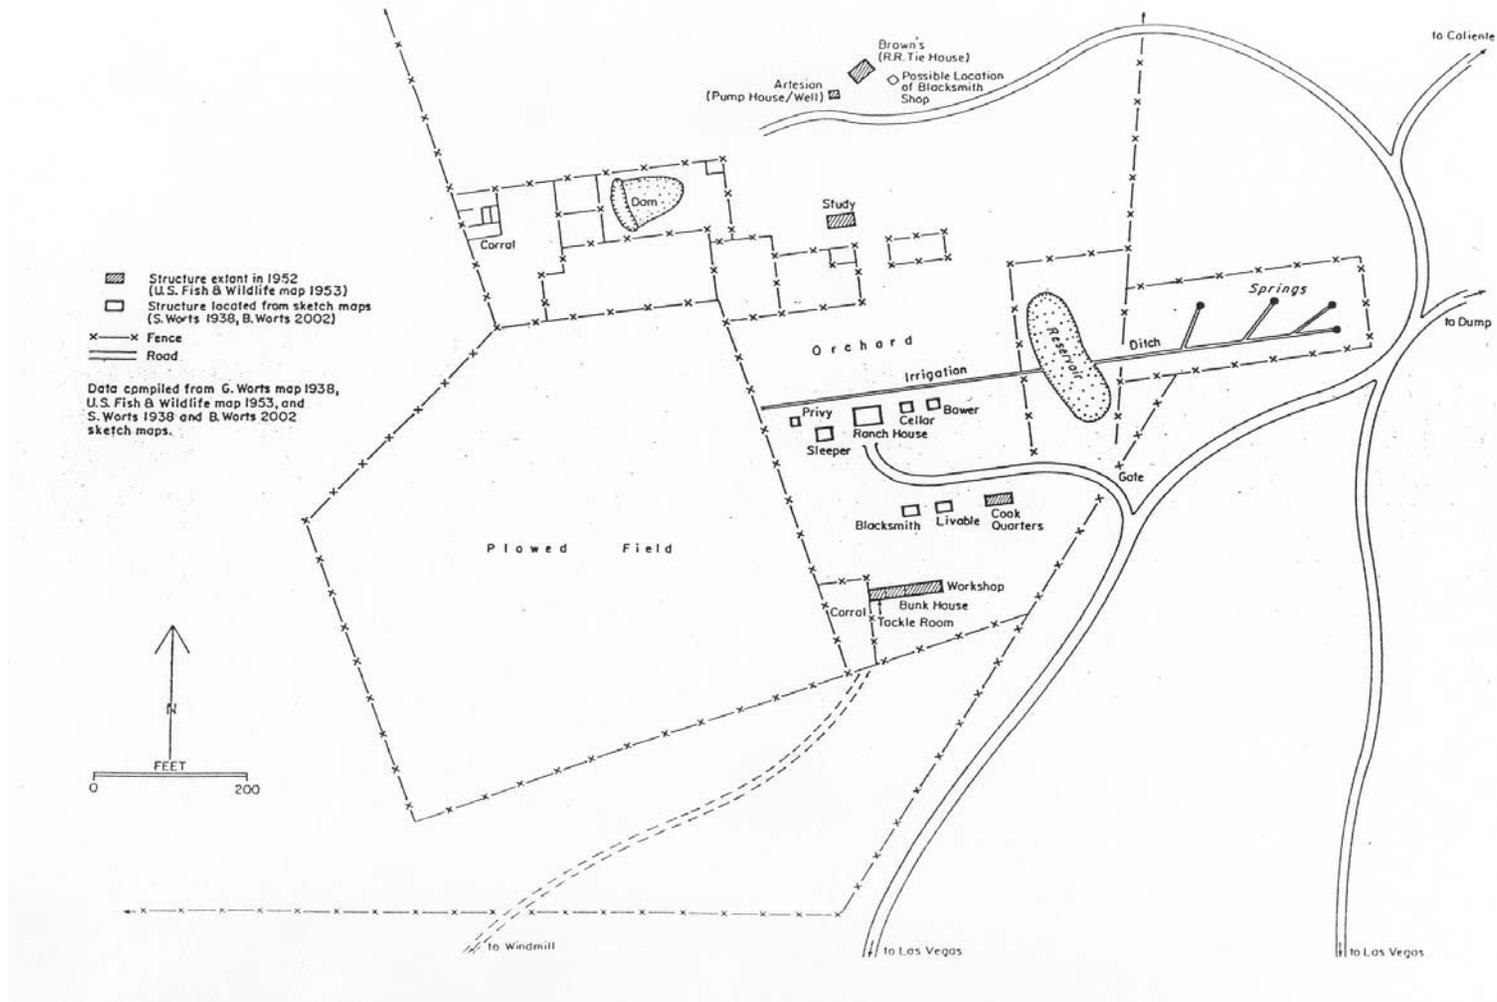
Figure 6.29. Layout of the Corn Creek Ranch in 1938, compiled from S. Worts sketches (1937), R. Worts sketch (2002), and Nevada Water Rights Surveyor C.D. Baker map to accompany Worts filing on Corn Creek Springs (Nevada Water Resources, App. 10198, 1938).

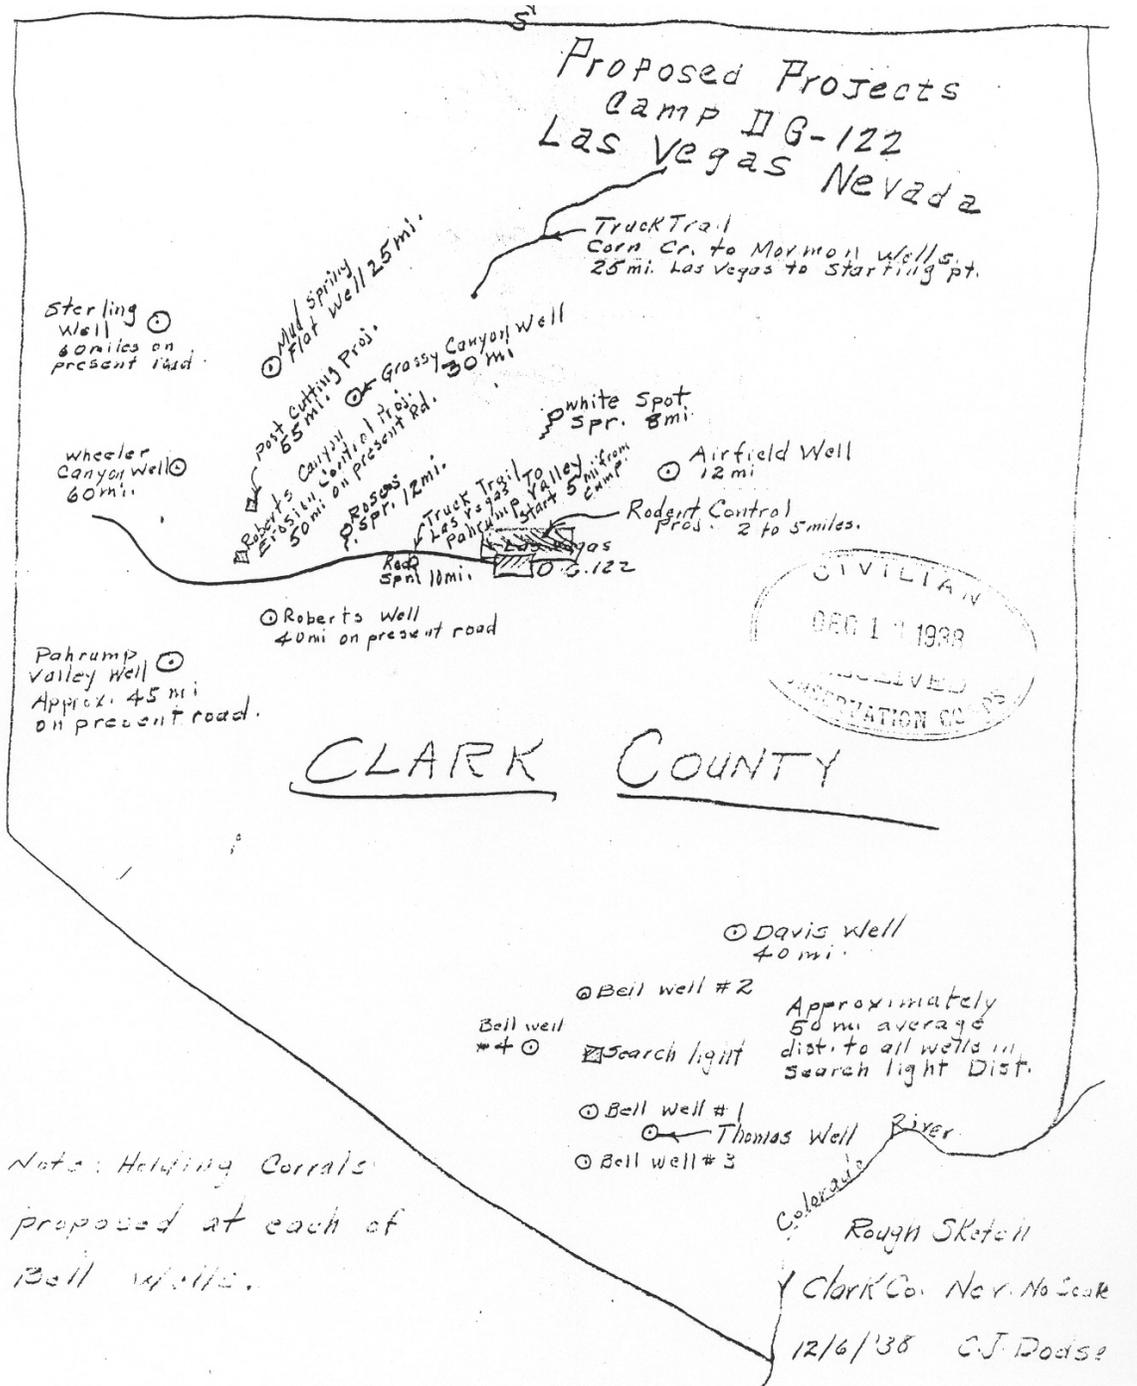
Figure 6.30. Map of the proposed CCC projects, Camp DG-122, Las Vegas, Nevada, 1938 Inspection Reports, DG-122-W, NARA RG 35.

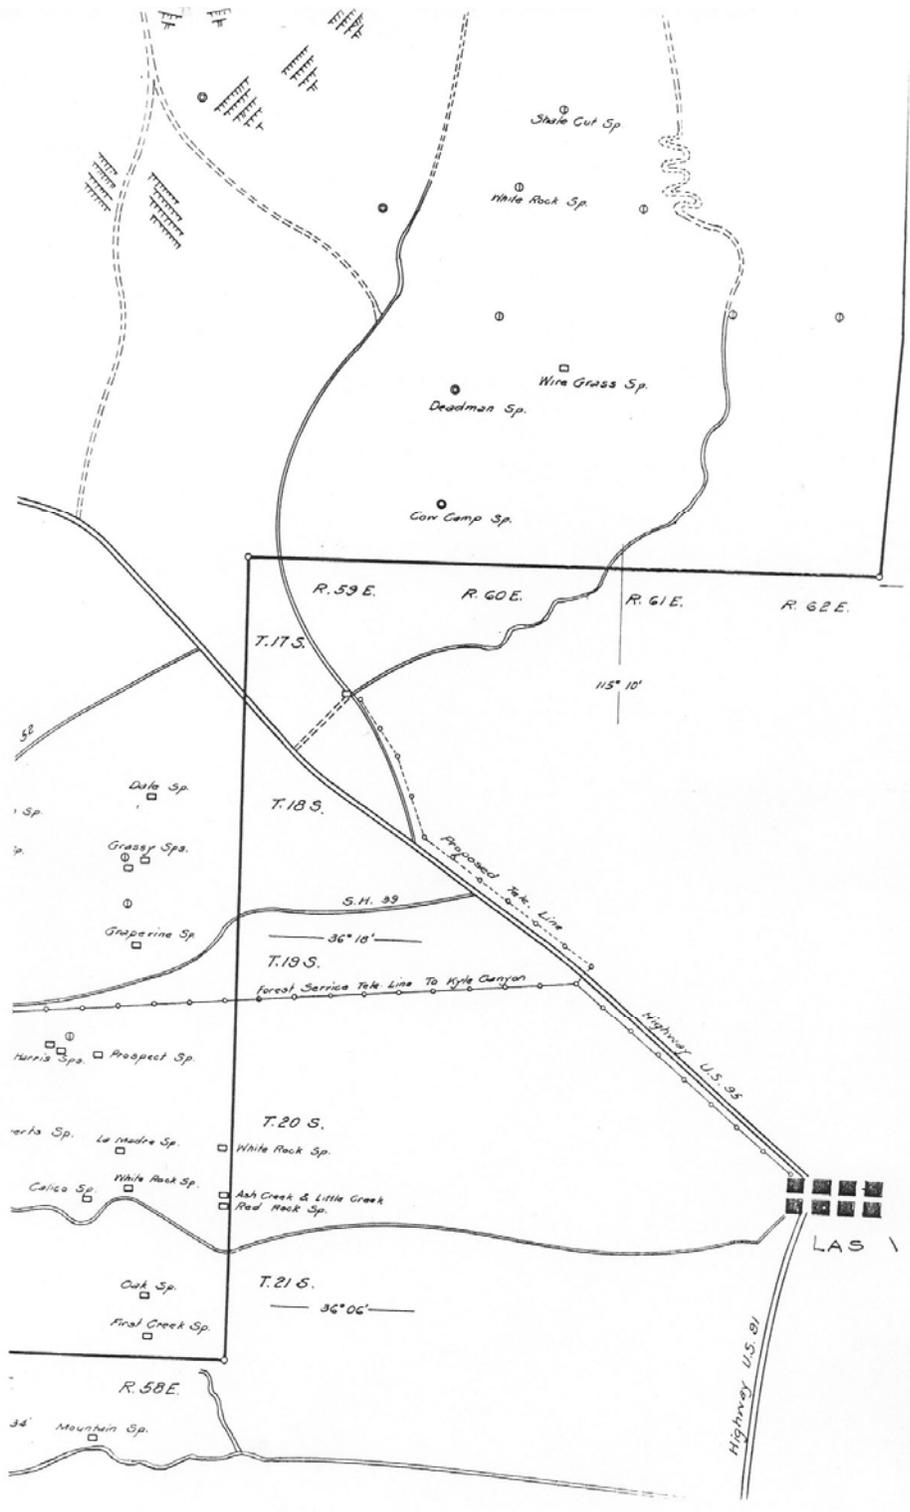
Figure 6.31. General Map, Desert Game Range, Clark and Lincoln Counties, Nevada, October 2, 1940. [Corn Creek is located at the northern end of the proposed Telephone Line.] (USFWS, District Engineer, Salt Lake City, M-Nev. 6-4.0, in map files, Corn Creek).

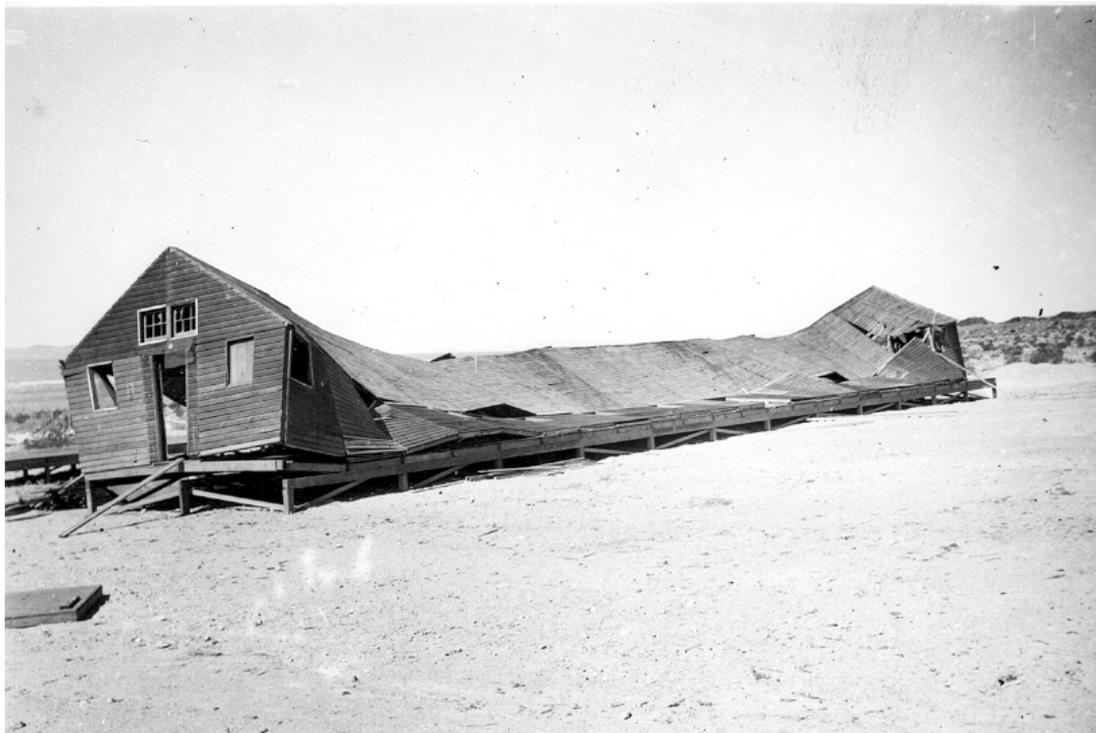
Figure 6.32. Collapsed CCC barracks building, 1941 (USFWS DNWR photo archives).

Back at Corn Creek, one of the five CCC barracks slated for completion in July 1941 blew down in a windstorm (Figure 6.32). Over a period of several years, materials such as electrical wire and lumber were recycled for use at the ranch, and the underground reservoir built by the CCC was converted to septic tank use for the ranch residences (DGR Annual Narrative 1951). The camp’s latrine was bulldozed (Zeller, personal communication, 2003), and one foundation was converted to a loading dock. This structure appears to be built on the same kind of foundation as described for the Las Vegas camp; it was made of wood rather than concrete. The structure had a wooden floor, which is still visible at the edges of the dock, under the present covering.

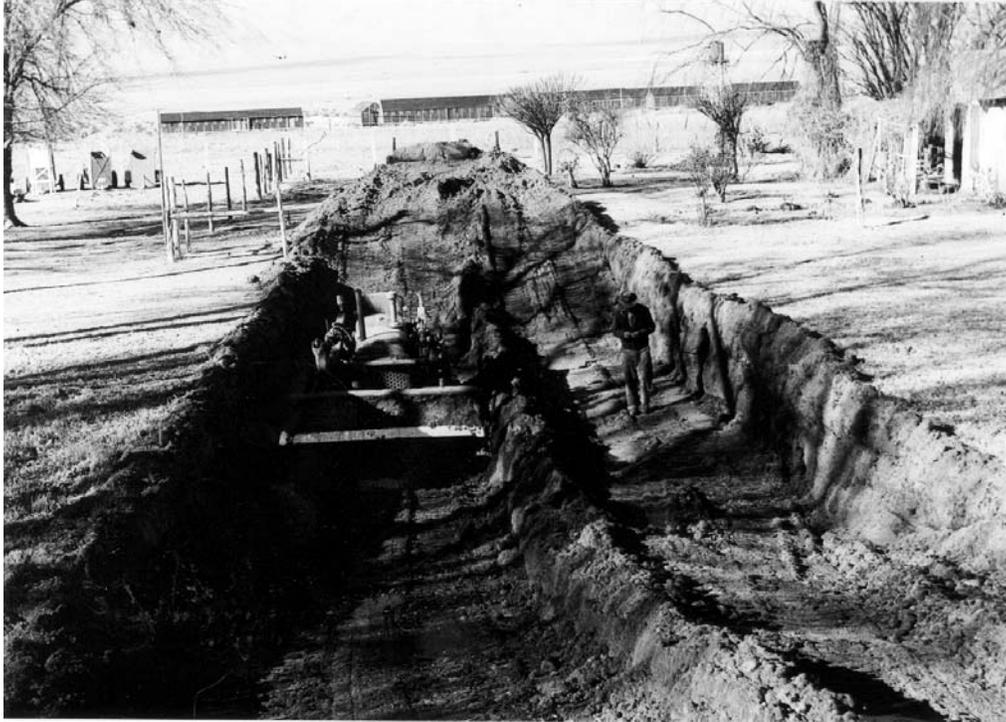
Figure 6.33. CCC Camp at Corn Creek, January 1942. Viewed from the main ranch compound, the old ranch house is at the right, and the basement excavation for the new Refuge Manager's residence is in the center. The water tank in the right background, located between the CCC camp and the old ranch house, probably served the CCC camp (USFWS DNWR photo archives).

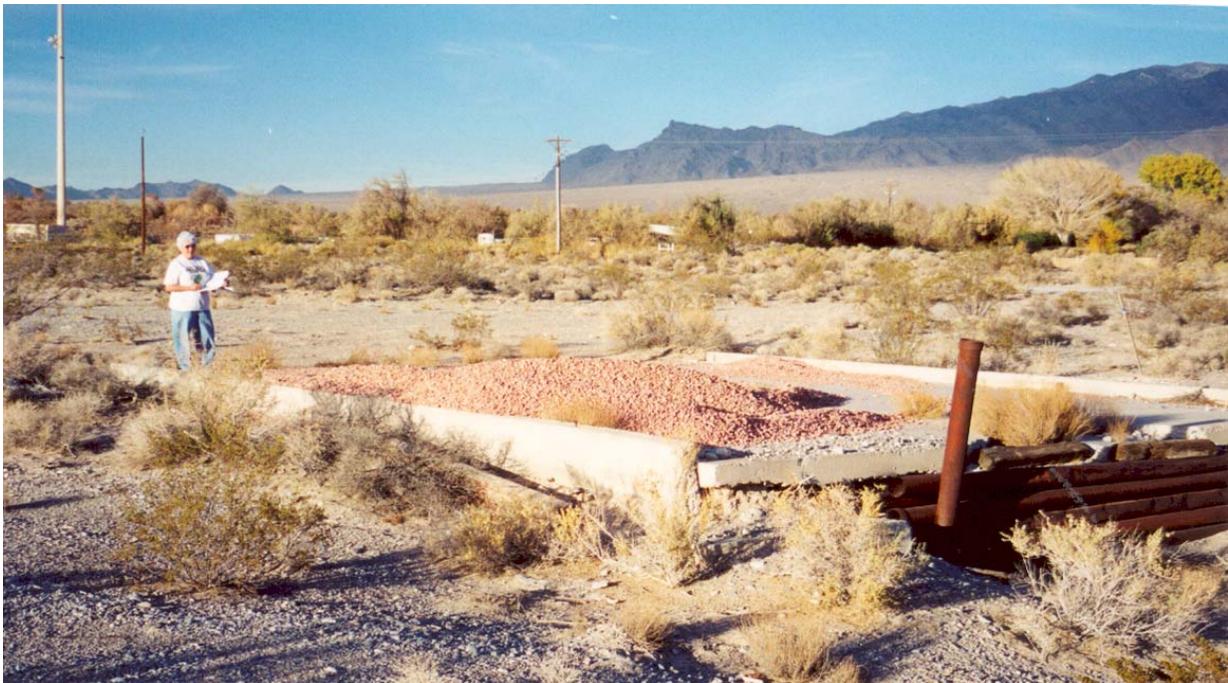
Figure 6.34. Looking north at CCC Concrete Slab # 2.

The only visible remains of the CCC camp are an artifact scatter and a set of building pads, all but one of which is made of concrete (Figure 6.34). One foundation, made into a loading dock in the early 1950s, is constructed of wood. Foundations of this type at the Las Vegas CCC camp, DG-122, were cause for concern to CCC inspectors, who feared they were not durable enough. The wooden foundation is elevated above the ground, and tongue-and-groove flooring is visible under its current surface. The type of flooring would indicate a building use as barracks, mess hall, or for classroom. Without a specific camp plot plan, it is not possible precisely to identify its purpose.

Concrete Slab # 1 is rectangular, measures 25 ft 11 inches by 10 ft 1 inch, and is oriented roughly north-south. A portion of the wood frame outside the foundation is present on the east edge of the slab. Concrete Slab # 2 measures 36 ft 11 inches by 30 ft 9 inches and is also oriented north-south (Figure 6.34). Bolts have been placed in the concrete approximately 5 inches apart along the top surface of the walls. The north wall has been removed and a 5 ft ramp installed. The foundation is currently being used as a storage area for gravel. Concrete Slab #3 appears to have functioned as a garage since a ramp leads into the structure from the south wall. The dimensions of the foundation are 37 ft 7 inches in length and 30 ft 10 inches in width and it is oriented north-south. The foundation is in good condition and imprints of burro tracks are visible in the surface of the concrete. Concrete Slab # 4 is the smallest slab of the six measuring 20 ft 7 inches by 10 ft

1½ inches. Two raised and sloped concrete platforms (4 ft long, 1 ft 10 inches wide, and 9 inches high), which are positioned in the center of the slab, suggest that a large piece of equipment was mounted on the platform, possibly a generator (Figure 6.35). Concrete Slab # 5, which is the largest of the foundations, probably represents what is left of the CCC structure pictured in Chapter 3. The slab is raised on concrete pillars that vary in height from 2 ft to 6 inches. The feature measures 49 ft 10 inches long by 29 ft 6 inches wide and it is oriented approximately east-west. Tongue and groove wooden floorboards protrude from under the slab along the edges of the foundation. It is possible that the original flooring was tongue and groove and then concrete was later poured over the flooring (Figure 6.36). This building probably functioned as some type of residence or bunkhouse. The northernmost slab, Concrete Slab # 6, measures 40 ft 11 inches by 20 ft 2½ inches. This slab is oriented northeast or southwest.

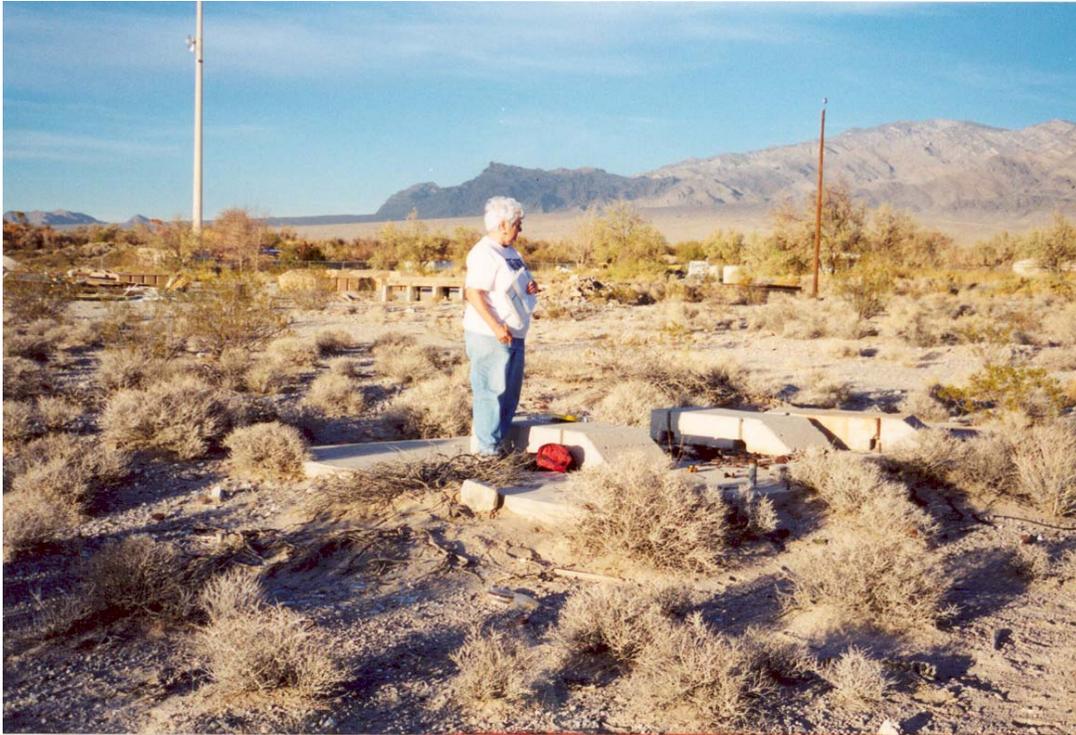
Figure 6.35. Looking north at CCC Concrete Slab # 4.

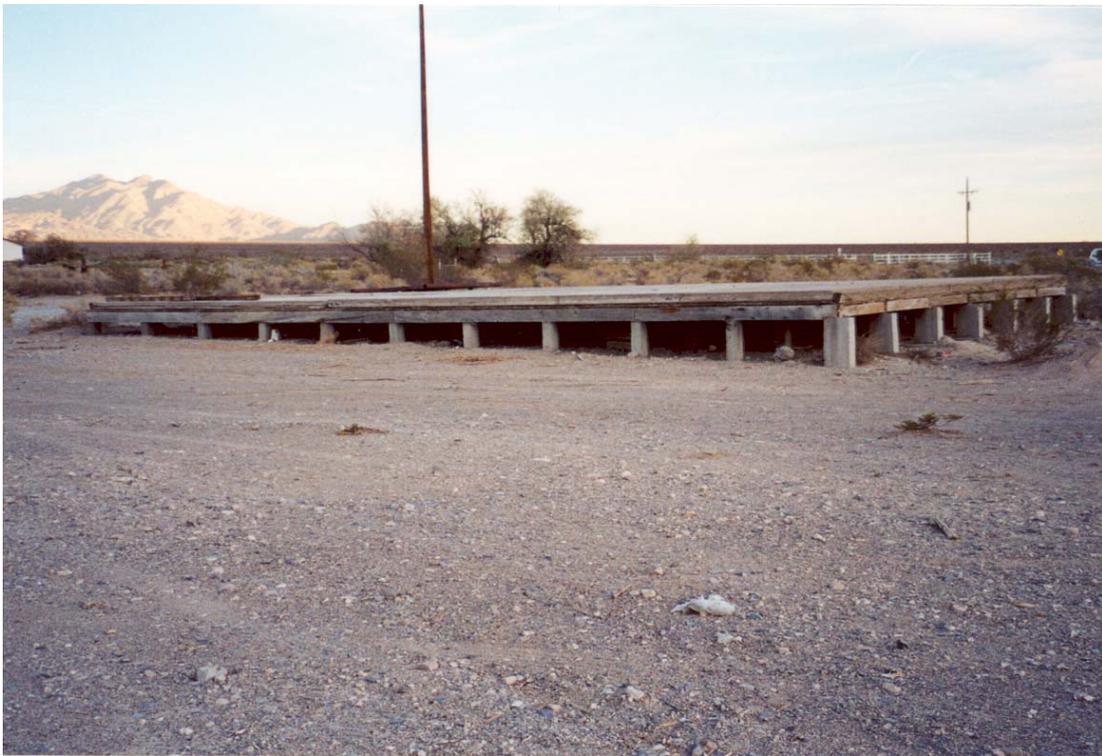
Figure 6.36. CCC Concrete Slab # 5.

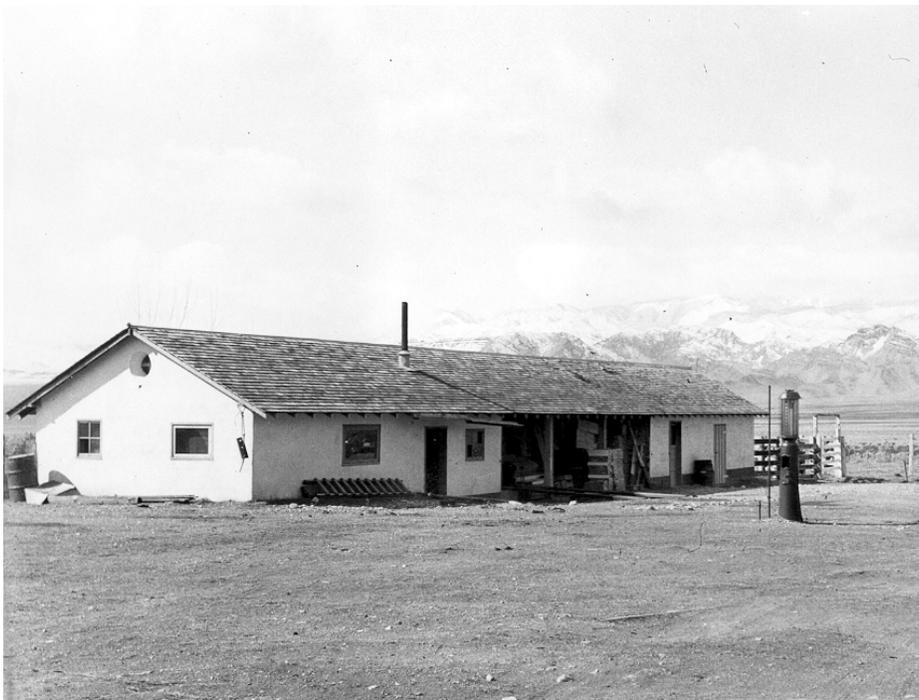
Figure 6.37 Equipment shed in 1942 (USFWS DNWR photo archives).

The “barn” (A) is described as a frame building in good condition, measuring $18 \times 100 \times 8$ [feet], with concrete foundation and shingle roof. There were two rooms, one 32×17 and the other 8×17 , with new wallboard ceilings. It was wired for electricity, and plastered. Most importantly, for purposes of identifying the building, the walls were constructed of railroad ties. The “barn,” valued at \$1150, is the shop, bunkhouse, and tack room built by Worts along the southern boundary of the ranch core in 1937 (Figure 6.37).

The Valuation of Improvements list of the Acquisition Examination Report called this a barn (A). It was described as a frame building, measuring 18 × 100 × 8, with shingle roof and a concrete foundation. Its two rooms measured only 32 × 17 and 8 × 17; the open center is not expressly included in the description, and is detectable only by comparing the stated total length of the building with the size of the two rooms. The rooms featured wallboard ceilings, were plastered and wired for electricity. Special note was taken that the walls were built of railroad ties.

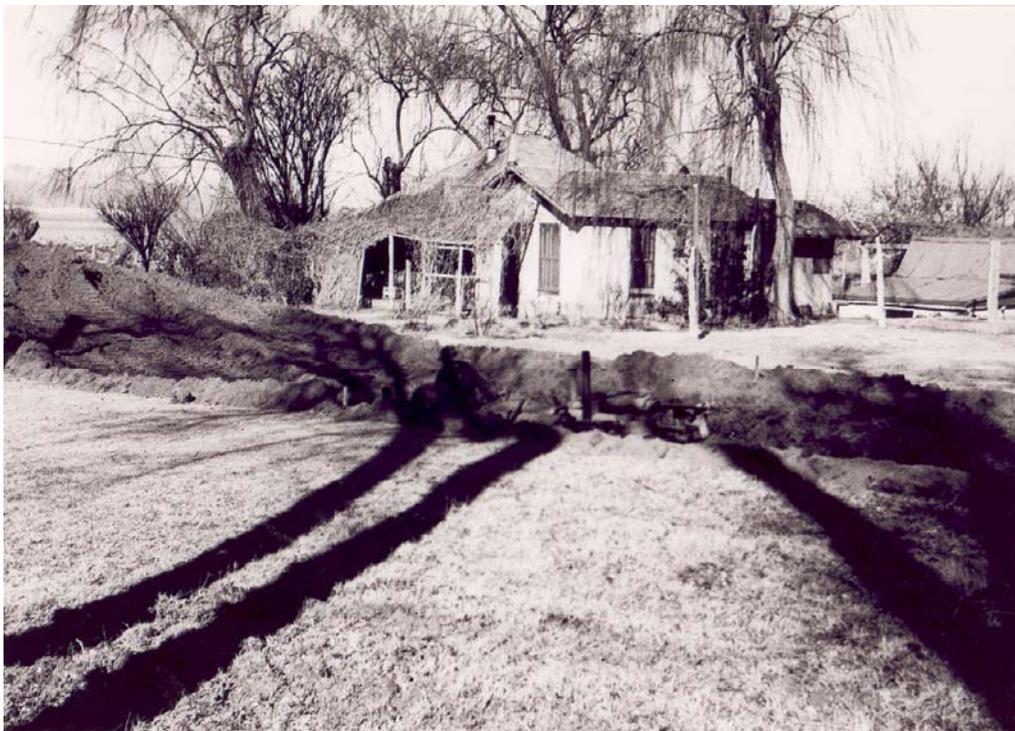
Figure 6.38. Main Ranch House in January 1942 (USFWS DNWR photo archives).

Of the five “cottages,” the main ranch house is the one identified as building (F). This was described as a frame building in poor condition, measuring $38 \times 33 \times 8$, with a shingle roof. Its foundation was made of railroad ties. The exterior of this six-room house was partly stuccoed, and the interior walls were of wall board with plastered ceilings and “soft [wood] flooring.” The house was wired and had an indoor shower bath, toilet, and washbasin. The examiner also noted the presence of personal property not figured in the \$600 valuation of the cottage. He listed an Electrolux Refrigerator, a gas stove, hot water tank, and Superfex oil heater (Figure 6.38).

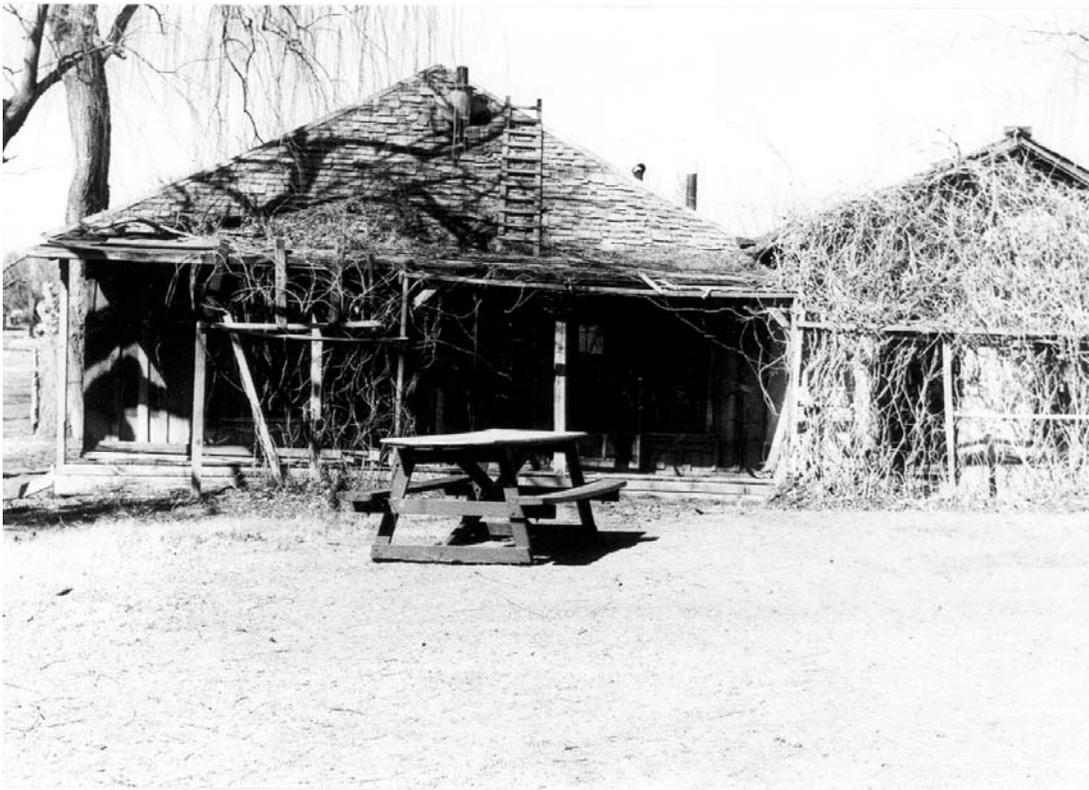
Figure 6.39. The Ranch House before it was torn down in 1950. The Worts' addition is on the right, and it was retained as Quarters 5 (USFWS DNWR photo archives).

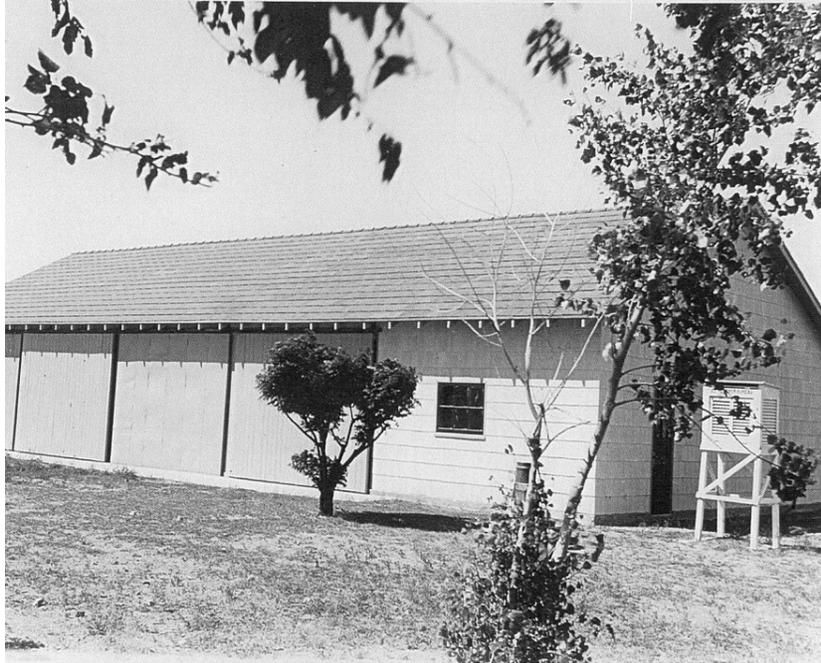
Figure 6.40. The Service Building in April of 1943 (USFWS DNWR photo archives).

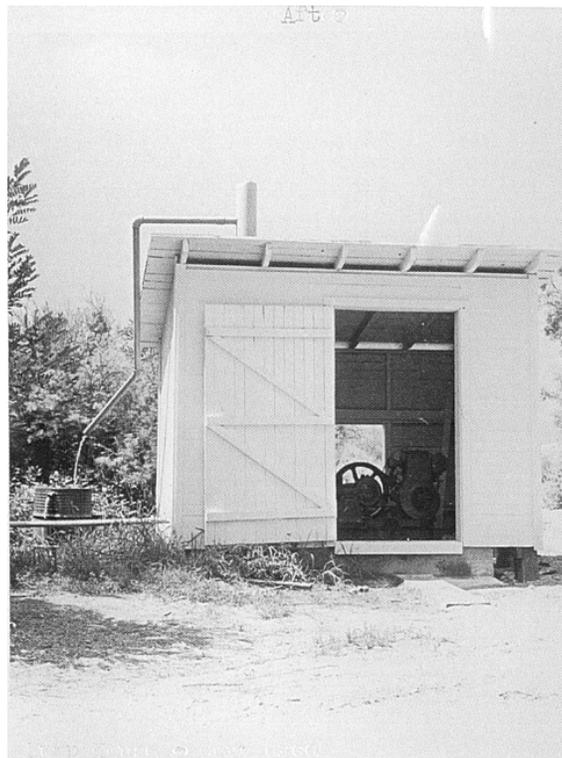
Figure 6.41. Pump House in 1946 (USFWS DNWR photo archives).

The pump was a “Wisconsin water pump,” transferred to Corn Creek from Red Rocks Wildlife Refuge, and the tank and tower were shipped from Upper Mississippi Wildlife Refuge. Water pressure increased dramatically after the pump and tower were hooked up: “Previously when the water faucet was turned on a very small stream emitted. Now when the faucet is open we have pressure equal to that in any city.” That summer, a concrete base was poured and the pump bolted to it. Finally Refuge Manager Groves noted that, also during the summer, a “simple, but storm and windproof shed” was erected on the concrete foundation to protect the pump. These improvements solved the problem of rain and blowing sand interfering with the pump operation (Narrative Report, Sept.-Dec. 1943: 7). The photo archives at Corn Creek contain an envelope with two photographs titled “Water pump on flowing well before construction of pump house. 1943.” A separate envelope labeled “Pump house. Corn Creek headquarters. Oct. 1946 O. V. Deming” includes a photograph of the pump house before and painting. The building was not painted until 1946. (Narrative Report, May-Aug., 1946: 19). This wooden pump house appears on the Corn Creek Plot Plan, 1953 (Figure 5.44).

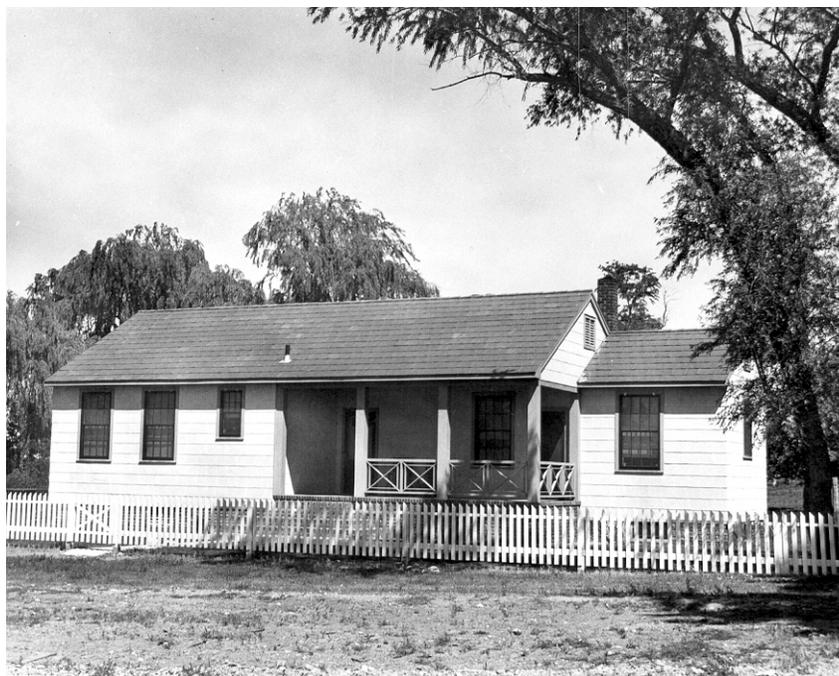
Figure 6.42. Refuge Manager's Residence in 1943.

A new residence for the Refuge Manager was one of the first needs identified by the FWS for its Corn Creek Headquarters. Originally, CCC labor was to build it, but that plan was scuttled when the camp was disbanded in August 1941. Refuge Manager Groves noted that funds had been appropriated in 1941 to construct the house (Narrative Report, Nov. 1941-Jan. 1942: 1); its location, south of the original ranch house, had been selected in 1940 (Narrative Report, Feb.-Apr., 1940: Photo A6). Ground was broken on the project in mid-February, 1942, and the residence was completed by the end of the fiscal year, June 30, 1942. Manager Groves and his family moved into the residence on July 6, 1942, and quickly built a redwood-picket fence to keep livestock away from the newly-planted lawn and shrubs (Figure 6.42). The fence was a cost-saving measure as well, since the courtyard had been graded and planted to sour clover as a soil builder. Groves allowed the FWS-owned horses to graze on it, saving at least \$40 in hay purchases (Summary of Year's Accomplishments, Apr. 1942-Apr. 1943: 3).

The family did without heat at first. When a Mueller No. 48 furnace was installed toward the end of 1942, Groves was very grateful. This furnace had been converted into a coal burner, which Groves noted "is not so nice nor as cheap to operate as an oil burner," but since it was wartime, obtaining fuel was much more certain (Narrative Report, Sept.-Dec.1942: 11).

In the years between construction of the house in 1942, and 1953, the Manager's Residence benefited from regular maintenance (sanding and finishing of floors, painting and re-painting). The knotty-pine paneled guest room and a bath were completed in the basement of the house in 1943 (Narrative Report, Sept-Dec. 1943: 7). Early in 1946, a dark room was improvised in the basement of the residence so that photographs depicting the development of the refuge during that period could be included in Manager Grove's report (Narrative Report, Jan.-April, 1946: 18). Subsequently, a dark room was constructed in the Service Building.

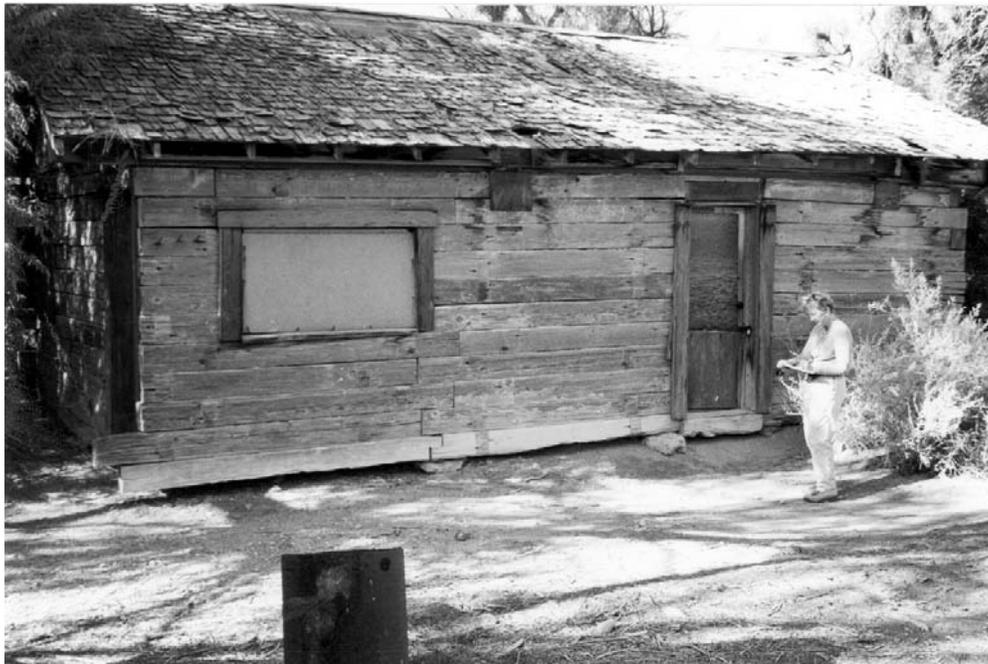
Figure 6.43. The Railroad Tie House as it appears today; note that the window has been boarded up.

The structure appears to rest directly on the ground, but a limestone rock has been placed at every tie butt or corner. The southeast corner has been undermined by animals to a depth of 18 inches and is not supported. The building has two roofs: an older low-pitch, corrugated metal one, with 3¼ inch × 1½ inches rafters 24 inches on center; and, built over the original roof, a medium-pitch one, with 2 × 4 rafters 25 inches on center supporting 1 × 6 inch sheathing that are covered with shingles. There are two chimney holes in the east elevation at the eave line, one of which holds an 8-inch ceramic flue pipe, with corresponding holes in the eaves above. At the southwest corner, the 12-inch limb of a mesquite tree rests directly on the open eave, causing the roof to part at the ridgepole and the fascia to pull loose.

The interior of the structure has been altered to provide storage space. It is divided into two rooms and has 3-inch tongue-and-groove flooring. In the east elevation, a window at the south end and a door near the north end provide 12% fenestration. A door at the east end and a window at the west end also provide fenestration of 12% in the south elevation. A window in the north elevation and a door in the west elevation afford 5% and 7% fenestration, respectively. The windows and doors are framed with 1 × 6 inch boards. The wooden doors are about 2½ x 5 inch; the window, about 2 × 3 ft. New glass has been put in the window (National Register Nomination Form, Corn Creek Site, on file Harry Reid Center).
