REFUGE PERIOD, 1939 - 1953

Civilian Conservation Corps at Corn Creek, 1939-1941

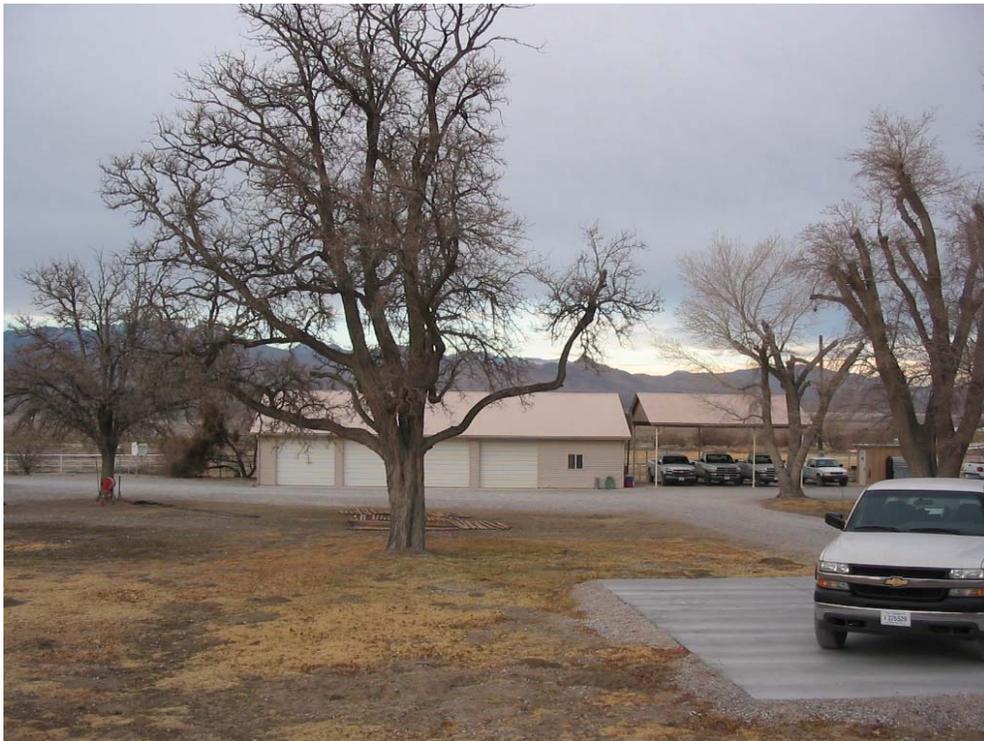
Figure 6.44. Photo of the front of the Service Building taken in 2007, looking west (FWS photo).

Constructed in 1943 (see Figure 6.41), this side gable Service Building measures 29 × 67 ½. It contains four garage bays and a closed shop bay, with pedestrian doors located on the gable ends (Figure 6.44). The building was made with a wood frame and a poured concrete foundation, and the original siding was asbestos shingle with a slate roof. When it was originally constructed, the Service Building had wood frame windows on each elevation, with five across the rear (Nevada SHPO Historic Resources Inventory Form, 2007:2). A darkroom was added in 1946. According to the form this building is one of only two that were designed and built for the refuge headquarters during the initial development period (prior to 1950). Along with the Refuge Manager’s House, the Service Building is the only building that was constructed at Corn Creek before supplies and funds were cut because of World War II.

The Service Building was remodeled in 1996, and a metal roof, vinyl siding, aluminum sash windows, and new over-head doors on the garage bays were put in place (Nevada SHPO Historic Resources Inventory Form, 2007:2). The dark room was also converted into a restroom at this time. The building is now used for vehicle storage and maintenance.

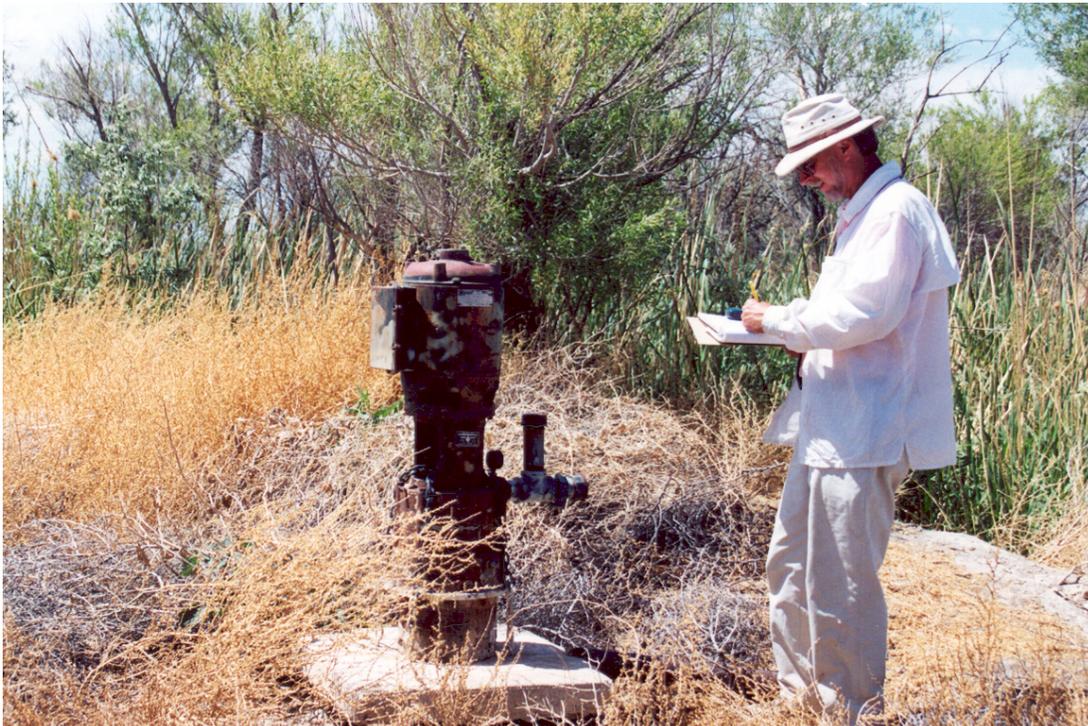
Figure 6.45. HRA Archaeologist Richard Ahlstrom recording the wellhead with pump.

A number of other interesting historic features and artifacts were also identified during the survey. These features include a well pump (Figure 6.45), roads, a dugout, the remains of a mine shaft, and a windmill, and various trash scatters. The windmill (Figure 6.46) and associated water well were built before the property was purchased by the FWS. The Civilian Conservation Corps may have used the well as a source of domestic water for their camp in 1941. There are also a few trash scatters and a road (Figures 6.47 and 6.48) found near the windmill. A metal frame made of railroad ties (Figure 6.49) was also found during the survey. Bob Worts, who lived on the ranch, remembered that this frame was used by his father to grade the dirt roads into the station. The frame was dragged behind the tractor or truck over the dirt road to level the washboard condition of the roads into the ranger station. The frame would have been used in the 1930s, and possibly earlier. The dugout (Figure 6.50) is a hollowed out area in a wash bank with a dirt floor and dirt wall. It also has a door made of milled timbers, a leather handle, and wire nails. Bob Worts remembers this dugout, although he does not know what it was or what it was used for. It was probably built before the 1930s.

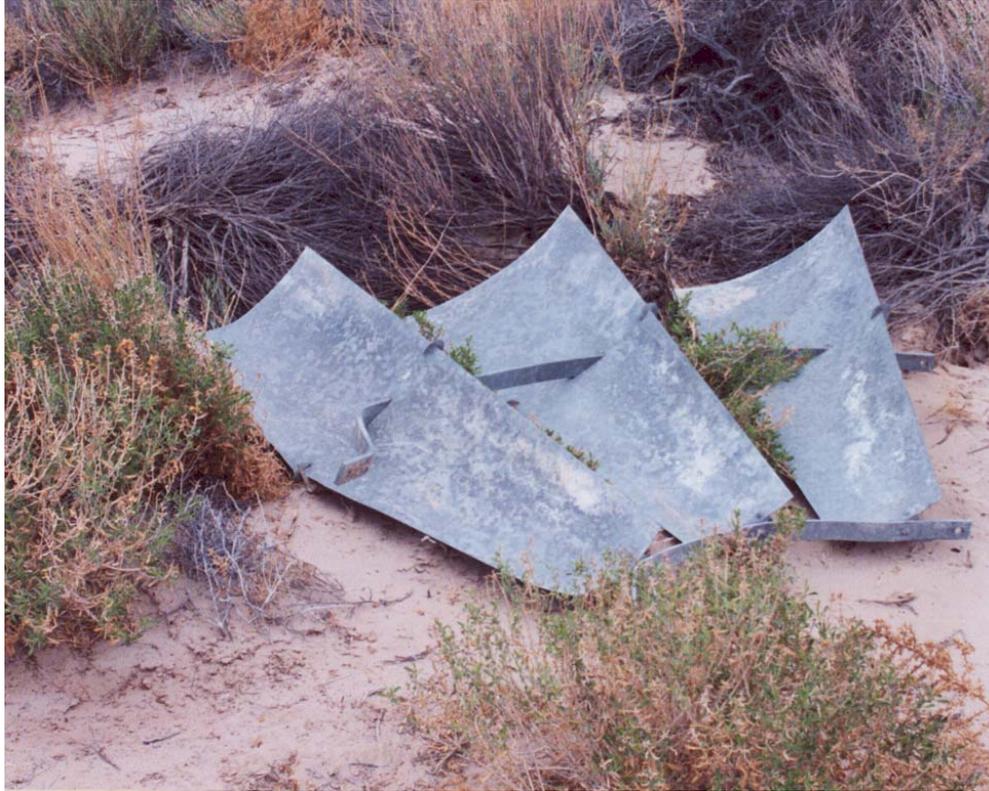
Figure 6.46. Windmill blades found during the survey of the Corn Creek Field Station.

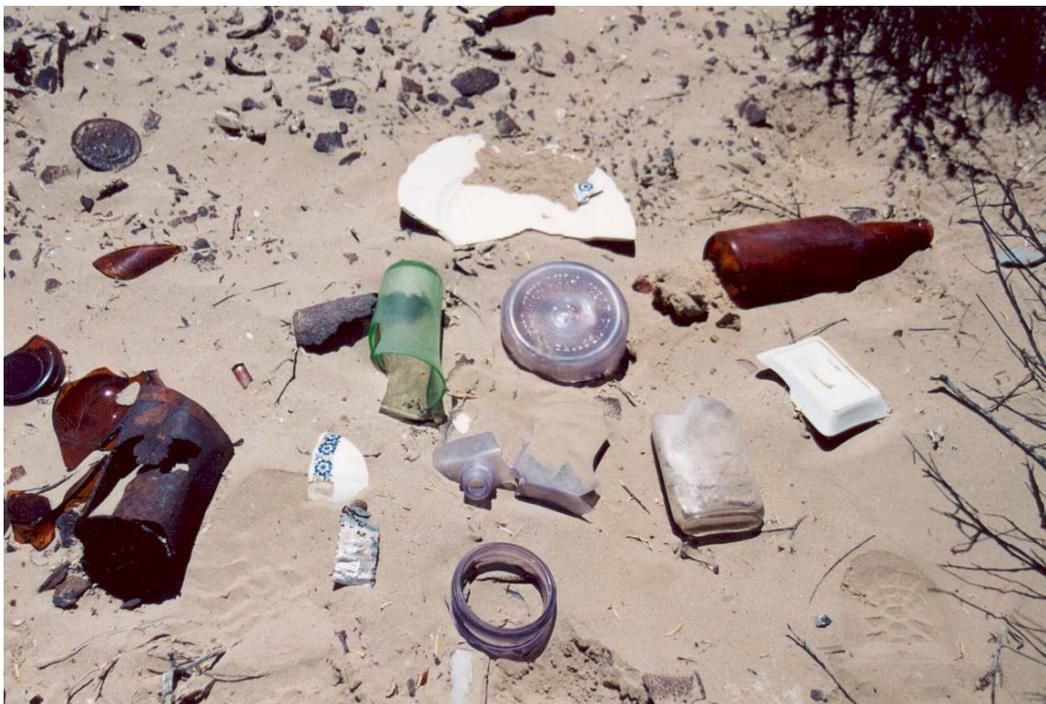
Figure 6.47. A historic trash pile identified during the survey of the Corn Creek Field Station.

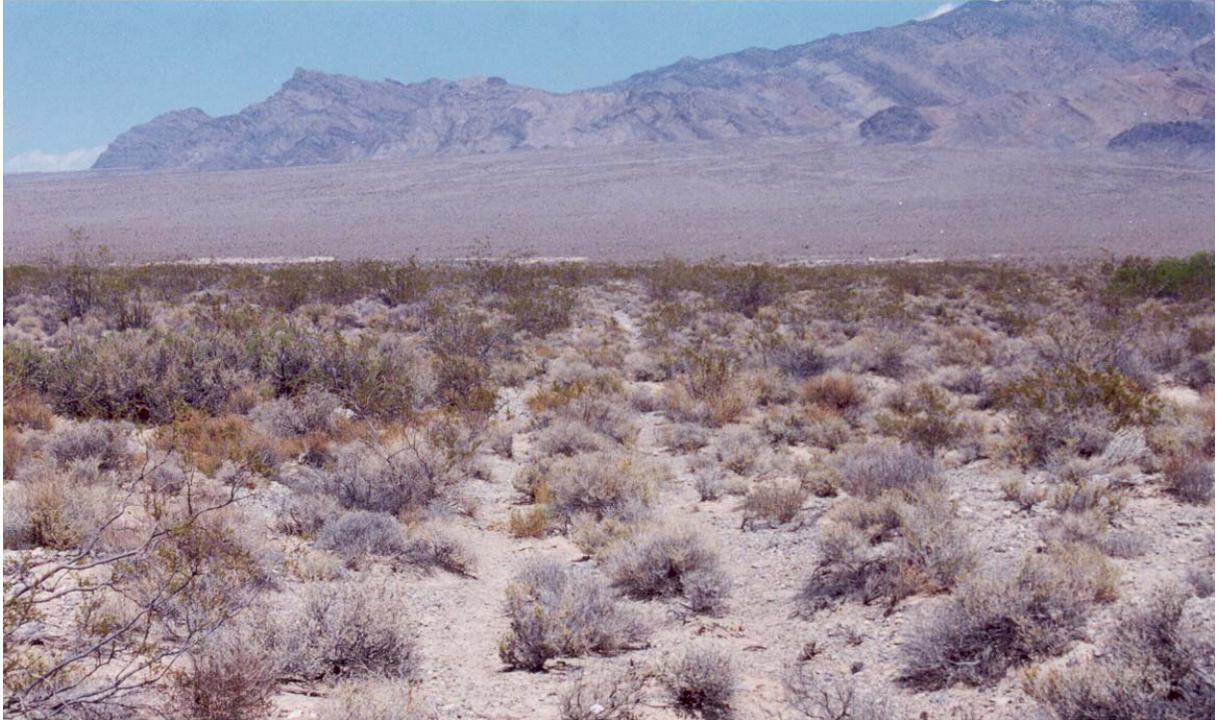
Figure 6.48. Historic two-track road identified during the survey of the Corn Creek Field Station.

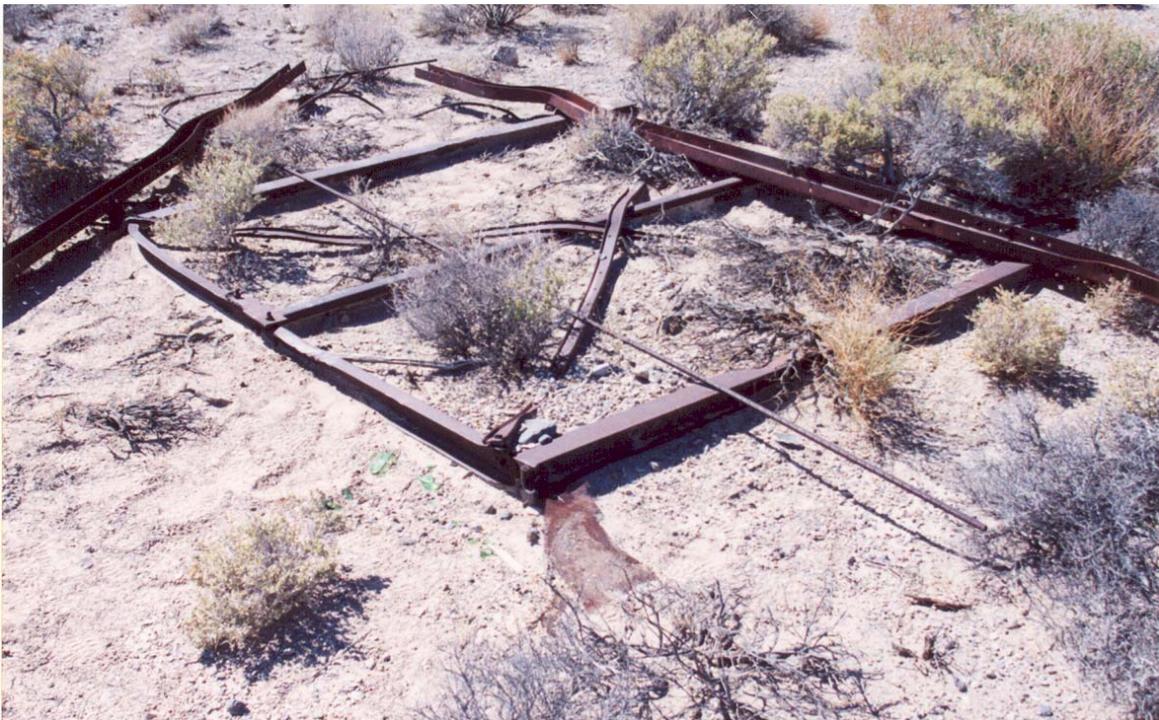
Figure 6.49. Metal frame made of railroad ties that Bob Worts said was used as a road grader in the 1930s.

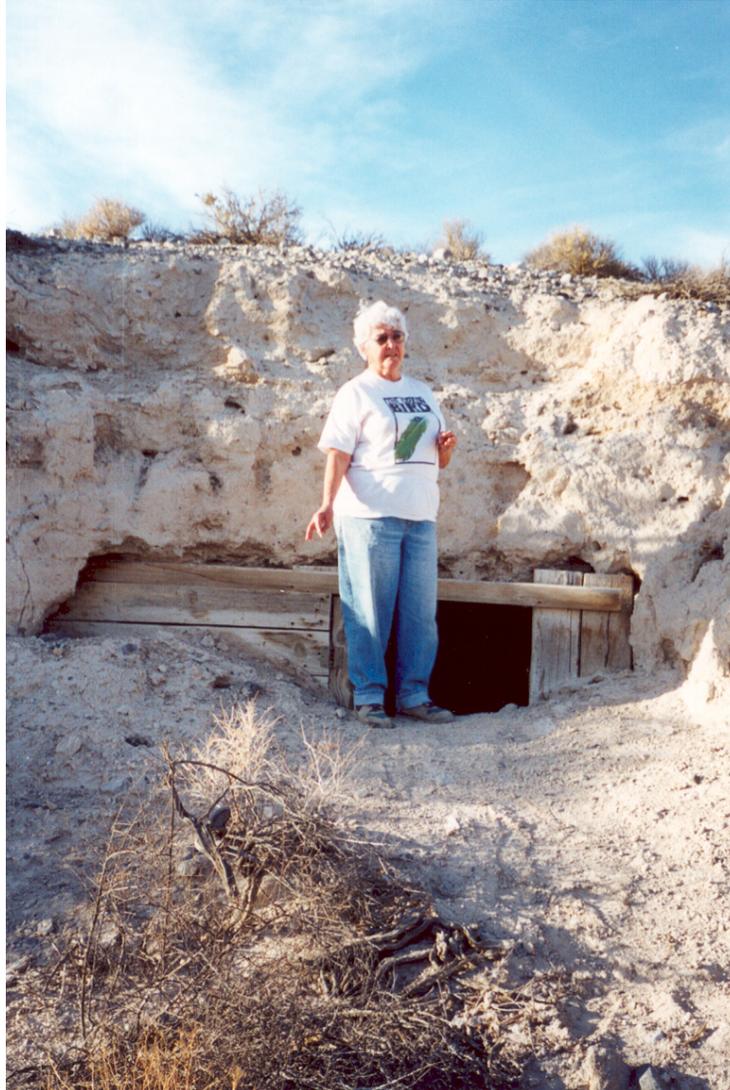
Figure 6.50. A dugout feature identified during the archaeological survey.
