**2007 ACCOMPLISHMENT REPORT
&
2008
SOUTH END COMPLEX
&
BASQUE WELLS & CRATERS FIRES
PROPOSED
BURNED AREA REHABILITATION PLAN**

UNIT: US Fish and Wildlife Service
Malheur National Wildlife Refuge

LOCATION: Princeton, Harney County, Oregon

DATE: September 6, 2007

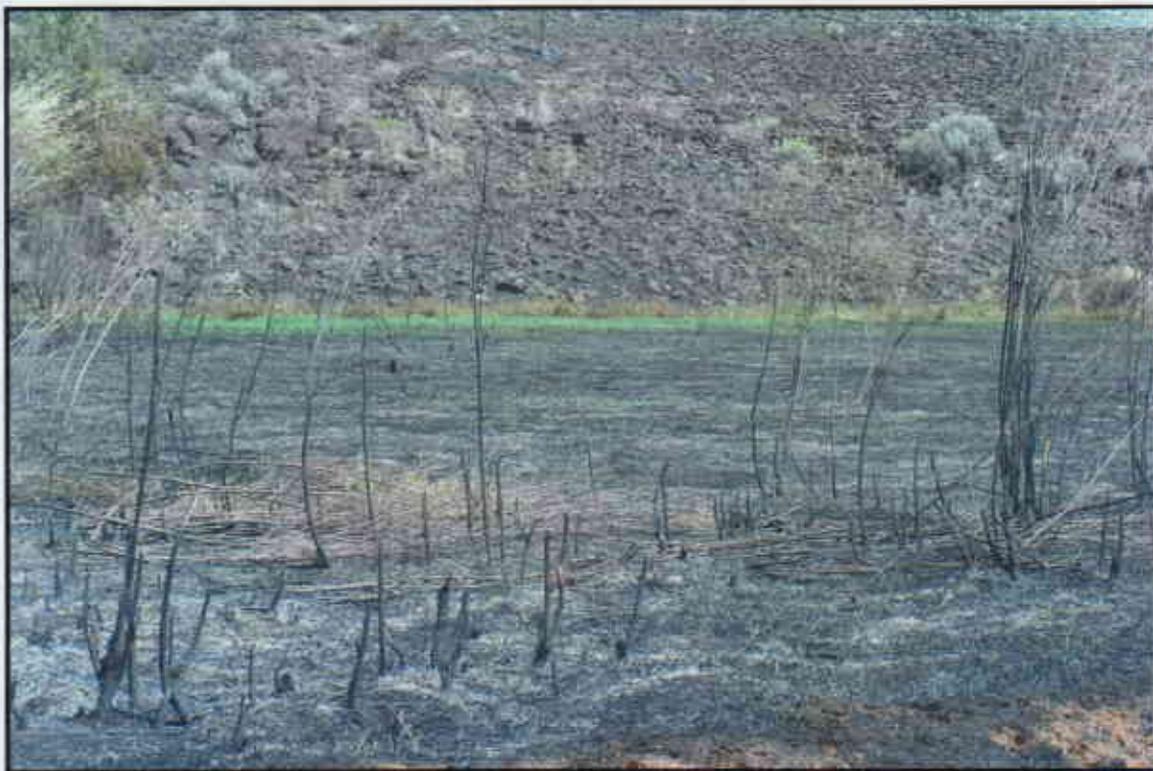
SOUTH BANK, MUD CREEK, 2006 GRANDAD BURN

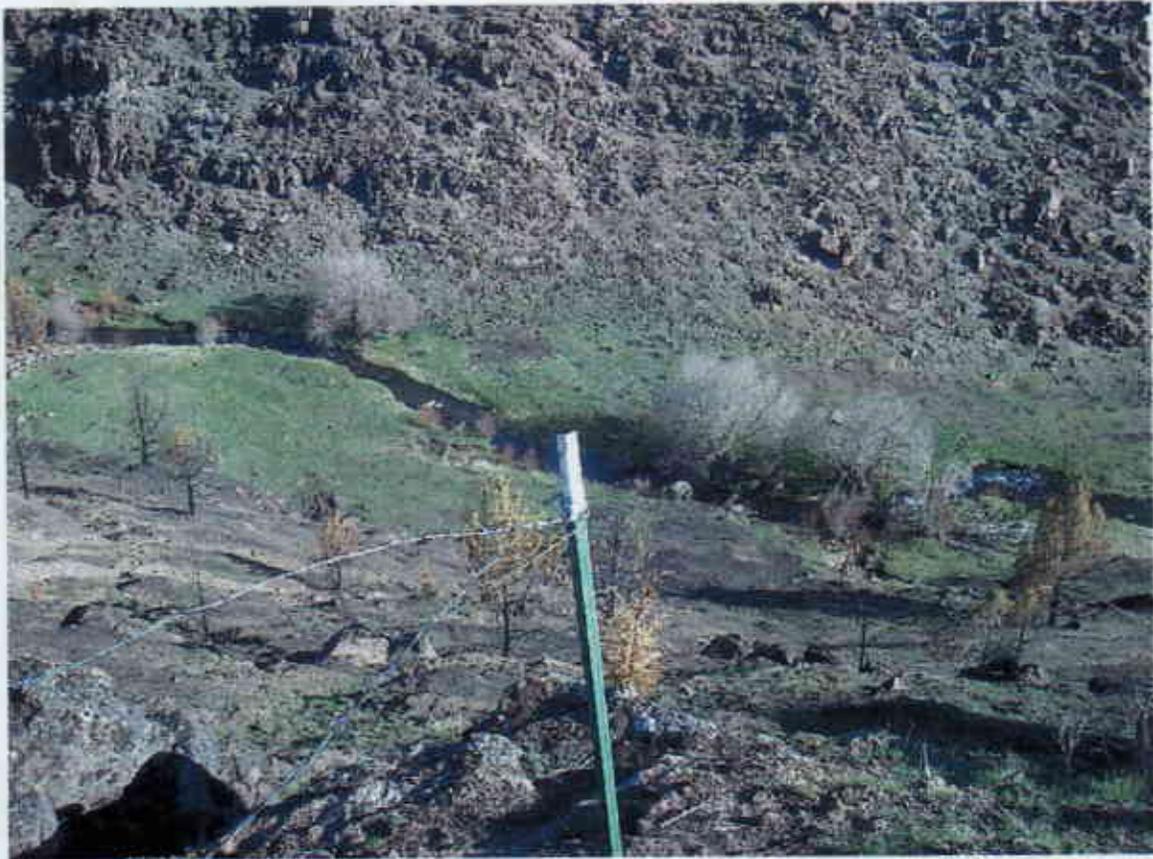
**BRIDGE CREEK BURN, AUGUST, 2006
PHOTO, APRIL 5, 2007**
