**MAPPING OF THE FORT DADE HISTORIC  
TRANSPORTATION NETWORK  
EGMONT KEY  
HILLSBOROUGH COUNTY FLORIDA**

**Volume I**

Office of the Regional Archaeologist  
Savannah Coastal Refuges  
1000 Business Center Drive, Suite 10  
Savannah, Georgia 31405

June 2007

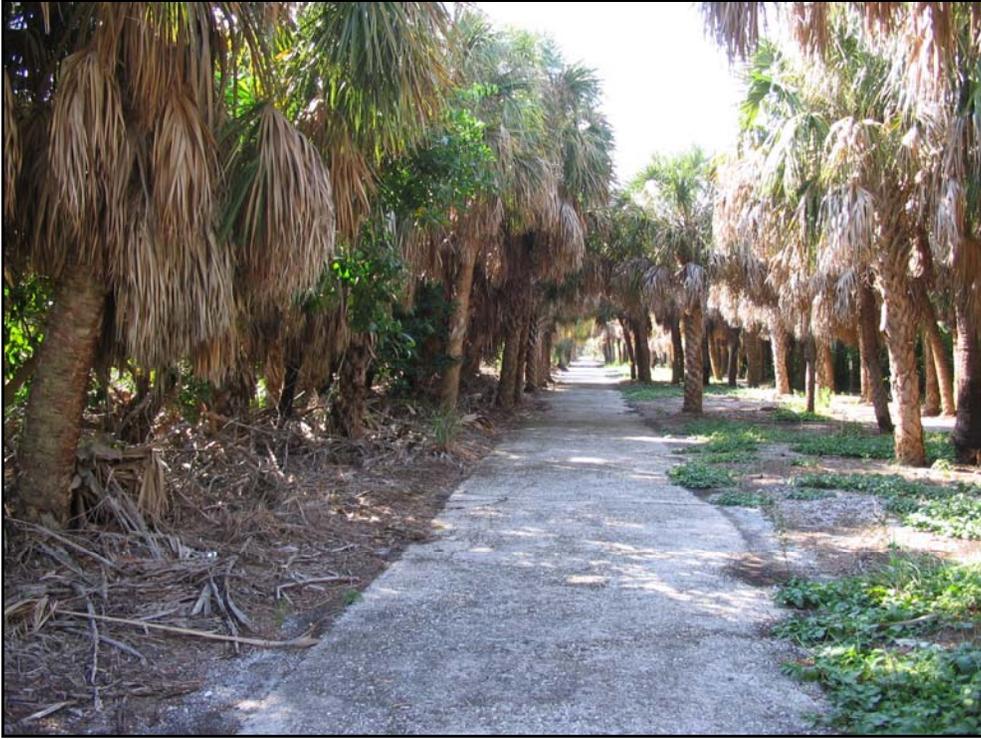
**Figure 5.** Looking south down the concrete portion of Palmetto Avenue, located near the eastern shoreline.

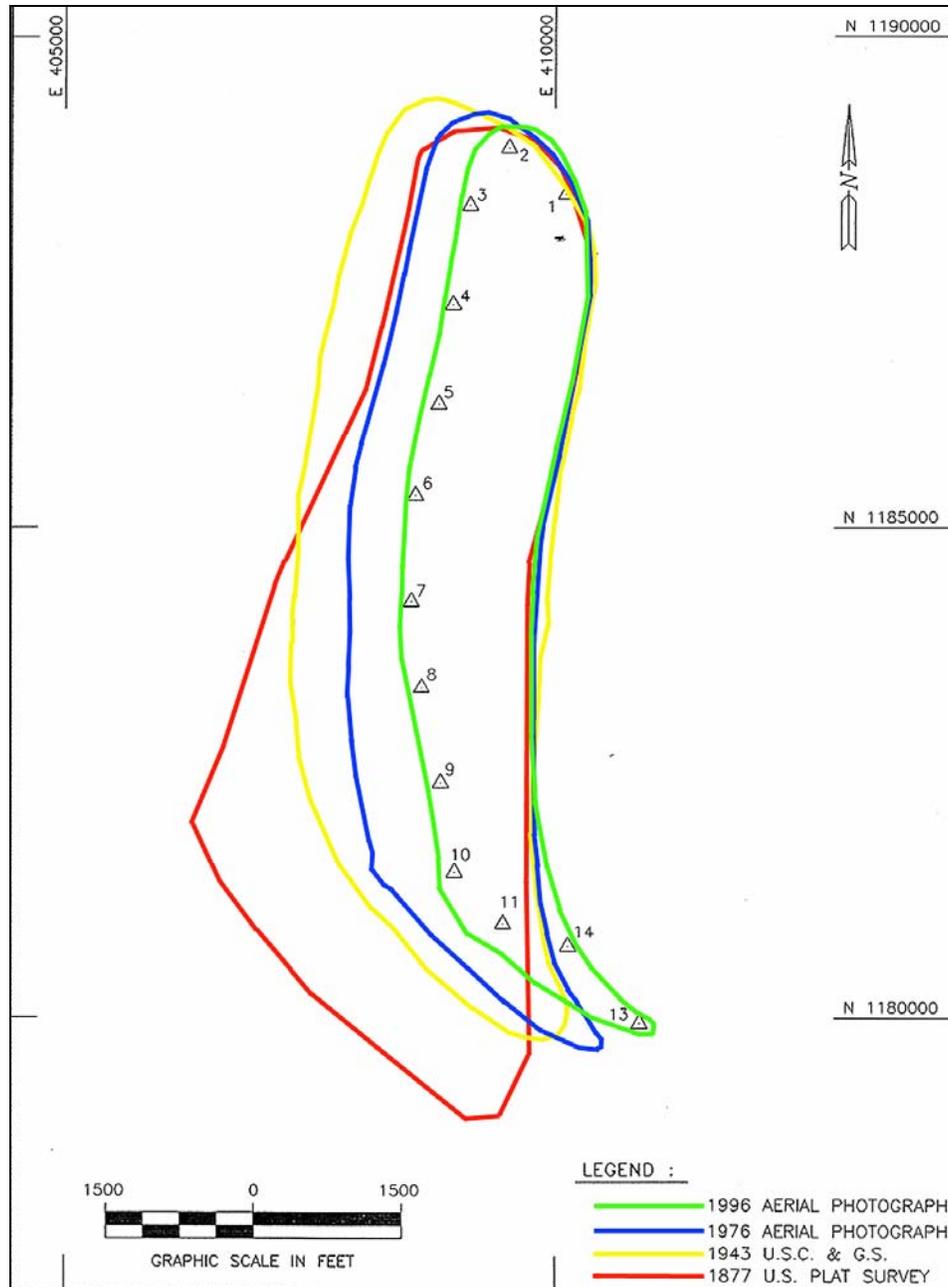
**Figure 9.** Shoreline changes on Egmont Key, 1877-1996 (Modified from Coastal Planning & Engineering 1997:Figure 7).

The 1997 erosion study indicated that the shorelines of Egmont Key are experiencing differential erosion. The western side of the island was highly erosional while the eastern side was relatively stable. The southern end of the island consisted of a sand spit that was migrating toward the east while the northern beach was experiencing moderate erosion (Coastal Planning & Engineering, Inc. 1997). The extreme erosion on the western side of the island and the moderate erosion at its northern end have outpaced deposition, at least in the past 100 to 130 years, such that the island has been significantly reduced in size. This erosion is related to an array of complex processes, including sea level rise, a decrease in the landward transport of offshore sands, and changes in tidal hydraulics and wave refraction. Kling (1997) suggests that severe hurricanes in 1921 and 1926 altered the entire Egmont ebb-tidal delta in such a way that it resulted in increased erosion, particularly along the southern end of the island. Hurricanes in the 1950s and 1960s have increased the rate of erosion on the island.

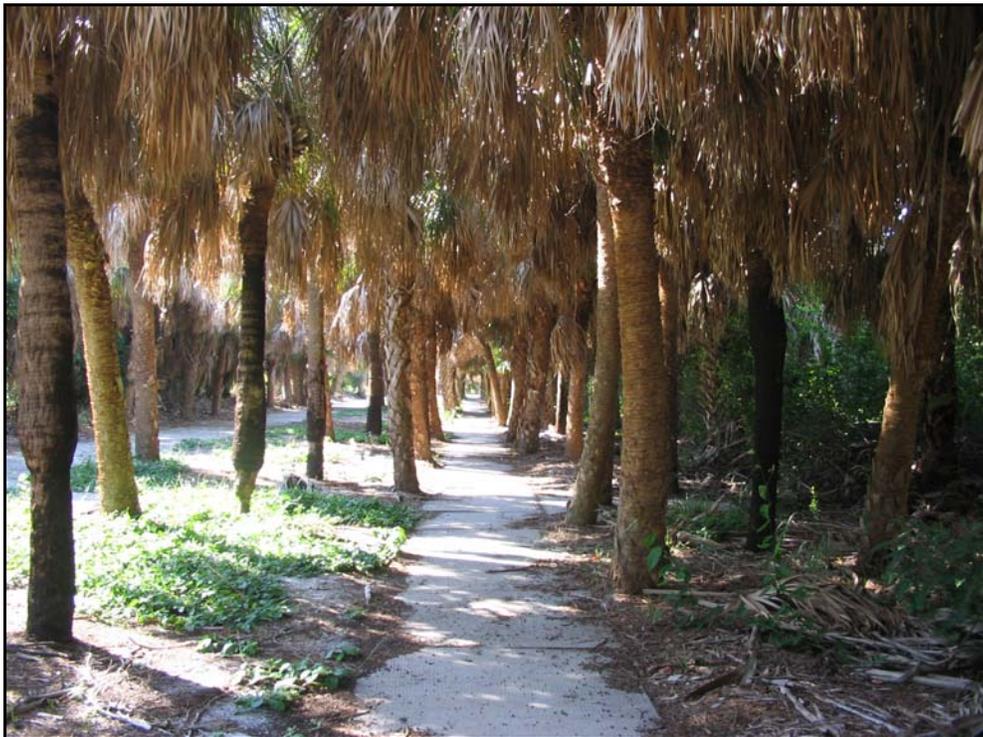
**Figure 13.** Concrete sidewalk that runs parallel to Palmetto Avenue near the eastern shoreline. Photograph taken facing south.

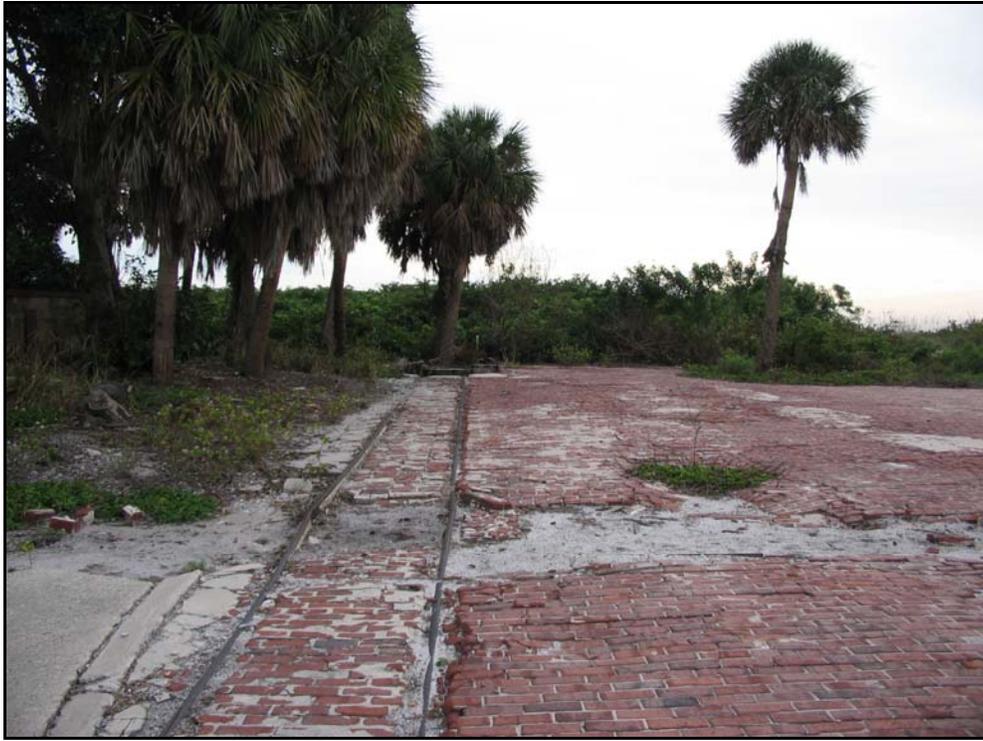
**Figure 14.** Photograph of an extant portion of the railroad track that led to the former location of the Quartermaster's Wharf on the eastern coast of the island, taken facing east.

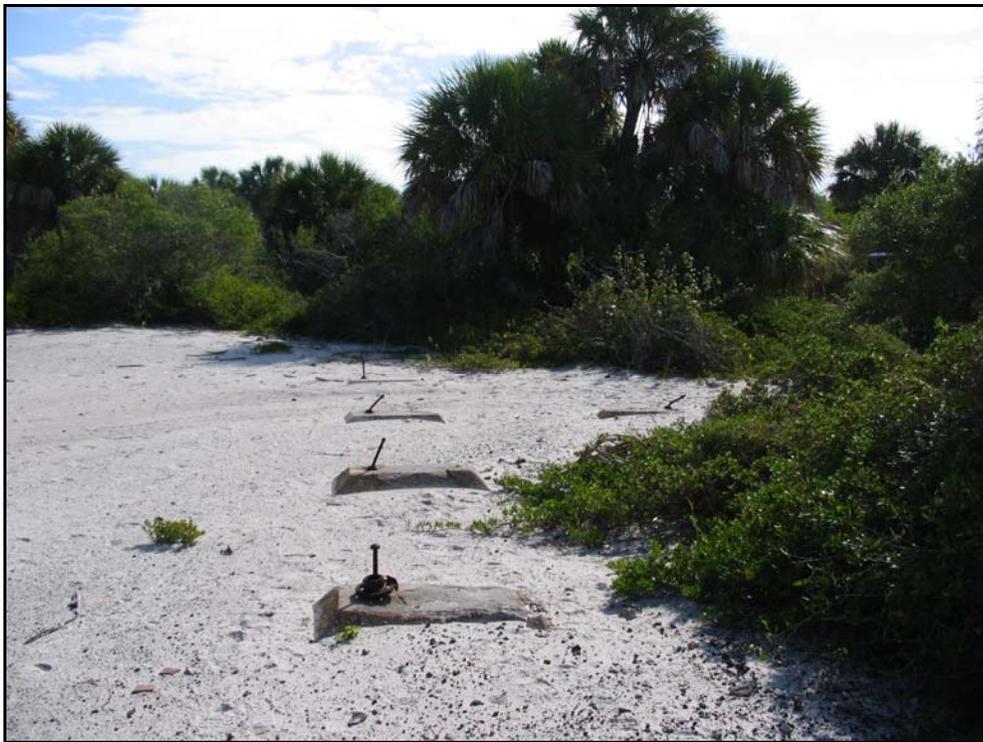
**Figure 15.** Photograph of the railroad supports located immediately north of the former coal shed, taken facing east.

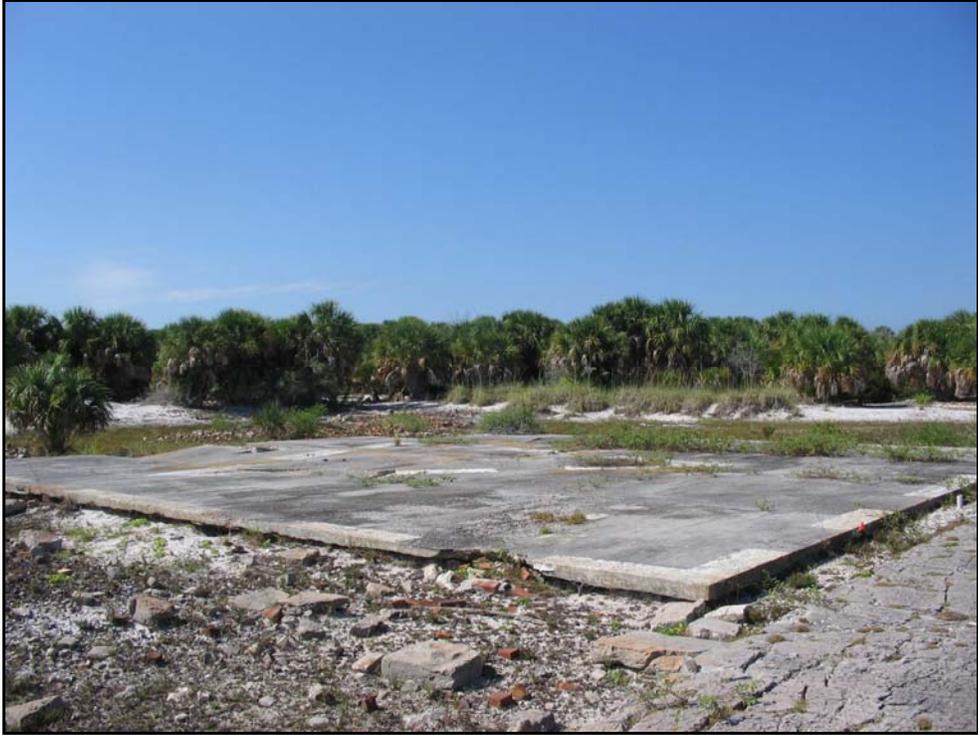
**Figure 16.** Photograph of the helicopter pad, taken facing southwest.

A Topcon GTS-226 Electronic Total Station was used to take 3,752 points to map the brick and concrete roads, concrete sidewalks (Figure 13), entrances, ramps, extant portions of the railroad (figures 14 and 15), and other relevant features associated with the Fort Dade transportation network (i.e., helicopter pad) (Figure 16) to create the base map. When possible, areas where former portions of the transportation network stood (i.e., the railroad, the majority of which was removed from the island in the early 1920s [McCall 1996, 1998] were investigated and mapped (see Figure 12). Portions of the brick road and concrete entrances covered in dense vegetation were also mapped when possible. The base maps of the historic transportation network created from this fieldwork are located in Appendix E.

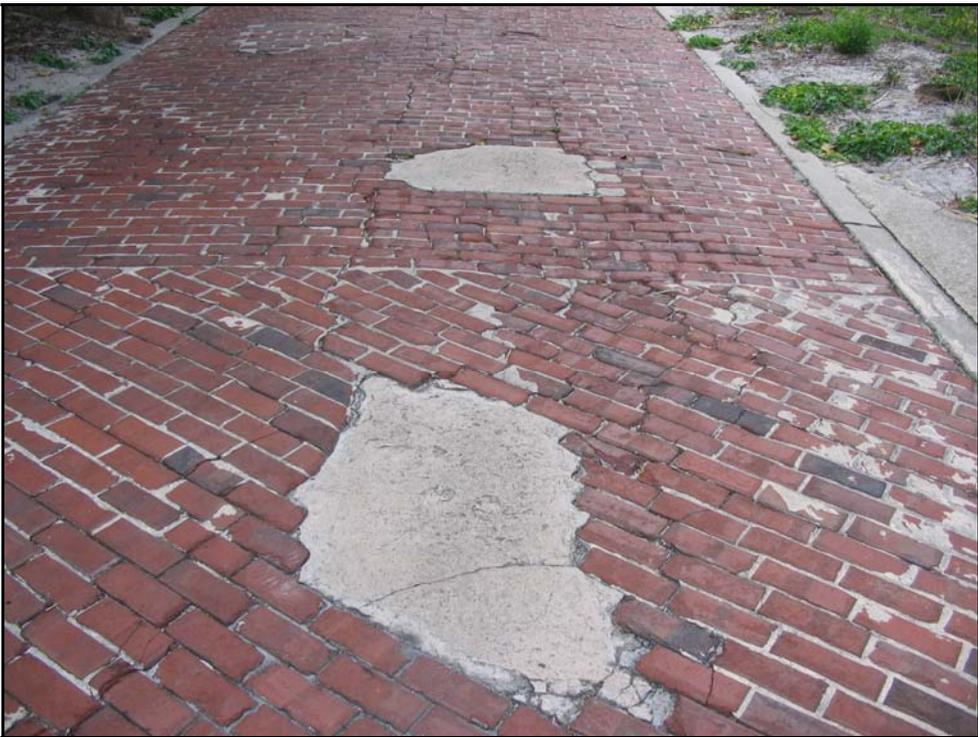
**Figure 17.** Photograph of typical patch found on the brick road.

Damage to the brick road was mapped and photographed. Three types of damage were recorded: patches (areas where the brick was covered in cement) (Figure 17), slumps (dips in the brick road) (Figure 18), and voids (areas of missing brick) (Figure 19). According to Florida Park Service (FPS) personnel (Watson 2006), damage to the road was caused mainly by heavy trucks used on the island after 1921. The U.S. Coast Guard patched some of the damage in the 1950s. Areas where the Florida Park Service had recently repaired the road by cementing bricks back into place (Watson 2006) were not recorded, as it was evaluated as not being damaged.

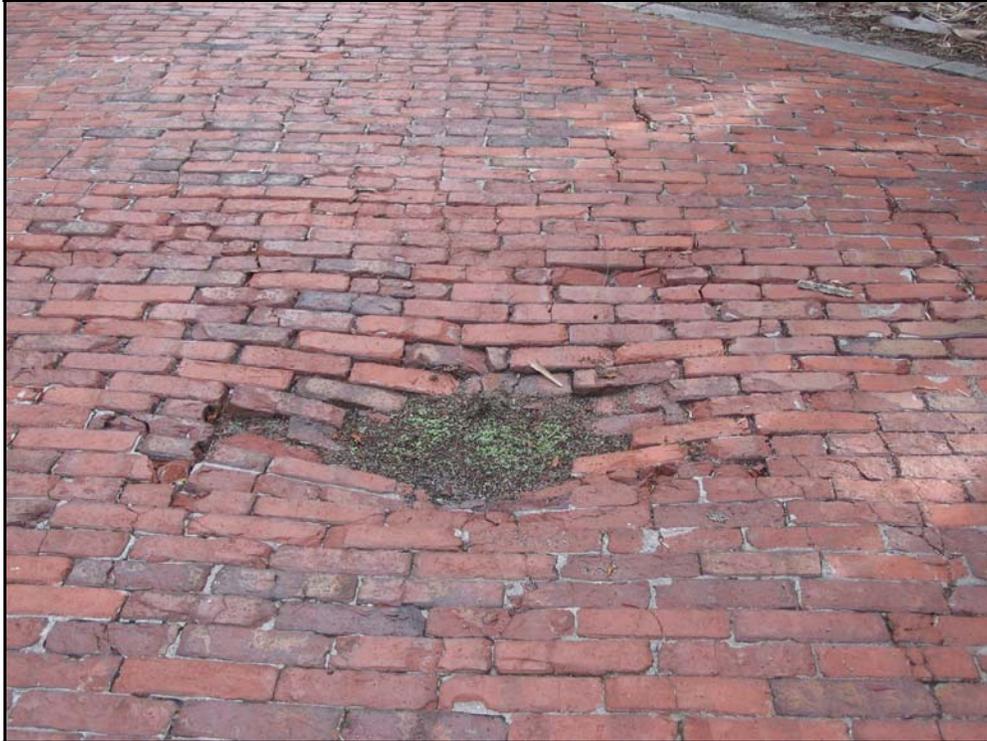
**Figure 18.** Photograph of a typical slump in the brick road.

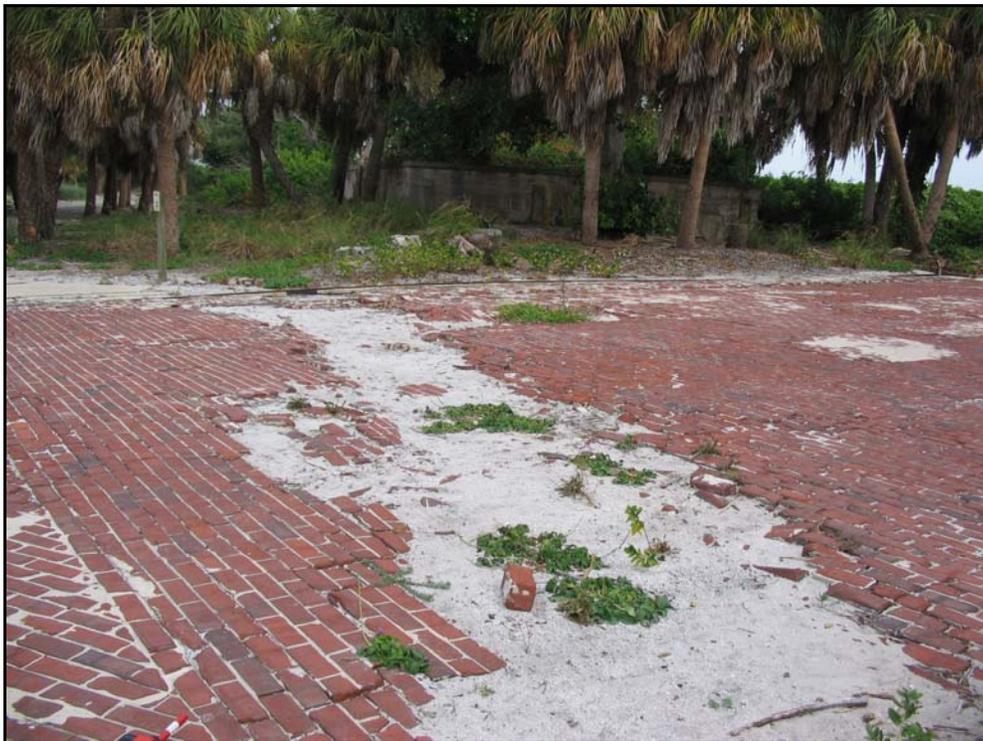
**Figure 19.** Photograph of a typical void found on the brick road, with a portion of the railroad visible in the background.

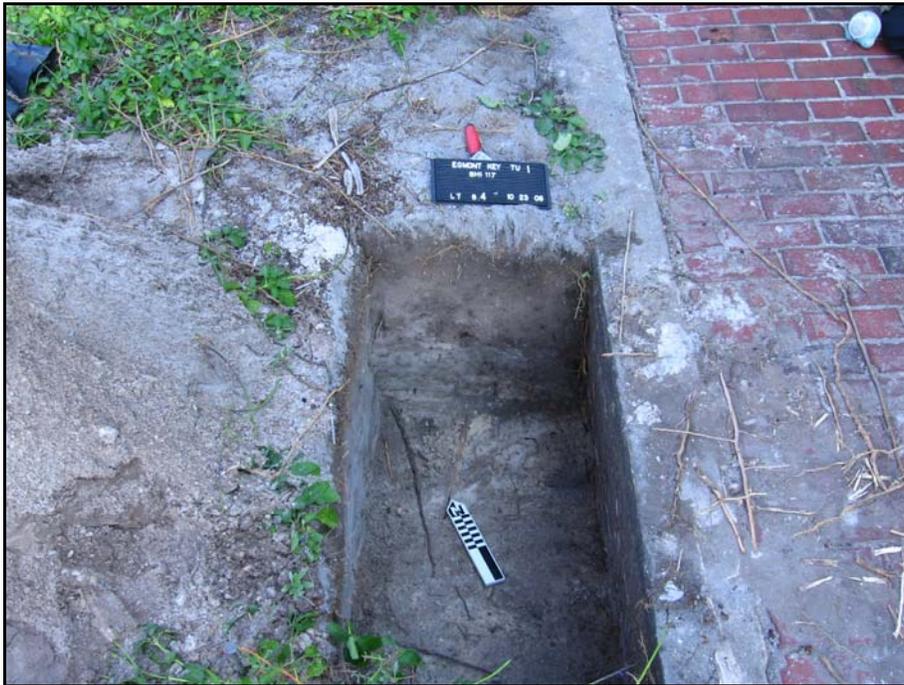
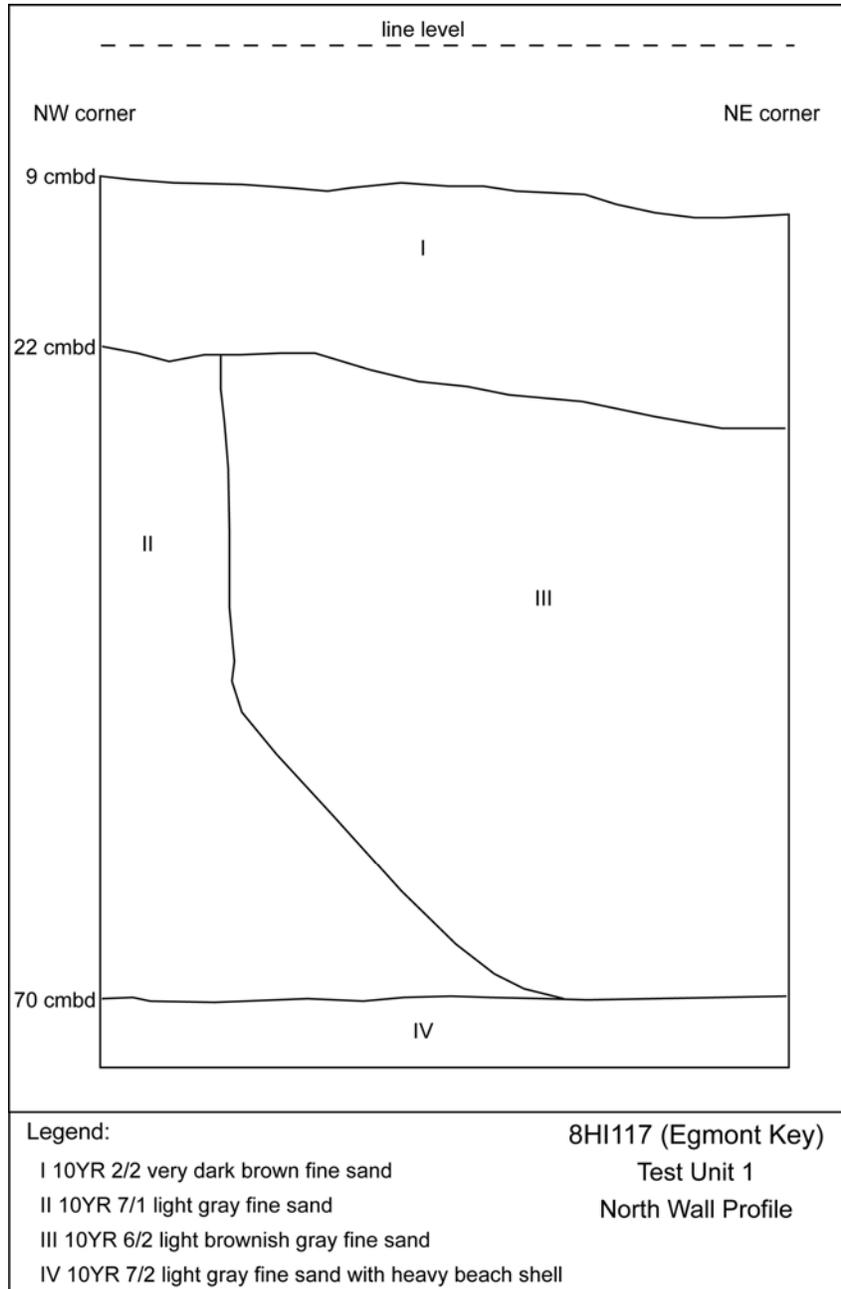
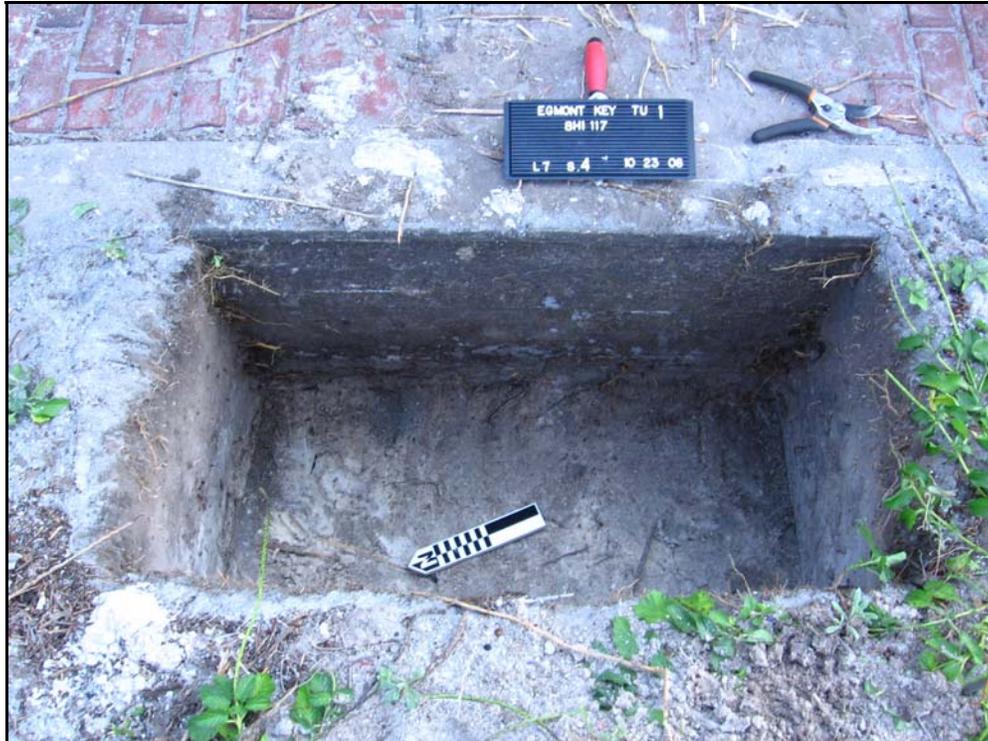
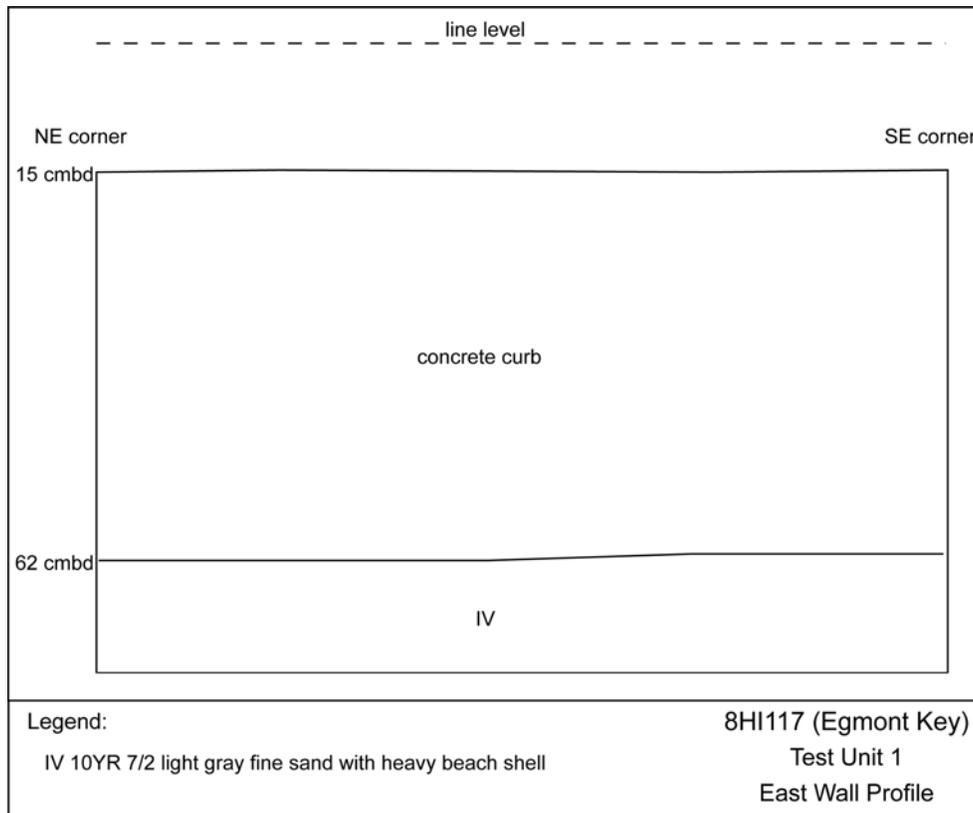
The excavation of TU 1 revealed four soil strata (figures 31 to 34). Stratum I consisted of very dark brown (10YR 2/2) very fine sand to a depth of 22 cm below datum (cmbd) (9 inches below datum [9 inbd]). Stratum II consisted of light gray (10YR 7/1) fine sand from 22 to 70 cmbd (9 to 26 inbd). Stratum III consisted of light brownish gray (10YR 6/2) fine sand that also extended from 22 to 70 cmbd (9 to 26 inbd). Stratum IV consisted of light gray (10YR 7/2) fine sand with heavy beach shell extending from 70 cmbd (26 inbd) to the base of the unit at 75 cmbd (30 inbd). Stratum III within the north wall of the test unit appears to have been previously excavated. This most likely occurred when the area was dug out to allow for the placement of the concrete curb when the brick road was being constructed (see Figure 32). The unit was excavated in 10-cm (4-in) arbitrary levels to a depth of 75 cmbd (30 inbd). Excavation of the unit was stopped after sterile sand with beach shell was reached at 70 cmbd (28 inbd). The east wall of the test unit, directly adjacent to the brick road, revealed a concrete curb that extended from the ground surface (15 cmbd [5 inbd] to 62 cmbd [24 inbd]), obscuring strata I through III within the wall profile. Stratum IV consisted of light gray (10YR 7/2) fine sand with heavy beach shell and was revealed at the base of the east wall, below the level of the concrete curb. Historic artifacts were recovered from strata I through III from 0 to 65 cmbd (0 to 26 inbd). Stratum IV was sterile of cultural material.

**Figure 31.** Photograph of the north wall of T.U. 1, taken facing north-northeast.

**Figure 32.** Sketch map of the north wall profile of Test Unit 1.

**Figure 33.** Photograph of the east wall of Test Unit 1, taken facing east-southeast.

**Figure 34.** Sketch map of the east wall profile of Test Unit 1.

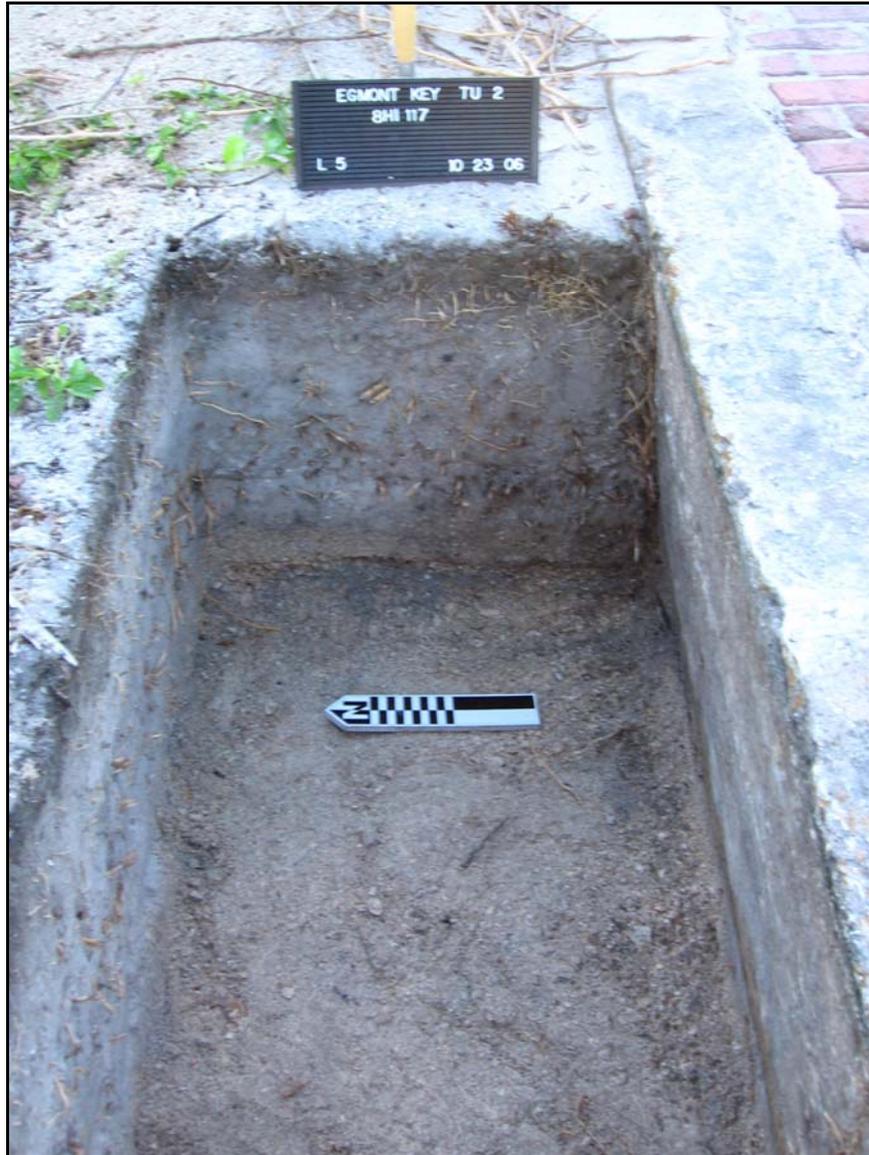
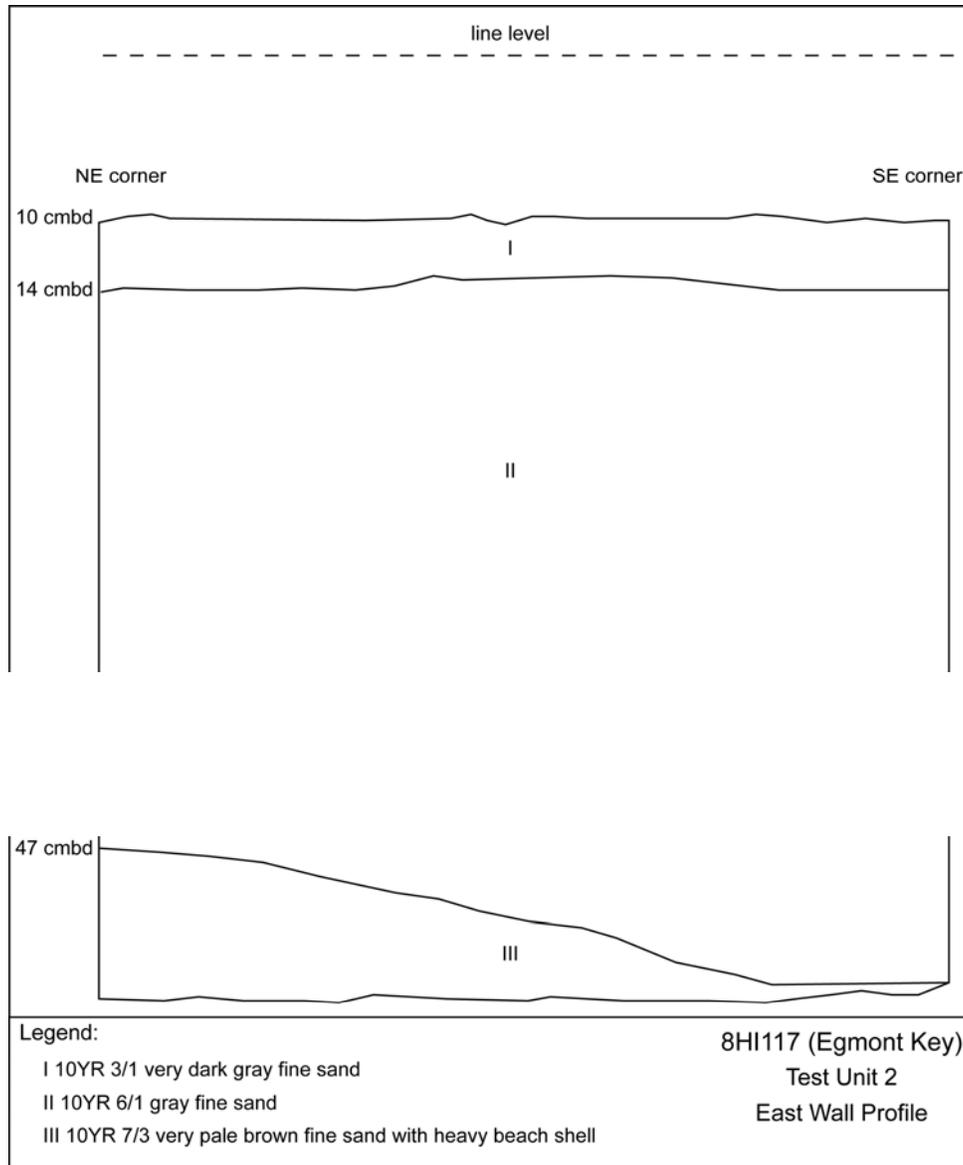
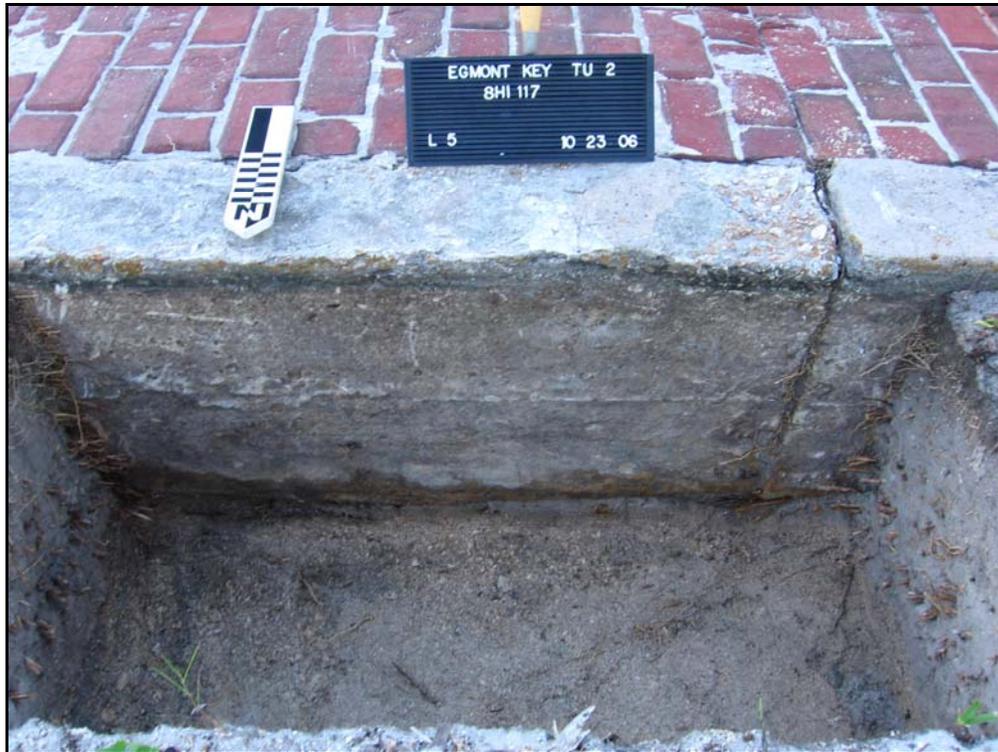
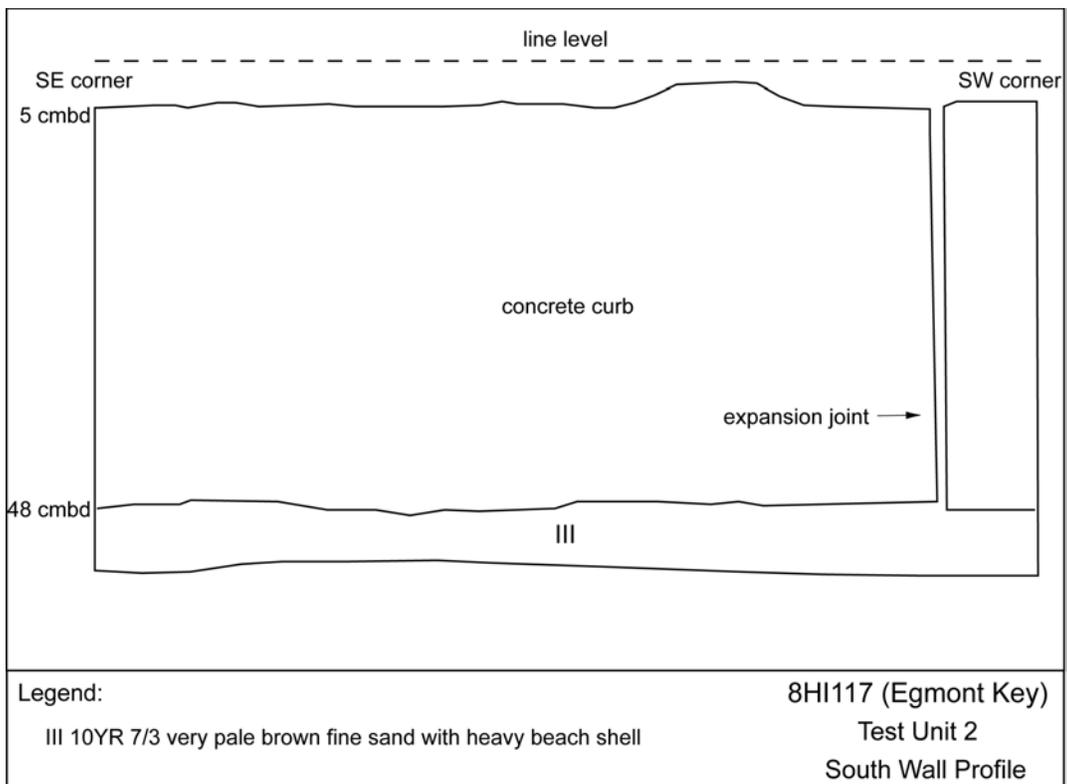
**Figure 35.** Photograph of the east wall of Test Unit 2, taken facing east.

**Figure 36.** Sketch map of the east wall profile of Test Unit 2.

**Figure 37.** Photograph of the south wall of Test Unit 2, taken facing south.

**Figure 38.** Sketch map of the south wall profile of Test Unit 2.

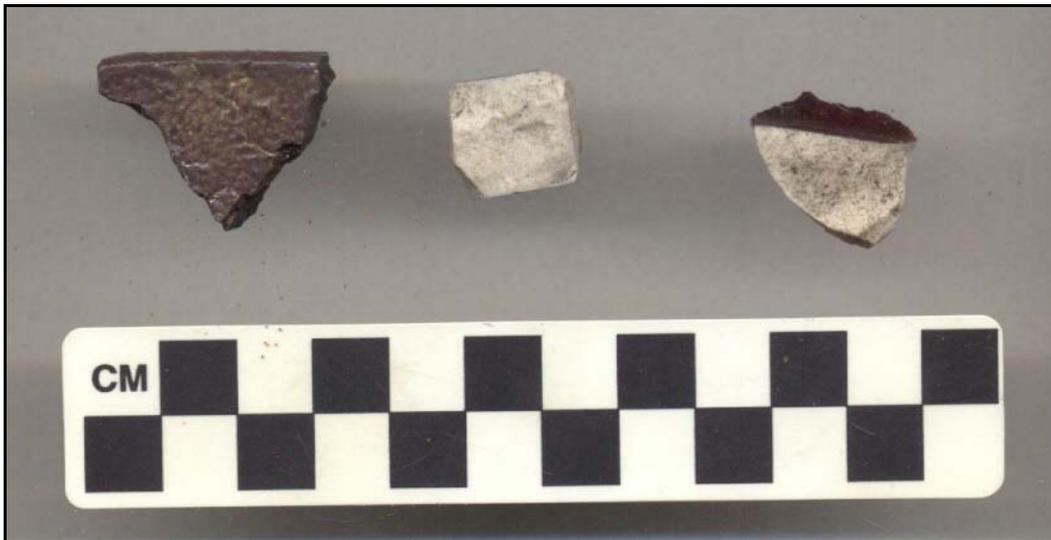
**Figure 39.** Earthenware artifacts recovered from test units 2 and 4. From left: FS no. 14 from TU 4, brown salt-glazed earthenware rim sherd; FS no. 7 from TU 2, grey-glazed earthenware body sherd; FS no. 7 from TU 2, brown-glazed earthenware fragment, transitional sherd.

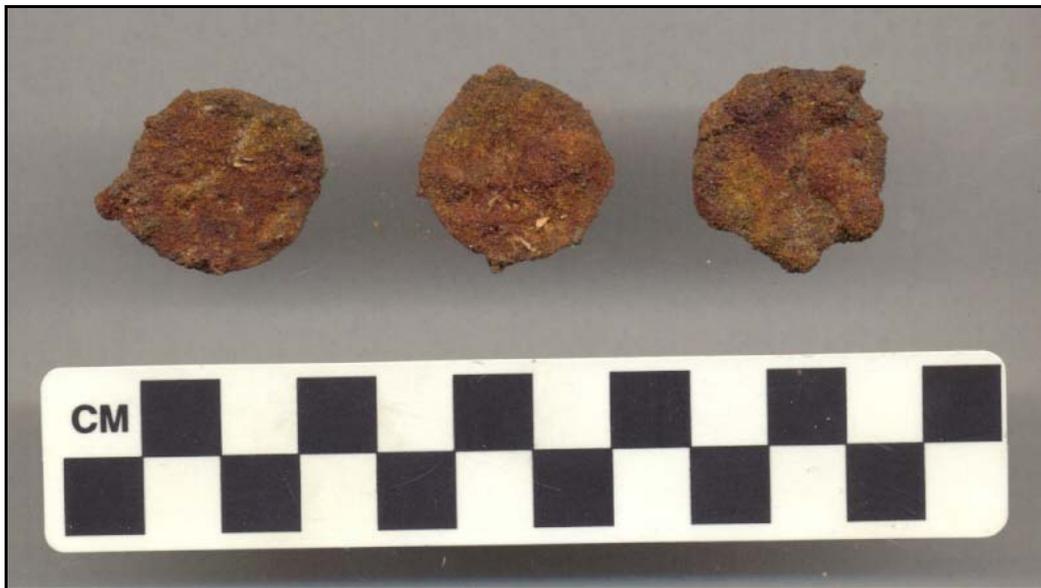
**Figure 40.** Metal disc artifacts recovered from Test Unit 2 (FS no.10).

suggest cooking using iron stoves and metal pans. Because much of the metal was corroded and could not be precisely identified, a large number of fragments were placed in the “indeterminate” category, but it is probable that they are related to baking and cooking. For example, a total 22 corroded metal disks measuring an inch in diameter were recovered from Levels 2-4; although they could not be identified, they may be ingredient container closures of some sort (Figure 40). Cooking activities are also suggested by the presence of a large, sawn cow rib found in Level 4.

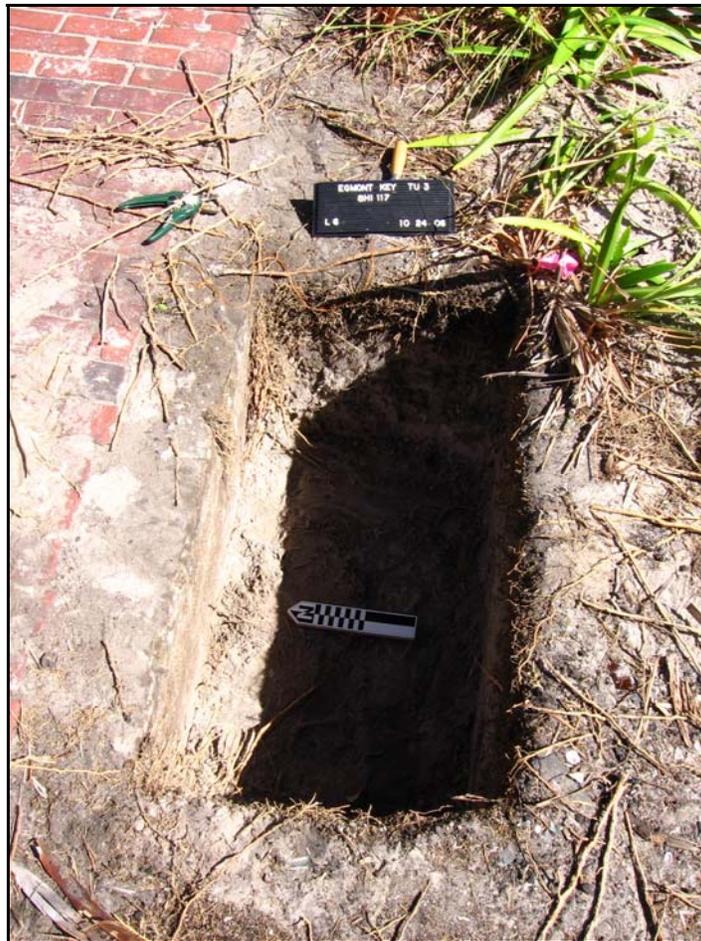
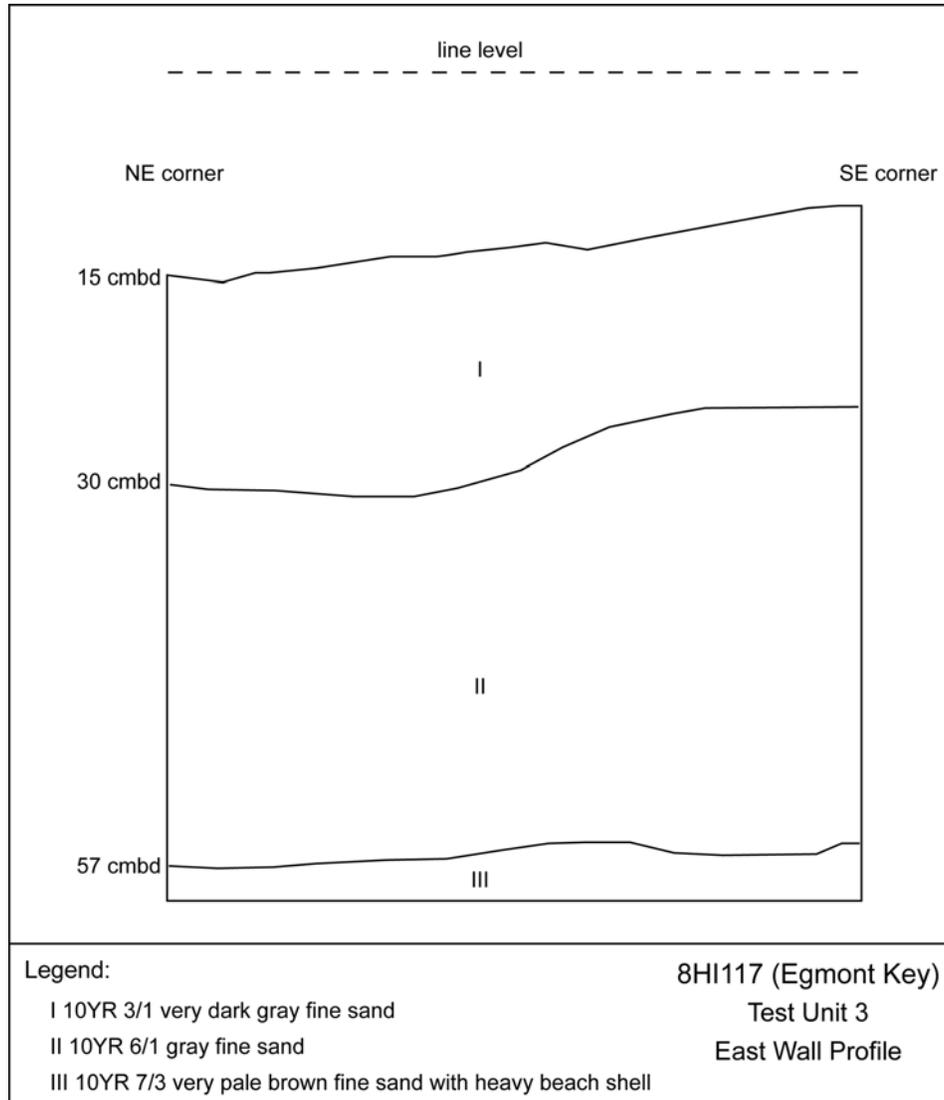
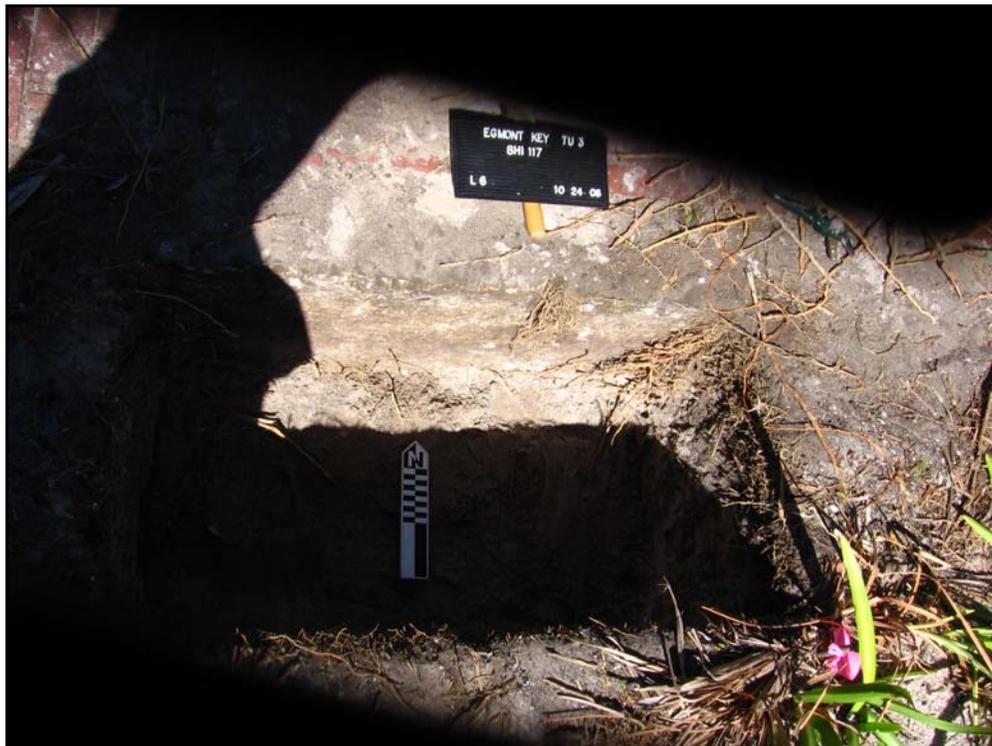
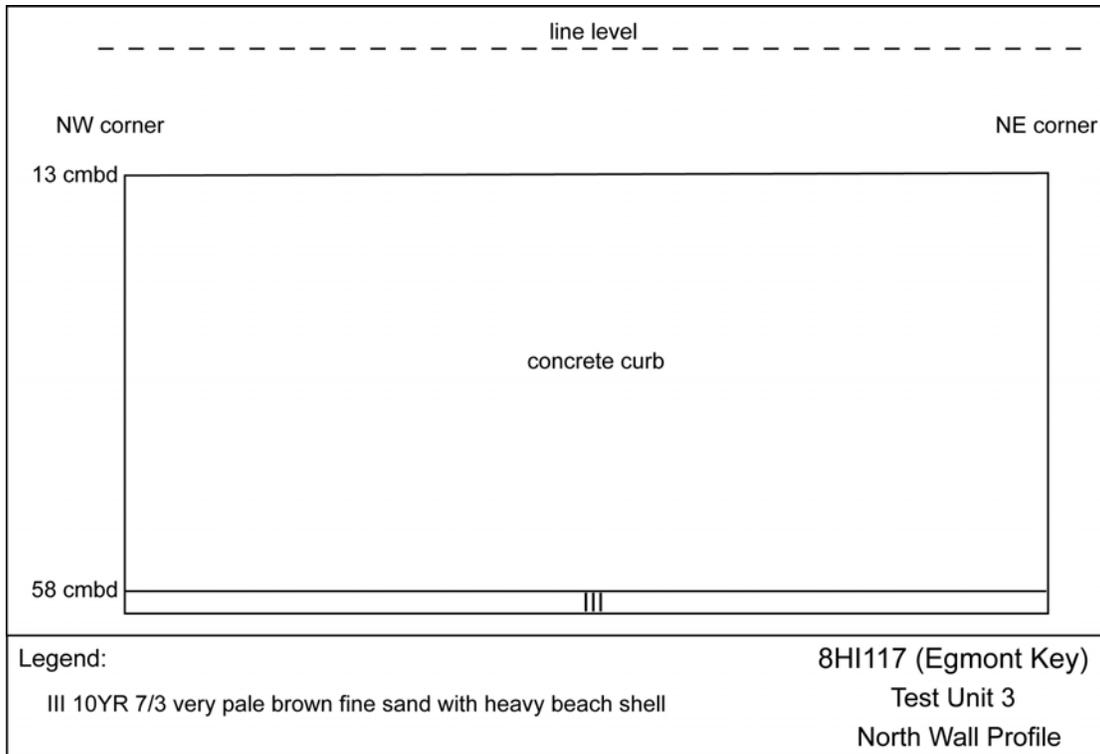
The excavation of TU 3 revealed three soil strata (figures 41 through 44). Stratum I consisted of very dark gray (10YR 3/1) fine sand from a depth of 15 to 30 cmbd (6 to 12 inbd). Stratum II consisted of gray (10YR 6/1) fine sand from 30 to 57 cmbd (12 to 22 inbd). Stratum III consisted of very pale brown (10YR 7/3) fine sand with heavy beach shell and extended from 57 cmbd (22 inbd) to the base of the unit at 60 cmbd (24 inbd). The unit was excavated in 10-cm (4-in) arbitrary levels to a depth of 60 cmbd (24 inbd). Excavation of the unit was stopped after sterile sand with beach shell was reached in Stratum III. The north wall of the test unit, directly adjacent to the brick road, revealed a concrete curb that extended from the ground surface (13 cmbd [5 inbd] to 58 cmbd [23 inbd]), obscuring strata I and II within the wall profile. Stratum III consisted of very pale brown (10YR 7/3) fine sand with heavy beach shell and was revealed at the base of the north wall, below the level of the concrete curb.

**Figure 41.** Photograph of the east wall of Test Unit 3, taken facing east.

**Figure 42.** Sketch map of the east wall profile of Test Unit 3.

**Figure 43.** Photograph of the north wall of Test Unit 3, taken facing north.

**Figure 44.** Sketch map of the north wall profile of Test Unit 3.

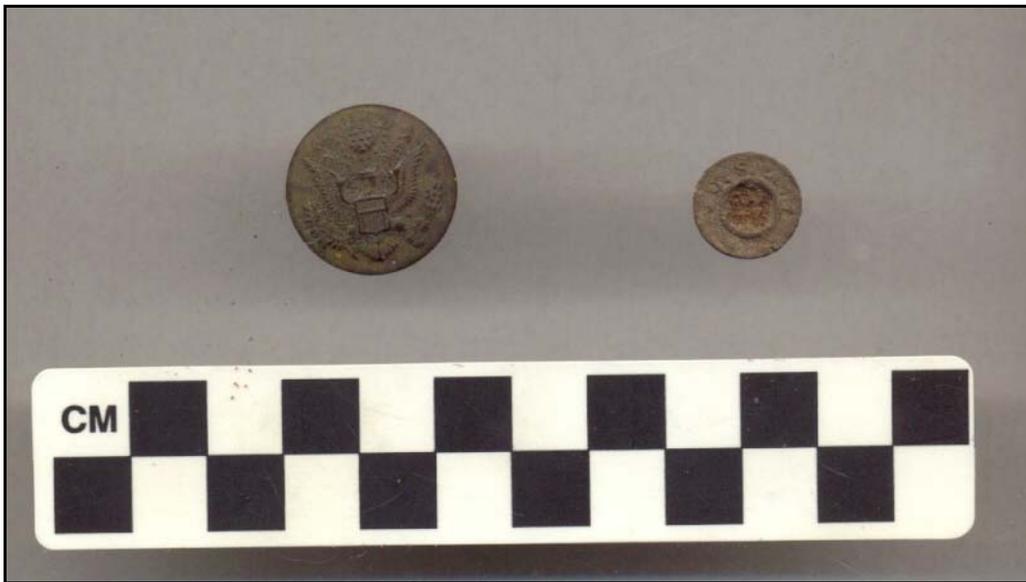
**Figure 45.** Buttons recovered from Test Unit 3. From left to right: brass shank button with US Army seal (FS no. 11); four-hole button with U.S.A. on front (FS no. 12).

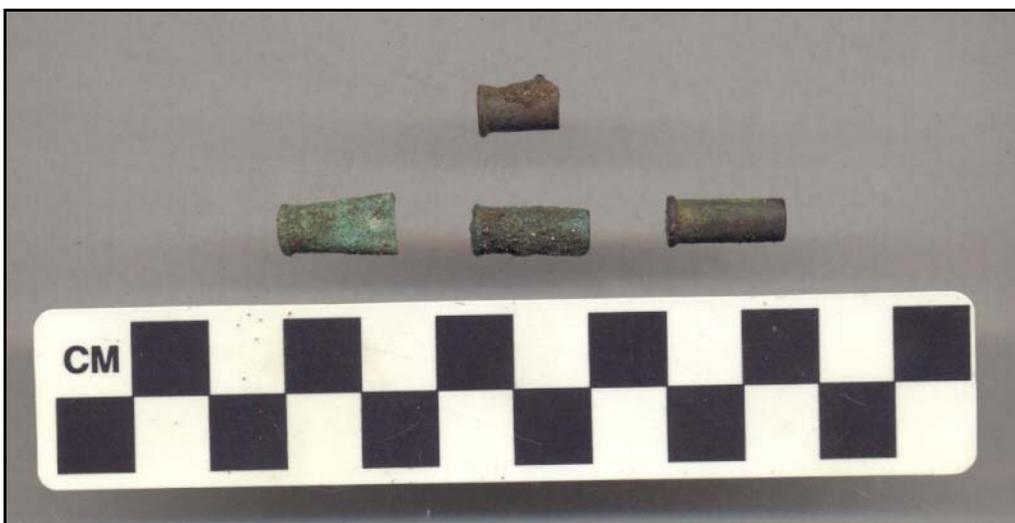
**Figure 46.** .22 caliber short (top row) and long cartridges recovered from Test Unit 3 (F.S. no. 12).

This unit is the only unit excavated that yielded evidence of weaponry. Twenty-four bullets and/or cartridge casings from various caliber weapons were recovered from Levels 1 and 2 in Test Unit 3. Cartridge casings and bullets from small-caliber arms (.22 long and short) were most common (Figure 46), although several larger caliber cartridges were found (.30-06 and .45 automatic). The .30-06 “spitzer” (pointed) bullet was the standard military round until 1954, but remained in use until the 1970s (Boddington 2005; Cartridge Collectors 2006). The .30-06 was introduced in 1906 (as the -06 on the caliber indicates); after World War I, a boat tailed, full-metal-jacketed bullet was developed. The .30-06 bullet found in TU 3 does not have a headstamp, but it is a .30-06 boat tail and thus postdates WWI (Figure 47) (Punnett 2003). Headstamps on all cartridges from this unit indicate that ammunition came from a variety of manufacturers (Table 6).

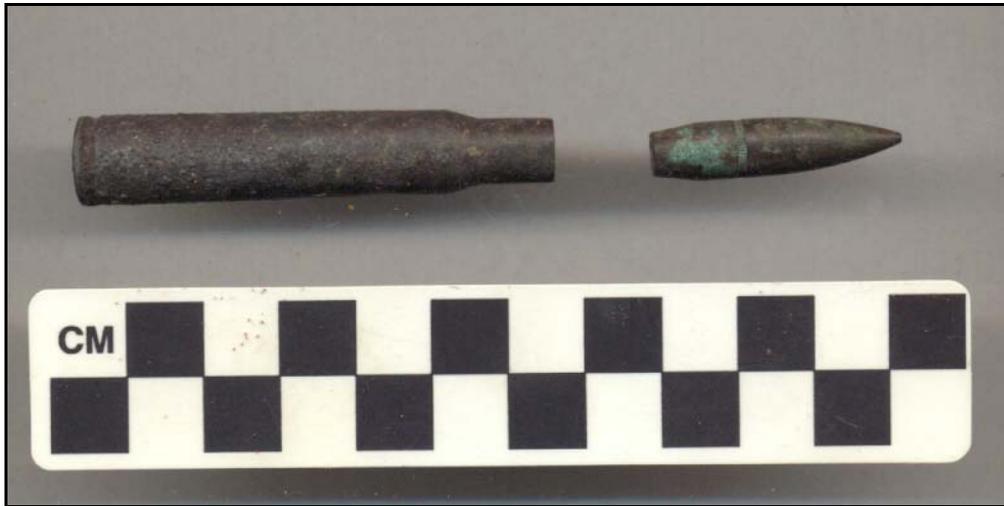
**Figure 47.** .30-06 cartridge (left) (FS no. 11) and boat tail bullet (F.S. no. 12) recovered from Test Unit 3.
