**MAPPING OF THE FORT DADE HISTORIC  
TRANSPORTATION NETWORK  
EGMONT KEY  
HILLSBOROUGH COUNTY FLORIDA**

**Volume I**

Office of the Regional Archaeologist  
Savannah Coastal Refuges  
1000 Business Center Drive, Suite 10  
Savannah, Georgia 31405

June 2007

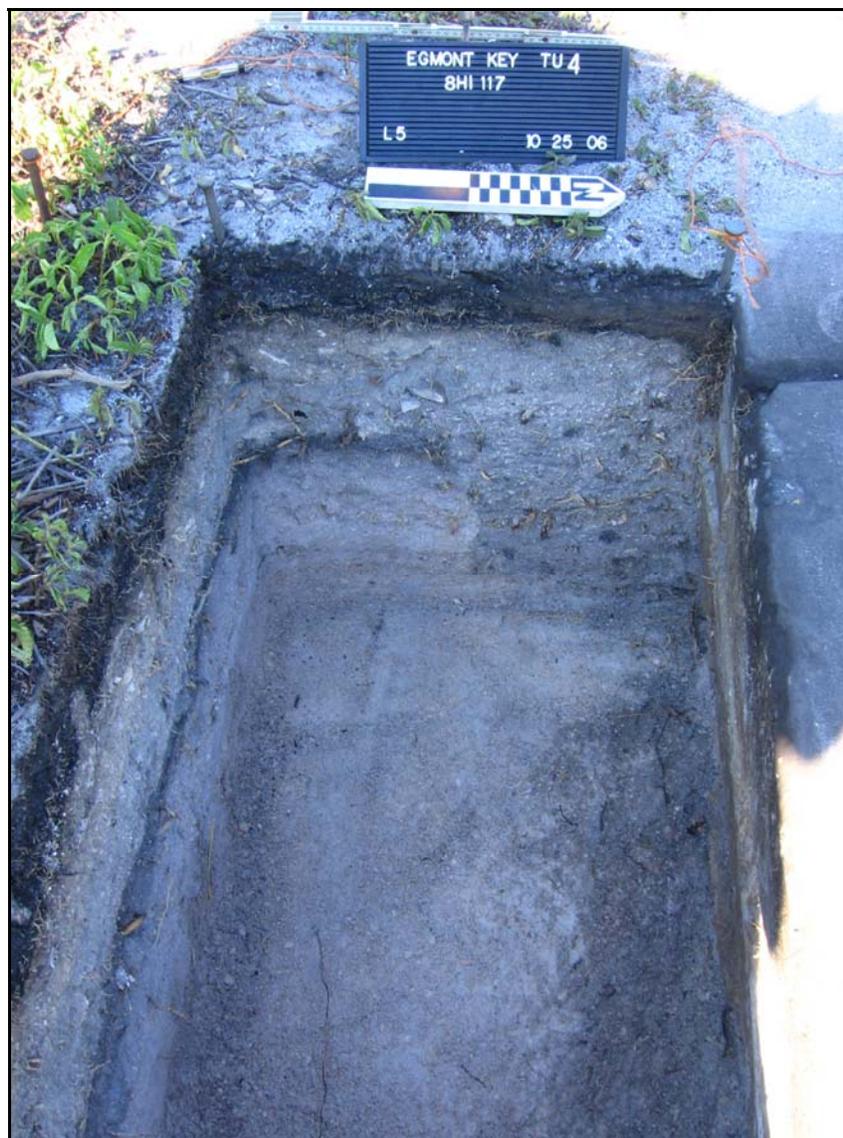
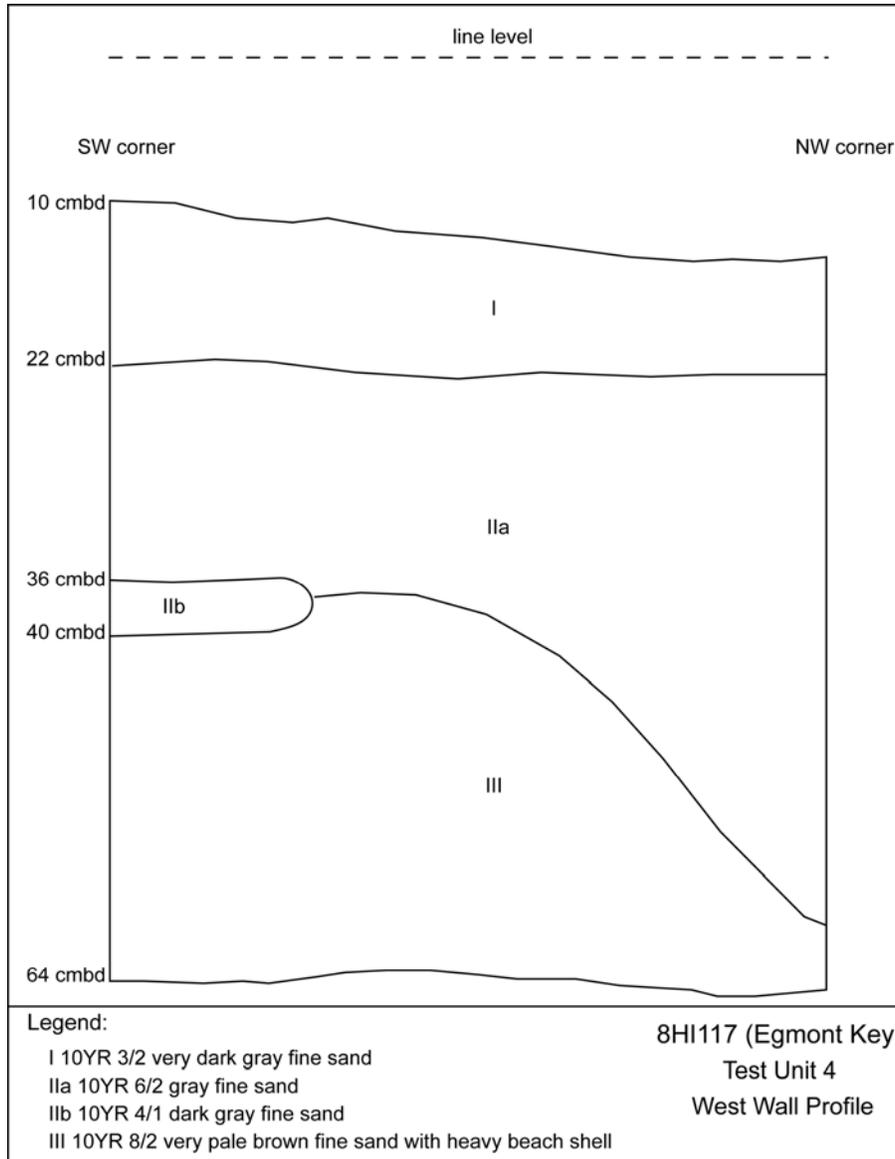
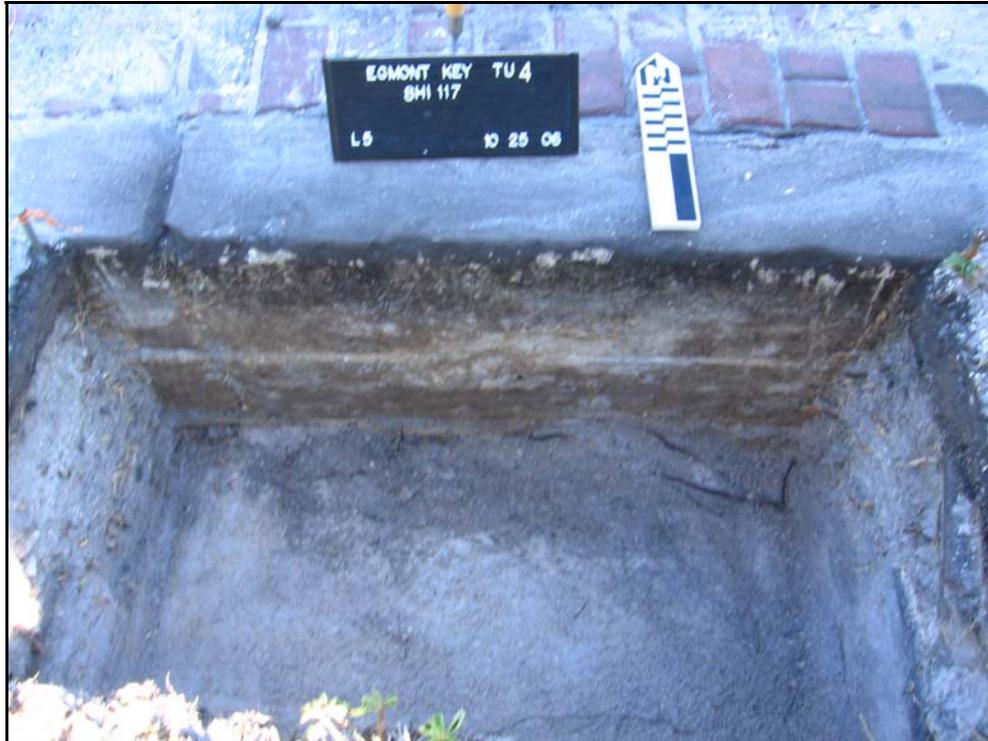
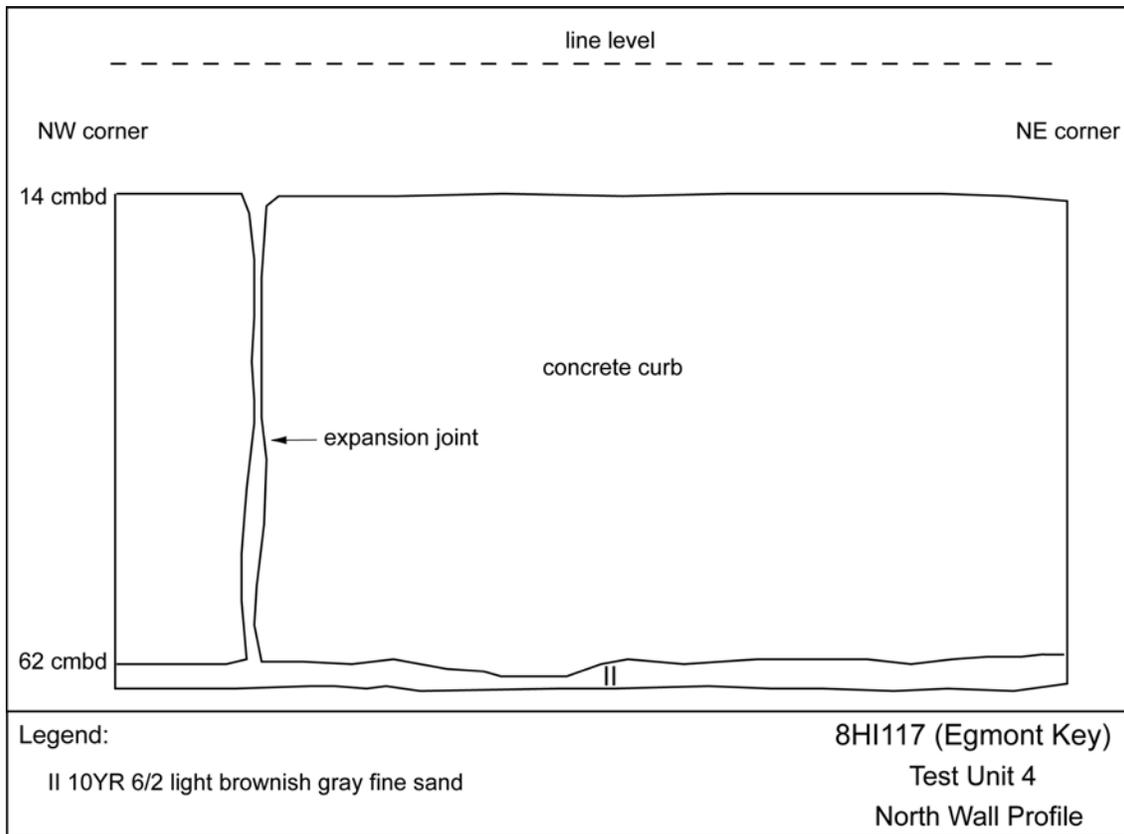
IIb consisted of dark gray (10YR 4/1) fine sand and extended from 36 cmbd (14 inbd) to 40 cmbd (16 inbd). Stratum III consisted of very pale brown (10YR 8/2) fine sand with beach shell and extended from 40 cmbd (16 inbd) to the base of the unit at 64 cmbd (25 inbd). A portion of Stratum IIa within the west wall of the test unit appears to have been previously excavated. This most likely occurred when the area was dug out to allow for the placement of the concrete curb when the brick road was being constructed (see Figure 49). The unit was excavated in 10-cm (4-in) arbitrary levels to a depth of 64 cmbd (25 inbd). Excavation of the unit was stopped after sterile sand was encountered in Stratum III. The north wall of the test unit, directly adjacent to the brick road, revealed a concrete curb that extended from the ground surface (13 cmbd [5 inbd] to 58 cmbd [23 inbd]), obscuring the wall profile. Stratum II consisted of light brownish gray (10YR 6/2) fine sand and was revealed at the base of the north wall, below the level of the concrete curb. Like TU 2, an expansion joint can be seen in the exposed concrete curb (see Figure 51).

**Figure 48.** Photograph of the west wall of Test Unit 4, taken facing west.

**Figure 49.** Sketch map of the west wall profile of Test Unit 4.

**Figure 50.** Photograph of the north wall of Test Unit 4, taken facing north.

**Figure 51.** Sketch map of the north wall profile of Test Unit 4.

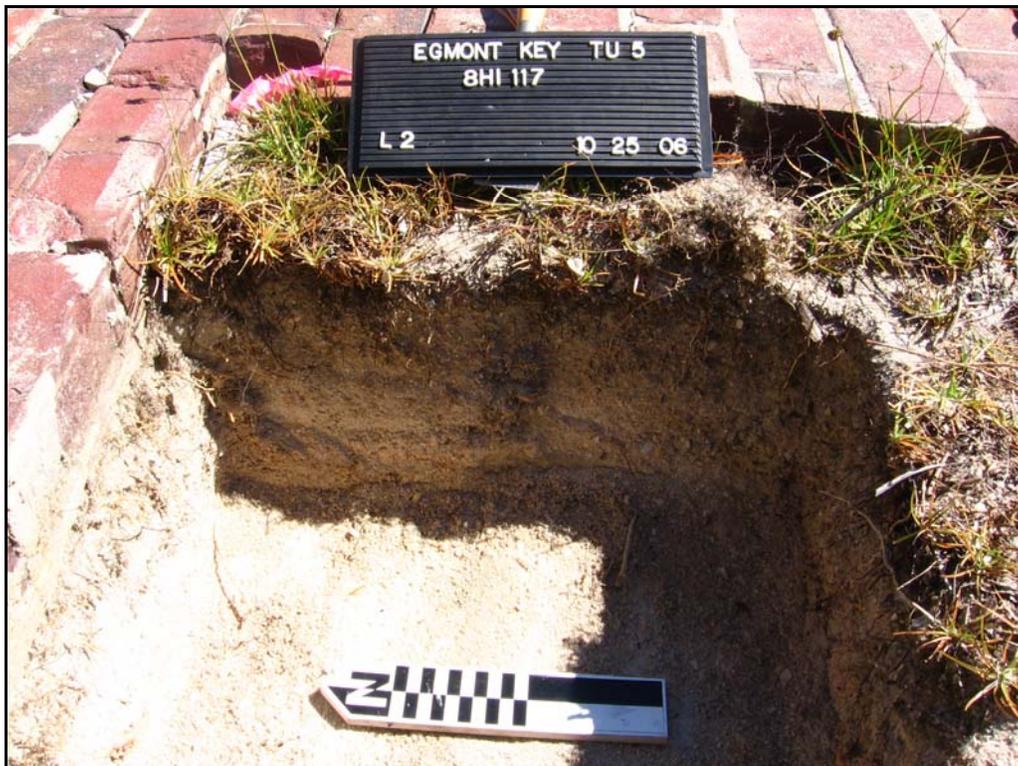
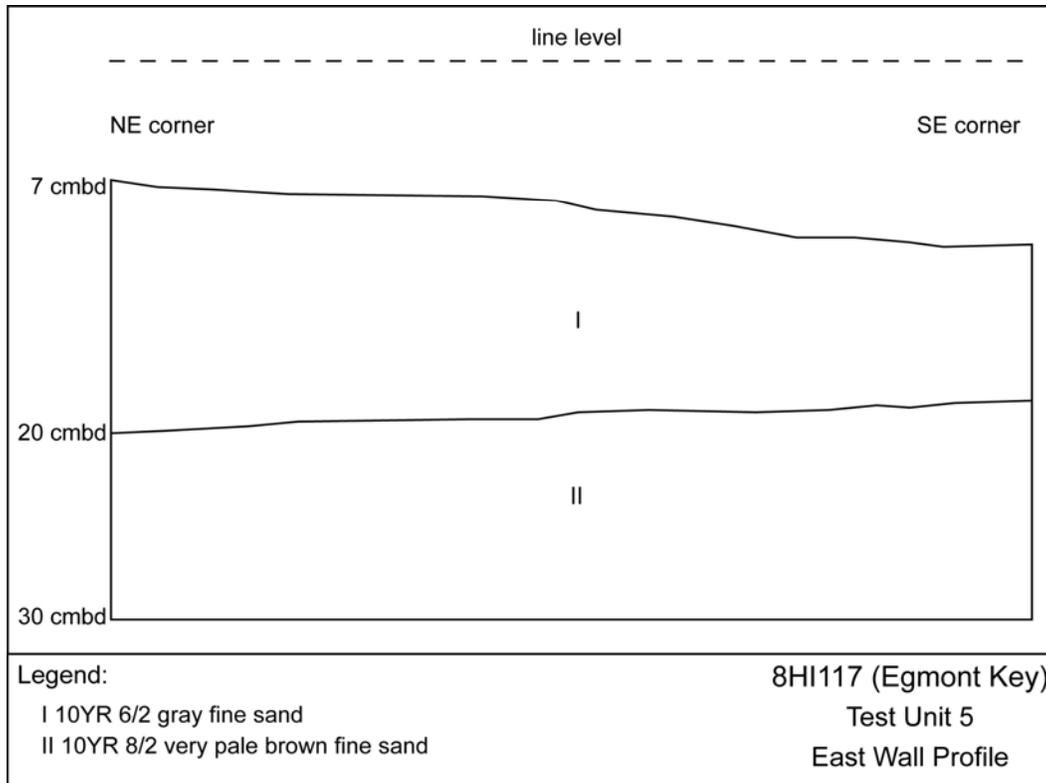
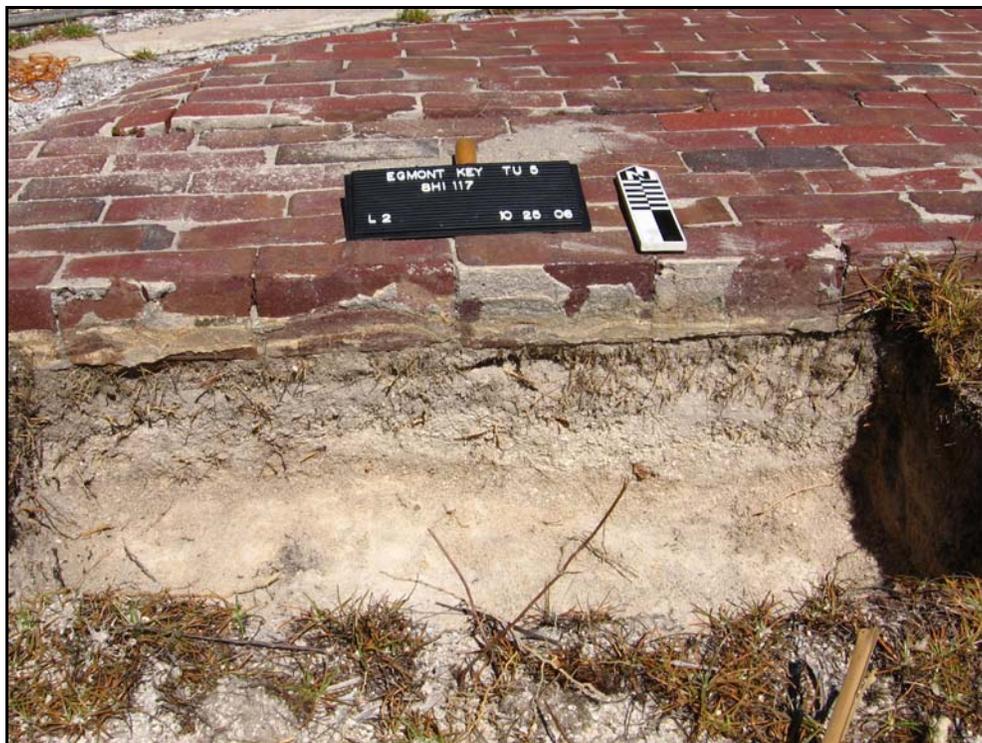
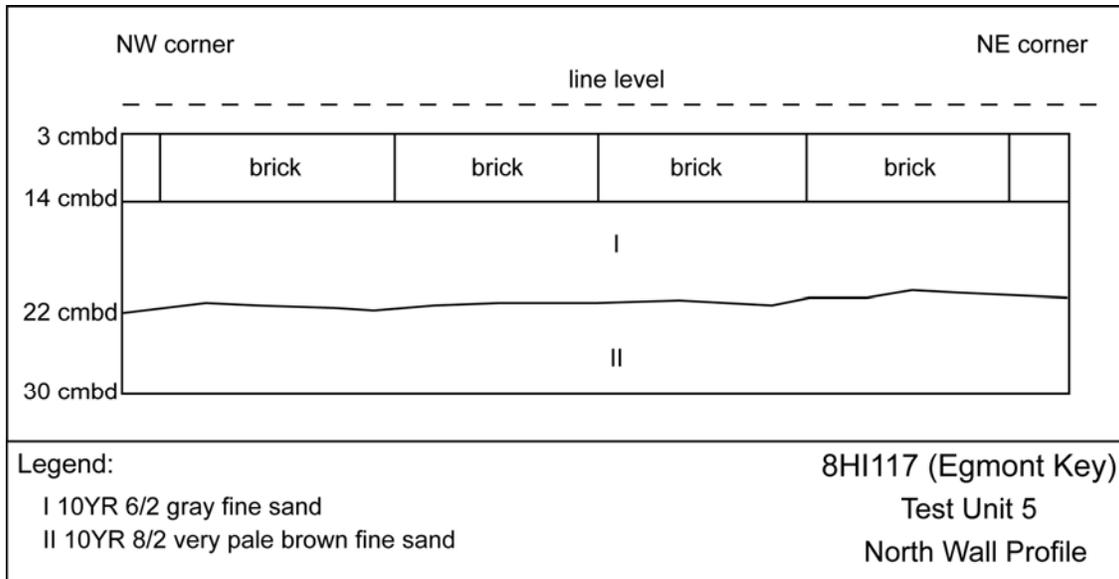
The excavation of TU 5 revealed two soil strata (figures 52 through 55). Stratum I consisted of gray (10YR 6/2) fine sand from a depth of 7 to 20 cmbd (3 to 8 inbd). Stratum II extended from 20 cmbd (8 inbd) to the base of the unit at 30 cmbd (12 inbd). The unit was excavated in 10-cm (4-in) arbitrary levels to a depth of 30 cmbd (12 inbd). Sterile soil was reached at 20 cmbd (8 inbd). Since there was no concrete curb in this test unit, it was only excavated to a depth great enough to expose the profile of the bricks located here and to examine the soil that they were originally placed upon. The north wall of the test unit, which is directly adjacent to the brick road, revealed an upper layer of bricks that extended from the ground surface (3 cmbd [1 inbd] to 13 cmbd [5 inbd]), obscuring part of Stratum I within the north wall profile. Stratum I consisted of gray (10YR6/2) fine sand and Stratum II consisted of very pale brown (10YR 8/2) fine sand.

**Figure 52.** Photograph of the east wall of Test Unit 5, taken facing east.

**Figure 53.** Sketch map of the east wall profile of Test Unit 5.

**Figure 54.** Photograph of the north wall of Test Unit 5, taken facing north.

**Figure 55.** Sketch map of the north wall profile of Test Unit 5.

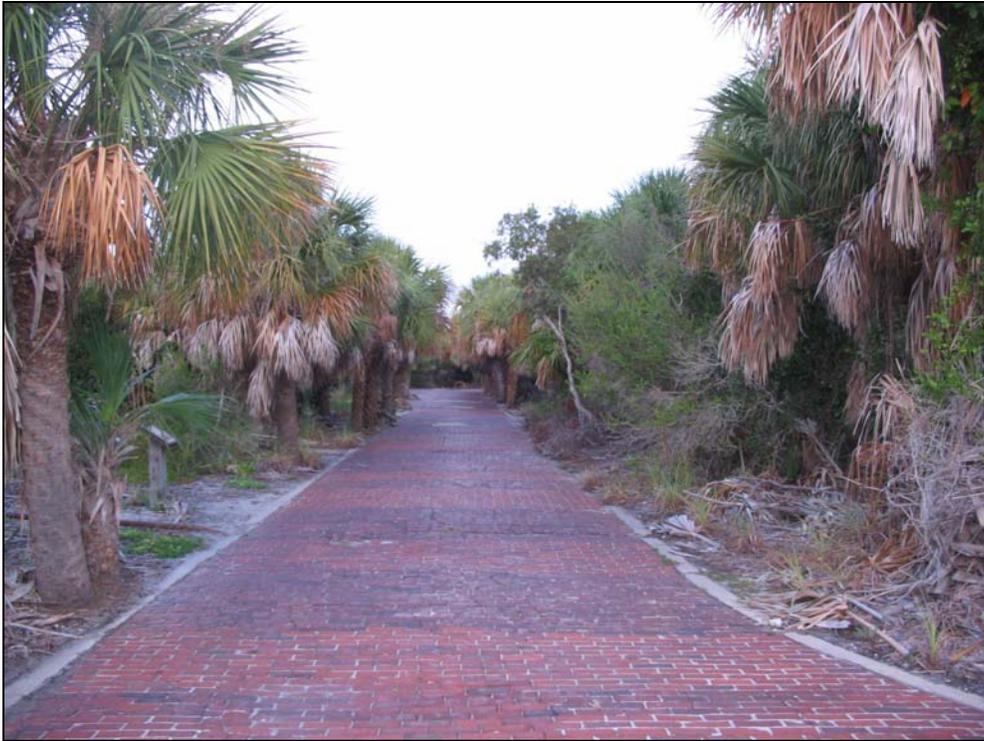
**Figure 56.** Photograph of the historic brick road on Egmont Key, taken facing west from the intersection of Division Street and the unnamed road to Quartermaster's Wharf.

Many of the concrete curbs that lined the historic brick roads of Florida were built with joints to prevent cracking from expansion and contraction as a result of temperature change. This was generally accomplished by laying pieces of 3/8- to 1-in. thick lumber with metal removal straps inside of the curbs. The lumber was removed once the brick road was laid and rolled (Flagler County 2006b). Expansion joints were found in the concrete curb within two test units (TU 2 and TU 4).

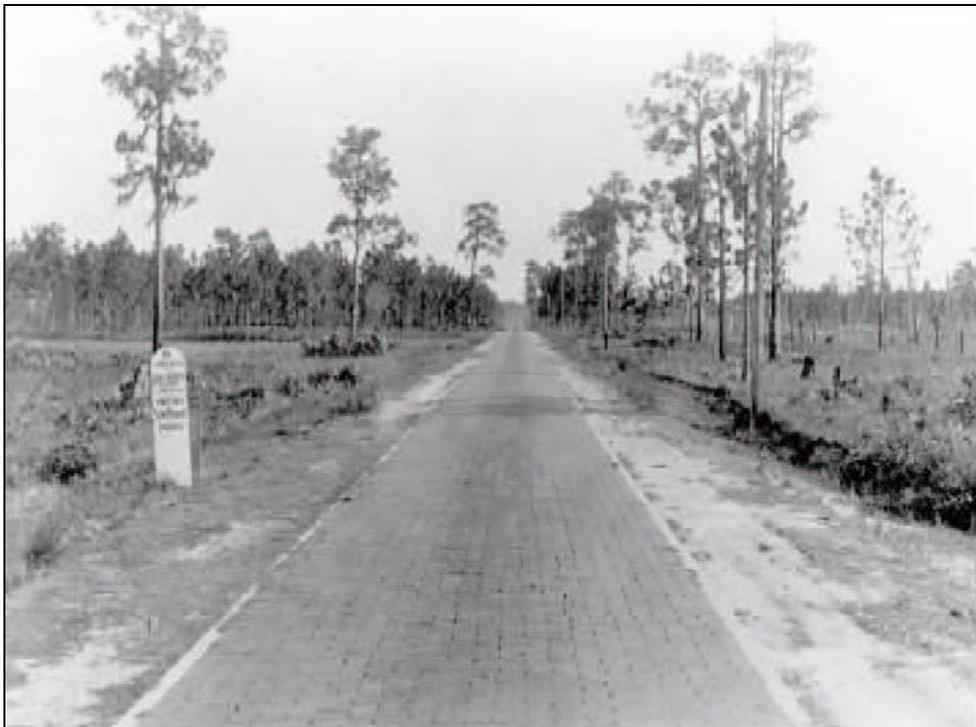
**Figure 57.** Early twentieth-century photo of the Dixie Highway. Image courtesy of Flagler County (2006c).

As Kanaski (1998a) previously mentioned, the brick road appears to have been laid directly on top of a compacted layer of sand. This is a common type of construction that was used on other brick roads built around the same time. The Old Brick Road, which extends for a distance of 11 miles between State Road 204 and the rural community of Espanola in St. Johns and Flagler counties, was constructed in a similar way to the brick road on Egmont Key according to documentation provided by Flagler County (2006a) (figures 56 and 57). In the early twentieth century, when both of these roads were constructed, the process of building brick roads consisted of selecting an alignment, clearing the area of vegetation and roots, moistening and packing the subgrade, then rolling it for firmness and uniformity before laying down the concrete curbing. The bricks were then laid in uniform courses. A crowbar was often inserted against the curb and used to push the bricks together (Flagler County 2006b). Two of the five test units excavated during this project (TU 1 and TU 4) revealed that the soil immediately adjacent to the brick road had been previously excavated to allow for the placement of the concrete curb.

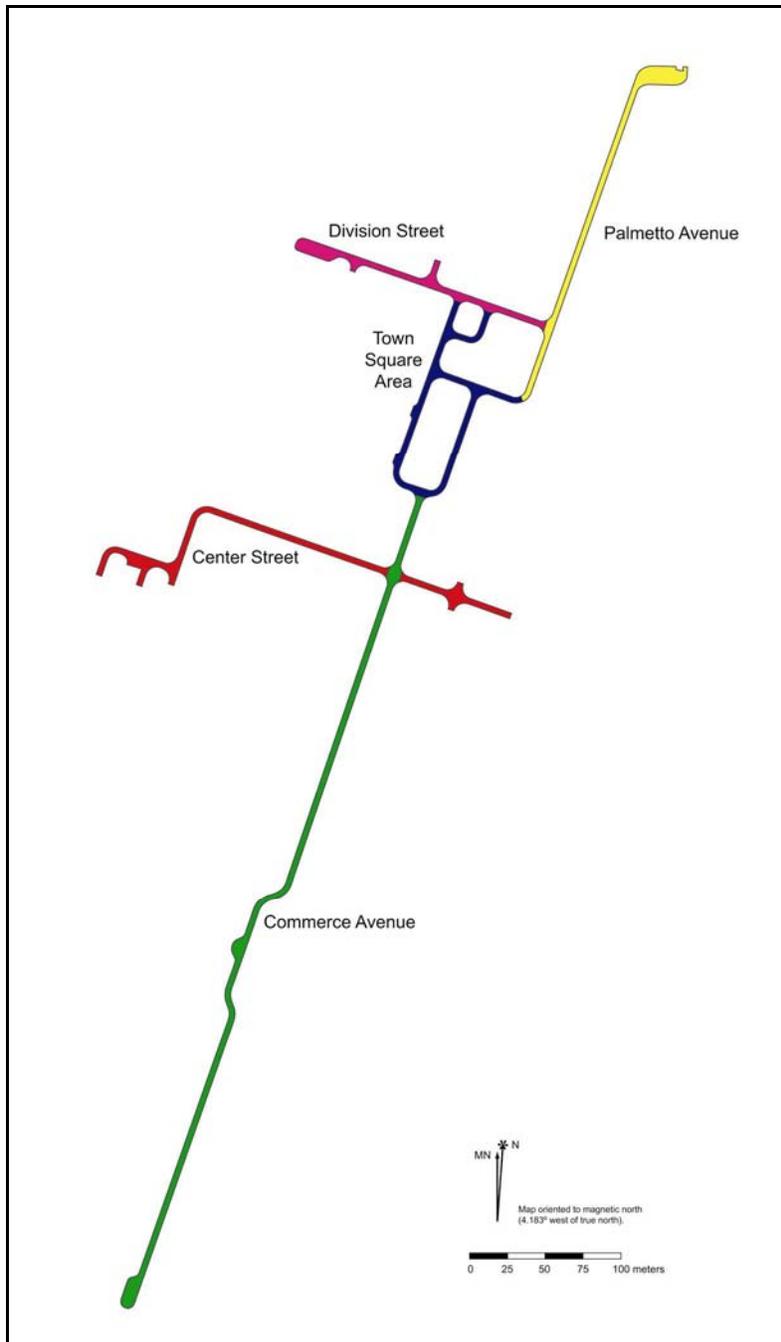
**Figure 58.** Map showing names of brick roads and brick road groupings used in text.

The various forms of damage mapped throughout the system of brick roads amounted to a total of 106 patches, 128 slumps, and 22 voids. The patches ranged in size from very small areas of only two or three bricks to extensive areas between 8 and 17 m (26 and 56 ft.) long and 2 to 5 m (7 to 16 ft.) wide at the western extreme of Center Street. An average slump measured about 1 m (3 ft.) wide by 2 m (7 ft.) long, although they ranged up to approximately 9 m (30 ft.) in length. Slumps smaller than about 0.5 m (2 ft.) diameter were typically not mapped. The depressed centers of the slumps ranged between approximately 5 and 15 cm (2 and 6 in.) in depth. The smallest void mapped was equivalent to a single missing brick, while the largest was an extensive area at and continuing northwest of the intersection of Commerce Avenue and Center Street which measured the full width of the road and 22 m (72 ft.) long. The voids were extremely variable in size.
