Upper Black River Road Crossing Restoration

Tin Shanty Bridge

Report Submitted to:
National Fish and Wildlife Foundation

Project # 99-279

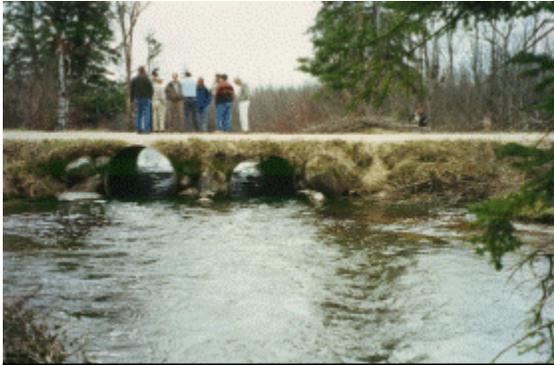
Figure 1. Tin Shanty Bridge, before restoration

partnered and pooled their funding to restore Tin Shanty Bridge. Concern had grown by local groups because this road/stream crossing was a large source of sand and silt pollutants into the watershed. The two culverts at the crossing acted as fish passage barriers as well (see Figure 1). The Upper Black River is renowned throughout Michigan as containing an excellent native brook trout fishery. The high sediment loads coupled with the lack of fish passage made the restoration of this road/stream crossing a high priority for all involved parties.

Restoration of Tin Shanty Bridge has alleviated the restriction in the river, allowing the river to regain its natural flow rates and natural stream bed, it no longer blocks fish passage, and the bottomless span compensates for 50 year storm events.

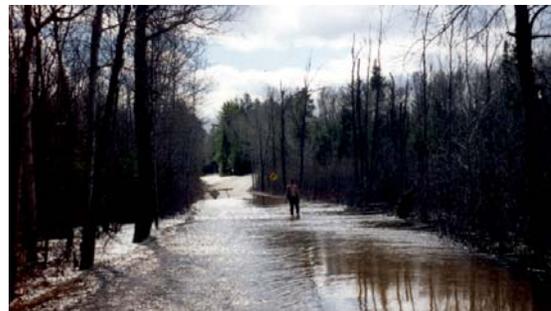
There were a number of problems that contributed to the sediment load in the stream and the blocking of fish passage. Due to inadequate culvert size this sand/gravel road periodically washed out during high water events (see Figure 2). The sand and silt from the road washed directly into the river, contributing several tons of sediment to the watershed with every incident. Sediment filled in several river-miles of brook trout spawning habitat, located directly downstream from the road/stream crossing. The culverts were also fish passage barriers to a native strain of brook trout. Spawning habitat is located both upstream and downstream of this road/stream crossing. The culverts were perched. Perched culverts mean that the culverts were not properly placed in the streambed. Downcutting resulted on the downstream side of the culverts, making fish passage from the downstream side challenging if not impossible. The restrictive size of the culverts backed up water, warmed it, and created an accelerated flow through the culverts to compensate for the size restriction. These factors effectively blocked fish passage.

Figure 2. Before restoration the road would wash out.

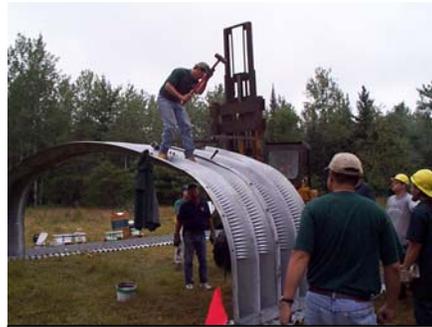
The "bottomless culvert" (bridge) was purchased from St. Regis Culvert, Inc., and was delivered the week of August 9th to an assembly site ¼ mile north of the road/stream crossing. The bridge came unassembled. Pieces fitted together with large nuts and bolts like a Tinker Toy from childhood days (see Figure 4). A forklift from the Otsego Road Commission was utilized to position the pieces during assembly. The Michigan Civilian Conservation Corps (MDNR) were the majority of the workers present, and members of the road commission and a representative from St. Regis were on-site at all times to supervise. The bridge was fully assembled in two days.

Figure 4. Assembly of bridge

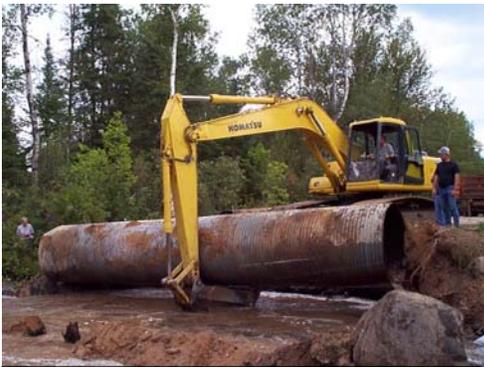
Figure 5. Culvert removal

Once the bridge was on-site the excavator began culvert extraction. Water was diverted through one culvert as the other (culvert) was removed.

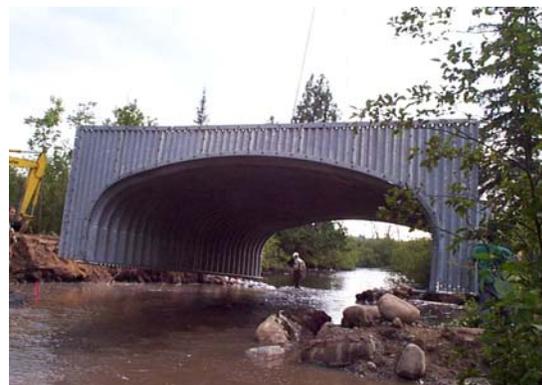
After the first culvert was removed the excavator leveled the area where the steel footings for the bridge would be placed. Removal of the second culvert soon followed, footings were leveled, and by 6:00PM the crane prepared to place the bridge. The bridge was placed and properly angled with the river by 7:30PM.

Figure 6. Placement of bridge by crane

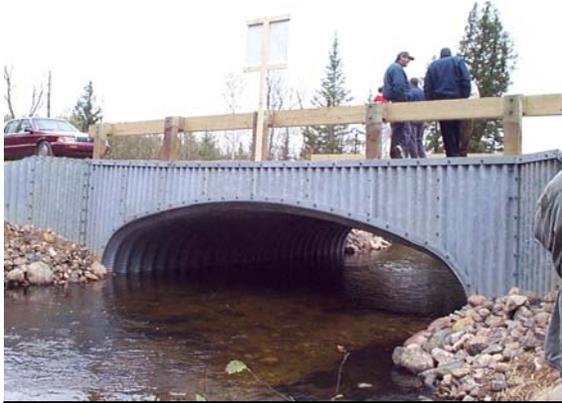
The Otsego Road Commission placed the wing-walls and placed the fill over the bridge for the next two days. Rock rip-rap was placed by the Upper Black River Watershed

Figure 7. Tin Shanty Bridge after restoration

Restoration Committee against the wing-walls and along the footing to assist with stabilization of the structure. The Montmorency County Conservation Club hired a work crew of college students to assist the road commission, and to do the final seeding and “clean-up” of the site. The water levels of the river were so restricted by the former culverts, that by August 24th, the day after culvert removal, the river levels above the bridge had

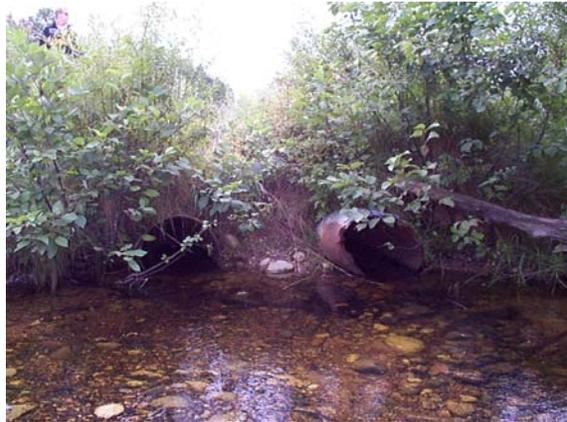
Figure 9. Road/Stream crossing impeding Tomahawk Creek. The culverts are barely functional.

ranking allows the Upper Black River Watershed Restoration Committee and natural resource agencies to focus their efforts and funds to repair the worst road/stream crossings. Each crossing will be listed individually in the inventory book, and the GPS coordinates have allowed a GIS specialist to pinpoint the road/stream crossings on a township map. The inventory will not be available in its entirety until the summer of 2000. A copy will be mailed to the National Fish and Wildlife Foundation as soon as it is available.
