# WATERSHED RESTORATION IN THE TRINITY RIVER BASIN

Bill Brock December 2015

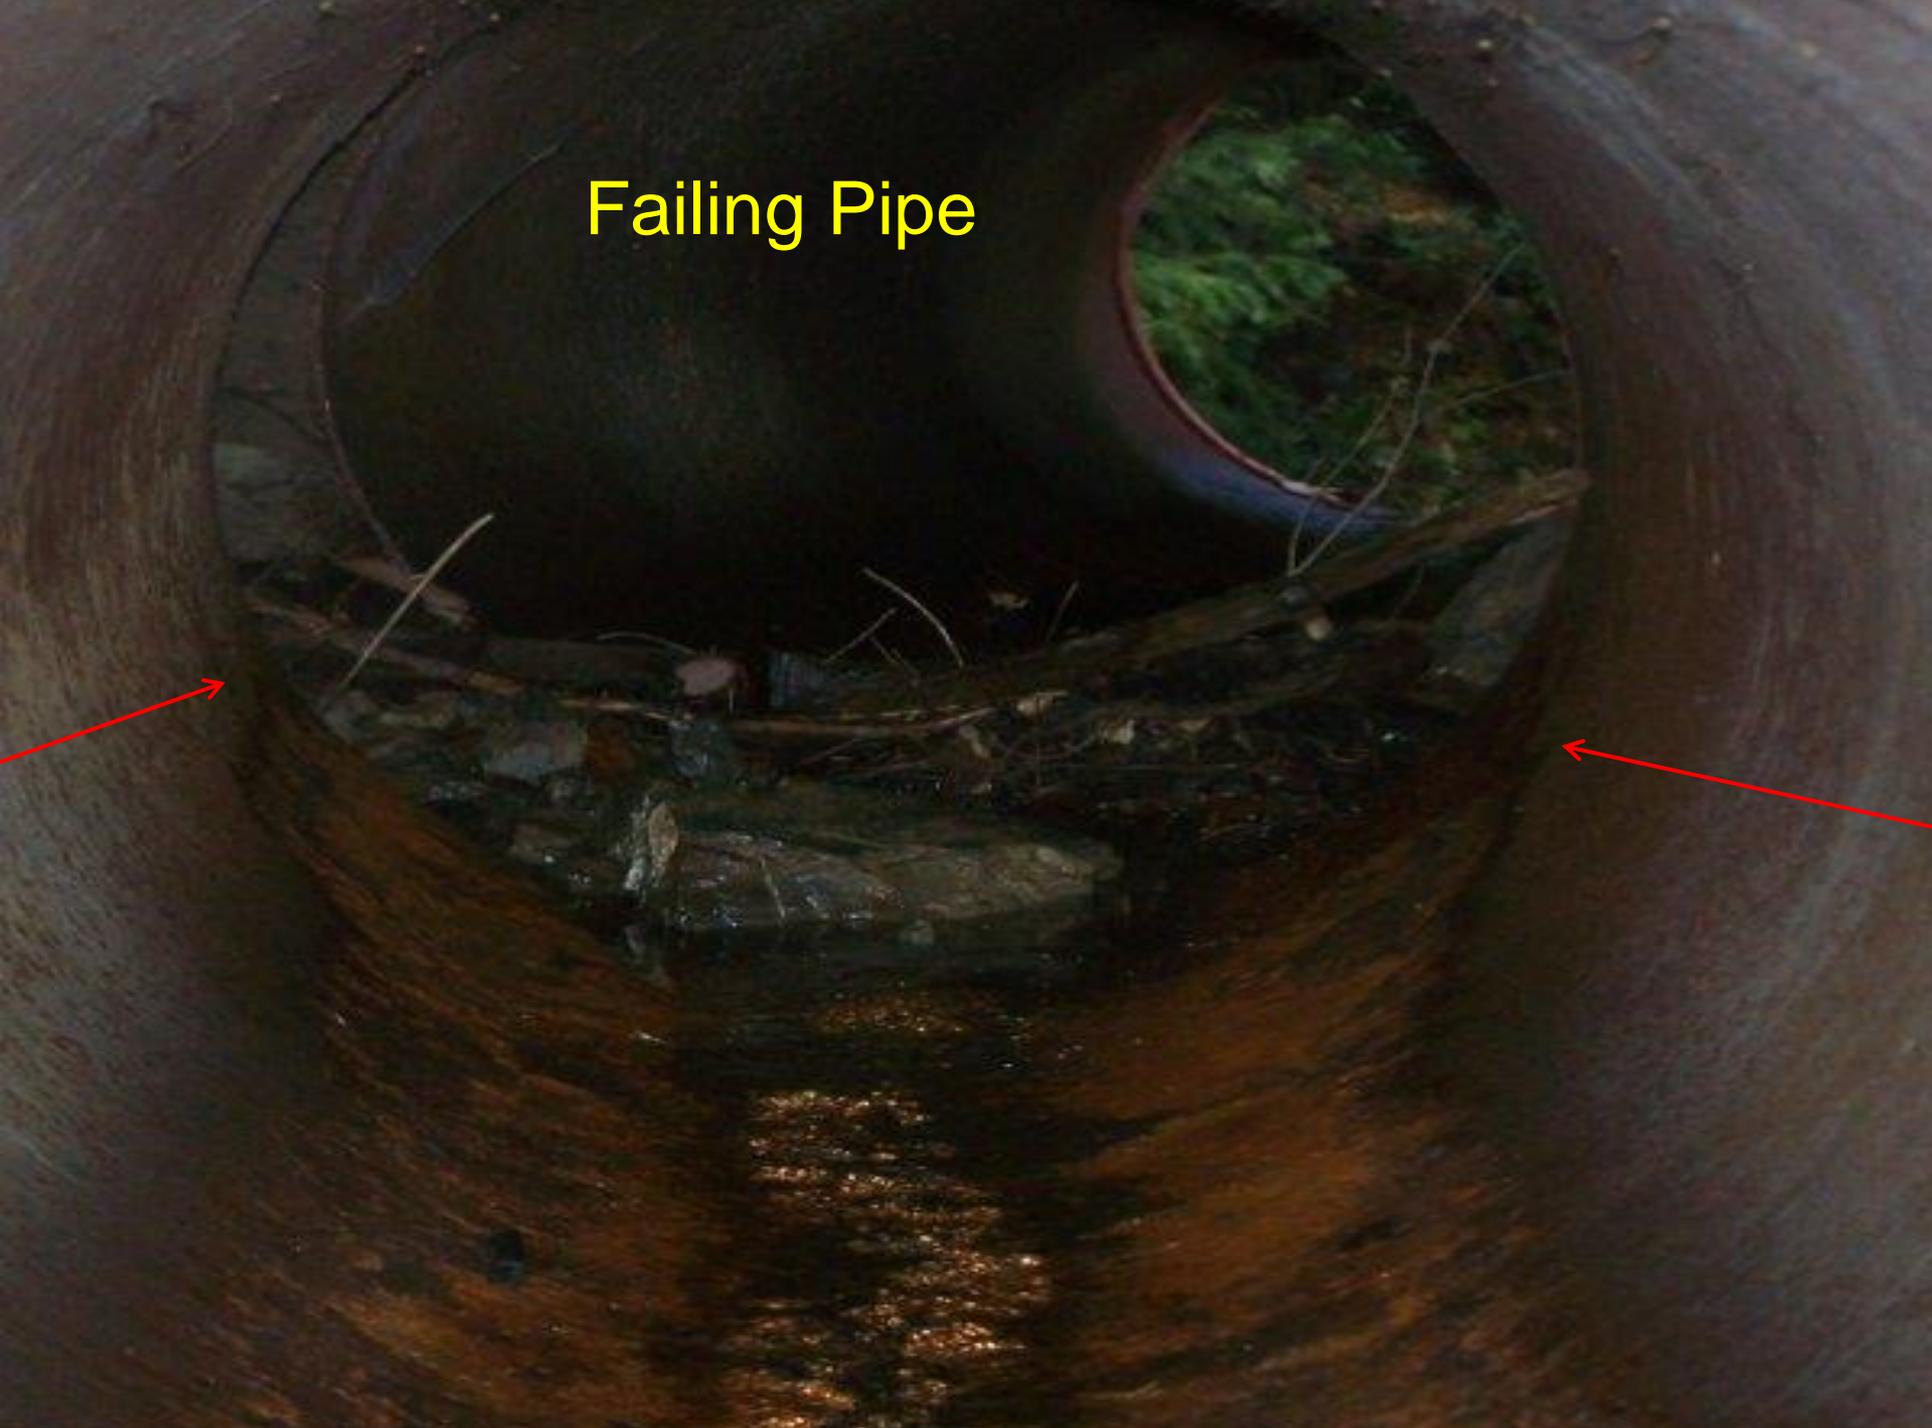
**Aging infrastructure &  
undersized pipes**

Failing Pipe

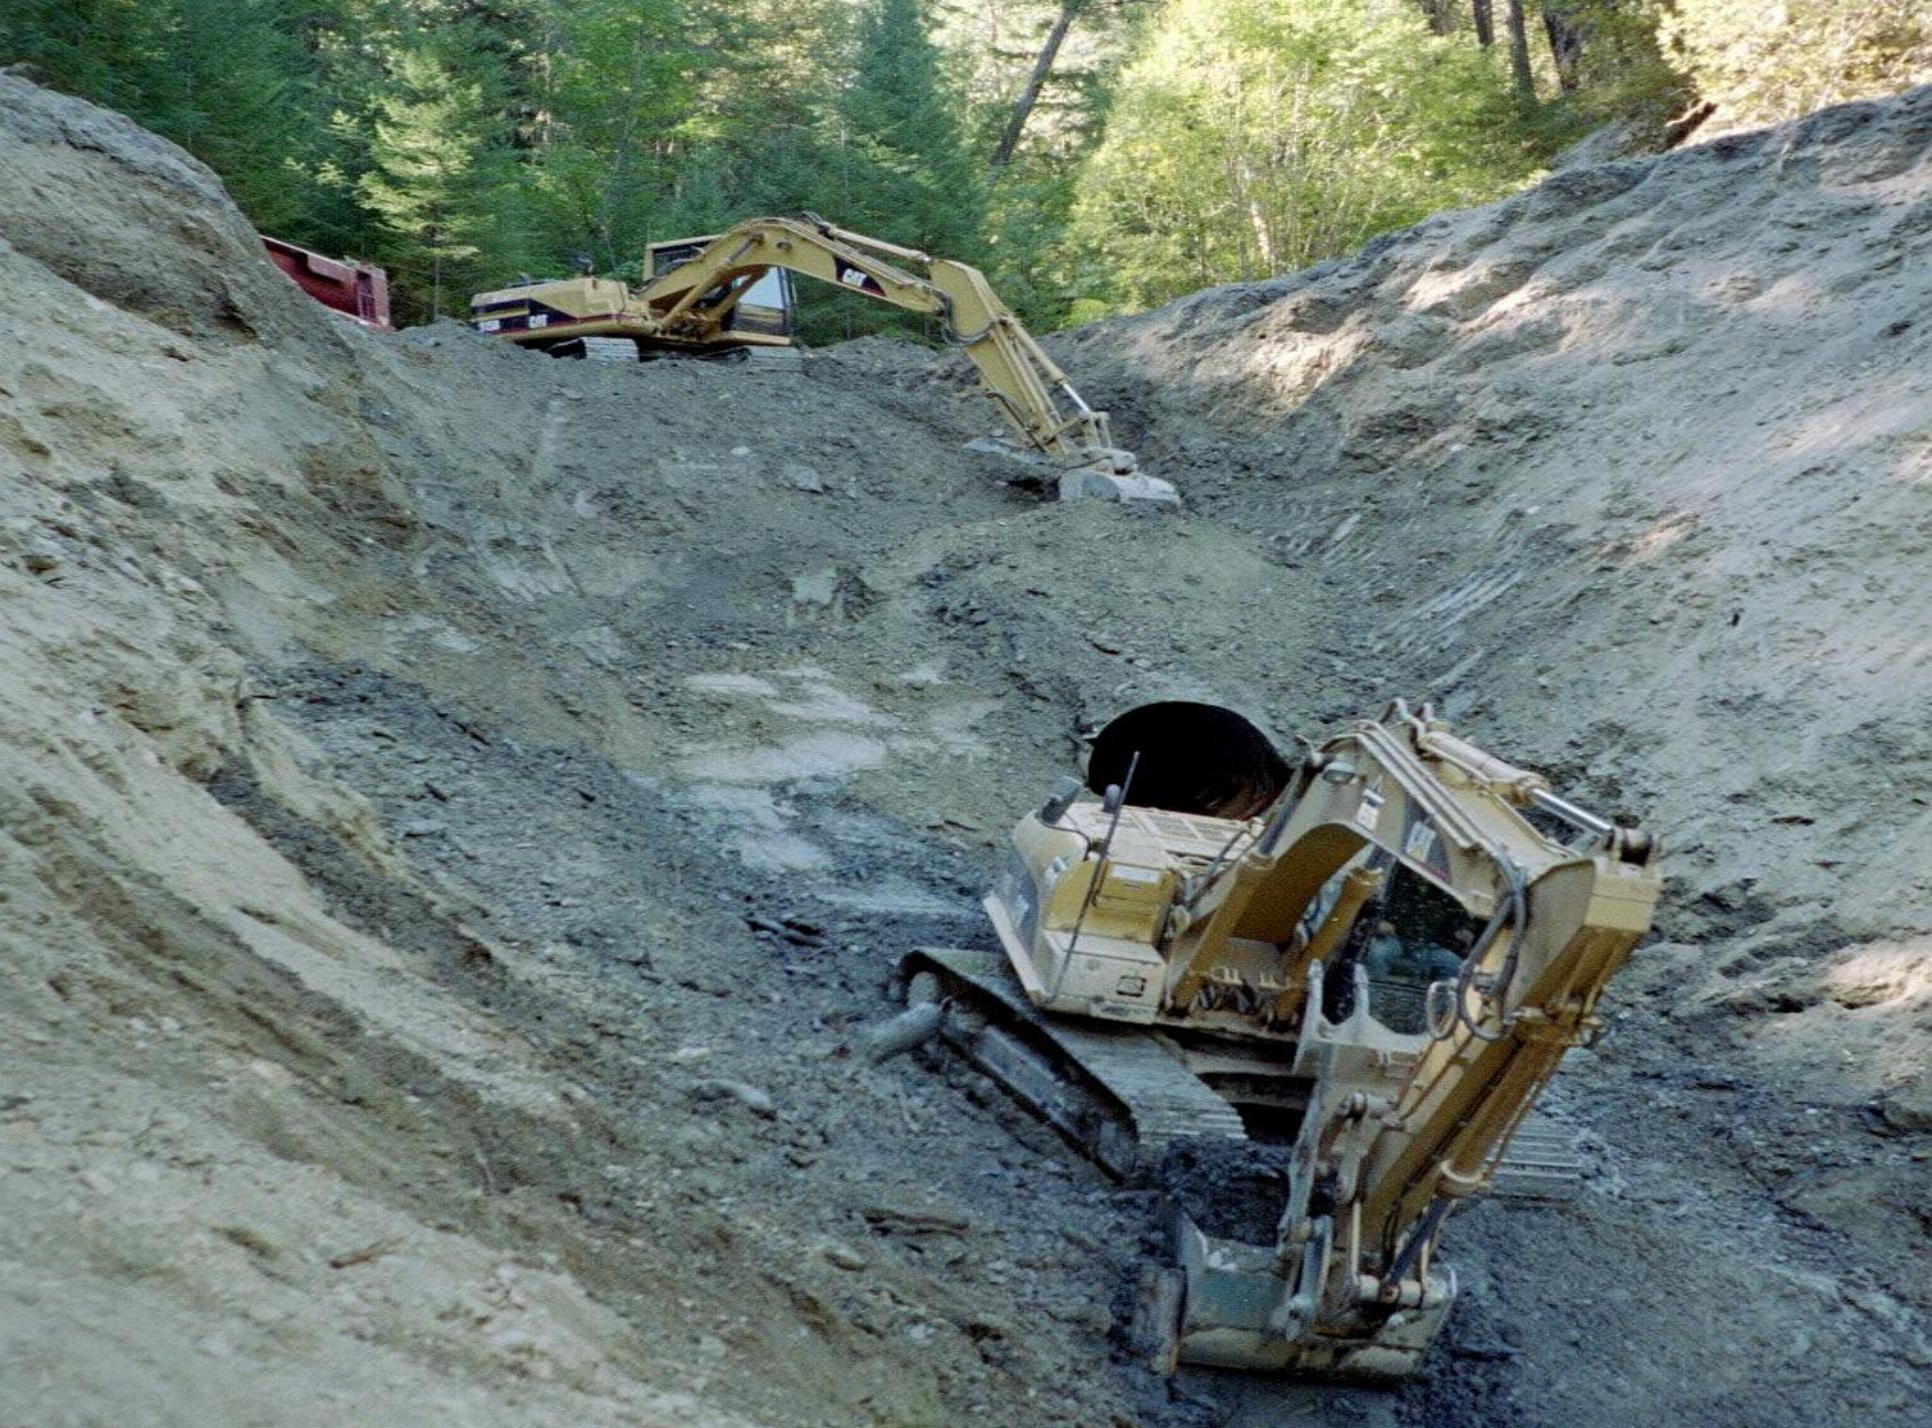
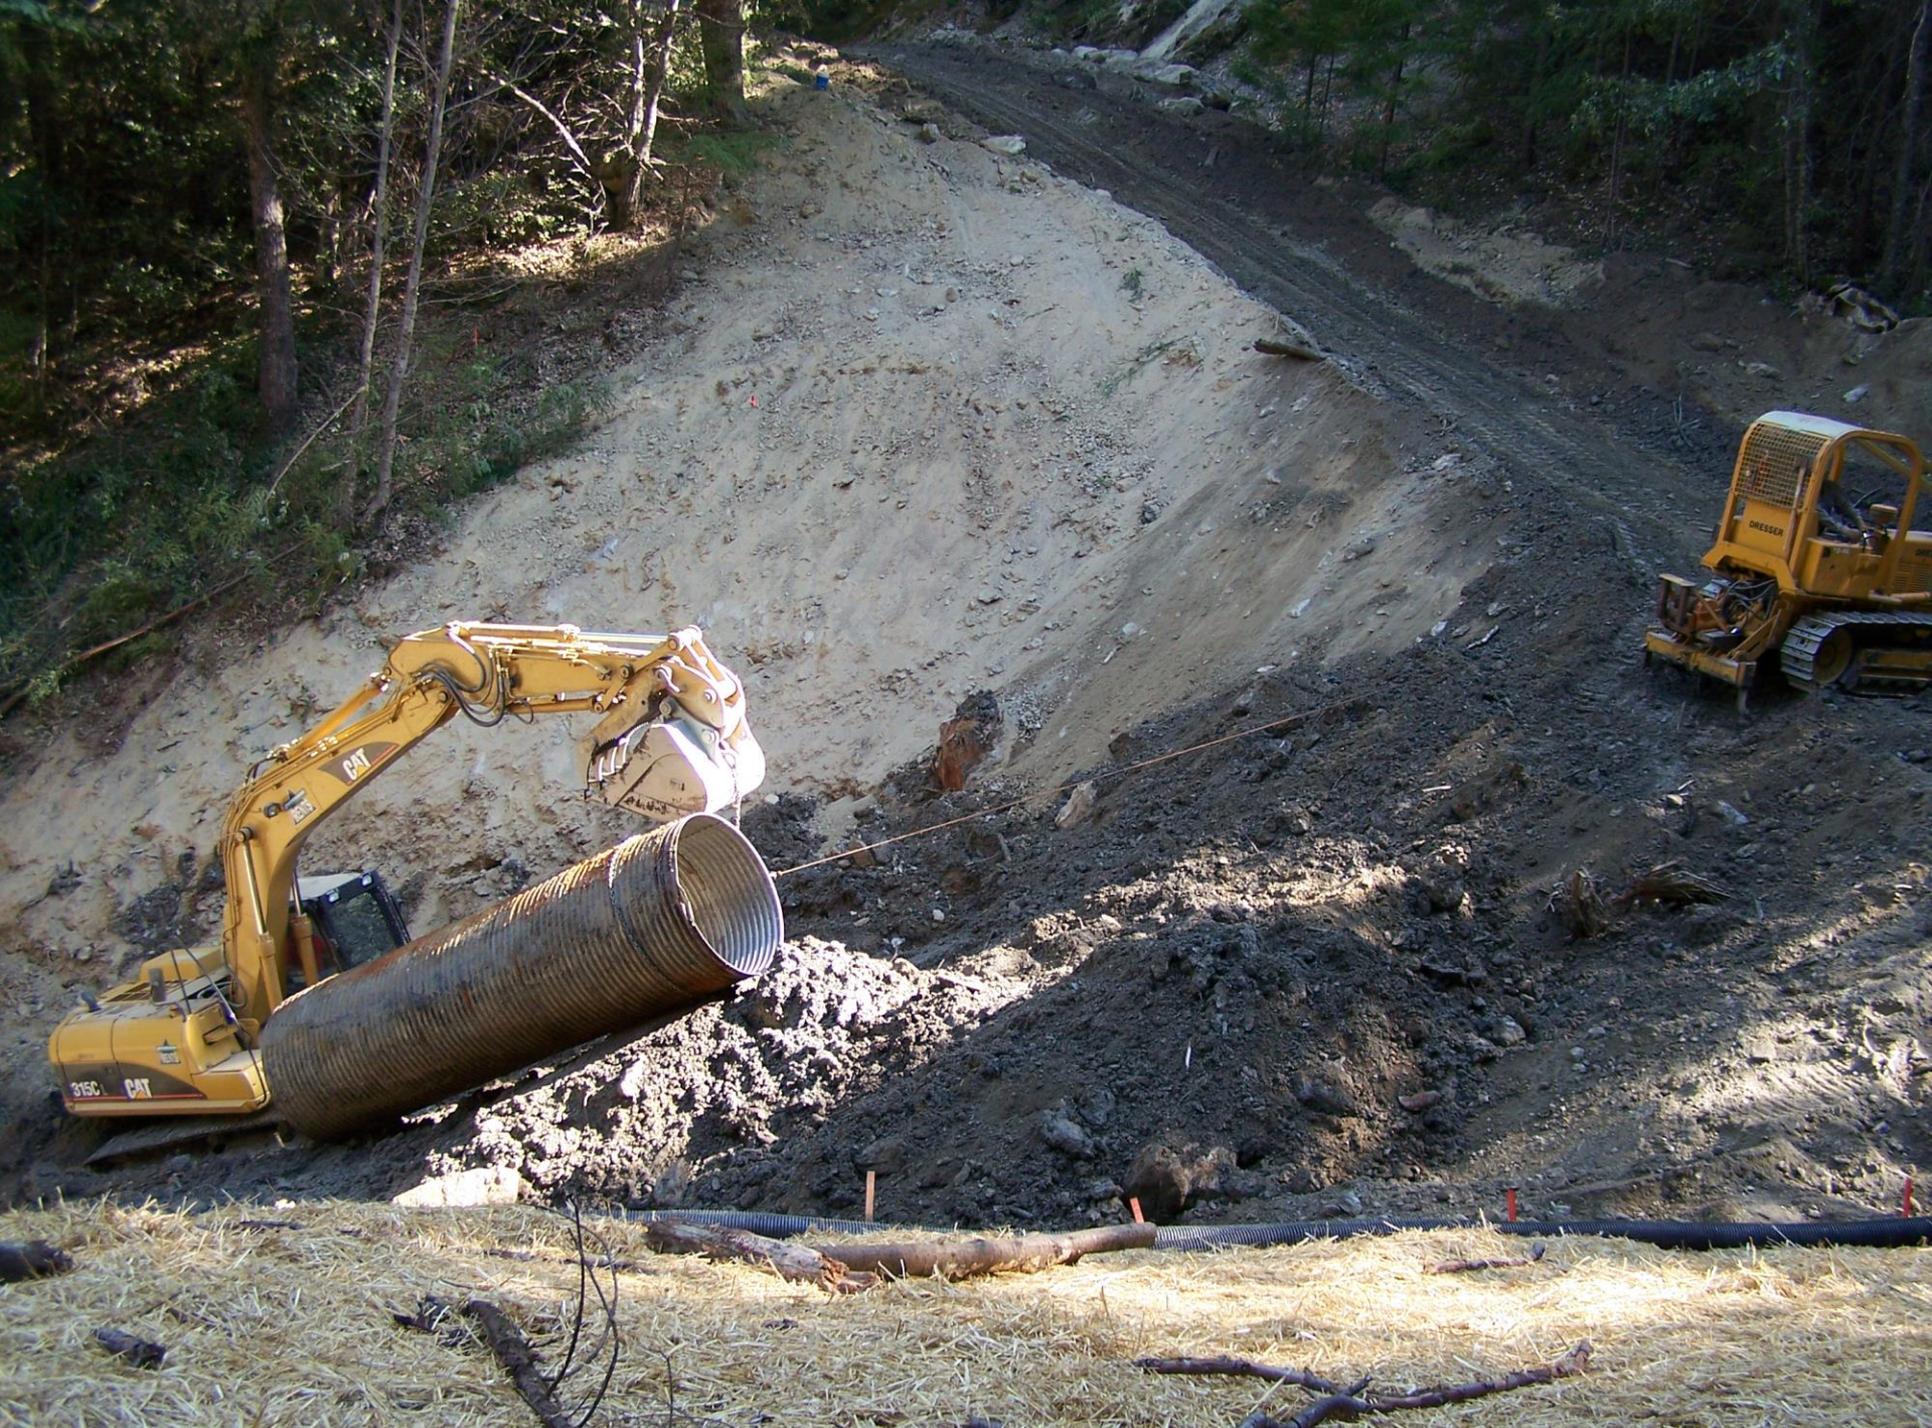
**Culverted stream crossings  
function similarly to  
'dams with holes in them'.**

**The steeper the terrain,  
the larger the fills,  
the bigger the dams!**

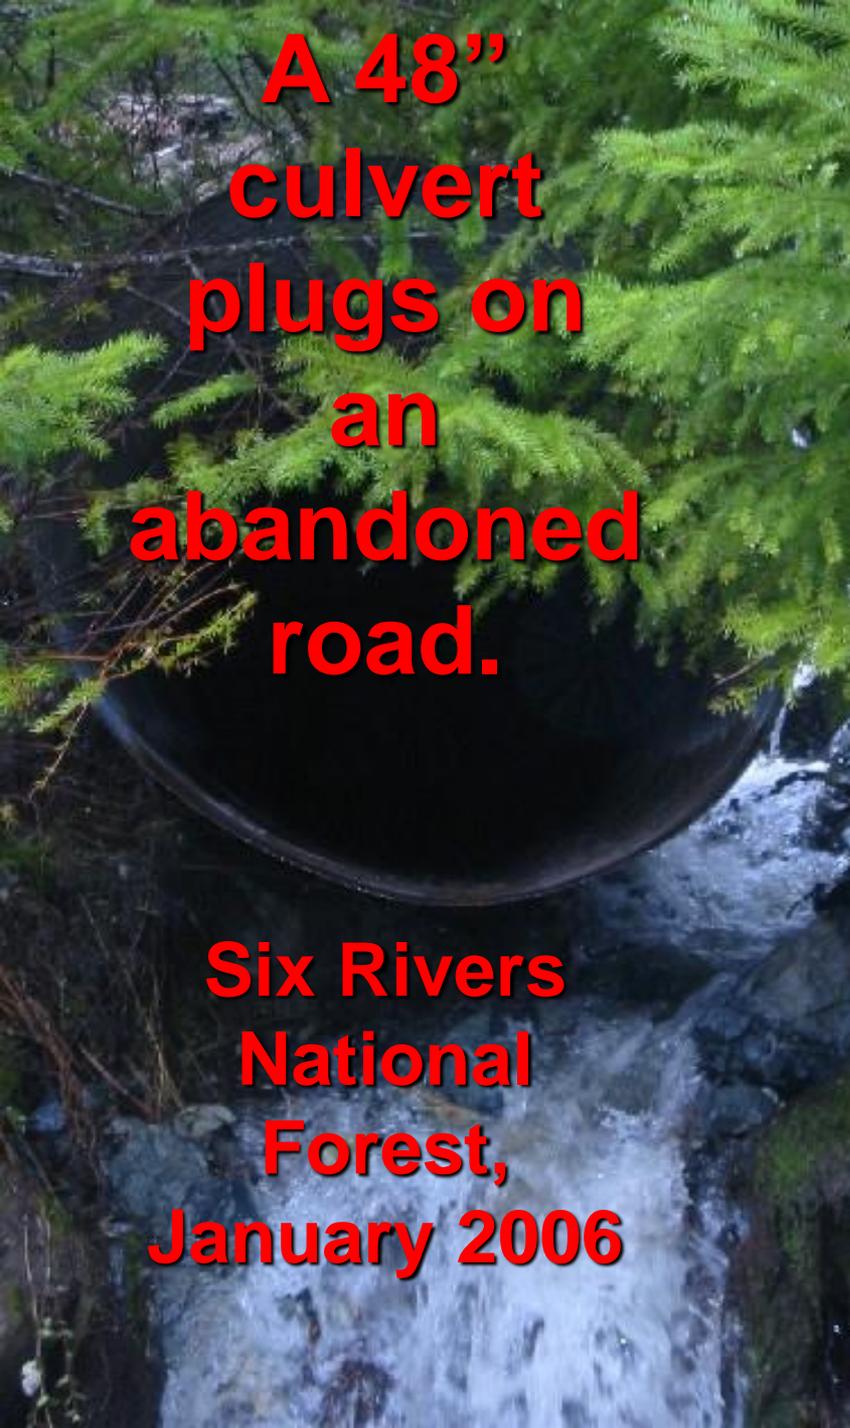
**A 48"  
culvert  
plugs on  
an  
abandoned  
road.**

**Six Rivers  
National  
Forest,  
January 2006**

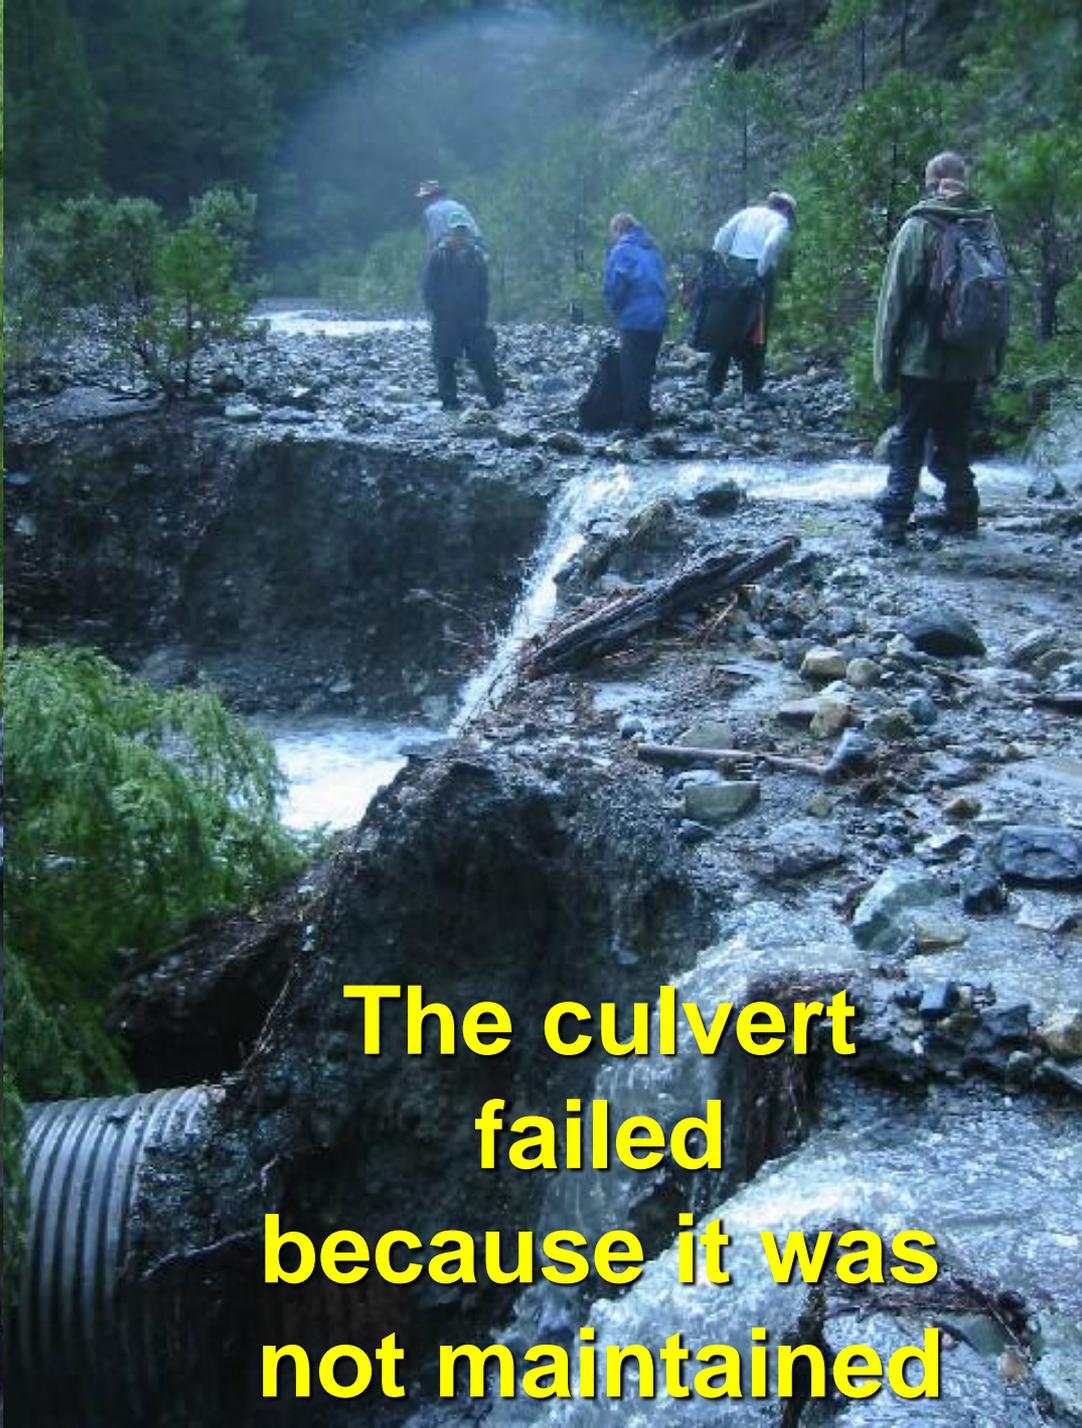
**The culvert  
failed  
because it was  
not maintained**

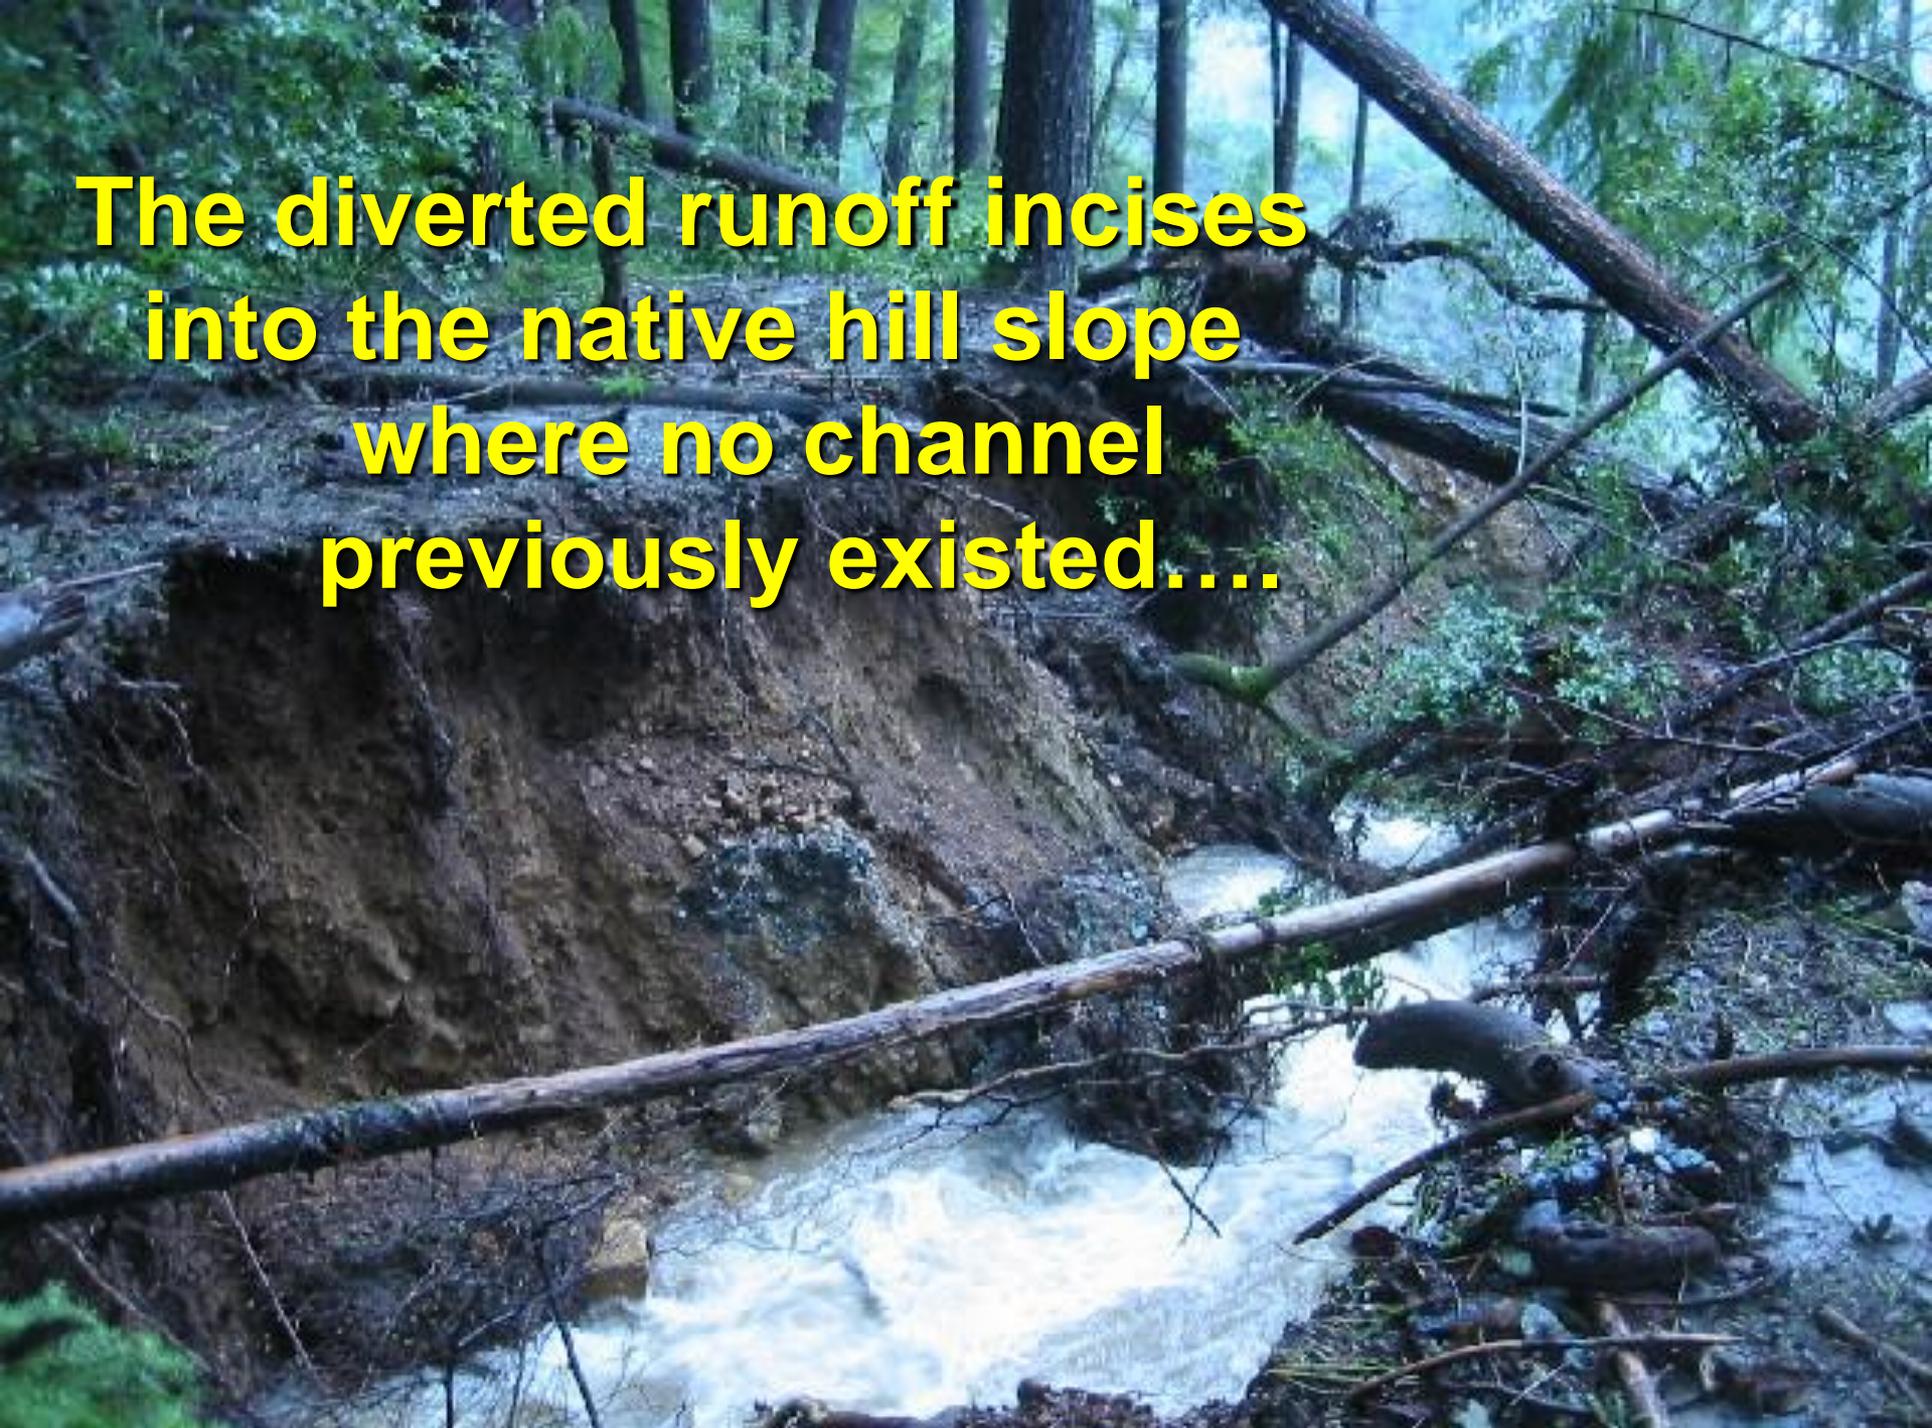
**The diverted runoff incises  
into the native hill slope  
where no channel  
previously existed....**

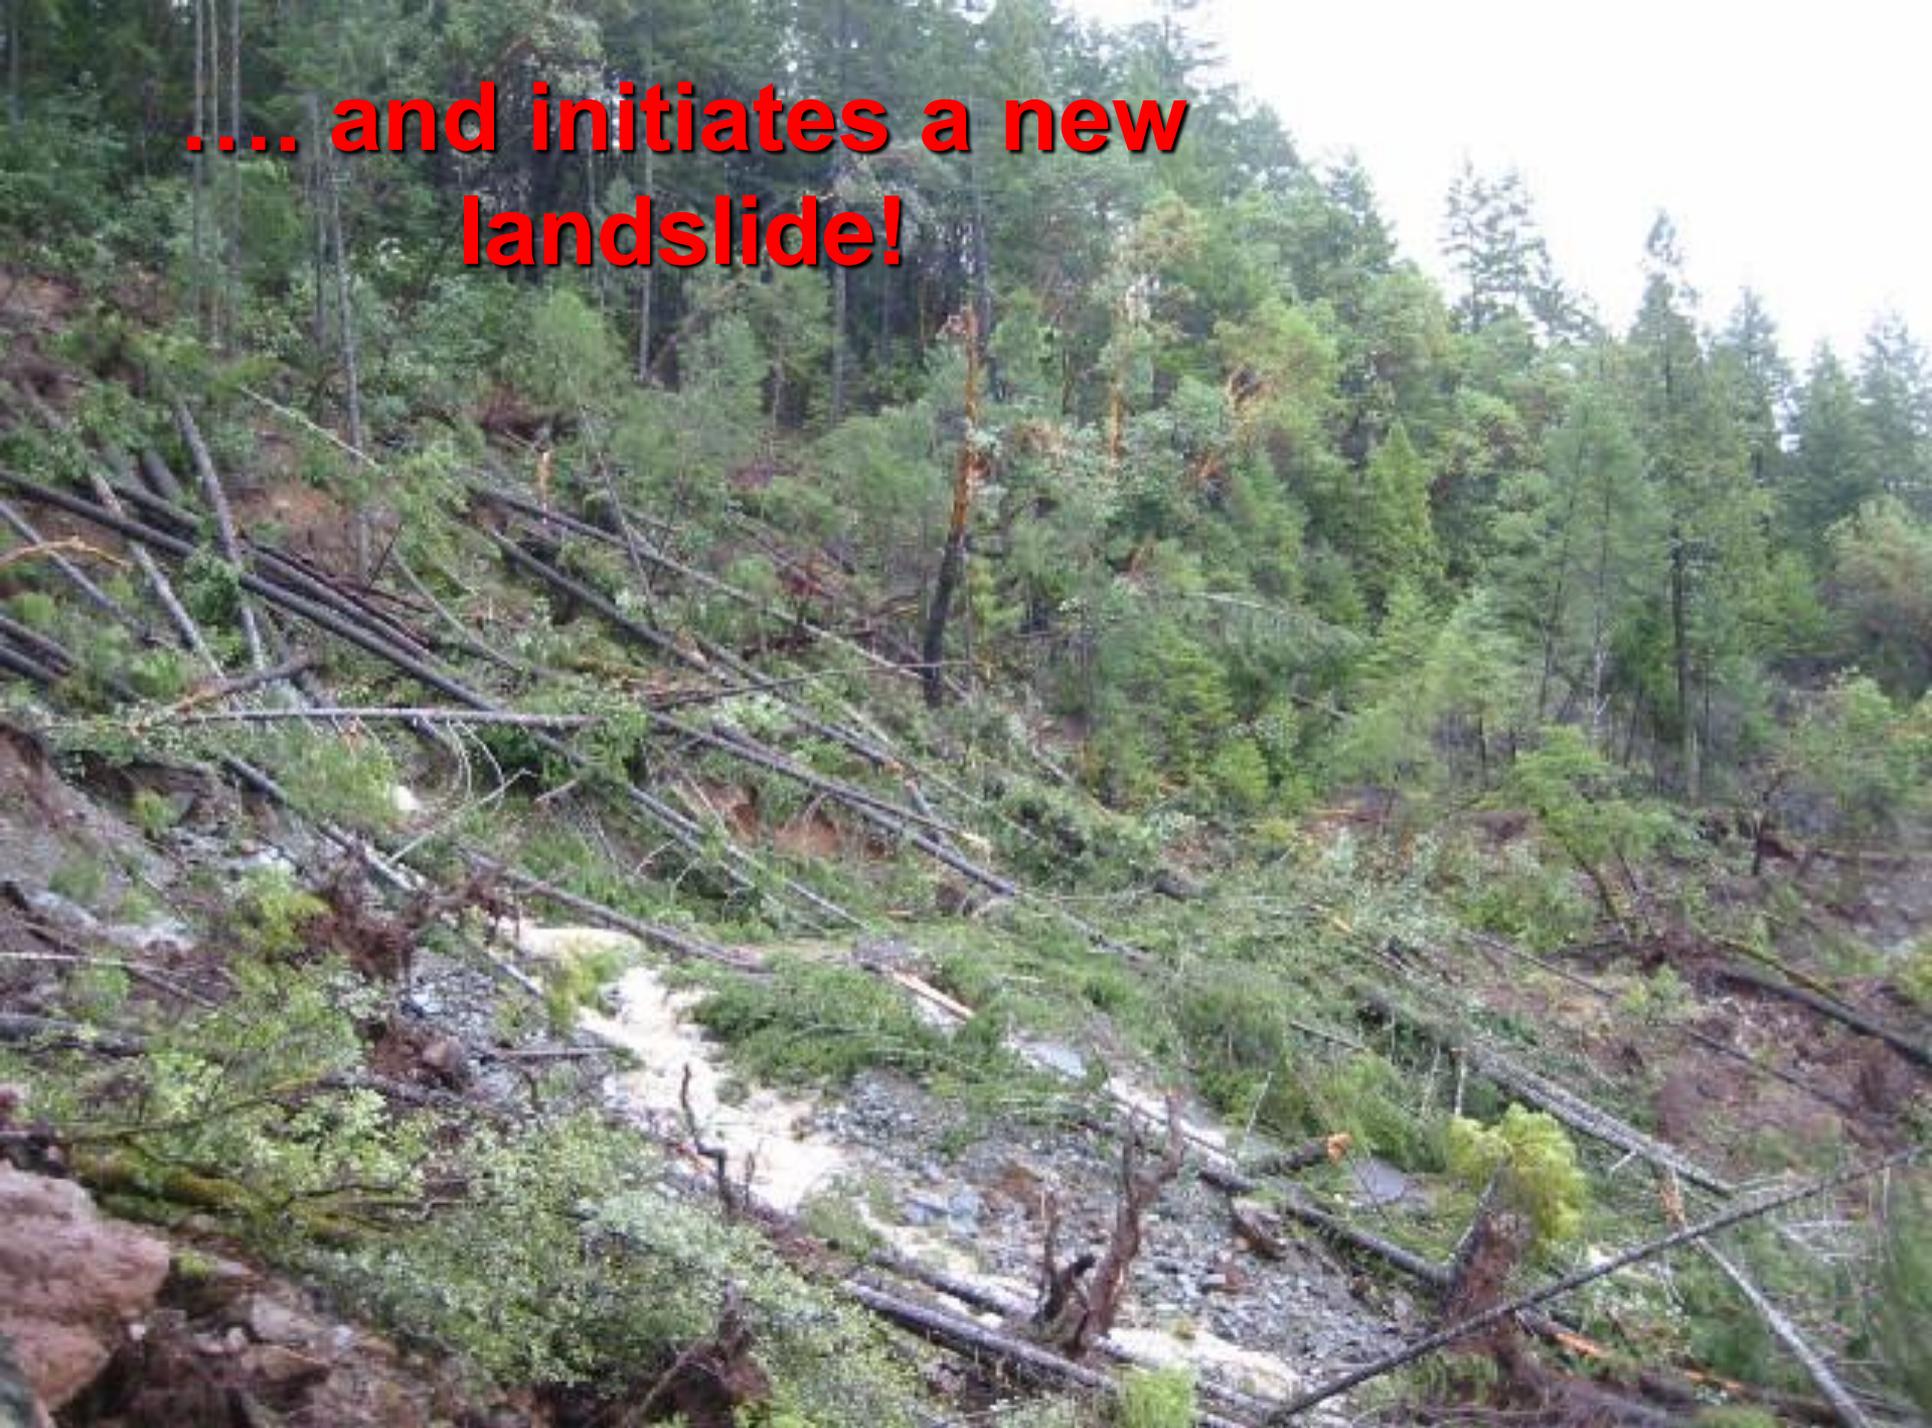
**.... and initiates a new  
landslide!**

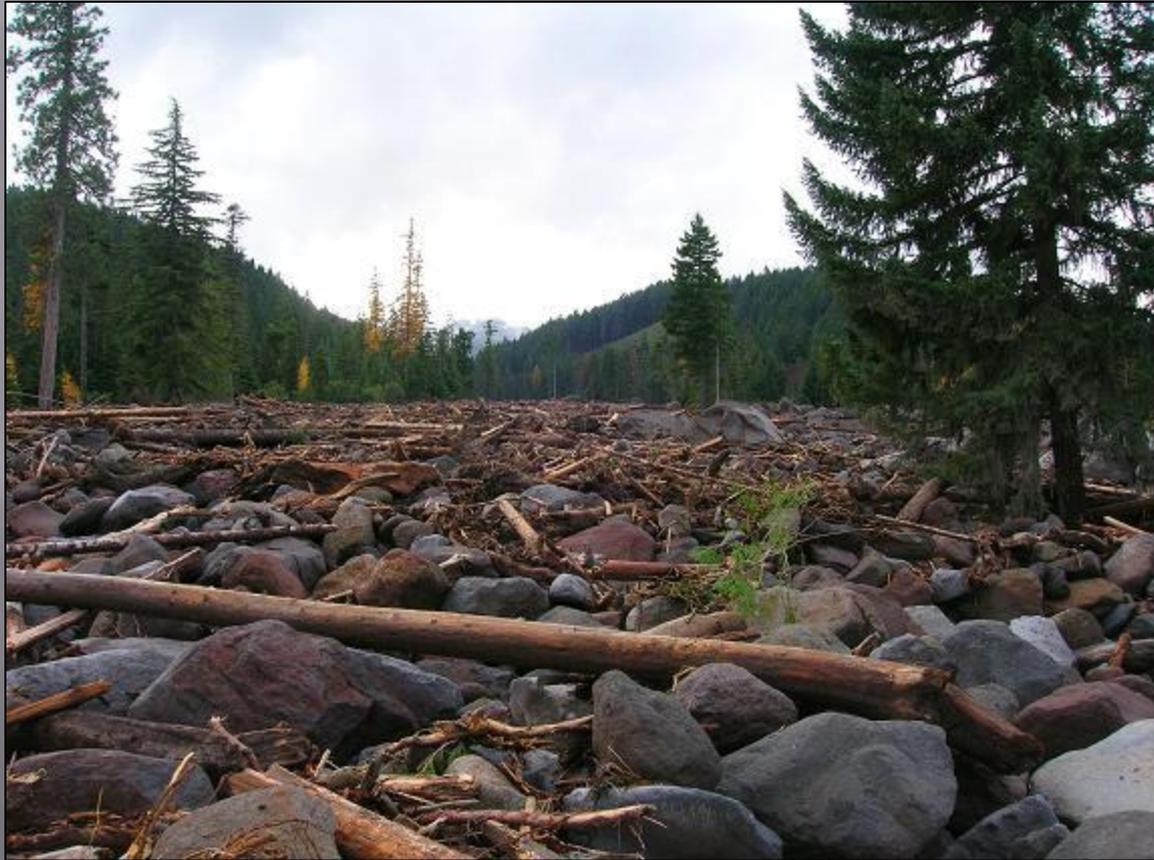
# Debris Torrent, Mt. Hood Nat'l Forest,

November 2006

Major depositional area upstream of a USFS road.  
Standing trees had limbs stripped off up to 50 feet  
above the ground!

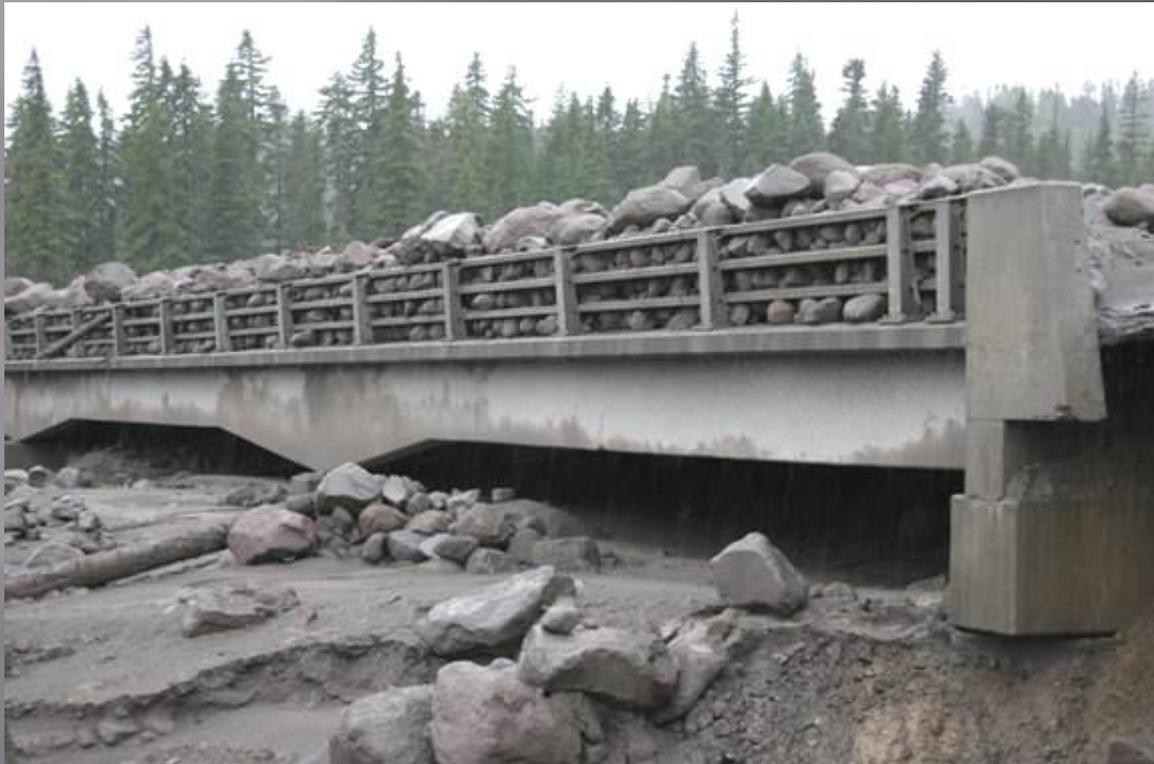
# Mt. Hood Nat'l Forest

November, 2006

**The Little White River is now 20 feet higher above the bridge upstream.**
