**U.S. Fish and Wildlife Service  
Columbia River Fish and Wildlife Conservation Office**

# **Tryon Creek Restoration Monitoring Project**

*City of Portland FY 2018 Progress Report*

**February 20, 2019**

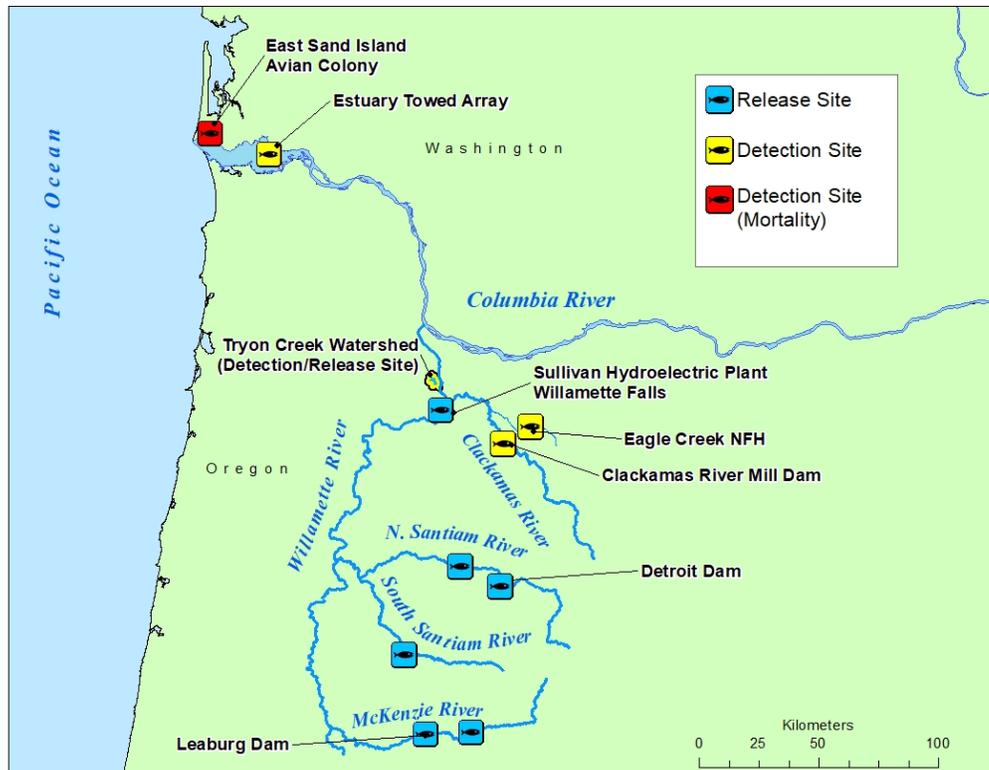
**Figure 13. Detections of PIT-tagged salmonids before or after detection in Tryon Creek 2012 - 2018. Chinook Salmon, Coho Salmon, *O. mykiss*, Cutthroat Trout, and hybrid trout tagged in Tryon Creek were detected outside of the Tryon Creek Watershed in the Lower Columbia River Basin. The Tryon Creek Mouth antenna (TCM) detected Chinook Salmon, Coho Salmon, and *O. mykiss* released upstream in tributaries to the Willamette River.**
