**U.S. Fish and Wildlife Service
Columbia River Fish and Wildlife Conservation Office**

**Evaluation of adult Pacific Lamprey
upstream passage at Warm Springs National
Fish Hatchery**

FY 2018 Annual Report

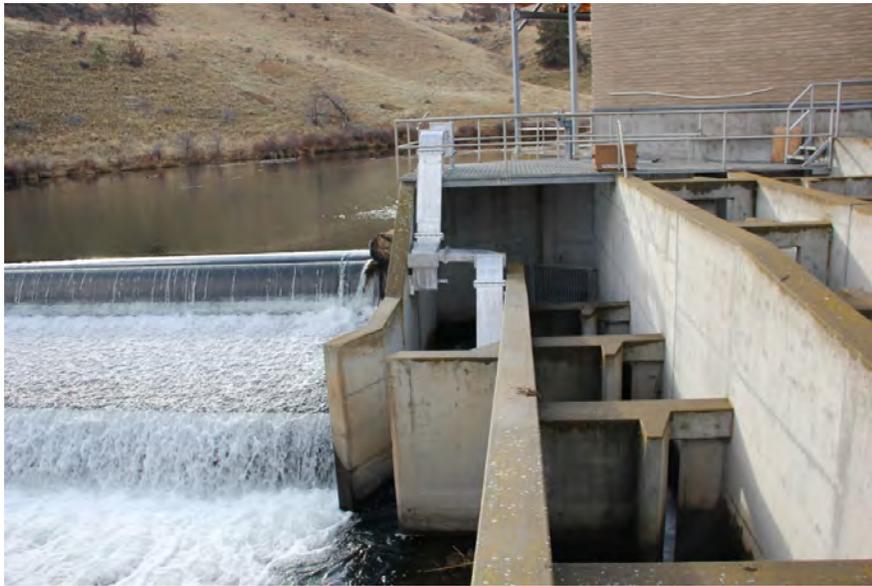
On the cover: The Lamprey Passage System at Warm Springs National Fish Hatchery, Warm Springs, Oregon.

The LPS is constructed of varying types and thicknesses of aluminum, which are listed in the fabrication drawings. For installation, water to the fishway was turned off (*note: ammocoetes were observed in sediment accumulations within the dry fishway*). The lower flume section was lowered into the raceway and secured to the concrete by underwater divers using pneumatic drills and stainless steel bolts. Individual sections of the LPS were bolted together as the installation progressed and then sealed with silicon at the seams (other options for the future could include neoprene gaskets). A 4" 150# stainless steel flanged ball valve (ASTM A351, ball and stem 316 S.S. with 1/8" rubber gasket for 4"-150# flange end, 8 bolts: 5/8"11 nc 18-8 S.S. bolts X 3 1/4" w/ HN, LW & FW; purchased from Yanke Machine Shop) was installed at the rest box to drain water for winterization. Water flow to the upwelling box is 80 gal/min and is provided by a Goulds 85GS30CBM 3HP 8STG 4" H.C. SUB pump (purchased from Xylem Water Solutions, Tualatin, OR), installed behind the hatchery intake screen. Plumbing from the submersible pump to the LPS upwelling box (on the fishway deck) is supplied through 3" PVC. An exit tube made of 8" corrugated plastic is attached to the 8" aluminum connector welded to the upwelling box. Modifications are expected of the exit tube and nearby flume sections to install a PIT reader and camera for monitoring.

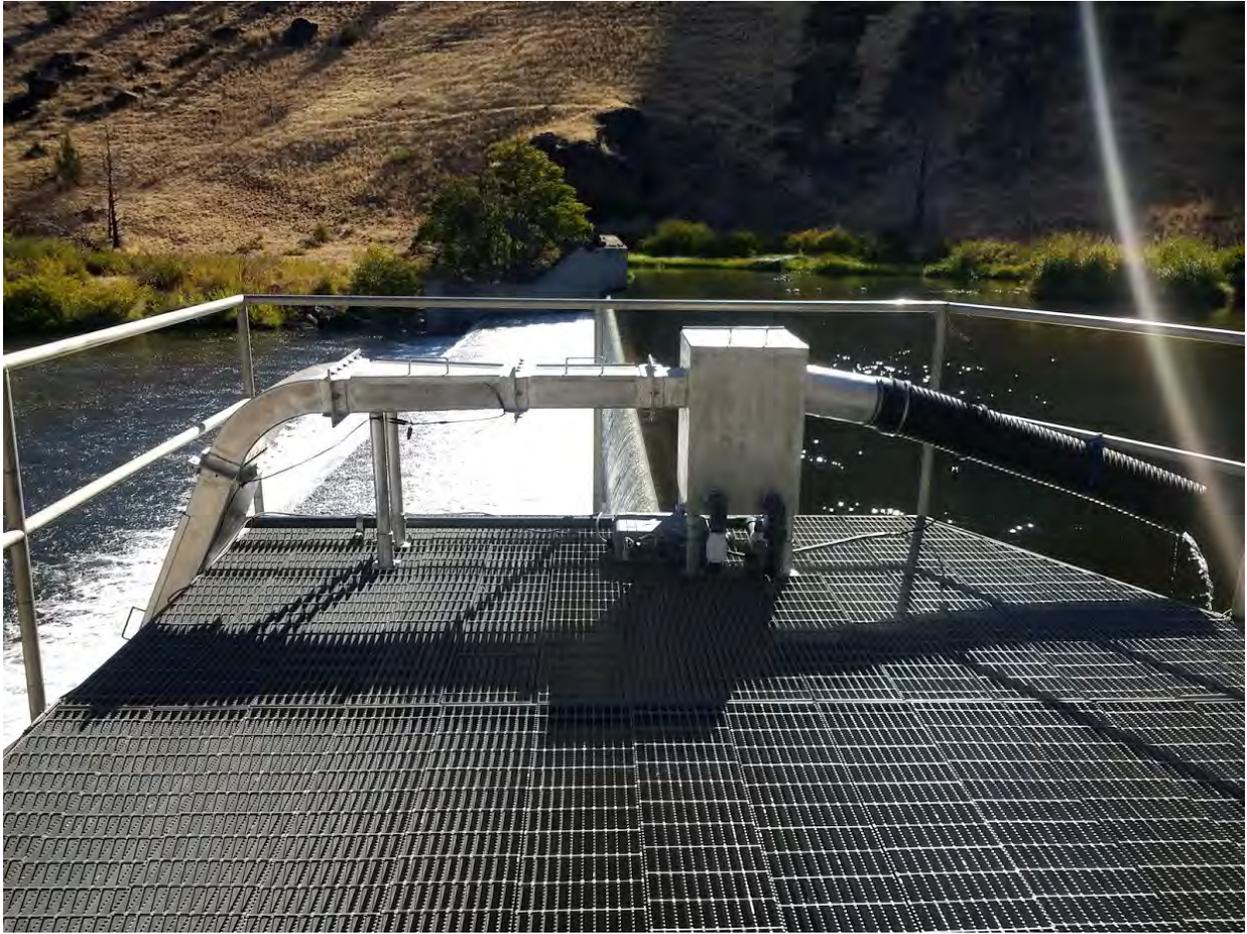
Figure 3. View of Warm Springs NFH ladder viewing platform and the top section of the LPS.

To detect lamprey successfully using the LPS, a circular antenna was installed around the 8" diameter corrugated plastic exit tube of the LPS (Figure 3) on June 7 2018. Two additional PIT antennas located in the WSNFH adult return fish ladder are able to detect lamprey moving through the fish ladder instead of using the LPS. All three antennas are connected to a Biomark Multiplexing Transceiver System (IS1001-MTS) switching between half and full duplex every 0.18 seconds. Data files are created daily and uploaded to PITAGIS.org.

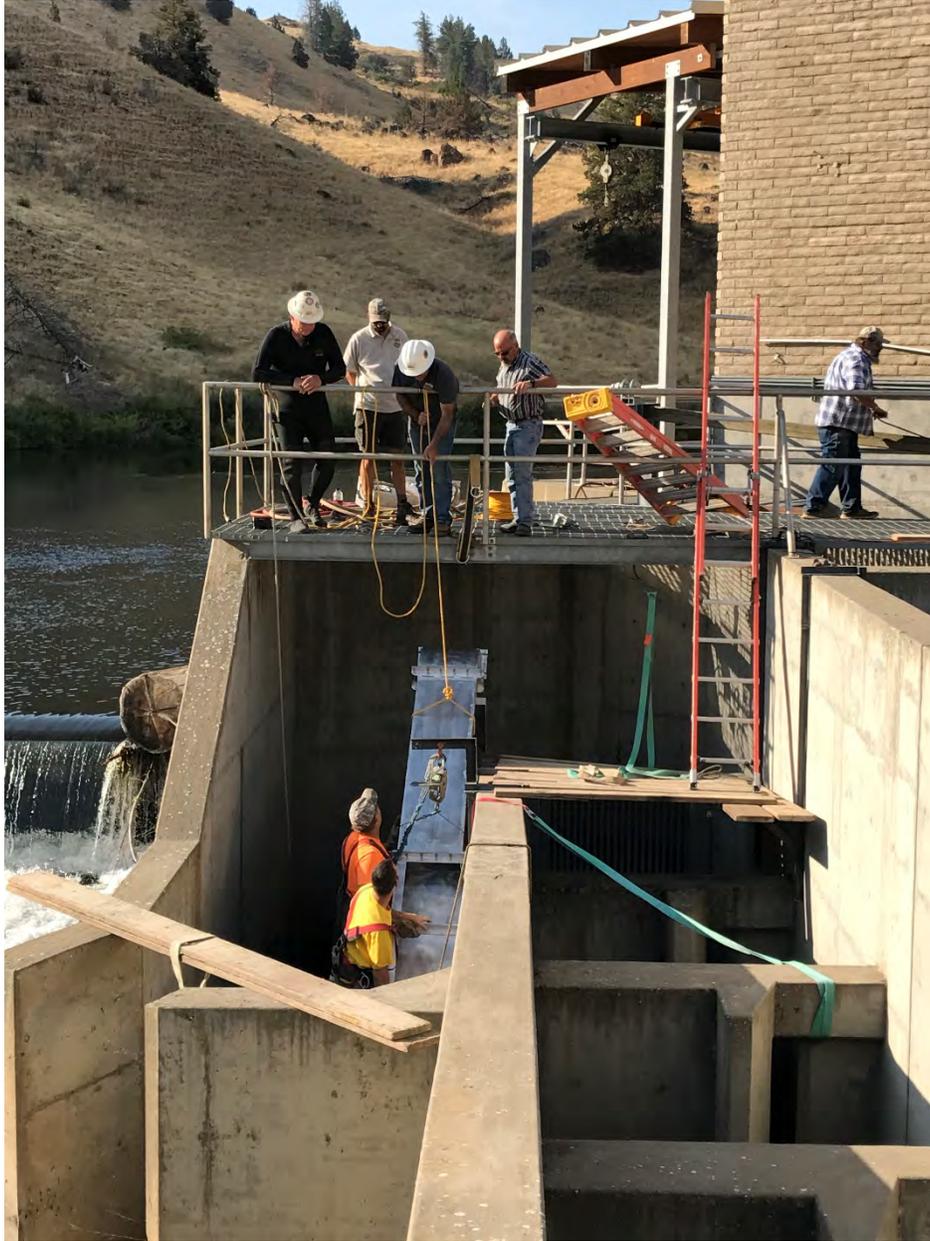
Figure a

Figure a. Installation was ordered from the in-water portion of the LPS (the lower half) to the upper half. This section was bolted to the fishway by an underwater diver.

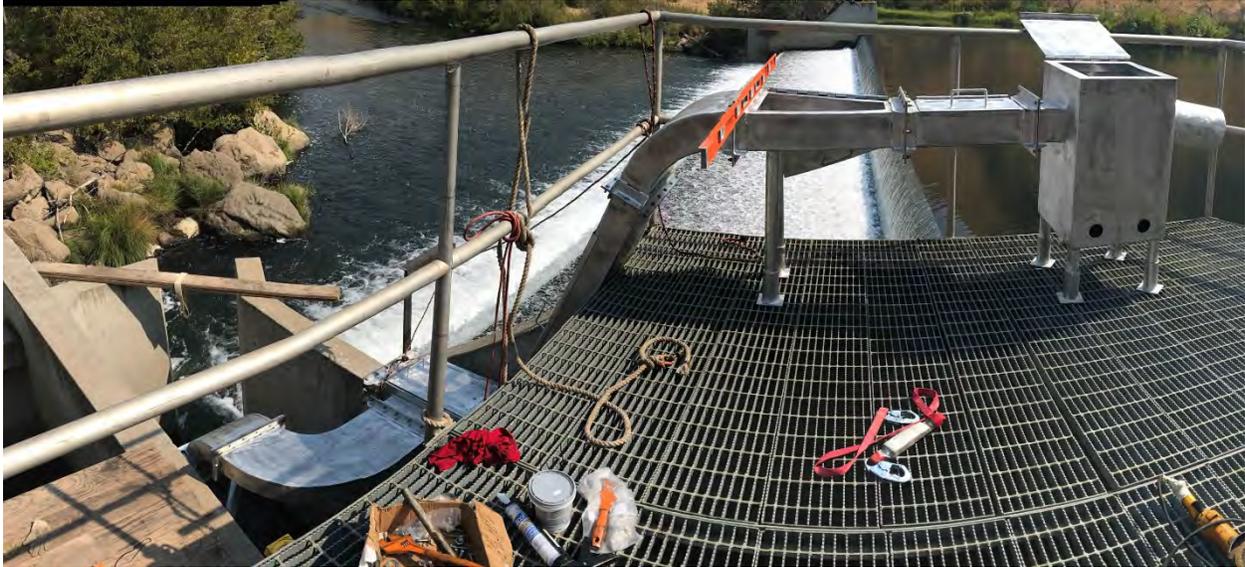
Figure b. This is the middle and upper parts of the LPS. The final section (far right) is an up-welling box that feeds water down the LPS towards both the downstream and upstream.

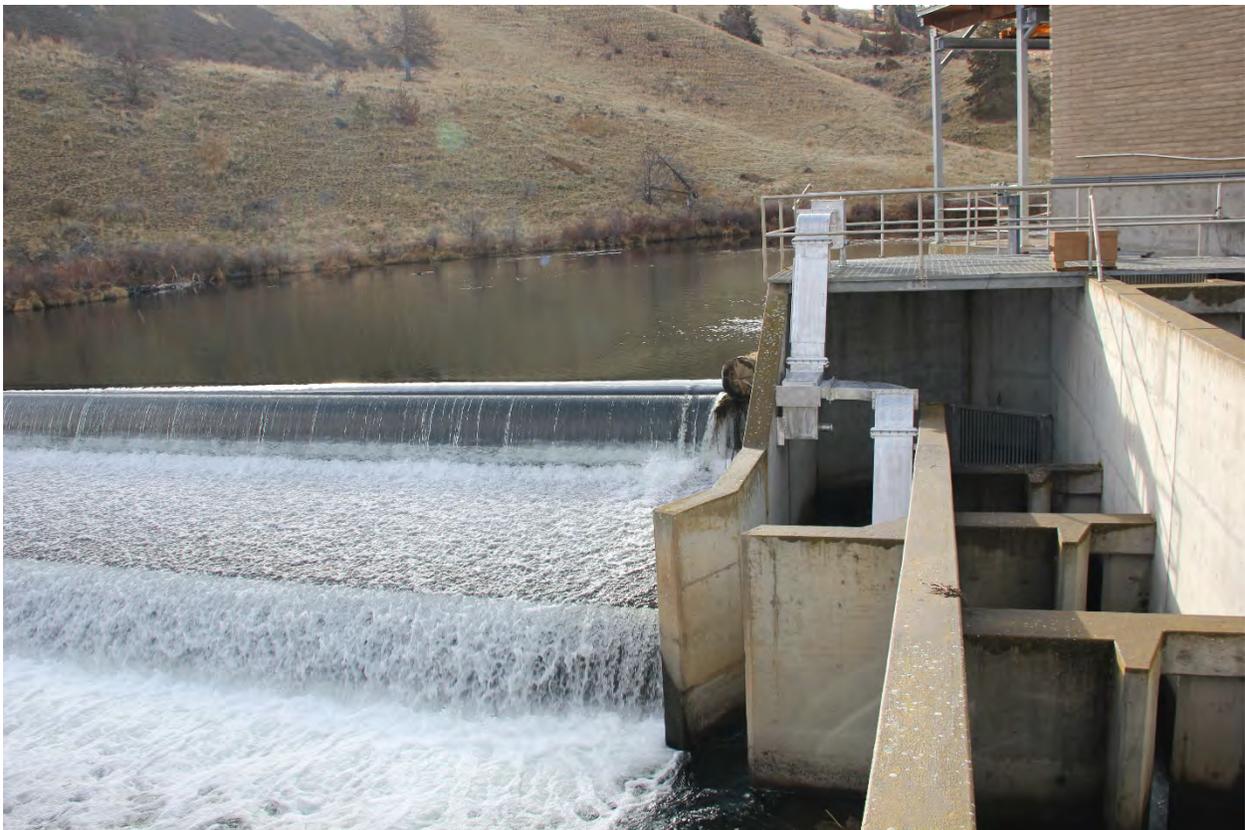
Figure c. The LPS installation was completed in September 2017. The plumbing for the LPS was completed April 2018 and marked the beginning of the operation of the LPS.
