**U.S. Fish and Wildlife Service
Columbia River Fisheries Program Office**

**2011 Reconnaissance Level Assessment of Fish Ladders
at The Dalles, John Day and McNary Dams for
Upstream Passage of Adult Pacific Lamprey**

FY 2011 Annual Report

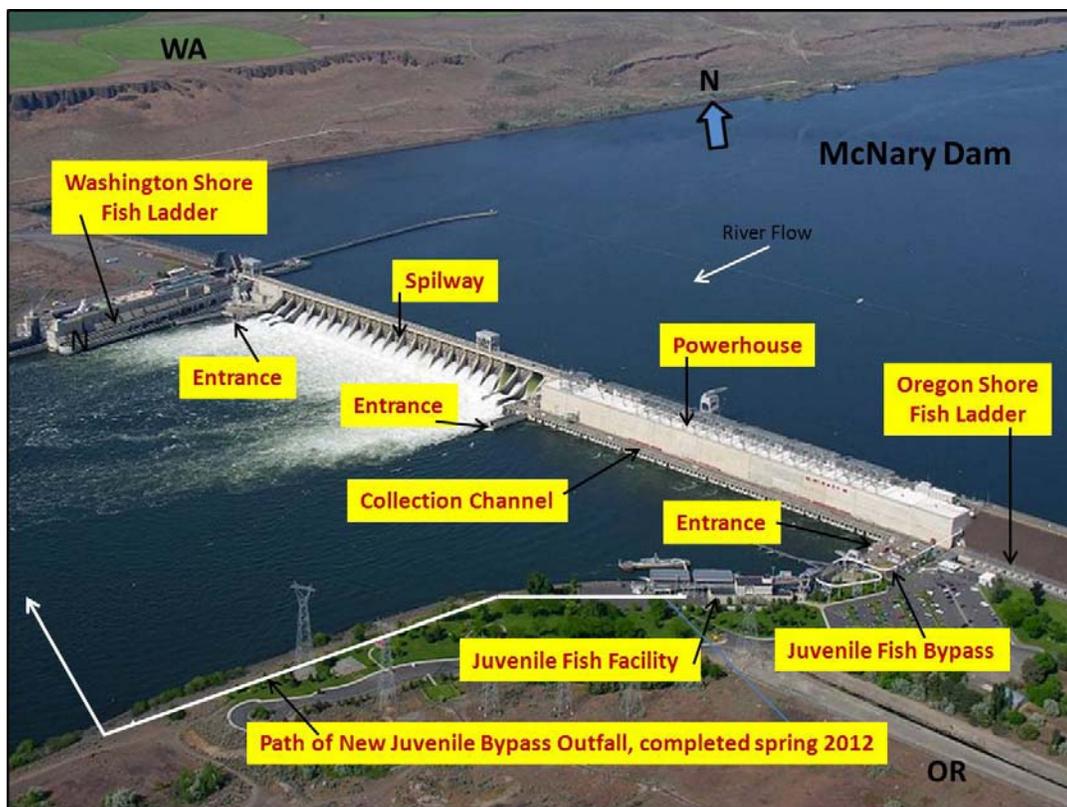
McNary Dam has three entrances that lead to a powerhouse collection channel and two adult ladders, (Figure 5). More detailed information can be found in Appendix C; Table C-1 and Figure C-1.

Figure 5. Overview of McNary Dam and fishways. Image by USACE.

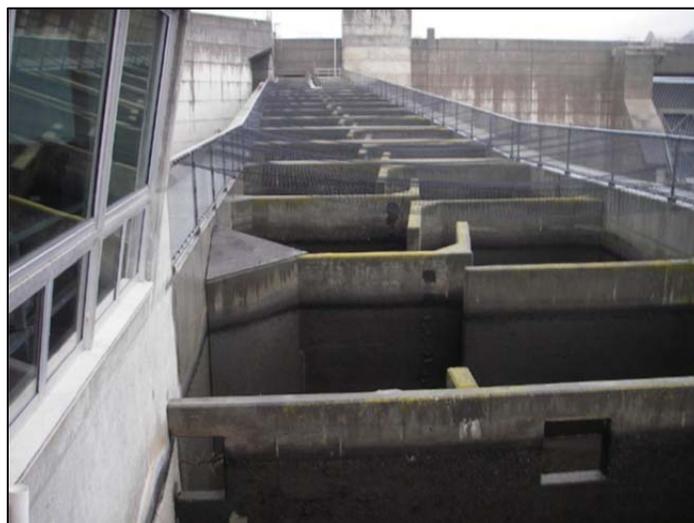
Figure 6. John Day North fish ladder exit section, before reconstruction. Image by USACE.

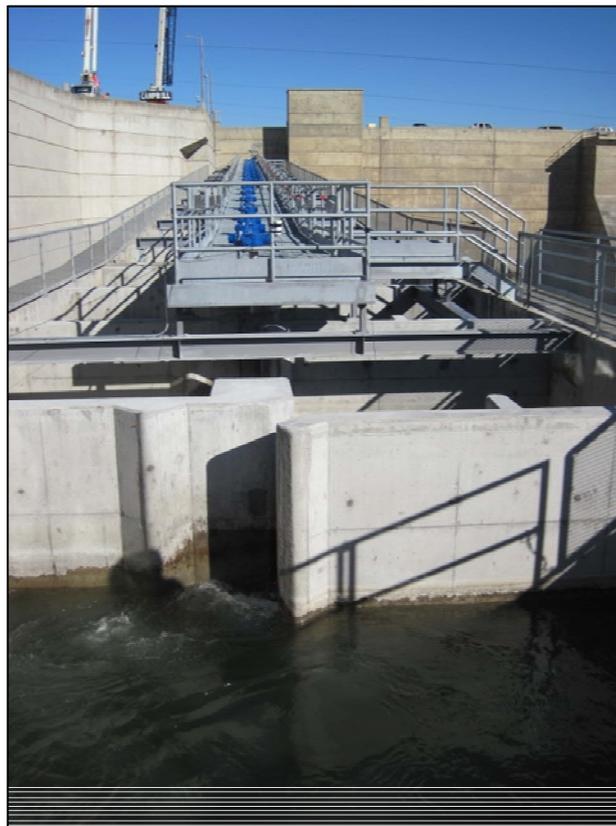
Figure 8. John Day North fish ladder post construction, new flow control vertical slot weirs. Image by USFWS.

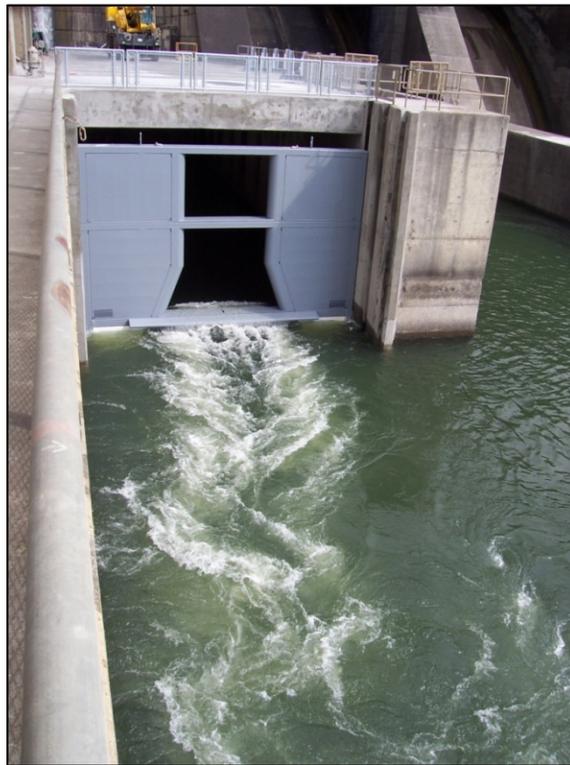
Figure 9. Keyhole fish ladder entrance weir at the John Day North Fish ladder, installed winter 2011-12. Image by USACE.

- Install modified keyhole entrance and velocity reducing structures on the ladder floor (Figures 9 and 10).
- Install LPS inside entrance.
- Smooth and round corners wherever possible.
- Provide safe resting areas in relatively quiet areas.
- Replace existing diffuser gratings with $\frac{3}{4}$ -inch lamprey criteria grating.
- Install lamprey diffuser plating at collection channel and lower ladder diffusers.

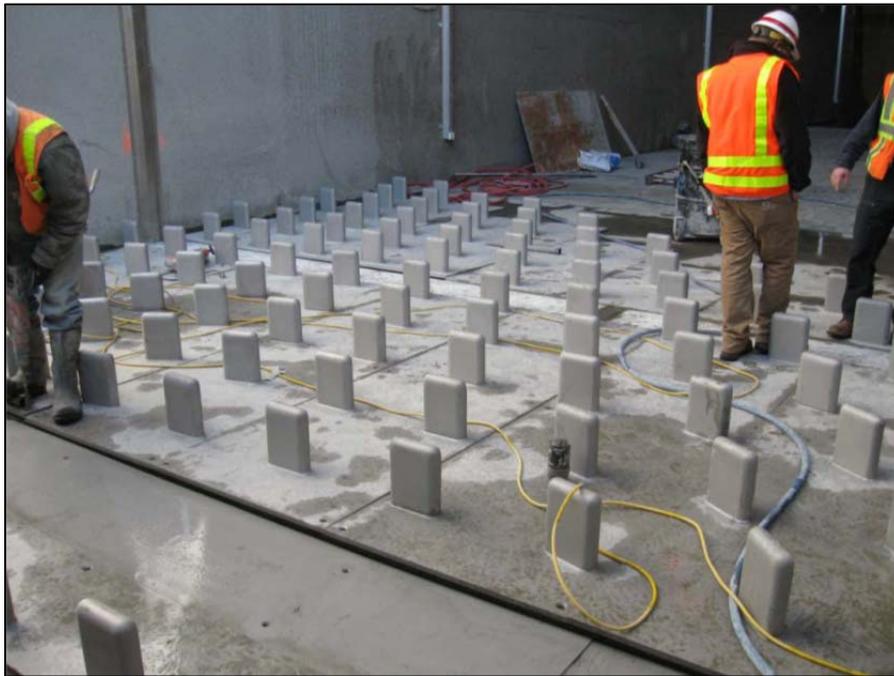
Figure 10. Bollard array installation at the floor of the entrance area of the John Day North Fish Ladder (March 2012). From USACE (2012d).

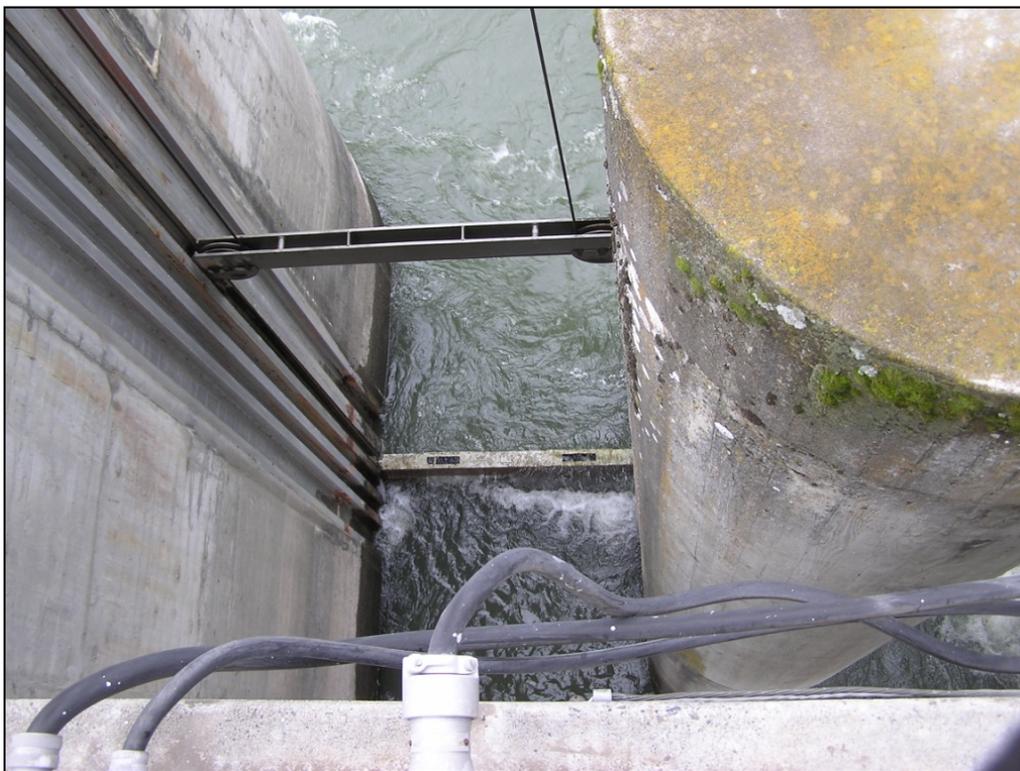
Entrance weir guides (Figure 12) have worn seals.

Figure 12. The Dalles East Fish Ladder weir entrance. Image by D. Benner.

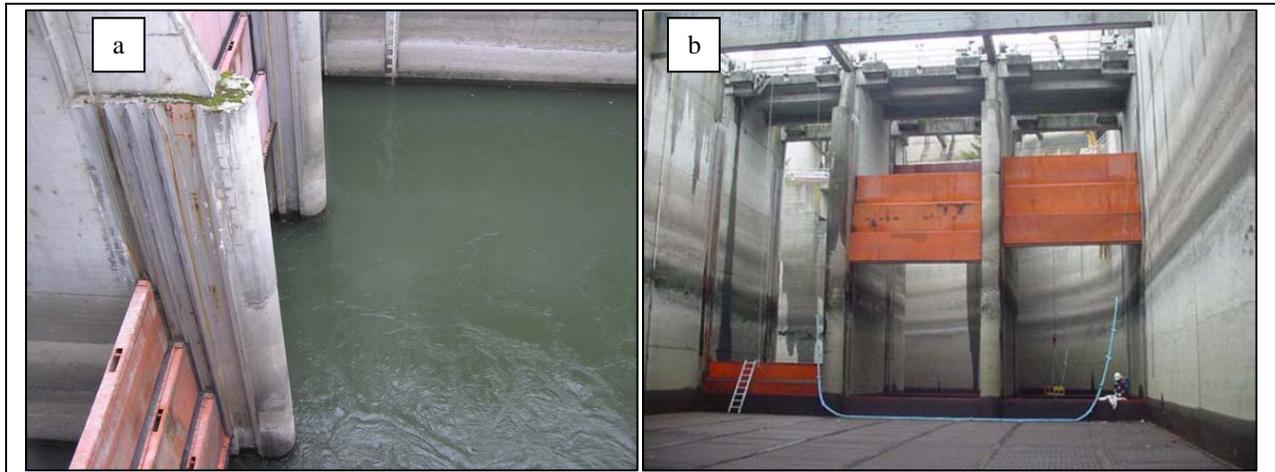
Figure 13. The Dalles East fish ladder junction pool. a. Watered up. b. Dewatered. Image a by D. Benner. Image b by USACE.

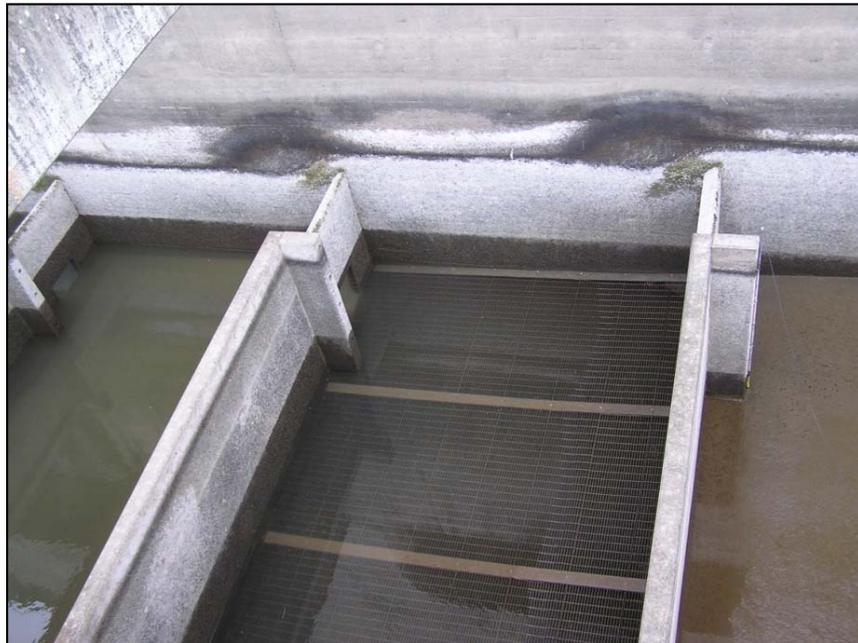
The lower ladder diffuser sections were visible (Figure 14). It was discussed that attaching plating along wall between weirs in connection with plating in front of orifice would give lamprey a good attachment surface between weirs and wouldn't be a drastic reduction in the total diffuser opening area.

Figure 14. The Dalles East fish ladder lower diffuser section. Water flow moves right to left. Image by D. Benner.

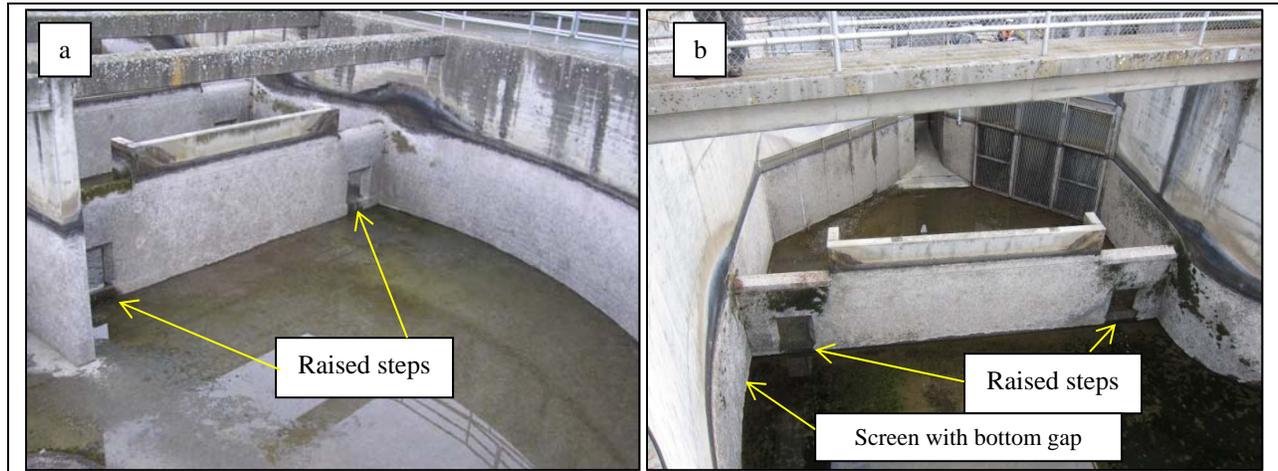
The bottom orifices at both turning pools in the East ladder (Figure 15) are stepped up above the floor of the ladder and present a 90° bend for lamprey to navigate.

Figure 15. The Dalles East fish ladder. a. Turning pool 1, looking upstream. b. End of turning pool 2, the count station is above the weir. Image a by D. Benner. Image b by G. Fredricks.

Based on these observations above ramps were installed at orifices in both turning pools (Figure 16) in January 2012 during the winter work period.

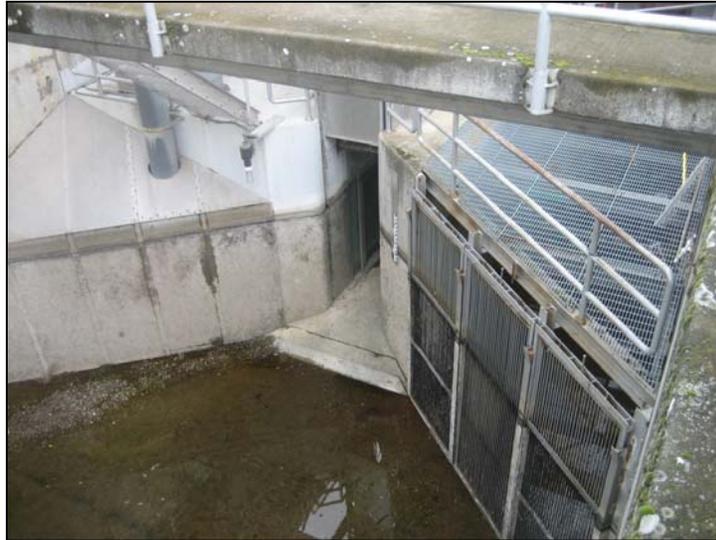
The ladder count station (Figure 17) has a mechanical crowder that can narrow the gap to about 18 inches if visibility becomes difficult for the observer/fish counter. The maximum width is not specified in the Fish Passage Plan (USACE 2012b).

Figure 17. The Dalles East fish ladder count station.

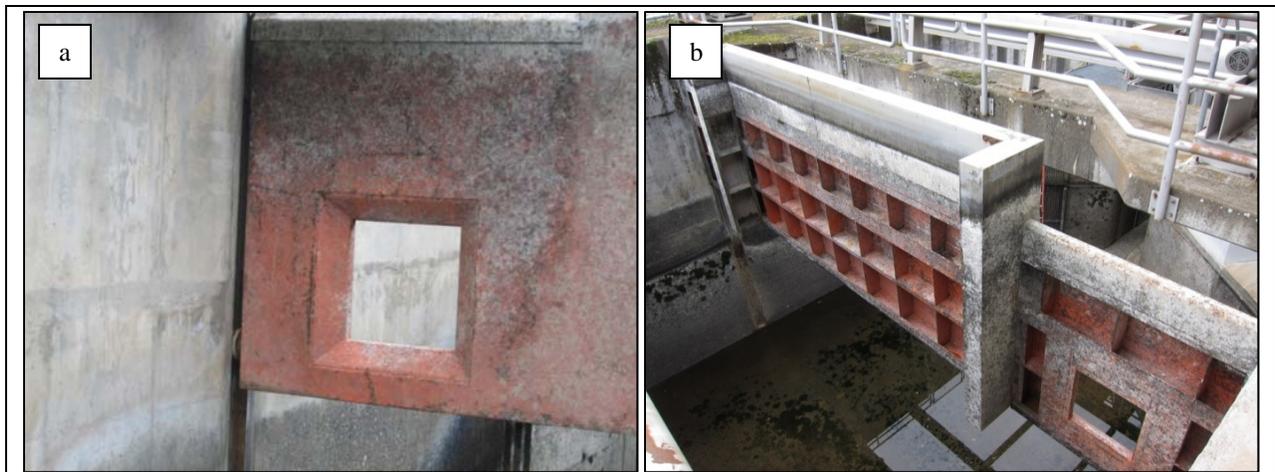
Above the count window are four removable flow control weirs with orifices stepped above the floor (Figure 18).

Figure 18. The Dalles East fish ladder. Removable flow control weir with orifice located upstream of the count window. a. Downstream face. b. Upstream face. Image a by D. Benner. Image b by G. Fredricks.

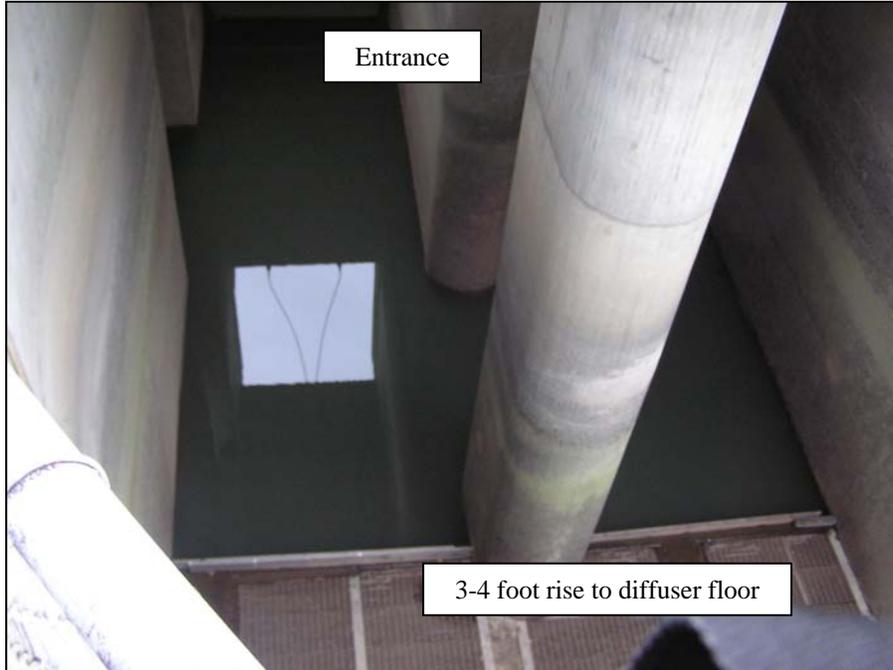
The floor of the fishway entrance rises straight up approximately three to four feet as it meets the diffuser floor. This is about a 40 foot distance (Figure 19).

Figure 19. The Dalles North fish ladder entrance. Image by D. Benner.

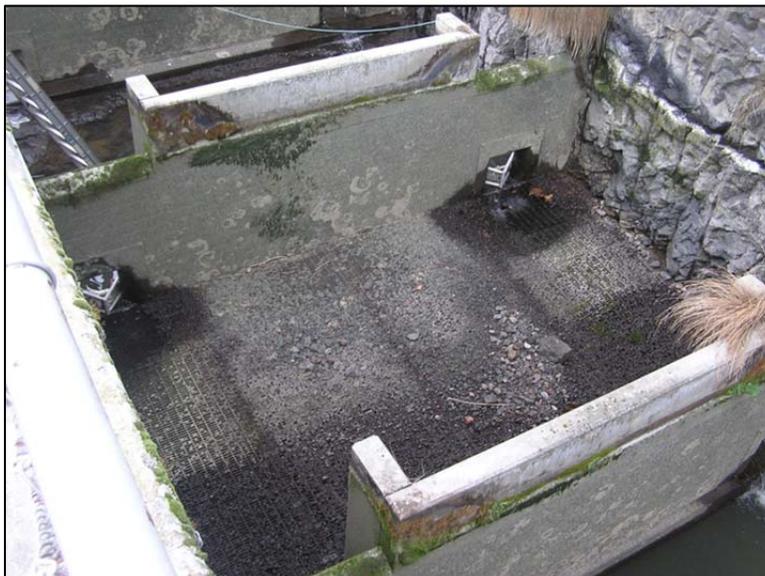
Many of the diffusers in between weirs that are no longer used are nearly filled in with rock from the channel (Figure 21).

Figure 21. Unused diffuser section in The Dalles north ladder filled in with rock. Image by D. Benner.

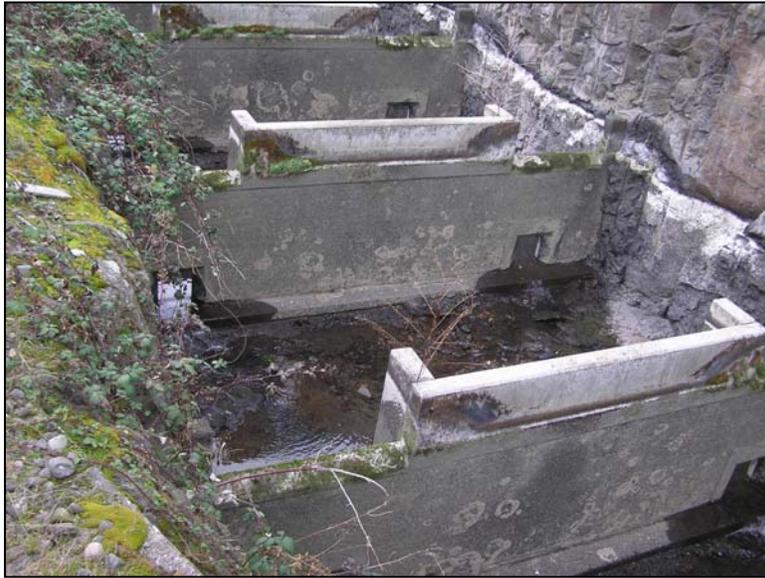
Figure 22. The Dalles North ladder, mid-ladder section. Submerged orifices are raised above the natural rock floor. Image by D. Benner.

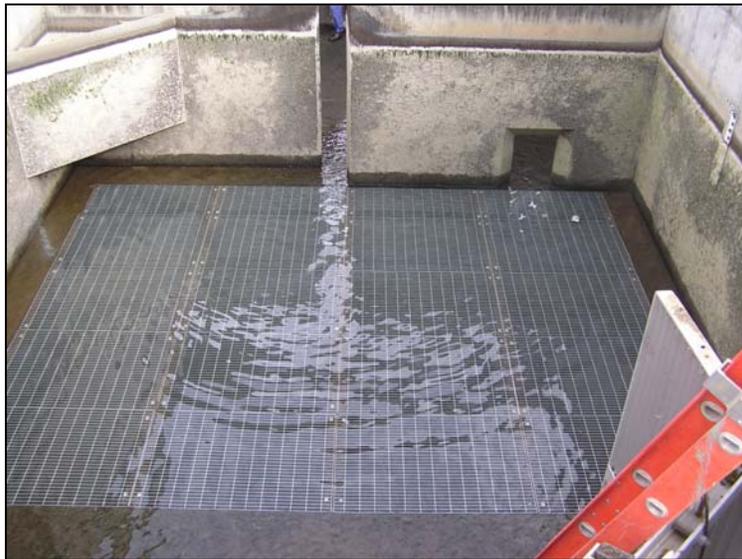
At the new diffuser gratings just upstream of the count station (Figure 23) several of the new clips used to anchor this diffuser grating were found to have already been failing during the inspection.

Figure 23. The Dalles Dam North ladder diffuser section above the count station.

OB, C- All anchors were to be checked and replaced if necessary. (ST)

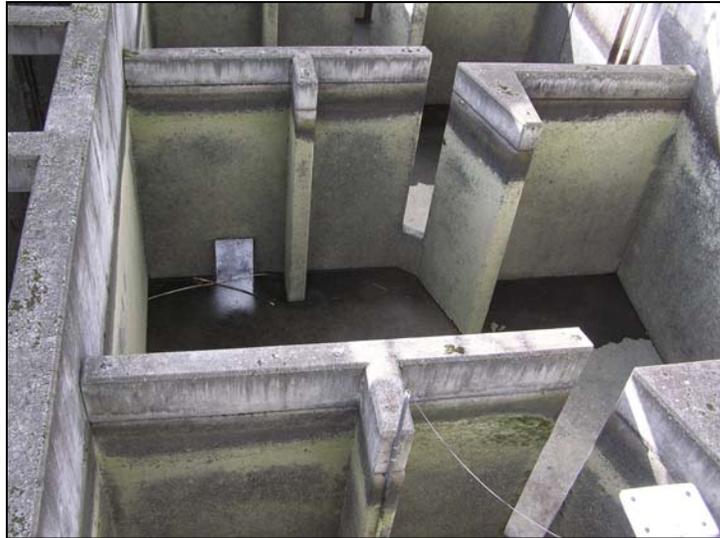
The flow control section upstream of the count station has slotted weirs, some flush with floor and others raised, and one submerged orifice flush with the ladder floor (Figure 24).

Figure 24. The Dalles Dam North ladder vertical slot flow control section above the count station. Image by D. Benner.

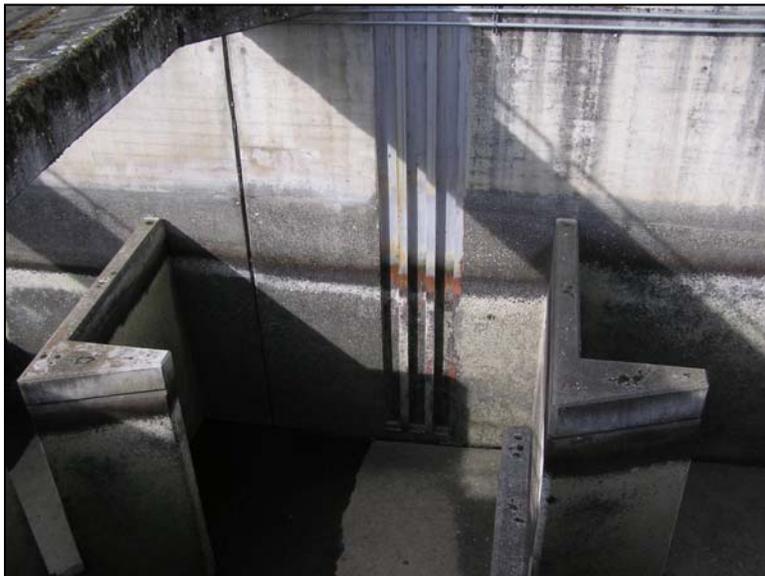
The vertical slotted weir section has old bulkhead slots (Figure 25) that are no longer in use (note electrical conduit installed across the slots).

Figure 25. The Dalles Dam North ladder vertical slot section with old bulkhead slots. Image by D. Benner.

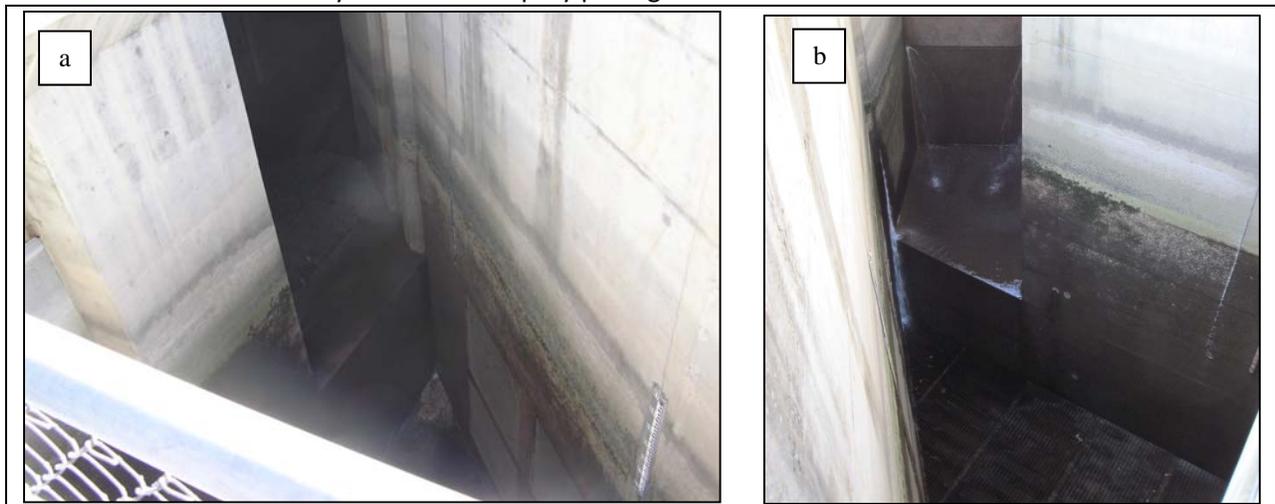
Between the entrance and the collection channel at John Day South Ladder there is a triangle shaped depression that goes about four feet deep down to diffusers (Figure 26). Thee diffusers in this triangle area are not used, so this depression could be filled in with concrete making it the same elevation as the entrance floor and collection channel floor or the diffuser gratings just covered completely. The inspection group was told there is not a great deal of delay in this area so simply the addition of bollards on the concrete lip to the collection channel or reducing nighttime entrance head differentials may be the most cost effective way to benefit lamprey passage.

Figure 26. John Day South ladder, junction between the entrance and the collection channel. Image a. by D. Benner. Image b. by USFWS.

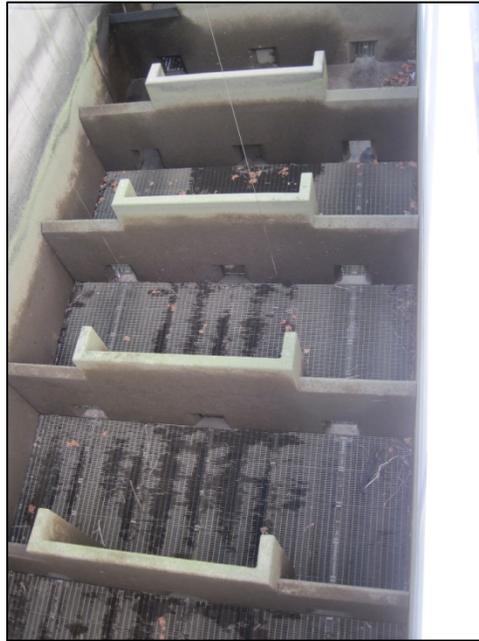
Figure 27. John Day South ladder, lower diffuser sections.

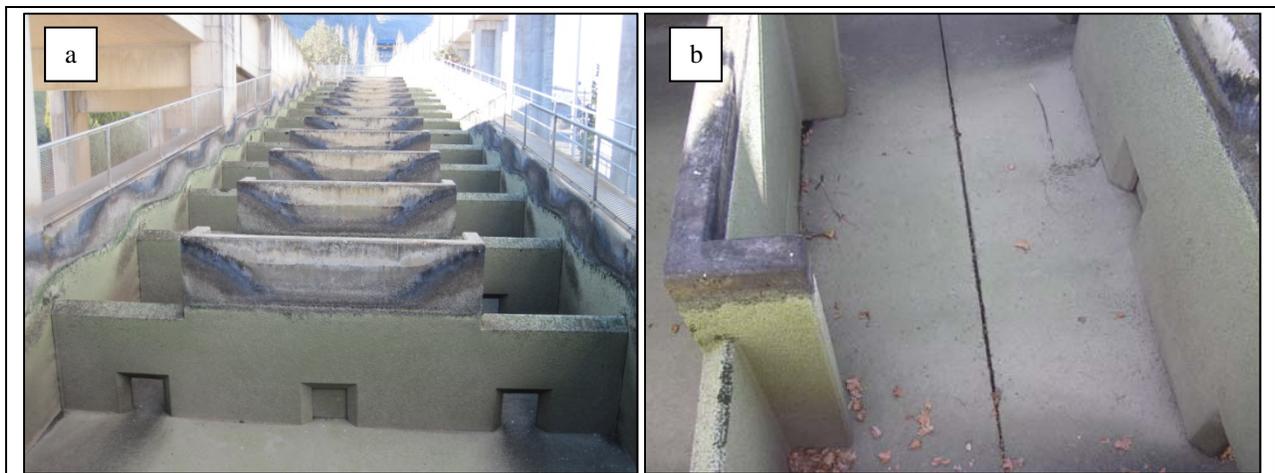
Above the lower diffuser section of the ladder overflow weirs with bottom orifices flush with the floor extend all the way up the count station and continue to the upper flow control weirs (Figure 28xa). Several expansion joints exist along the ladder (Figure 28b).

Figure 28. John Day South ladder. a. Overflow weirs with bottom orifices. a. Expansion joints in the ladder.

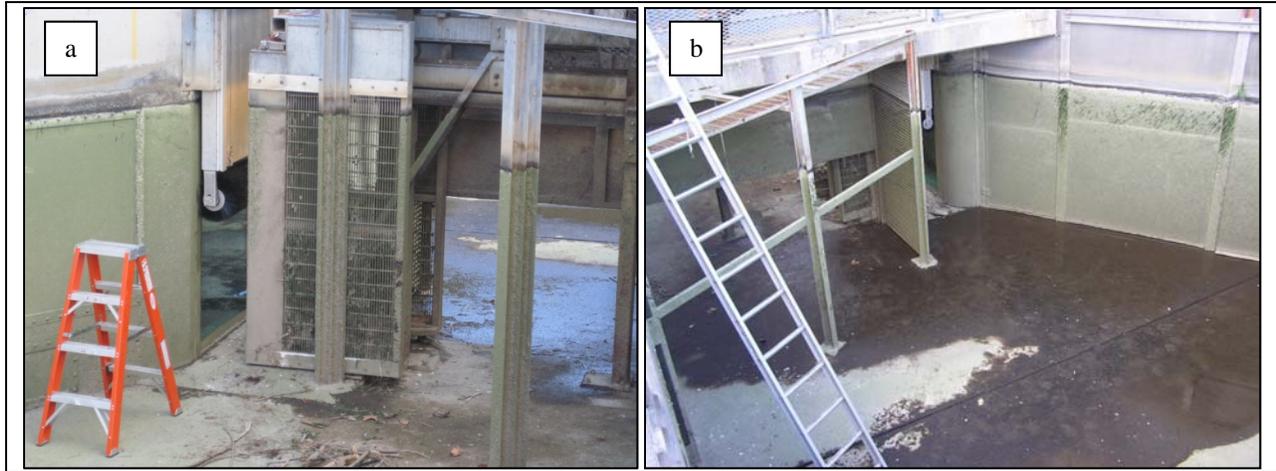
The floor of the count station slot and window (Figure 29) is flush with the floor of the ladder with no recesses for lamprey to hide in.

Figure 29. John Day South ladder count station, screens are removed. a. Entrance to slot. b. Exit from slot. Image a by USFWS. Image b by D. Benner.

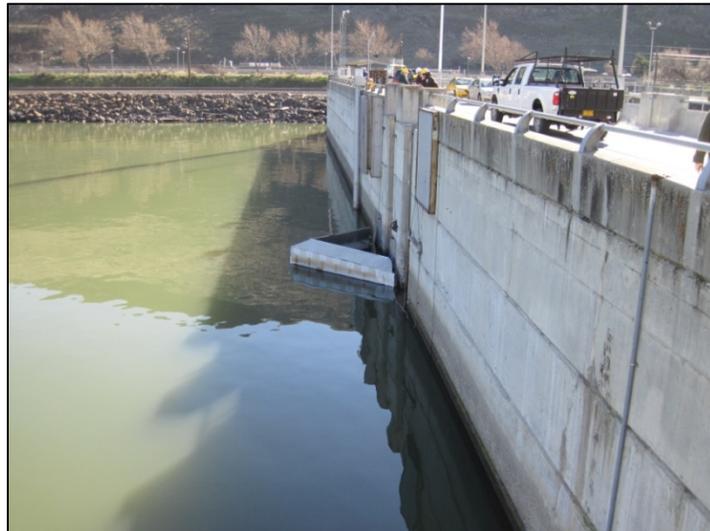
Figure 31. John Day South ladder exit to the forebay. Image by USFWS.

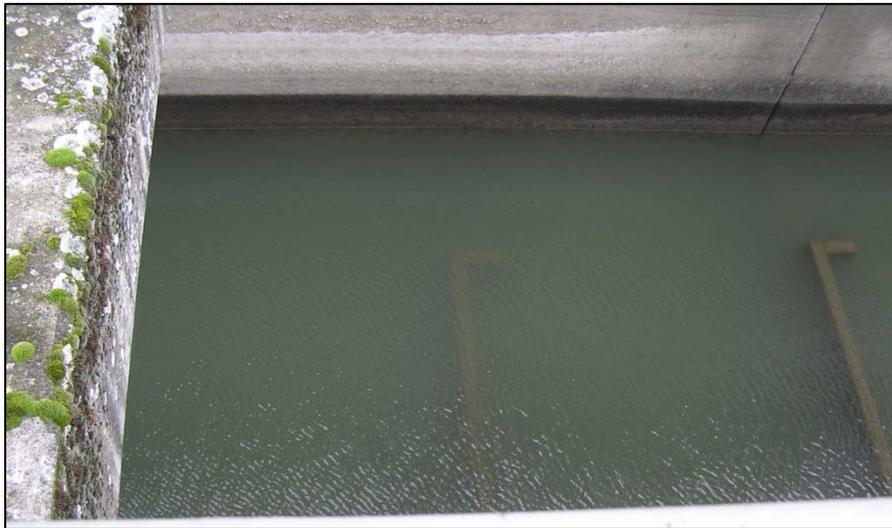
Figure 32. Lower McNary South fish ladder. Image by D. Benner.

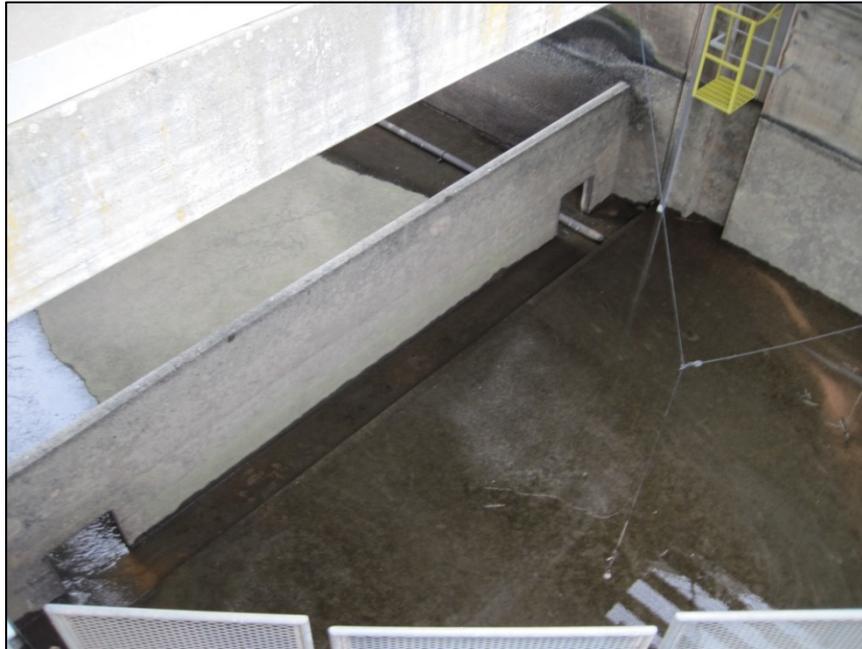
Figure 33. First weir below the McNary South ladder count station with 90° rise of floor directly upstream of the orifices. Image by USFWS.

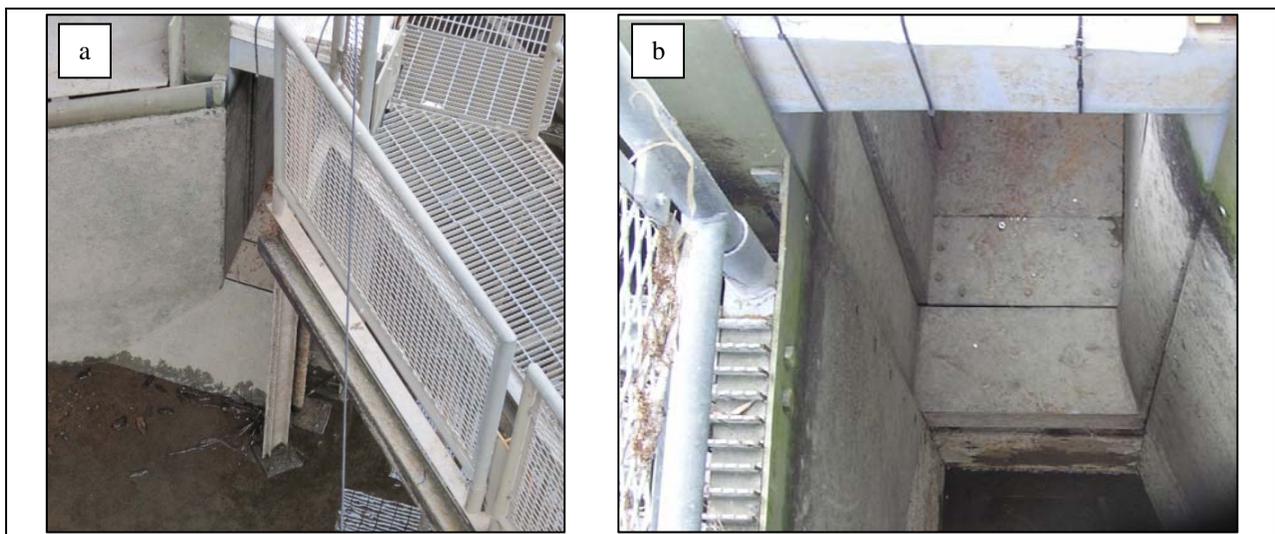
Figure 34. The McNary South ladder count station. a. Slot entrance. B. Slot exit. Image a. by USFWS. Image b. by D. Benner.

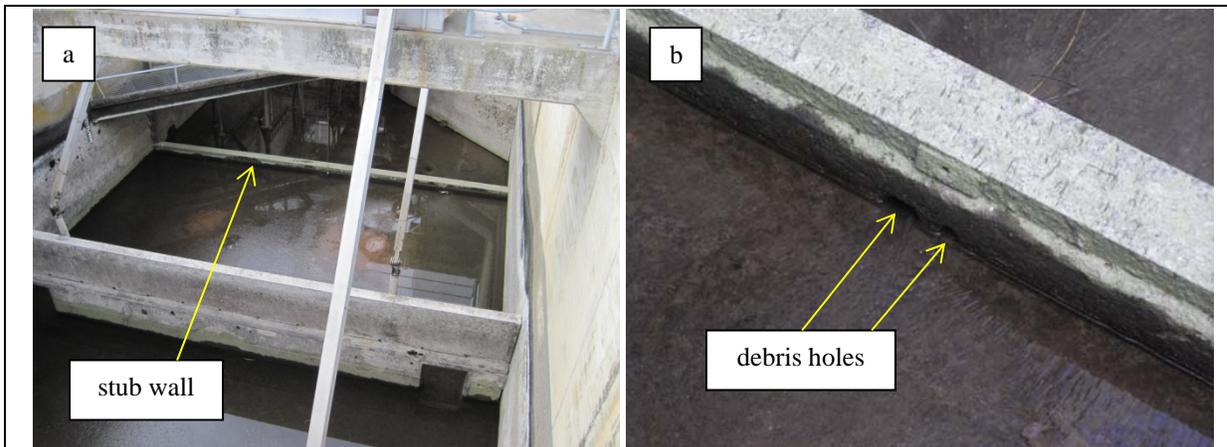
Figure 36. McNary South Ladder immediately upstream of count station. a. One foot high stub wall between count station and first tilting weir. b. Close up of small debris holes in stub wall. Image a. by USFWS. Image b. by D. Benner.

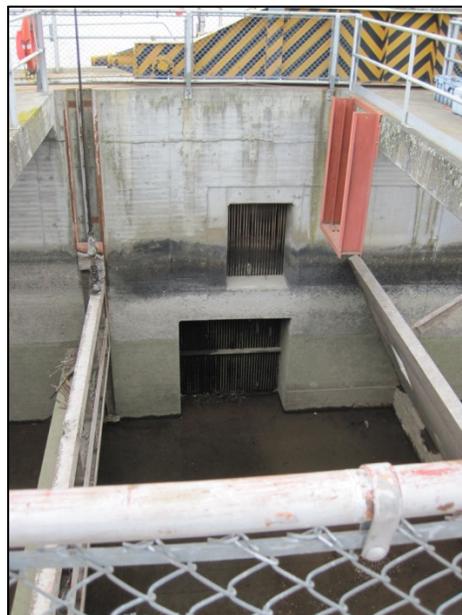
Figure 37. McNary South ladder tilting weir section, with auxiliary water trash racks. Image by USFWS.

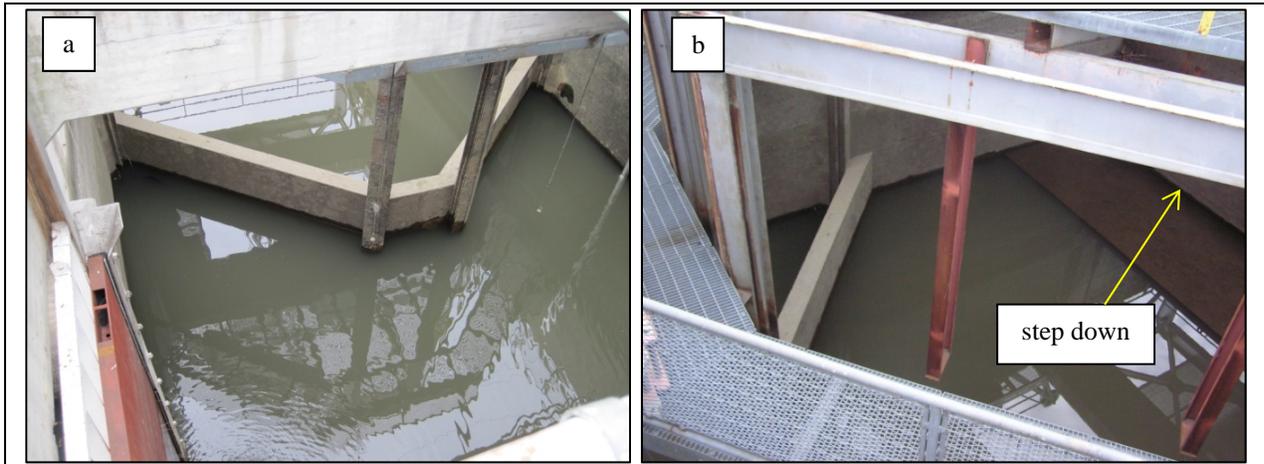
Figure 38. McNary South fish ladder exit section between the count station and the fishway exit. a. V-shaped stub wall that is approximately 2-3 feet high. b. 6 inch step down in floor elevation. Image a. by USFWS. Image b. by D. Benner.

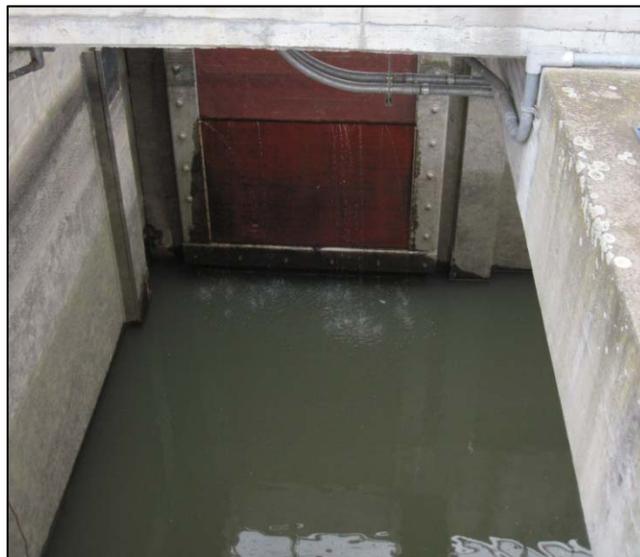
Figure 39. McNary South ladder exit gate. Image by USFWS.

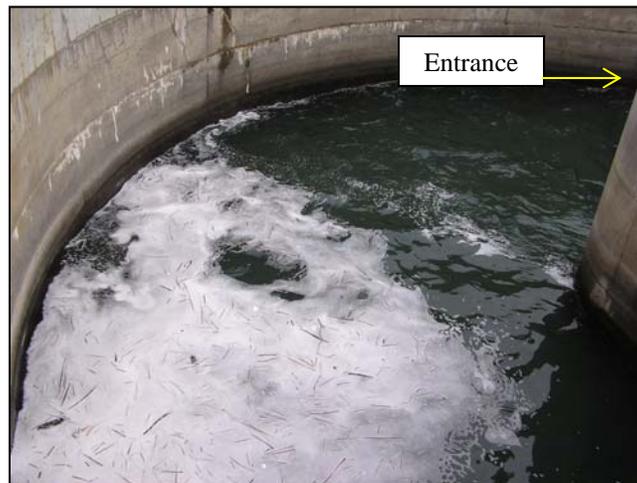
Figure 40. McNary Dam North ladder, turn at the bottom of the ladder just upstream of the entrances. Image by D. Benner.

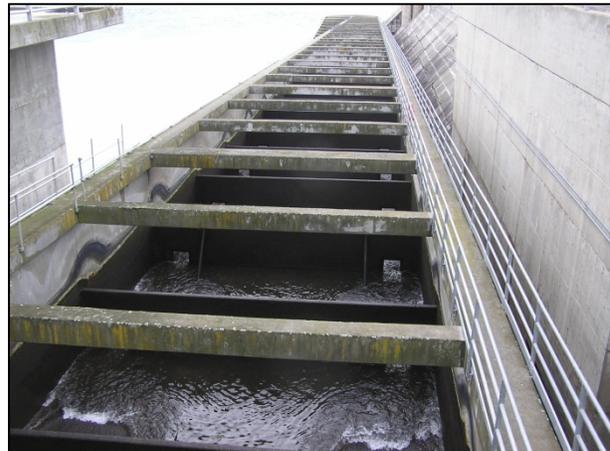
Figure 41. McNary Dam North ladder section 2, looking down the ladder. Image by D. Benner.

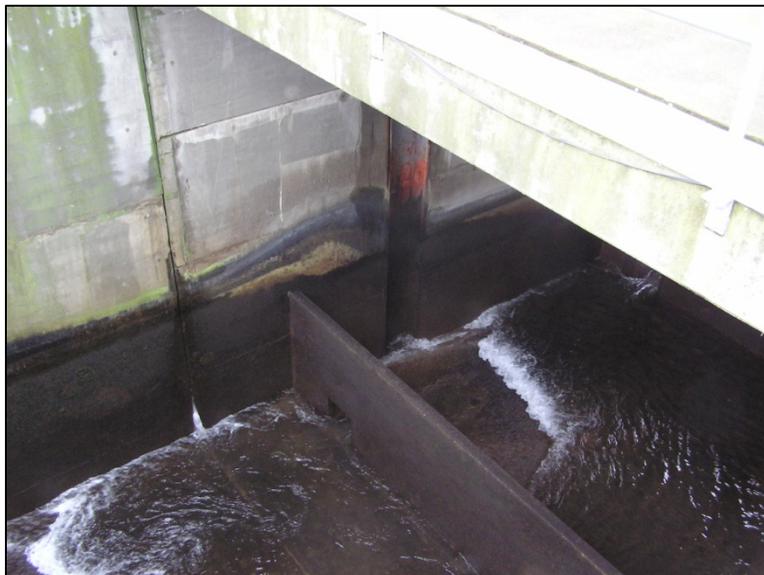
Figure 42. McNary North Ladder downstream of count station with old bulkhead slots in the wall. Image by D. Benner.

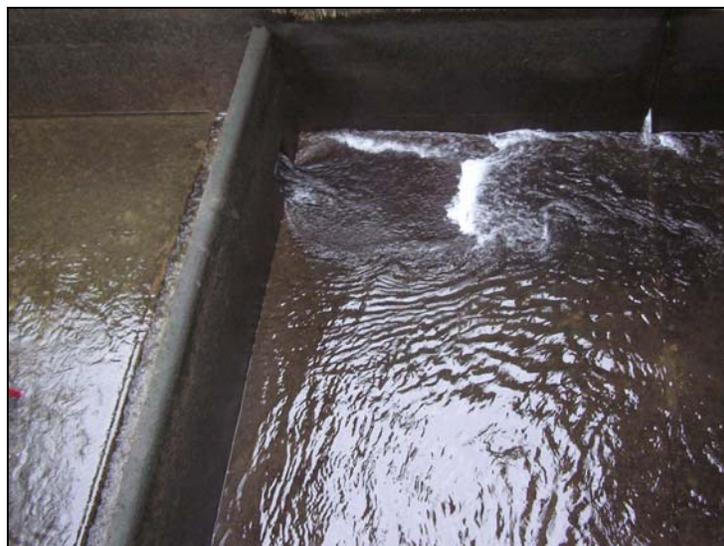
Figure 43. McNary North ladder immediately downstream of count station with elevated orifices on the downstream (right) side. Image by D. Benner.

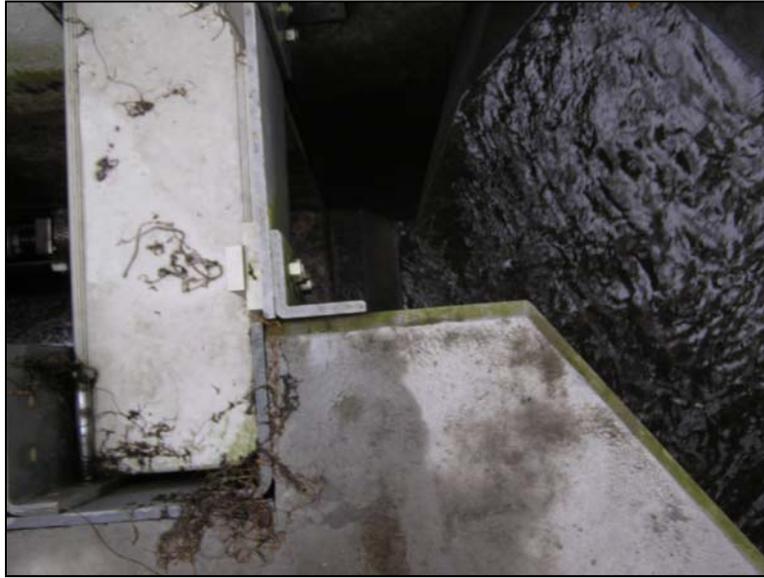
Figure 44. The McNary North ladder count station exit slot. Image by D. Benner.

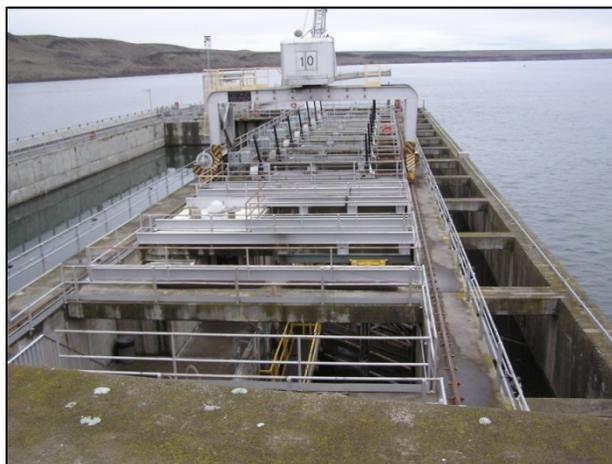
Figure 45. McNary Washington shore ladder tilting weir flow control and exit section. Image by D. Benner.

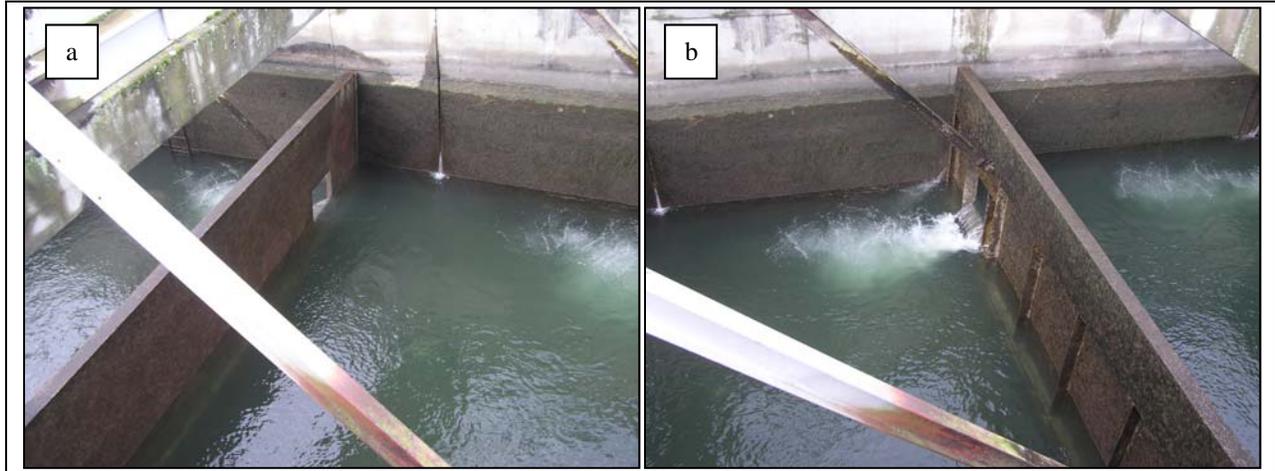
Figure 46. McNary North ladder tilting weirs. a. Downstream face of weir. b. Upstream face of weir. Images by D. Benner.
