Nine Mile Run Aquatic Ecosystem Restoration

From STINK CREEK
to
Beautiful VALLEY

NMR Sec 206 Aquatic

Ecosystem Restoration Project

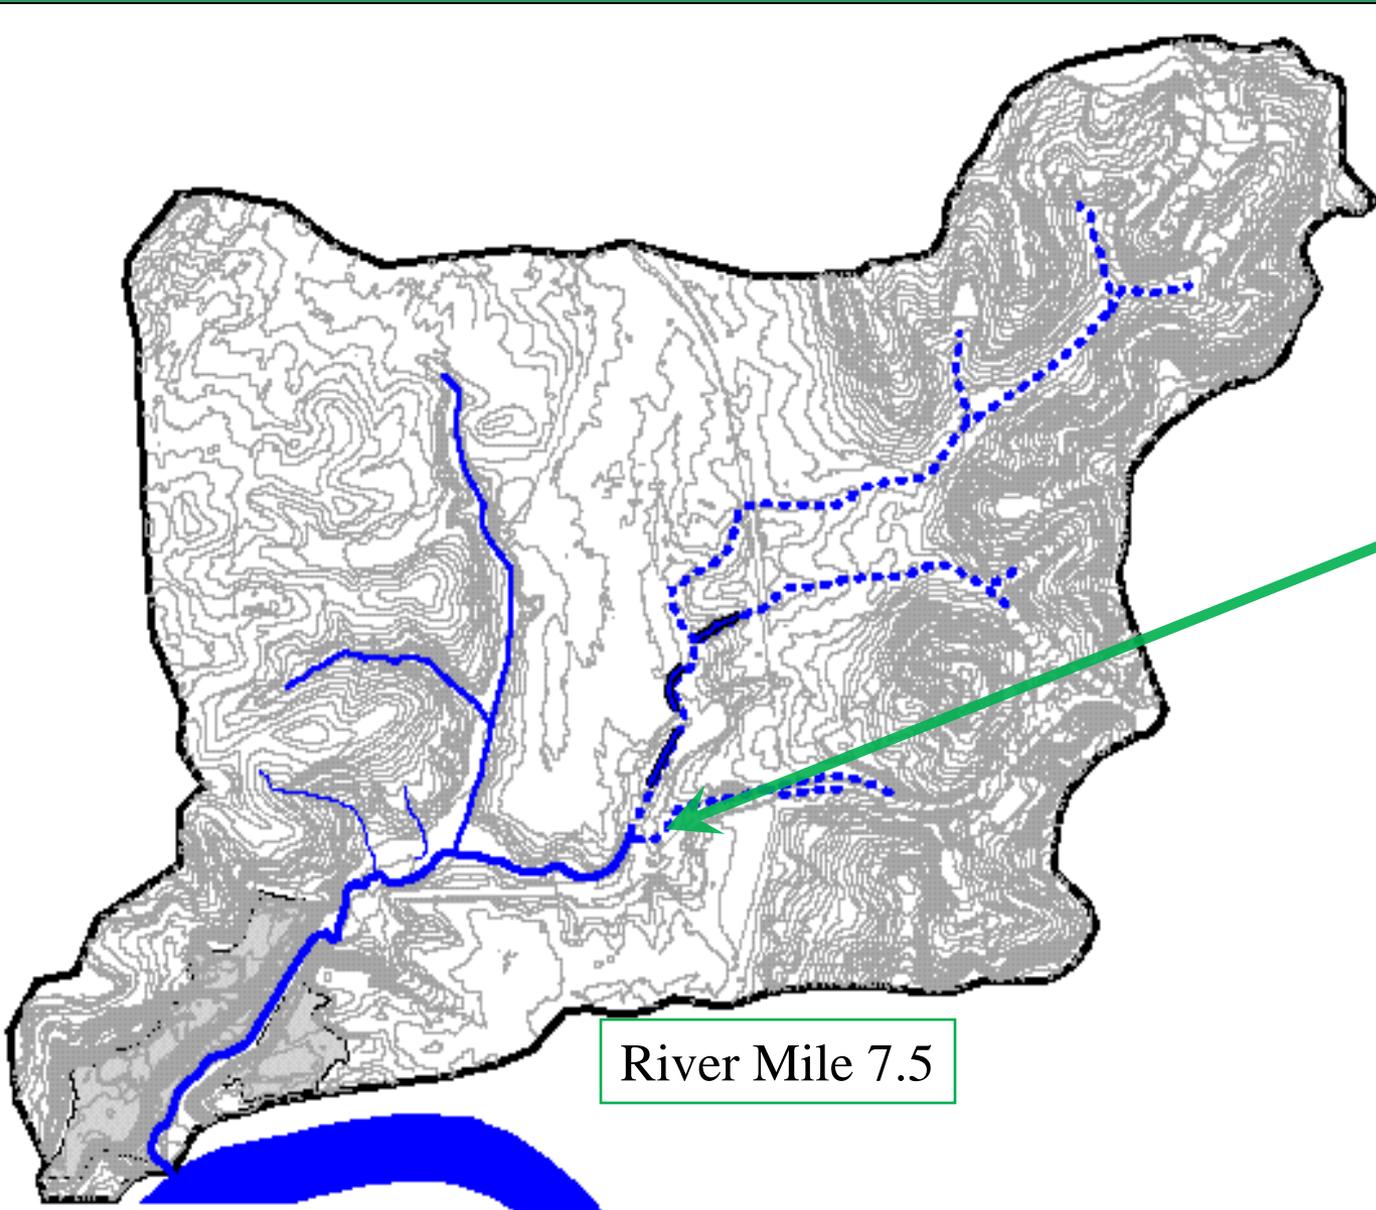
Nine Mile Run Culverted Stream and Tributaries

Nine Mile Run is an urban stream, 1.8 miles in length from Braddock Avenue Culvert to its mouth at the Monongahela River

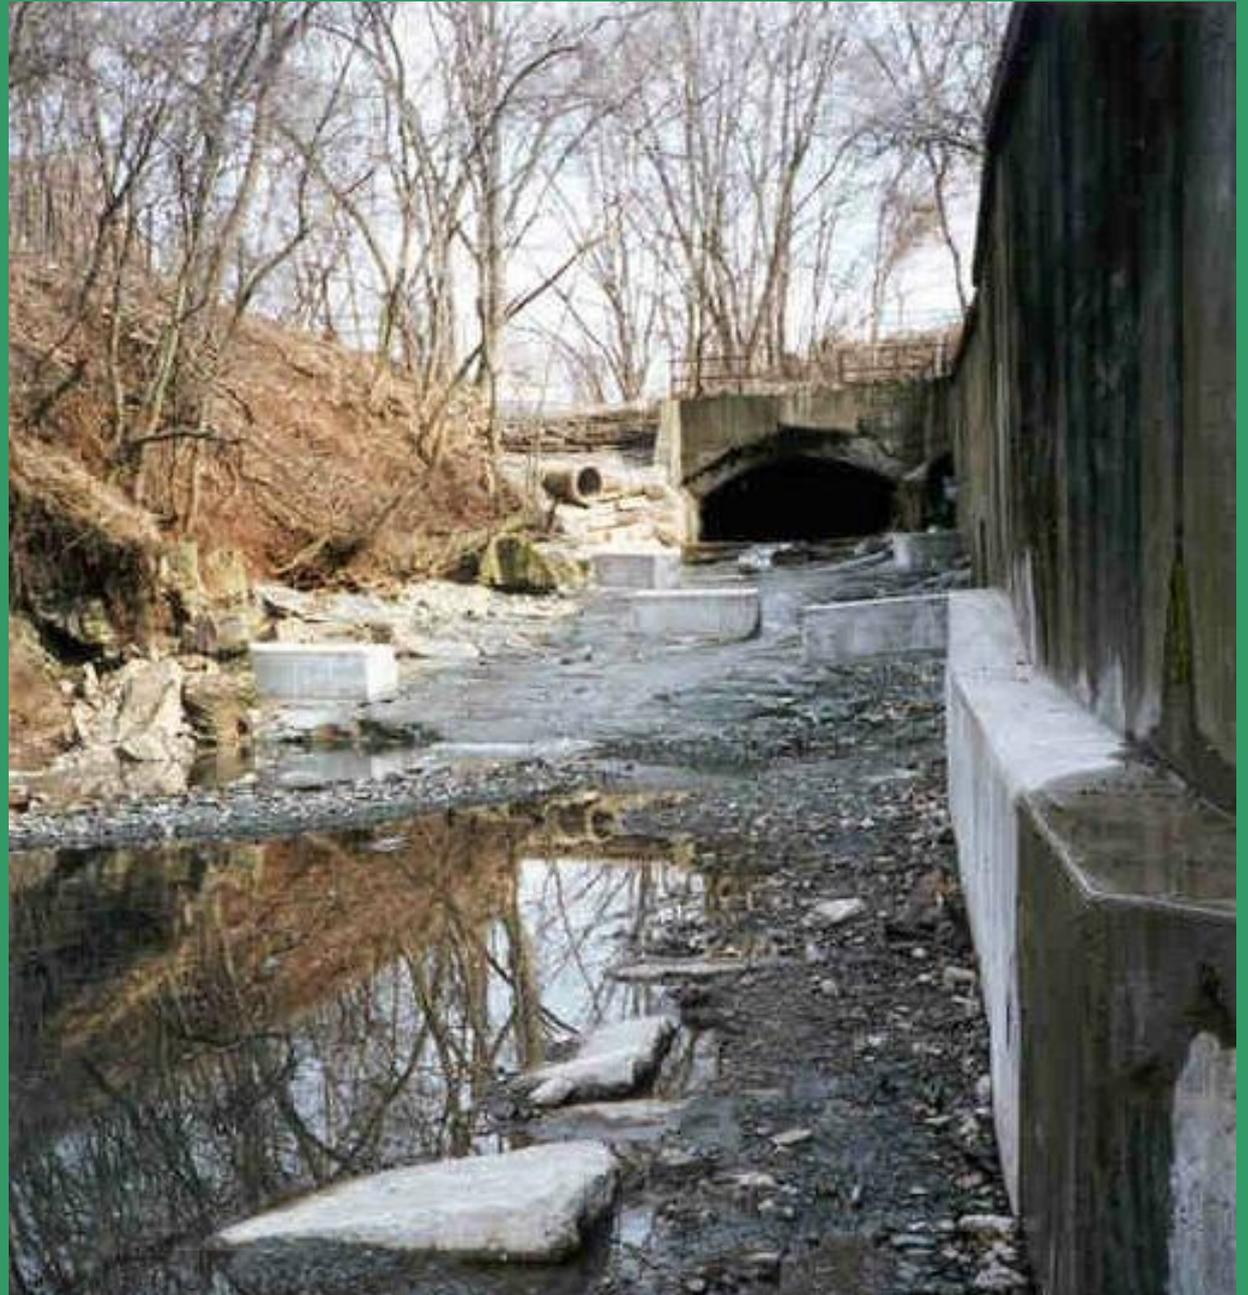
Braddock Avenue Culvert

Dry
weather

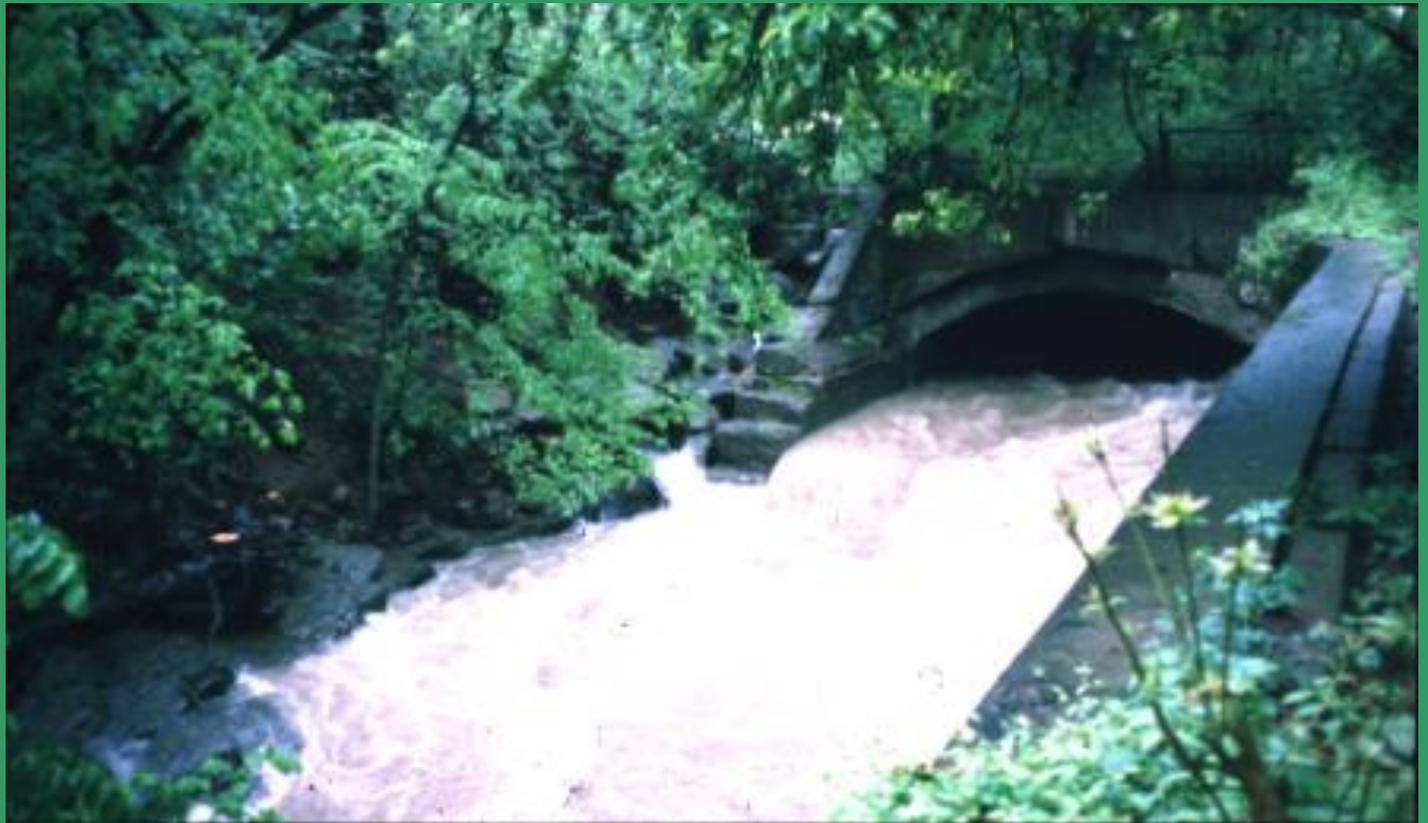
Braddock
Avenue
Culvert

Storm Water Discharges

Wet
Weather

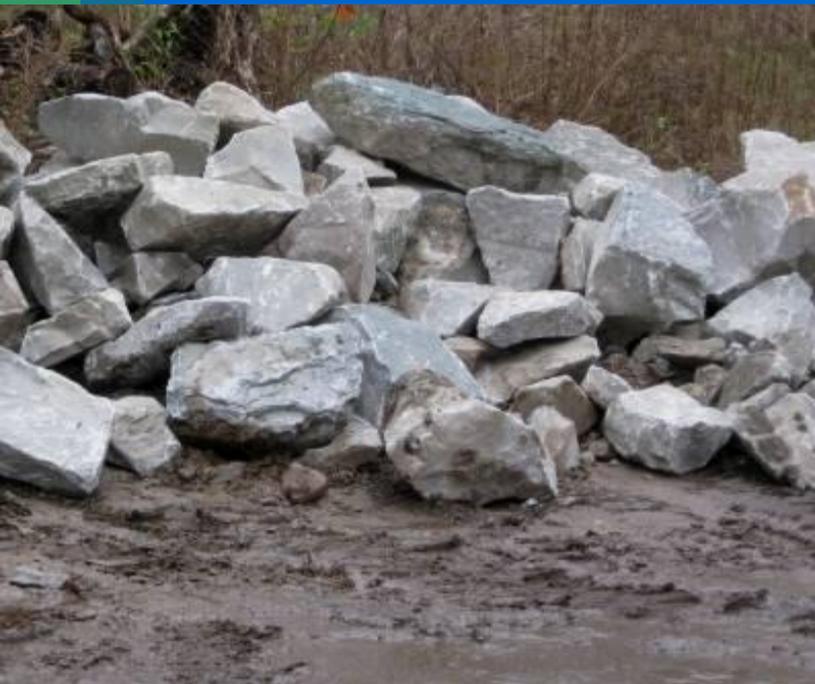
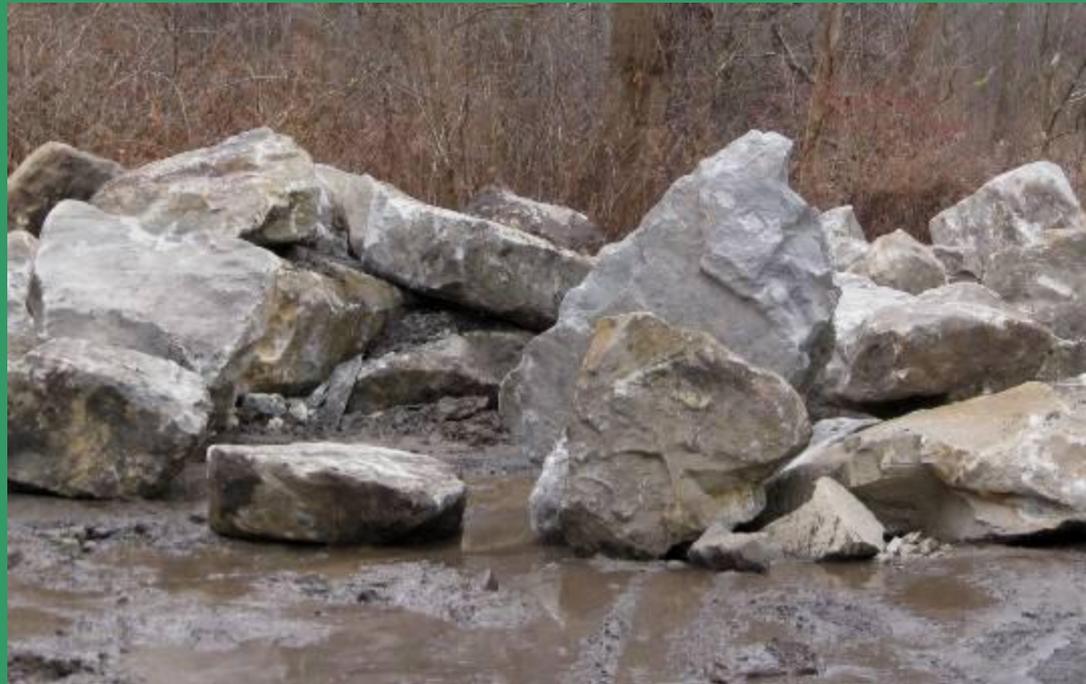
R-5 & R-6 stone on left (used for key & to choke larger stone), large riprap on right used for Engineered Rocked Riffles (ERR), Single Stone Bendway Weirs (SSBW), & bank stabilization.

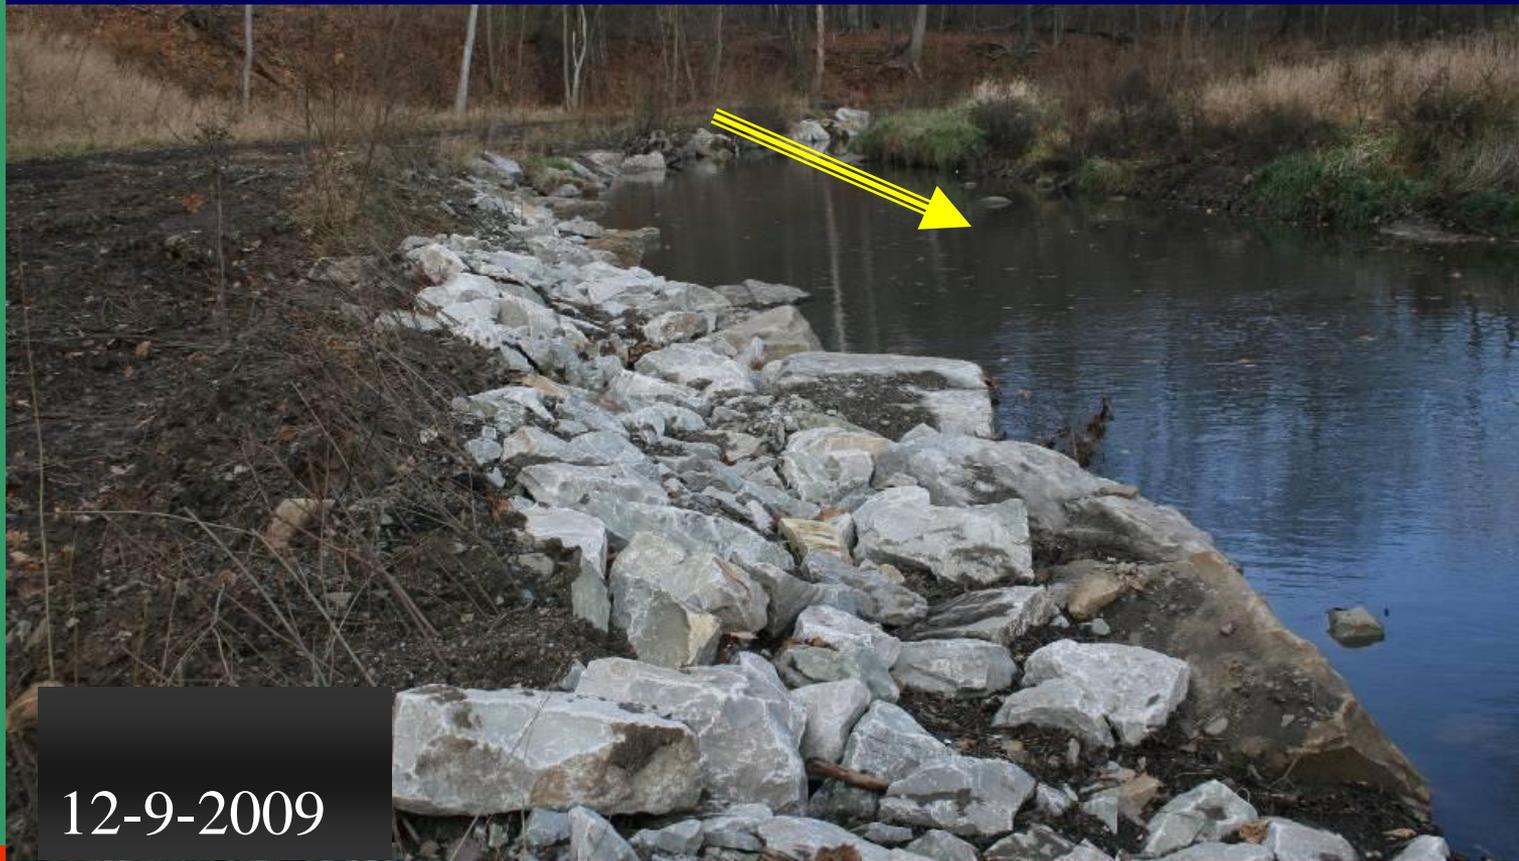
Bend #2

Reconstruction Dec. 2009
from big summer storm (June 9)
damage

Rebuild the Engineered Rocked Riffle
& extend & vegetate keys.

bank protection, veg, & Single Bendway Weir . Flat bench will provide flow to the DS point bar.

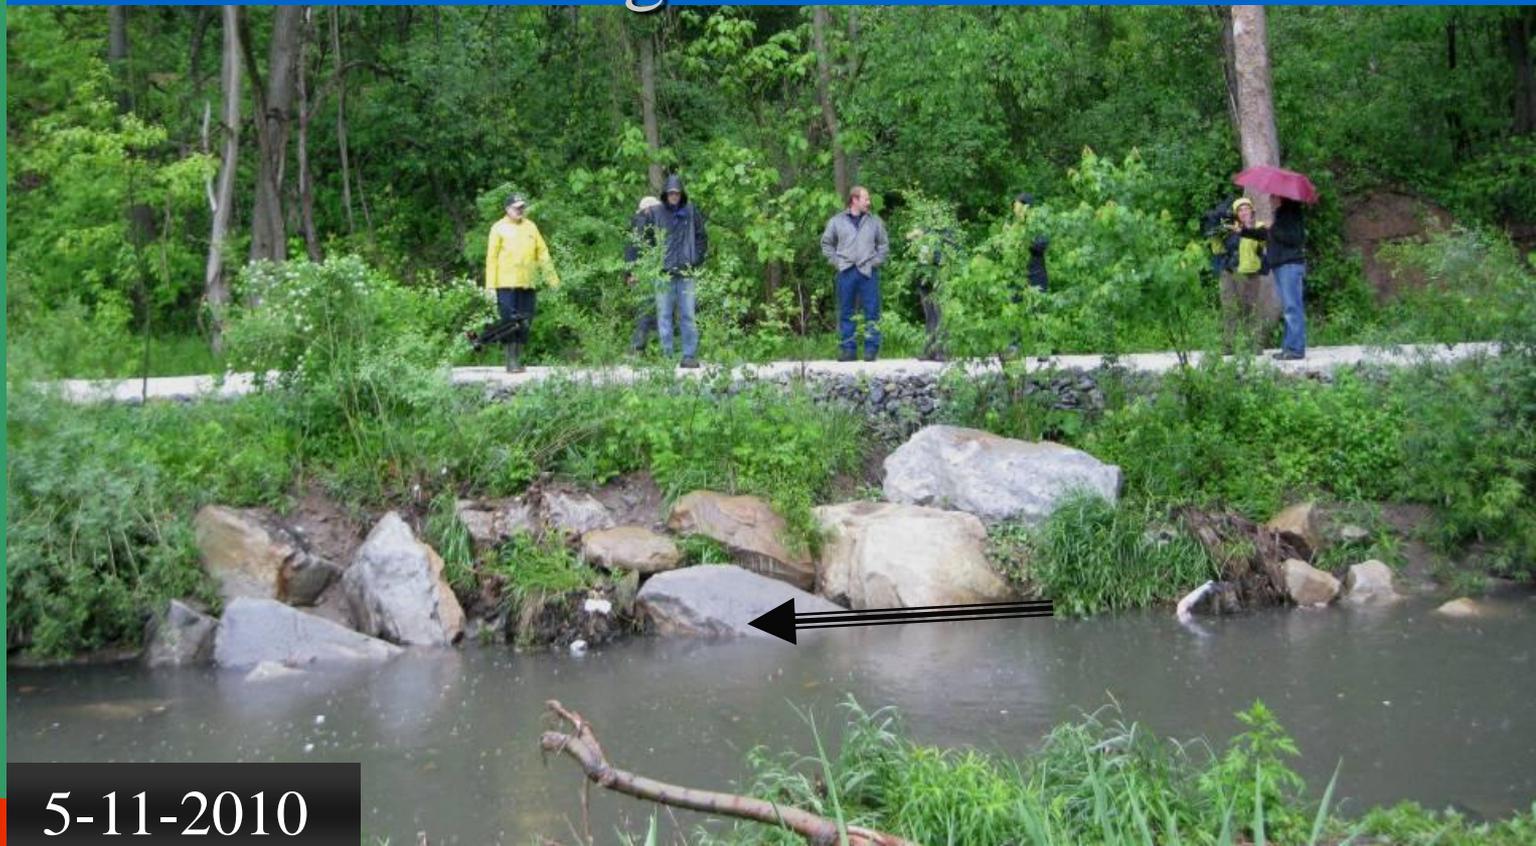
RAIN & HIGHER FLOW-Looking @ a right bank repair. Deep but Bendway Weirs are working well.

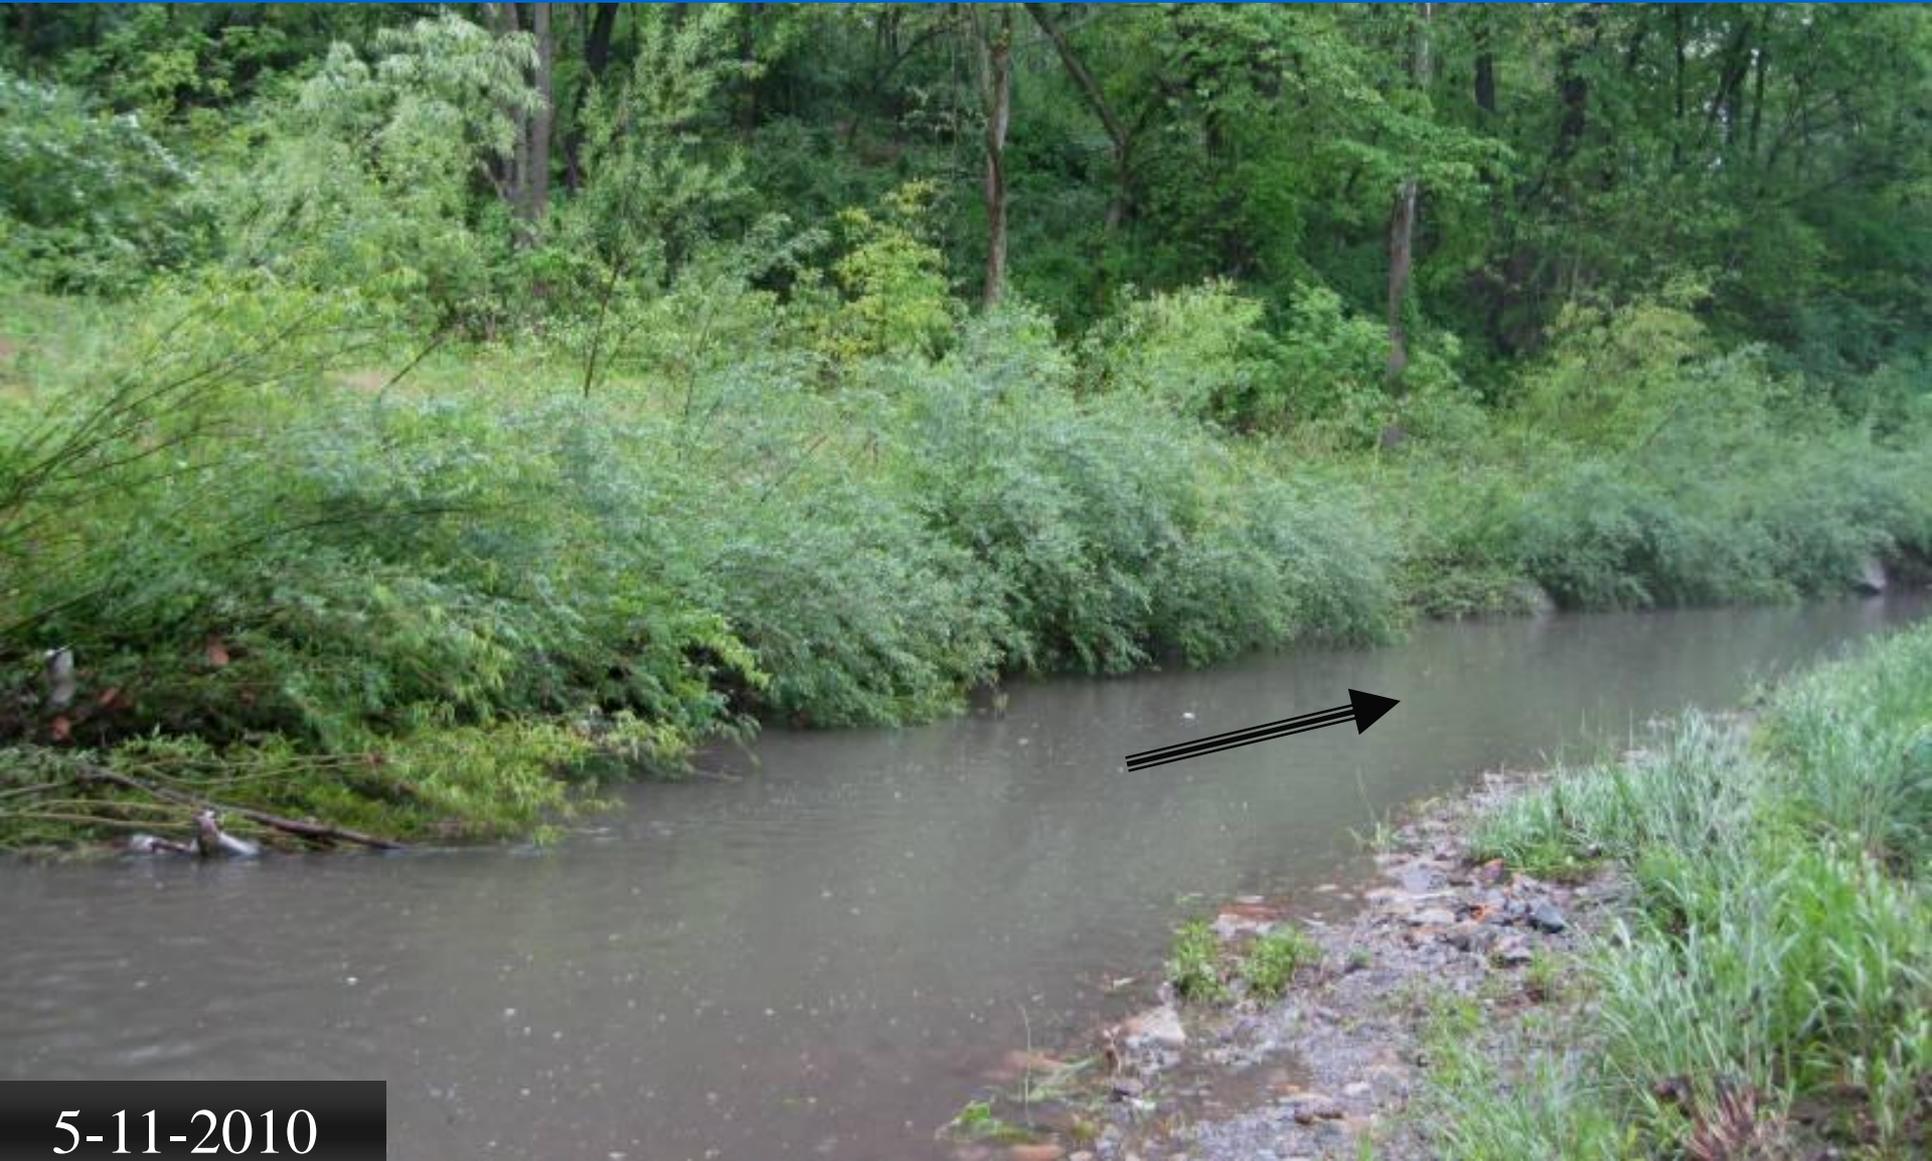
RAIN & HIGHER FLOW-Looking DS @ great Bend #4 veg.

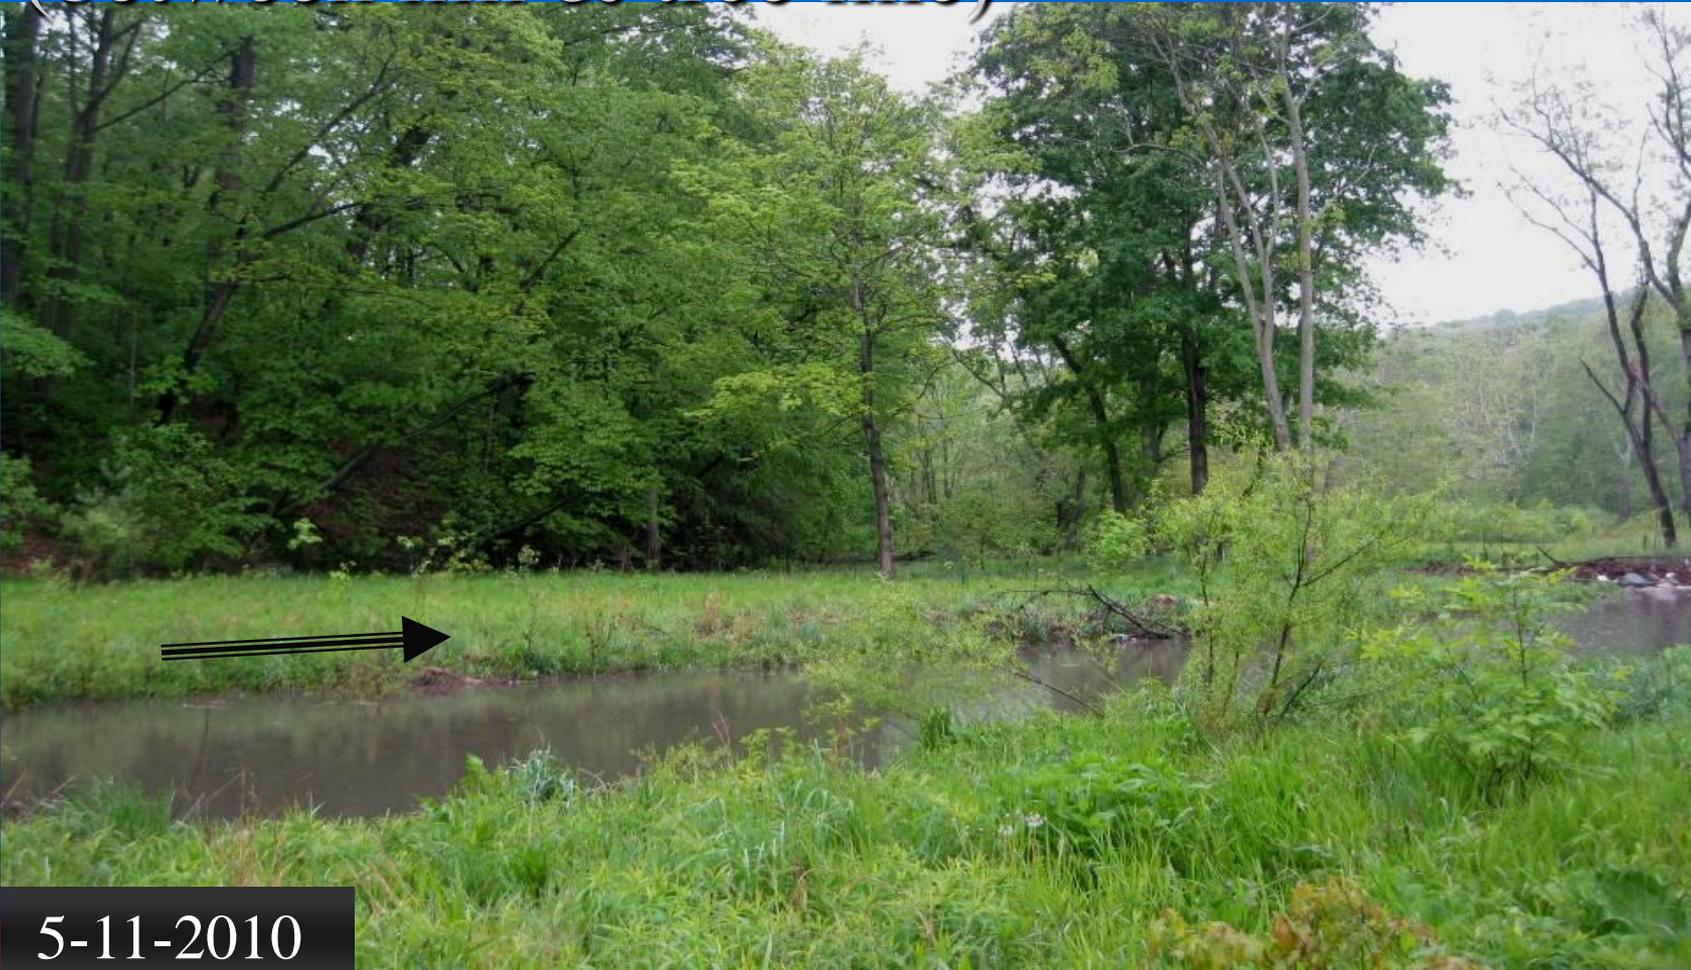
RAIN & HIGHER FLOW-Looking DS @
where the old channel was located
(between hill & tree line)

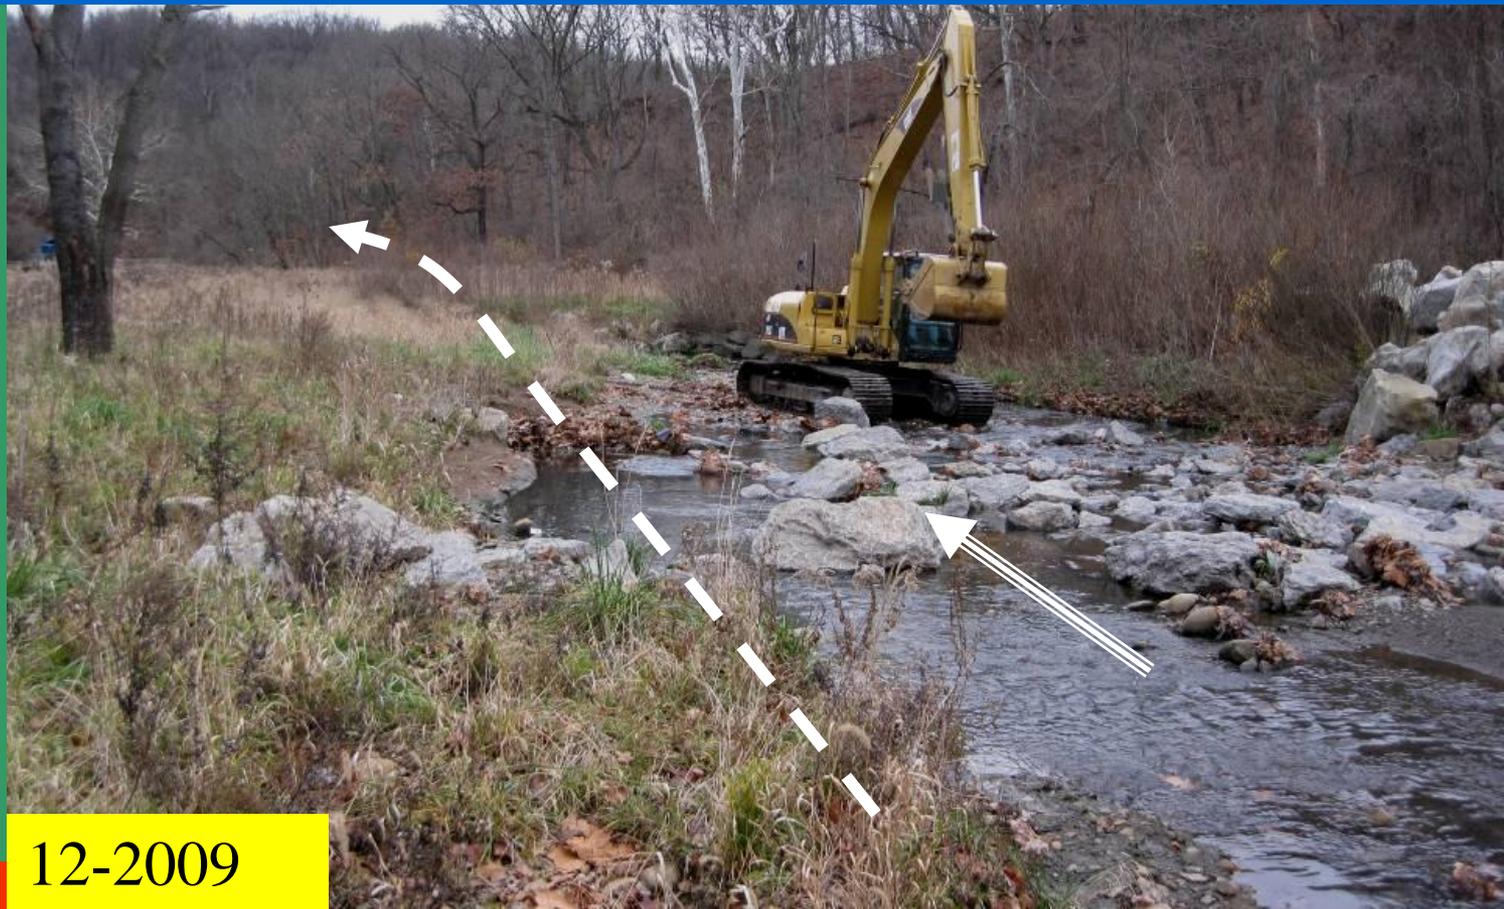
Looking DS @ blown out left key & left bank of the Bend #5 ERR (all to left of dotted line).

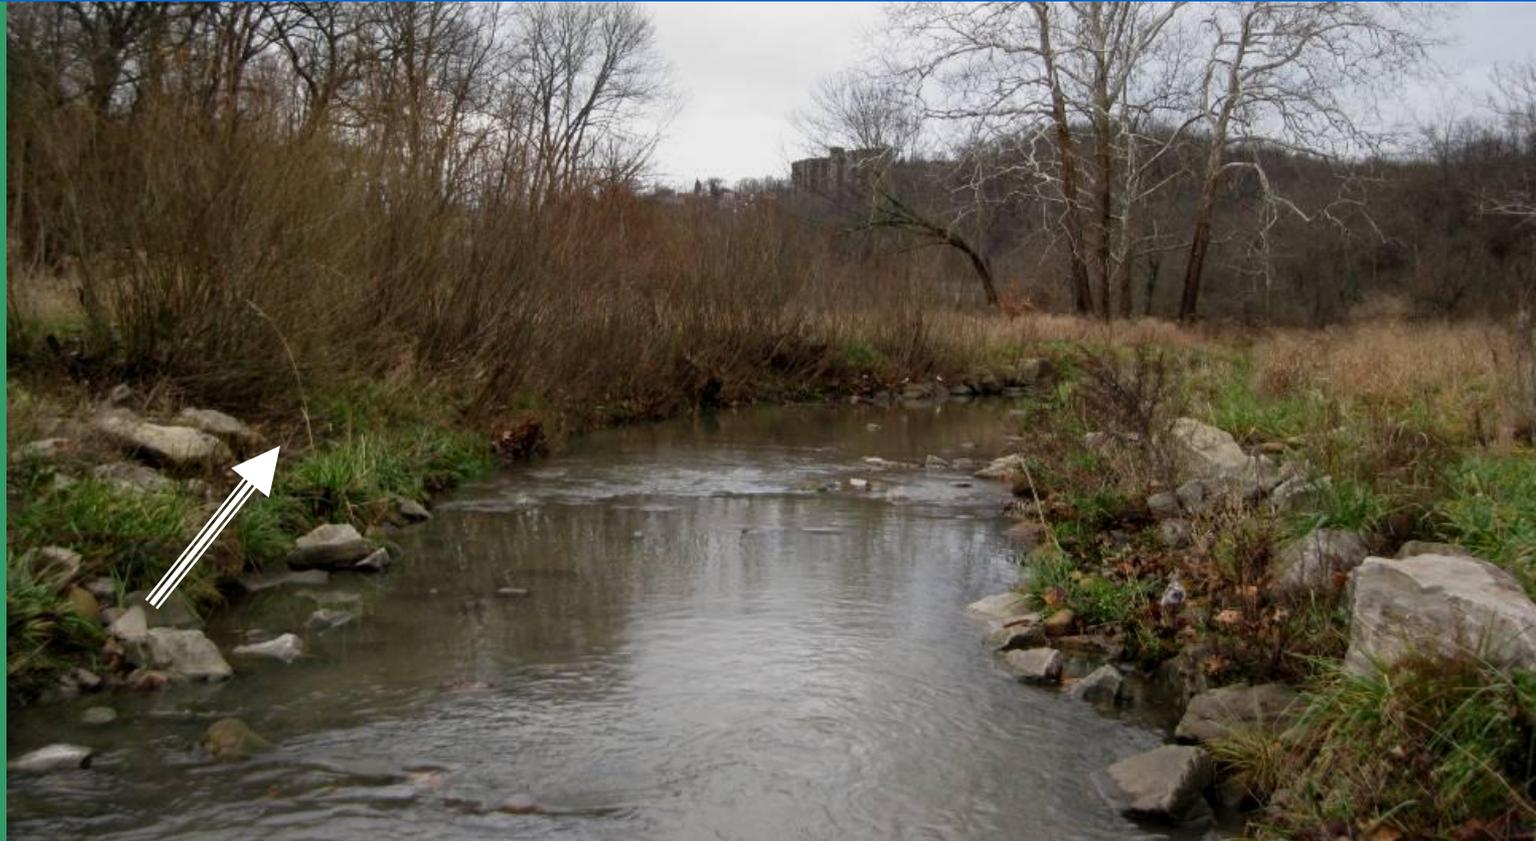
Looking DS into Bend #6. Bend protection is in good shape, willow growth is dense & vigorous.

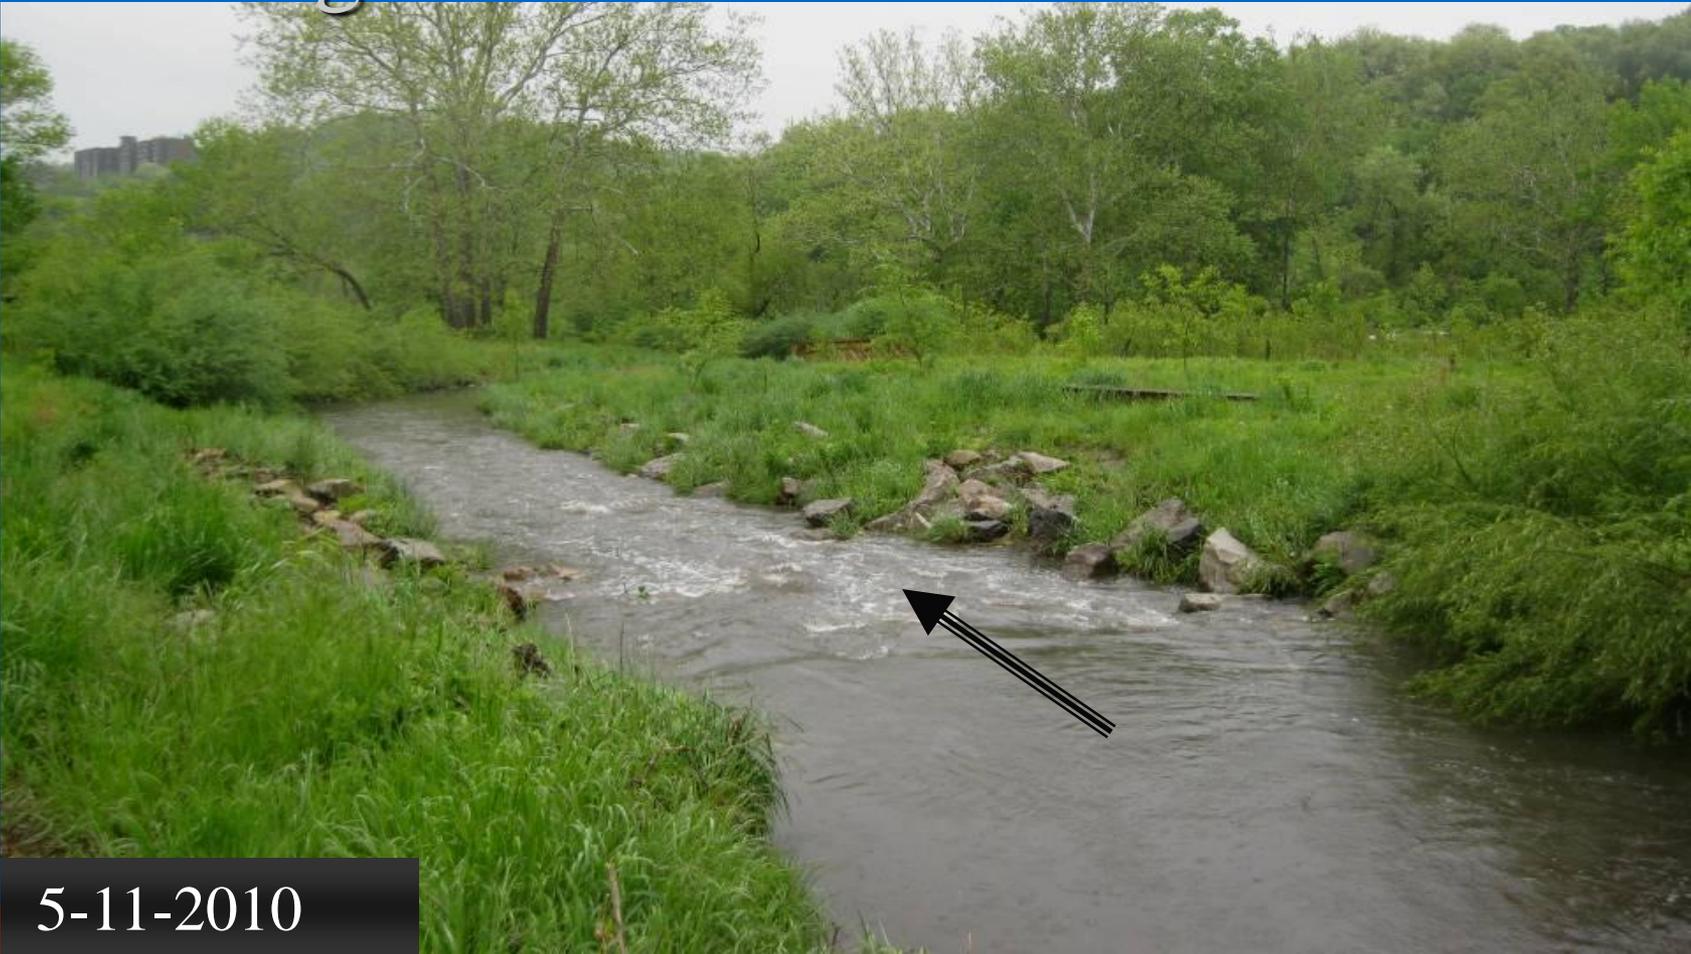
RAIN & HIGHER FLOW-Looking DS @
the DS crossing & into Bend #6. Flow
well-aligned.
