# Geomorphic Monitoring of the Patapsco River Following the Removal of the Simkins Dam, Patapsco River, Maryland

Graham C. Boardman

**McCormick  
Taylor**  
Engineers & Planners  
Since 1946

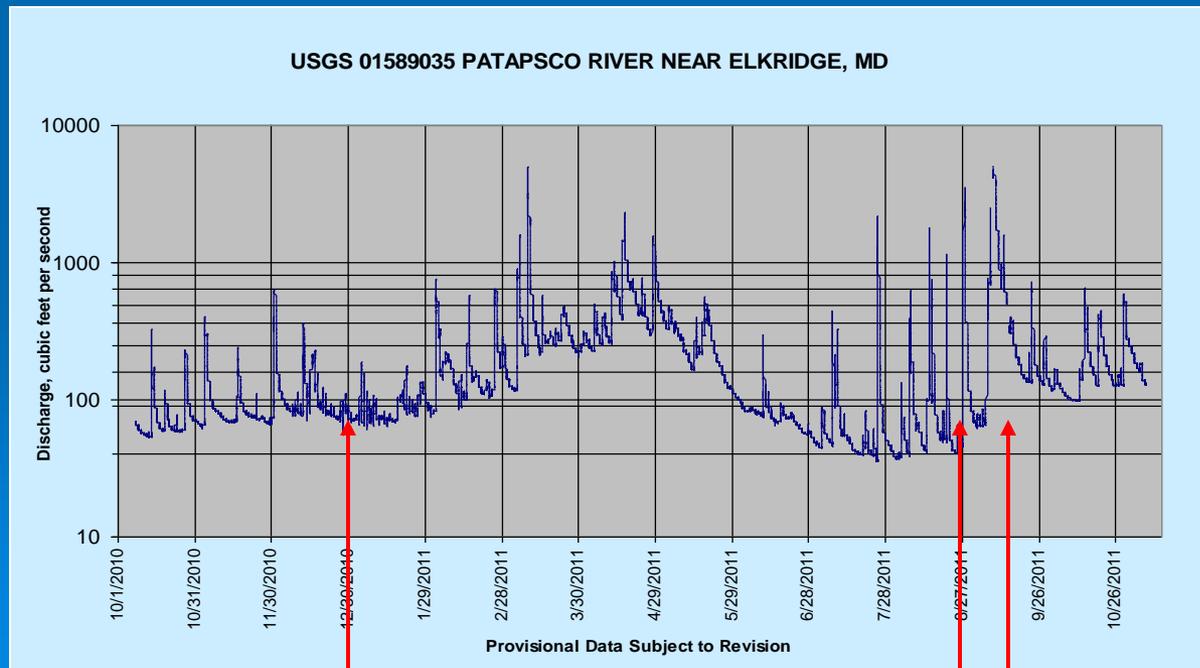
# Storm Events- Elkridge Gage

Approximately 3.5 river miles downstream of Simkins Dam

- 5010 cfs 3/10/11
- 3270 cfs 3/28/11
- 2500 cfs 7/25/11
- 2500 cfs 4/28/11
- 2300 cfs 4/17/11
- 2300 cfs 4/13/11
- 1600 cfs 3/7/11

9/8/11 TS Lee, Recorded as 16,600 cfs at Hollofield Gage

Dam Removal

Hurricane Irene/TS Lee

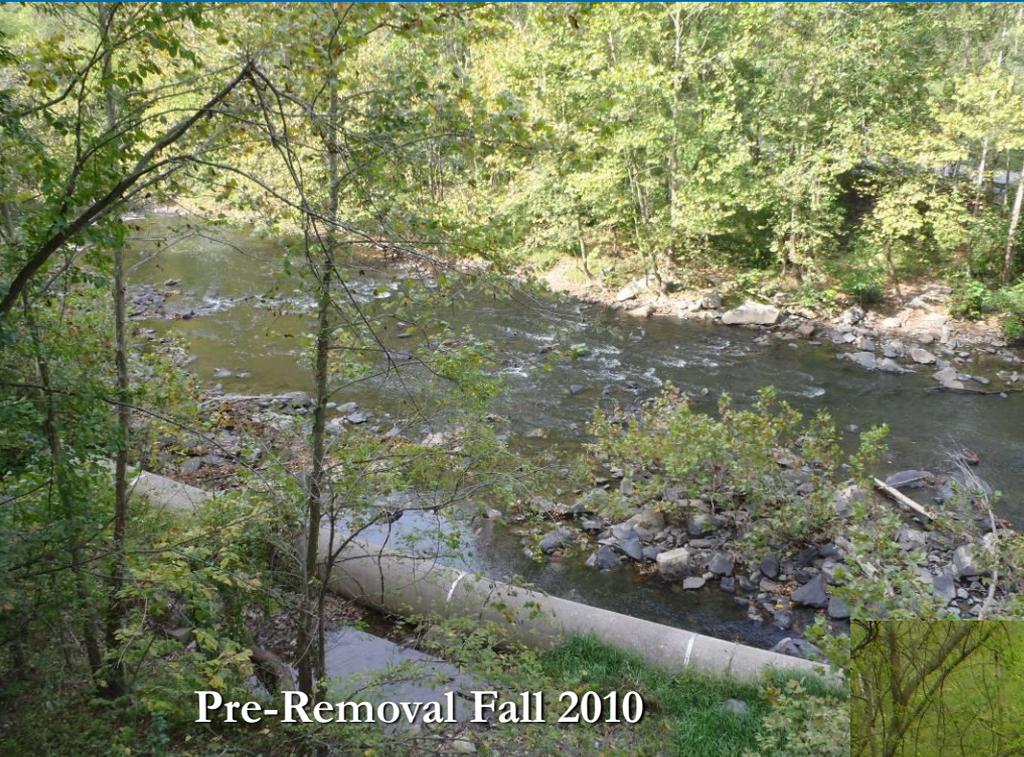
Pre-Removal Fall 2010

A photograph of a river in Fall 2010, before the removal of a culvert. The river is narrow and flows over a rocky bed. A concrete culvert is visible on the left side of the river, partially submerged. The surrounding area is densely wooded with green trees.

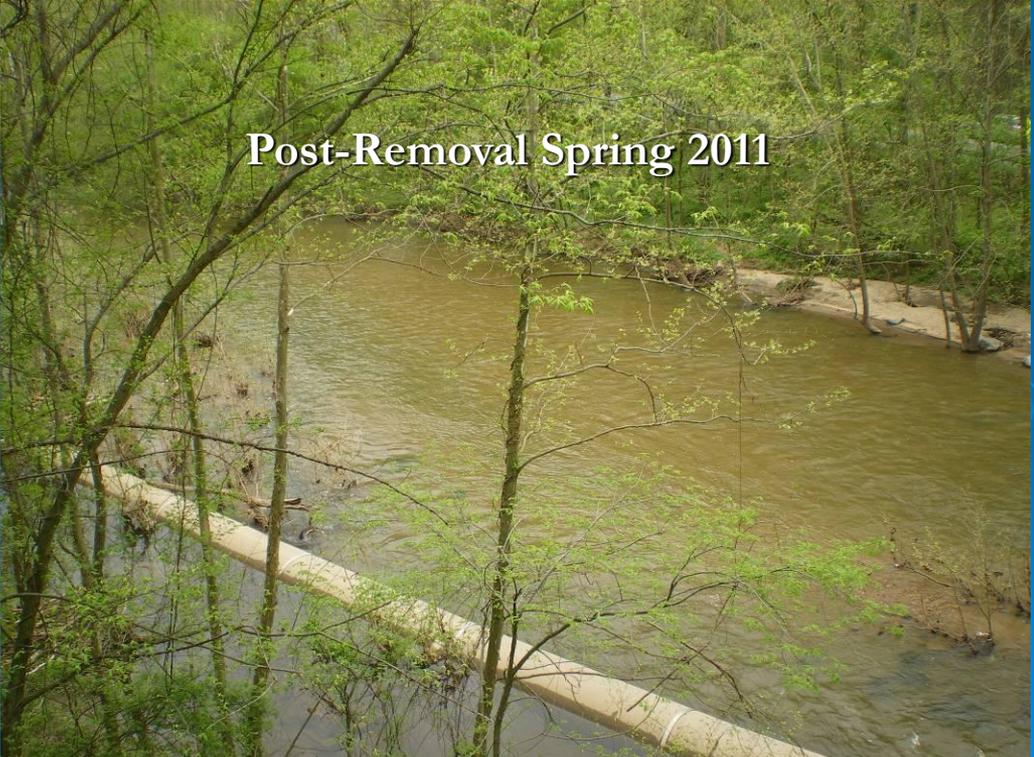
Post-Removal Spring 2011

A photograph of the same river in Spring 2011, after the removal of the culvert. The river is wider and flows over a sandy and silty bed. The concrete culvert is now a large log floating in the water. The surrounding area is densely wooded with green trees.

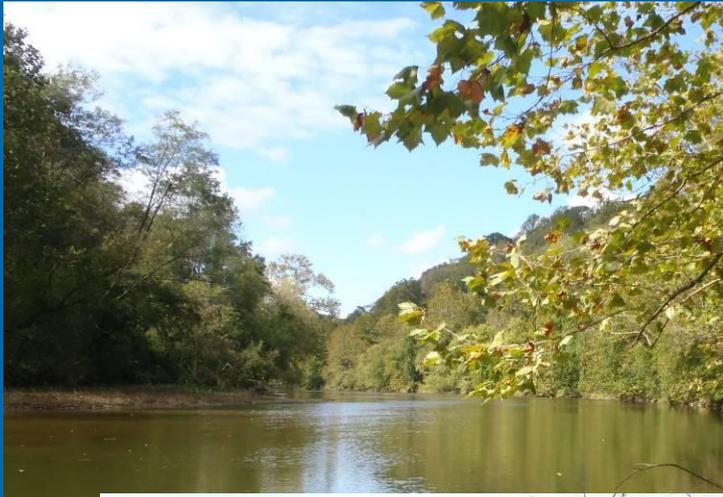
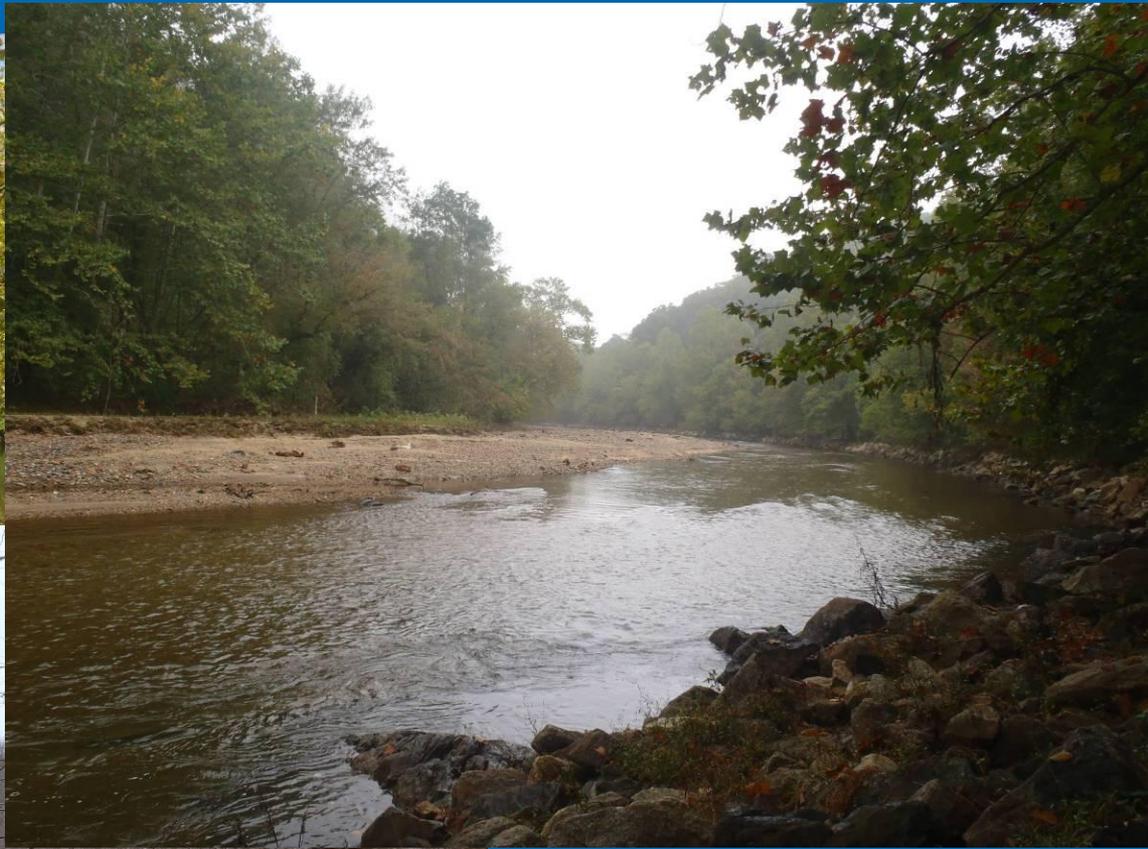
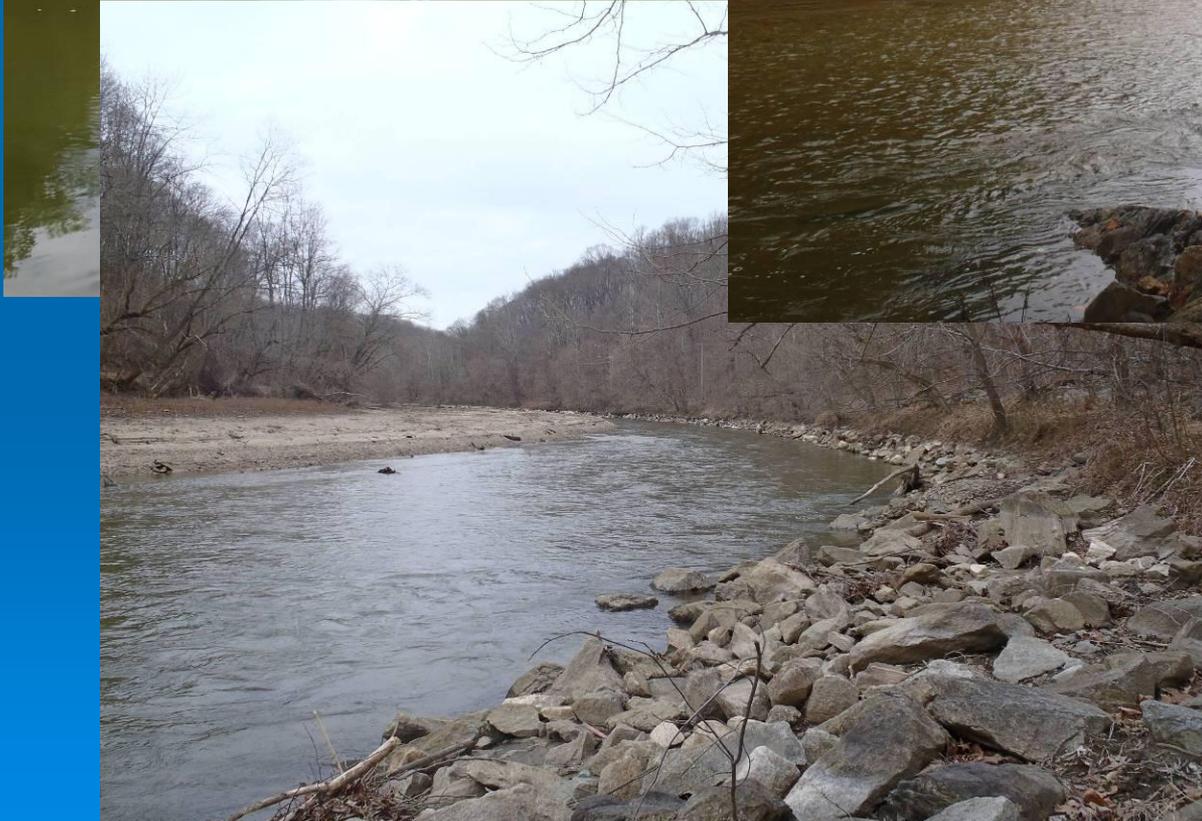
Channel downcutting  
and widening in  
Simkins  
Impoundment

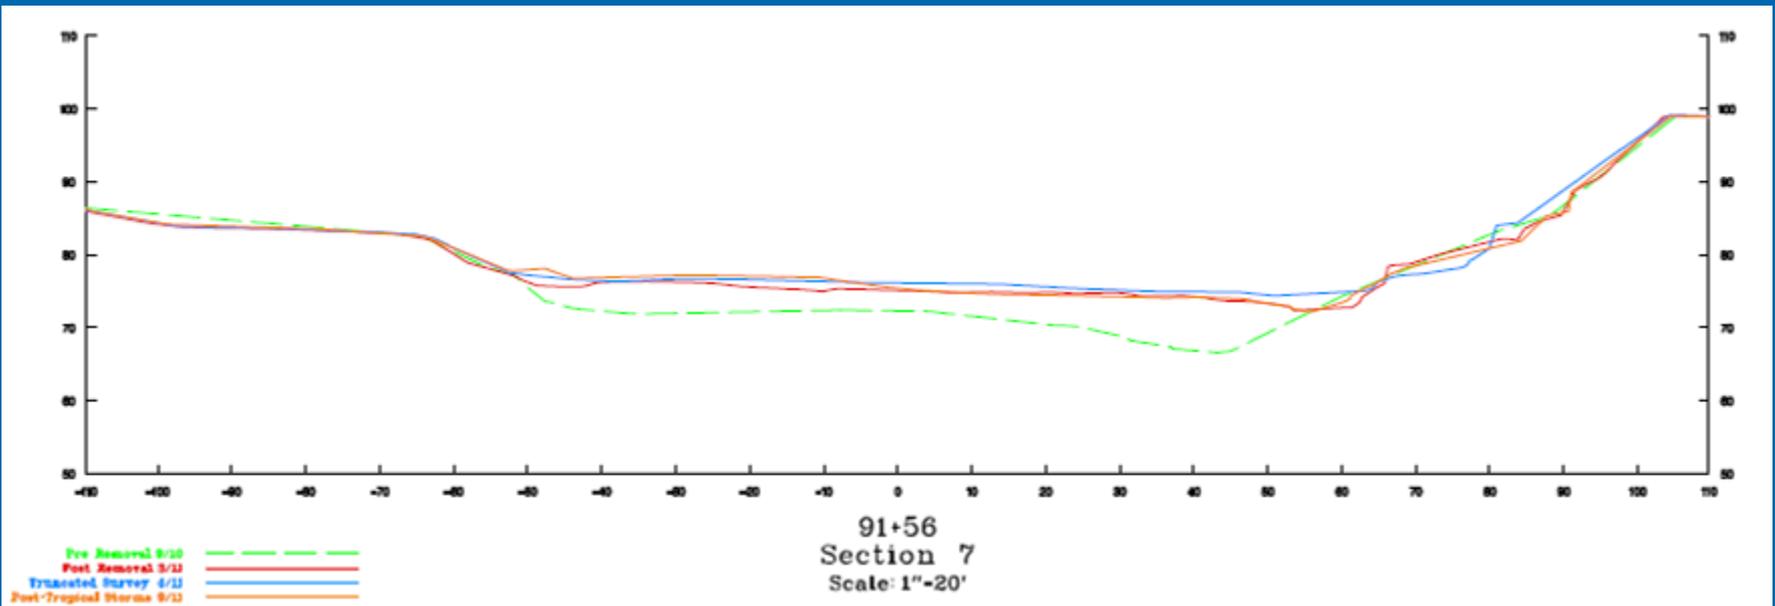
RS 59800- 2800' DS of Simkins Dam  
 1500' US of Bloede Dam  
 443.44 SF Net Fill

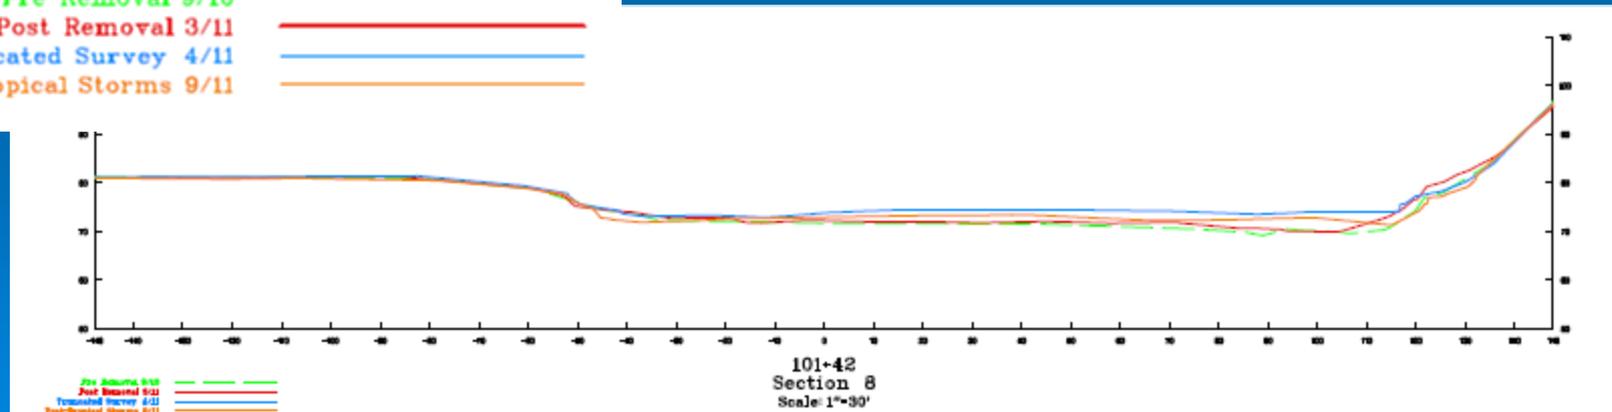
RS 58500- 4100' DS of Simkins Dam  
 200' US of Bloede Dam 450.91 SF Net Fill BUT Cut Post Storms

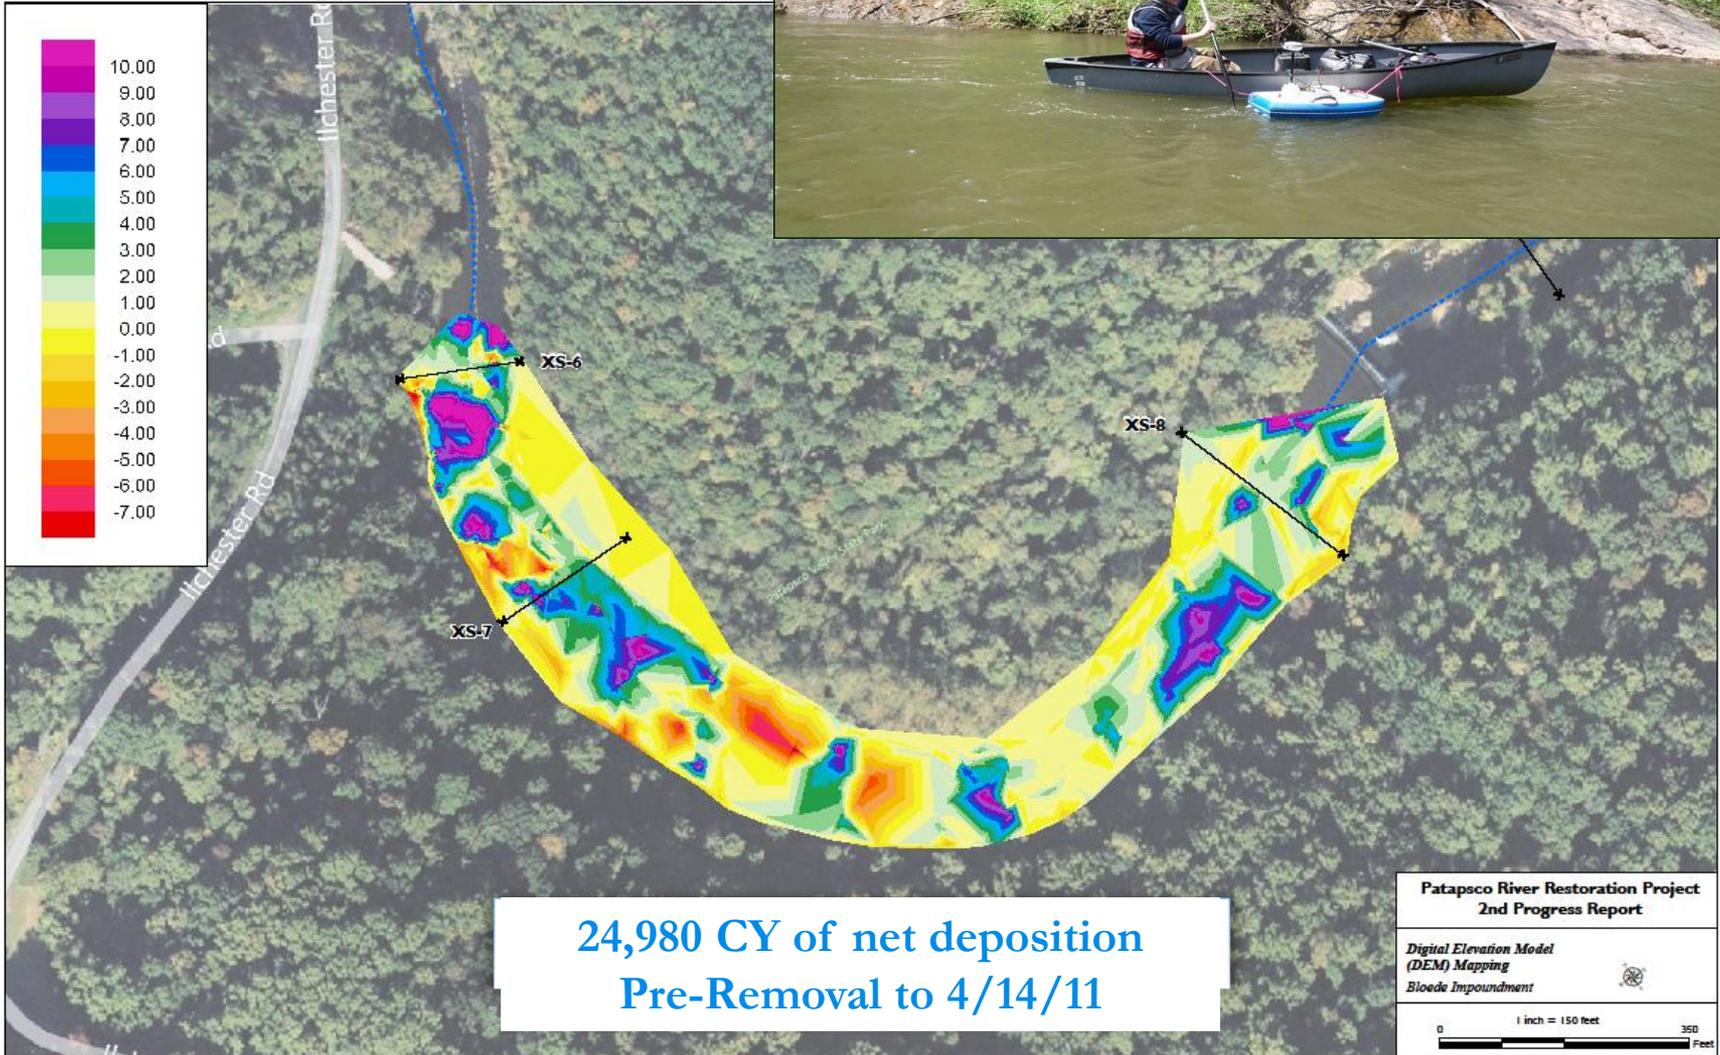
24,980 CY of net deposition  
Pre-Removal to 4/14/11

Digital Elevation Model  
(DEM) Mapping  
Bloede Impoundment

0 1 inch = 150 feet 350  
Feet

DEM Area	Station To	Station From	Area SY	Net Cut/Fill CY	Net Cut/Fill TONS	Survey Dates
Simkins	58400	60100	75901	<b>-41,799</b>	<b>-45,217</b>	September 2010 and April 2011
Bloede	62650	66300	38236	<b>24,980</b>	<b>28,710</b>	September 2010 and April 2011
DEM 1	48100	49150	19689	1,301	1,495	October 2010 and April 2011
DEM 2	42800	46700	71513	-115	-132	October 2010 and April 2011
DEM 3	37600	39000	36440	1,472	1,692	October 2010 and April 2011

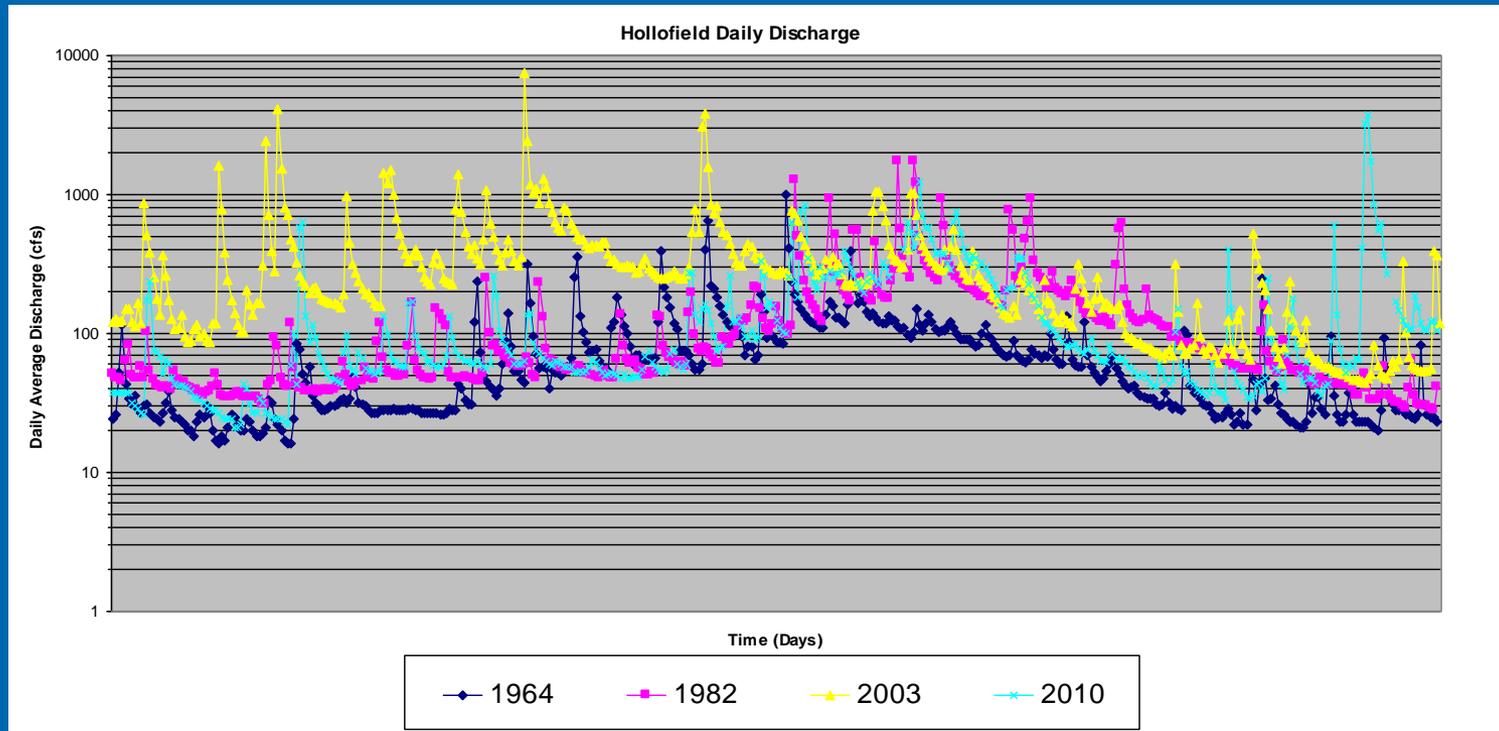
Figure 7. Patapsco River daily average discharge at USGS gauging station #01589000 for three typical water years (including two months [August and September] of previous water year).

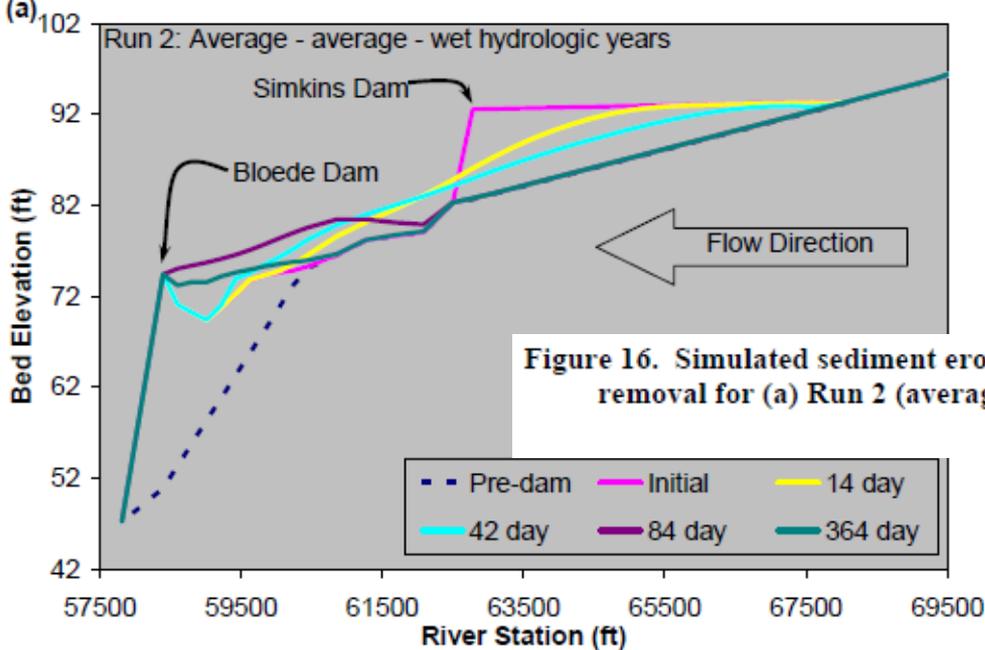
Figure 16. Simulated sediment erosion and deposition upstream of Bloede Dam following Simkins Dam removal for (a) Run 2 (average-average-wet year scenario); and (b) Run 3 (dry-average-wet year scenario).
