**Hydrologic and Hydraulic
Processes and Connectivity
In
Altered Mid-Atlantic Riverine
Systems**

**Mid-Atlantic Stream Restoration
Conference @ Rocky Gap**

**Ward Oberholtzer, P.E.
Century Engineering, Inc./Landstudies Inc.**

November 2011

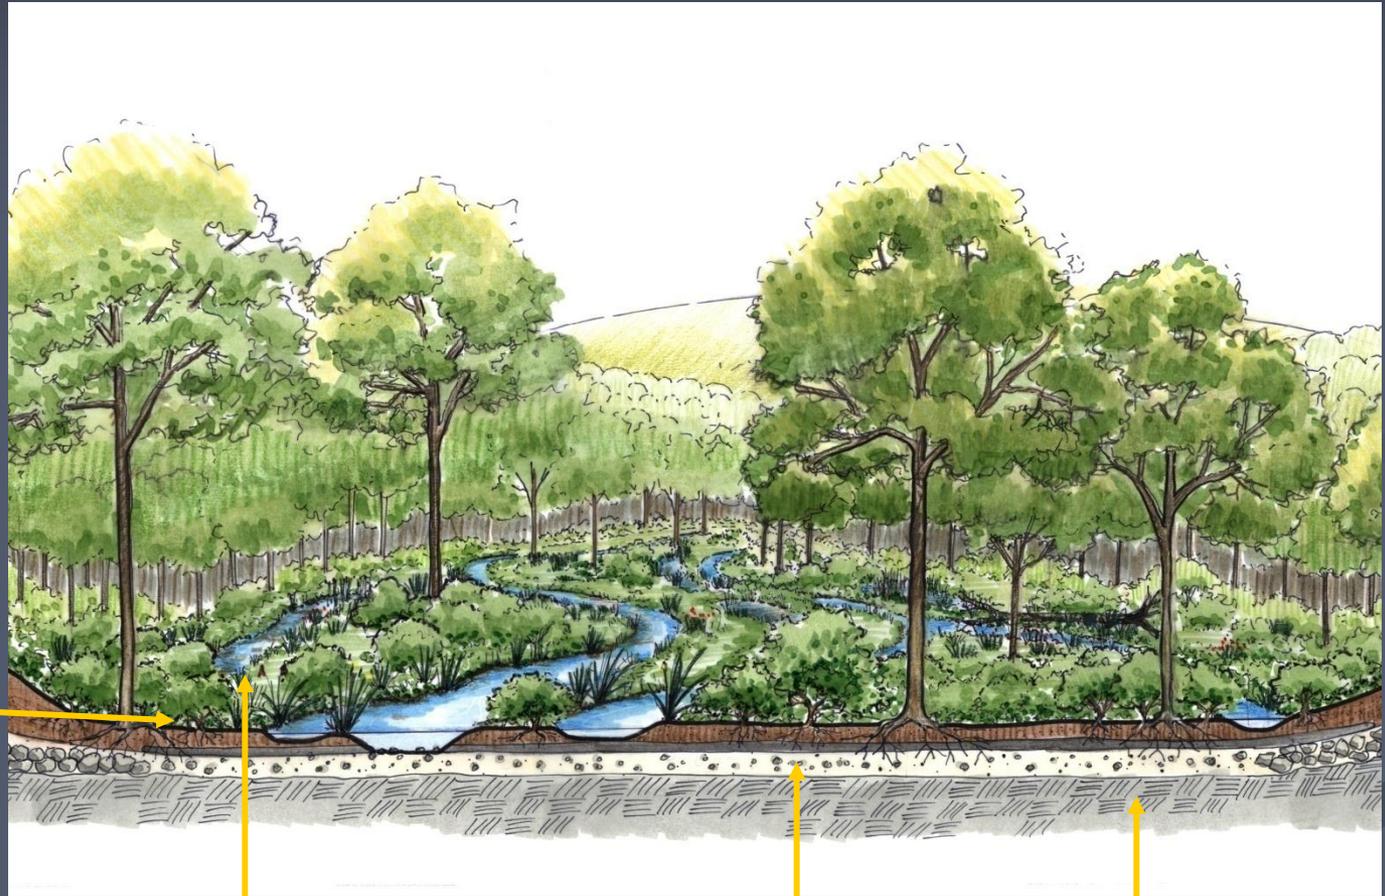
Natural Piedmont Stream Valley

Floodplain elevation has no link to coarse grain bed load transport or design storm. Based on the thickness of post-settlement alluvium and present degree of incision into the recent or older deposits.

Connectivity
between
Rooting Zone,
Groundwater,
and
Stream Flow

Roots extend
to groundwater

Floodplain Soils –
Shallow, Peaty, Organic

Cobble/Gravel Bed
(Groundwater)

Bedrock

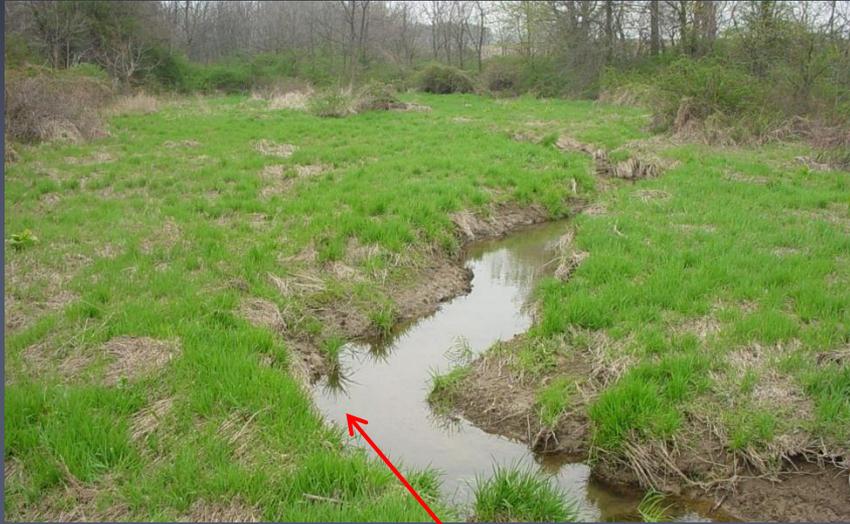
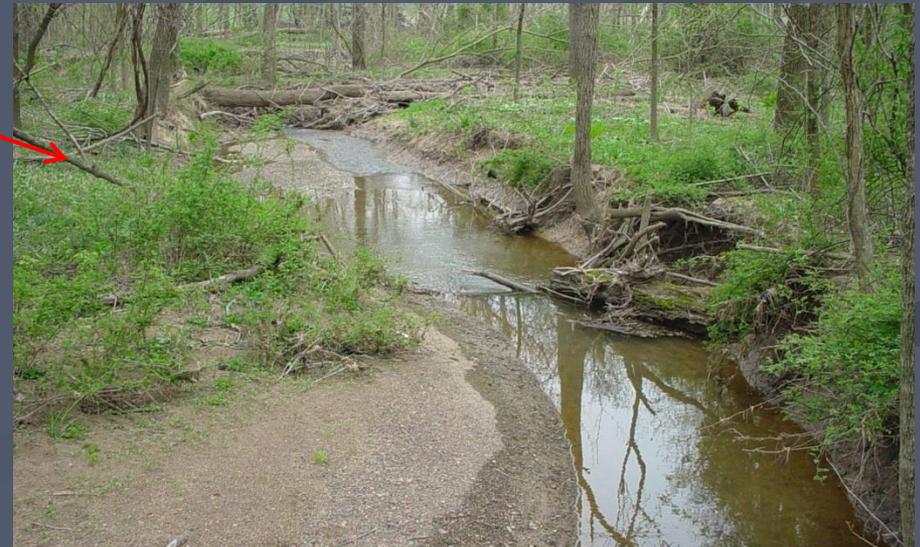
Little Swatara Watershed

UPSTREAM
Perched

*Low Energy System
with Poor Habitat*

200 feet apart

DOWNSTREAM
Incised

*Higher Energy System
Exhibiting Lateral Migration
and Poor Habitat*

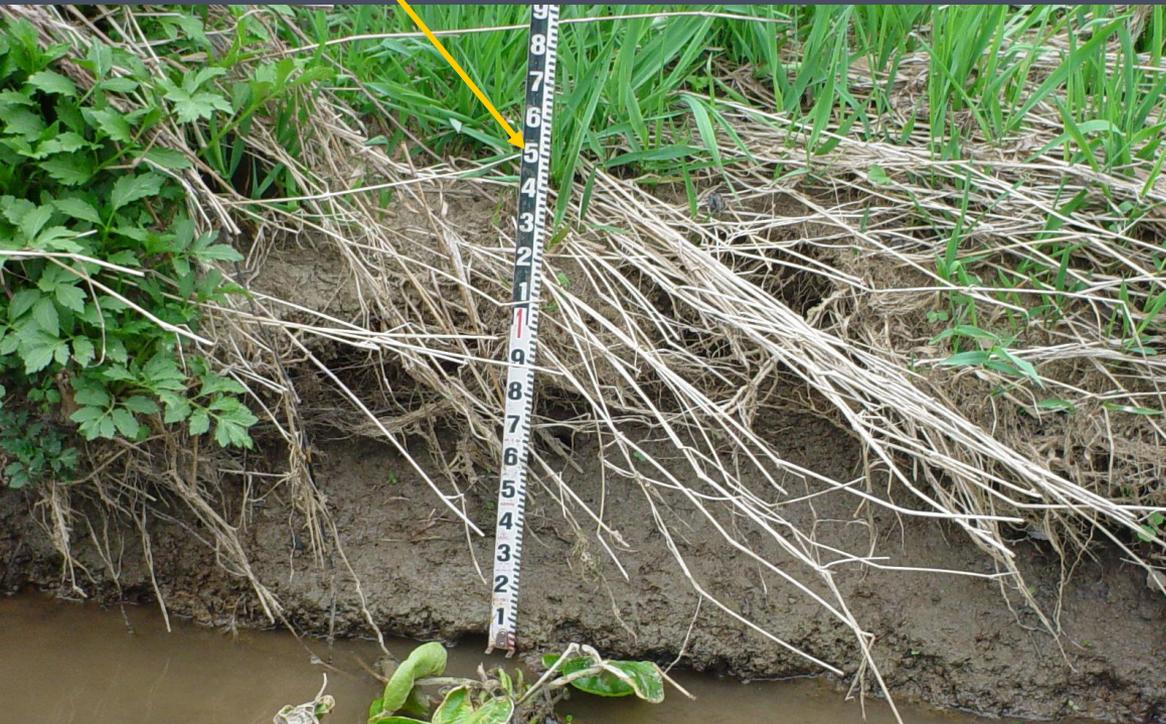
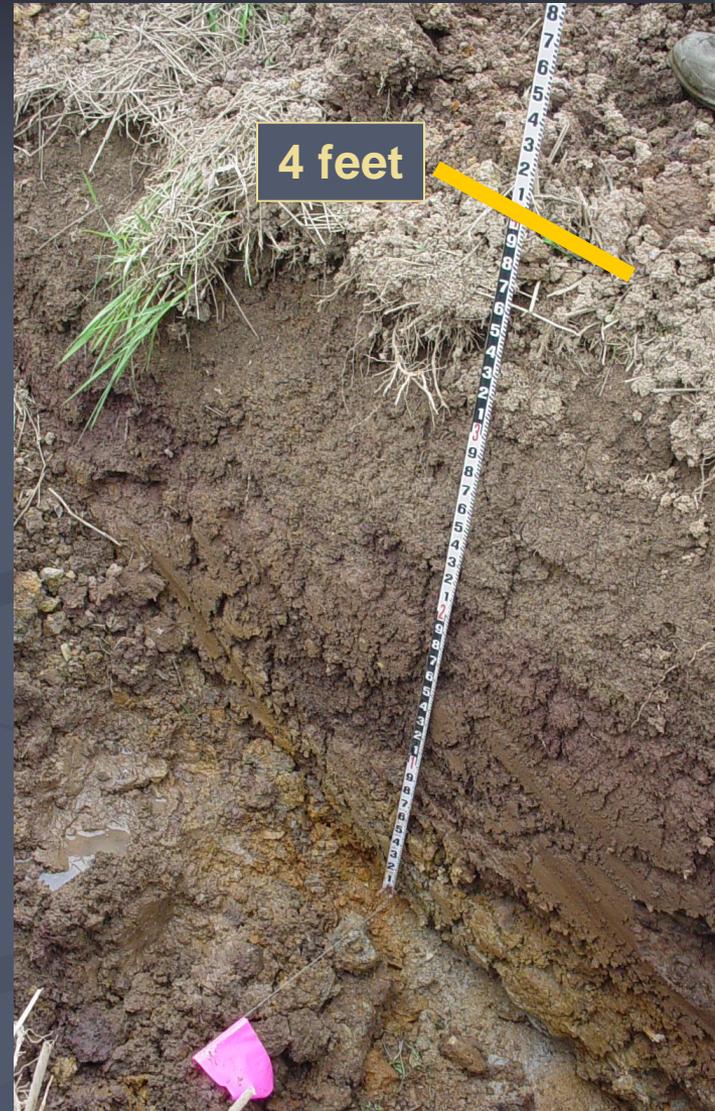
1.5 feet

Perched Stream Channel
Groundwater Impacts

4 feet

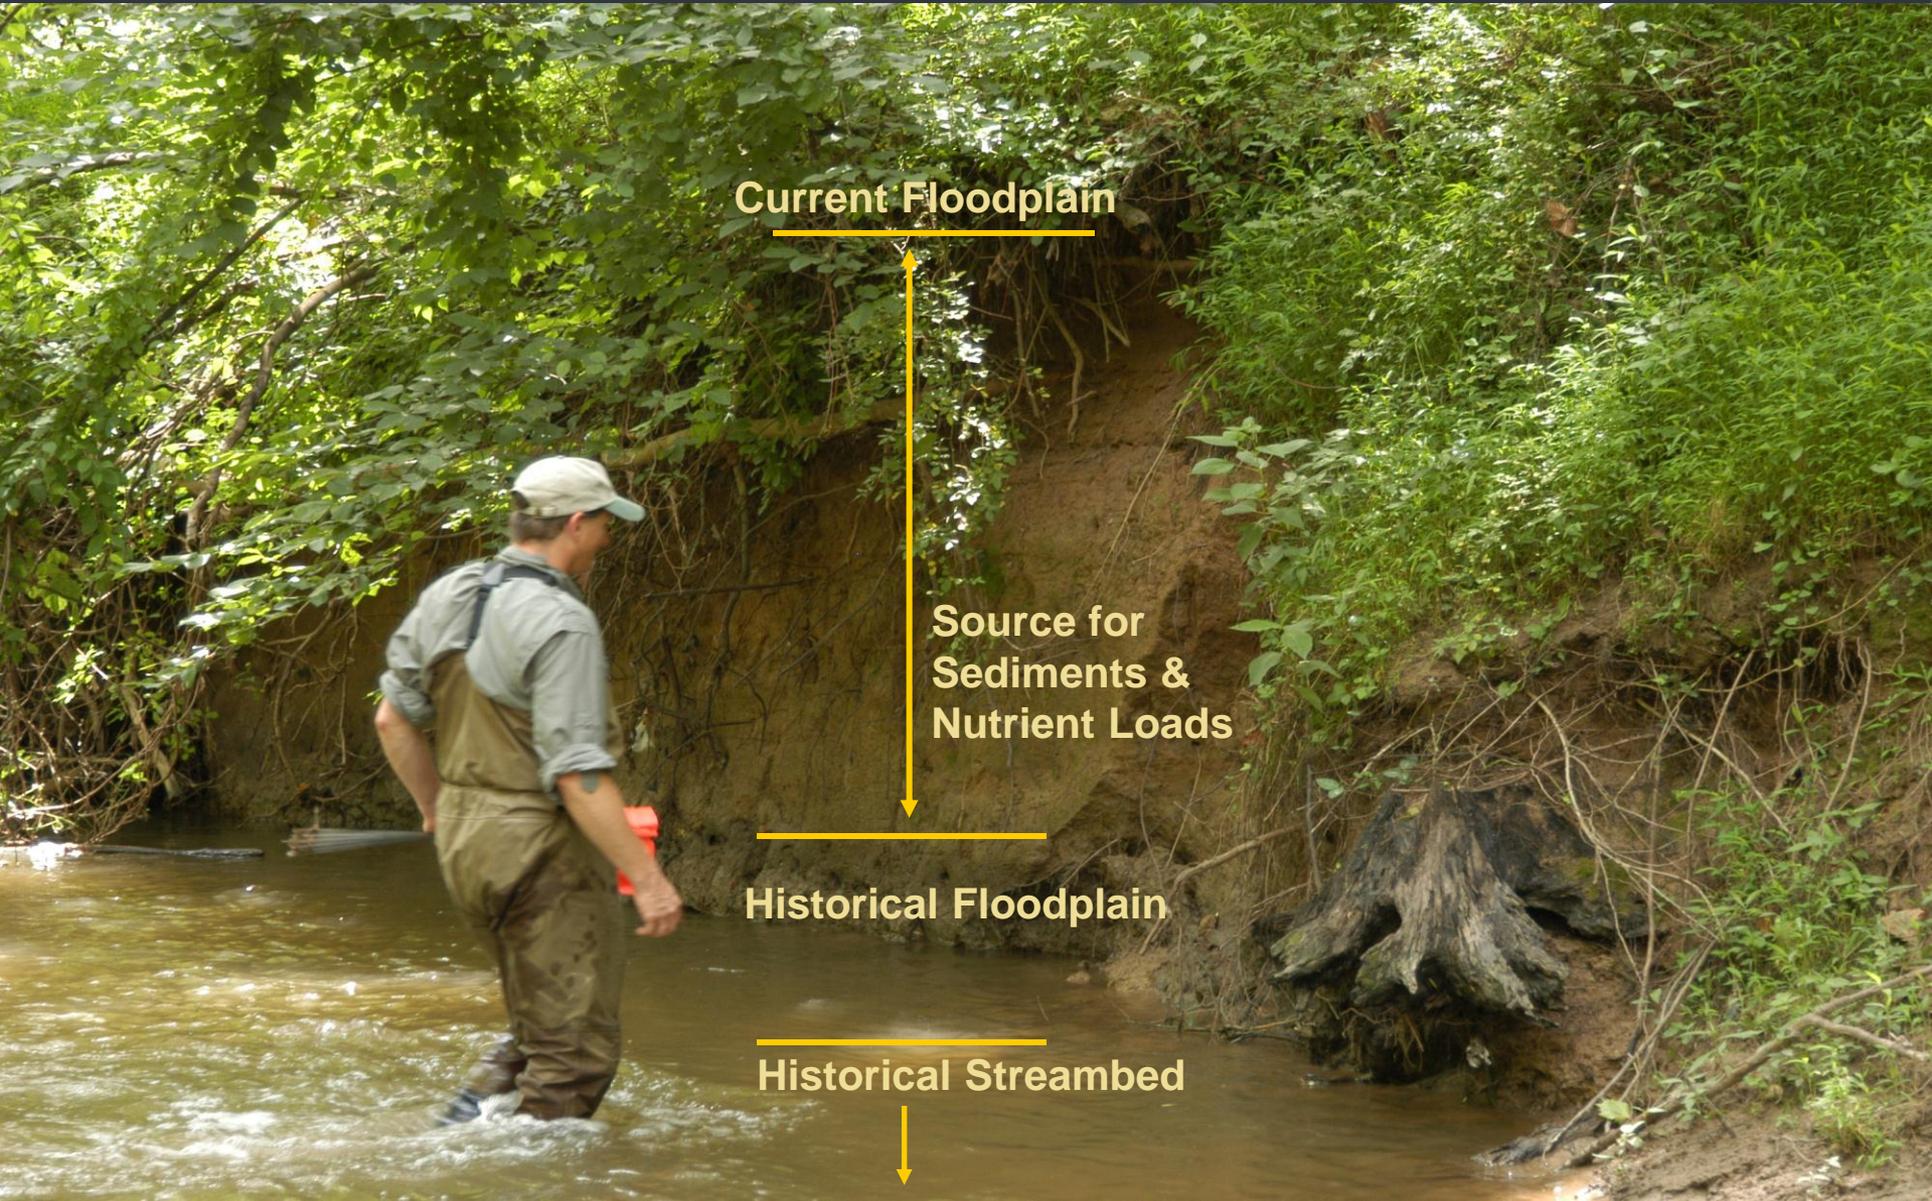
Post-Settlement Sedimentation

Current Floodplain

**Source for
Sediments &
Nutrient Loads**

Historical Floodplain

Historical Streambed

Five Meter-High Cutbank of Laminated Silts and Clays

Colonial-Era
Dam Remnants

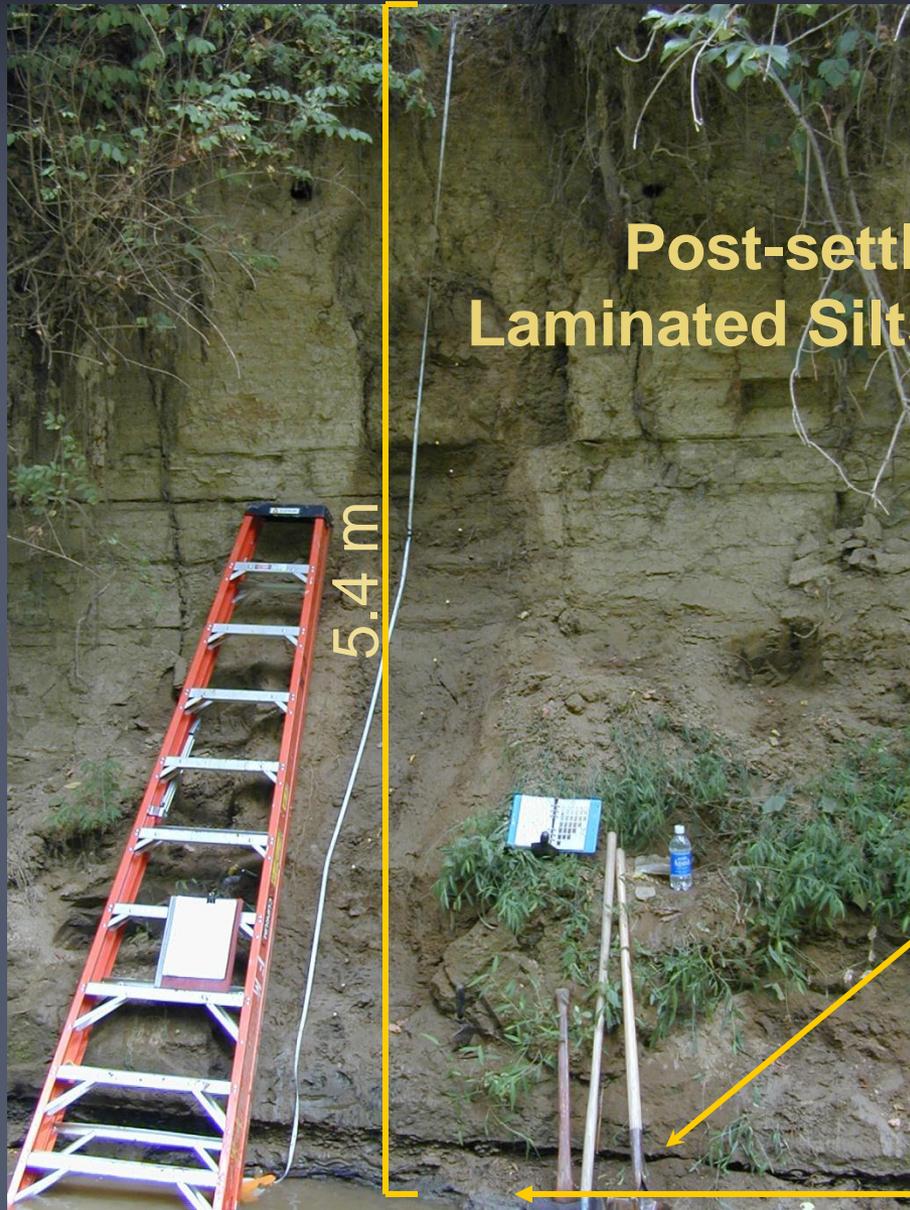
West Branch
Little Conestoga

Post-settlement
Laminated Silts and Clays

Leaf Mat:
Chestnut, White
Oak, Red Oak, &
Sycamore
1660-1810 Cal AD

Peaty Clay:
1510-1660 Cal AD

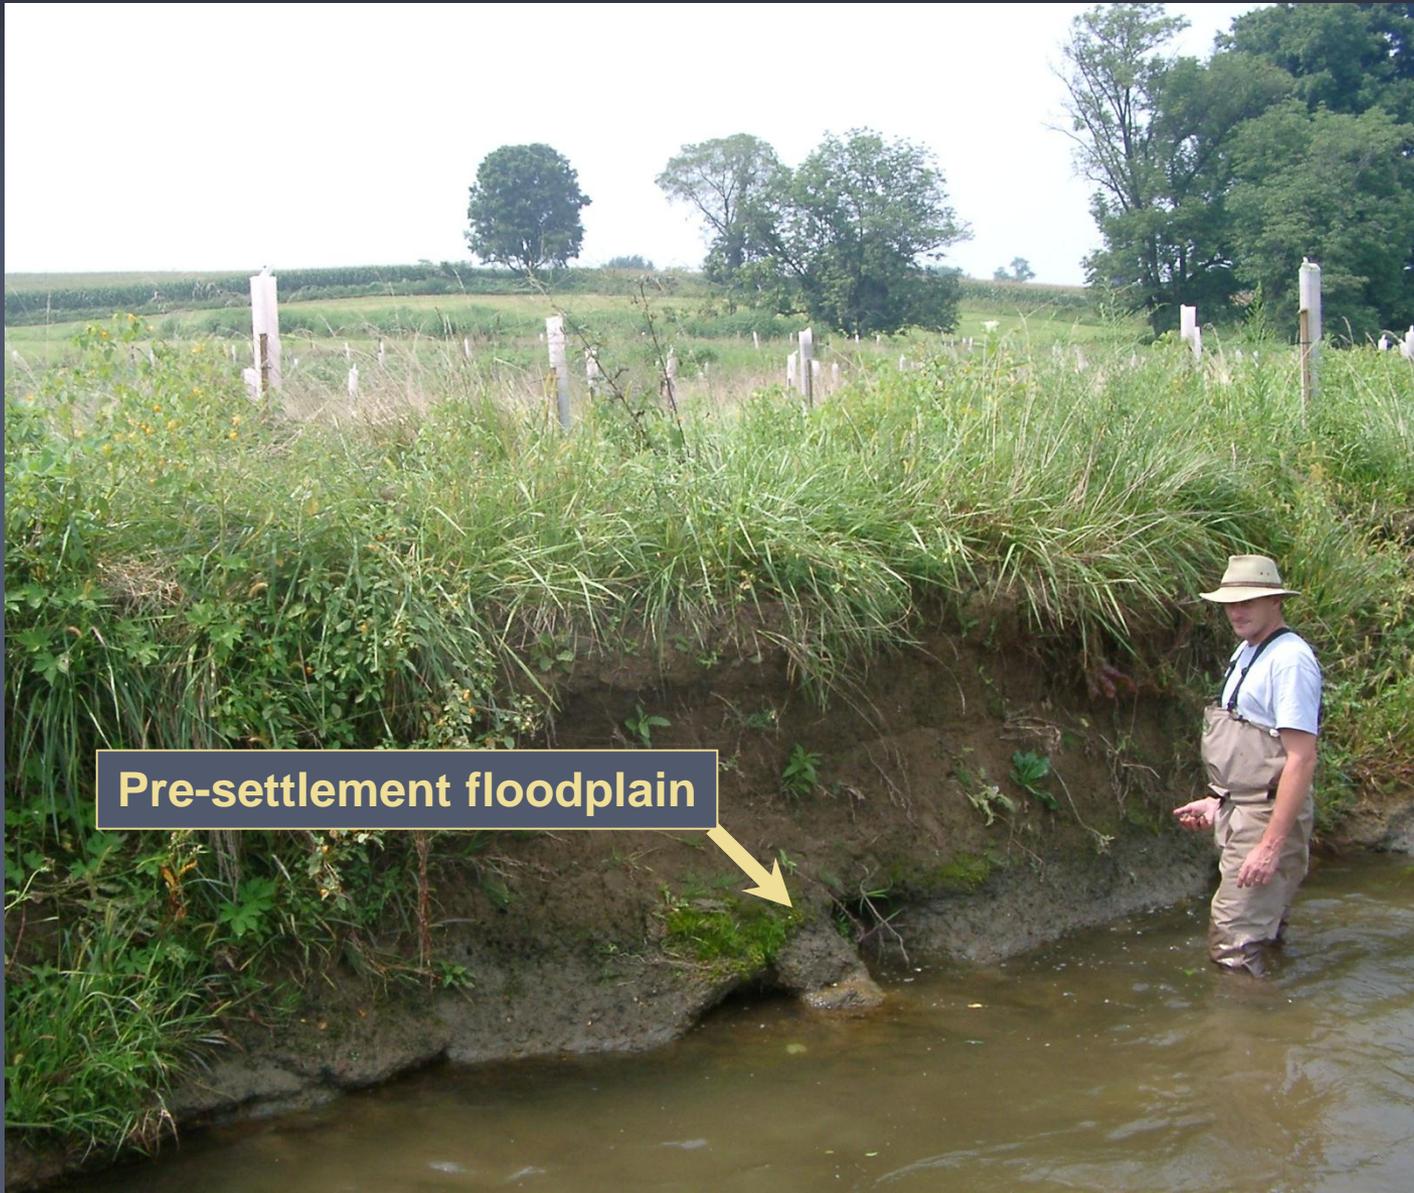
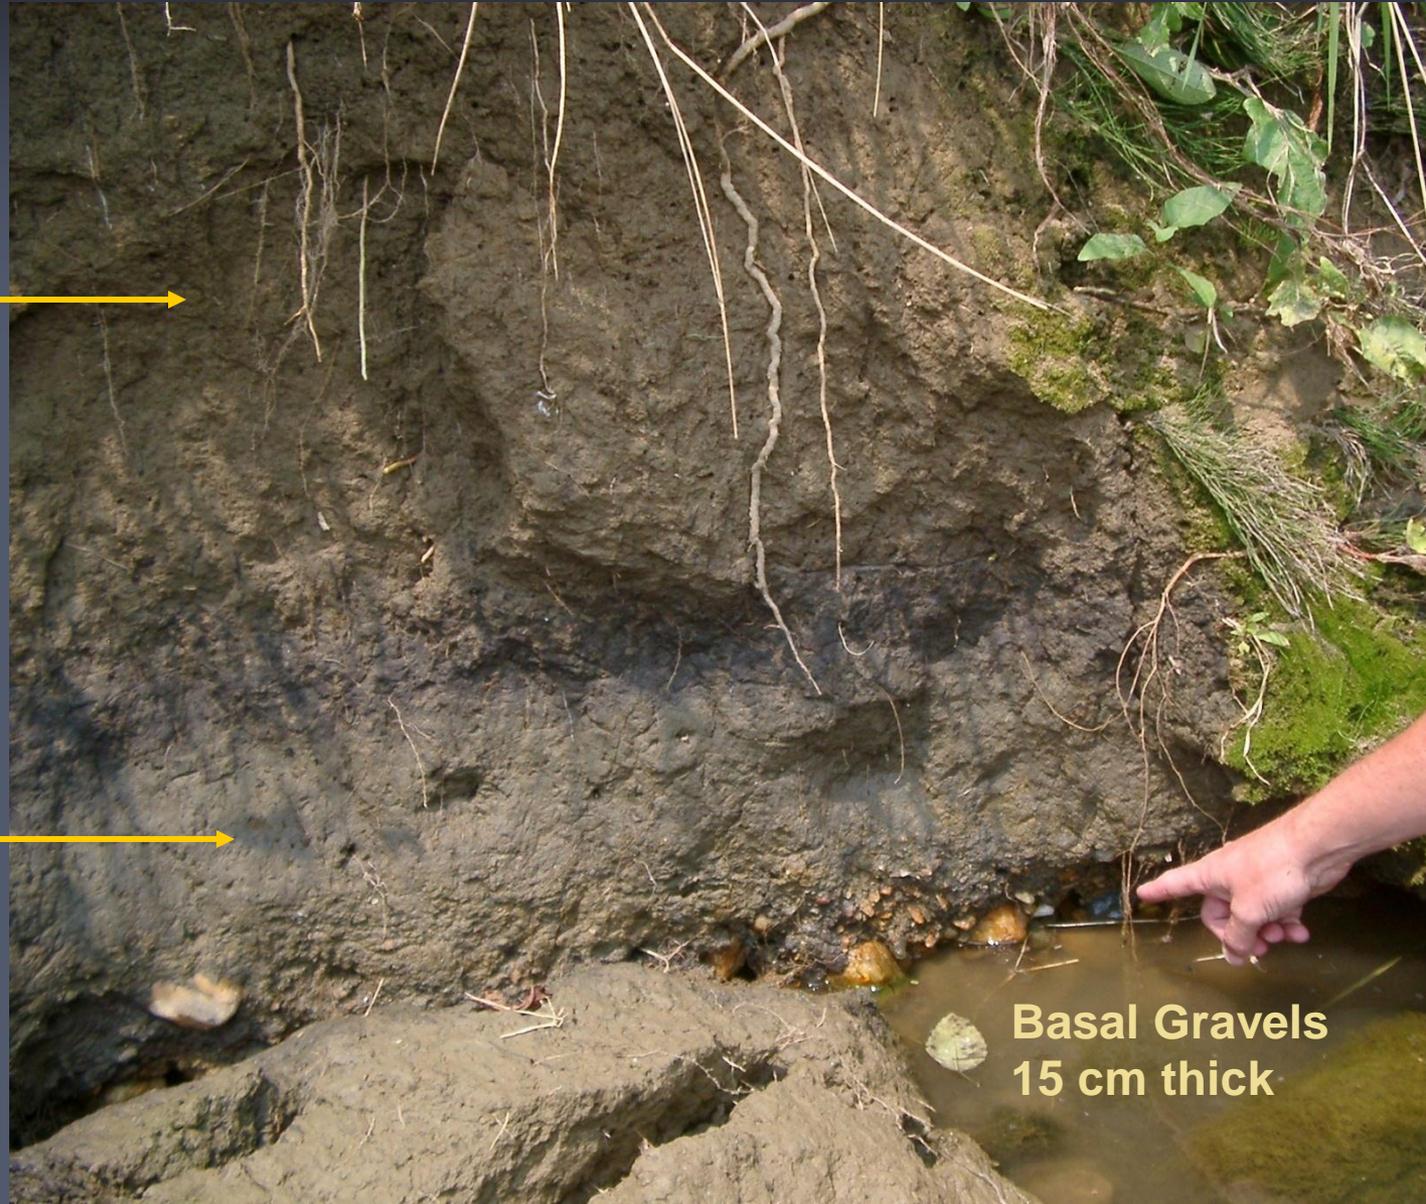
Big Spring Run

Pre-settlement floodplain

Post-Settlement
Alluvium
1 m thick

Pre-Settlement
Peaty Clay
20 cm thick

Basal Gravels
15 cm thick

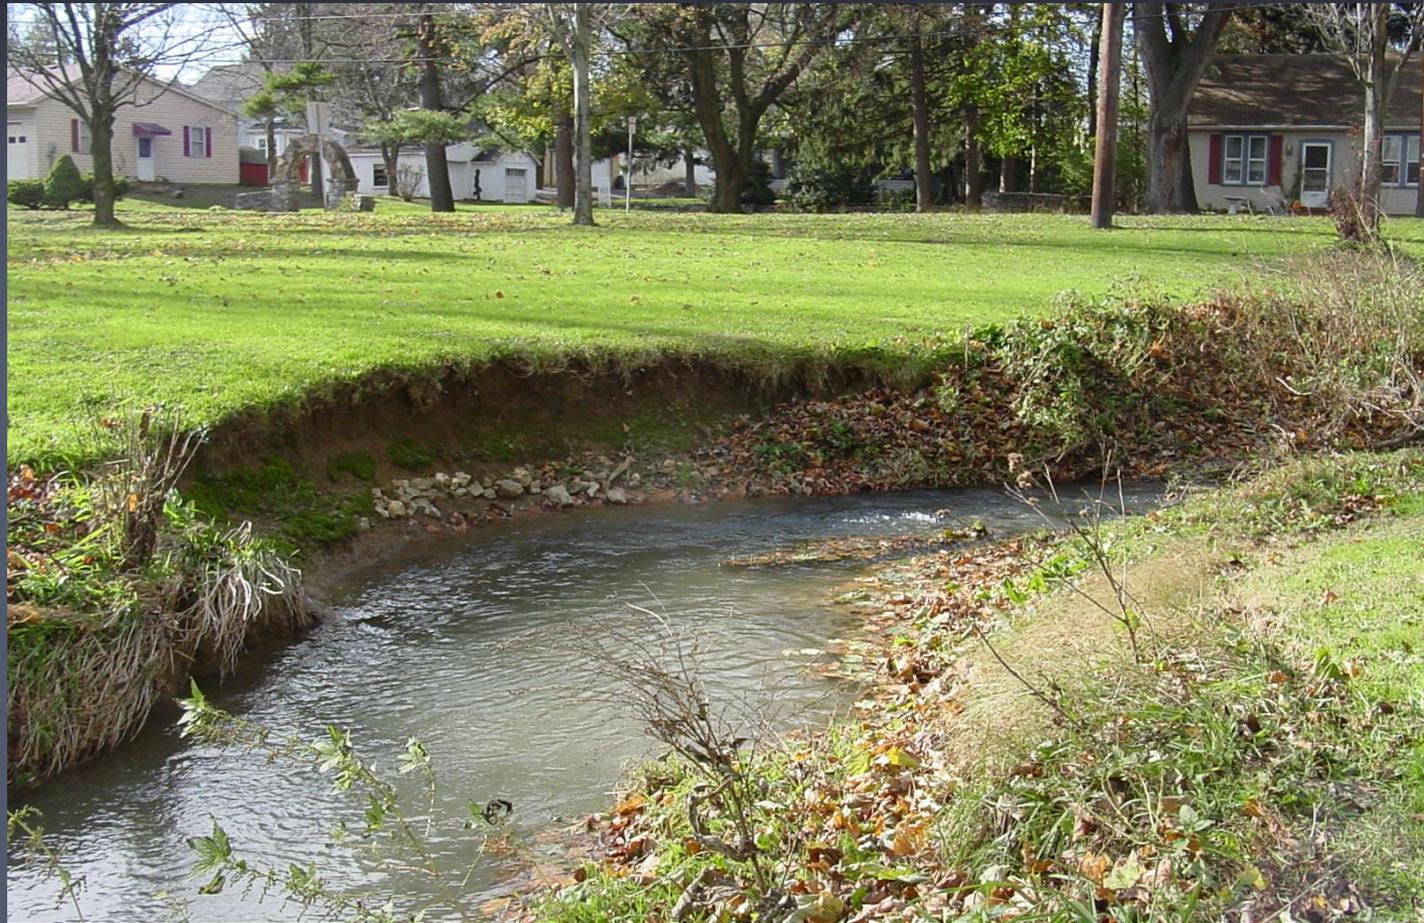
New Street Ecological Park

This section of the stream bank in New Street Park shows clear evidence of heavy erosion.

Channel capable of transporting nutrients and fine sediment downstream for most precipitation events throughout the year.

Before Restoration

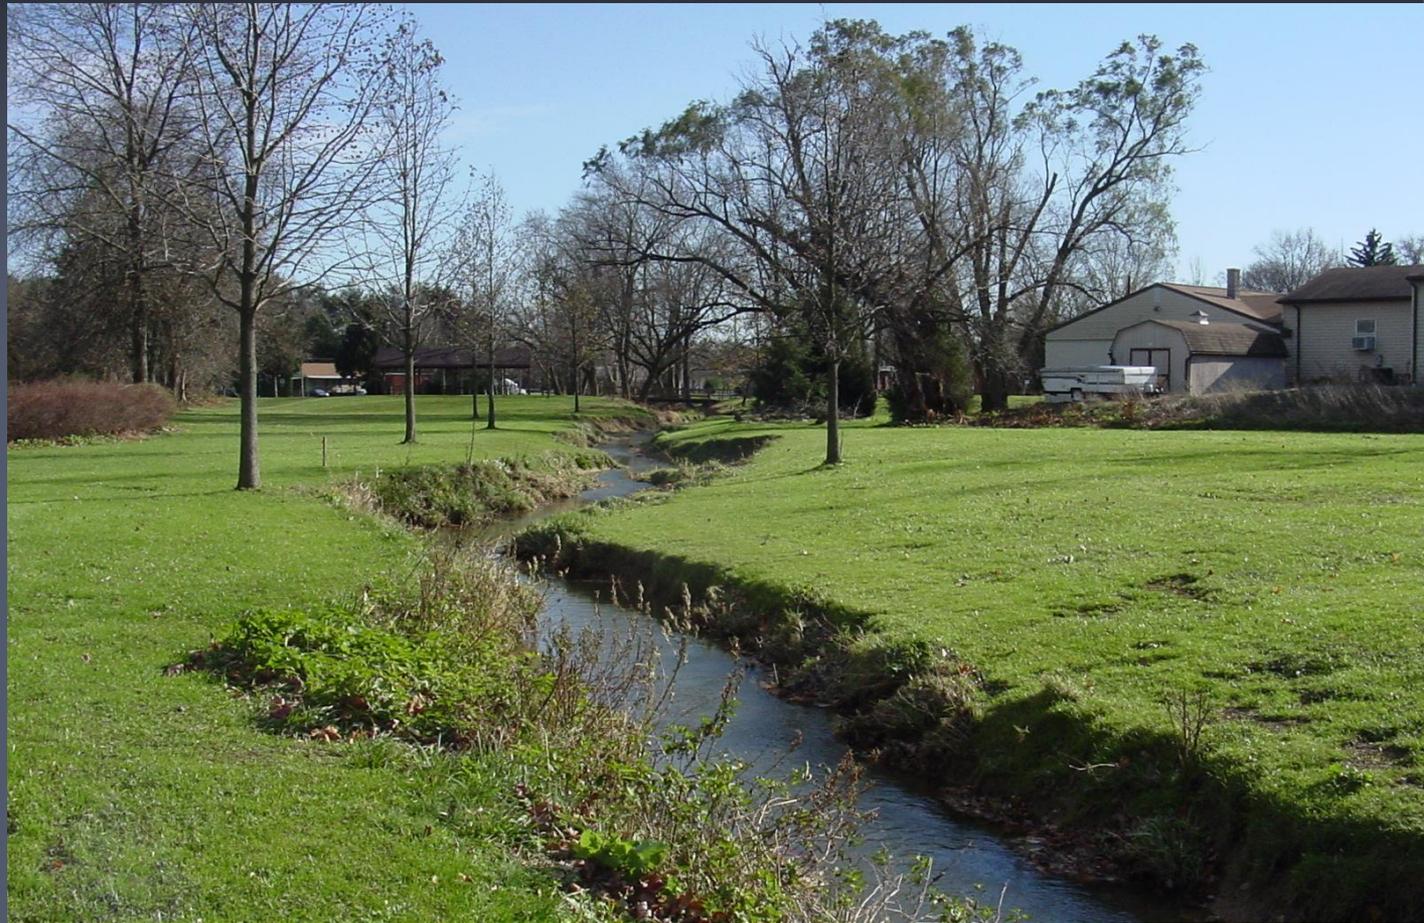
New Street Ecological Park

Relatively straight
with little
floodplain and
channel
interaction.

Channel is
temporary storage
for both fine
sediment and
nutrients before
the next storm
event transports
downstream.

Before Restoration

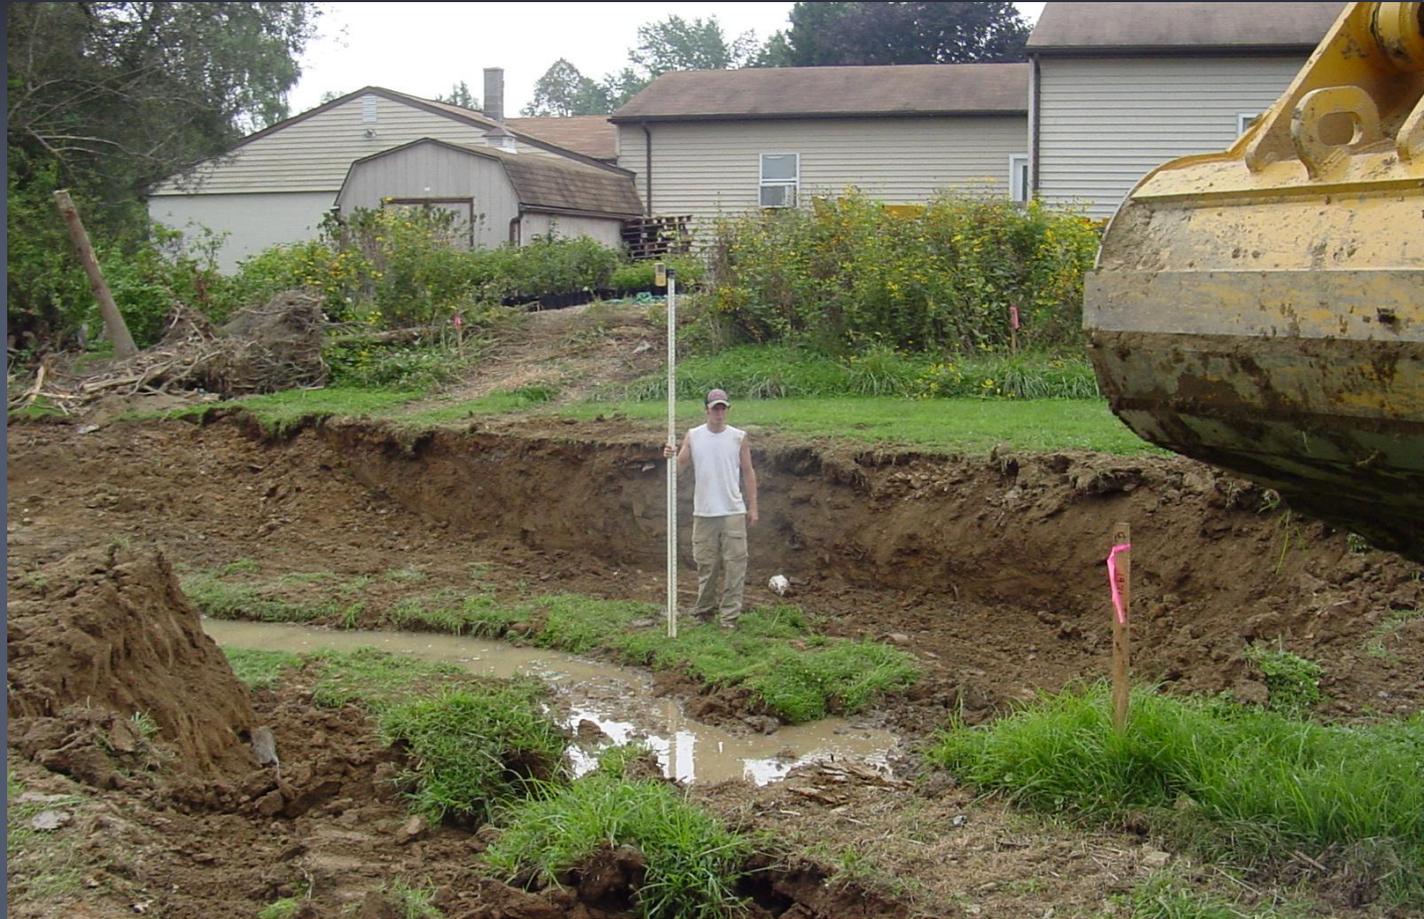
New Street Ecological Park

The small proposed channel is designed to meander across the valley and maximize floodplain and channel interaction.

First flush from precipitation will access floodplain and remove nutrients and sediment loadings from upstream flows reducing in-channel nutrient and fine sediment storage and transport.

During Restoration

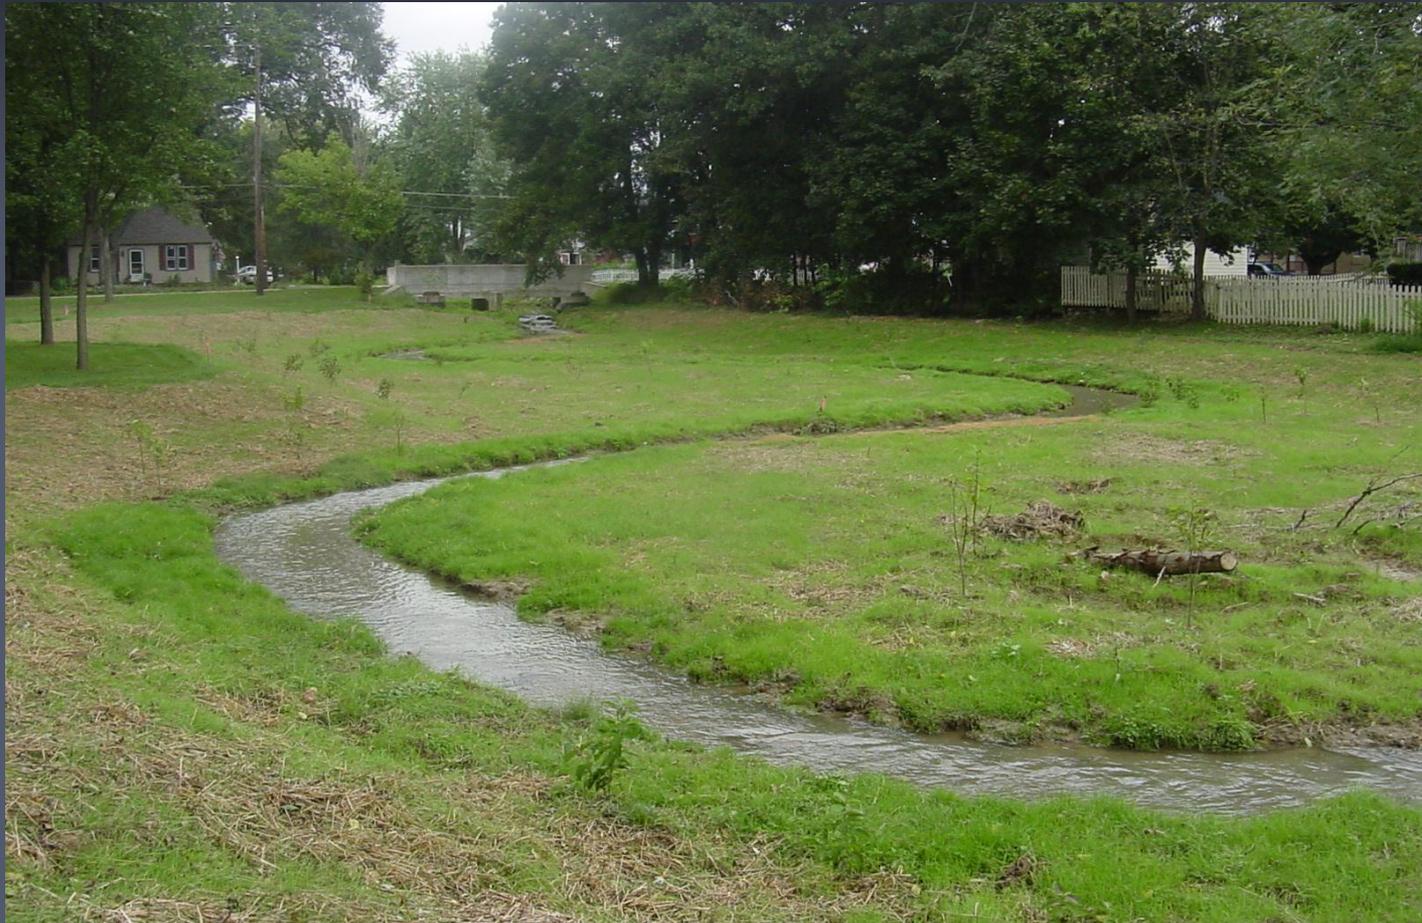
New Street Ecological Park

The newly constructed channel flows in gentle, wide meanders through New Street Park. The new floodplain is now attached to the channel, so that high flows will move easily out of the channel, helping to maintain channel stability over the long term, thus reducing erosion and sedimentation.

After Restoration

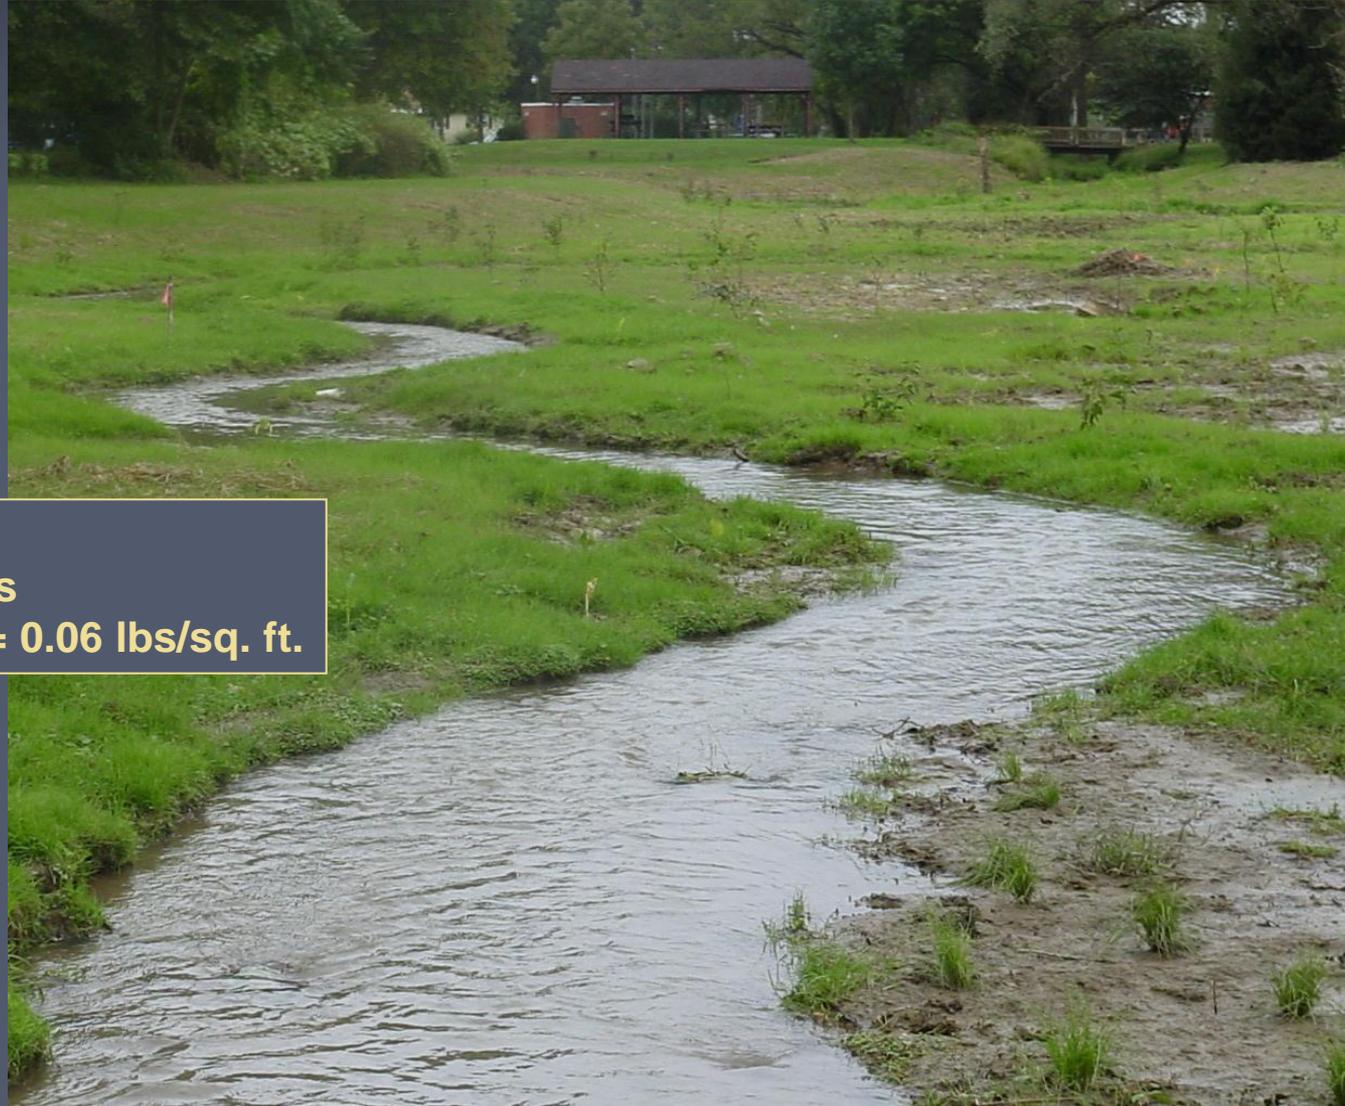
New Street Ecological Park Floodplain Restoration Project

First year
after restoration

D.A. = 3.7 sq. mi.
Design Discharge = 3.3 cfs
Design Bounding Stress = 0.06 lbs/sq. ft.

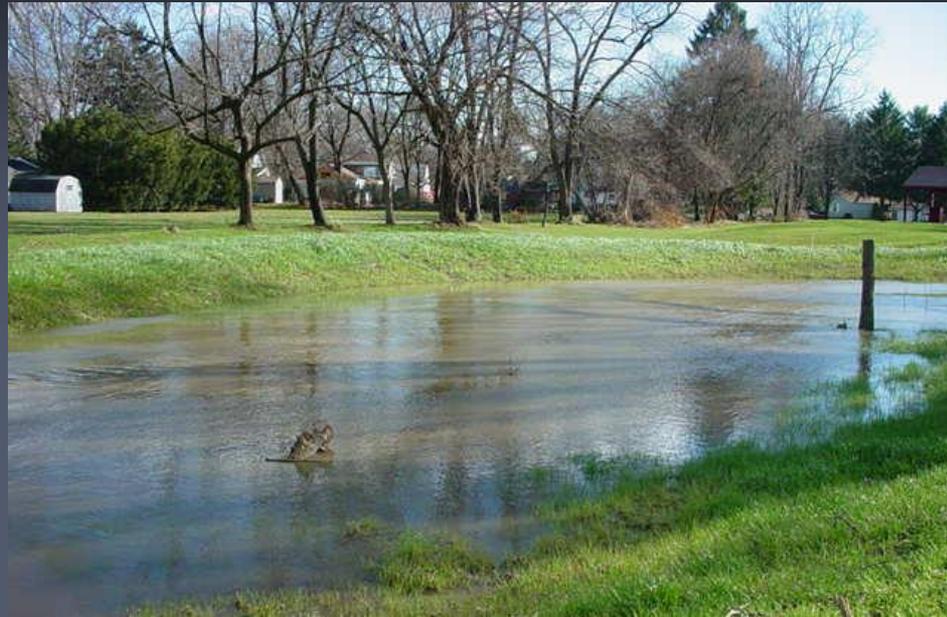
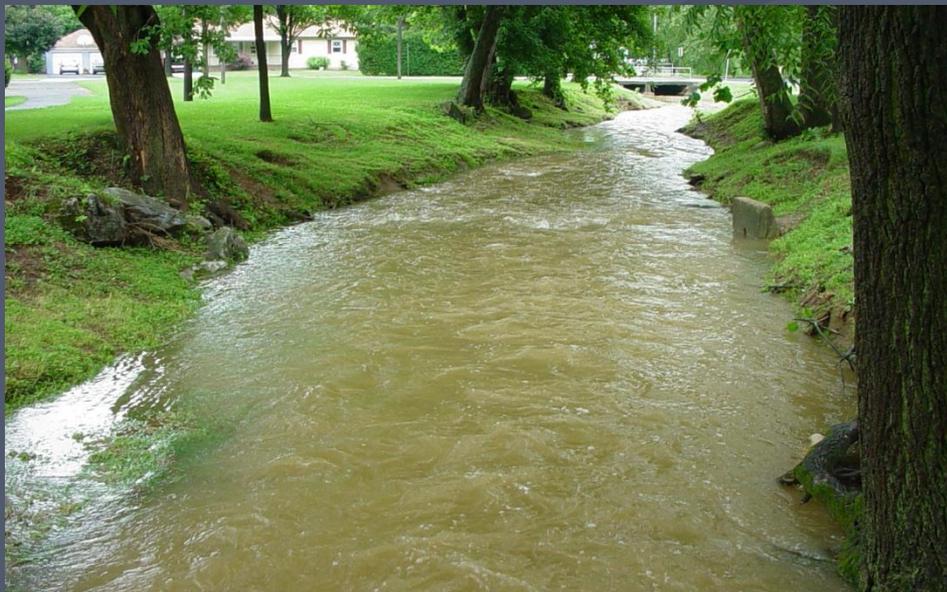
New Street Ecological Park

Differences in energy levels and floodplain storage functions during flood flows are apparent.

Restoration Site

FLOOD FLOW

Immediately Downstream of Restoration Site

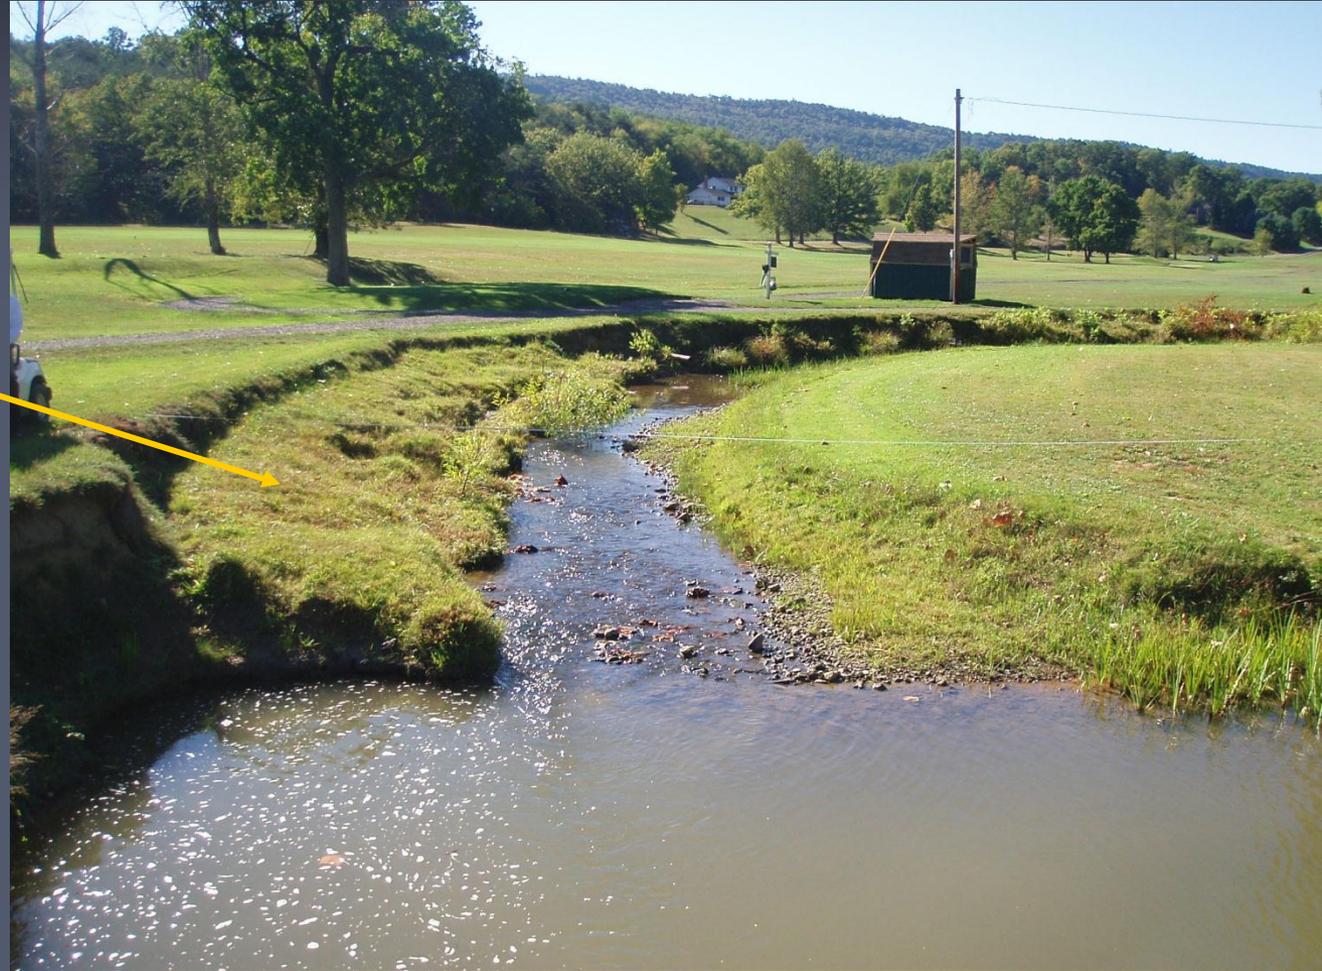
Shober's Run at Bedford Springs Resort

Slumping Banks

Before Restoration

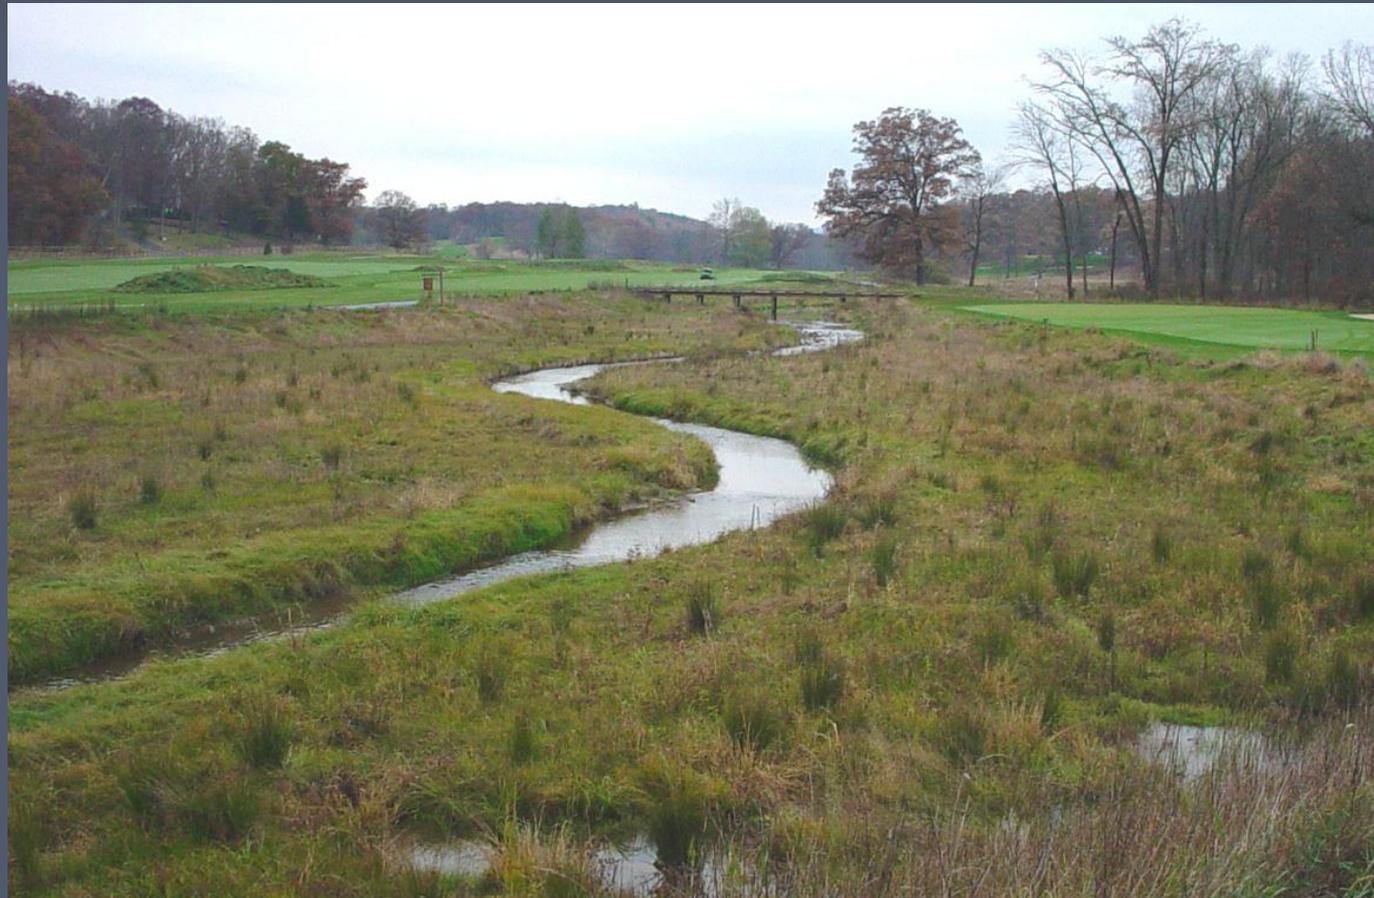
Shober's Run at Bedford Springs Resort

D.A. = 14 sq. mi.

Design Discharge = 30 cfs

Design Bounding Stress = 0.2 lbs/sq. ft.

First year after
restoration

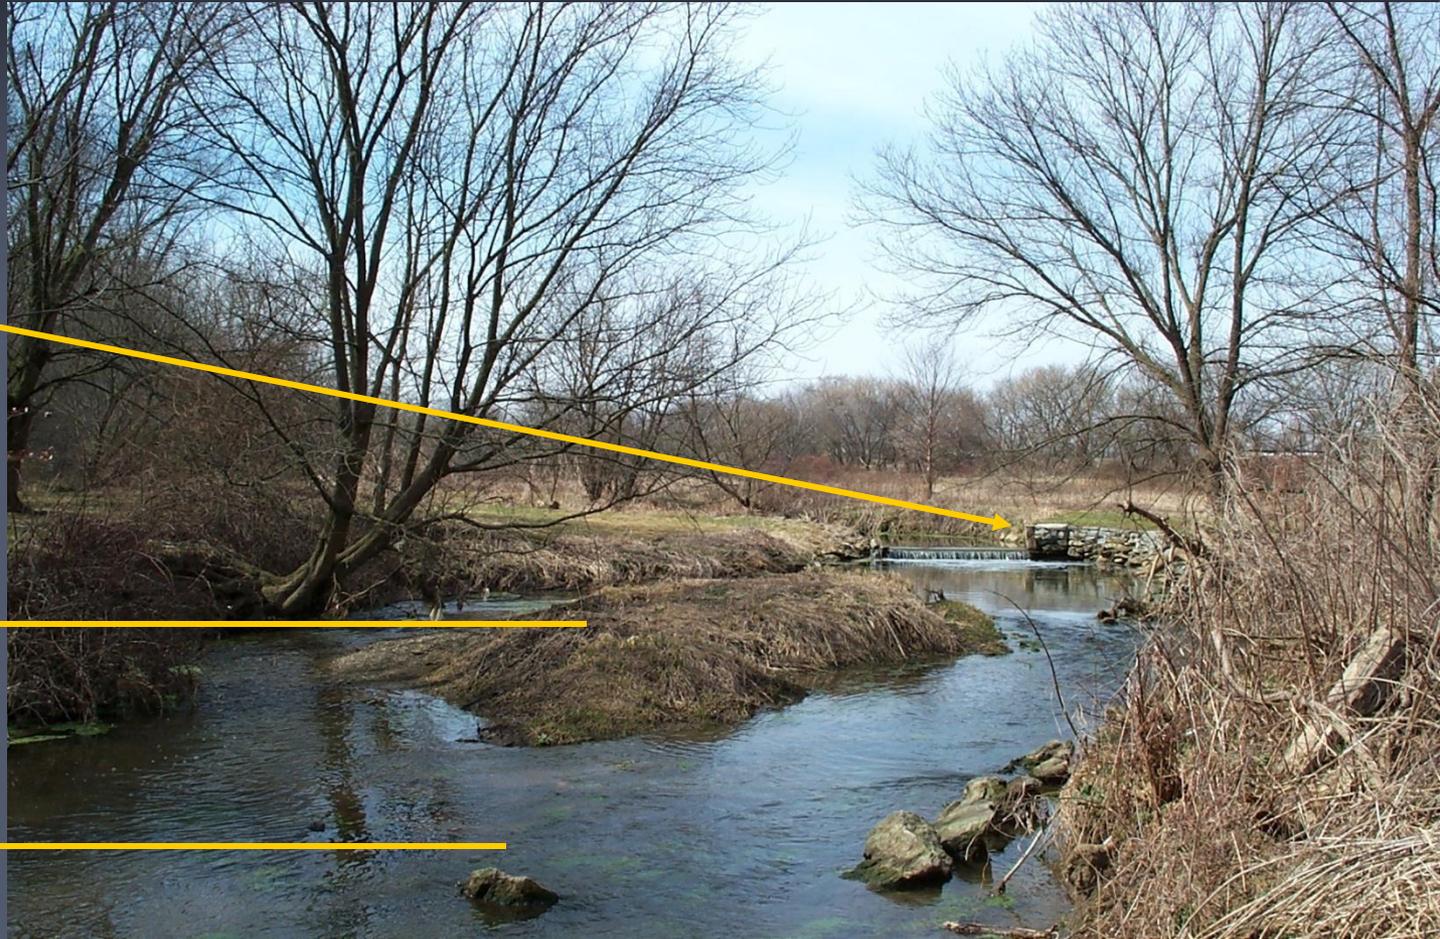
Lititz Run - Banta Site

Low-head dam

A large area of
mid-channel
deposition

Overly-wide
channel

Before Restoration
