**Hydrologic and Hydraulic
Processes and Connectivity
In
Altered Mid-Atlantic Riverine
Systems**

**Mid-Atlantic Stream Restoration
Conference @ Rocky Gap**

**Ward Oberholtzer, P.E.
Century Engineering, Inc./Landstudies Inc.**

November 2011

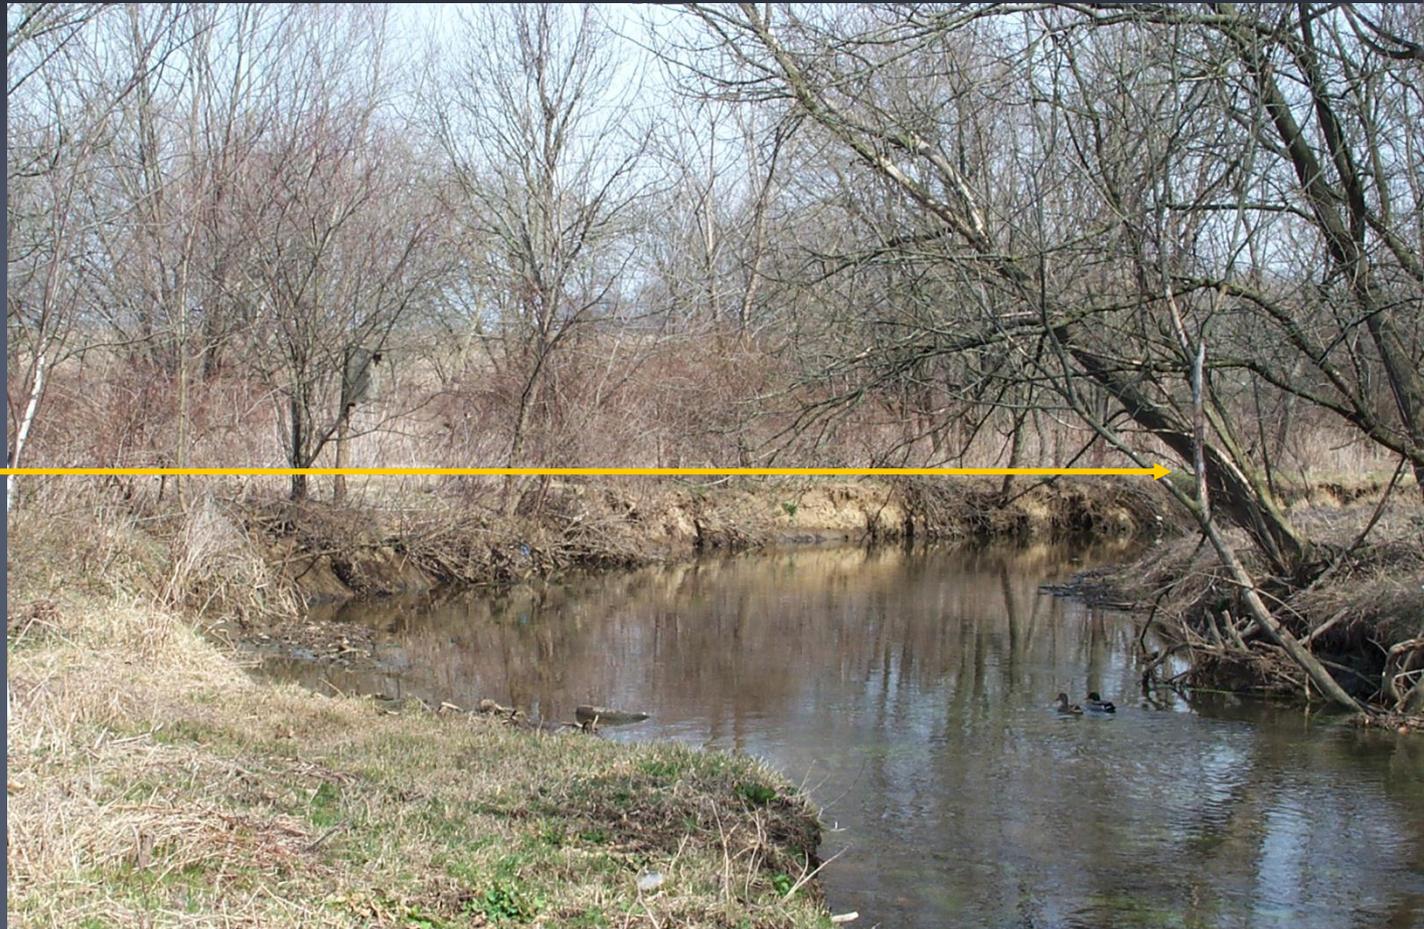
Lititz Run – Banta Site

Leaning tree is evidence of bank instability. Once it falls into the channel and creates a debris jam, further channel and bank erosion will ensue.

Before Restoration

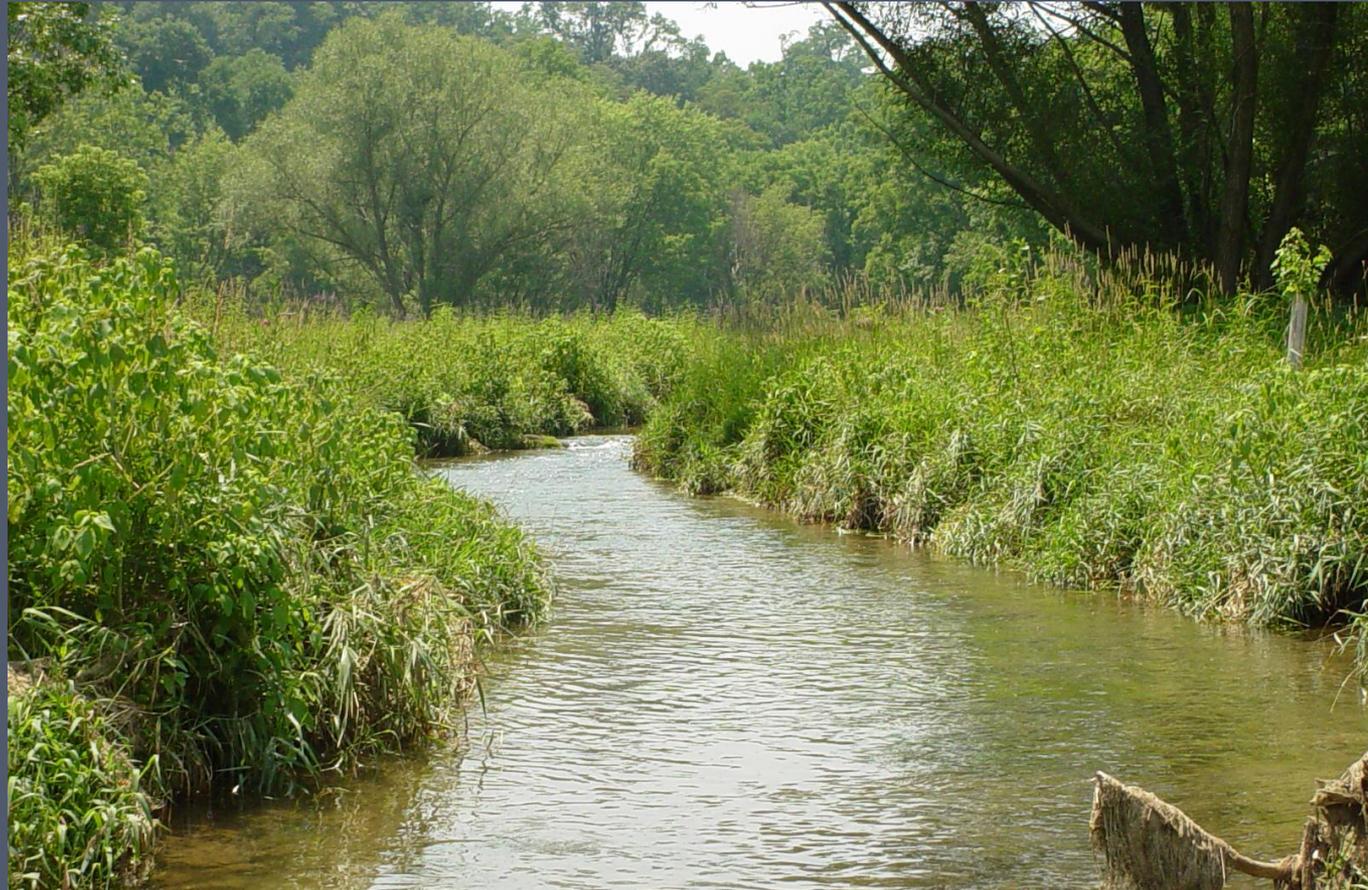
Lititz Run - Banta Site

Floodplain Restoration Project

D.A. = 12 sq. mi.

Design Discharge = 55 cfs

Design Bounding Stress = 0.2 lbs/sq. ft.

Third year after
restoration

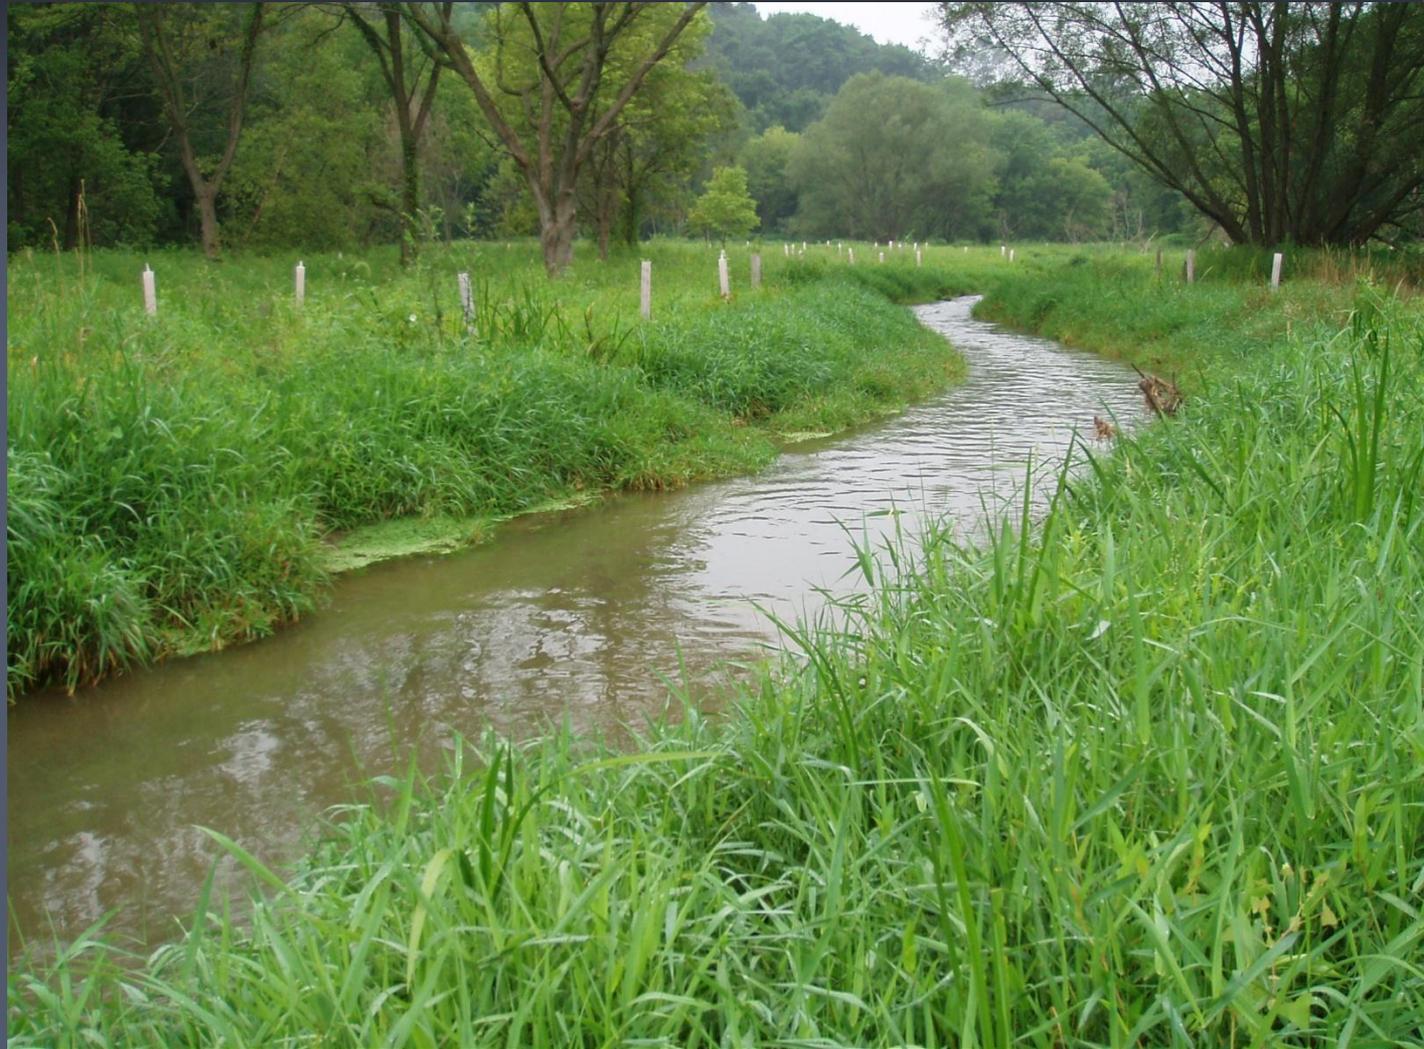
Lititz Run – Banta Site

The channel was relocated to the center of the stream valley, at the lowest, and natural, elevation for the channel. The new channel is shallow and narrow, with banks rising only 12 to 18 inches above the water surface.

After Restoration
